Executive Summary

The Houston-Galveston Area Council's (H-GAC) Targeted Monitoring Project focuses on the region's most prevalent pollutant – bacteria. The goal is to examine ten watersheds in various land cover types to identify bacteria sources (Table 1). A seven-year geometric mean analysis defining the severity of impairment was performed on each assessment unit (AU) within the region. H-GAC ranked waterways using the highest geomean relative to the state standards for contact recreation. Assessment units were selected by 1) highest geomean identified, 2) land cover type, and 3) accessibility and feasibility of the waterway for field investigations (Figure 1).

Bintliff Ditch (1007T_01)

Bacteria Monitoring Report

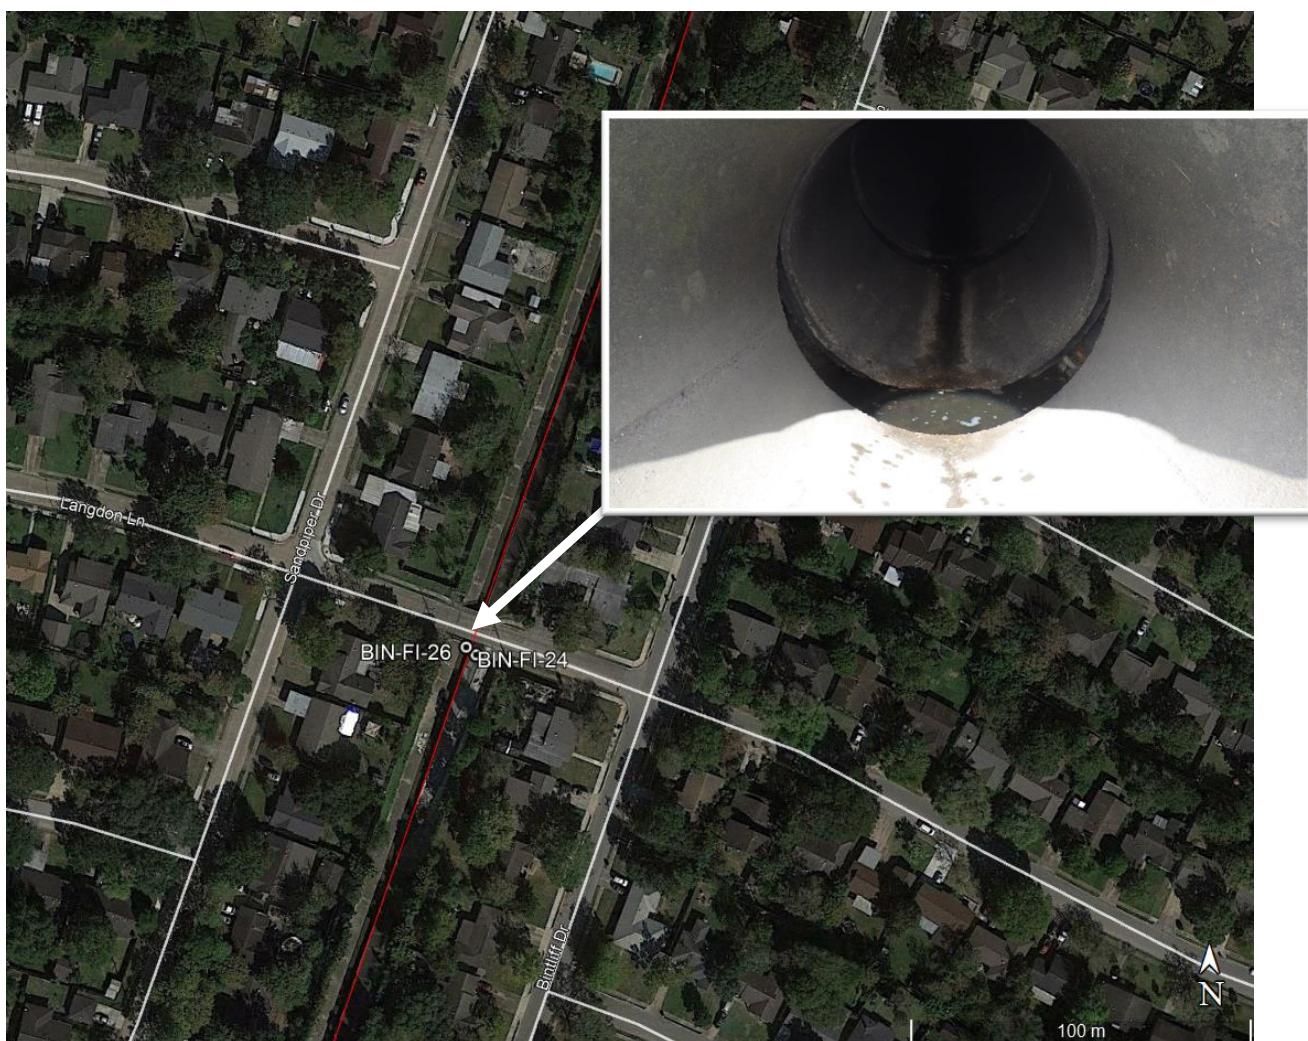
This site is located at on the right bank in a residential area. This site is associated with a concrete pipe with a 40-inch diameter. The water depth was only 0.03 inches within the pipe, but the concrete drainage was broken, and water was pooling up before it could exit the outfall. One ambient bacteria sample was collected directly from the pooled water at the base of the broken pipe and it had a bacteria value of 24,200 MPN/100ML. Further investigation is recommended. Photo taken shows broken concrete drainage and pooling.

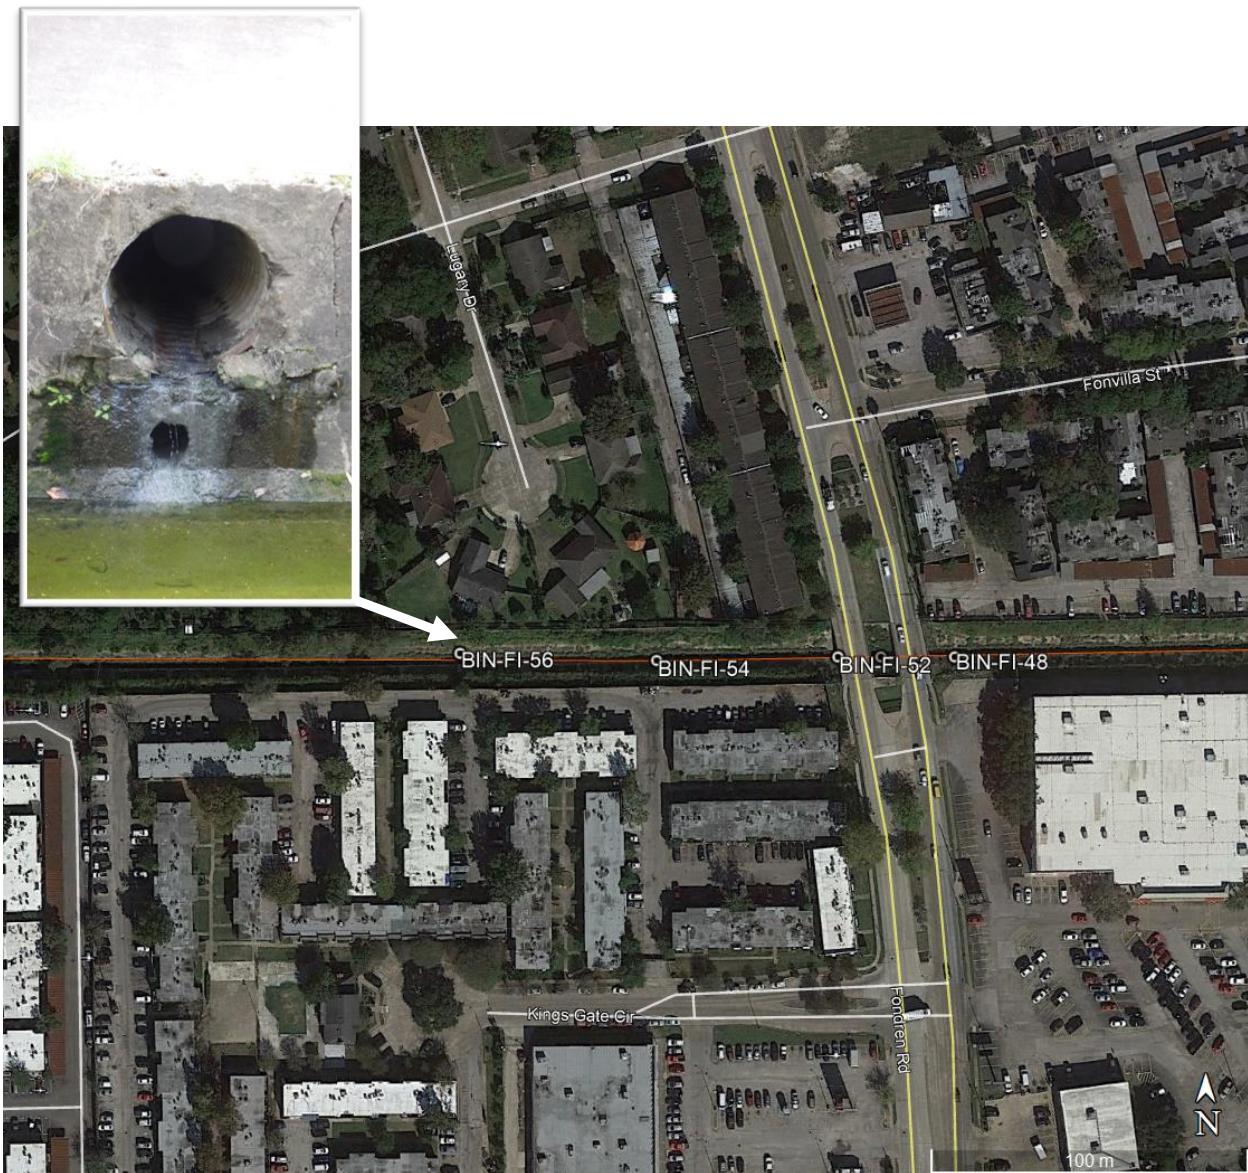
Referral site: BIN-FI-56

This site is located between a residential area and apartment complexes along the tributary of Bintliff Ditch. This pipe was located on the right bank and was a metal pipe with a diameter of 24-inches. There was 0.13 inches of water in the pipe with a milky hue. A bacteria value of 24,200 MPN/100ML was collected downstream of the pipe. The upstream sample detected 3,260 MPN/100ML, indicating that this pipe is introducing high bacteria levels to the stream. Samplers also noted a strong sewage smell coming from this pipe. Further investigation is suggested. Photo taken shows concrete drainage and milky colored water.

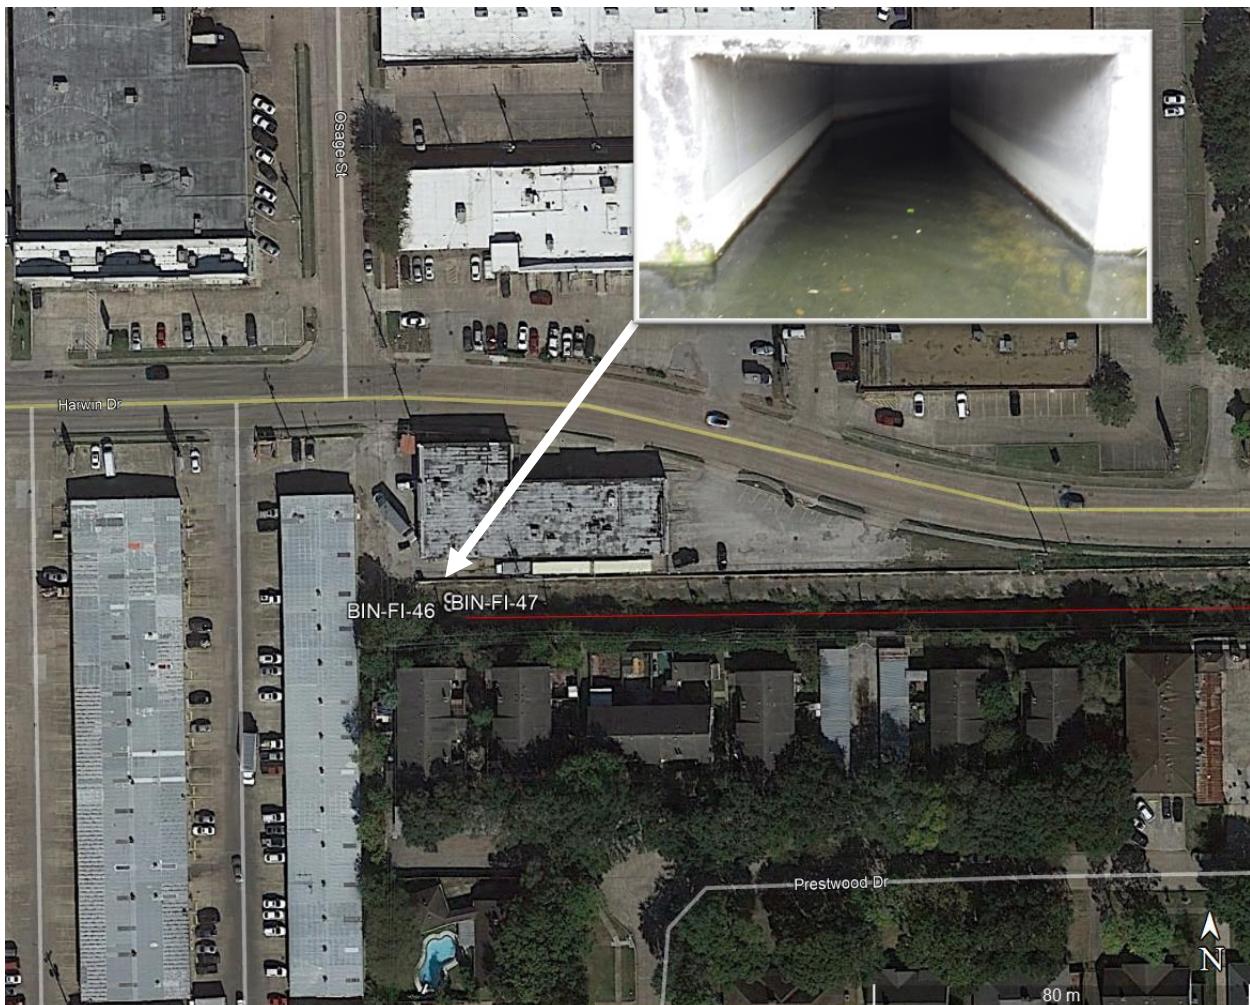
Referral site: BIN-FI-47

This site is located on the very top of the main assessment unit. There are two culverts, and 47 was the culvert on the left bank. The square, concrete culvert was 46-inches tall and there was 12 inches of water. One ambient sample was collected in this location, slightly upstream in the culvert with a bacteria value of 19,900 MPN/100ML. This site is located in a highly commercial area, positioned beside multiple strip malls but no specific bacteria source was identified. Further investigation is recommended. Photo taken facing upstream looking into the culvert as it goes underground.

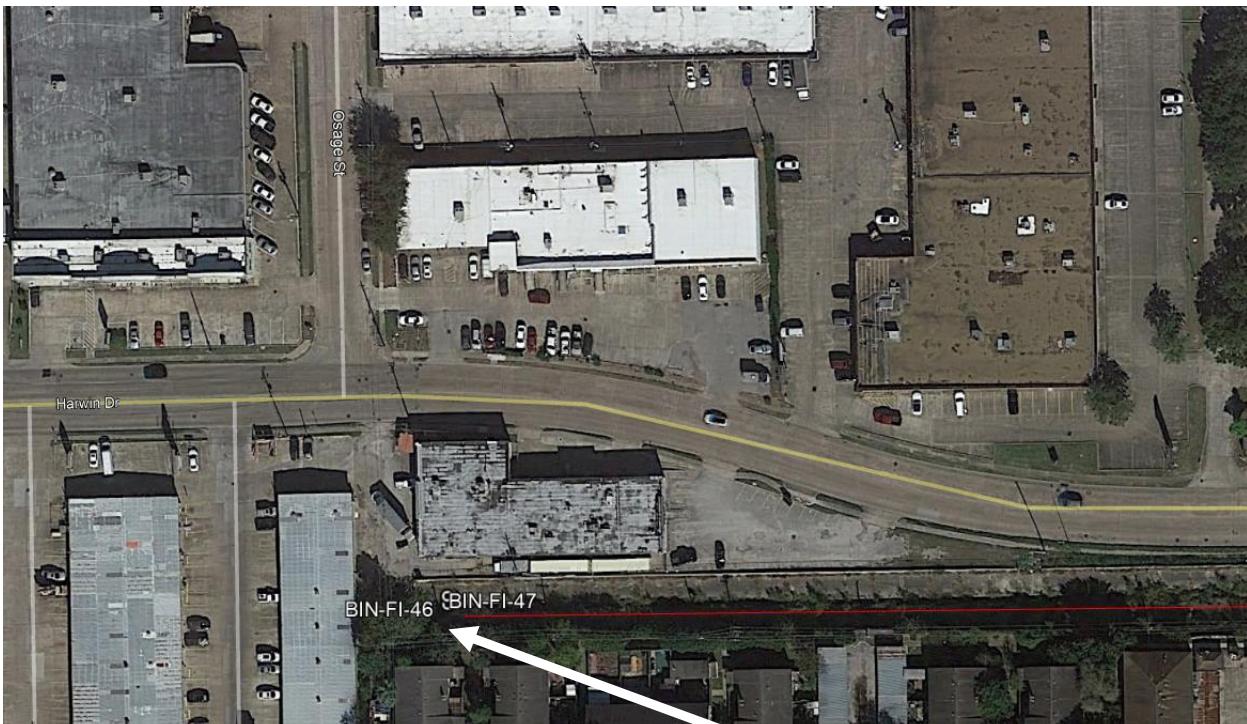
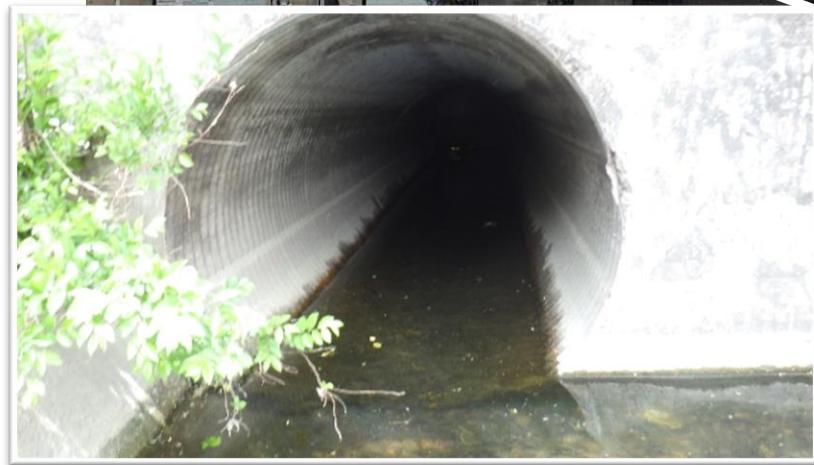
Referral site: BIN-FI-46

This site is located directly next to site 47, but on the right bank. This round, metal culvert had a diameter of 52 inches and about 6 inches of water flowing in the pipe. The one ambient sample collected at the mouth of this pipe yielded a bacteria value of 15,500 MPN/100ML. Further investigation is recommended. Photo taken shows the sampled pipe facing upstream.

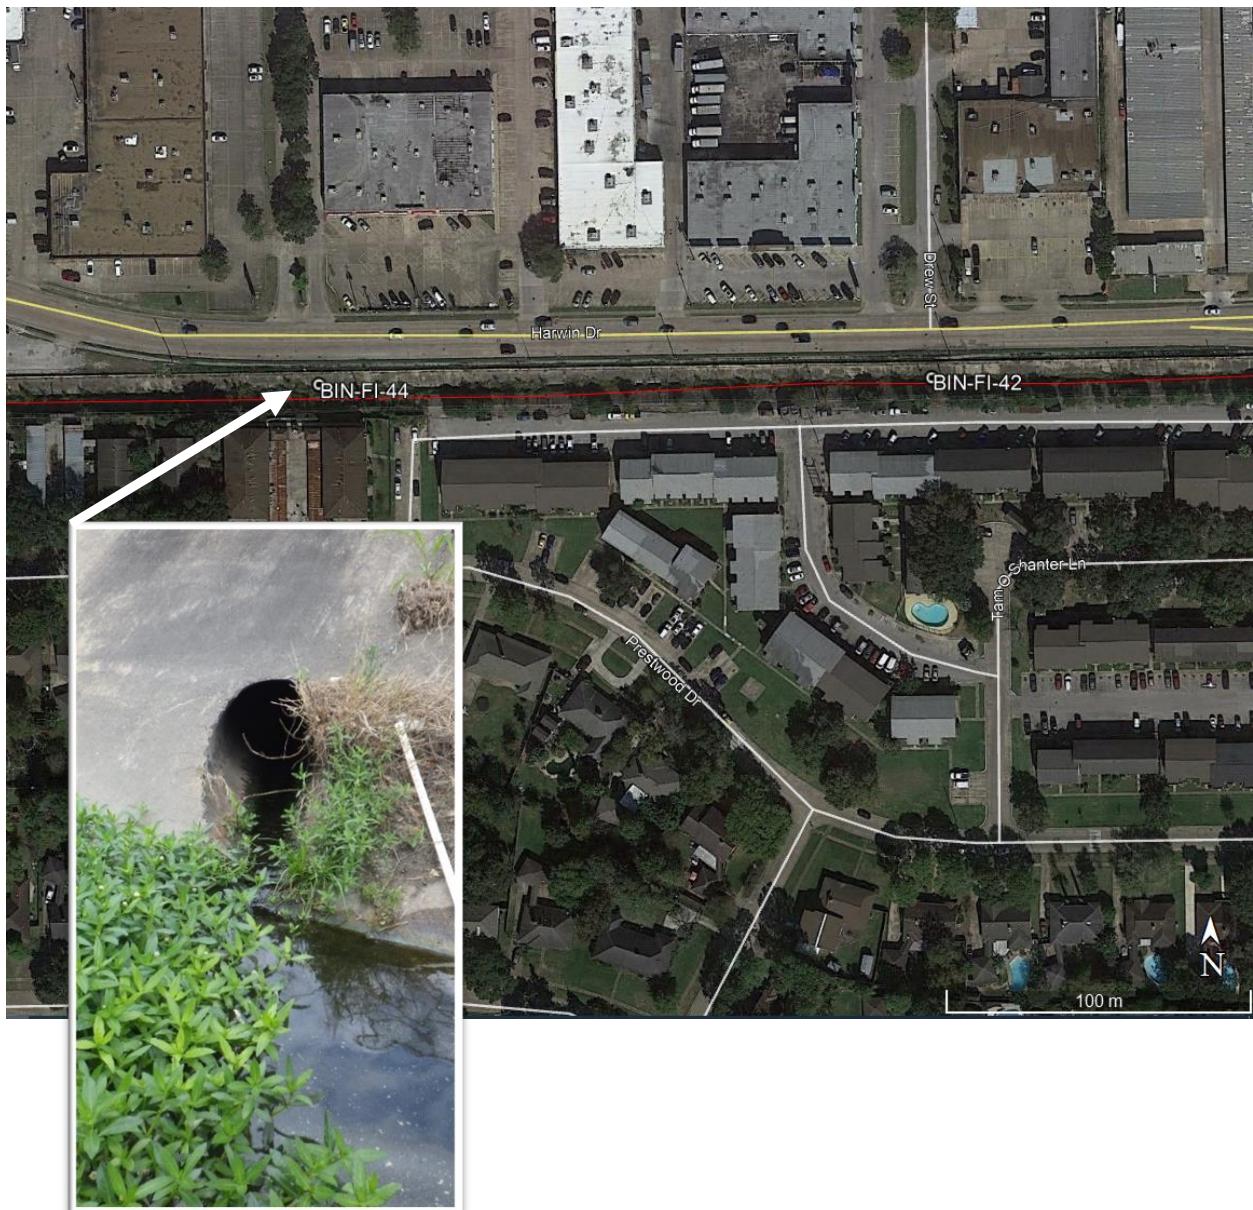
Referral site: BIN-FI-44

This site is located at along the left bank surrounded by vegetation. This concrete outfall had an inner diameter of 25 inches and vegetation growing in it. Water in the pipe was 0.5 inches deep and was only trickling out into the stream. A bacteria value of 4,110 MPN/100ML was collected downstream of the pipe. Upstream, a sample with a value of 145 was collected with a difference of 3,965 MPN/100ML. The outflow was contributing bacteria to the assessed stream and there was a sheen on the water exiting the pipe. Further investigation is suggested. Photo taken facing the left bank shows the concrete outfall.

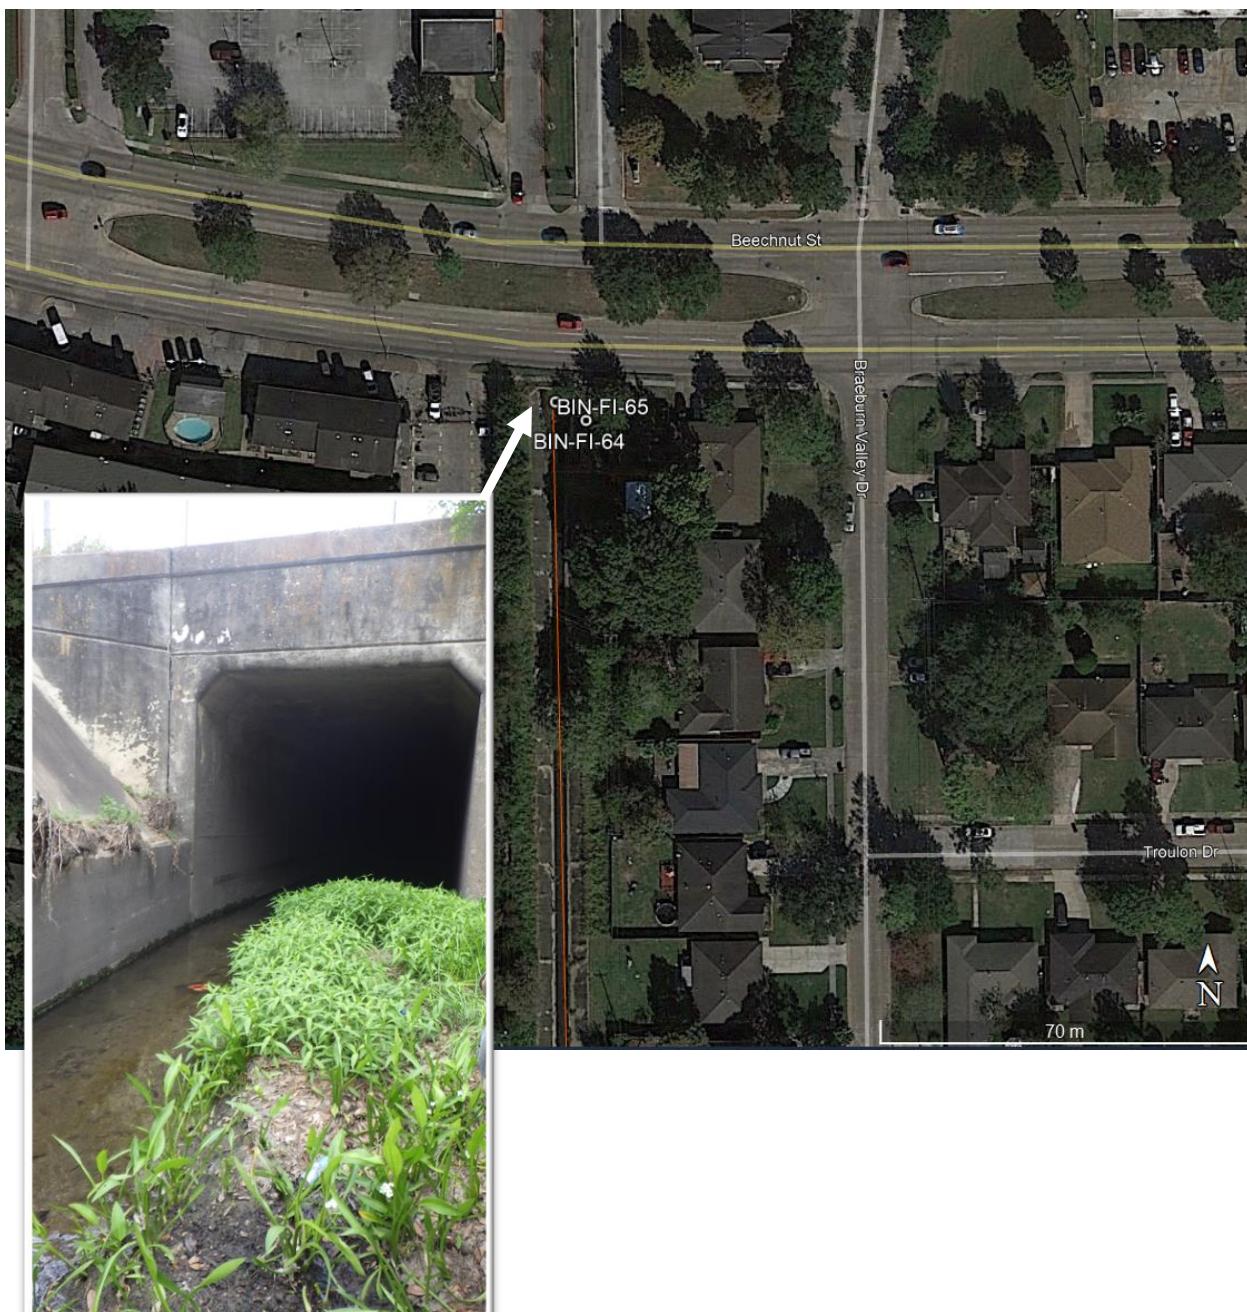
Referral site: BIN-FI-65

This site is located along the tributary to Bintliff Ditch. The culvert was located on the right bank in a residential area, just downstream of where the tributary runs belowground under Memorial Hermann Southwest Hospital. One sample was collected from this large concrete culvert. The sample collected had a bacteria value of 1,120 MPN/100ML. The water exiting this culvert had a very oily surface. A specific source for the oil and bacteria was not identified. Photo shows large culvert on the right bank.

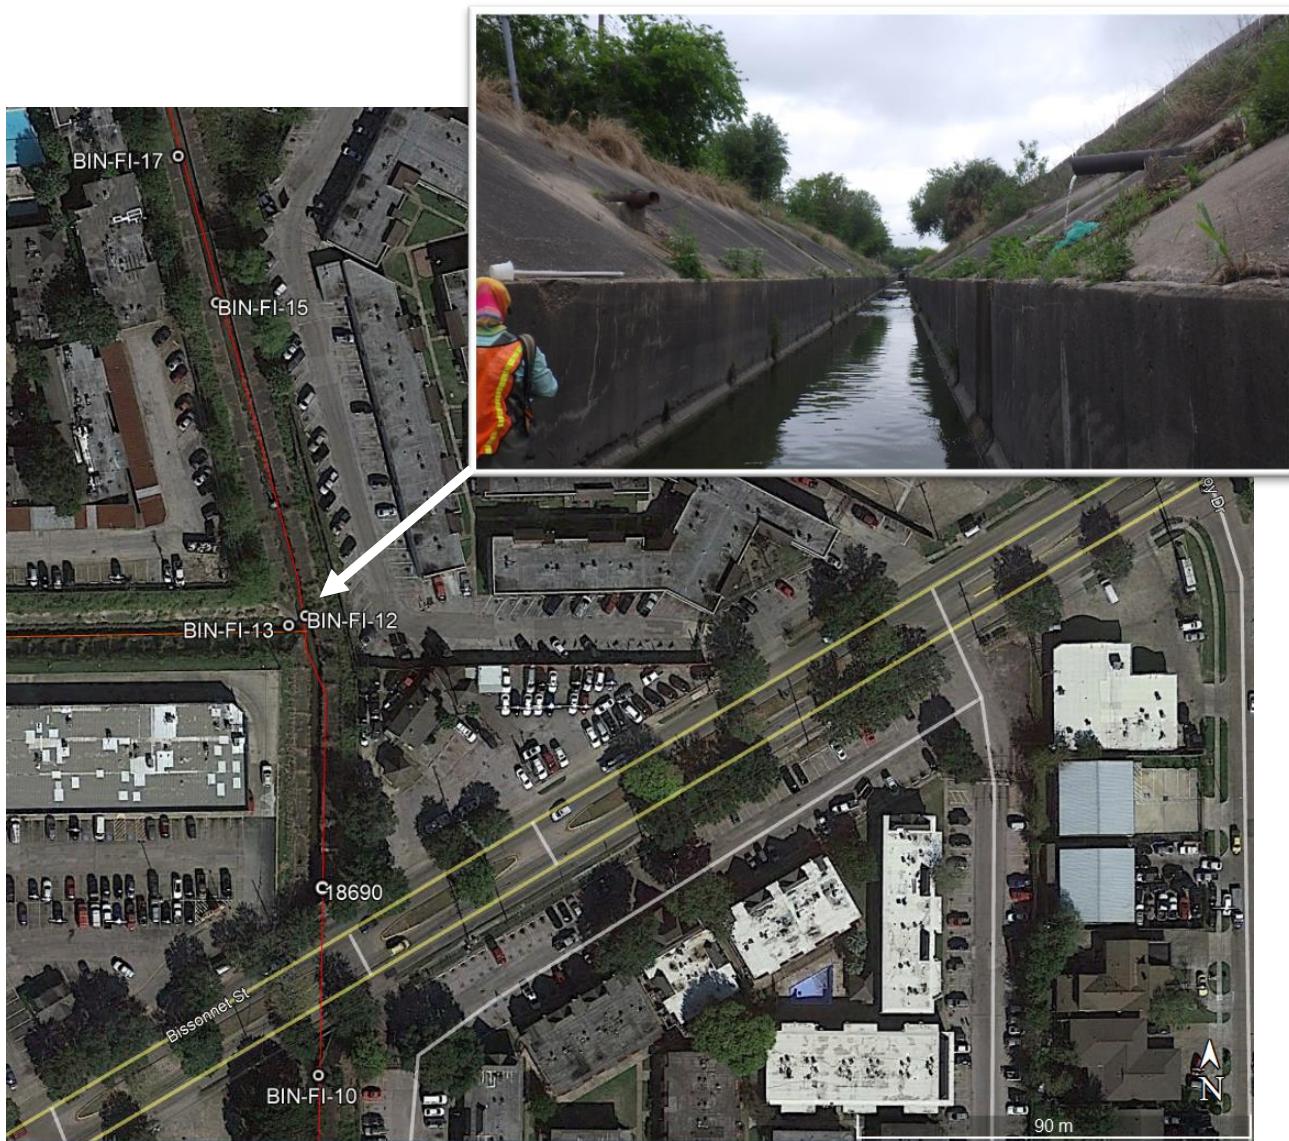
Referral site: BIN-FI-12

This site is located just upstream of the confluence of Bintliff Ditch and its tributary, near multiple apartment complexes. This metal pipe has an inner diameter of 6 inches and used to span across the entire channel, but has broken and is leaking into the stream from the side of the left bank. There is approximately 0.5 inches of water flowing out of the pipe. A direct sample was collected from the leaking pipe with a bacteria value of 1,020 MPN/100ML. The correct party should be notified of this leaking pipe and elevated bacteria load. Photo shows the two sides of the pipe that once spanned over the entire stream.

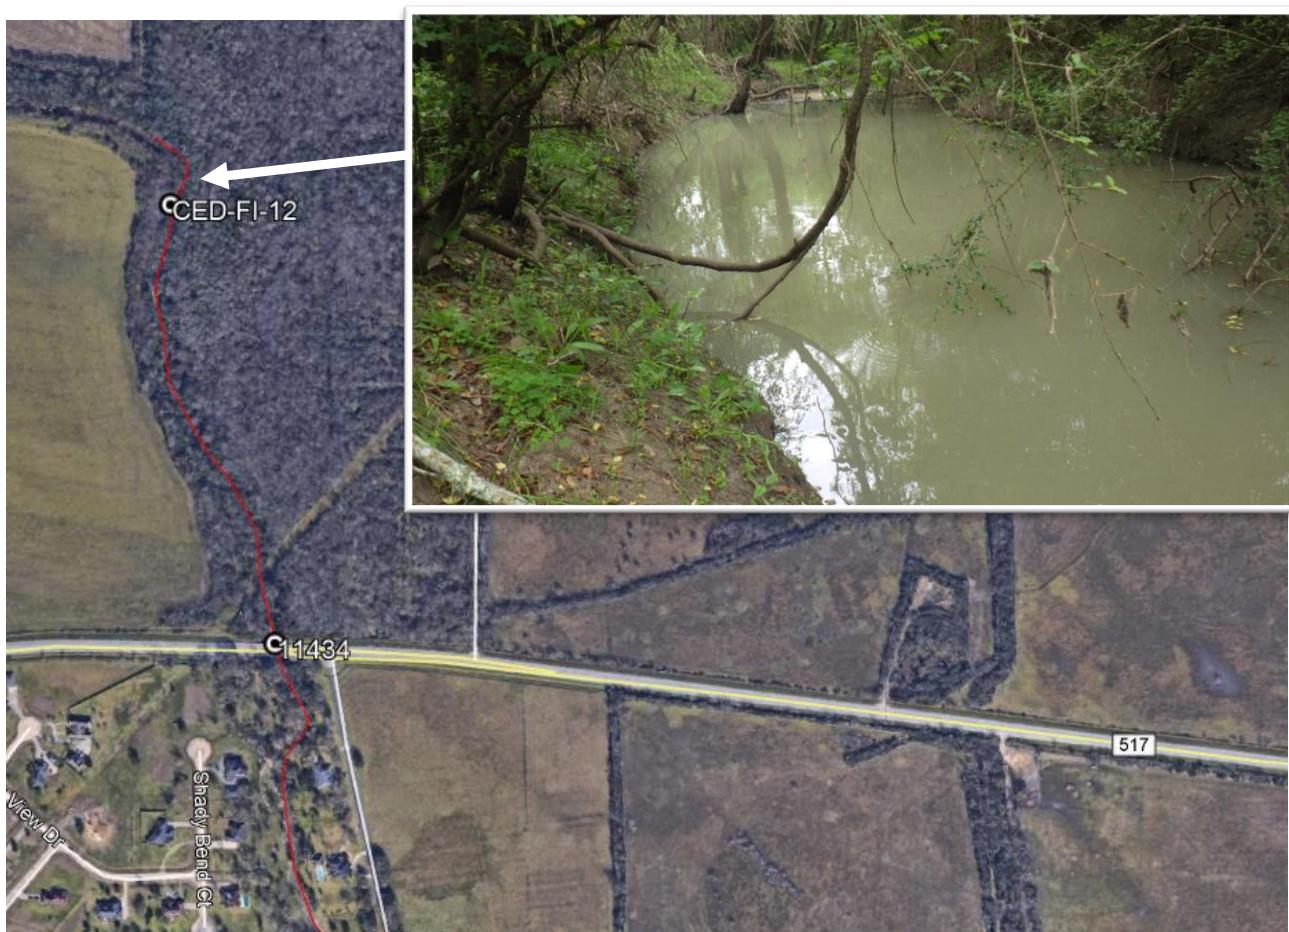
This site is located at the most upstream point of the Cedar Creek assessment unit, north of FM517. There is no pipe or outflow associated with this location, but an ambient sample was collected. This sample had an *E.coli* bacteria value of 1010 MPN/100mL. This indicates that there is likely a bacteria source contributing to the creek upstream of assessment unit 1103E_01. Further investigation upstream of the studied assessment unit by the proper authorities is recommended. Photo taken of the area upstream where the ambient sample was collected.

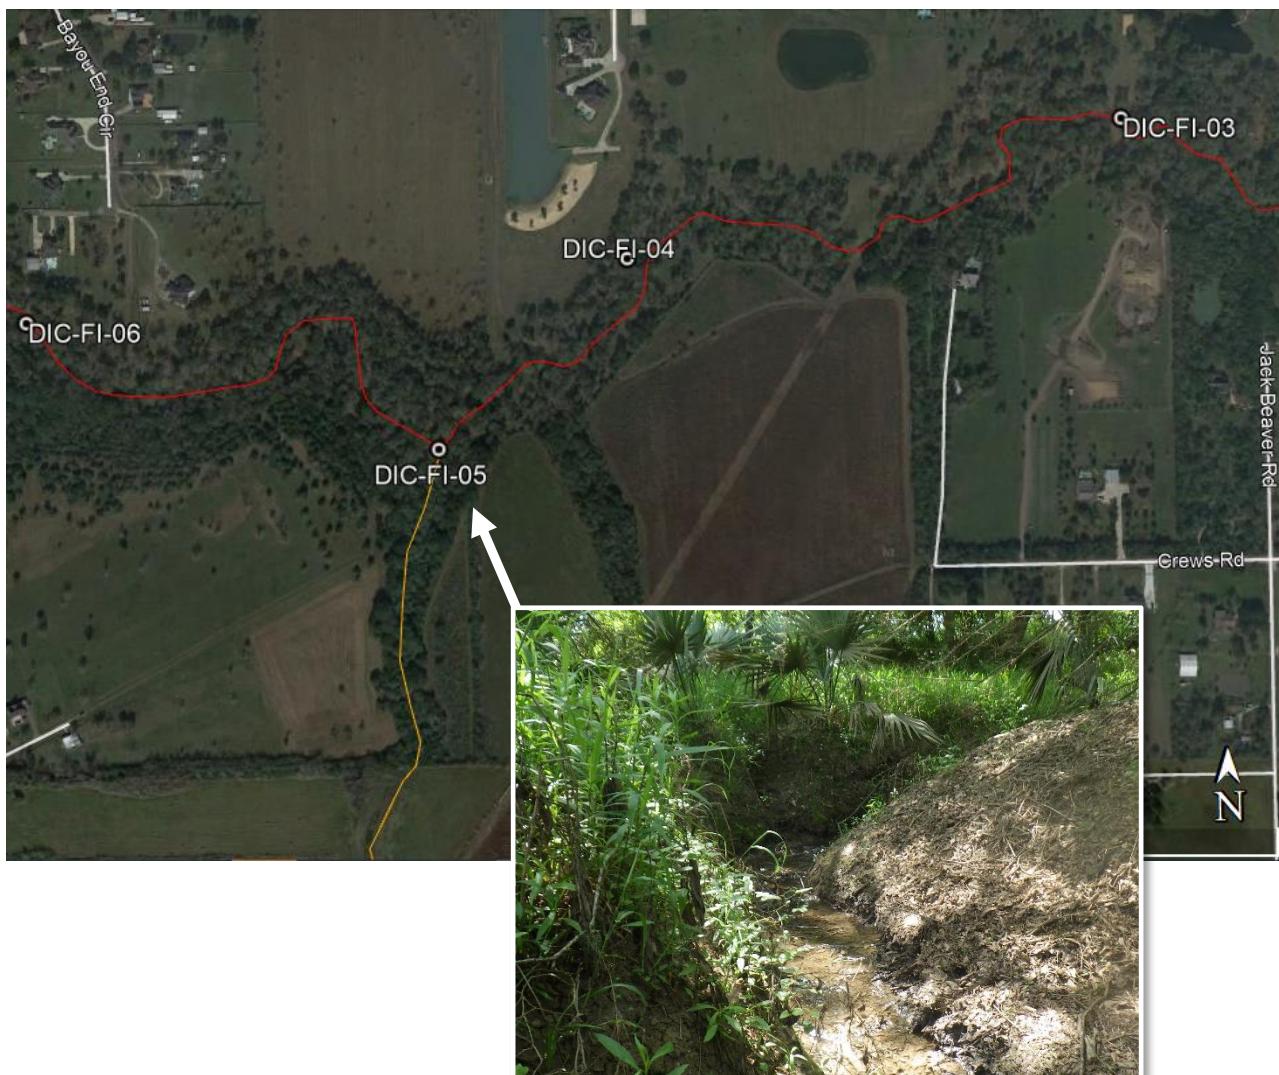
This site is located at the most downstream section of tributary #2 to Dickinson Bayou on the right bank. An ambient sample was collected from the tributary with a bacteria value of 988 MPN/100ML. Further investigation of potential bacteria sources contributing to this tributary is recommended. Photo taken facing upstream in the tributary which enters the bayou on its right bank.

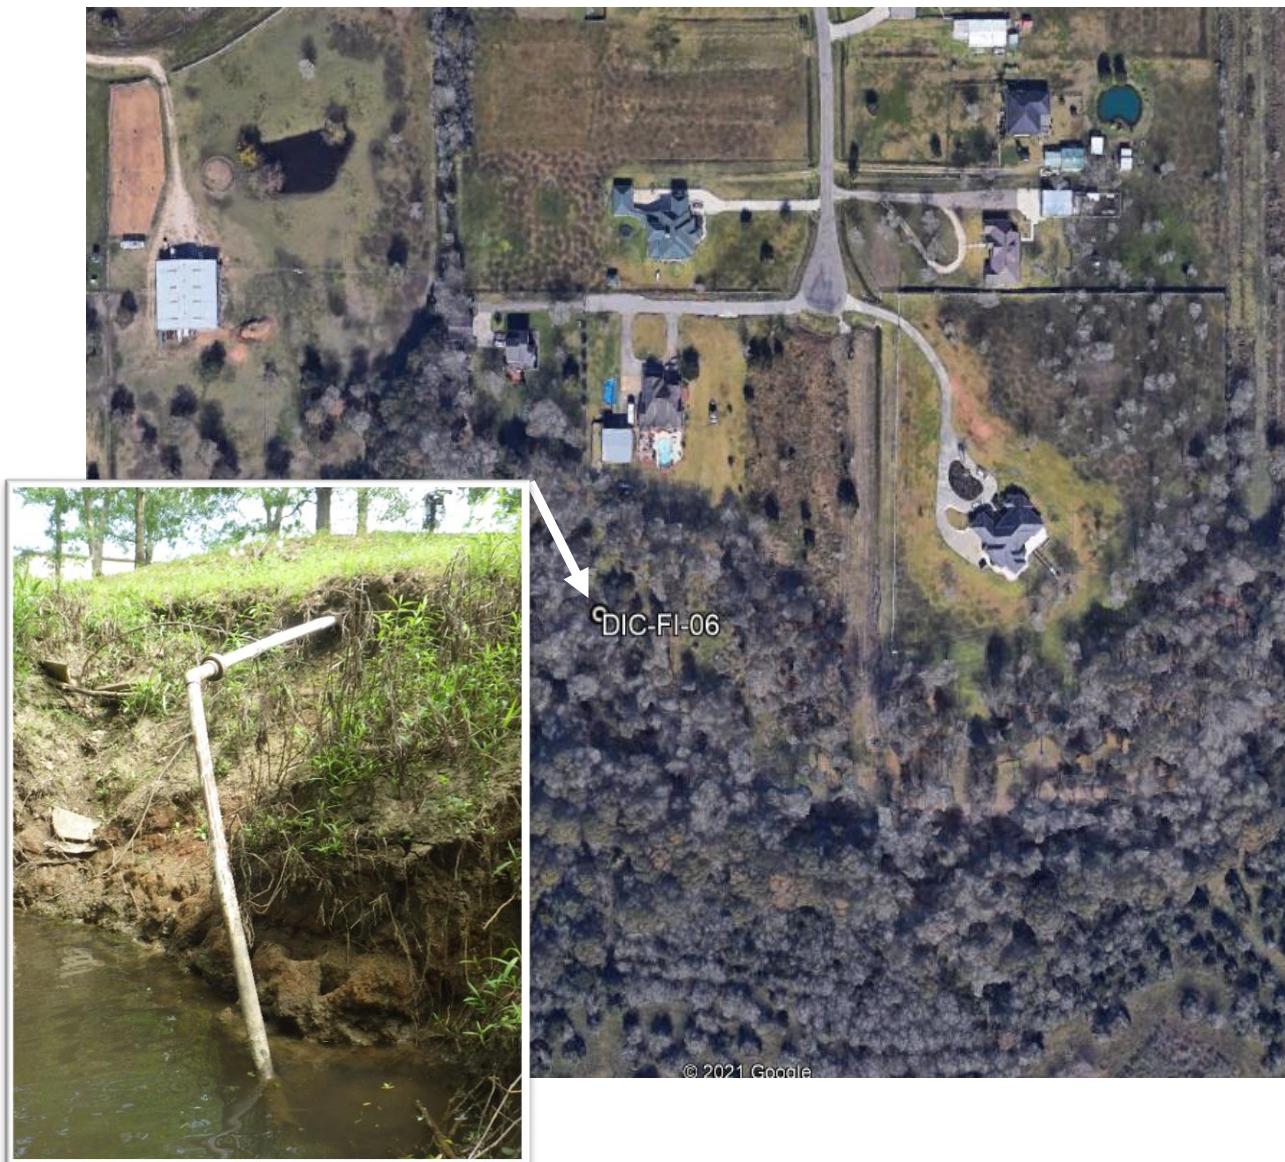
Referral site: DIC-FI-06

This site is located at in a residential area. The outflow pipe was a long, submerged PVC pipe with an inner diameter of approximately 2 inches. It appeared that the pipe ran underground from near a home along the stream and was unpermitted. We were unable to confirm whether the pipe was flowing, but the water sample collected downstream of the outflow had an *E. coli* bacteria value of 1020 MPN/100ML while the upstream value was only 813. This indicates that the outflow from this unregulated pipe may be contributing to the elevated bacteria count in the stream and further investigation is recommended. Photo taken shows mentioned PVC pipe along the left bank.

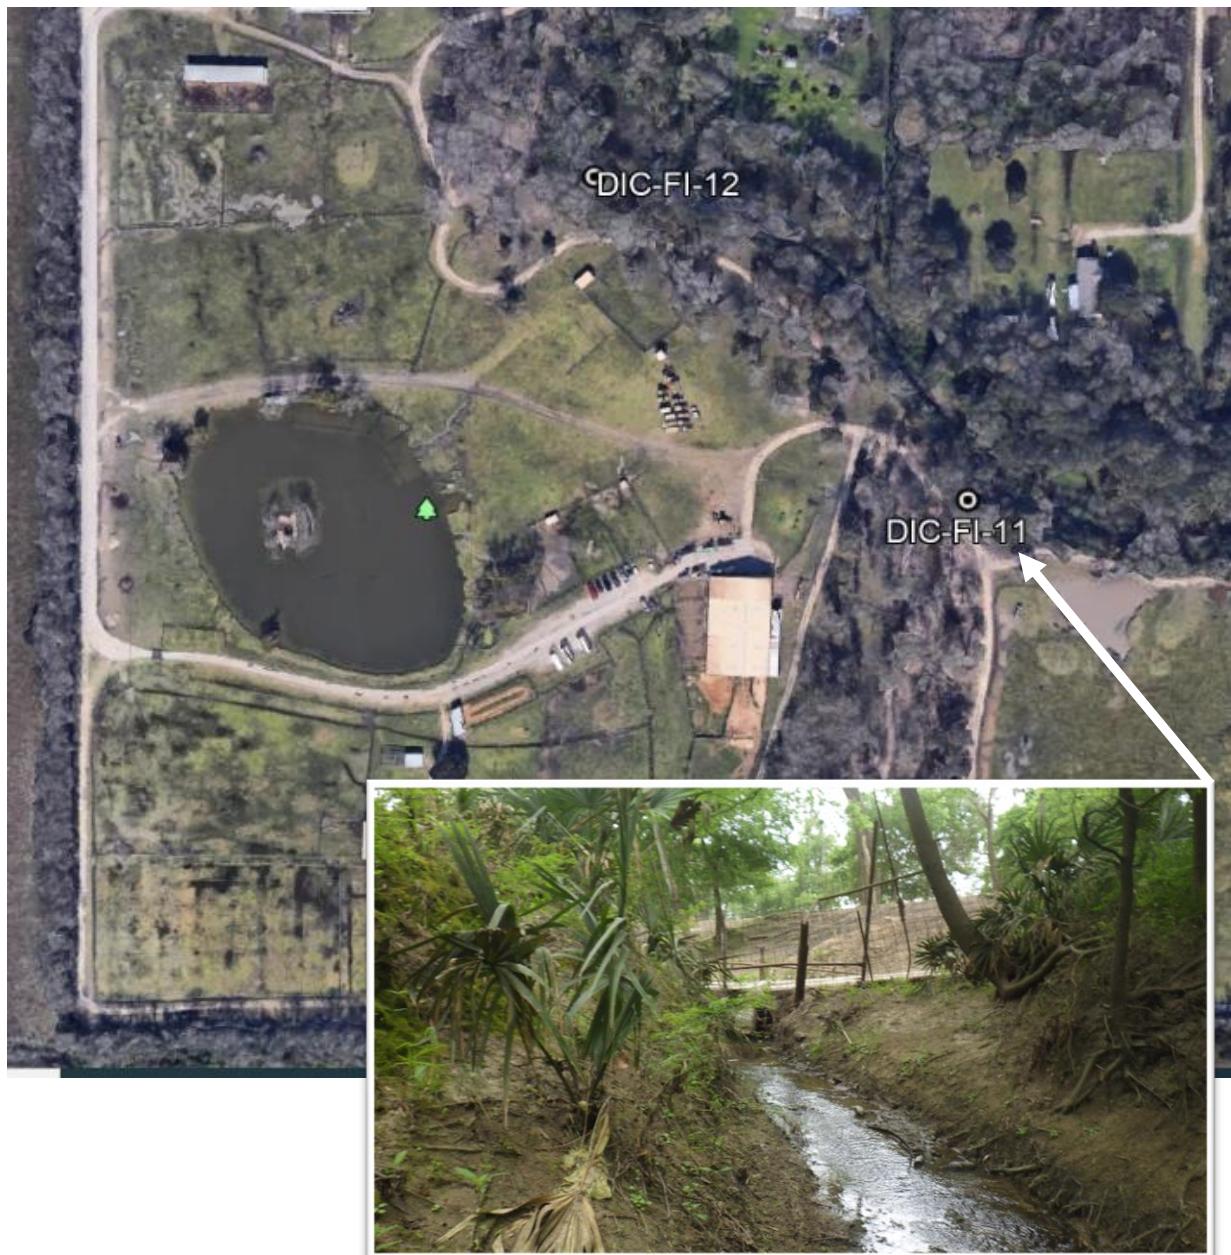
Referral site: DIC-FI-11

This site is located along the right bank of Dickinson Bayou just downstream of site DIC-FI-12 in a rural, residential area. Like DIC-FI-12, this site describes an ambient sample collected from a tributary flowing from the Bayou Wildlife Zoo located off of FM517 on the right bank of Dickinson Bayou. The bacteria value of the sample collected directly from the tributary was 529 MPN/100ML. Further investigation of potential bacteria sources contributing to this tributary is recommended. Photo taken shows tributary flowing from within the Bayou Wildlife Zoo fence.

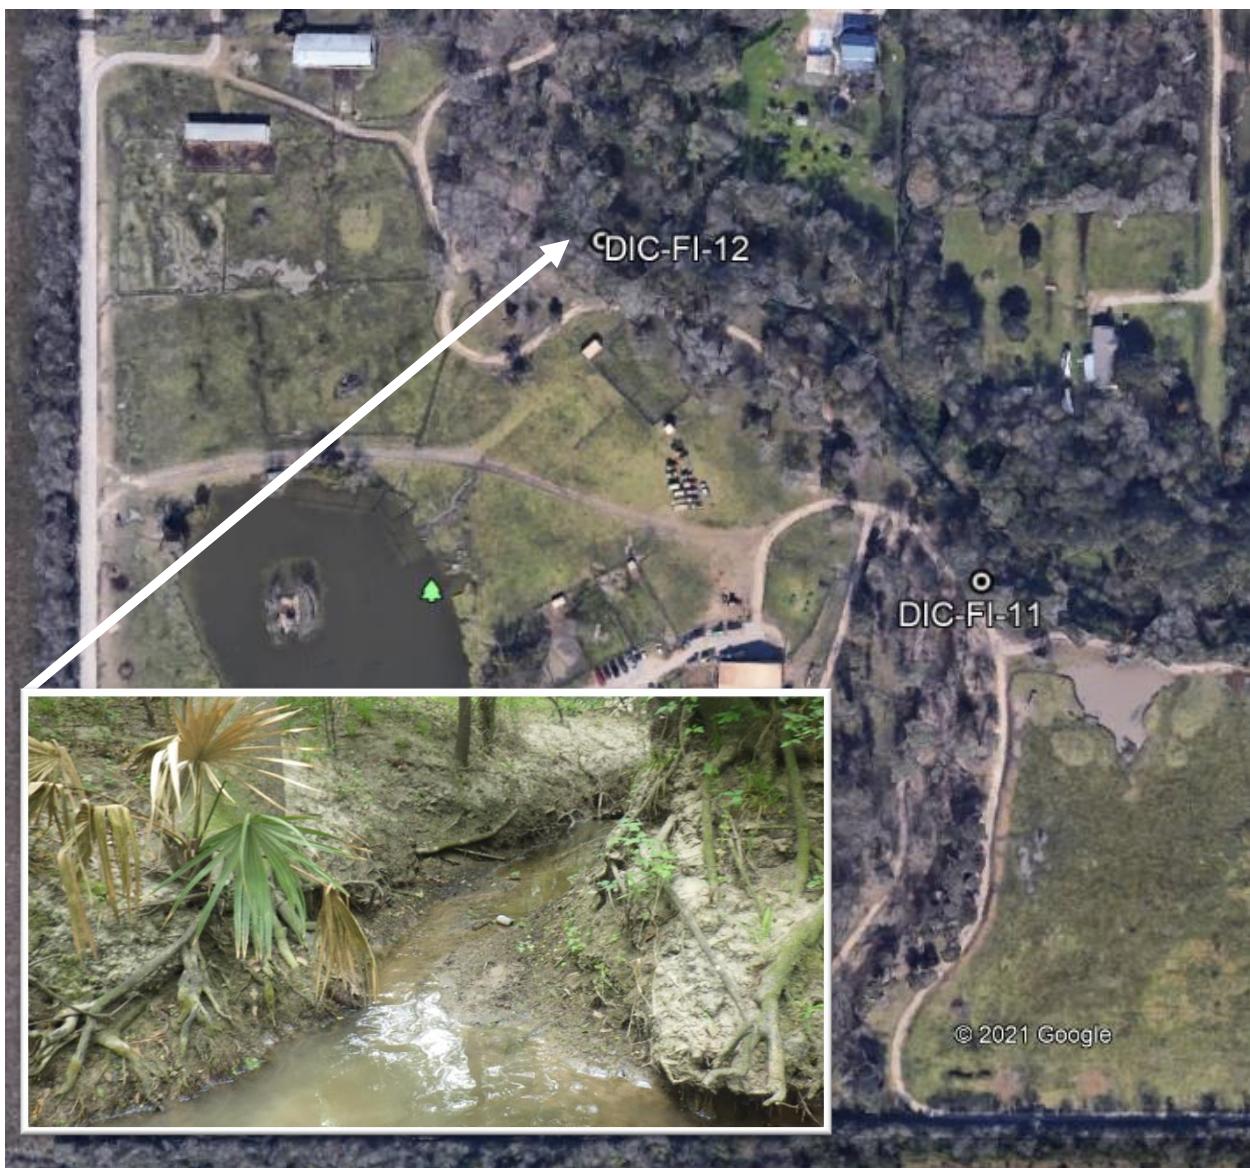
Referral site: DIC-FI-12

This site is located along the right bank of the stream and describes an ambient sample collected from a connecting tributary. The water sample was collected directly from the tributary and had an *E. coli* bacteria count of 3450 MPN/100ML. This tributary runs through the Bayou Wildlife Zoo. Further investigation of potential bacteria sources contributing to this tributary is recommended. Photo taken shows tributary coming from the Bayou Wildlife Zoo.

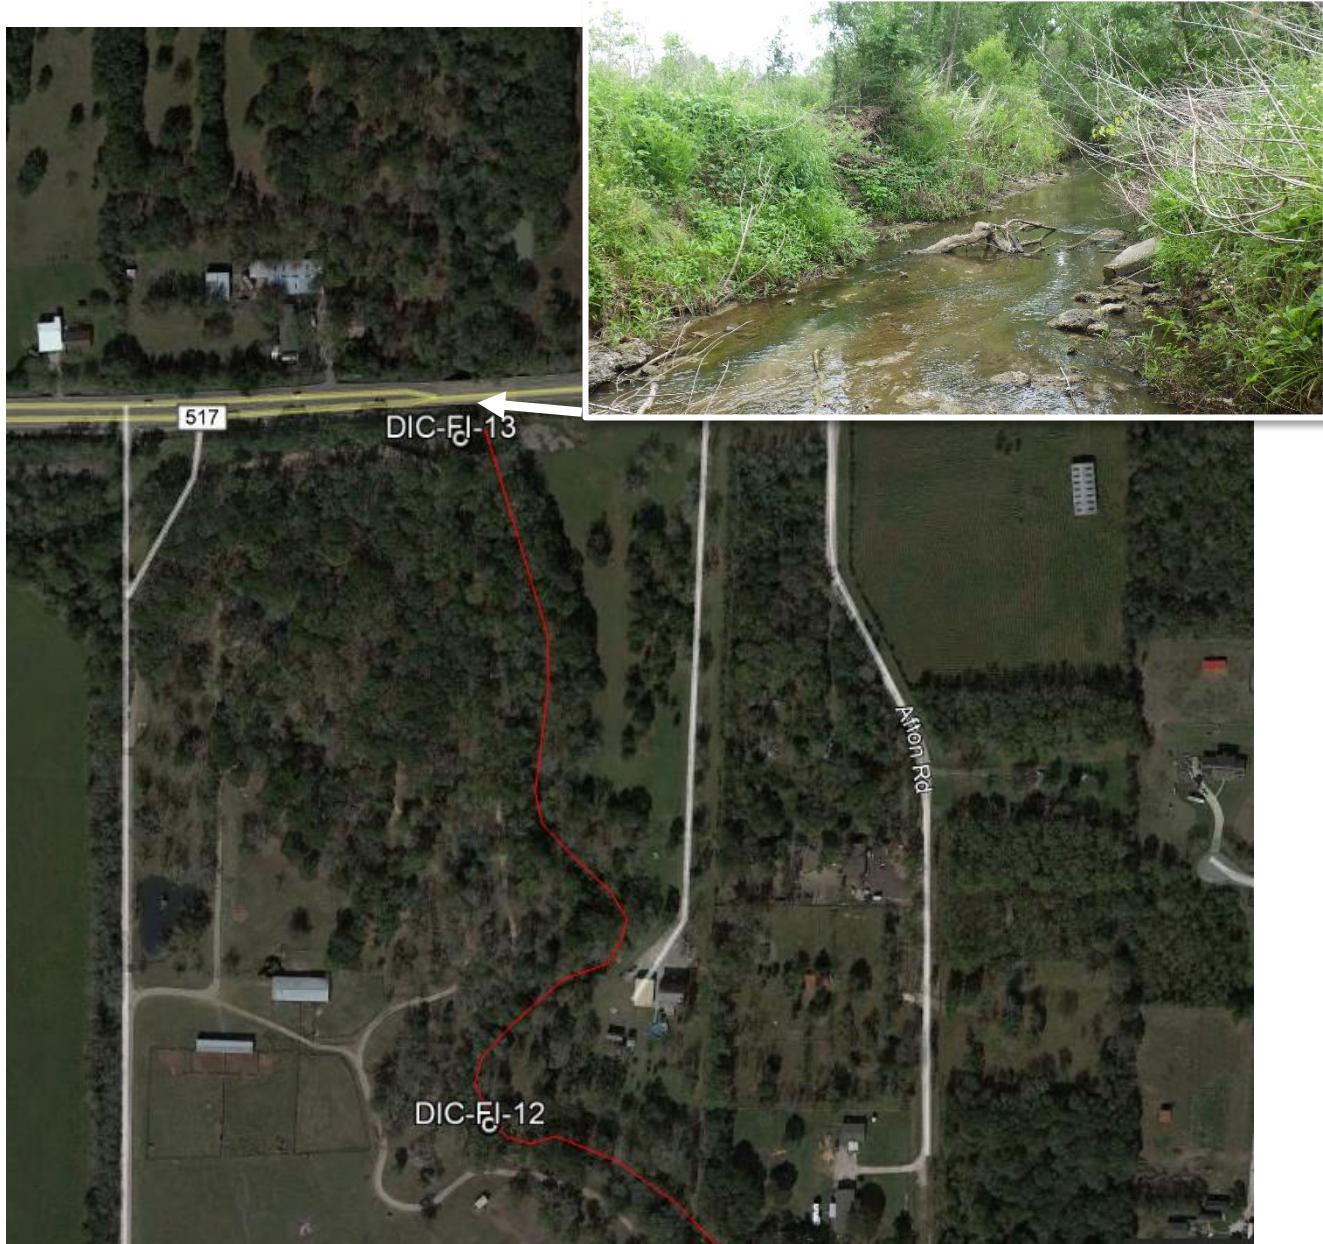
Referral site: DIC-FI-13

This site is located at the most upstream point of the Dickinson Bayou assessment unit in question. There is no pipe or outflow associated with this location, but an ambient sample was collected on the downstream side of the FM 517 bridge crossing. This sample had an *E.coli* bacteria value of 426 MPN/100ML. This indicates that there is likely a bacteria source contributing to the bayou upstream of assessment unit 1104_01. Further investigation upstream of the studied assessment unit by the proper authorities is recommended. Photo taken from just downstream of the bridge crossing at FM517 facing downstream.

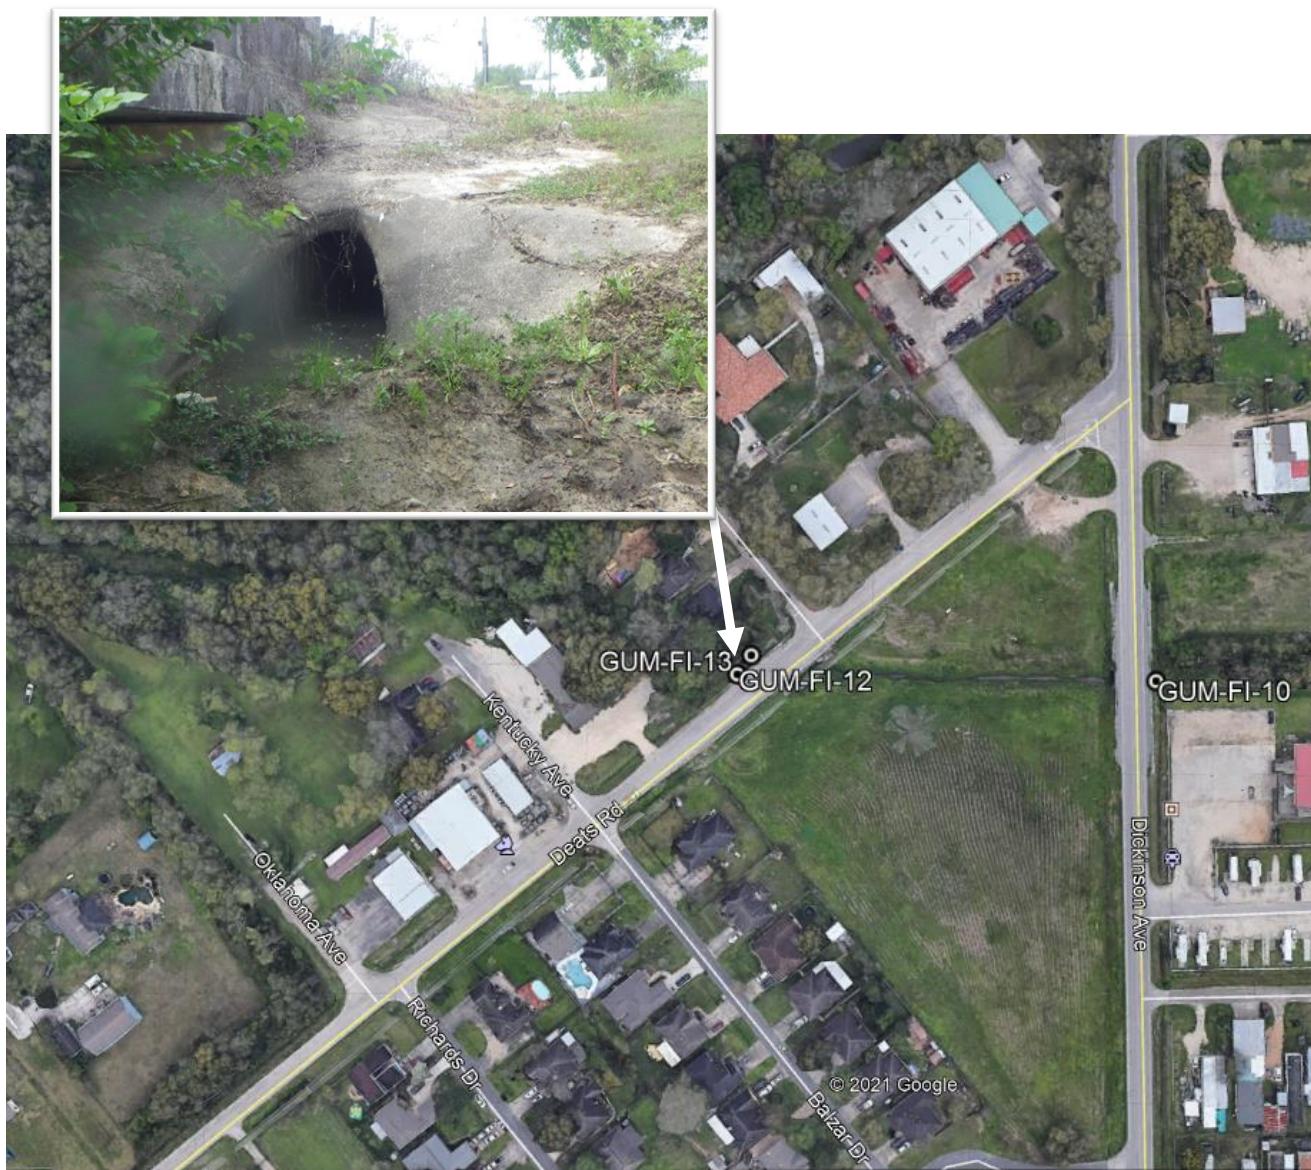
This site is a drainage ditch along the right bank located underneath a bridge. This is a concrete pipe, 25 inches in diameter, with a water depth in the pipe of 6 inches. The highest bacteria value of >24,200 MPN/100ML was collected downstream of the outflow. The upstream sample had an *E. coli* bacteria value of 369 MPN/100ML. A sheen was also observed coming from this drainage pipe flowing into the main stream assessment unit. Further investigation is necessary to identify potential bacteria sources. Photo taken shows the concrete drainage pipe facing the right bank.
