Executive Summary

The Houston-Galveston Area Council's (H-GAC) Targeted Monitoring Project focuses on the region's most prevalent pollutant – bacteria. The goal is to examine ten watersheds in various land cover types to identify bacteria sources (Table 1). A seven-year geometric mean analysis defining the severity of impairment was performed on each assessment unit (AU) within the region. H-GAC ranked waterways using the highest geomean relative to the state standards for contact recreation. Assessment units were selected by 1) highest geomean identified, 2) land cover type, and 3) accessibility and feasibility of the waterway for field investigations (Figure 1).

Bintliff Ditch (1007T_01)

Bacteria Monitoring Report

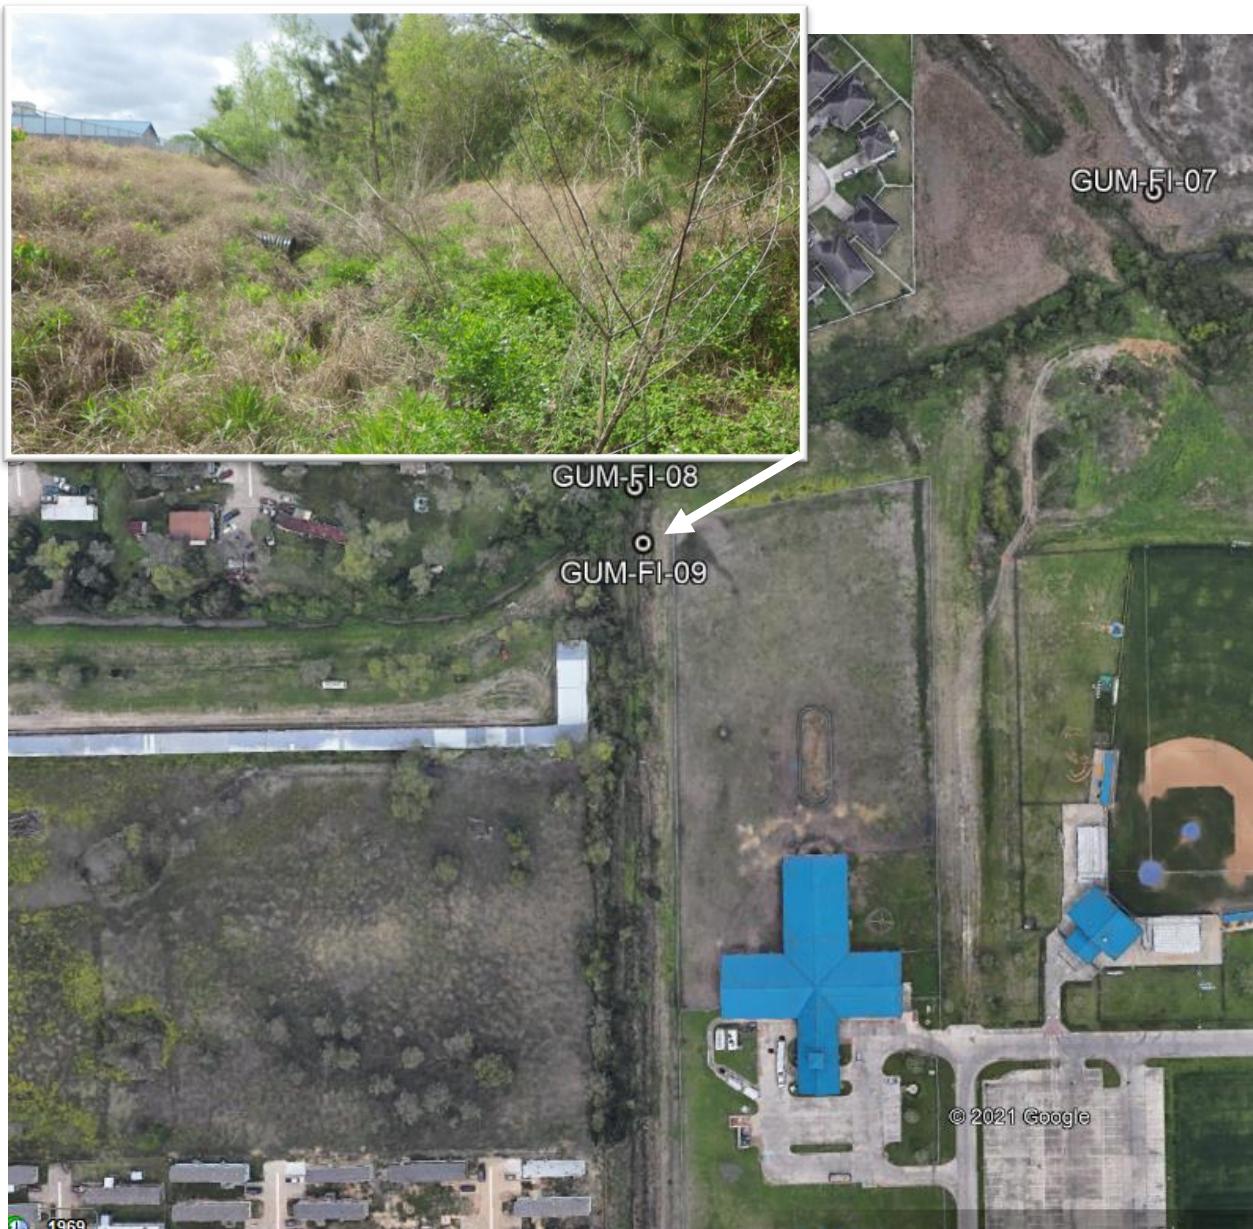
Referral site: GUM-FI-09

This site is located in the third tributary, which runs alongside a high school. The sample collected was an ambient sample taken within the tributary. The *E. coli* bacteria value associated with this sample was of 3,450 MPN/100ML. This indicates high levels of bacteria in this tributary, further investigation is necessary. Note: there appears to be a livestock program at the school near this tributary. Photo taken shows the upstream habitat of the tributary and its location along the high school.

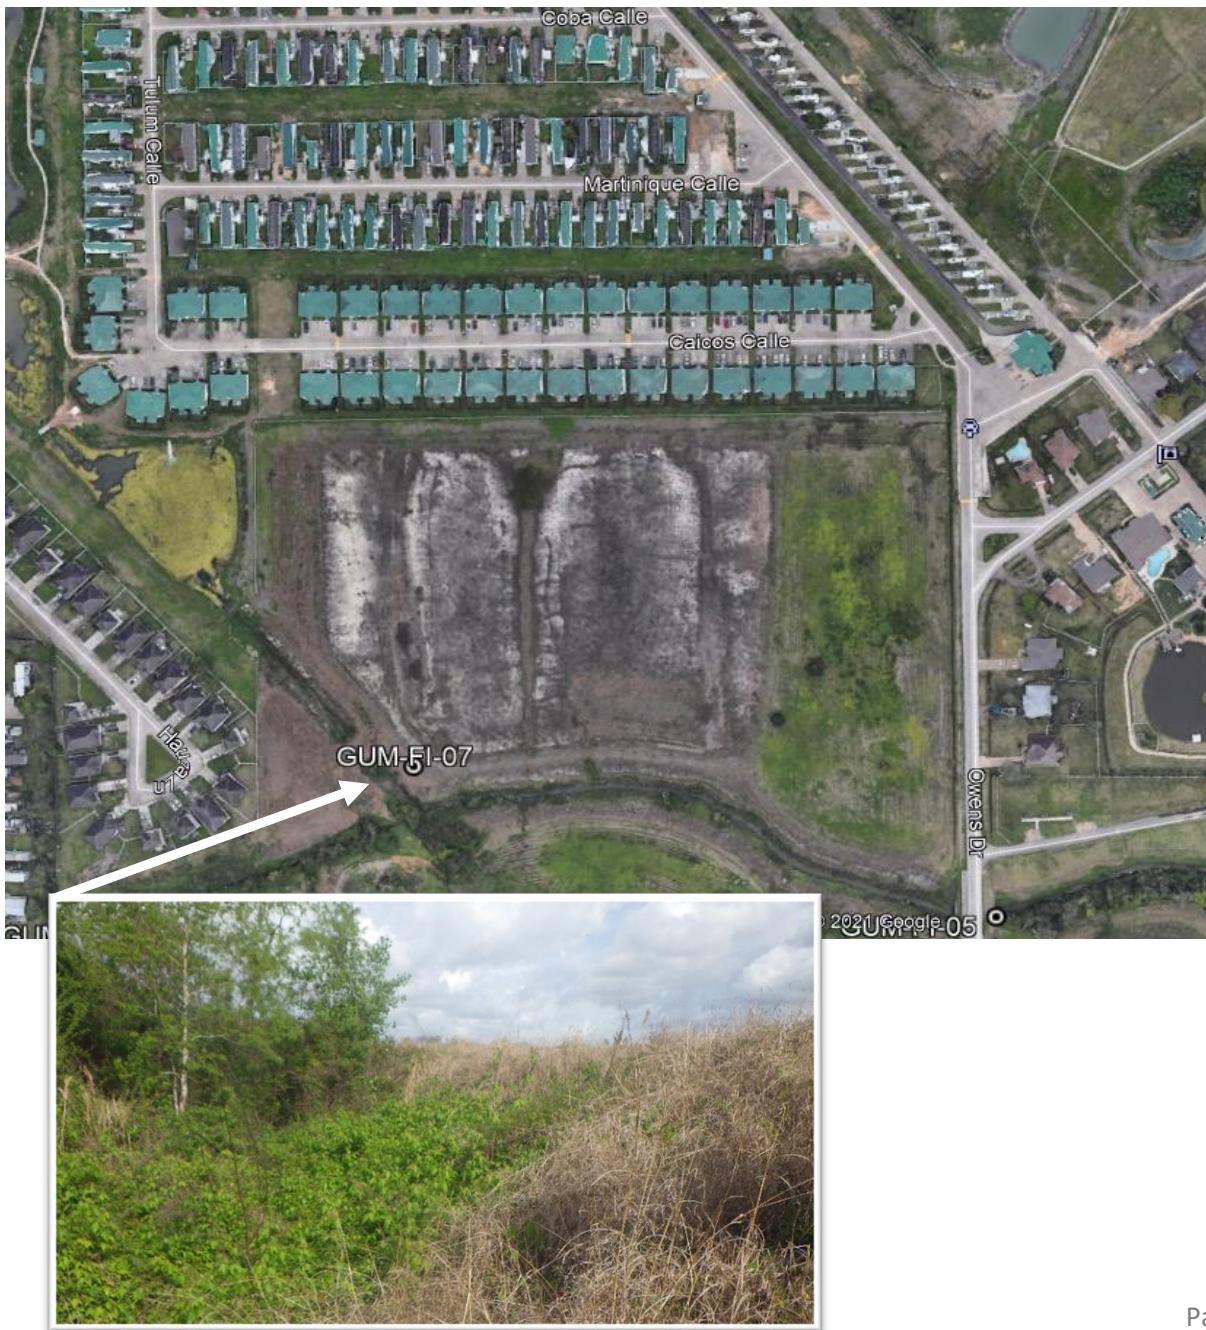
Referral site: GUM-FI-07

This site is located on the second tributary along the main AU. This site includes one ambient sample collected at a downstream point on the tributary. The *E. coli* bacteria value associated with this sample was 933 MPN/100ML. This sample was collected downstream of a neighborhood and rental park including townhomes, houses, and mobile homes. There is a pond upstream of the sample as well, which could also contribute to the high bacteria load. Photo taken shows the upstream habitat of the second tributary.

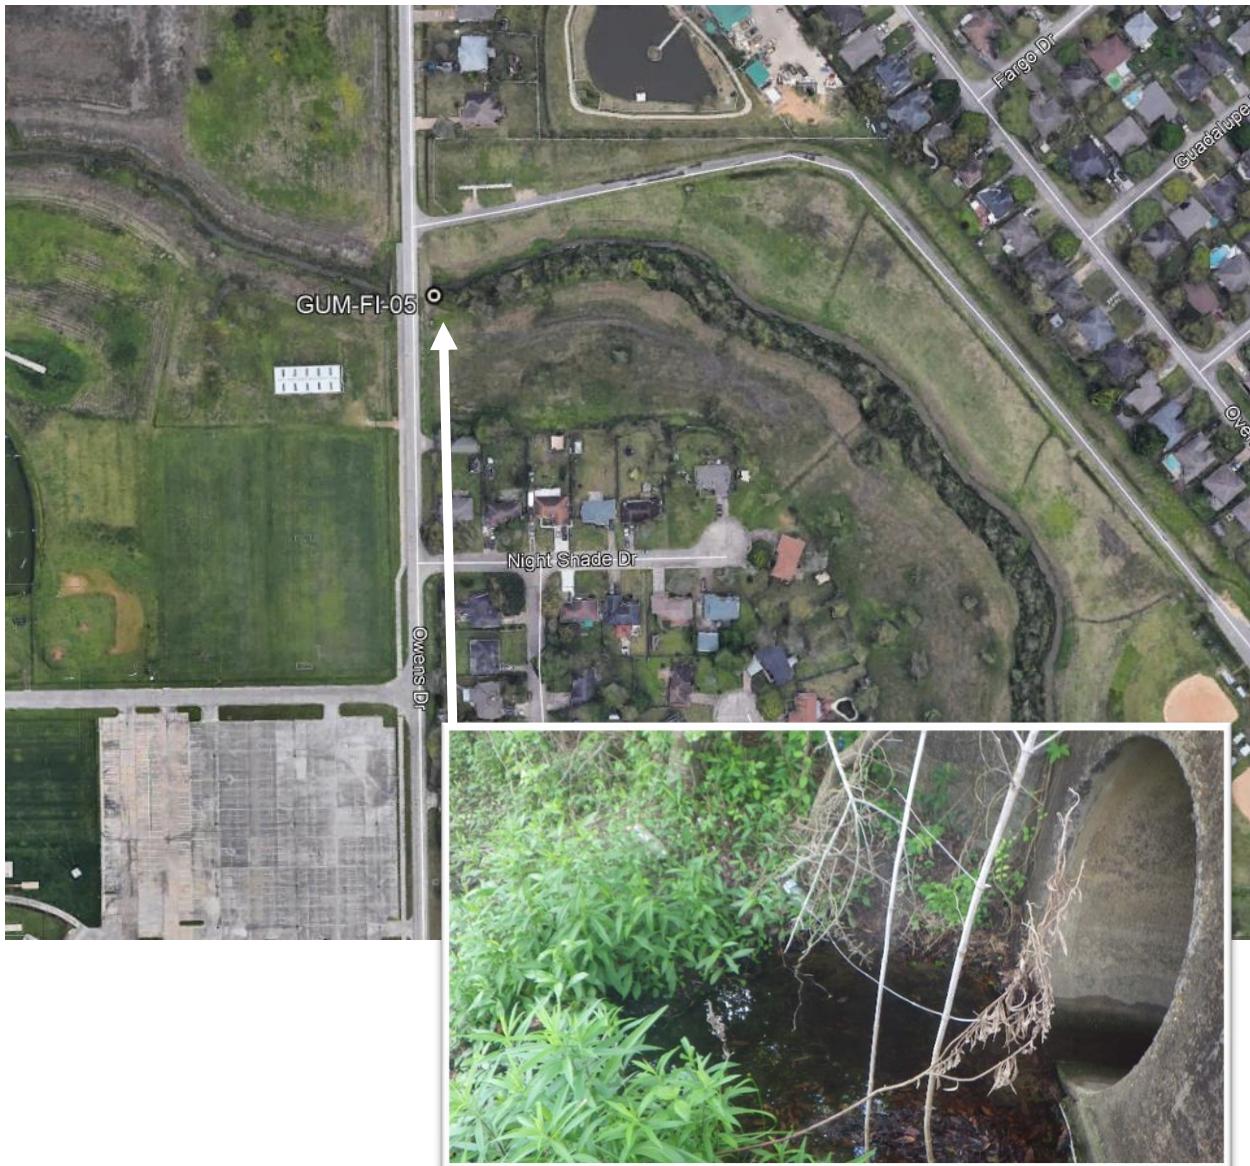
Referral site: GUM-FI-05

This site is located at the right bank on the downstream side of the Owens Dr. bridge crossing. The outfall was a roadside drainage pipe made of concrete with an inner diameter of 40 inches. The water depth in the pipe was 0.13 inches. Only one sample was collected at this location because the water pooled before flowing into the stream. This sample had an *E. coli* bacteria value of 393 MPN/100ML. This value indicates that there is a bacteria source further upstream contributing to this outfall. Runoff in this ditch is likely from the high school or nearby neighborhoods but further investigation is needed. Photo taken shows the concrete drainage pipe with pooling water before falling and flowing into the stream.

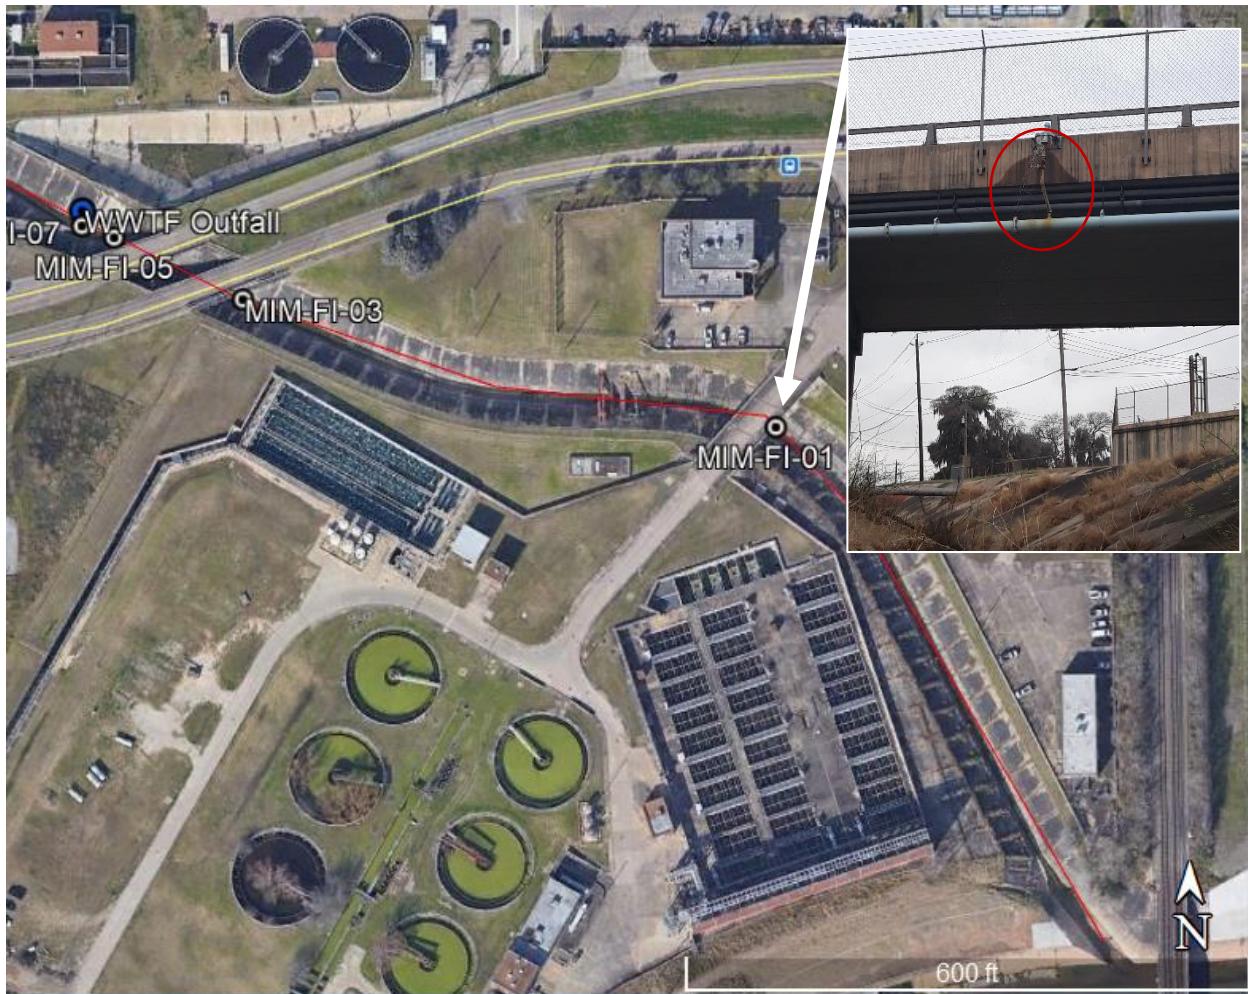
This site is a leaking metal pipe, ~ 12 inches in diameter that runs along the bridge (perpendicular to the segment) within the waste water treatment facility property, downstream of Beechnut St. The sample was collected where the leaking/spraying water was entering the segment and it had a bacteria value of 169 MPN/100ML. The ambient sample collected just upstream of the bridge outside of the influence of the leaking pipe had a bacteria value of 108 MPN/100ML (MIM-FI-02) indicating that the leaking pipe may be a source of elevated bacteria. Photo of leaking pipe taken looking upstream.

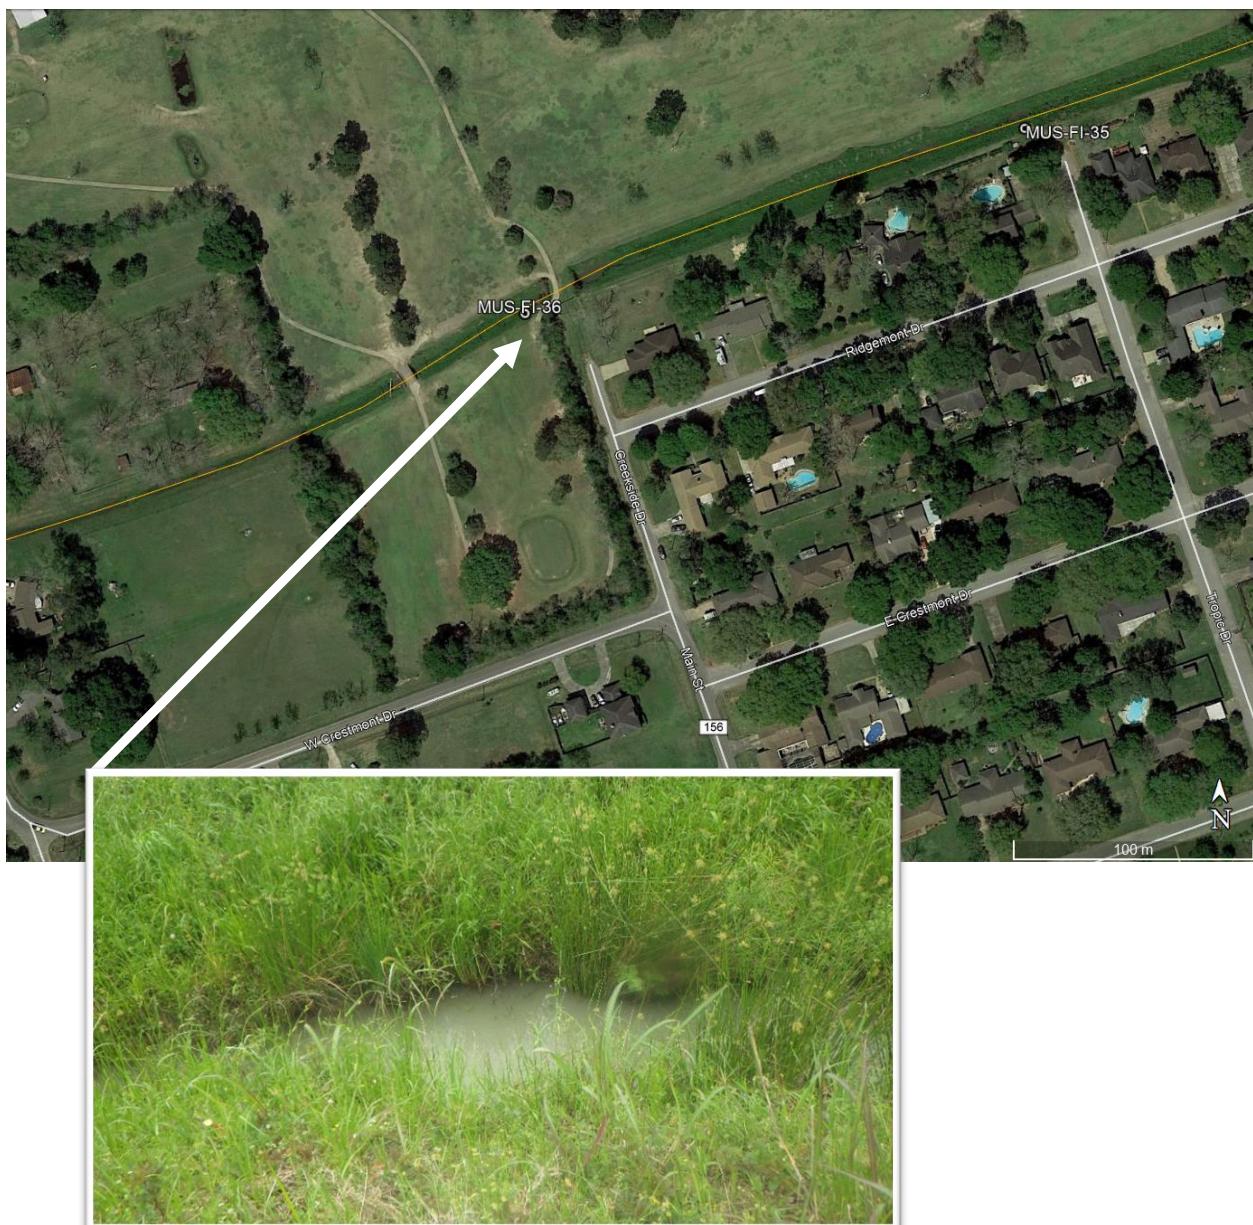
This site is located within a golf course along the fourth tributary of the Mustang Bayou segment. An ambient sample was collected from an isolated pool within the channel of the tributary. The *E. coli* bacteria value from the sample collected was 24,200 MPN/100ML. The water in the pool was very murky. It is recommended that this area is investigated further. Photo taken shows the vegetated pool where the sample was collected.

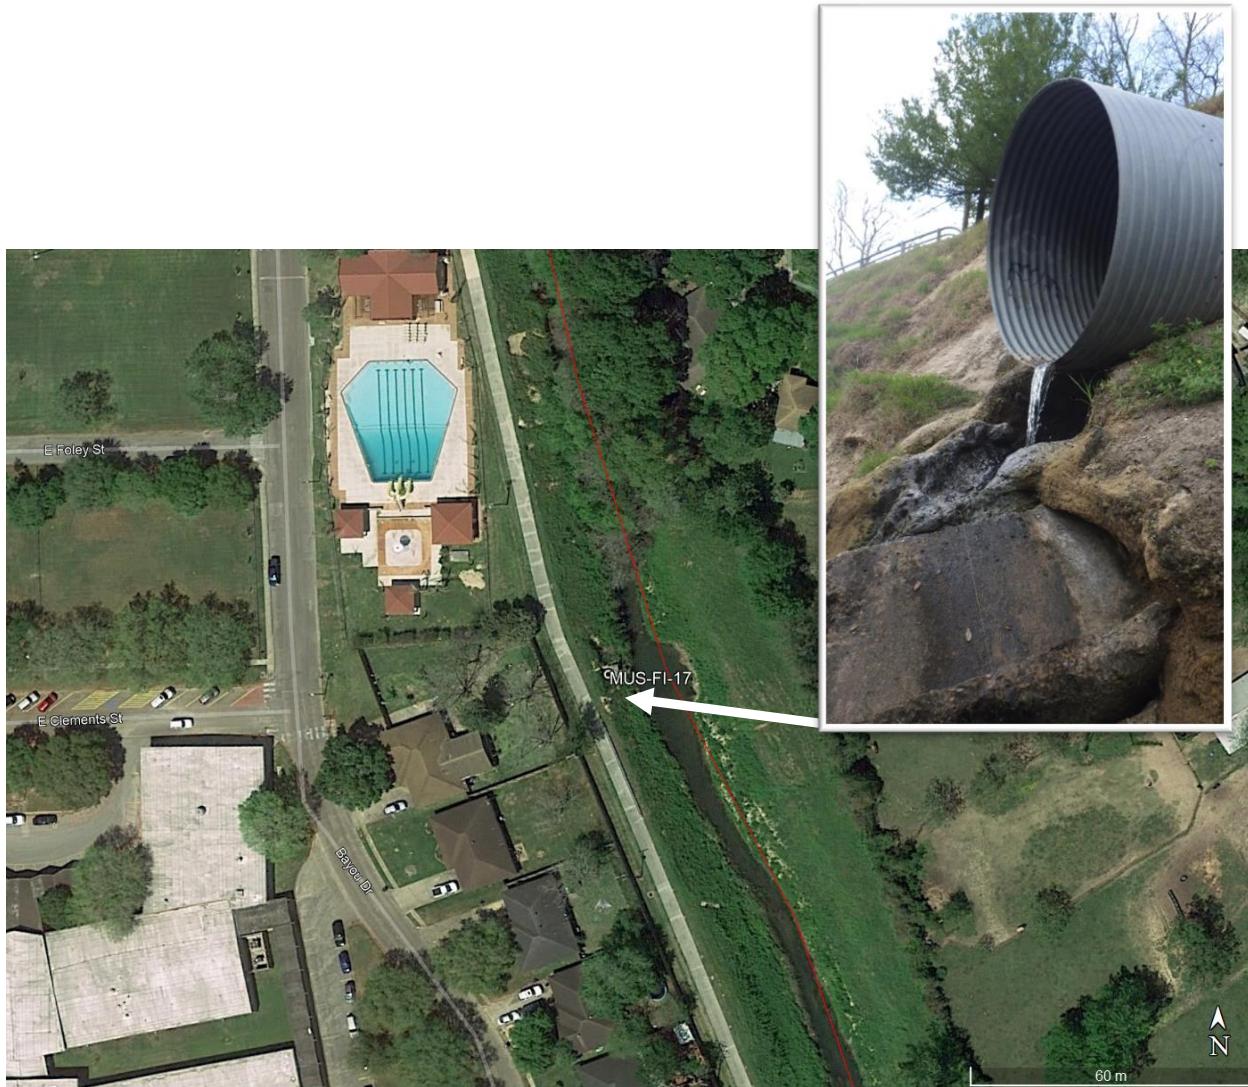
Referral site: MUS-FI-17

This site is located on the right bank in a residential area. The pipe associated with this site is metal with an inner diameter of 60 inches. There was 1 inch of water in the pipe with a consistent flow. The downstream sample collected bacteria value of 24,200 MPN/100ML while the upstream sample was 754 MPN/100ML, giving a difference of 23,446 MPN/100ML. The field crew noted that the water flowing from the pipe smelled of effluent. Further investigation is recommended. Photo taken shows pipe and amount of outflow.

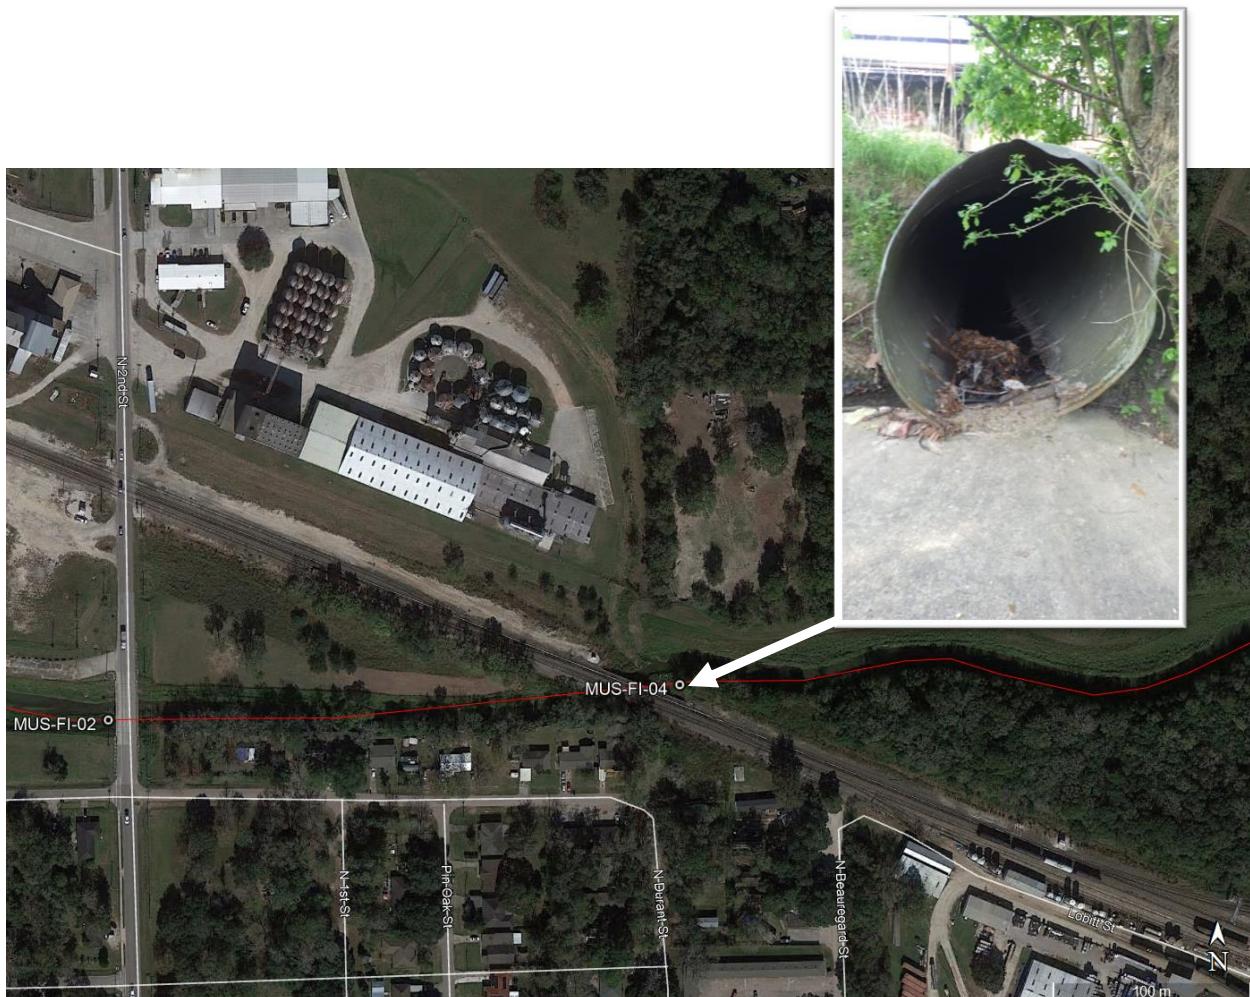
Referral site: MUS-FI-04

This site is located in a residential area and is a metal pipe with an inner diameter of 58 inches. The water in the pipe was 1 inch deep and the field crew noted that it smelled of effluent. The bacteria value of 24,200 MPN/100ML was collected directly from the pipe which had rusted out on the bottom. The upstream sample had an *E. coli* bacteria value of 2,380 MPN/100ML, giving a difference of 21,820. Further investigation is necessary. Photo taken shows rusted out bottom of pipe.

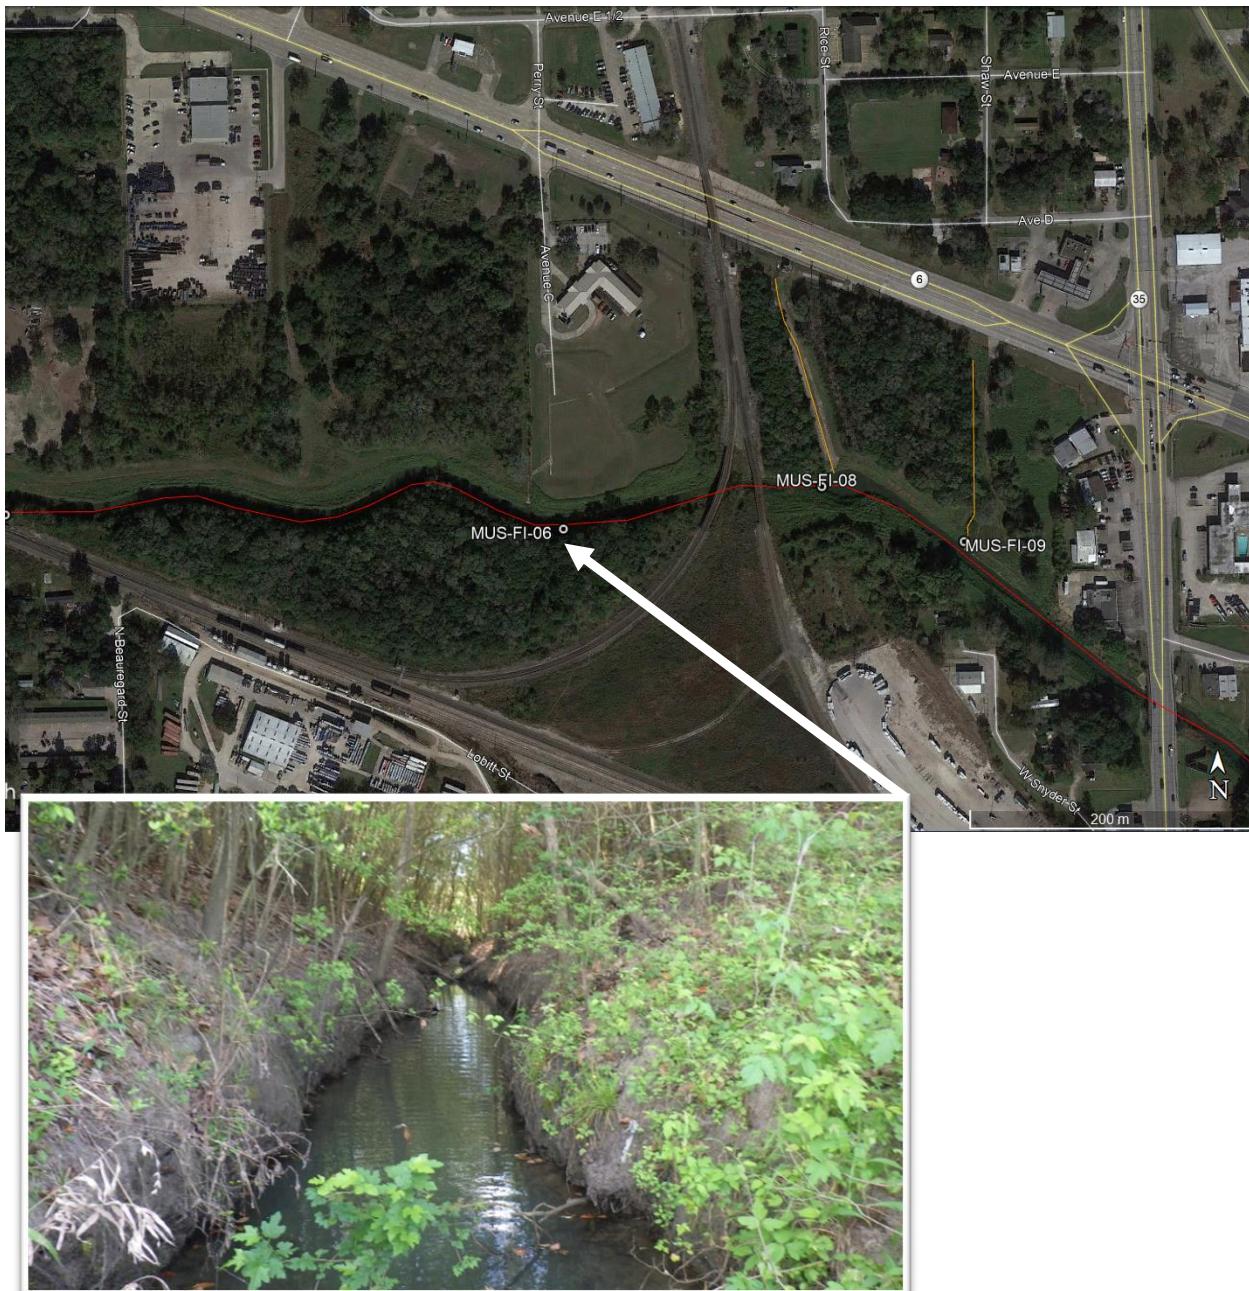
Referral site: MUS-FI-06

This site is located at just downstream of MUS-FI-04. An ambient sample was collected in this tributary (about 15 ft upstream in the tributary). Cloudy water and no flow was observed by the field crew. This ambient sample had an *E. coli* bacteria value of 15,500 MPN/100ML. Further investigation is suggested. Photo taken facing upstream in the tributary sampled.

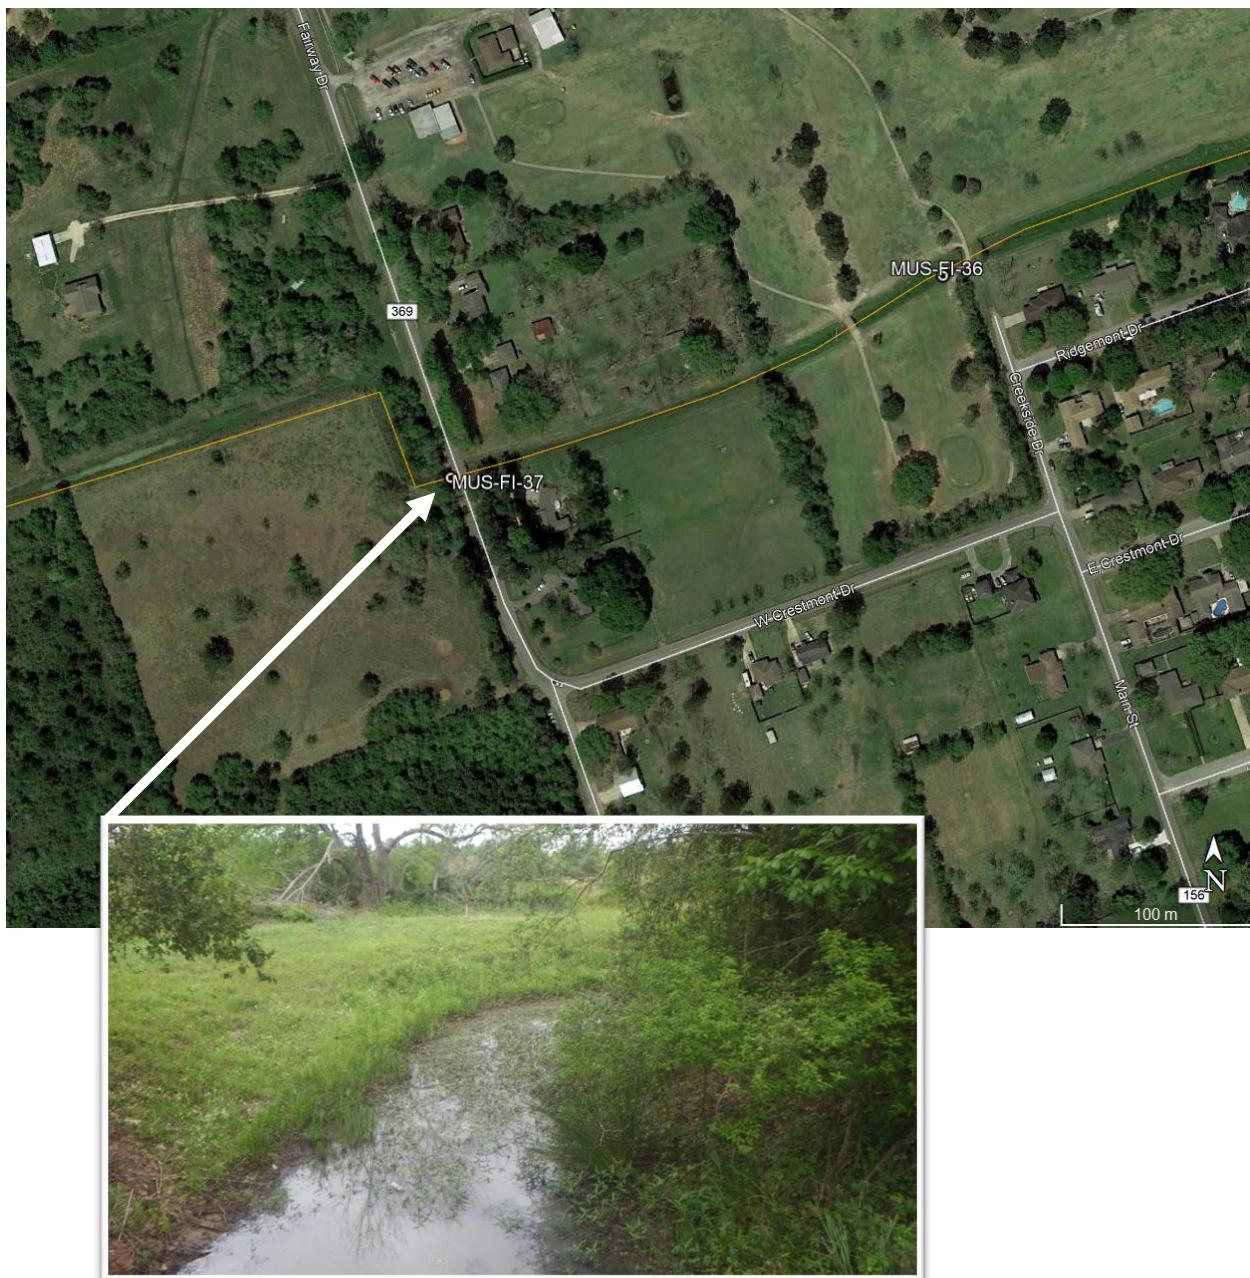
Referral site: MUS-FI-37

This site was located along the fourth tributary to the Mustang Bayou assessment unit. An ambient sample was pulled from an isolated pool within the channel of the tributary. The water in this pool was murky and stagnant. The *E. coli* bacteria value of this sample was 7,270 MPN/100ML. Further investigation is suggested. Photo taken shows the pool sampled.

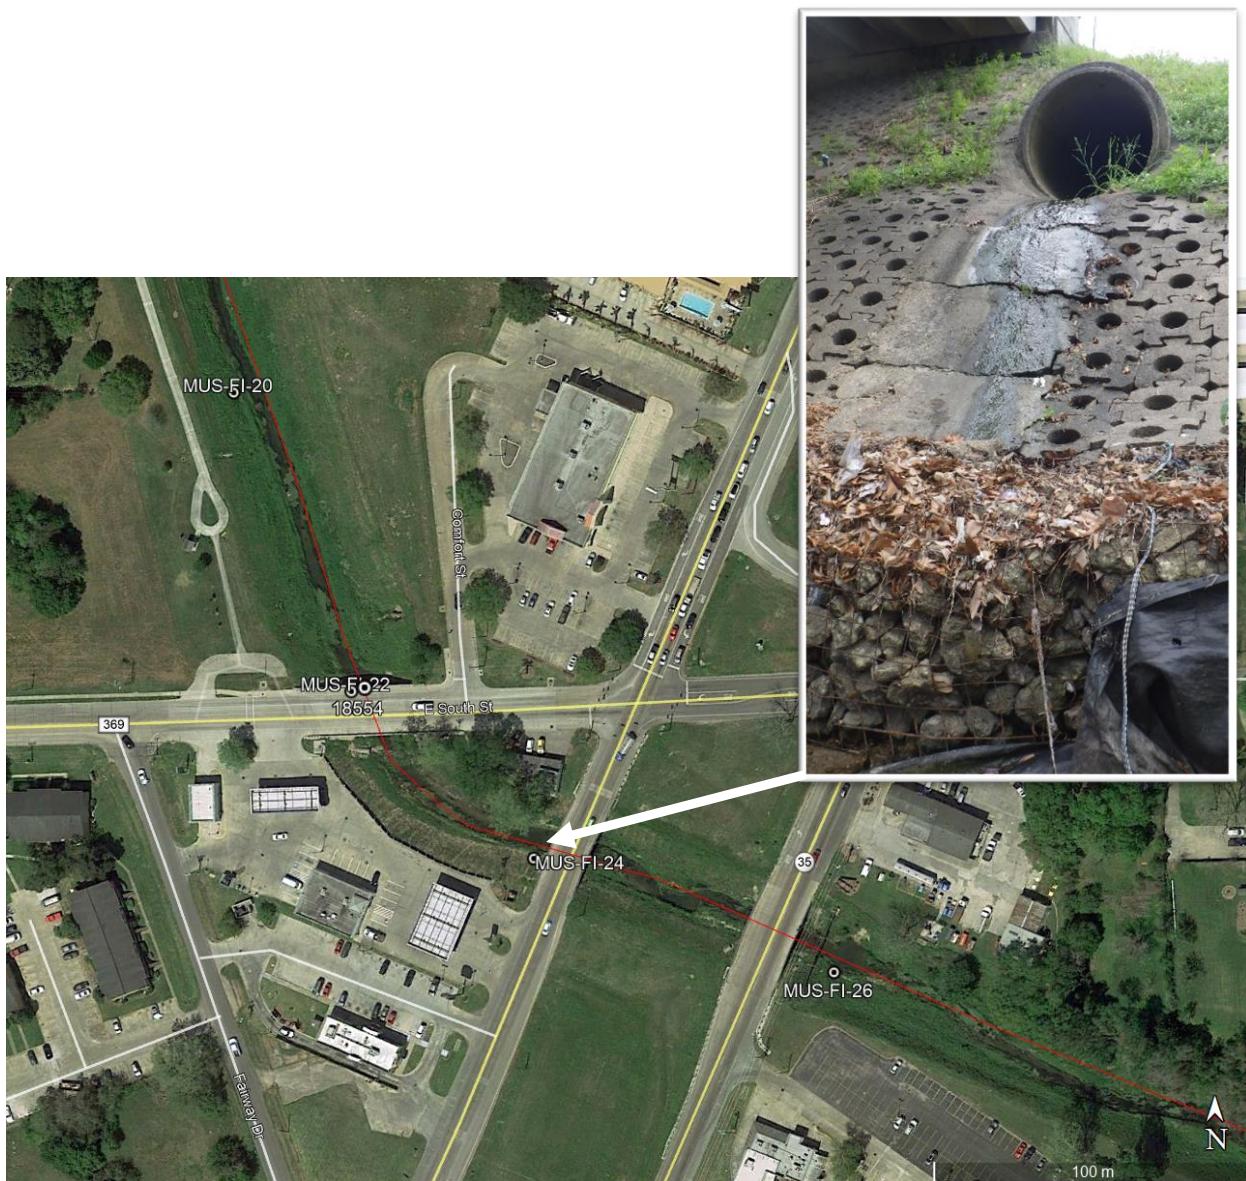
Referral site: MUS-FI-24

This site is located on the right bank in a commercial area with high vehicle traffic. The pipe is concrete with an inner diameter of 45 inches. The depth of water in the pipe was 0.75 inches, which then flows through concrete rubble before entering the stream. There was some algae growing along the path of flow. The bacteria value of 4,350 MPN/100ML was collected at the downstream location. The upstream sample had a value of 34 MPN/100ML, giving a difference of 4316 MPN/100ML. Photo taken concrete pipe and rubble on the right bank.

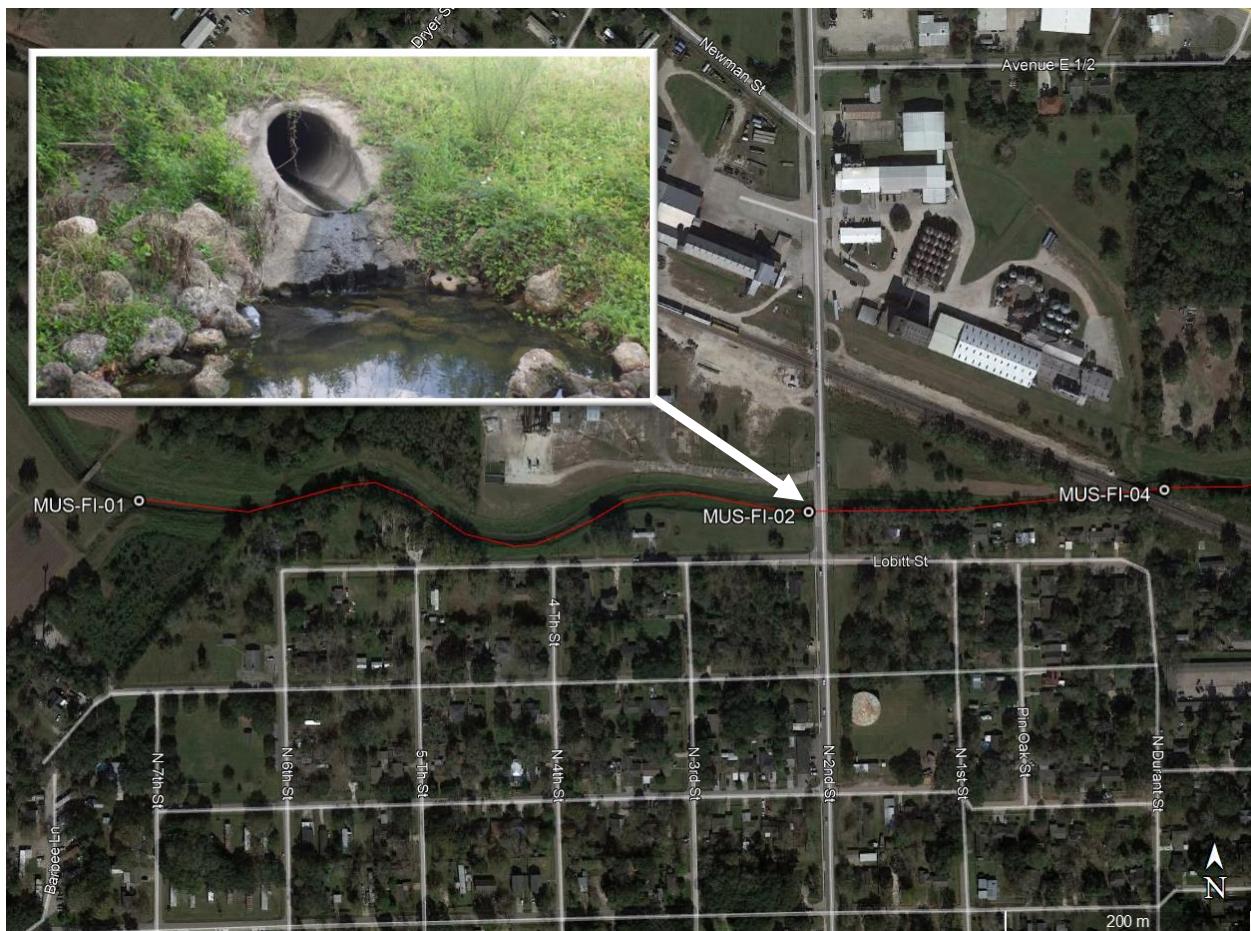
This site is located at next to a bridge in a mainly residential area. The pipe is 40 inches in diameter and made of concrete. Water depth within the pipe was 0.38 inches. The upstream sample had an E. coli bacteria value of 259 MPN/100ML while the downstream was 3,870 MPN/100ML. Further investigation is needed to identify the bacteria source at this site. Photo taken shows concrete pipe on the right bank.
