Pasadena Intersection Safety Study

**Final Report
by the**

**Center for Transportation Safety
Texas Transportation Institute
Texas A&M University System**

Pasadena Safety Study Revised Intersection Report

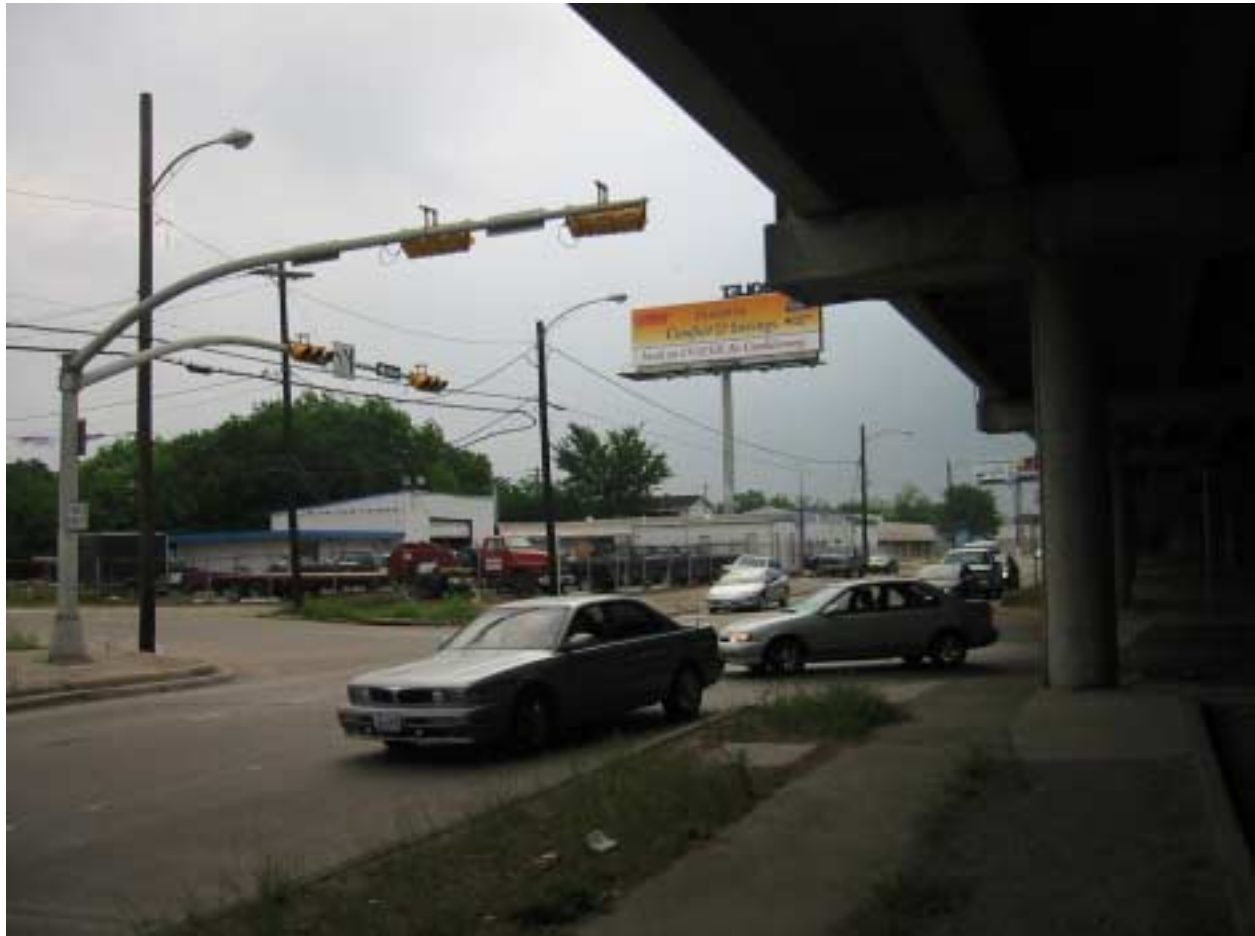
Figure 9. View of Westbound traffic at SH 225 @ Main.

AM peak period, the WB SH 225 through traffic and the northbound (NB) Main left-turning traffic had the highest volumes (see Figure 9). During the PM peak period, the dominant movement was the EB SH 225 traffic turning right onto to NB Main. In addition to traffic count data, signal timings were also provided. All red and yellow clearance intervals were adequate based on standard practice.

- Accounted for almost 33% of crashes on WB frontage road and NB Main and 23% of crashes on EB frontage road and NB Main.
- Caused by cars crashing into other left-turners (i.e., drivers in the Left Turn Only lane tried to go straight while the through/left lane is turning left; or, both vehicles turned left but failed to maintain the lane and caused a sideswipe type crash).

- Crashes coded as improper lane utilization (Disregard Turn Marks at Intersection) or failure to maintain lane.
- The crashes could be caused, in part, by:

- the poor condition of pavement markings under the bridge which delineate lane usage;
 - the lack of advanced signage placed before the intersection for all of the allowable directional movements;

1. **LEDs** – installing 12-inch lenses or 12 inch Light Emitting Diodes (LEDs) with signal backplates will generally reduce the amount of collisions at a given intersection and improve the visibility of the signal. A TTI research study (6) found that larger lenses and LEDs increased the visibility of the light. Adding backplates as well increased the conspicuity of the signal head and reduced the red light running experience by 13 to 25 percent. In this report, TTI will recommend the upgrade of all signal sections to LED signal heads with backplates at all intersections discussed, based on knowledge from the study mentioned above, other national research results, and general field experience. At this location, 12-inch LEDs are currently present for the Red light indication on the frontage roads, but all other colors are incandescent and no LEDs exist on the intersecting street.

2. **pavement markings** - improving pavement markings and reflectorized Raised Pavement Markers (RPMs) at the intersection as a whole will assist traffic in maintaining proper lane assignment; currently, these treatments are faded and in very poor condition across the board.

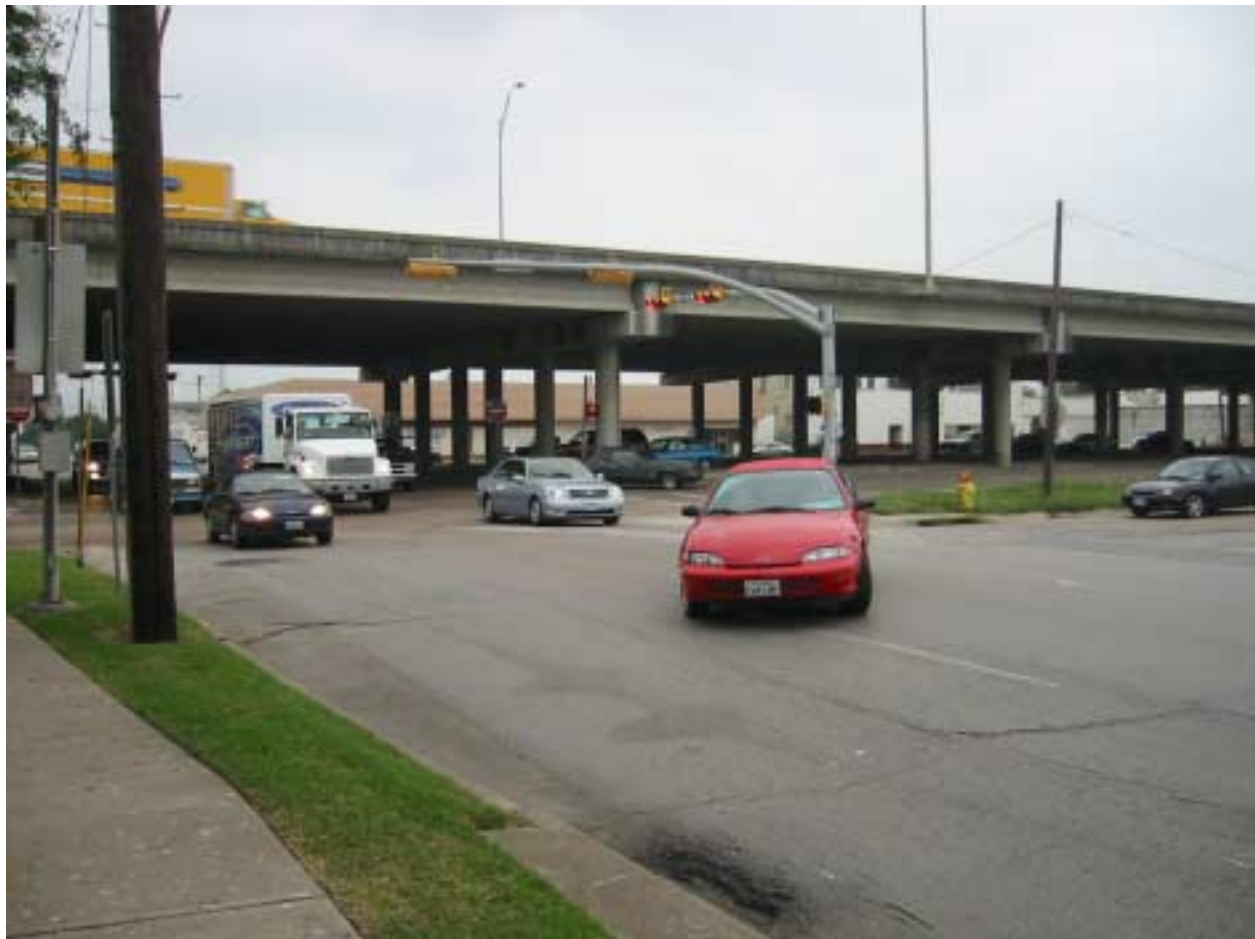
Figure 10. Southbound Traffic at SH 225 @ Shaver.

- Accounted for 18% of crashes on WB frontage road and SB Shaver and 22% of crashes on EB frontage road and SB Shaver.
- Caused by cars crashing into other left-turners (i.e., drivers in the Left Turn Only lane tried to go straight while the through/left lane is turning left; or, both vehicles turned left but caused a sideswipe type crash)
- Crashes coded as improper lane utilization (Disregard Turn Marks at Intersection), failure to maintain lane (Turned Improperly- Wrong Lane), or Driver Inattention.
- The crashes could be caused, in part, by:
 - the poor condition of pavement markings under the bridge which delineate proper lane usage;
 - the lack of advanced signage placed before the intersection for all of the allowable directional movements;
 - alignment issues with the through-lanes past the intersection which could encourage drivers in the far left-lane to go straight;

- Accounted for 12% of crashes on EB frontage road and SB Shaver
- Caused by cars crashing into other right-turners (i.e., drivers in the Right Turn Only lane tried to go straight while the through/right lane is turning right; or, both vehicles turned right but failed to maintain proper lane and caused a sideswipe type crash)

- Crashes coded as improper lane utilization (Disregard Turn Marks at Intersection), failure to maintain lane (Turned Improperly- Wide Right), or Failed to Drive in Single Lane.
- The crashes could be caused, in part, by:
 - the poor condition of pavement markings on the approach to the 225 EB frontage road intersection with SB Shaver which delineate proper lane usage;
 - the lack of advanced signage placed before the intersection for all of the allowable directional movements; and
 - alignment issues with the through-lanes past the intersection which could encourage drivers in the far right-lane to try to go straight.

1. **LEDs** – installing 12-inch lenses or 12 inch Light Emitting Diodes (LEDs) with signal backplates will generally reduce the amount of collisions at a given intersection and improve the visibility of the signal. A TTI research study found that larger lenses and LEDs increased the visibility of the light. Adding backplates as well increased the conspicuity of the signal head and reduced the red light running experience by 13 to 25 percent. At this location, only the red lights on the frontage roads currently have the 12-inch LEDs, and all others are incandescent.
2. **pavement markings** - improving pavement markings and reflectorized RPMs to the intersection as a whole will assist traffic in maintaining proper lane assignment; currently, these treatments are faded and in very poor condition across the board.

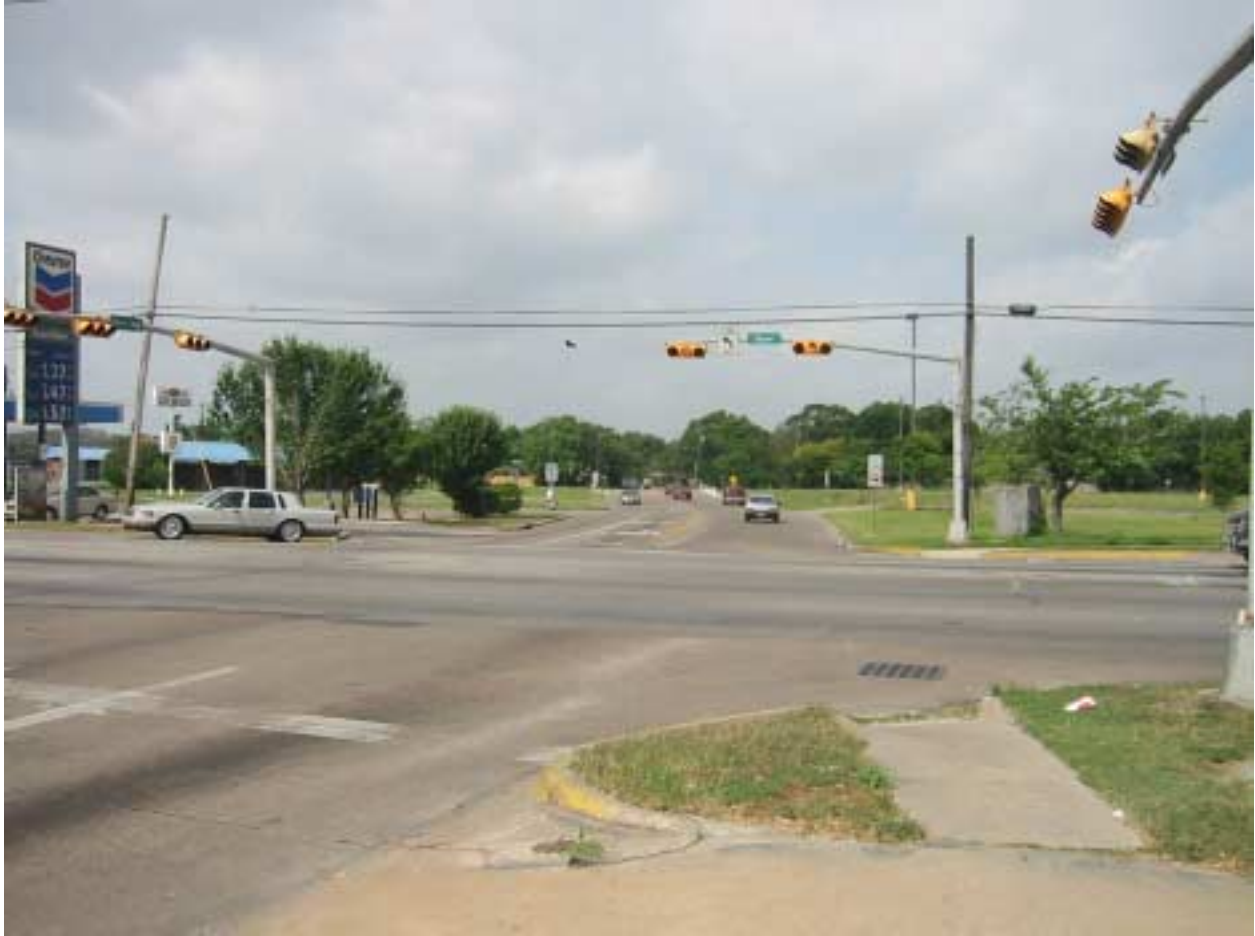
Figure 11. Westbound Traffic on Shaver @ Queens.

- There were 14 left-turning vehicle collisions which accounted for 34% of crashes at the Shaver and Pauline/Queens intersection.
- 10 of the 14 involved movement from vehicles turning from Pauline or Queens onto Shaver, while the other 4 were from NB vehicles on Shaver turning onto Queens.
- Most of the crashes were coded as a Failure to Yield ROW – Turning Left, but a couple were attributed to Driver Inattention or Disregard Stop and Go Signal.
- The crashes could be caused, in part, by a lack of education (provided by signage) as to who is required to yield the ROW.

- Accounted for 34% of crashes at the Shaver and Pauline/Queens intersection.
- Most of the crashes in this group were coded as Disregard Stop and Go Signal or Disregard Stop Sign or Signal.
- The crashes could be caused, in part, by:
 - violation of driver expectancy that the light will remain green,
 - inattentiveness of driver to the signal,
 - poor conspicuity of the light, or
 - a lack of law enforcement in the area.

- Accounted for 24% of crashes at the Shaver and Pauline/Queens intersection.
- Most of the crashes in this group were coded as Followed Too Closely or Failed to Control Speed.
- The crashes could be caused, in part, by:
 - violation of driver expectancy that the light will remain green and that the car in front will not be braking for a yellow or red light,
 - inattentiveness of driver to the signal, or
 - poor conspicuity of the light.

2. **pavement markings** – applying fresh pavement markings such as stop bars may reinforce the boundaries of the intersection and increase the awareness of drivers as to the proper stopping location.
3. **enforcement** – although a speed study was not conducted at this location, it is recommended that one be performed as a justification for enhanced enforcement in this area; enforcement of both speed limits and red-light stop compliance should help reduce the number and seriousness of the crashes at this intersection.

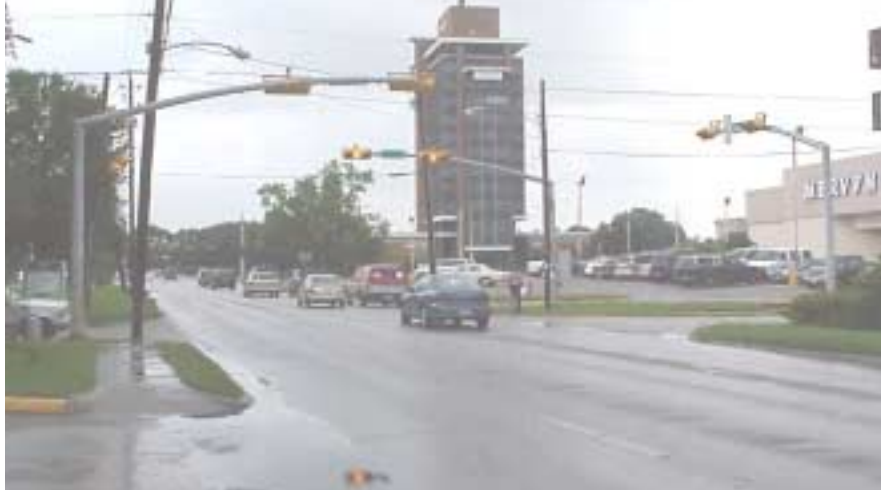
Figure 12. Traffic Moving Northbound through the Pasadena @ Curtis Intersection.

General traffic counts from the area were provided by the City of Pasadena. Intersection turning movement counts were also provided for each intersection for the AM peak, Midday, and PM peak periods, as shown in Figure A-4 in Appendix A. The traffic trend is to flow NB in the AM period and SB in the PM peak period on Pasadena with very little traffic on Curtis (see Figure 12).

1. **signage** – adding regulatory signs to the signal arms above all approaches that say Left-Turn Yield on Green will help drivers know that they must yield to oncoming traffic; AND
2. **overlap phase** – changing the current signal sequence (see Figure 13) to include an overlap phase (see Figure 14) and adding appropriate signage (e.g. Left Turn Protected on Green) to the signal arms on Pasadena. With this signal phase change, there is no need to have an additional lane to store turning vehicles. However, as with all signal timing changes recommended in this report, additional studies may be required to determine the impact on delay.
