Targeted Bacteria Monitoring Project

FY25 Final Report – Assessment Unit: 1006D_02 Halls Bayou

Houston-Galveston Area Council
3555 Timmons Lane, Suite 100 Houston,
TX 77027

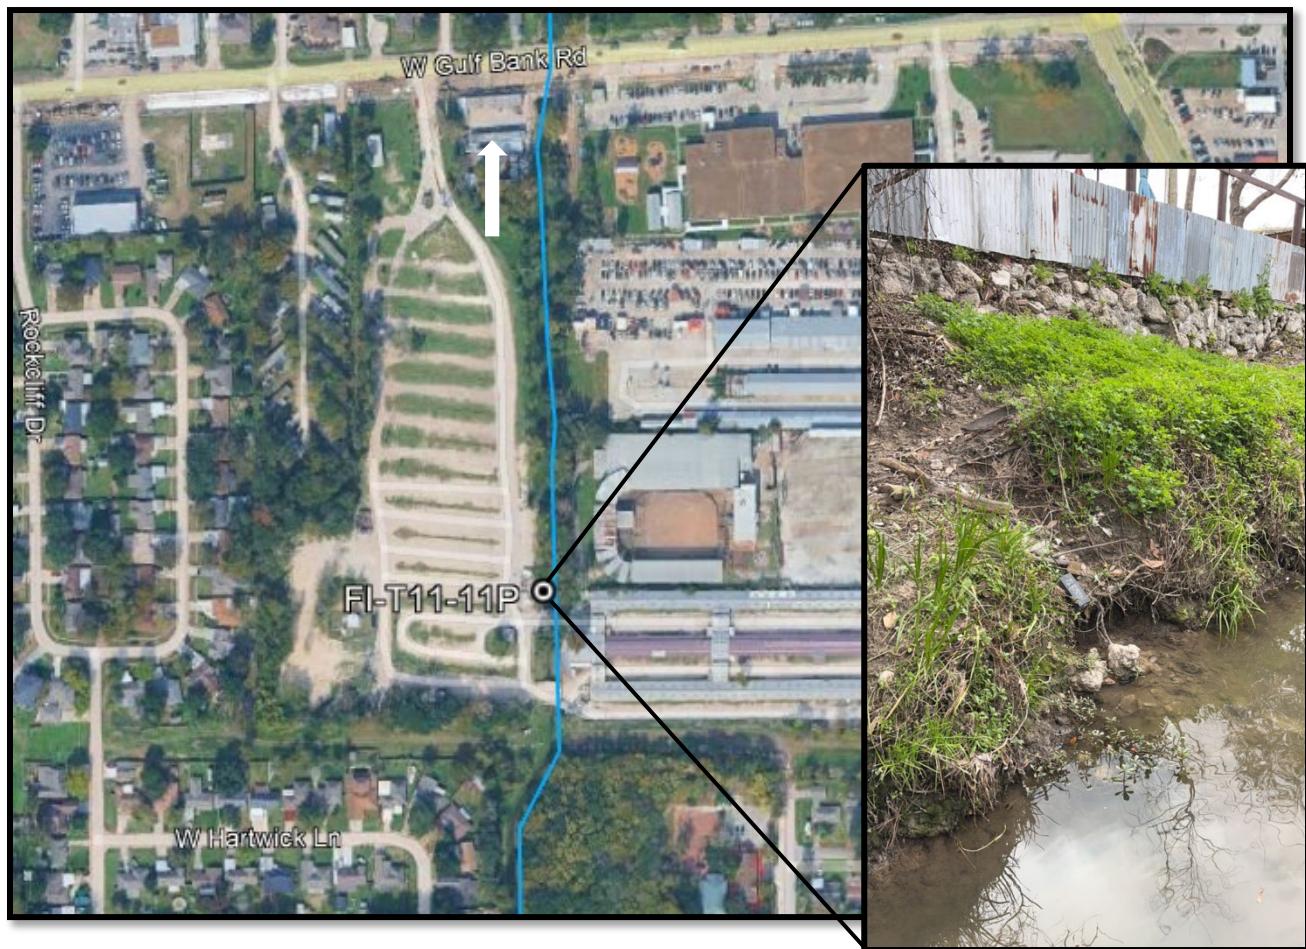
Sample FI-T11-11P (>242,000 colonies/100 mL) was collected in the mixing zone below a ditch with little flow coming into Tributary 11 on the right bank (Figure 11). The ditch appeared to be stemming from under metal fences which, upon further inspection were determined to be surrounded by properties featuring a livestock area and Sunny Flea Market at 8705 Airline Drive. This location was just downstream from a bridge crossing with three culvert openings.

Figure 11. Referral Site FI-T11-11P. Map showing proximity to livestock area, Sunny Flea Market, and subset image of tributary view. White arrow indicates direction of flow within the tributary. Blue line indicates tributary line.

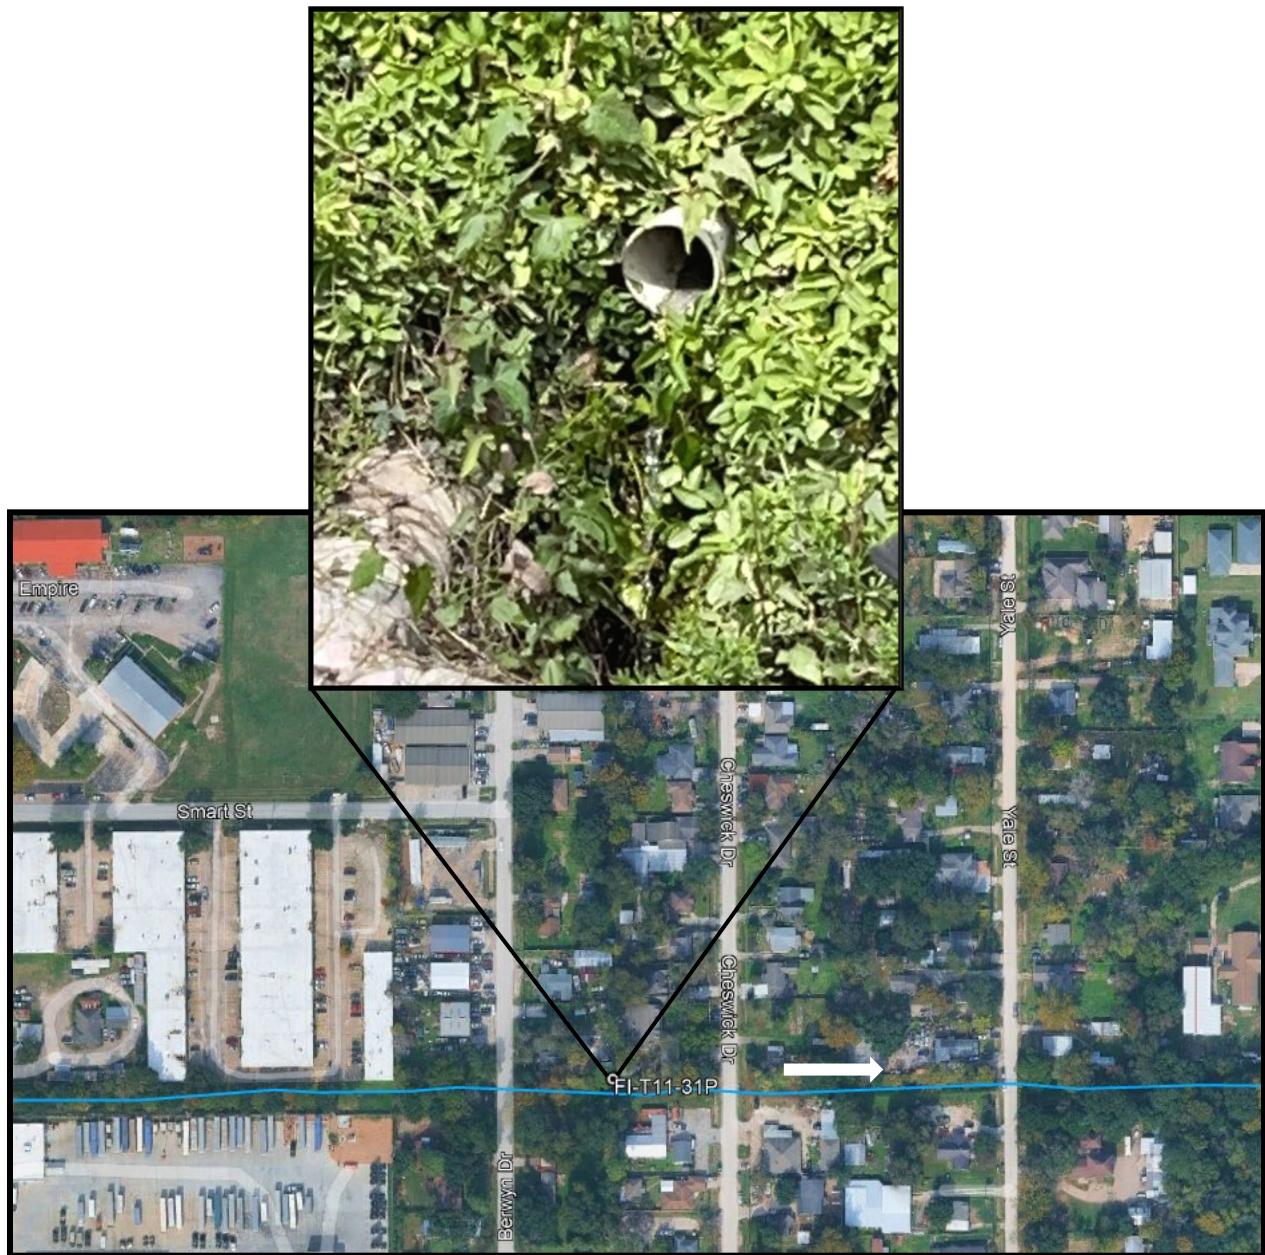
Referral site: FI-T11-31P

This sample was collected directly from the upper flowing PVC pipe on the left bank of the Unnamed Tributary of Halls Bayou between Berwyn and Cheswick Drive (Figure 12). This pipe is five inches in diameter with < 0.25 inches of water within the pipe at the time of sample collection. Bacteria results from this pipe had a value of >242,000 colonies/100mL. This neighborhood was noted during the desktop review to feature both permitted and non-registered OSSF.

Figure 12. Referral Site FI-T11-31P. Map showing proximity to residential neighborhood and subset image of tributary view. White arrow indicates direction of flow within the tributary. Blue line indicates tributary line.

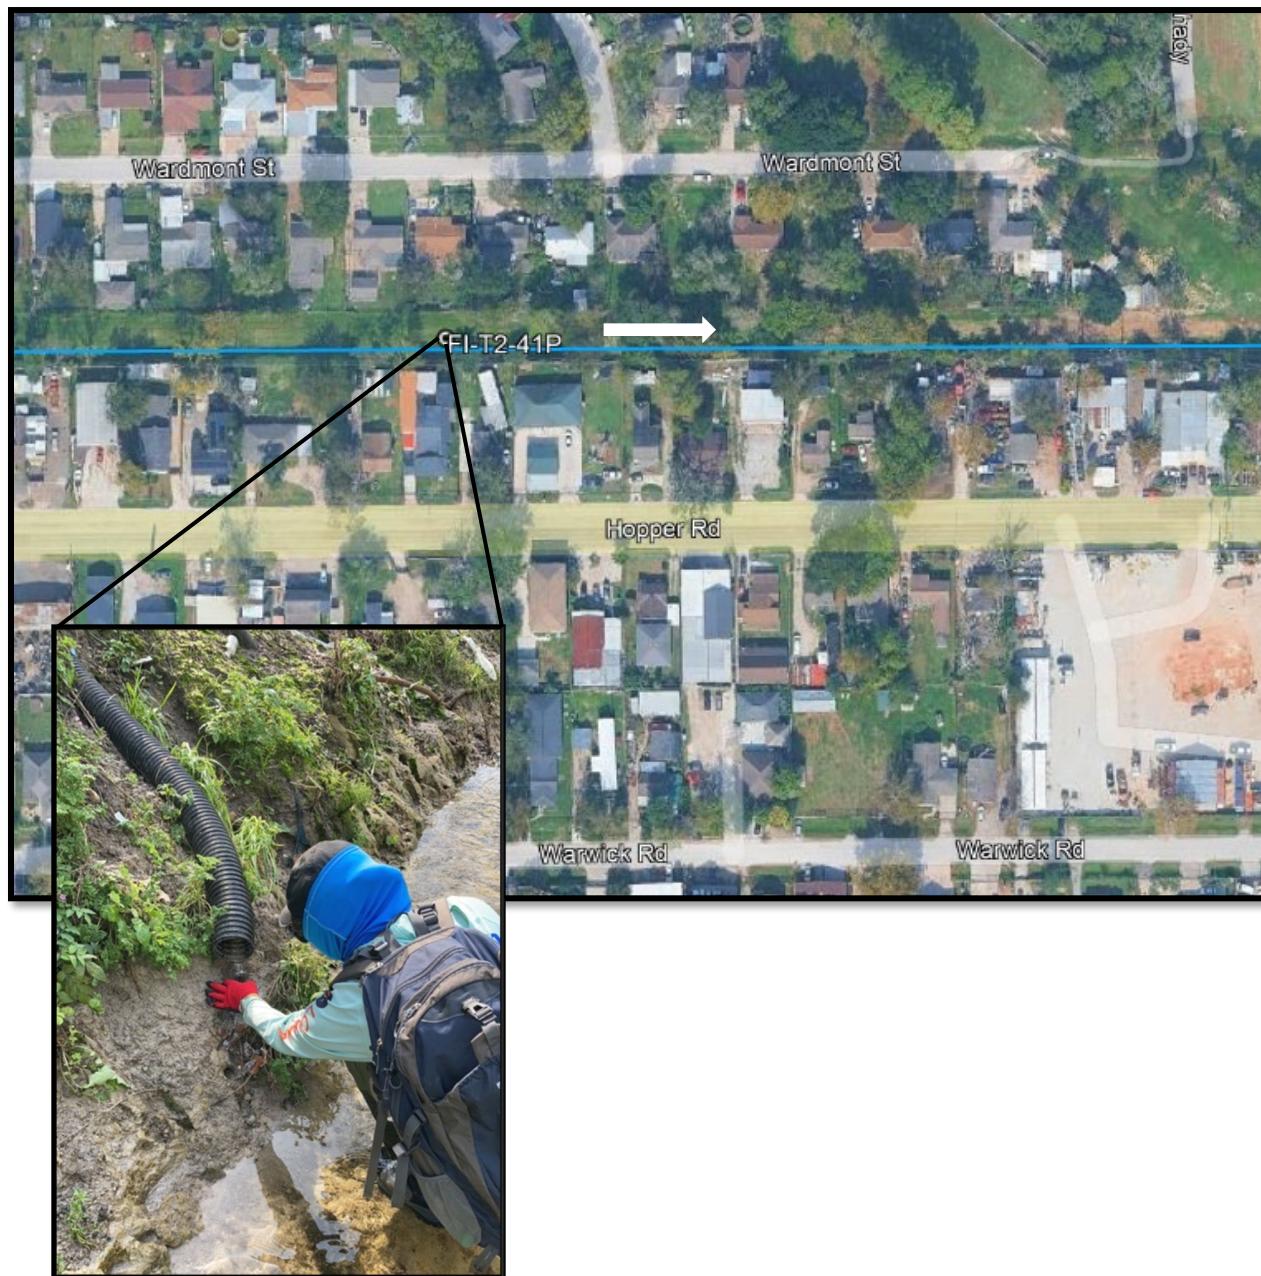
This was a direct sample taken from a four-inch black plastic corrugated pipe on the right bank of the Unnamed Tributary of Halls Bayou (Figure 13). Two pipes were observed leaking from the property, with the water carried down by the sampled pipe with a water depth < 0.25 inches. Field staff noted a potent sewer smell in the air. This sample had a bacteria value of >242,000 colonies/100 mL.

Figure 13. Referral Site FI-T2-41P. Map showing proximity to residential neighborhood and subset image of tributary view. White arrow indicates direction of flow within the tributary. Blue line indicates tributary line.

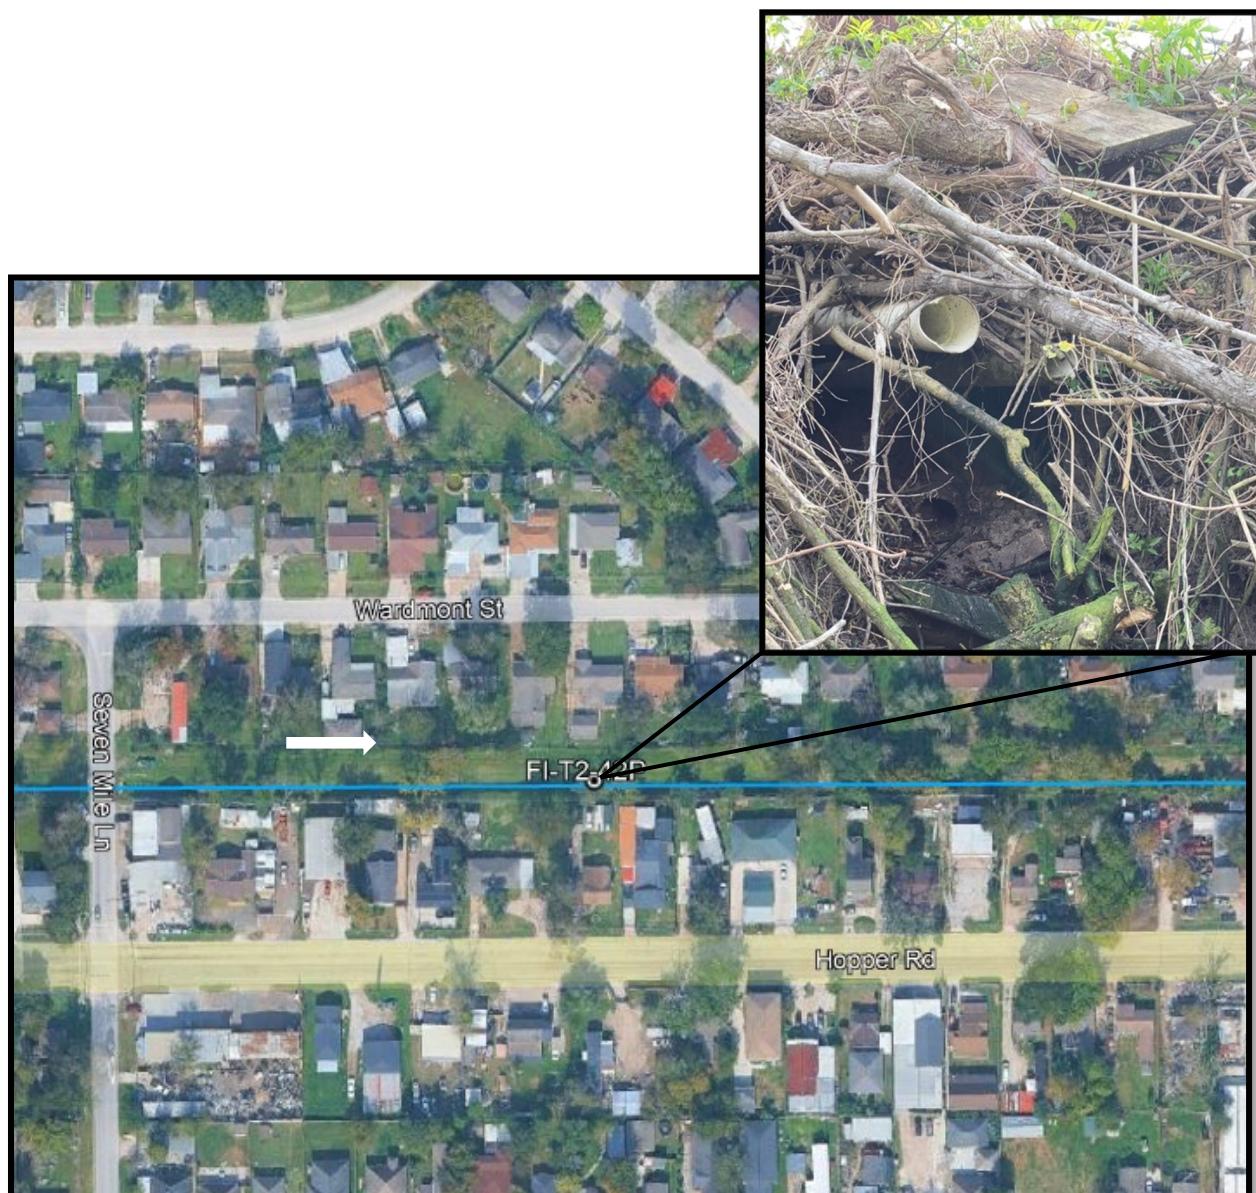
The location for this sample featured two white plastic pipes on the right bank (Figure 14). Field staff only collected a sample from the pipe on the right due to an insufficient amount of sampleable water flowing from the left pipe. There was a significant amount of roots surrounding the pipe. This sample had a bacteria value of 57,900 colonies/100 mL and was approximately 21.62 meters upstream from referral site FI-T2-41P. Field staff noted that they passed three more small diameter (approximately 4 inch or less) pipes from residential properties on the way to the next sample location, however, they were all dry.

Figure 14. Referral Site FI-T2-42P. Map showing proximity to residential neighborhood and subset image of tributary view. White arrow indicates direction of flow within the tributary. Blue line indicates tributary line.

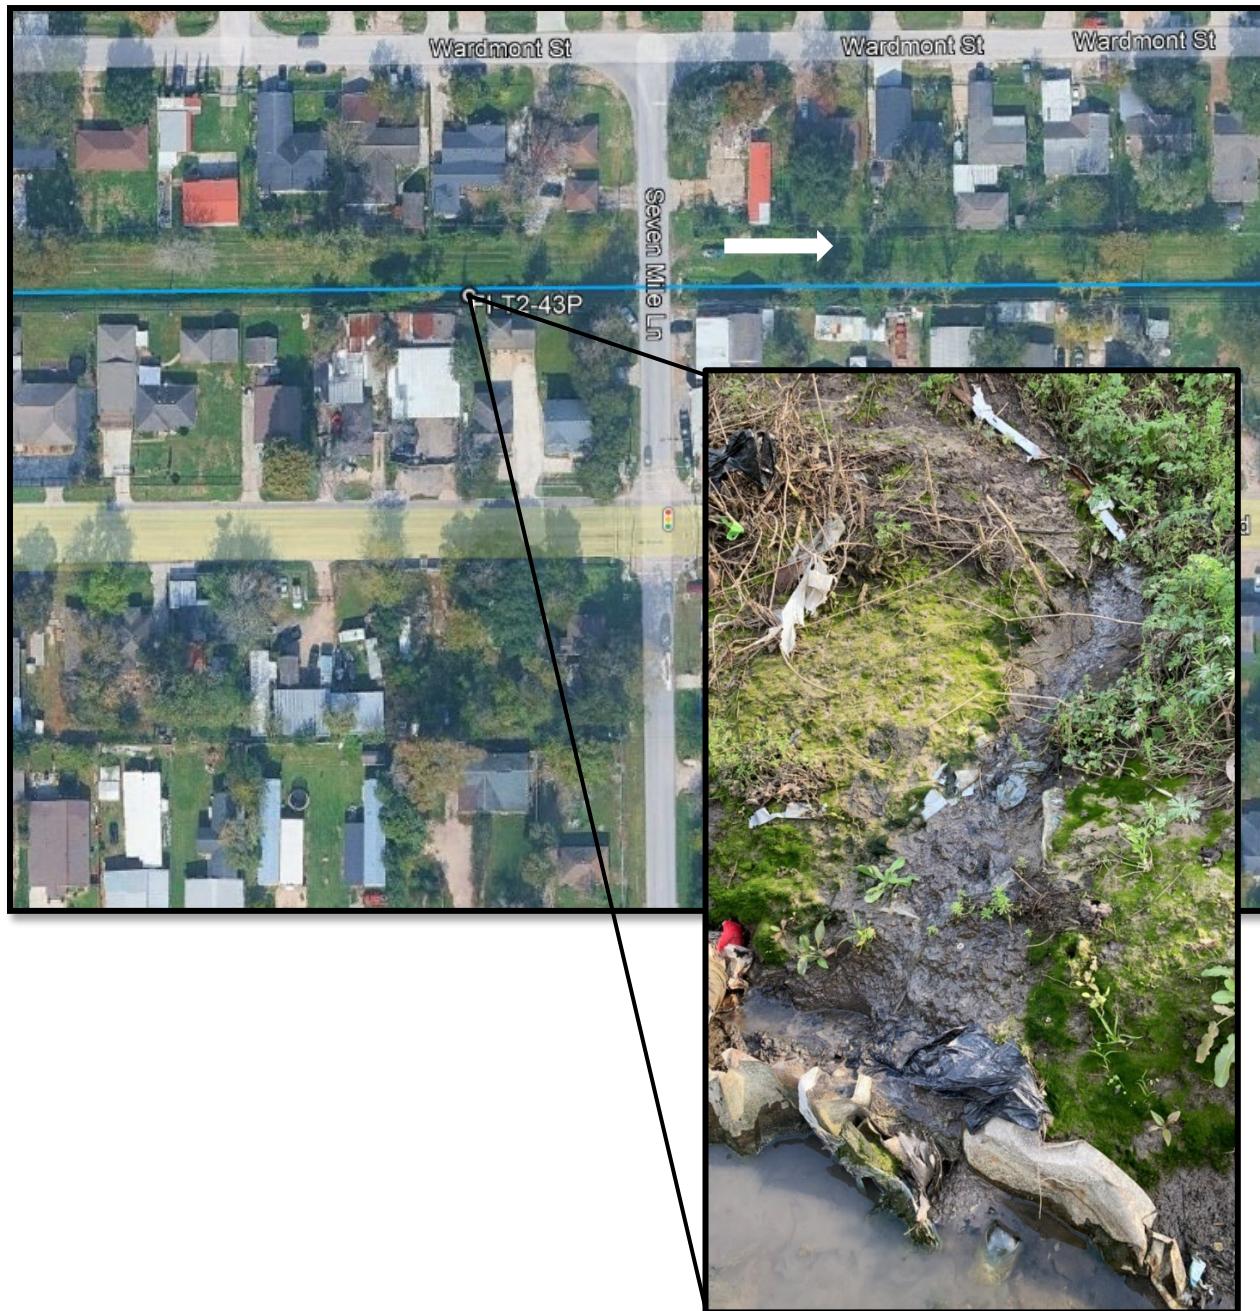
This sample was taken from an open top earthen ditch on the right bank of the Unnamed Tributary of Halls Bayou from a fenced residential property (Figure 15). Field staff noted that a pipe was not observed, and litter was present at the sampling location. The bacteria value at this sample location was 24,800 colonies/100 mL.

Figure 15. Referral Site FI-T2-43P. Map showing proximity to residential neighborhood and subset image of tributary view. White arrow indicates direction of flow within the tributary. Blue line indicates tributary line.

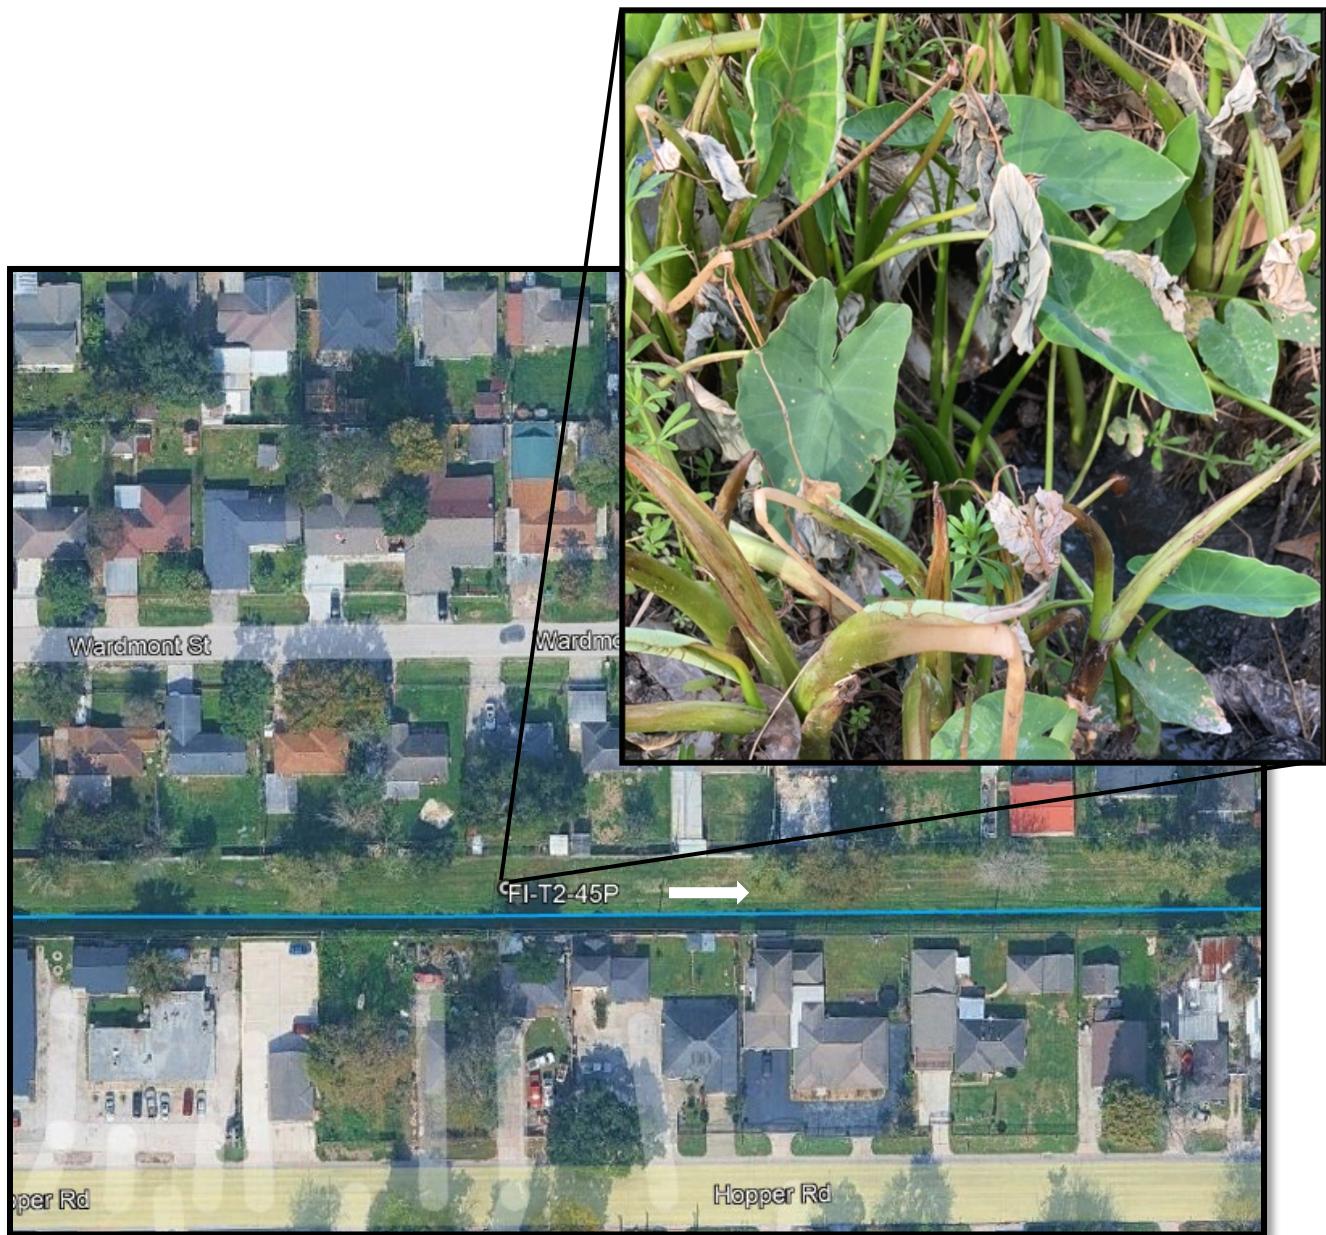
This was a direct sample collected from a small pool of water being held in a depression on the left bank of a slightly flowing four-inch diameter white PVC pipe (Figure 16). This pipe originated from a residential property with a bacteria value of 16,200 colonies/100 mL.

Figure 16. Referral Site FI-T2-45P. Map showing proximity to residential neighborhood, permitted OSSF, businesses and subset image of tributary view. White arrow indicates direction of flow within the tributary. Blue line indicates tributary line.

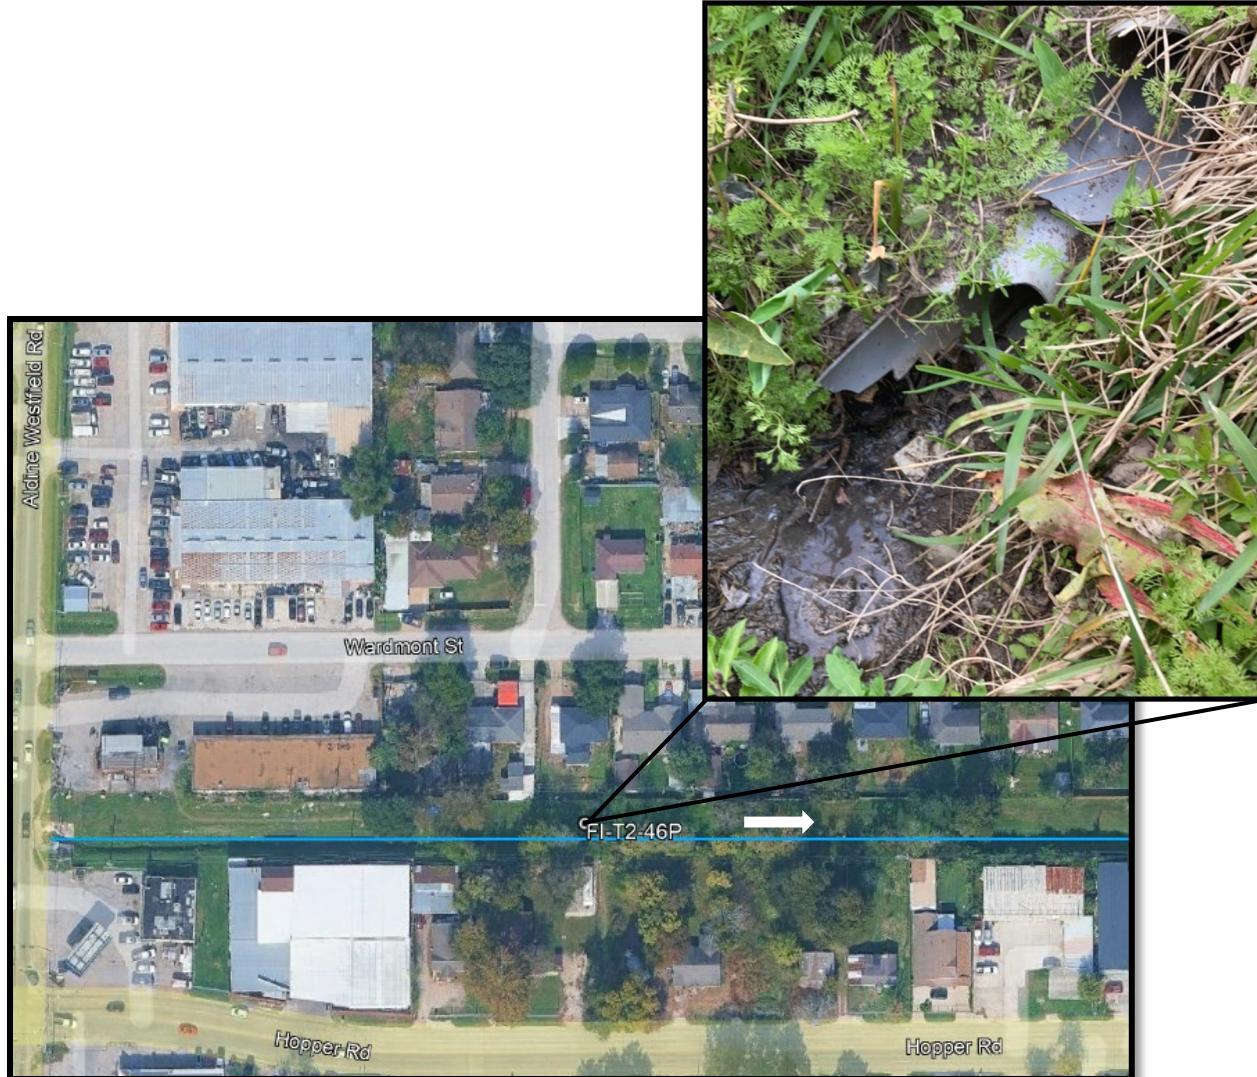
This was a direct sample from a four-inch PVC pipe on the left bank of the Unnamed Tributary of Halls Bayou (Figure 17). This pipe stemmed from a residential property with two pipes stacked on top of each other, however, only the bottom pipe was flowing. This sample had a bacteria value of >242,000 colonies/100 mL.

Figure 17. Referral Site FI-T2-46P. Map showing proximity to residential neighborhood and subset image of tributary view. White arrow indicates direction of flow within the tributary. Blue line indicates tributary line.

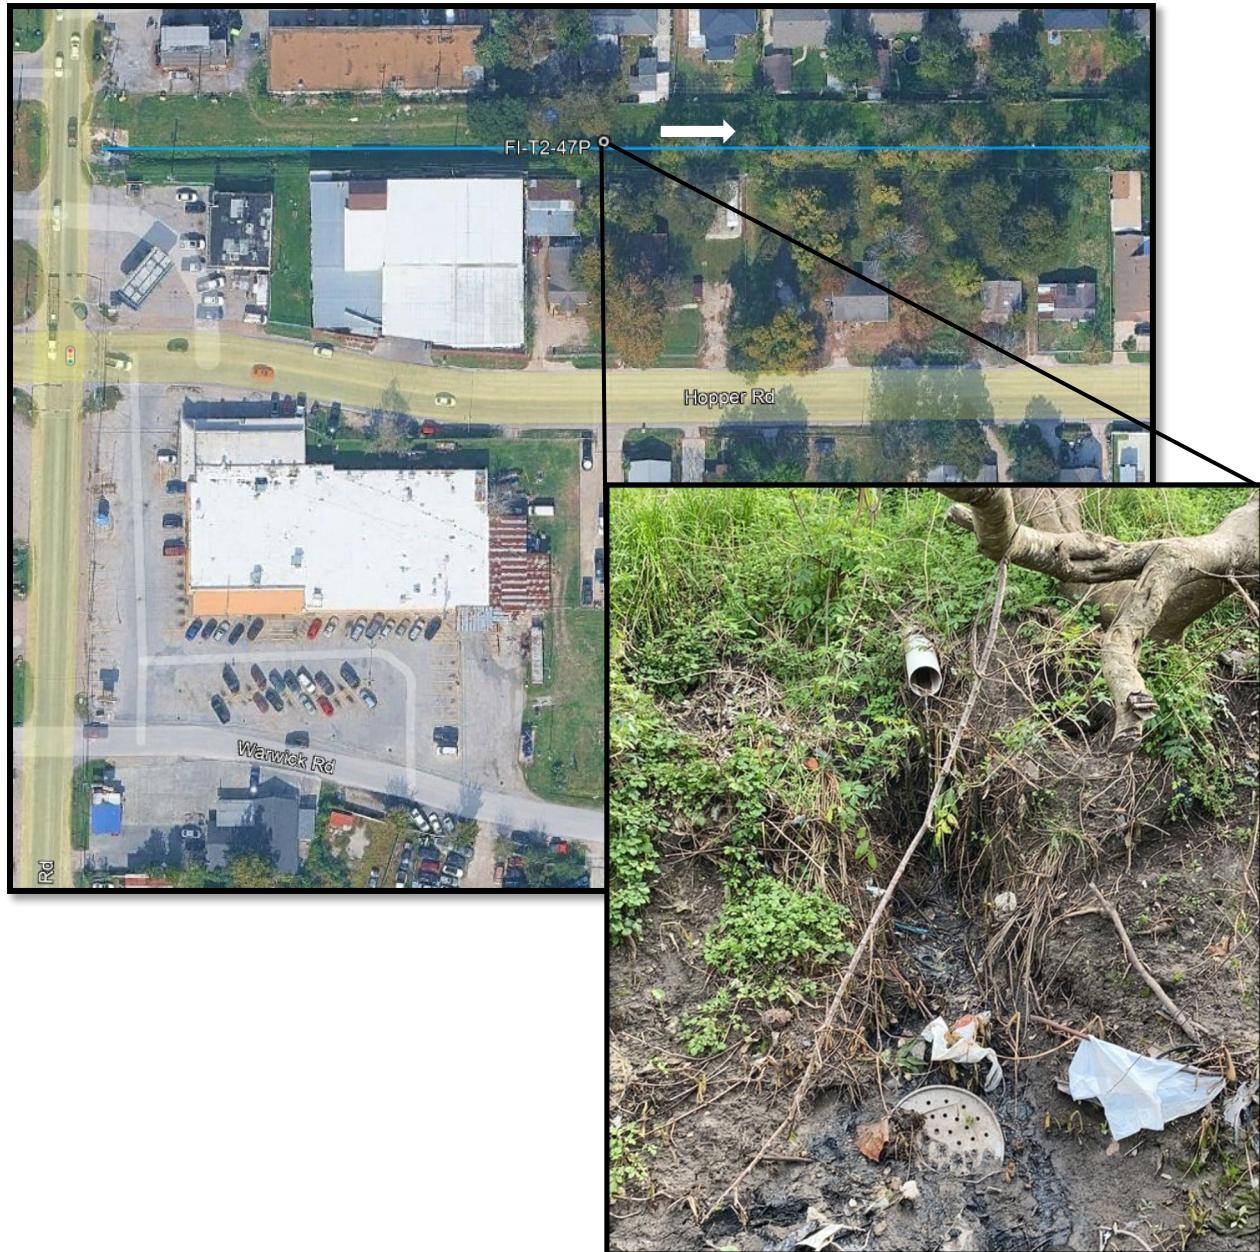
This sample was taken directly from a four-inch white PVC pipe from a residential property on the right bank of the Unnamed Tributary of Halls Bayou with a bacteria value of >242,000 colonies/100 mL (Figure 18). This sample location was 28.32 meters upstream of the previous referral site.

Figure 18. Referral Site FI-T2-47P. Map showing proximity to residential neighborhood, business properties and subset image of tributary view. White arrow indicates direction of flow within the tributary. Blue line indicates tributary line.

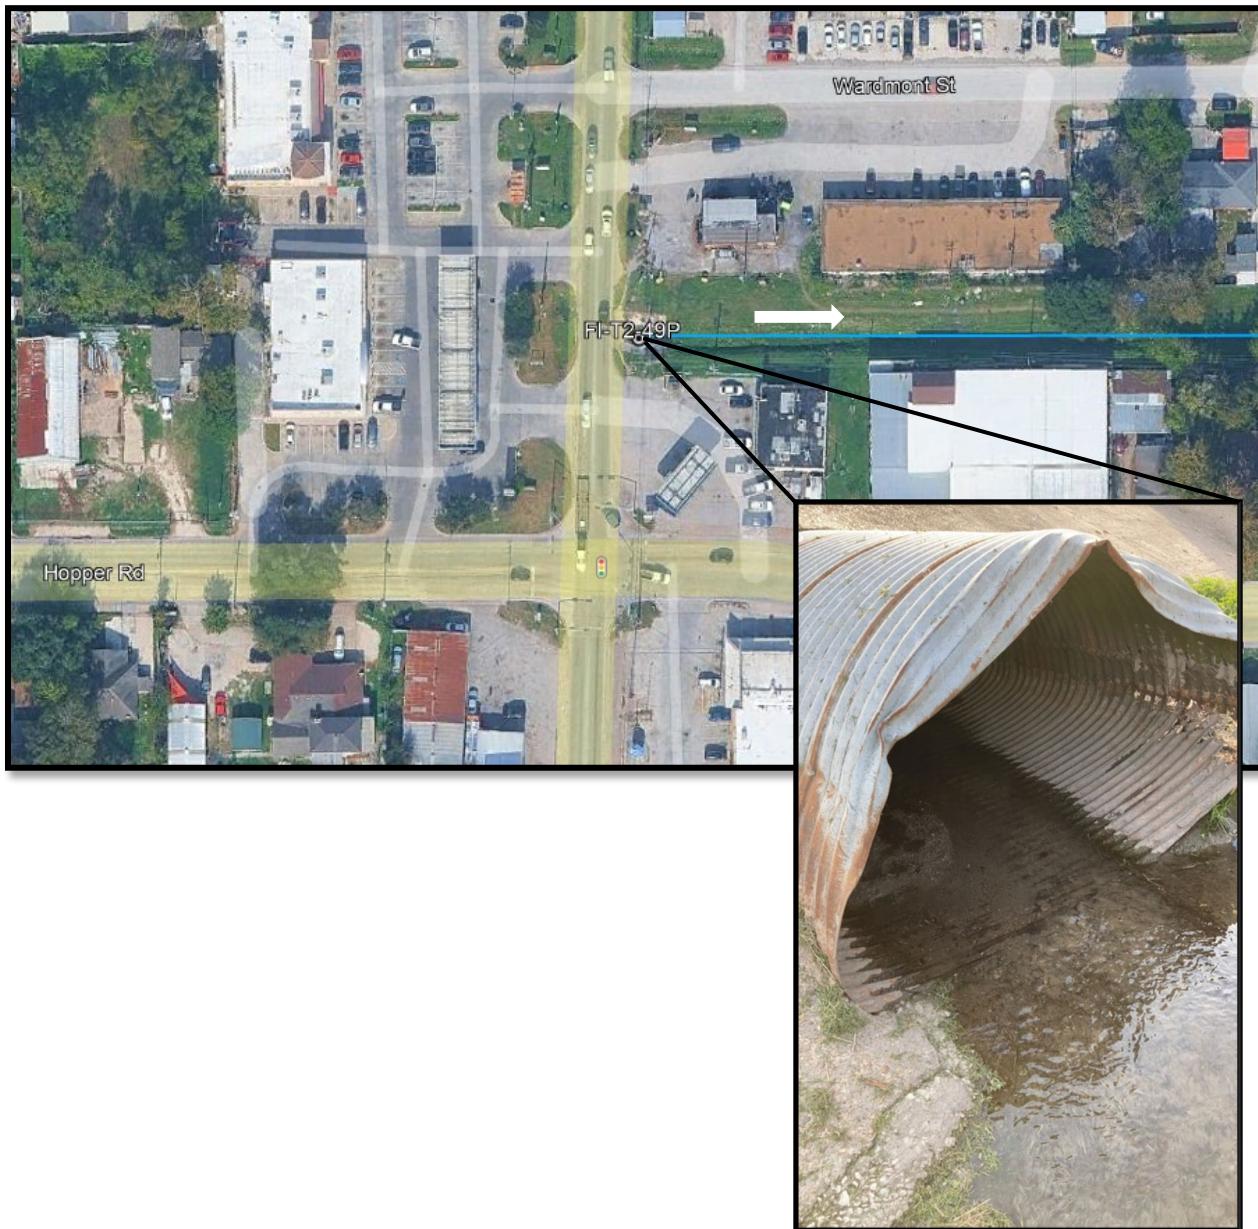
Sample FI-T2-49P (>242,000 colonies/100 mL) was taken from a partially submerged outfall pipe on the right bank at the start of the Unnamed Tributary at Aldine Westfield Road (Figure 19). Another sample was taken from a smaller outfall pipe located on the left bank with a bacteria value of 2,560 colonies/100 mL. This area was just north of the business property featuring a food truck and field staff observed a possible homeless encampment in a concrete culvert under a bridge upstream of the outfalls.

Figure 19. Referral Site FI-T2-49P. Map showing start of tributary, proximity to business property and subset image of tributary view. White arrow indicates direction of flow within the tributary. Blue line indicates tributary line.

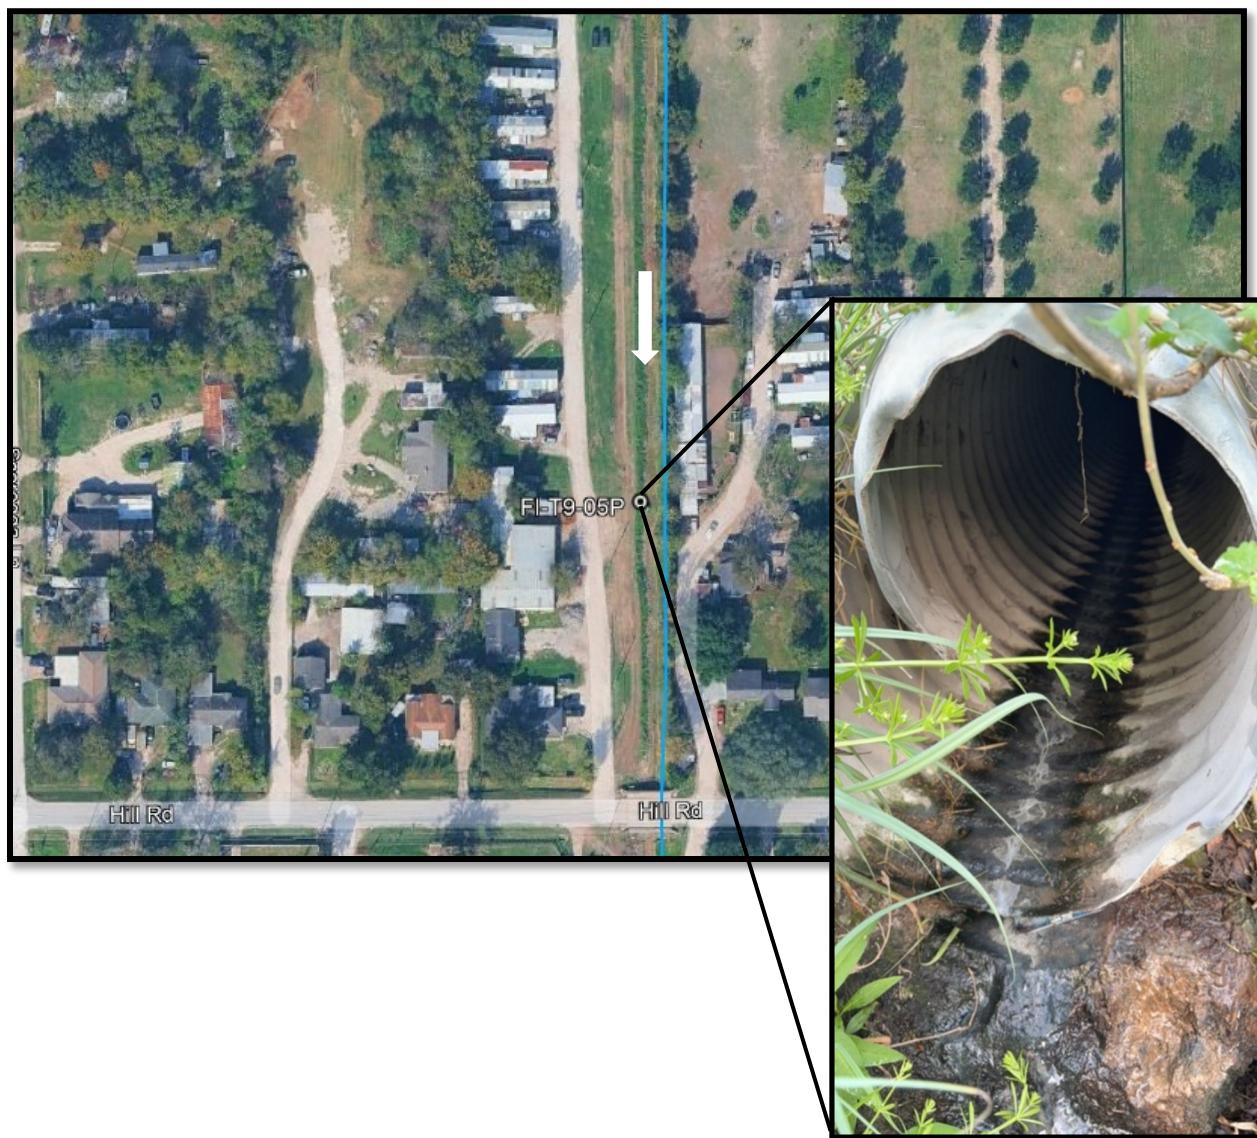
Sample FI-T9-05P (20,100 colonies/100 mL) This was a direct sample from a 24-inch outfall pipe on the right bank of the Unnamed Tributary of Halls Bayou ([Figure 20](#)). Field staff noted a white film inside the pipe and a sewage smell originating from the outfall. This sample point was near wooden and metal shacks that contained horses on the left bank just upstream of the sample location and horses were observed on the right bank. Manufactured homes are present on both banks and towards the east of the sample location there is a large estate featuring a pond in the back.

Figure 20. Referral Site FI-T9-05P. Map showing proximity to horse shacks, manufactured homes, and large estate as well as subset image of tributary view. White arrow indicates direction of flow within the tributary. Blue line indicates tributary line.

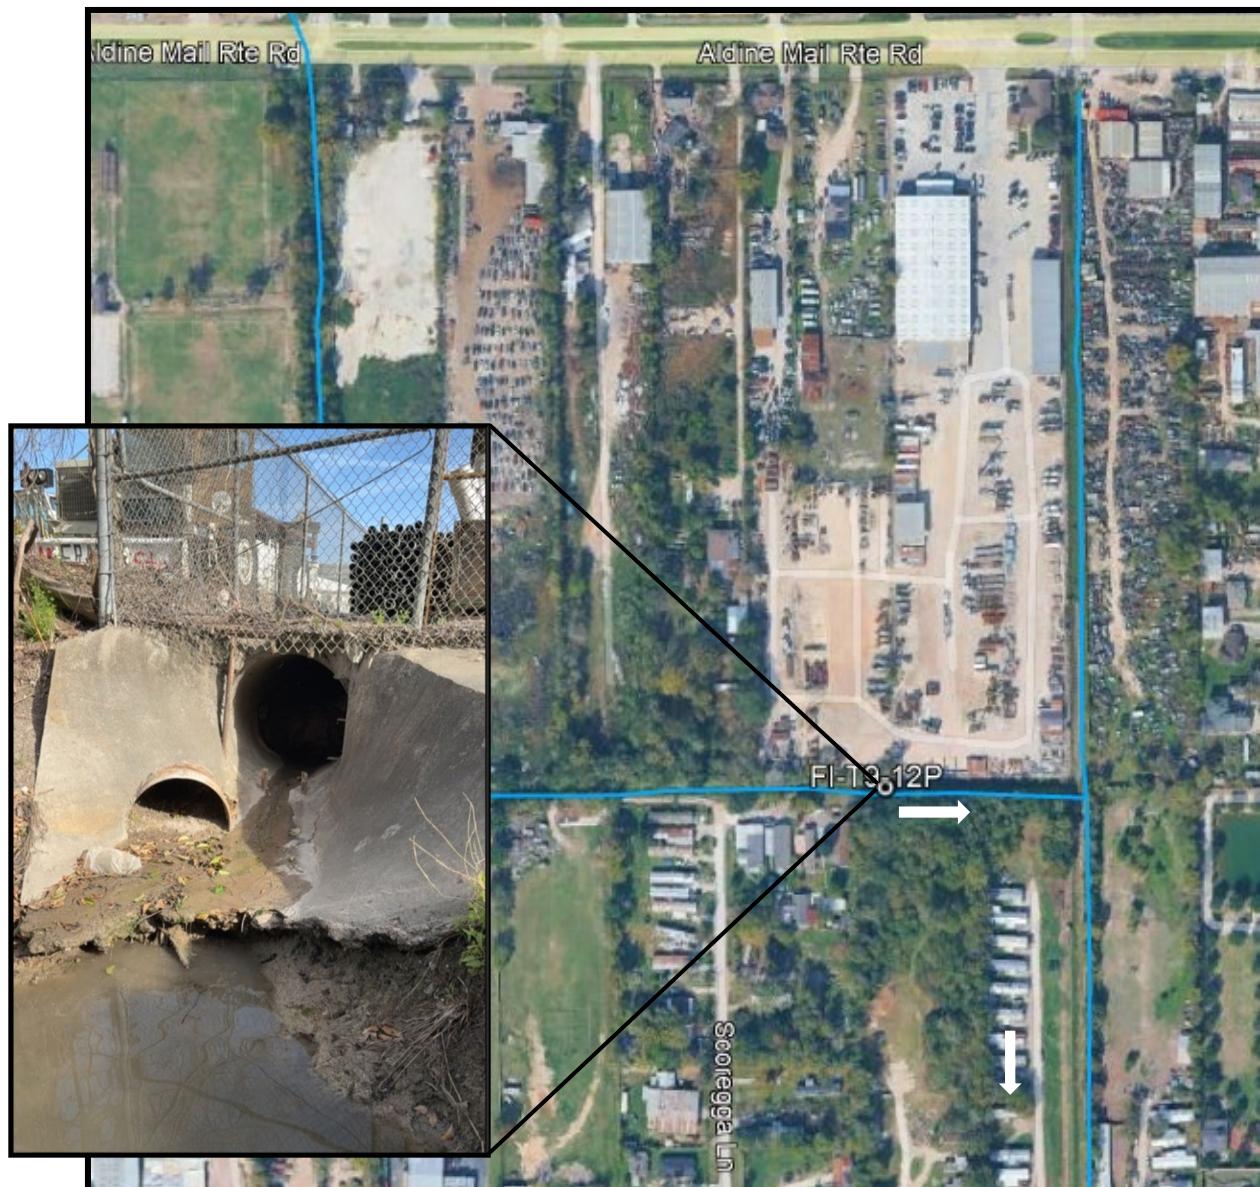
This location is at a point where the Unnamed Tributary of Halls Bayou splits west approximately 370 meters downstream of Aldine Mail Rte. Road (Figure 21). Field staff continued west where they collected a sample directly from the top concrete outfall pipe (36 inches in diameter) on the left bank. The bacteria value of this sample was 36,100 colonies/100 mL. Just north of the sample point, there appeared to be a sizeable property undergoing construction presumably owned by North Houston Pole Line on Aldine Mail Rte. Road. Also, field staff observed an oil sheen in the tributary near the sample location.

Figure 21. Referral Site FI-T9-12P. Map showing proximity to construction property and subset image of tributary view. White arrow indicates direction of flow within the tributary. Blue line indicates tributary line.

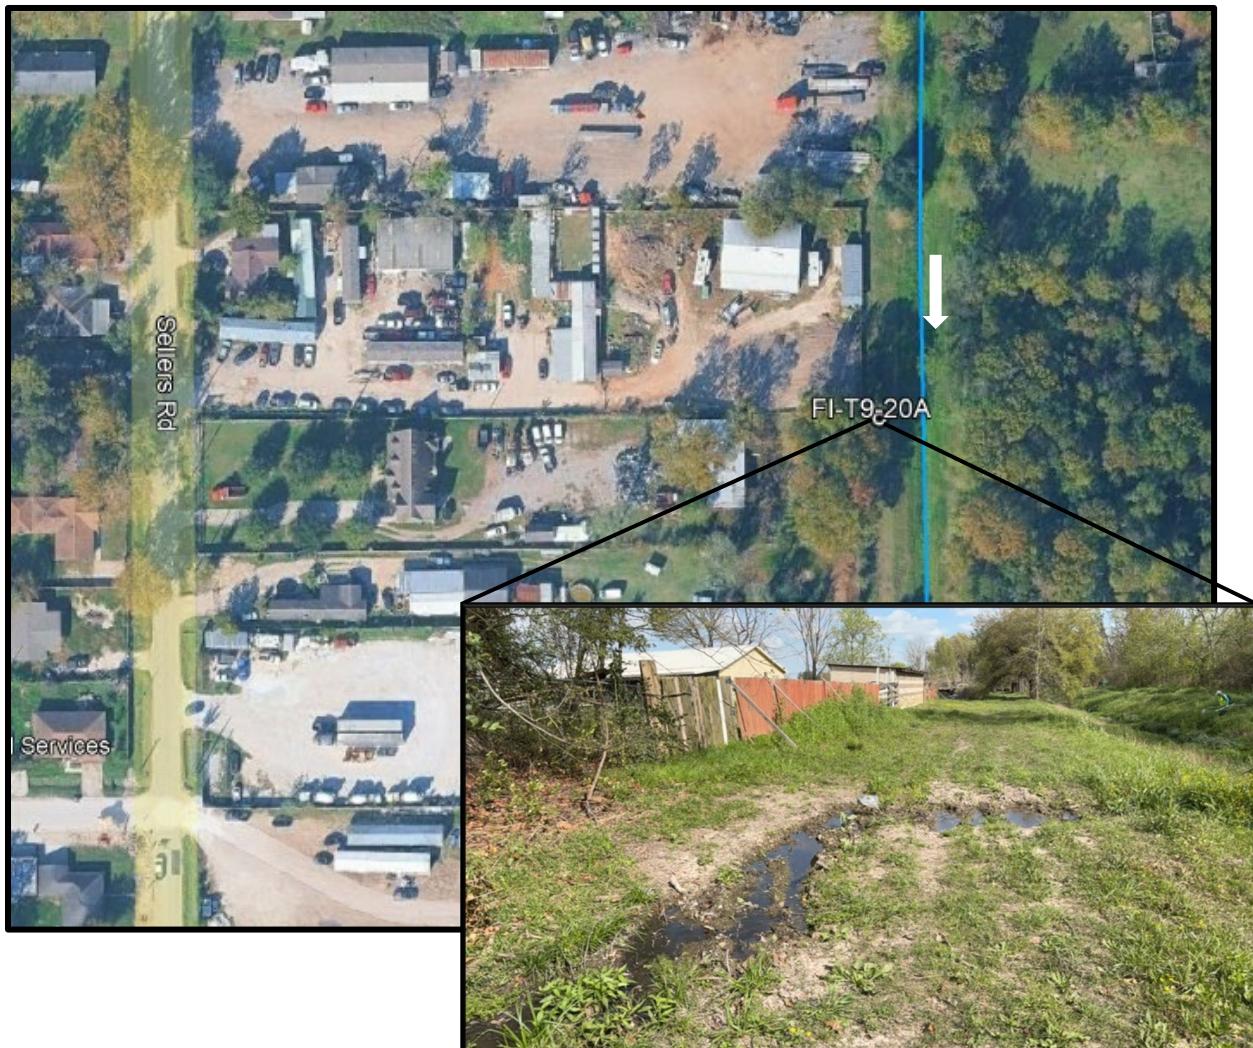
Sample FI-T9-20A (21,400 colonies/100 mL) This was an ambient sample taken from overland runoff on the right bank with slightly trickling waterflow (Figure 22). The sample point was located east of Sellers Road just behind what appears to be a mixed-use property.

Figure 22. Referral Site FI-T9-20A. Map showing proximity to surrounding properties and subset image of tributary view. White arrow indicates direction of flow within the tributary. Blue line indicates tributary line.

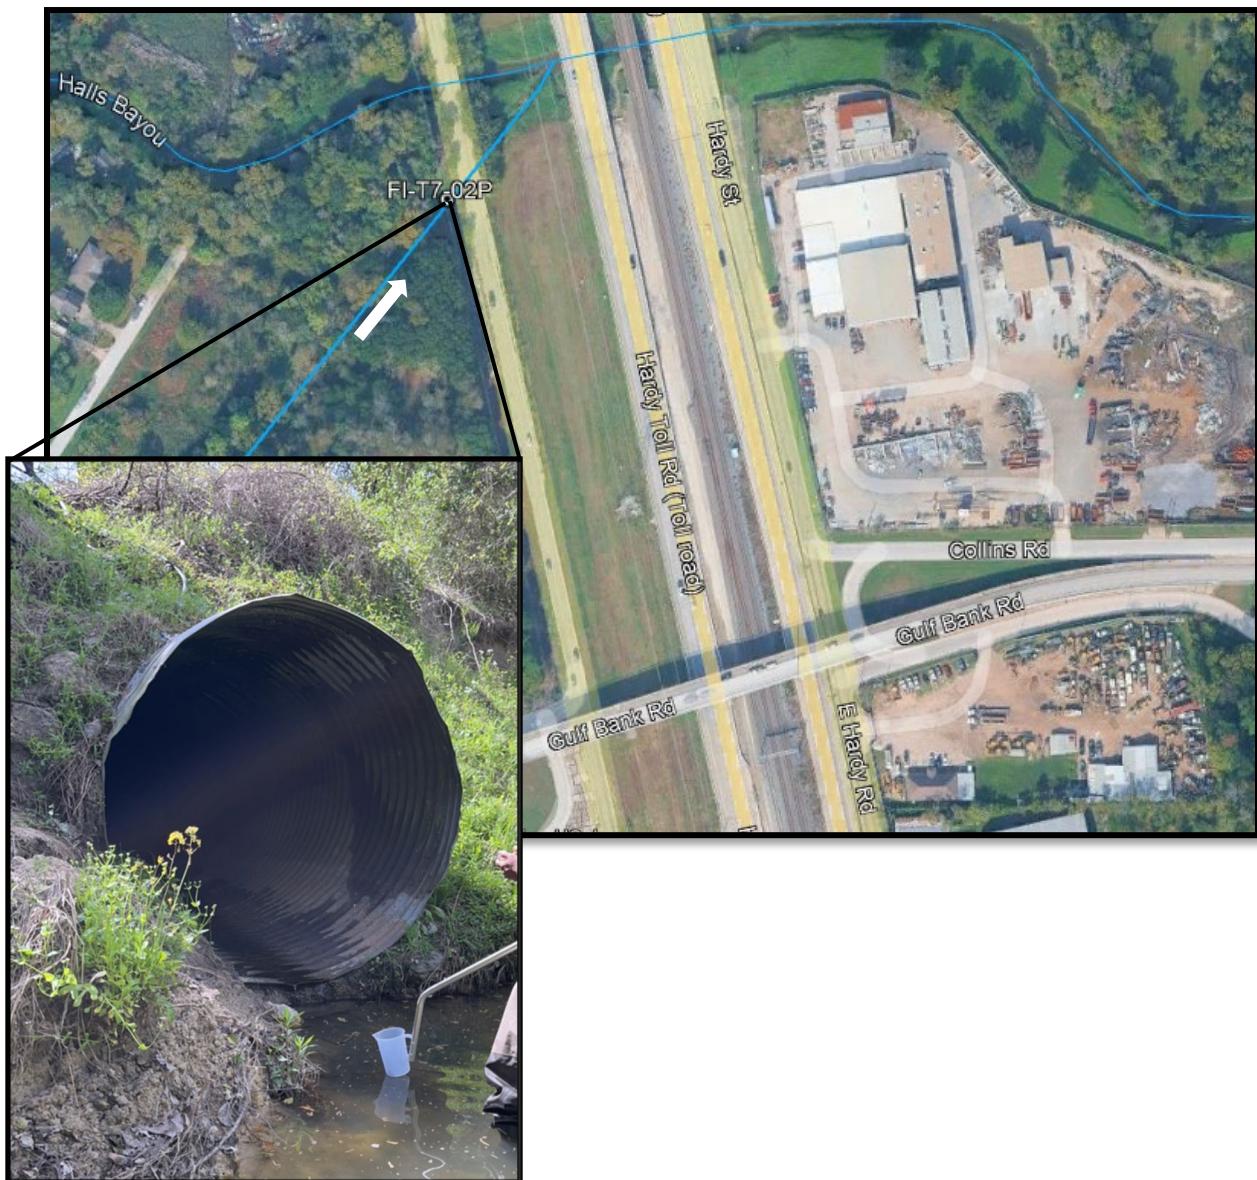
This pipe was located just upstream of Hardy Street, approximately 75.5 meters upstream of where tributary 7 flows into Halls Bayou (Figure 23). This was a direct sample taken from a 72-inch corrugated pipe on the right bank of the tributary with a bacteria value of 5,280 colonies/100mL. Field staff observed a slight sheen on the water's surface.

Figure 23. Referral Site FI-T7-02P. Map showing tributary 7 and subset image of tributary view. White arrow indicates direction of flow within the tributary. Blue line indicates tributary line.
