Targeted Bacteria Monitoring Project

FY25 Final Report – Assessment Unit: 1006D_02 Halls Bayou

Houston-Galveston Area Council
3555 Timmons Lane, Suite 100 Houston,
TX 77027

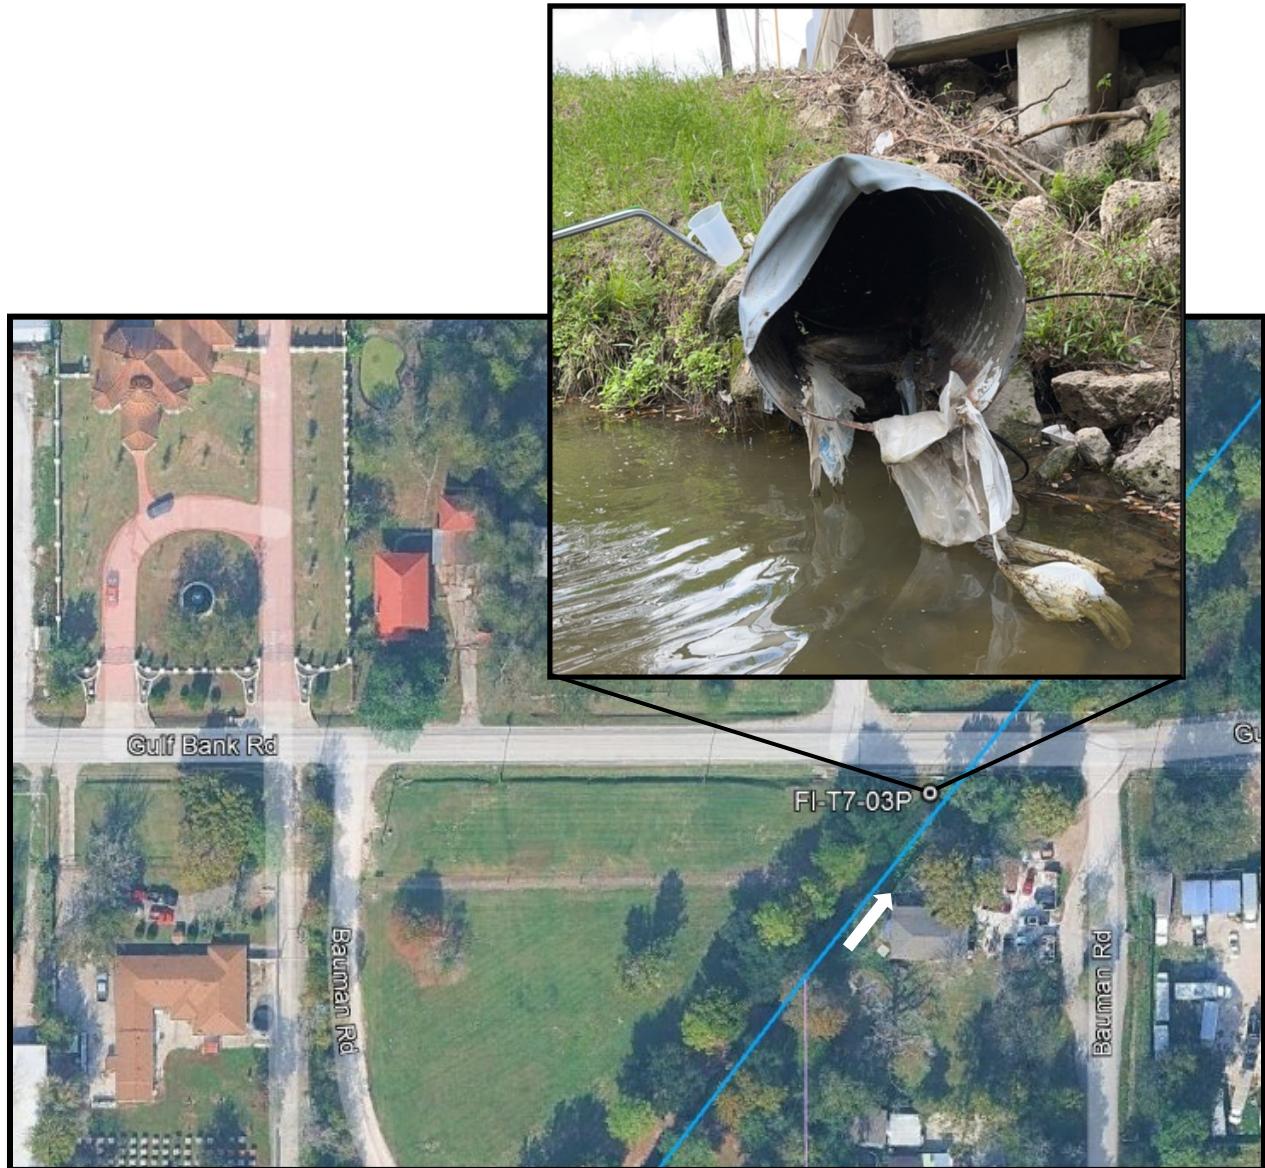
This was a direct sample taken from a 23 inch slightly crushed metal pipe on the left bank just upstream of a bridge at Gulf Bank Road (Figure 24). This pipe was rusted out on the bottom and had < 0.25 inches of water trickling out. This sample had a bacteria value of 7,170 colonies/100 mL.

Figure 24. Referral Site FI-T7-3P. Map showing proximity to residential property and subset image of tributary view. White arrow indicates direction of flow within the tributary. Blue line indicates tributary line.

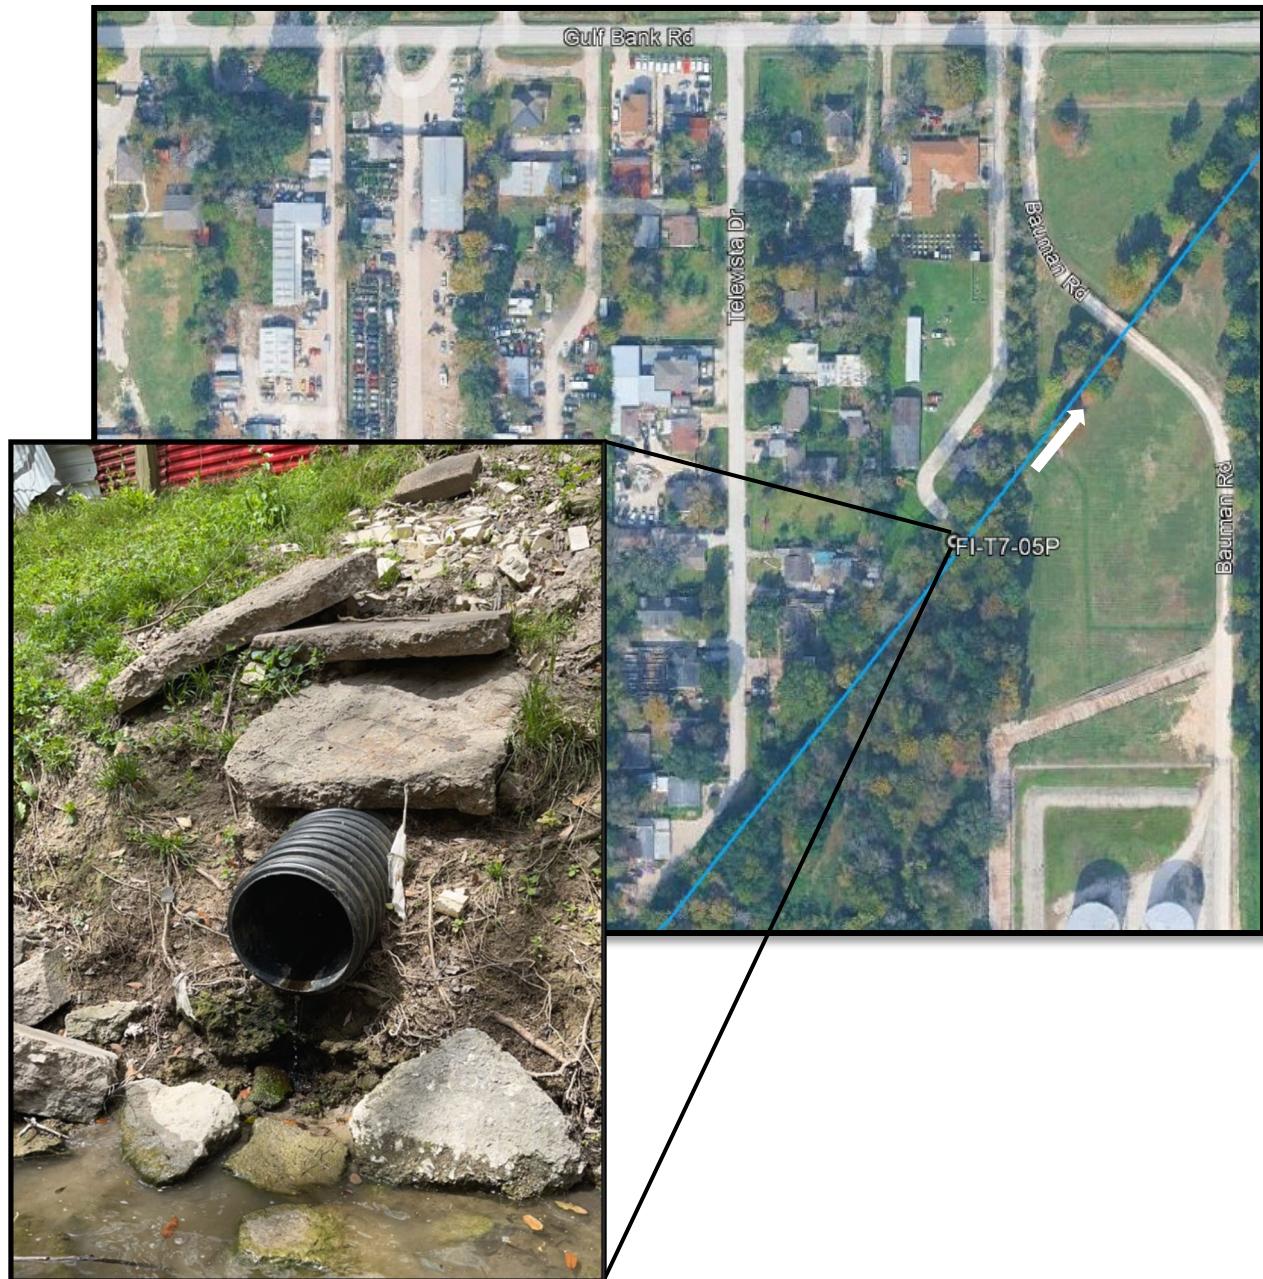
Sample FI-T7-05P (2,110 colonies/100 mL) was a direct sample from a corrugated outfall pipe on the left bank of the tributary (Figure 25). The sample location is approximately 78 meters east of Televista Drive behind residential properties and auto sales lots.

Figure 25. Referral Site FI-T7-05P. Map showing proximity to Televista Dr, residential properties, and subset image of tributary view. White arrow indicates direction of flow within the tributary. Blue line indicates tributary line.

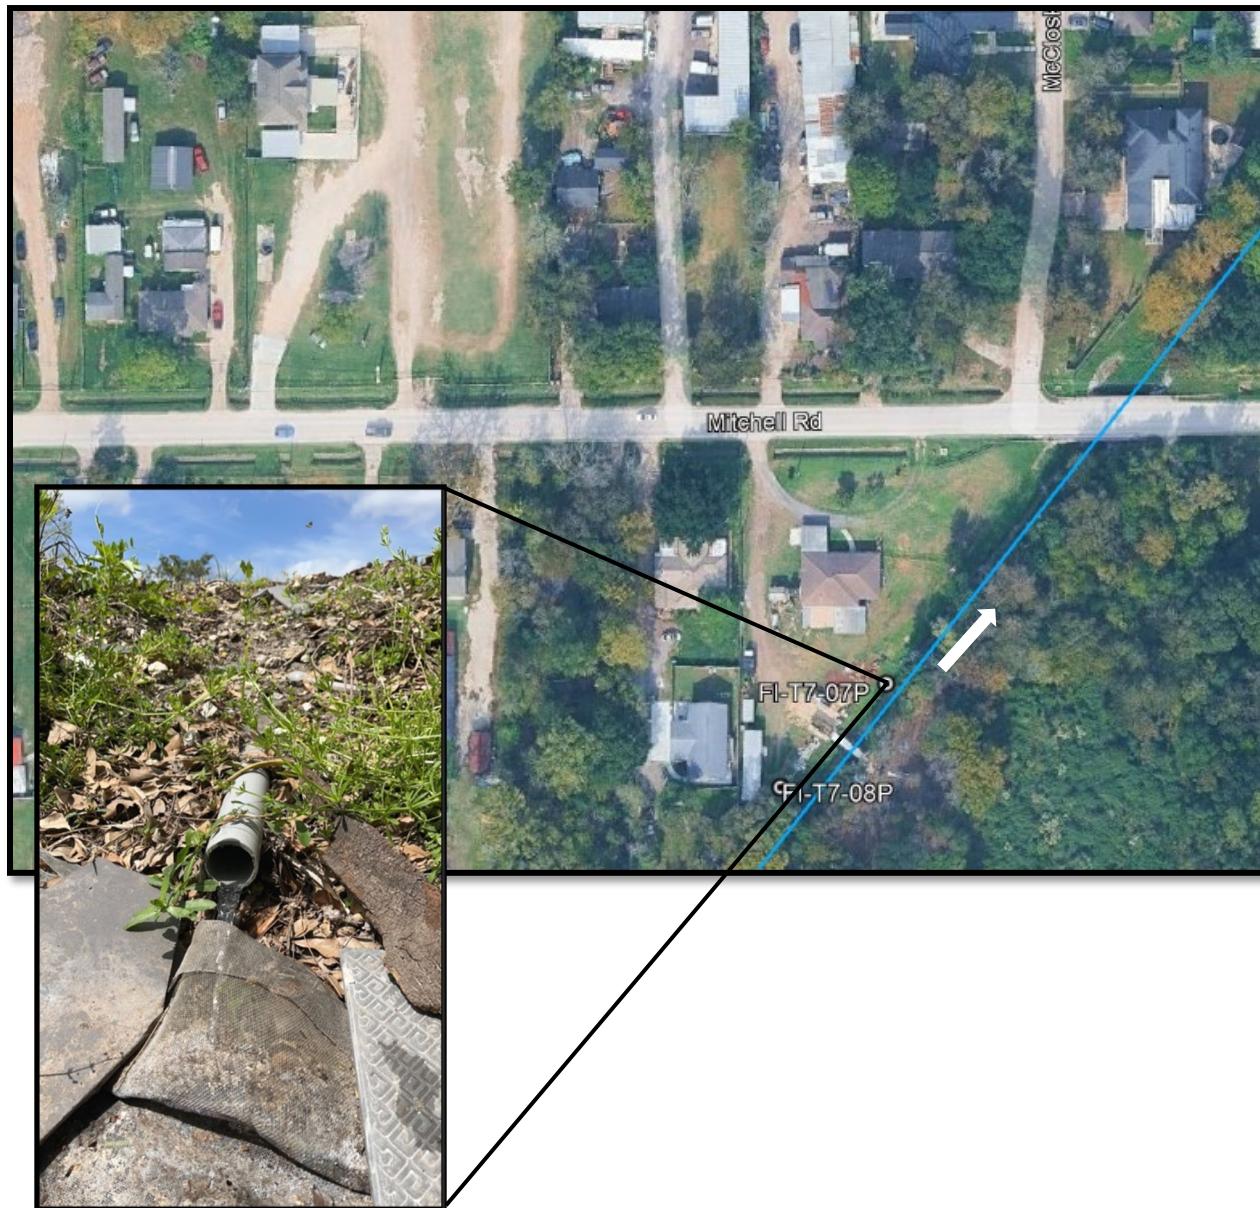
Sample FI-T7-07P (>242,000 colonies/100 mL) was directly taken from a pipe with trickling water behind a residential property, approximately 60 meters upstream of Mitchell Road (Figure 26). Based on H-GAC internal datasets, it appears that this sample point is located within a neighborhood that contains unregistered OSSFs.

Figure 26. Referral Site FI-T7-07P. Map showing proximity to residential property and subset image of tributary view. White arrow indicates direction of flow within the tributary. Blue line indicates tributary line.

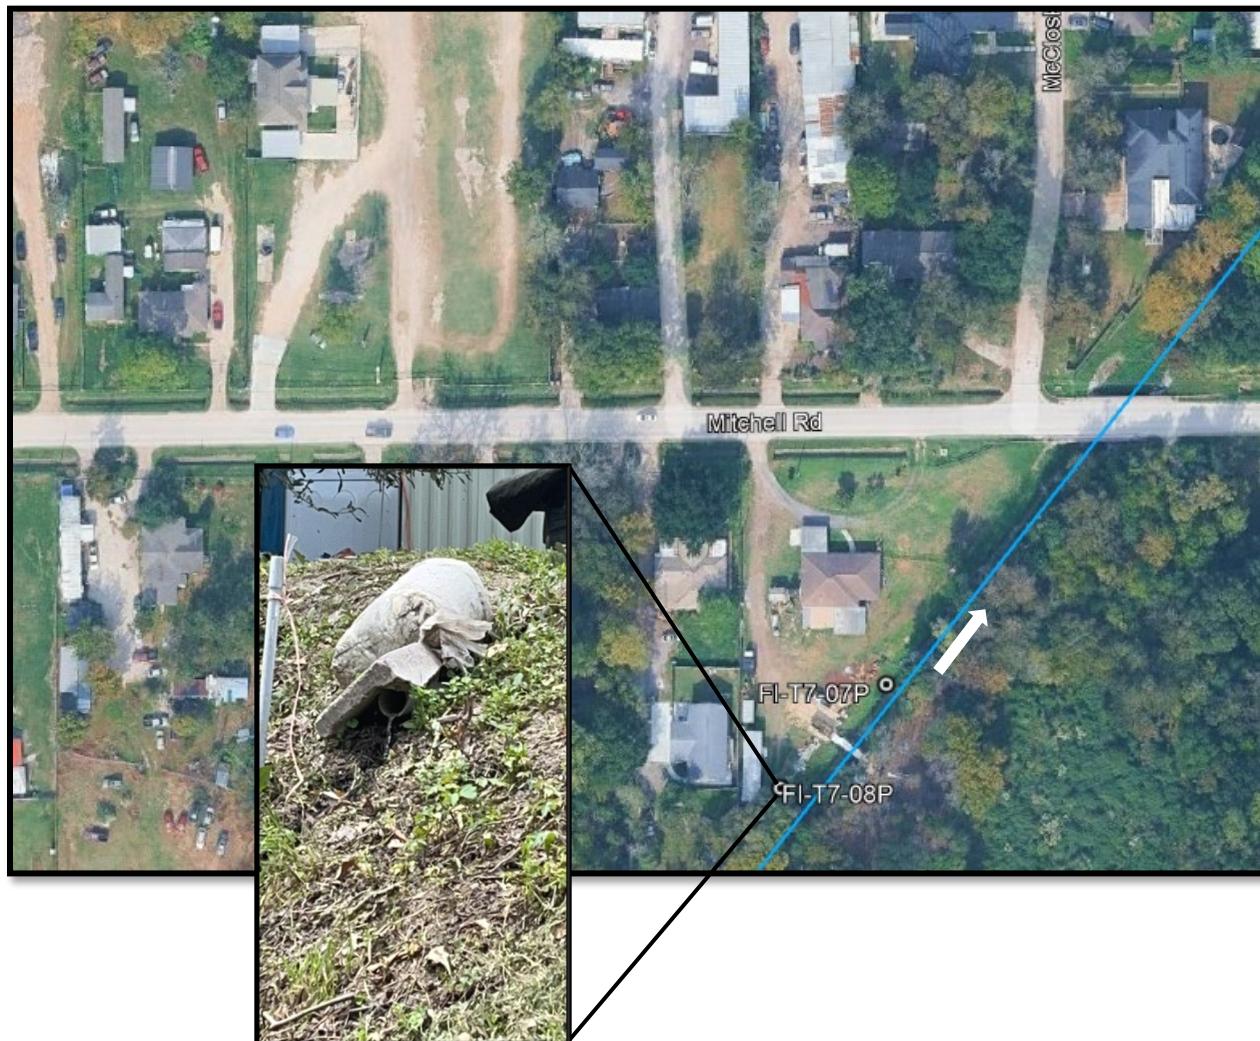
This sample was collected on the left bank directly from a pipe with < 0.25 inches of water flowing (Figure 27). The bacteria value of this sample was 36,500 colonies/100 mL. This pipe is located approximately 33.4 meters upstream of the previous referral site (FI-T7-07P) and appears to be stemming from residential properties located in the same neighborhood.

Figure 27. Referral Site FI-T7-08P. Map showing proximity to previous sample FI-T7-07P, residential properties, and subset image of tributary view. White arrow indicates direction of flow within the tributary. Blue line indicates tributary line.

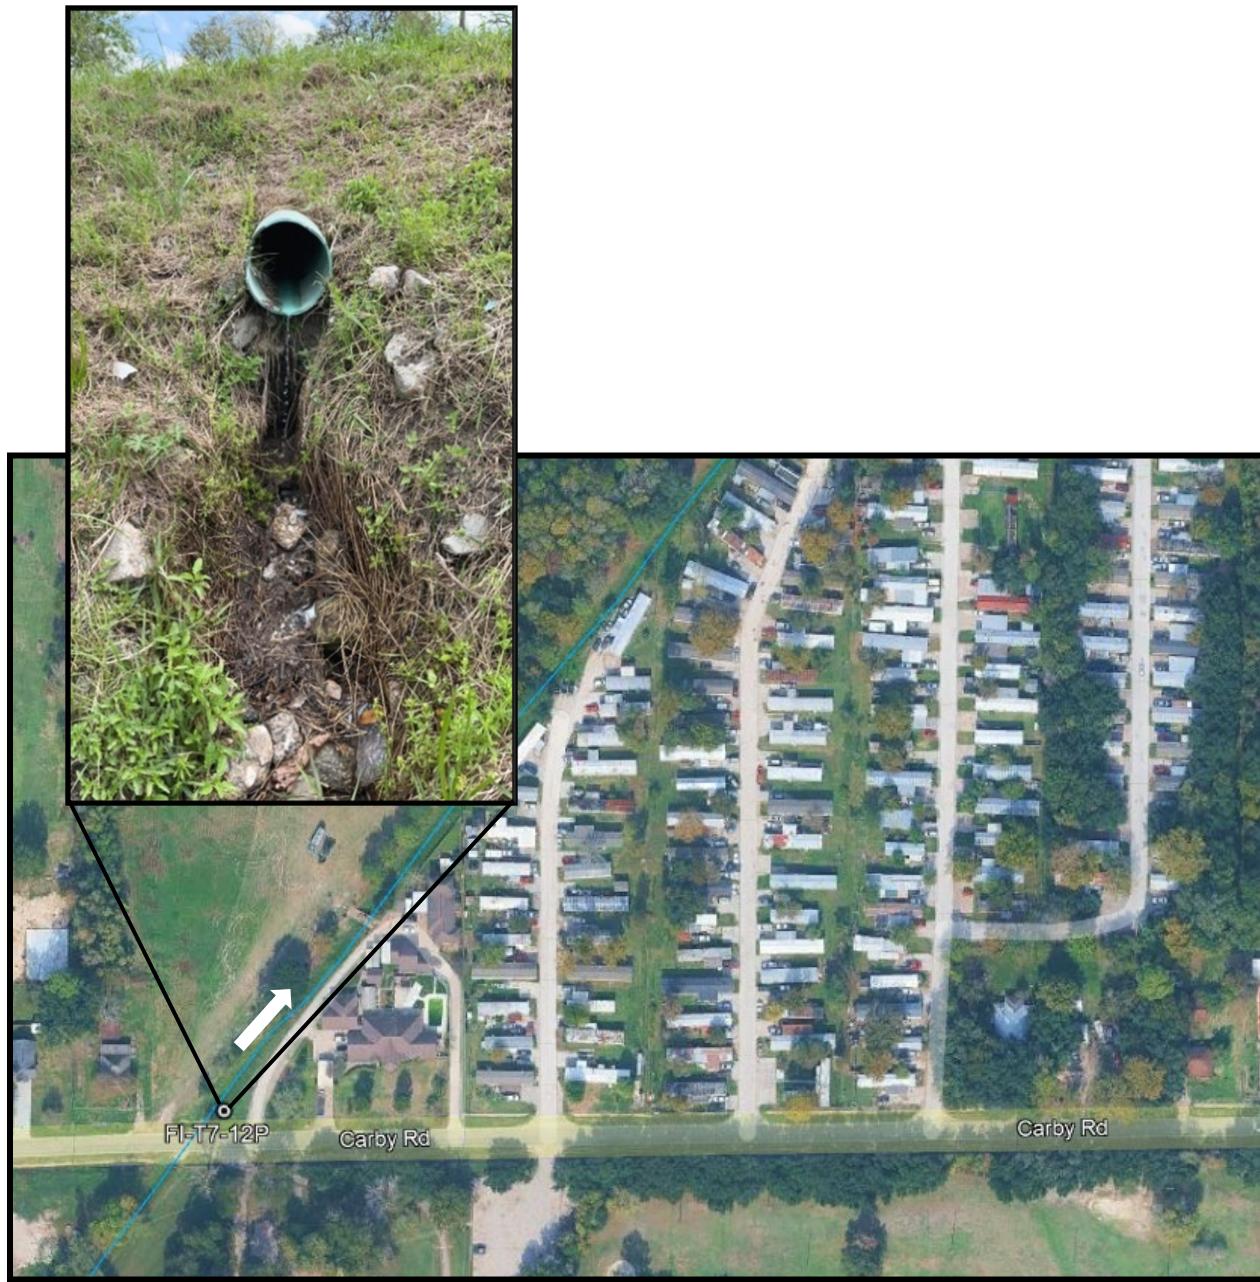
Sample FI-T7-12P (>242,000 colonies/100 mL) was taken directly from a blue pipe on the right bank of the tributary (Figure 28). Field staff noted that the water flowing out smelled like cleaning solution and sewage. The sample point was located just off Carby Road, approximately 5.0 meters southwest of a property that has a permitted OSSF (197272).

Figure 28. Referral Site FI-T7-12P. Map showing proximity to property with OSSF, neighborhood park, and subset image of tributary view. White arrow indicates direction of flow within the tributary. Blue line indicates tributary line

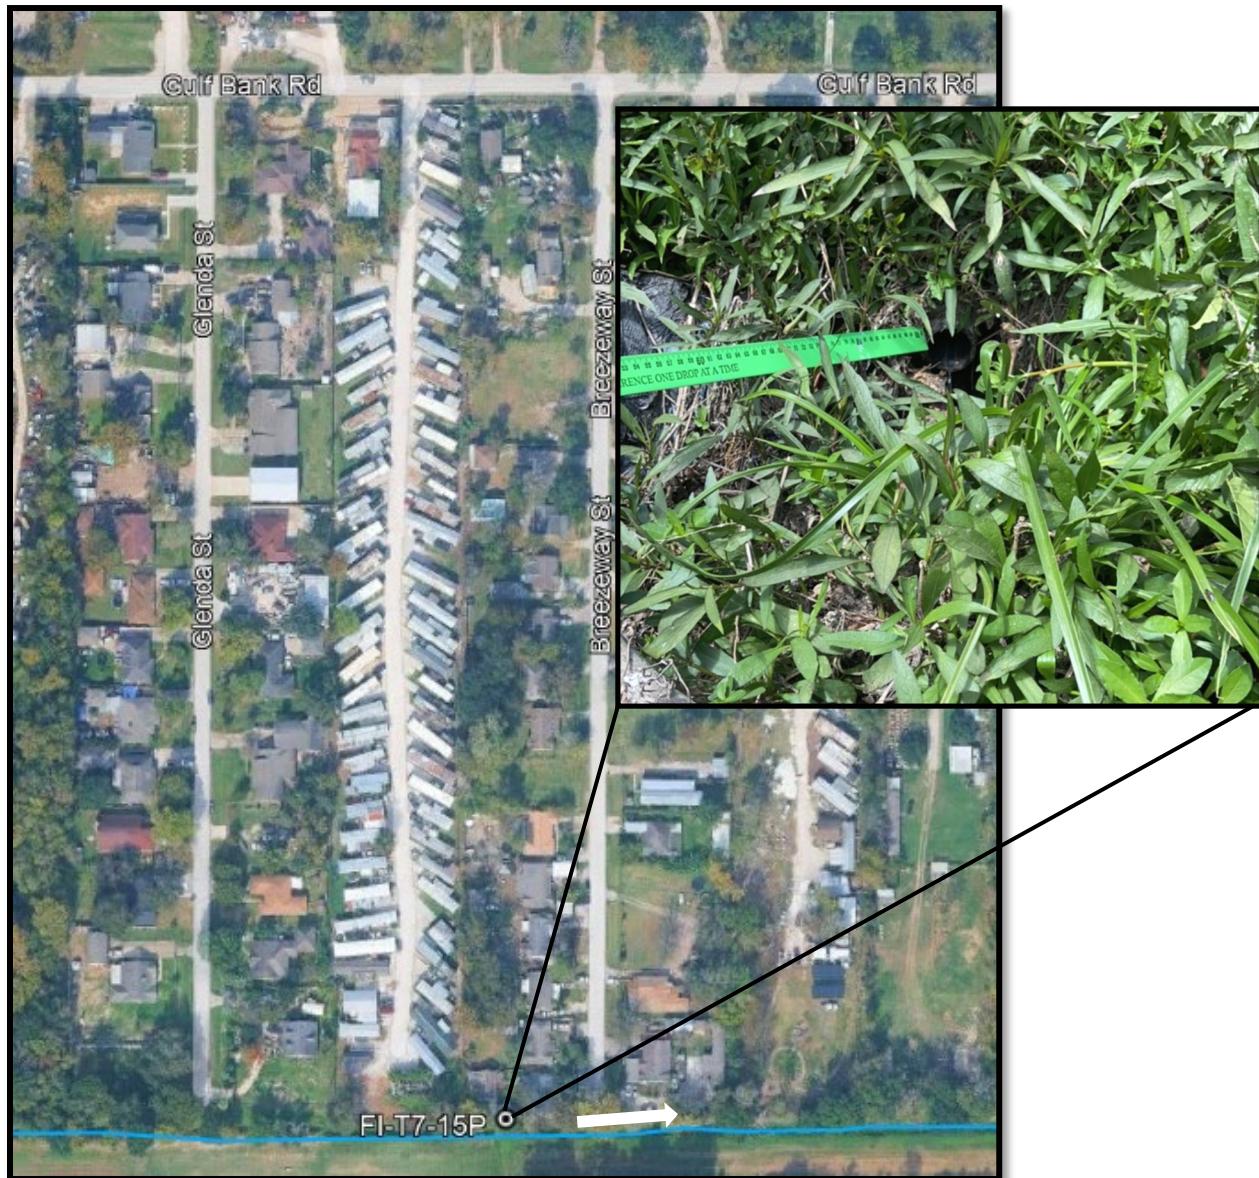
Figure 29. Referral Site FI-T7-15P. Map showing proximity to residential neighborhood, permitted WWTF outfall, closed manufactured home park, and subset image of tributary view. White arrow indicates direction of flow within the tributary. Blue line indicates tributary line.
