BACTERIA IMPLEMENTATION GROUP'S TOP FIVE MOST AND TOP FIVE LEAST IMPAIRED WATER BODIES

PRELIMINARY ACTION REPORT

August 4, 2016

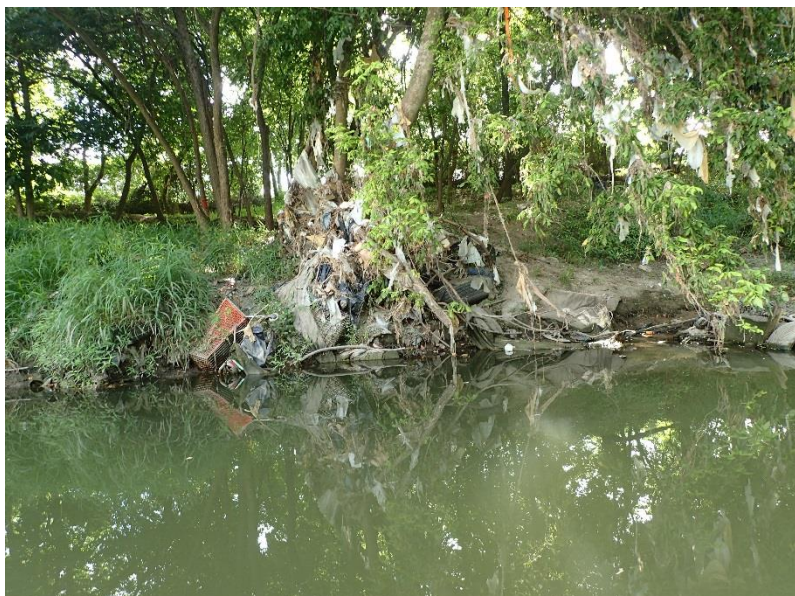
The most significant observation recorded during the Little White Oak Bayou survey was the litter and trash problem along the entire waterway. Portions of Little White Oak's banks were completely covered in trash and debris ranging from tires, shopping carts, plastics, Styrofoam, aluminum, and clothing. Trees along the lower portion of the waterway were covered in trash, likely from high flow conditions washing significant amounts of litter downstream that become trapped in branches and wrapped around tree trunks (Figures 11-14). However, even with the accumulated trash, there were abundant amounts of wildlife and aquatic organisms observed during the field surveys. Turtles and various bird species were common, many of which have made homes in the littered trees, shopping carts and tires. Alligator gar were also observed, primarily at the mouth of storm drains and outfall locations.

Figure 11. Shopping cart and litter on water bank

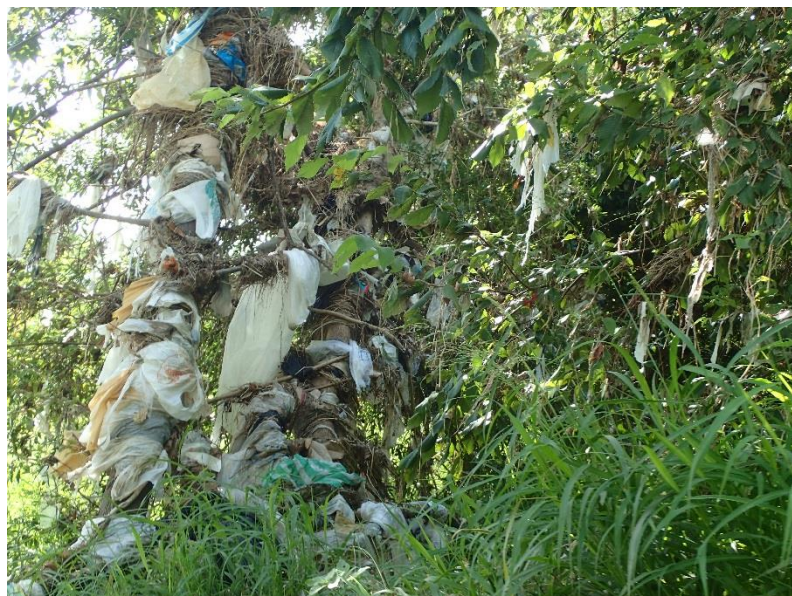
Figure 12. Trash wrapped around tree trunks in lower portion of Little White Oak

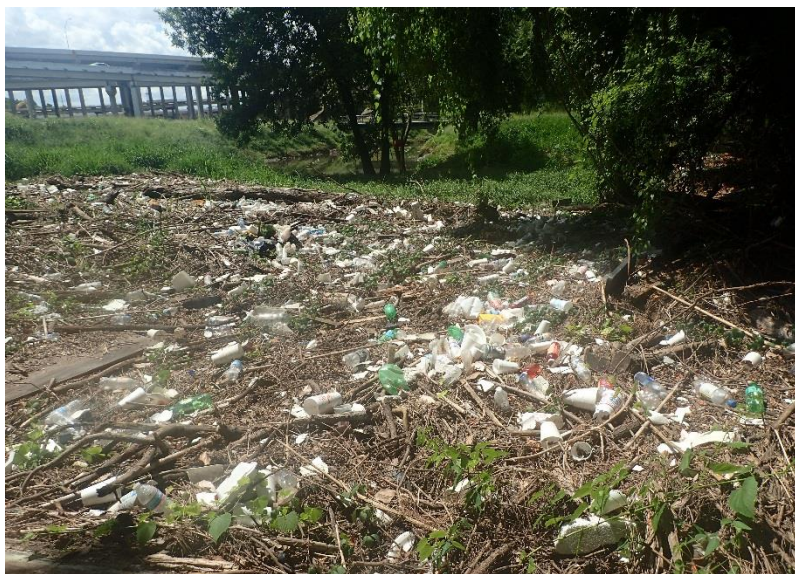
Figure 13. Trash accumulated on water banks near I-45 bridge

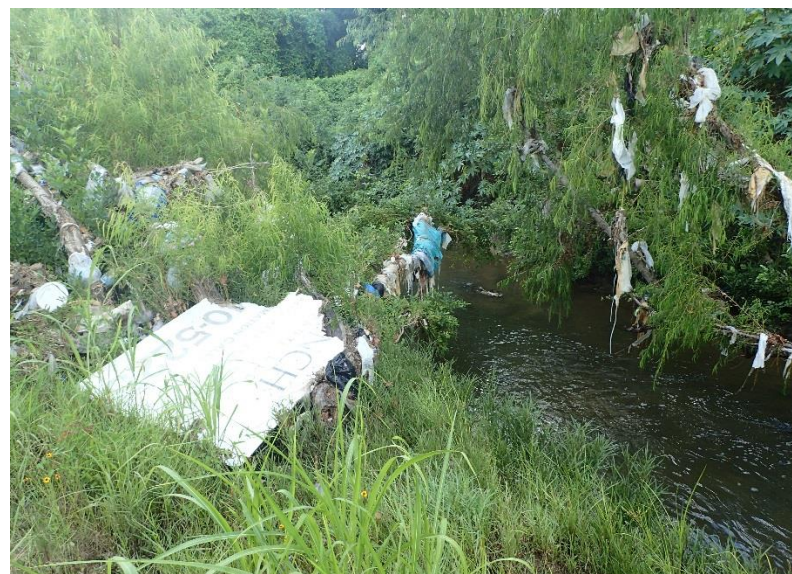
Figure 14. Washed up trash trapped by tree branches

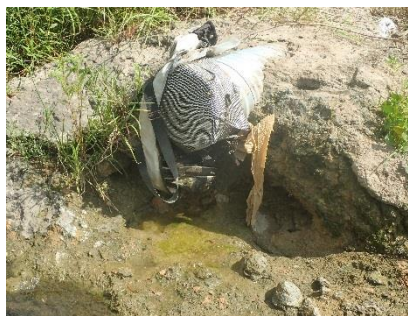
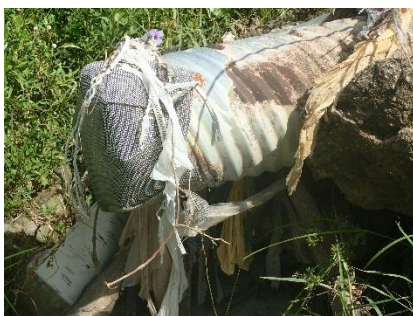
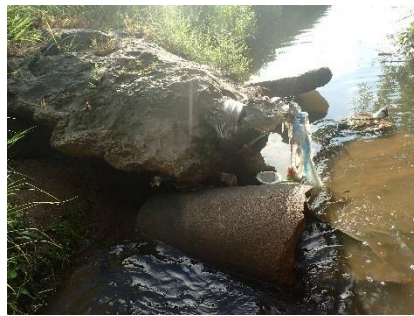
- 1) Three suspicious outfall pipes adjacent to the Moody Park area had metal screened covers attached to the ends. One of the three pipes had a small amount of discharge dripping from the outfall, but not enough for sample collection and bacteria screening. Locations for the screened outfalls can be found in Table 3 (Tier II ID 033, 035, and 040). Refer to Figures 15-17 for images of the three suspicious outfall pipes.

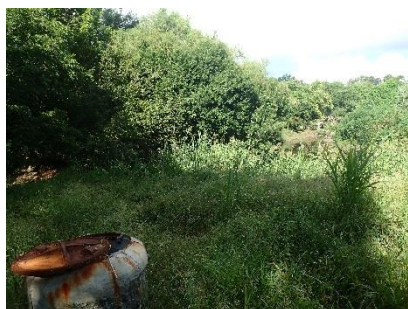
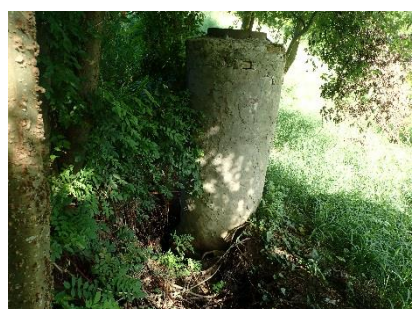
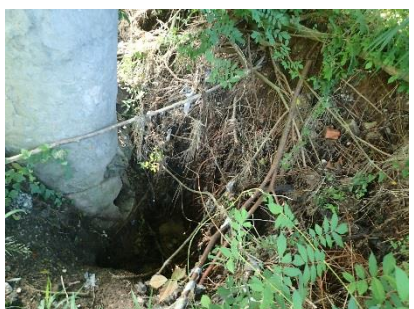
- 2) Two sewer manholes require follow-up investigation. One manhole (Tier II ID 047) was found along the Bayou with an open lid likely from a recent sewer overflow. The smell of sewage inside the manhole could be detected from the bank. A second damaged manhole was found along the Bayou (Tier II ID 052). This manhole was about six feet tall with a large hole in the cement casing. Another hole was found in the ground by the sewer manhole. It was unclear if this was an active or abandoned manhole, but further investigation is recommended to ensure raw sewage does not discharge at the location. Refer to Table 3 for locations of each manhole, and to Figures 18-20 for images of each.

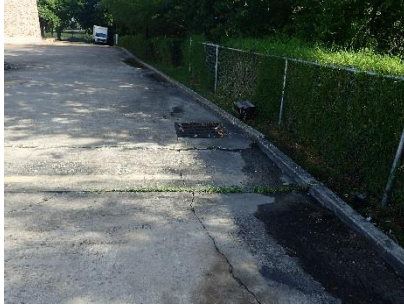
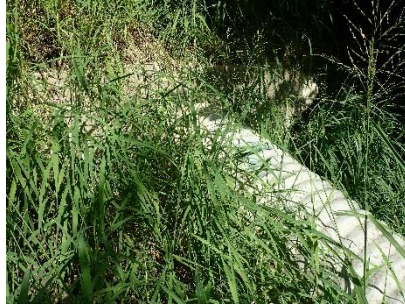
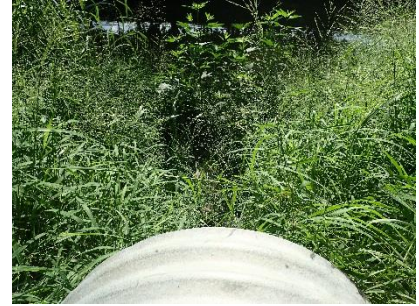
- 3) A suspicious drain line from the Astro Inn's parking lot leads directly into Little White Oak Bayou on the right bank upstream of the West Cavalcade Street bridge. There was no discharge at the outfall at the time of sampling, but a surface water sample (019) was collected directly downstream of the pipe line resulting in an *E.coli* concentration of 7,300 cfu/100mL. Additional investigation is recommended to ensure this is not an illicit discharge. Refer to Table 3 (No. 31) for GPS coordinates and to Figure 21-23 for images of the drain line and parking lot.

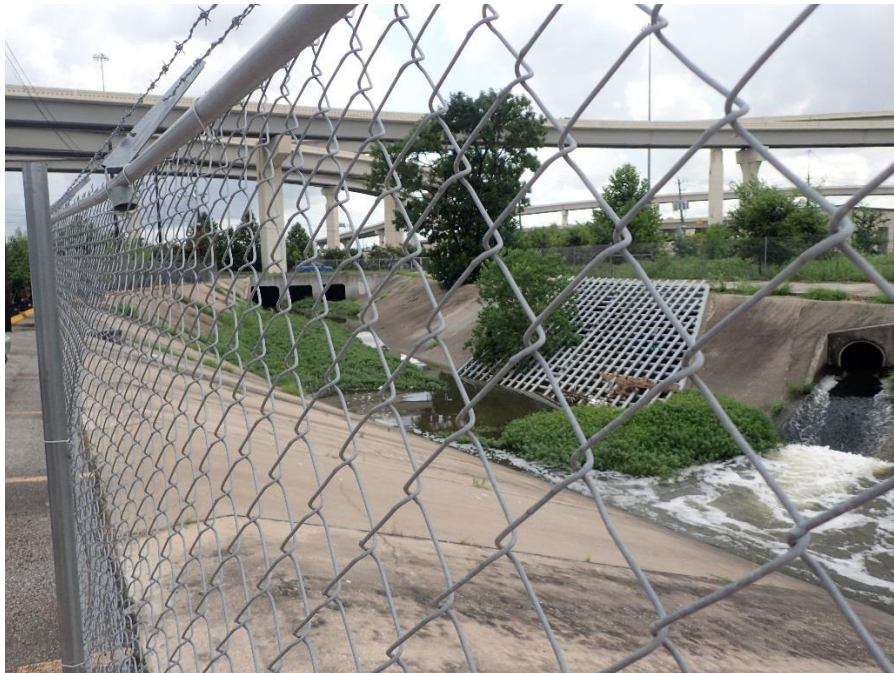
Figure 28. Stormwater detention outfall adjacent to plant nursery at southwest corner of I-10 and Beltway 8 intersection

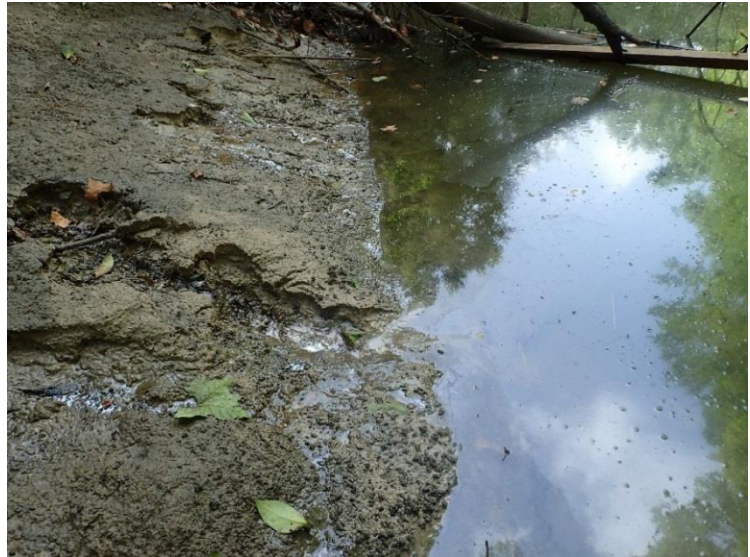
Noteworthy findings include sample 033 collected at a bend in the stream segment where trash accumulation was observed and apparent groundwater discharge was present. A slight sheen was visible on the water surface at the same location disturbed by the groundwater movement in the otherwise stagnant water (Figure 31). Two dilapidated pipes were observed at sample location 034 where high bacteria levels were detected. One pipe was bored under the waterway (Figure 32) while the other crossed above the water at street level. A concrete slab was found on the floor of Rummel Creek just downstream of the Rummel Creek Road bridge (Figure 33). The concrete was impeding water flow and creating high algae accumulation on the upstream side of the slab. Samples were taken upstream and downstream of the concrete slab, and bacteria levels were higher upstream where water flow was slower (sample 039). Algae was common throughout the waterway but appeared particularly dense north of Memorial Drive near Rummel Creek Elementary School (Figures 34-35). The sample collected at this location (sample 036) had the highest bacteria concentration collected during the Rummel Creek survey.

Figure 31. Groundwater discharge and surface sheen at sample 033

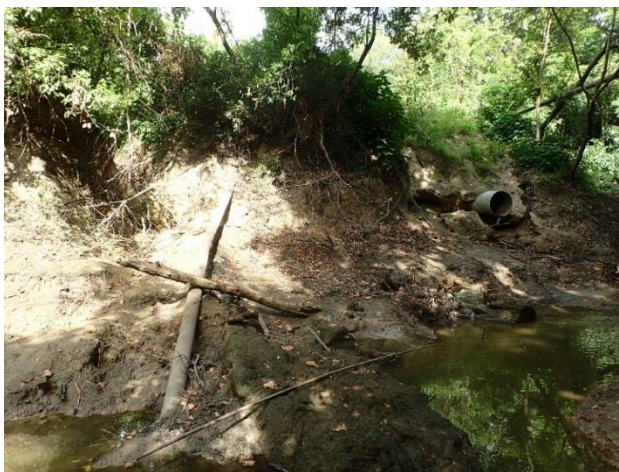
Figure 32. Pipe and outfall near sample 034

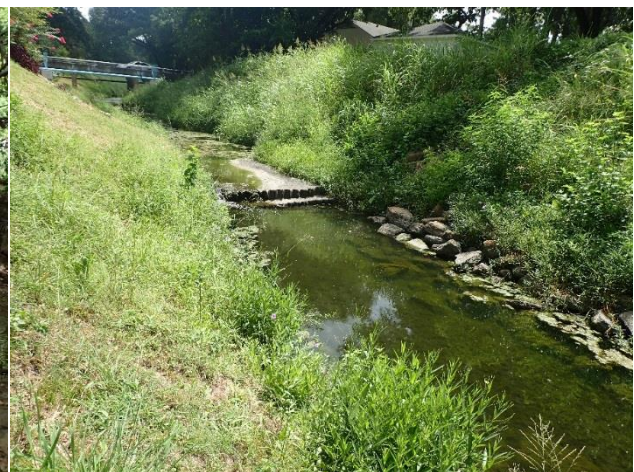
Figure 33. Concrete slab downstream of Rummel Creek Road

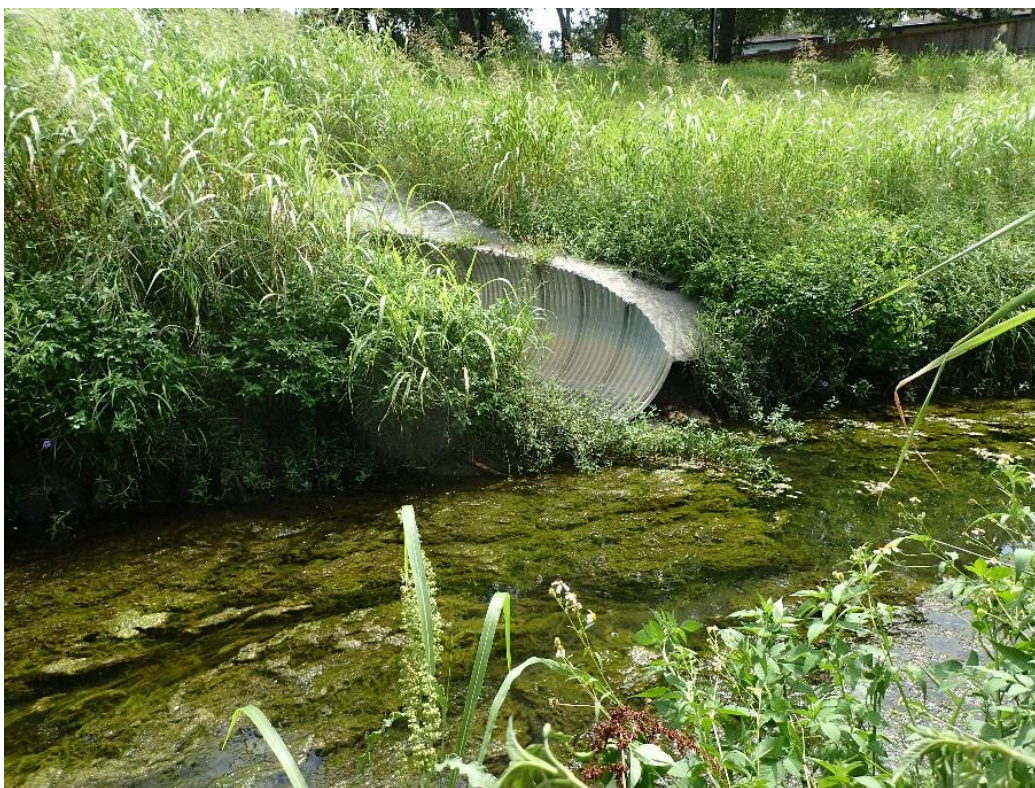
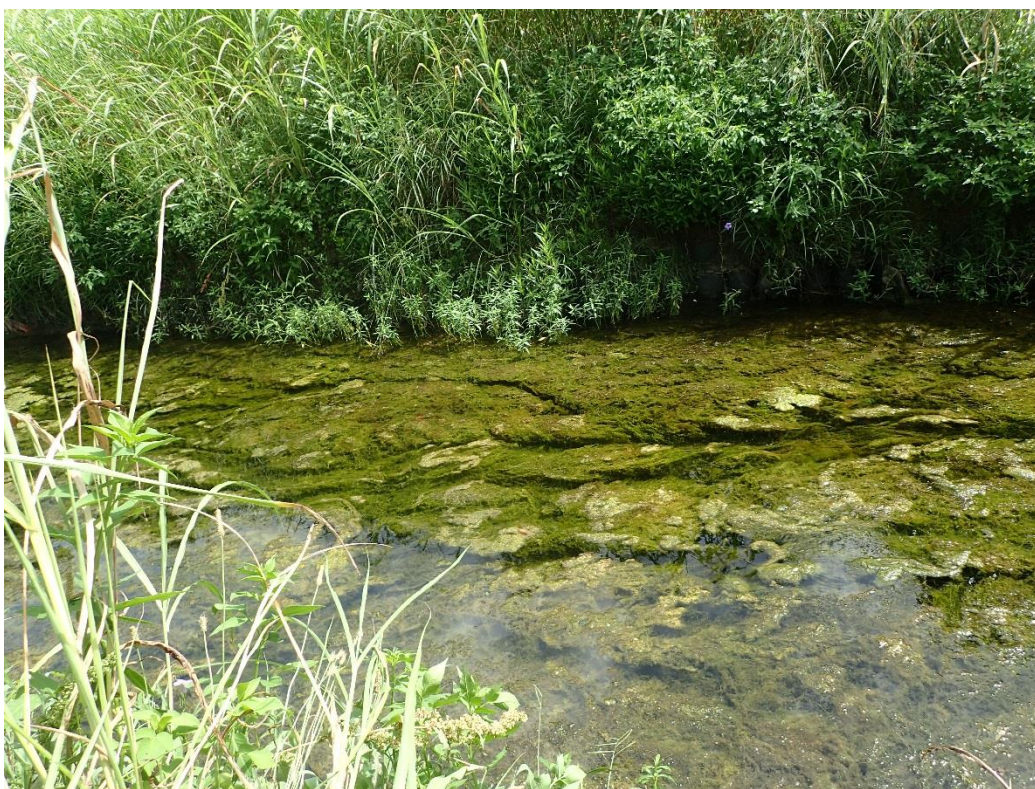
Figure 34. Dense algal blooms near Rummel Creek Elementary School (sample 036)

Figure 35. Dense algal blooms near Rummel Creek Elementary School (sample 036)

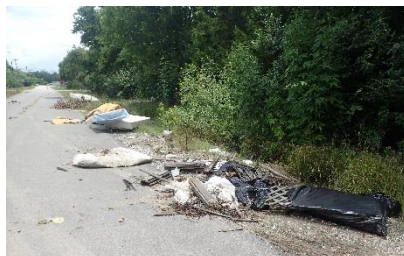
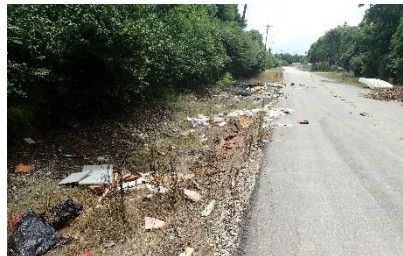
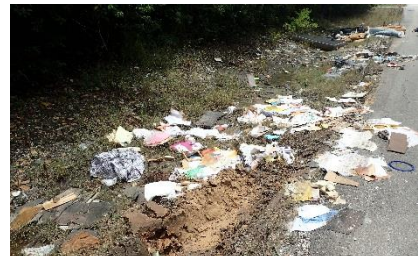
Figure 40. Illegal dumping

Figure 41. Illegal dumping

Figure 42. Illegal dumping

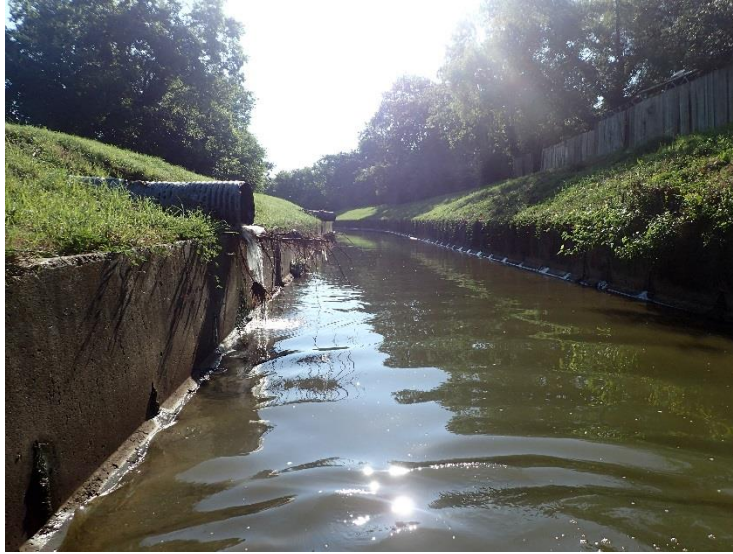
Noteworthy findings include the high bacteria loading from an outfall (sample 008) directly downstream of the CRP monitoring station off Tiffany Drive (Figure 46). Discharges from this outfall would not be captured in routine CRP monitoring due to its location. Two large concrete storm drains directly downstream of the South Post Oak Road bridge (Figure 47-48) had high *E. coli* concentrations (samples 013 and 014). Another high bacteria source discharging into the canal was a small tributary north of Beltway 8, sample 021 (Figure 49).

Figure 46. Outfall with dry weather discharge downstream of CRP monitoring station (sample 008)

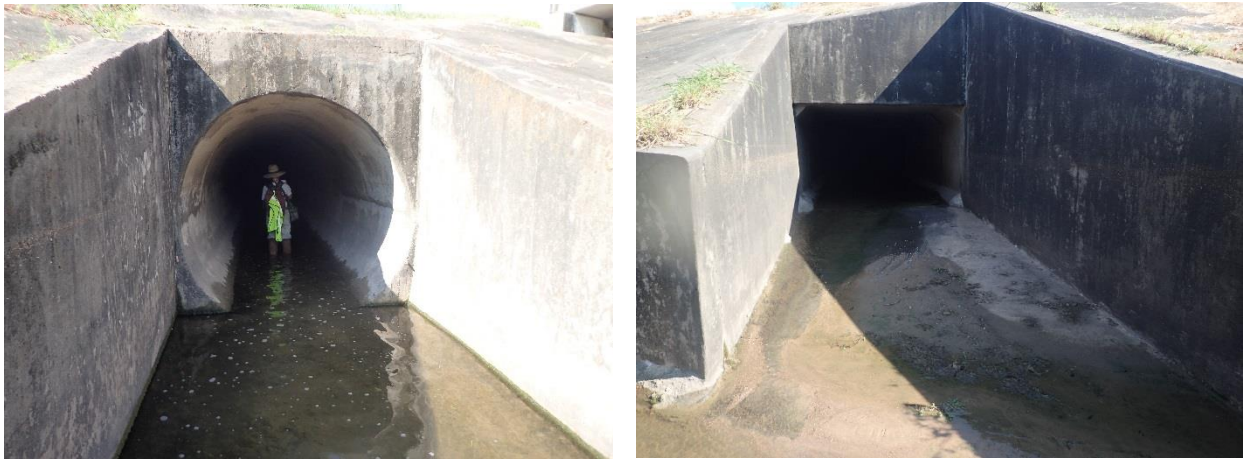
Figures 45 and 46. Storm drains downstream of the S. Post Oak Road bridge (samples 013 and 014)

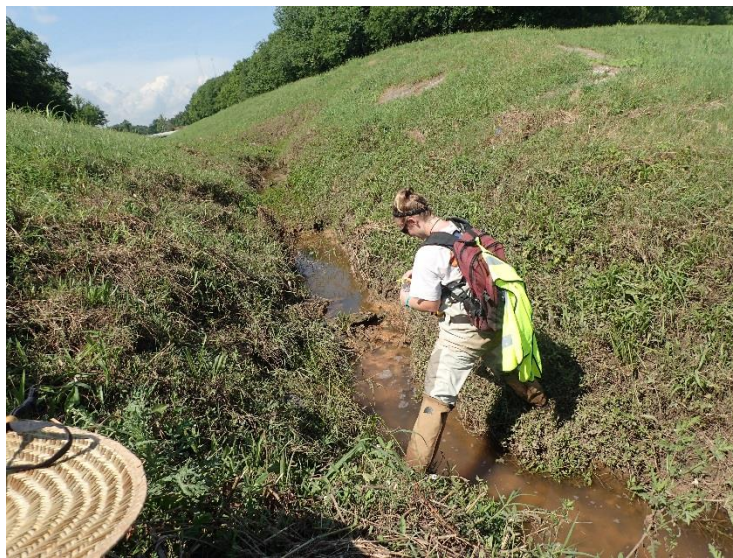
Figure 47. Tributary north of Beltway 8 with high bacteria concentration (sample 021)

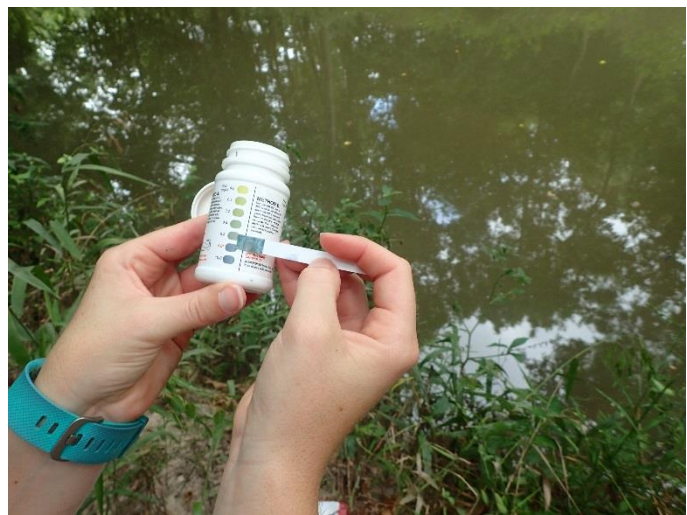
The most significant observation recorded during the Upper Panther Branch surveys was the strong odor and presence of chlorine throughout the waterway. Chlorine test strips were used at the majority of sample locations to detect estimated chlorine levels. All chlorine test strips tested positive for chlorine with *at least* 1.0 mg/L present for every sample tested (Figure 55). Many of the stormwater drainage tributaries had lower levels of chlorine and higher bacteria concentrations compared to the main stem of Upper Panther Branch. Further investigation is recommended in order to identify where the chlorine was originating.

Figure 55. Chlorine test strip result for Upper Panther Branch sample 004

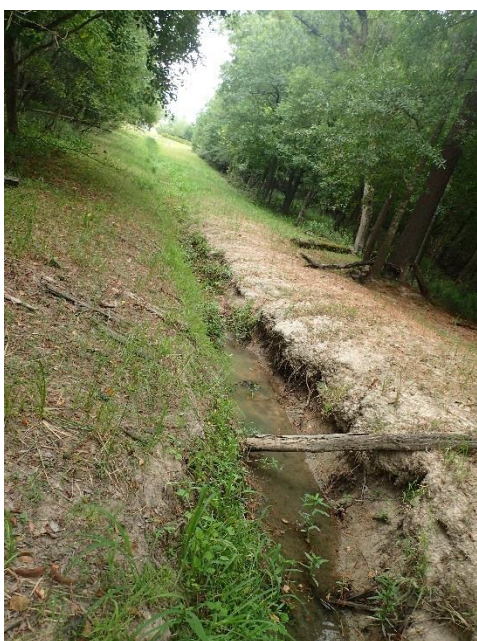
Noteworthy findings include the high bacteria loading from a stormwater drainage tributary (Tier II ID 065) originating from the subdivision off Grogans Mill Road (Figure 56). Homeowners were seen walking their dogs along the drainage tributaries in this area, making pet waste a potential contributor of bacteria at this location. Another stormwater drainage tributary (Tier II ID 072, sample 009) coming from the sporting facility on Marisco Place had high *E.coli* concentrations, I with the water sample having a strong petrochemical smell likely from surface runoff from the adjacent parking lot (Figure 57). Several of the tributaries feeding into Upper Panther Branch had a very distinct reddish tint (Figures 58-60). It was unclear if this was a result of impacts from different soil types or if there were other factors. However, there did not seem to be a correlation between bacteria concentration and red water at these sample locations.

Figure 56. Stormwater drainage tributary with high bacteria concentration (Tier II ID 065, sample 003)

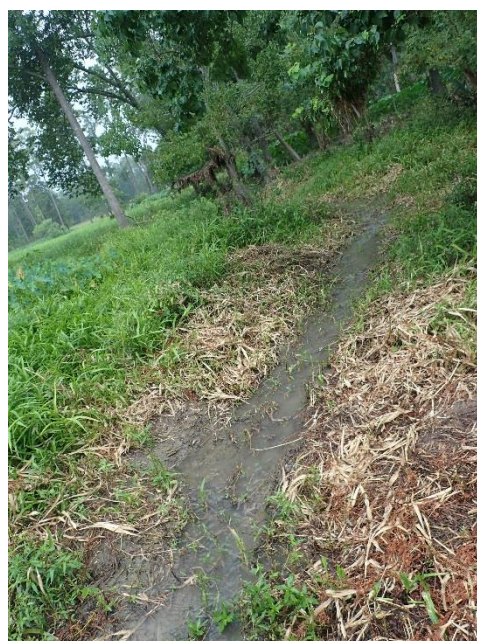
Figure 57. Stormwater drainage tributary with high bacteria concentration (Tier II ID 072, sample 009)

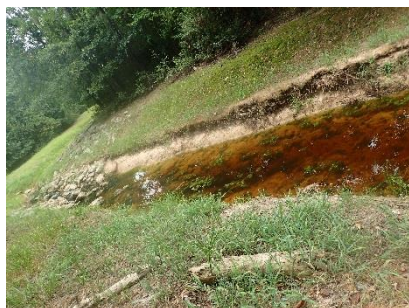
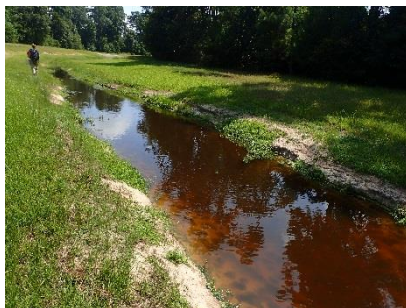
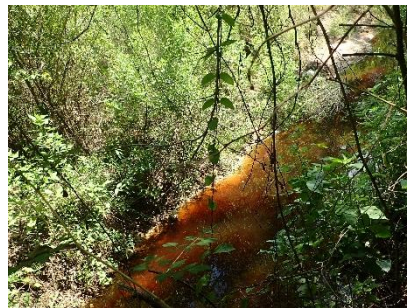
Figures 58-60. Red tinted waters in the tributaries of Upper Panther Branch
