# Bacteria Source Identification Report

## BIG's Top Five Most and Top Five Least Impaired Water Bodies Project

Project is funded through grants from the U.S. Environmental Protection Agency through the Texas Commission on Environmental Quality's (TCEQ) Galveston Bay Estuary Program (GBEP)

Paniz Miesen  
Senior Environmental Planner  
Houston-Galveston Area Council  
3555 Timmons Lane Suite 100  
Houston, TX 77027  
(832) 681-2523  
[Paniz.miesen@h-gac.com](mailto:Paniz.miesen@h-gac.com)

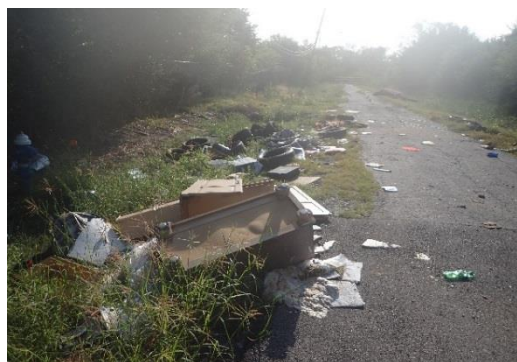
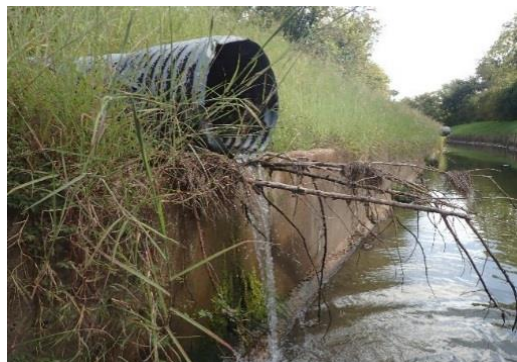
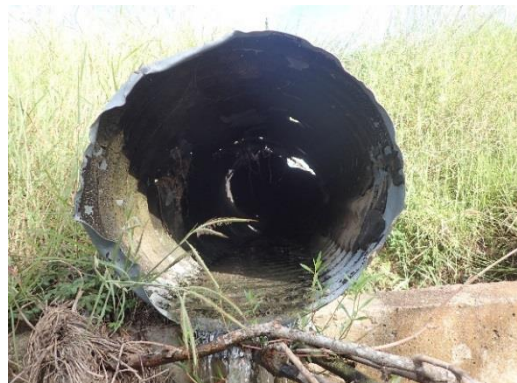
Station 8 is a metal outfall located at the downstream end of the Canal C-147 watershed boundary adjacent to a residential neighborhood and a number of auto body junk yards. Illegal dumping of trash, tires, and large debris was common in the area (Figure 5). Figures 6 and 7 are photos of the outfall taken during the dry weather sampling event. Based on these results, the City of Houston initiated an investigation at this outfall location in September 2016 and detected a potable water leak. Information about corrective actions related to the potable leak are unknown. However, Phase II investigations resulted in wet and dry weather samples with *E.coli* concentrations that are now in compliance with state standards (Table 6).

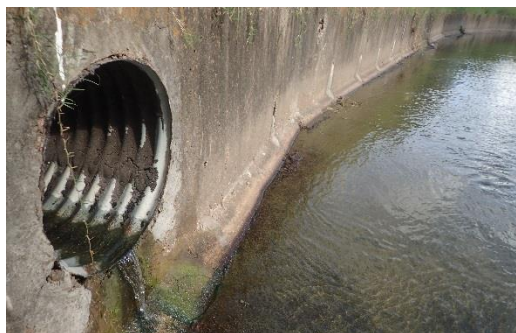
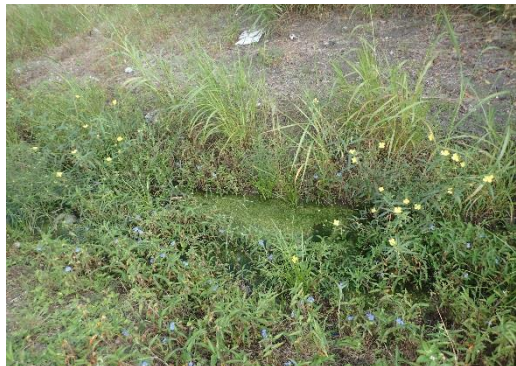
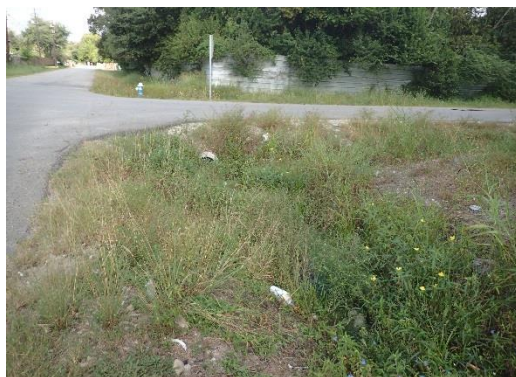
Station 8.1 is a metal outfall located approximately 85 meters upstream of the station 8 outfall (Figure 8). This outfall was not discharging during the Phase I survey so no bacteria screening samples were collected. However, during the Phase II survey, this outfall was intermittently discharging water during both wet and dry weather sampling events. The outfall is located directly underneath the Tiffany Street bridge across the street from a number of junk yards and residential homes. H-GAC field staff attempted to follow the outfall pipe to its origin and found that it is connected to the ditch running along the north side of Tiffany Street (Figures 9 and 10).

Samples were collected directly from the discharging outfall during both wet and dry weather events. Only the wet weather sample had an *E.coli* concentration that exceeded the state water quality standard of 126 MPN/100mL (Table 7).

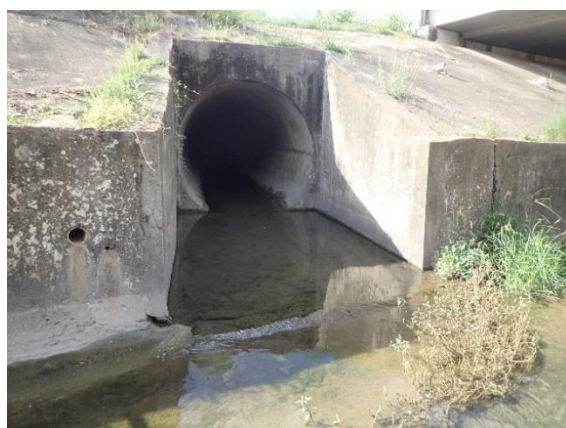
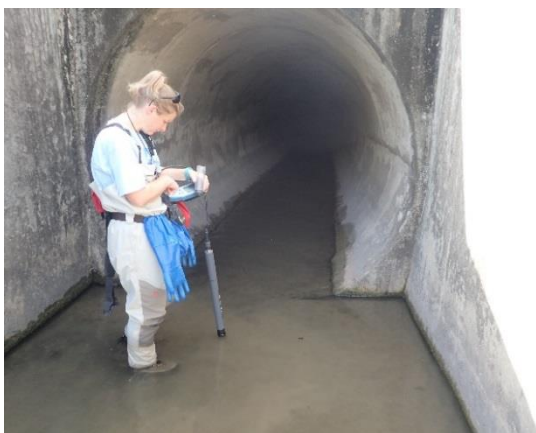
Both wet weather and dry weather samples collected at this location had *E.coli* concentrations that exceeded the state water quality standard of 126 MPN/100mL (Table 8). The high bacteria concentrations detected during both wet and dry weather events implies there is a consistent source of bacteria discharging into Canal C-147 at this location regardless of weather conditions. Schools of fish were observed swimming in the storm drain during all sampling events. Additionally, the pH level inside the storm drain during the wet weather event was significantly higher than levels outside the storm drain. Further investigation is recommended at this station.

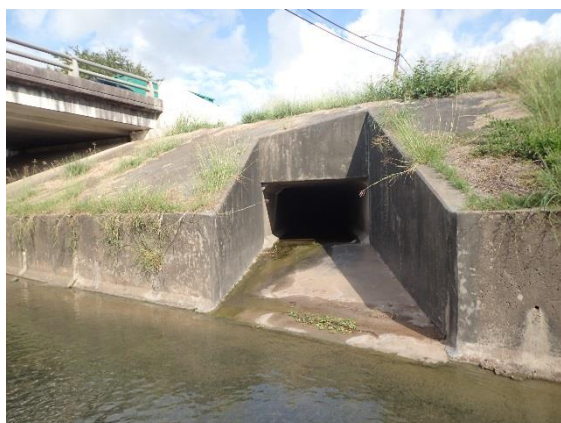
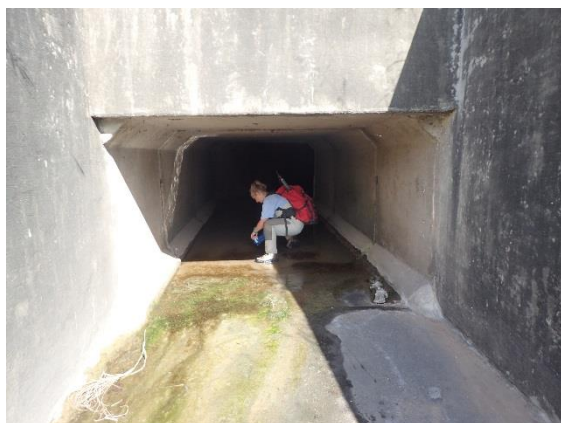
During the dry weather event, there was only a shallow trickle of water discharging from the storm drain (Figures 13 and 14). The water appeared clean and colorless with no particular odor, but was too shallow for the collection of field water quality data using the multiparameter data sonde. There was a significant difference in *E.coli* concentrations between the wet weather and dry weather sampling events (Table 9). Further investigation is recommended at this location to identify the cause for this variation during different weather conditions.

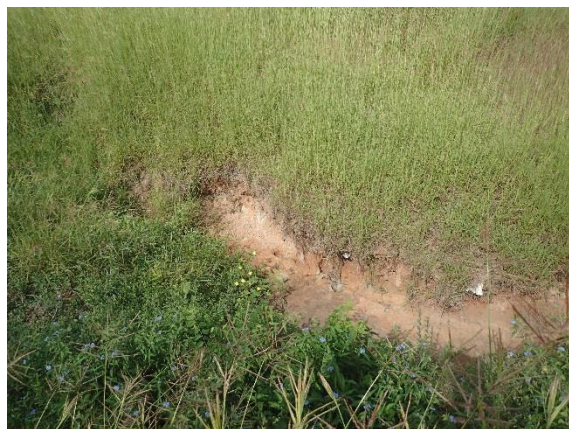
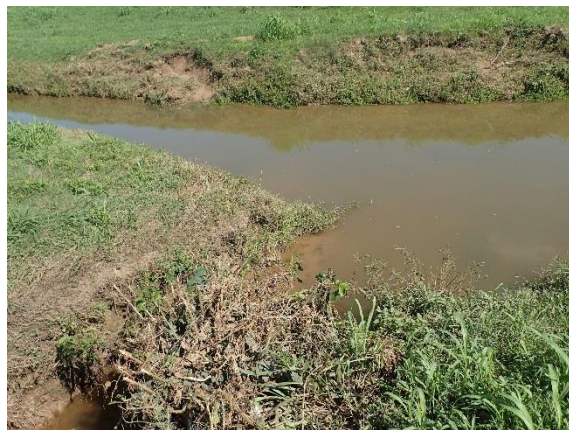
The tributary was dry during the dry weather event on October 19, 2016, so no dry weather sample was collected at this location (Figure 15). Wet weather samples were collected on November 7, 2016 following a significant rain event. The sample for station 17 was collected at the confluence of the tributary with Canal C-147 (Figure 16). A second sample was collected at station 17.1 located approximately 150 meters upstream of station 17. Both wet weather samples collected along this tributary resulted in an *E.coli* concentration of 24,200 MPN/100mL. This station was the most significant source of bacteria to Canal C-147 identified during Phase I and Phase II of the project. Further investigation is recommended.

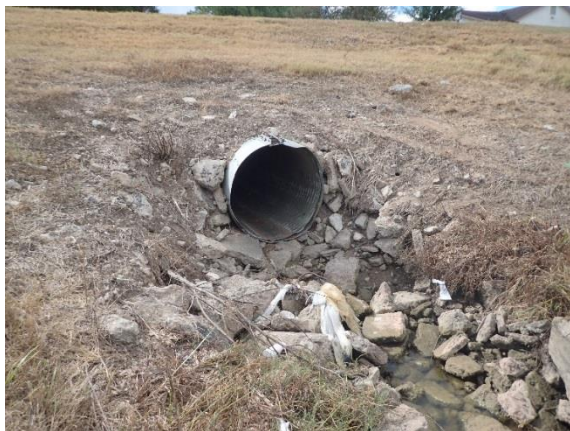
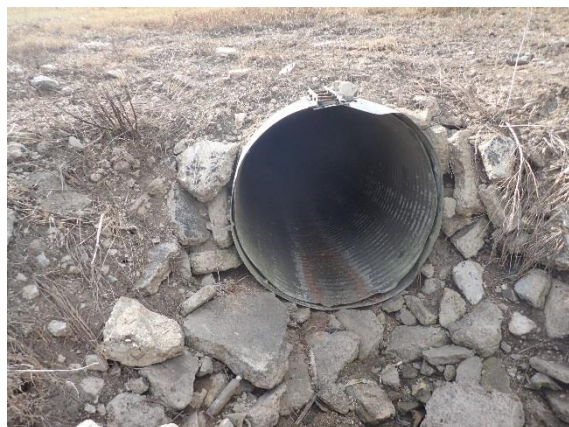
There was no discharge observed during the dry weather event conducted on October 19, 2016 (Figures 17 and 18) resulting in no dry weather samples collected at this location during Phase II investigations. A wet weather sample was collected on November 7, 2016. A sample was collected directly from the outfall and field water quality data from the data sonde were taken from the shallow pool of water accumulated in front of the outfall. The resulting bacteria concentration was 3,650 MPN/100mL which is significantly greater than the state water quality standard for *E.coli* (Table 11).

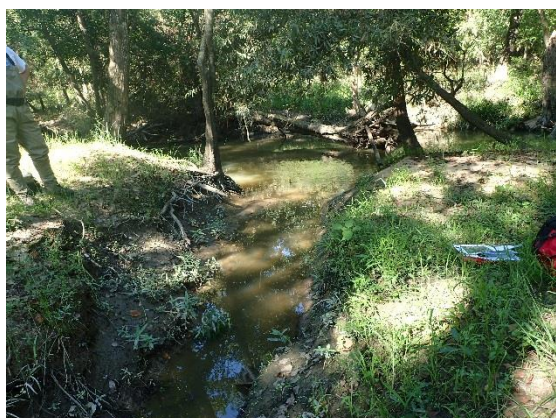
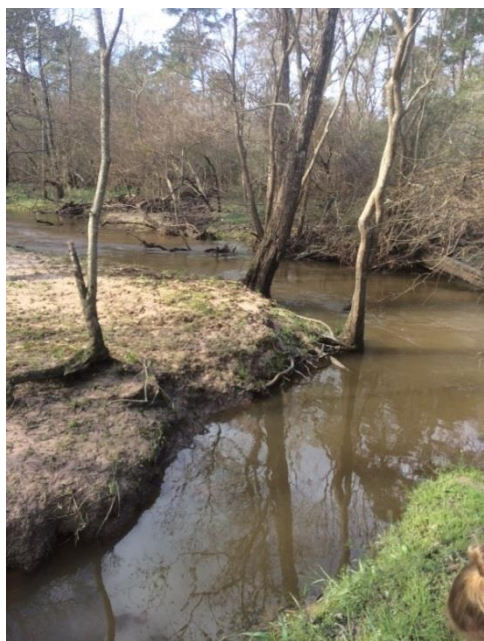
The dry weather sample collected on September 28 (Figure 23) was in compliance with state water quality standards for bacteria (Table 13). Chlorine test strips detected a chlorine level of approximately 0.65 mg/L at this location during the dry weather event. The wet weather event conducted on February 15, 2017 (Figure 24) resulted in a significantly higher bacteria concentration with levels measuring at 7,270 MPN/100mL (Table 13).

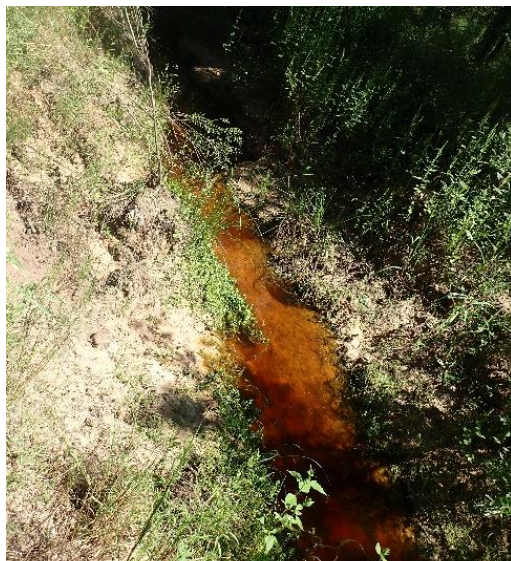
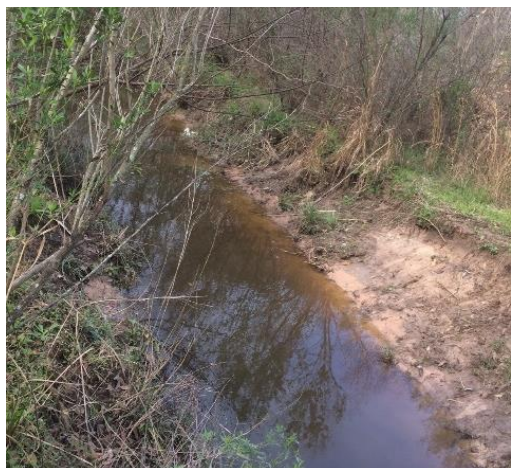
The dry weather sample collected on September 28 (Figure 25) was just above the state water quality standard for *E.coli* measuring at 185 MPN/100mL (Table 14). The water was consistently red in color at this location during all dry weather surveys conducted for this project. No chlorine was detected at this station. The wet weather event conducted on February 15, 2017 (Figure 26) resulted in the significantly higher bacteria concentration of 7,270 MPN/100mL (Table 14).

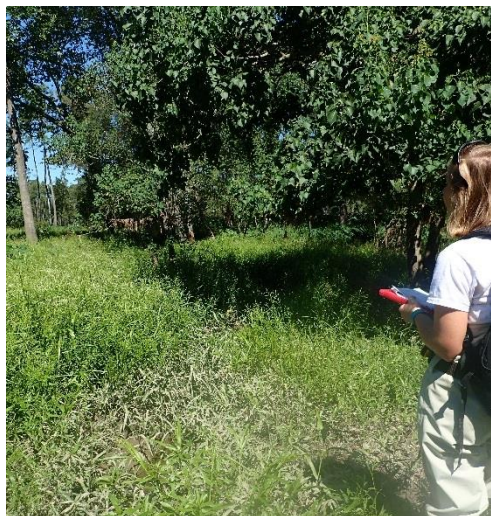
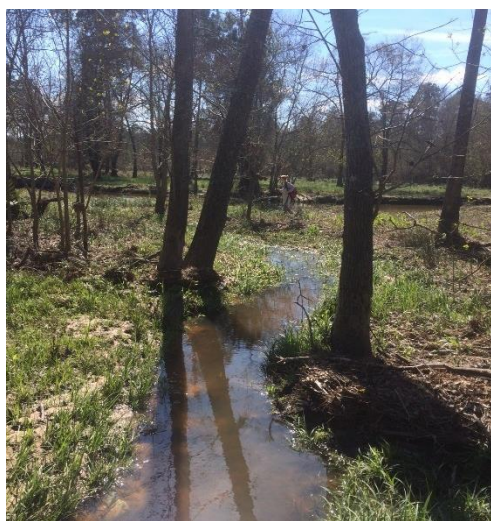
The dry weather sample collected on September 28 (Figure 27) was in compliance with state water quality standards for bacteria (Table 15). The water had a strong chemical odor during this sampling event and chlorine test strips detected a chlorine concentration of approximately 0.1 mg/L. The wet weather event conducted on February 15, 2017 (Figure 28) resulted in a bacteria concentration of 5,790 MPN/100mL (Table 15).

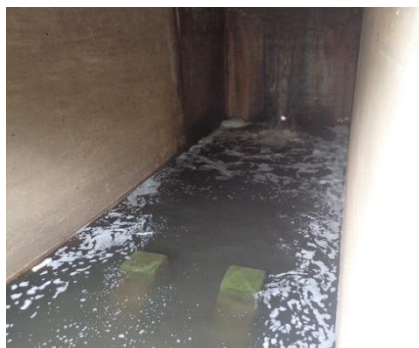
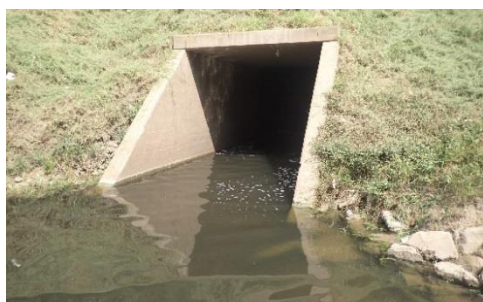
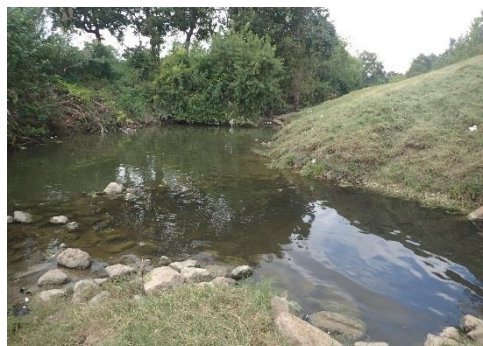
Station 8 is a large outfall located at the southern end of Moody Park adjacent to a parking lot off Fulton Street. The outfall was consistently discharging large volumes of water into Little White Oak Bayou during all Phase I and II investigations (Figures 31-32). Homeless activity was commonly observed at this location.

Samples were collected directly downstream of the outfall during Phase II investigations (Figure 33). The dry weather sample collected on October 11, 2016 was just over the state water quality standard for bacteria measuring at 199 MPN/100mL (Table 16). However, the wet weather sample collected on February 15, 2017 resulted in the much higher bacteria concentration of 24,200 MPN/100mL.

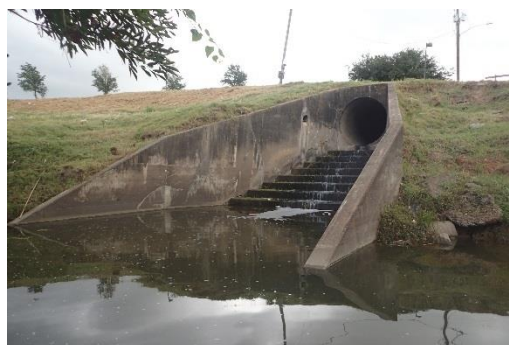
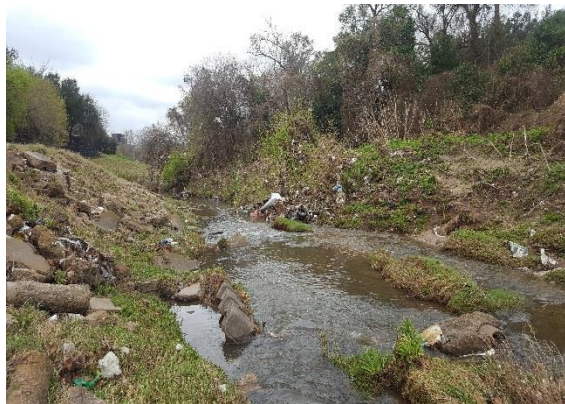
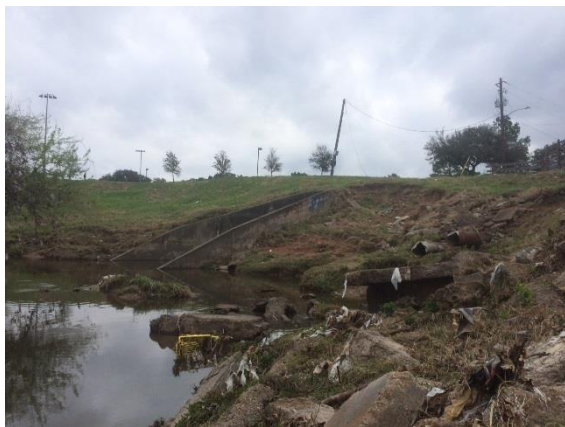
Samples were collected directly downstream of the storm drain during Phase II investigations. The dry weather sample collected on October 11, 2016 resulted in an *E.coli* concentration of 1,080 MPN/100mL, making it one of the highest bacteria sources to Little White Oak Bayou during the dry weather event (Table 17). However, the wet weather sample collected on February 15, 2017 resulted in a much higher bacteria concentration of 24,200 MPN/100mL.

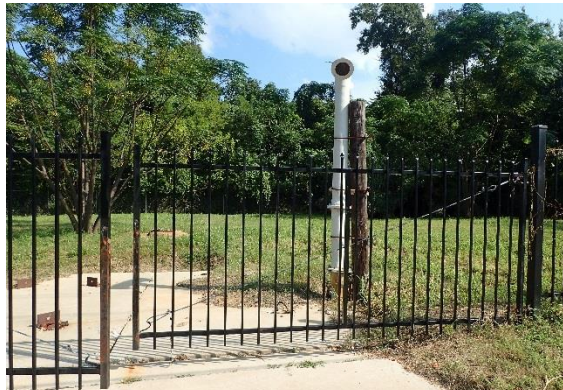
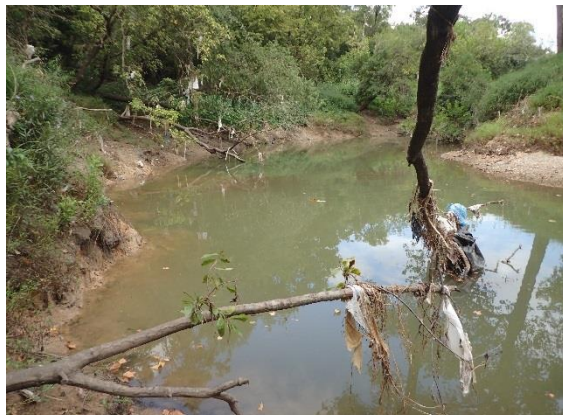
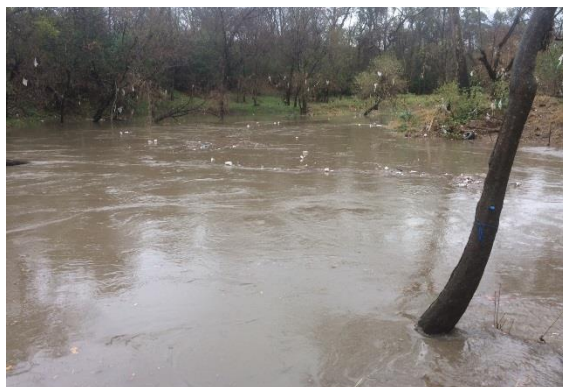
The dry weather sample collected at this location on October 11, 2016 (Figure 38) resulted in an *E.coli* concentration of 161 MPN/100mL, slightly exceeding the state water quality standard. The wet weather sample was collected approximately 20 minutes after a significant rain event on February 14, 2017. The water level was high and large amounts of trash and debris were flowing with the water downstream (Figure 39). The *E.coli* concentration for the wet weather event was 24,200 MPN/100 mL, significantly higher than the dry weather concentration (Table 18).

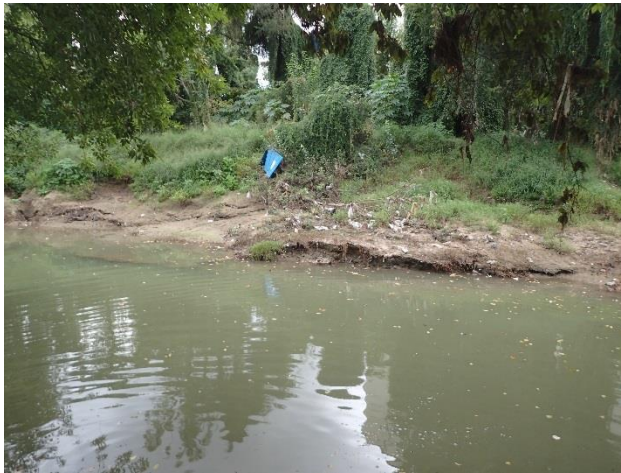
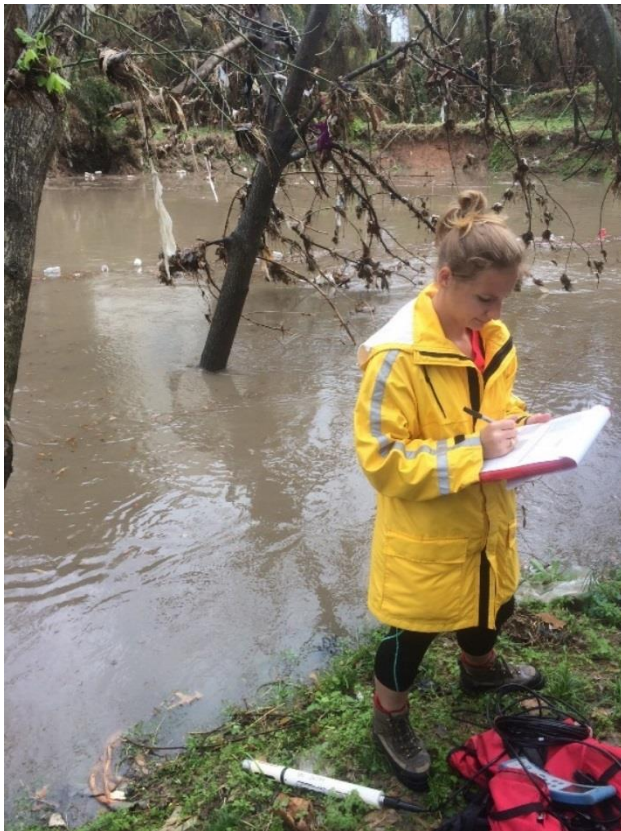
The dry weather sample collected on October 11, 2016 (Figure 40) resulted in an *E.coli* concentration of 393 MPN/100mL. This concentration is more than twice the concentration observed upstream of the junction box. However, the wet weather sample collected on February 14, 2017 (Figure 41) had the same bacteria concentration as the sample collected upstream of the junction box (Table 19).

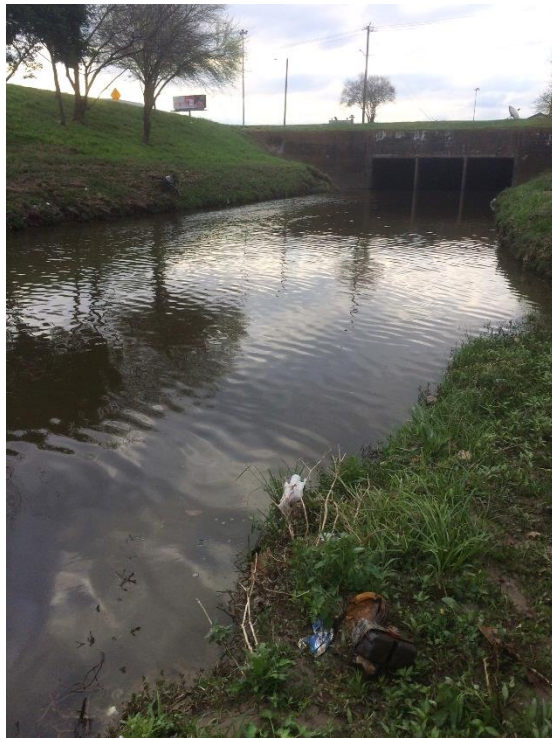
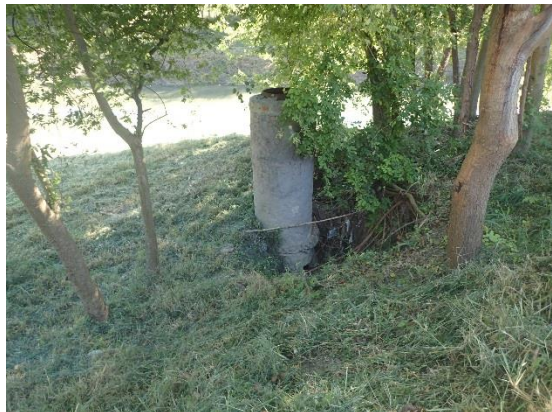
Station 17 is located at Vincent Street and Coronado Avenue directly upstream of where the waterway goes underground at I-45 (Figure 42). A faulty manhole was observed on the right bank approximately 52 meters upstream of this station. The manhole was about 6 feet above ground and the cement casing had a large hole. A hole in the ground was also observed next to the manhole with evidence of recent sewage overflows visible (Figure 43).

The dry weather sample collected on October 11, 2016 had an *E.coli* concentration of 197 MPN/100mL. The wet weather sample collected on February 15, 2017 was significantly higher at 24,200 MPN/100mL (Table 20).

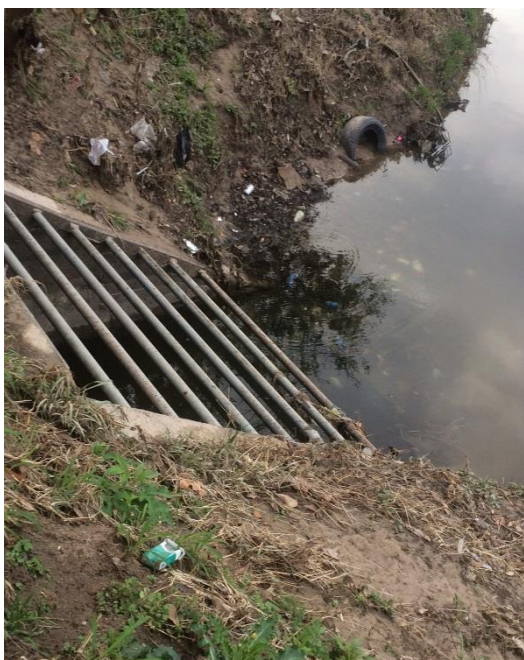
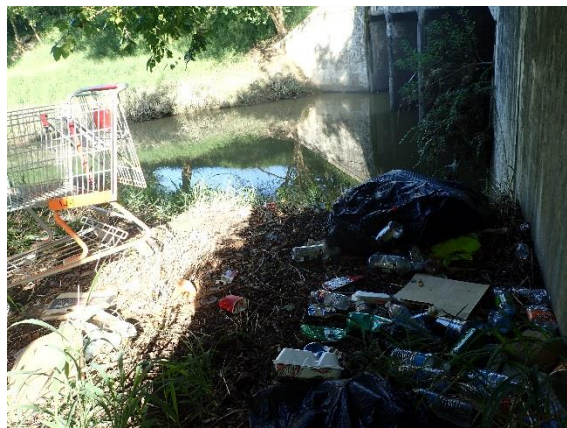
Station 18 is an outfall located on the left bank of Little White Oak Bayou to the south of the Cavalcade Street bridge (Figure 44). Homeless activity is common at this location with furniture and other debris observed on the bank (Figure 45). Alligator gar and other large fish species were observed at the mouth of this outfall during Phase I and Phase II investigations.

The dry weather sample collected on October 11, 2016 resulted in a bacteria concentration of 355 MPN/100mL. The wet weather sample collected on February 15, 2017 was significantly higher measuring at 11,200 MPN/100mL (Table 21). Although the wet weather sample concentration was slightly lower than the surface water samples collected upstream of this location, this outfall is still considered to be contributing a consistent amount of bacteria into Little White Oak Bayou regardless of weather conditions.

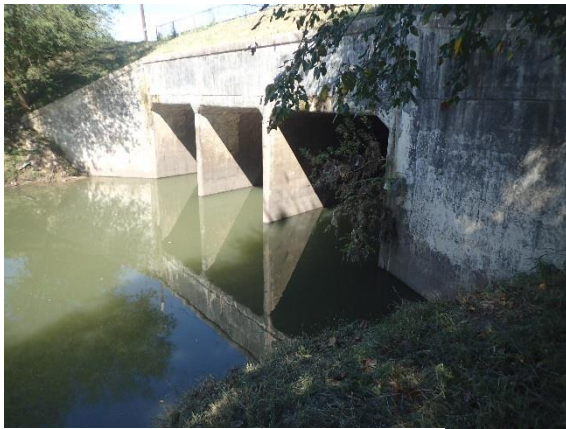
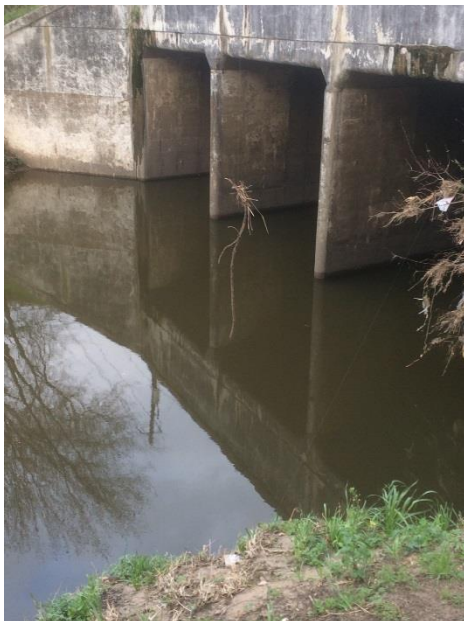
Both the dry weather (Figure 46) and wet weather (Figure 47) bacteria concentrations were greater than levels found at outfall station 18.1 (Table 22) indicating that a more significant source of bacteria is located upstream of this location.

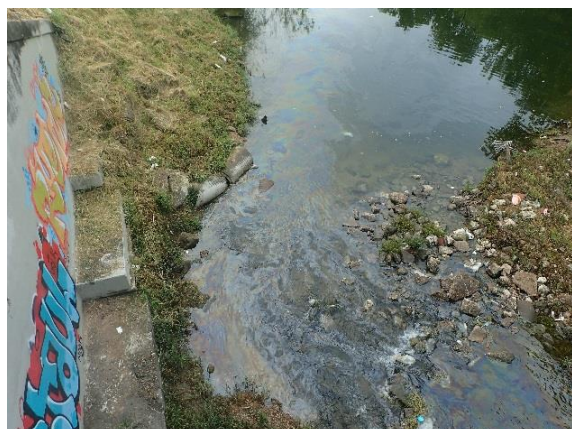
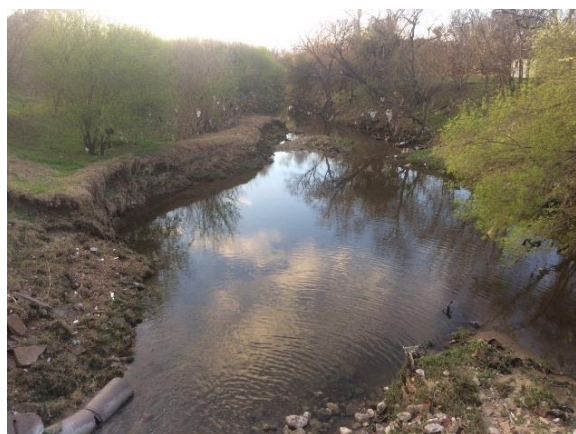
A dry weather sample was collected on October 11, 2016. At the time of sample collection, a strong odor of diesel was detected and an oily sheen was observed on the surface of the water (Figure 48). The *E.coli* concentration was 7,700 MPN/100mL which was the highest bacteria concentration collected during the dry weather event at Little White Oak Bayou. The wet weather sample collected on February 15, 2017 (Figure 49) resulted in a significantly higher bacteria concentration of 24,200 MPN/100mL. The same *E.coli* concentration was detected for all surface water samples collected on February 15, 2017 that were located downstream of this station. Further investigation upstream of this location is recommended to better evaluate specific bacteria sources impacting Little White Oak Bayou.

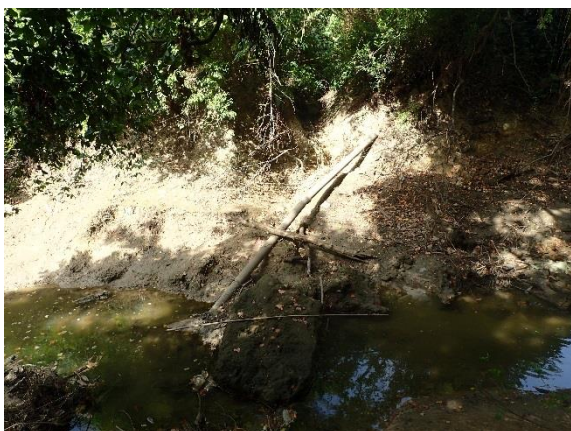
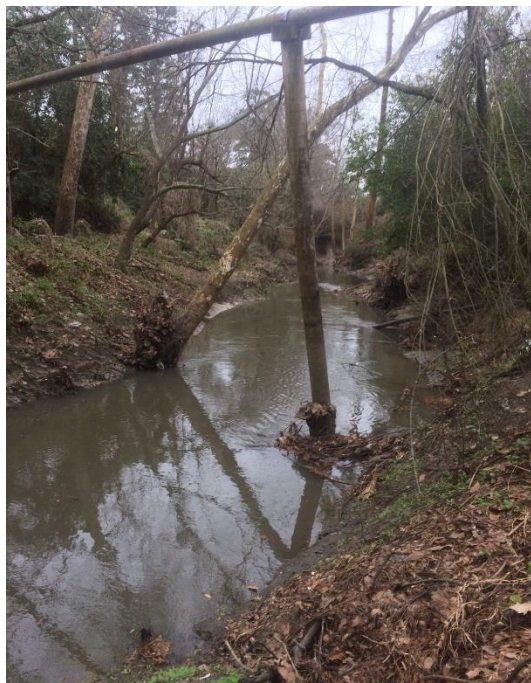
Station 34 is located at the southern end of the Rummel Creek watershed boundary downstream of the Edith L Jones Nature Conservancy. The station can be accessed through dense vegetation at the end of Hermitage Lane in a residential neighborhood. Old pipelines were observed along the stream bottom, although it was unclear if they were still operating or not (Figure 52).

A dry weather sample was collected on December 14, 2016 resulting in a bacteria concentration slightly exceeding the state water quality standard (Table 24). The wet weather sample was collected on February 14, 2017 immediately following a significant rain event (Figure 53). The bacteria concentration for the wet weather sample was 8,660 MPN/100mL which was significantly higher than the dry weather sample, but was the lowest wet weather concentration observed in Rummel Creek.

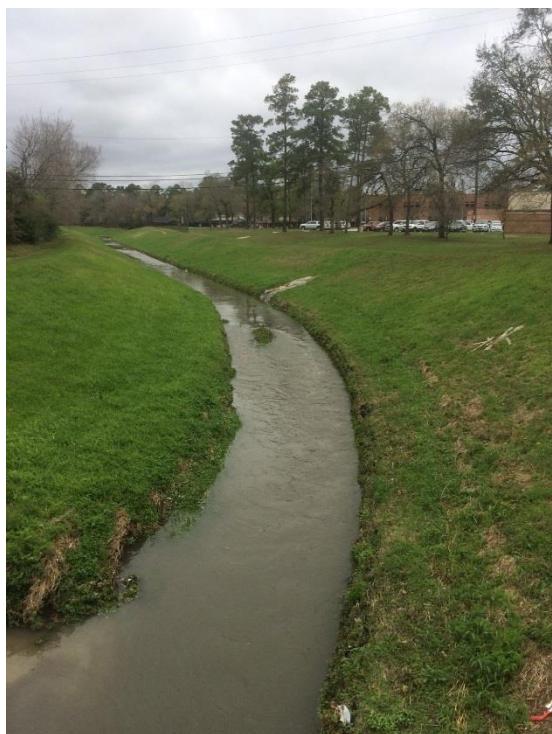
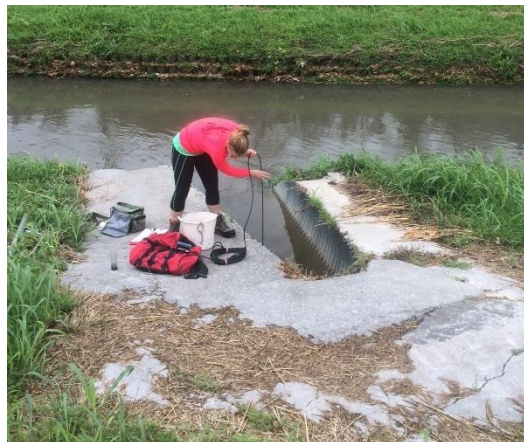
Station 36 is an outfall located downstream of Rummel Creek Elementary directly upstream of the bridge at Memorial Drive (Figure 54). This station is one of the highest contributors of bacteria into Rummel Creek during both Phase I and Phase II investigations. The outfall was discharging during all station visits, regardless of weather conditions.

The dry weather sample collected on December 14, 2016 resulted in an *E.coli* concentration of 1,860 MPN/100mL. The wet weather sample collected immediately following a significant rain event on February 14, 2017 (Figure 55) was significantly higher measuring at 24,200 MPN/100mL.

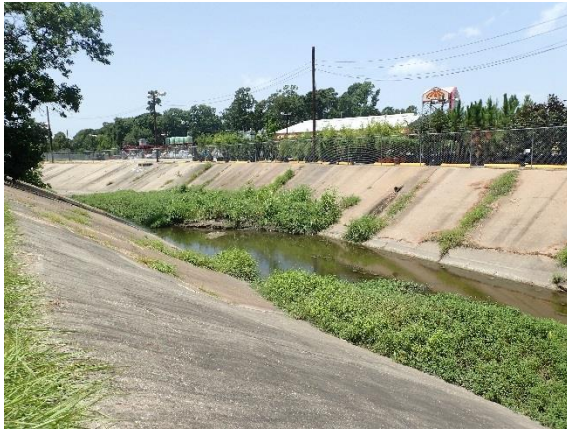
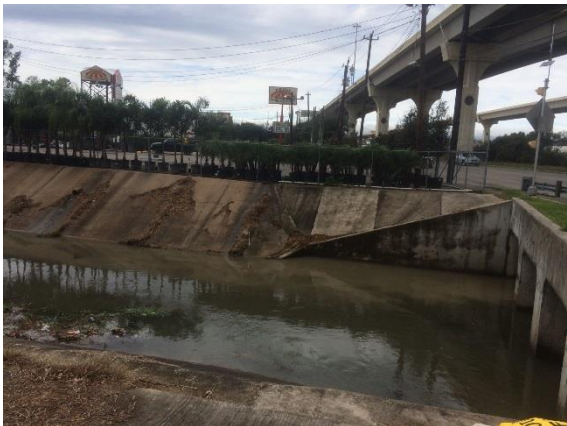
The dry weather sample collected on December 14, 2016 resulted in a bacteria concentration of 933 MPN/100mL, making this station one of the highest contributors of bacteria to Rummel Creek during dry weather conditions. At the time of the wet weather survey on February 14, 2017, the water discharging from the left bank was darker in color whereas water discharging on the right bank looked brown and cloudy, likely from heavy sediment loads from the recent rains (Figure 57). The wet weather *E.coli* concentration was significantly greater than the dry weather sample measuring at 12,000 MPN/100mL (Table 26).

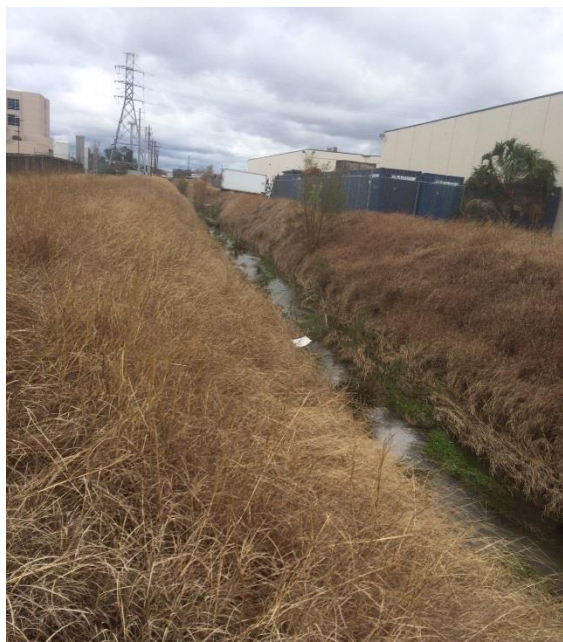
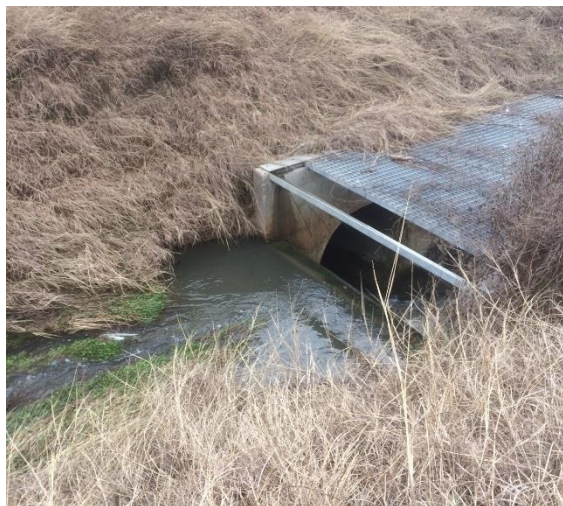
No sample was collected during the dry weather event on December 14, 2016 due to no flowing water at this station. The wet weather sample collected on February 14, 2017 resulted in an *E.coli* concentration of 19,900 MPN/100mL (Figure 60).
