PRELIMINARY PAVEMENT ASSESSMENT

THE CITY OF WEST UNIVERSITY PLACE TEXAS

BUFFALO SPEEDWAY

May, 2010

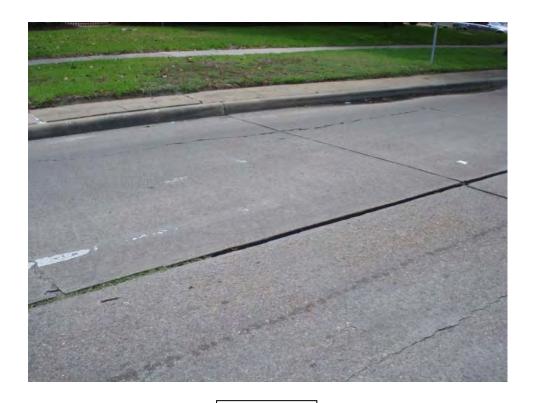
Location 1

Location No.	Description	Recommendation for repair		
1	Sunken joint, cracks	Replace ¼ panels – 150 LF		
2	Spawling	Clean & repair with high strength grout		
3	Large Cracks	Replace ¼ panels – 40 LF		
4	Spawling	Clean & repair with high strength grout		
5	Multiple cracks	Replace ¼ panel – 20 LF		
6	Multiple cracks	Replace ¼ panel – 30 LF		
7	Sunken joint, cracks	Replace ¼ panels – 70 LF		
8	Spawling	Clean & repair with high strength grout		
9	Spawling	Clean & repair with high strength grout		
10	Large cracks	Replace ¼ panel – 25 LF		
11	Spawling	Clean & repair with high strength grout		
12	Large crack (previously sealed)	Replace ¼ panels – 60 LF		
13	Storm inlet damage	Repair/Replace Inlet		
14	Multiple cracks	Replace ¼ panel – 20 LF		
15	Spawling at patch	Clean & repair with high strength grout		
16	Spawling at patch	Clean & repair with high strength grout		
17	Spawling & cracking	Replace ½ panel – 10 LF

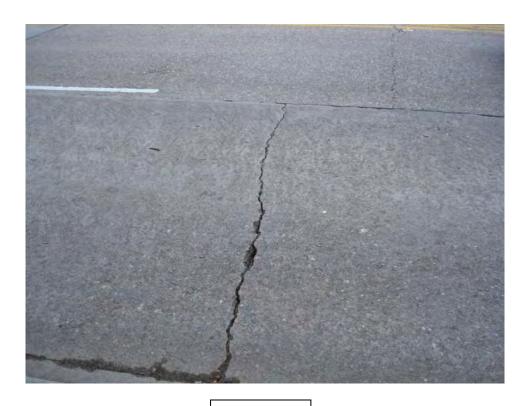
Location 19

18	Sunken pavers @ crosswalk	Re-bed pavers		
19	Large cracks	Replace ¼ panel – 20 LF		
20	Multiple cracks	Replace ¼ panel – 20 LF		
21	Multiple cracks	Replace ¼ panels – 60 LF		
22 .	Spawling on old & new pavement	Clean & repair with high strength grout		
23	Storm inlet sunk & spawling	Replace inlet & repair spawling		
24	Cracks	Replace ¼ panels – 40 LF		
25	Large cracks	Replace ¼ panels – 40 LF, ½ panel 20 LF		
26	Three cracked panels	Replace center ¼ panels – 70 LF		
27	Spawling	Clean & repair with high strength grout		
28	Multiple cracks	Replace ¼ panel – 25 LF		
29	Cracked panels	Replace center ¼ panels – 70 LF		
30	Cracks in panel adjacent to inlet	Replace ¼ panel – 25 LF		
31	Multiple cracks	Replace ¼ panels – 45 LF		
32	Multiple cracks	Replace ¼ panel – 25 LF

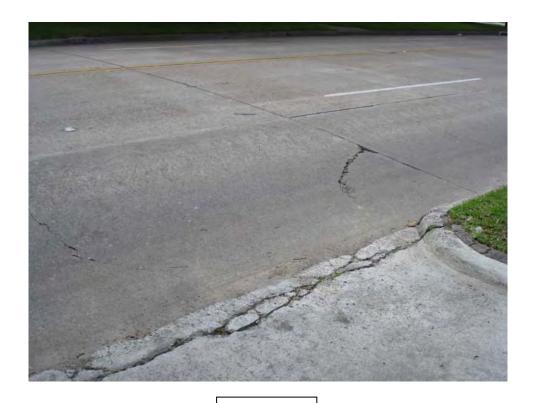
Location 34

Location No.	Description	Recommendation for repair			
33	Cracked panel @ inlet	Replace ¼ panel – 25 LF			
34	Multiple cracks				
35	Cracks	Replace center 1/4 panels - 60 LF			
36	Cracks	Replace ¼ panel – 10 LF			
37	Multiple cracks	Replace ¼ panel – 20 LF			
38	Two cracked panels	Replace ¼ panels – 60 LF			
39	Two cracked panels	Replace ¼ panels – 60 LF			
40	Large crack	Replace ¼ panel – 20 LF			
41	Multiple cracks	Replace ¼ panels – 70 LF			
42	Large crack in multiple panels	Replace ¼ panels – 150 LF

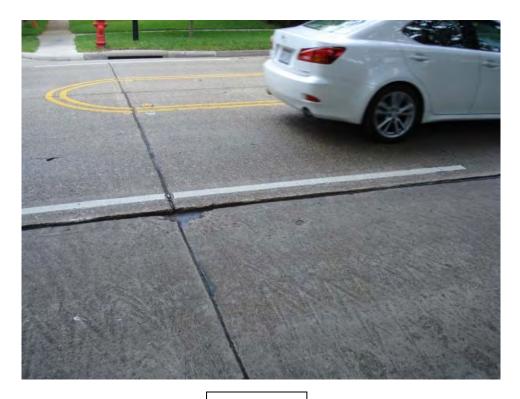
Sunken Joint

It was also noted that there is apparent evidence that the roadway may have sunken in some locations since at some of the joints the pavement panel is about one inch lower than its adjacent panel. The observed locations of these "sunken joints" are noted on the maps and a nominal linear footage for slab jacking is included in the cost estimate.
