Targeted Bacteria Monitoring Project Executive Summary

Overview

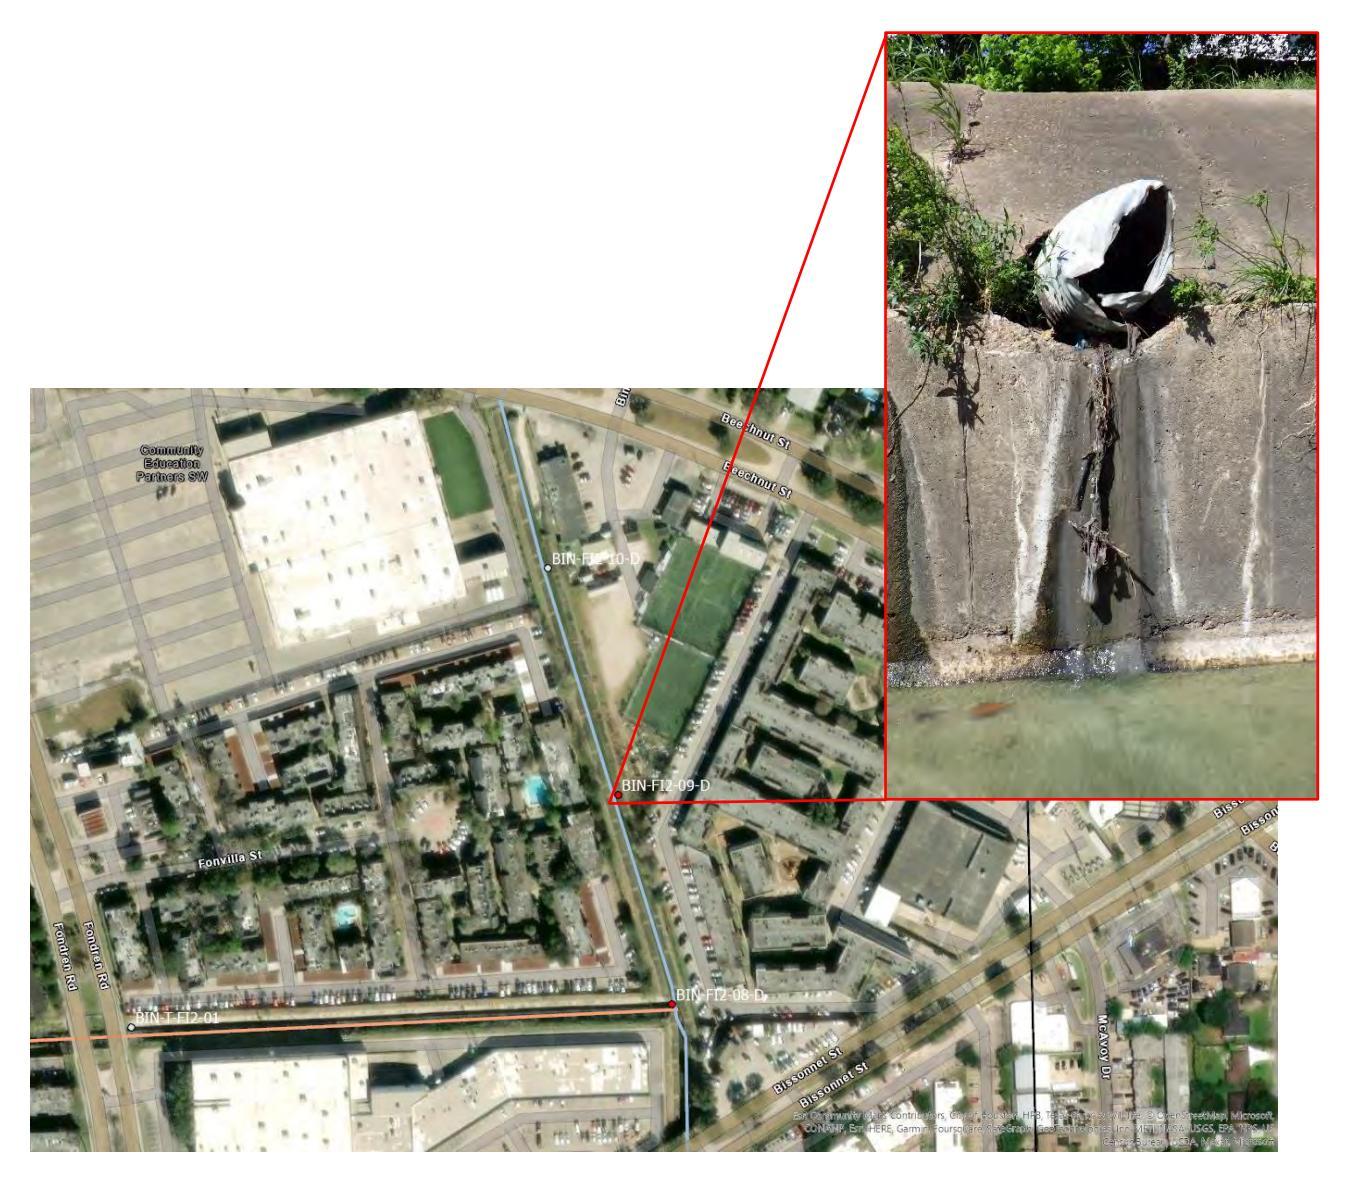
This is an approximately 20 in. diameter metal pipe located on the right bank of Bintliff Ditch. Water within the pipe was 0.1 in. deep and trickling into the segment. The pipe was partially collapsed and rusted through and the concrete around the pipe was broken. There are apartments located in the area on the right bank. A sample just 0.05 m downstream of the pipe had a bacteria value of > 242,000 MPN/100 mL. The ambient sample collected upstream of the pipe had a bacteria value of < 100 MPN/100 mL. This pipe is a high priority referral site for the proper local authority.

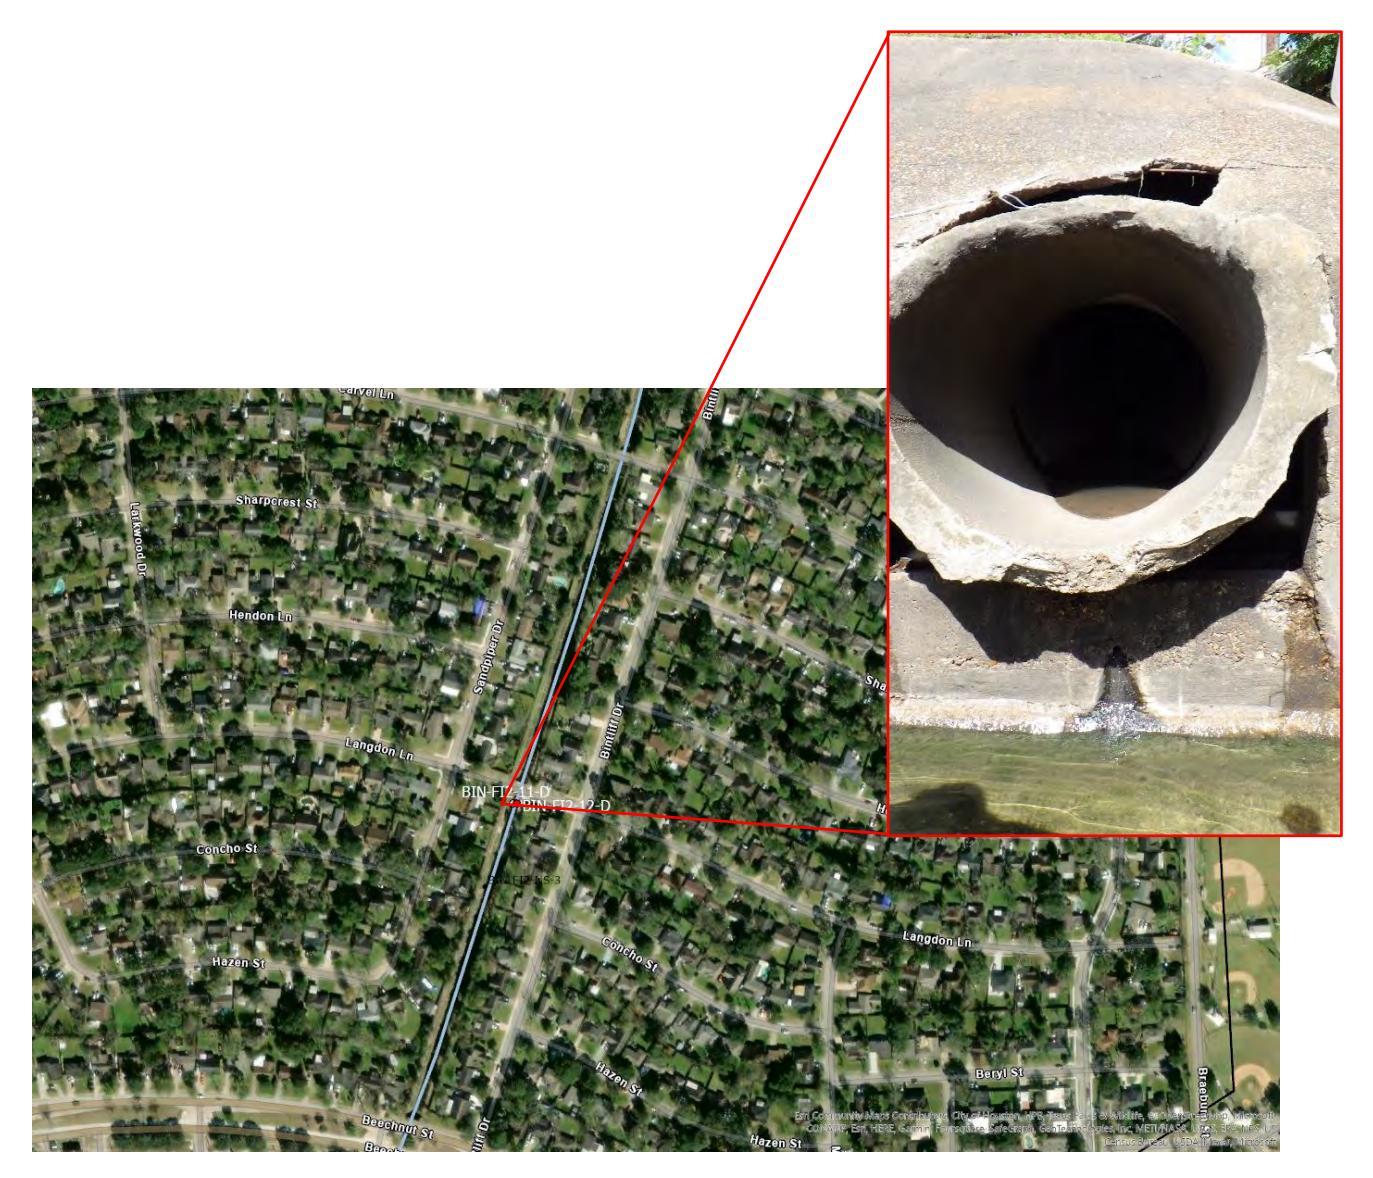
Referral site: BIN-FI2-12-D - High Priority

This is a 40 in. diameter concrete pipe located on the right bank of Bintliff Ditch. Water within the pipe was 0.1 in. deep and trickling into the segment through cracks in the cement wall. The cement pipe and the cement around the pipe was collapsed and broken. The field crew noted that the water was "sudsy". There are single-family homes located in the area on the right bank. A sample just 0.1 m downstream of the pipe had a bacteria value of > 242,000 MPN/100 mL. The ambient sample collected upstream of the pipe had a bacteria value of 112,000 MPN/100 mL. This pipe is a high priority referral site for the proper local authority. Note: there was also a pipe located on the left bank directly across from this pipe which had significant flow and smelled like chlorine but had a much lower downstream bacteria value of 4,040 MPN/100 mL and was not referred.

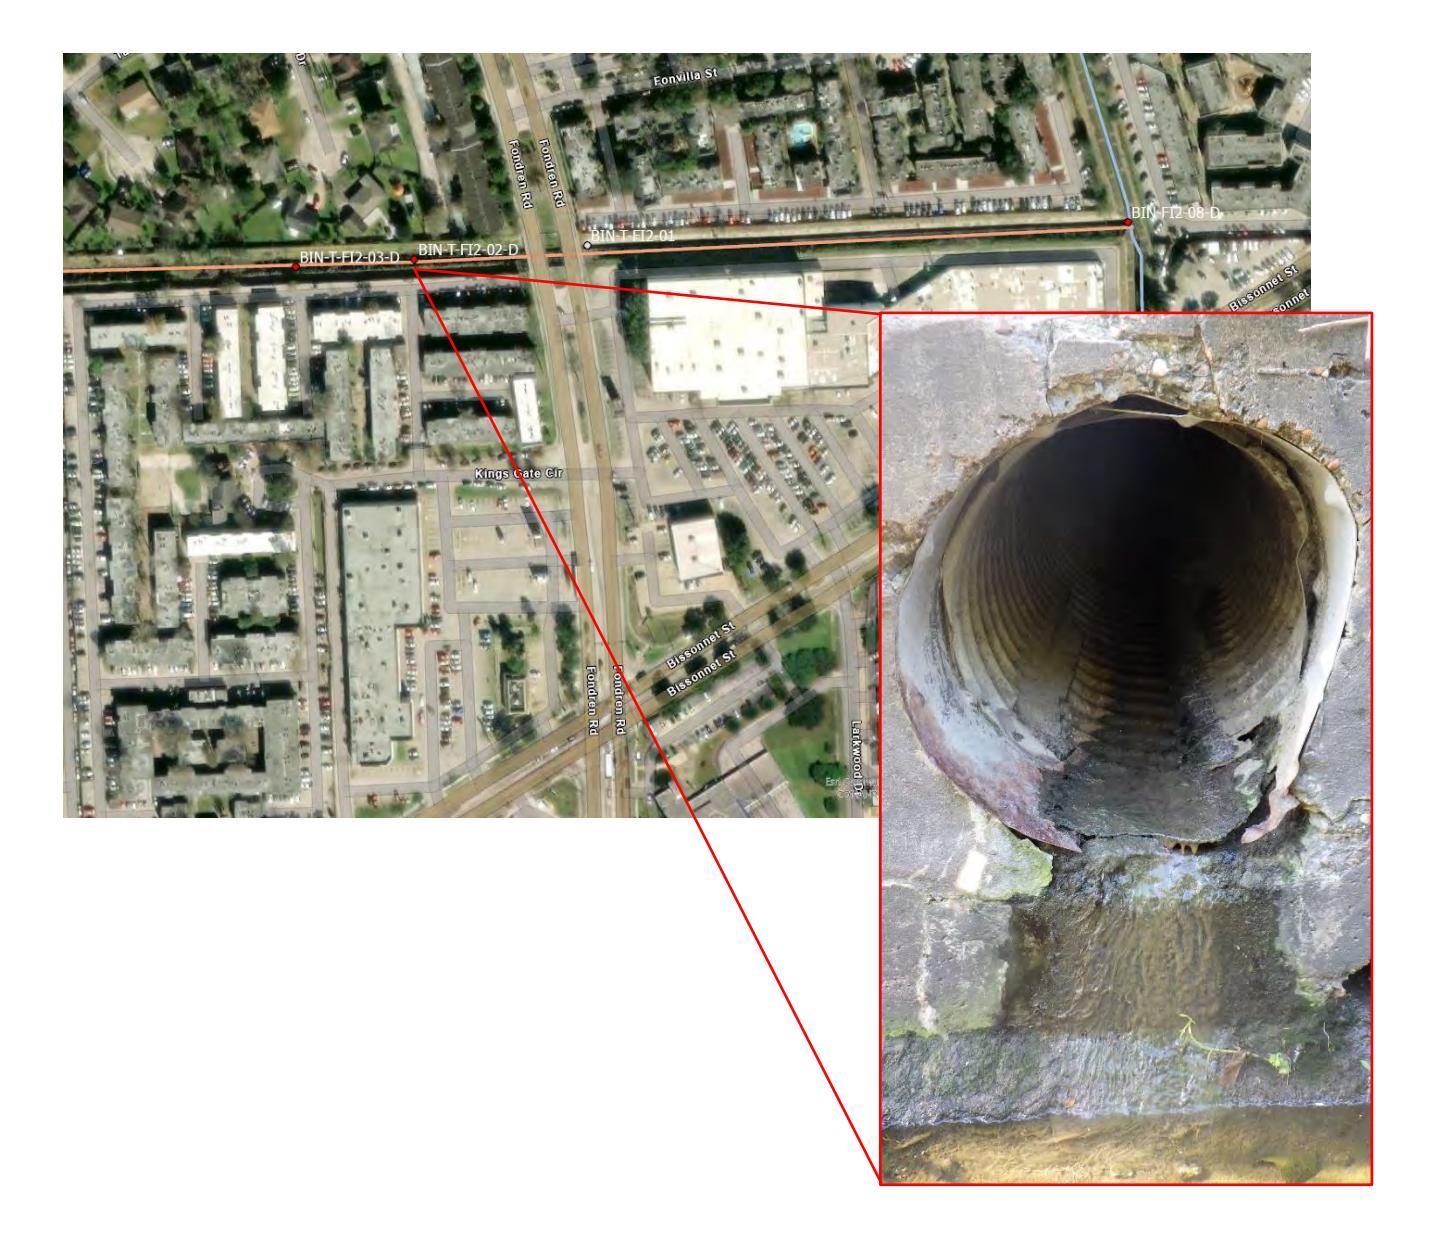
This is a 25 in. diameter metal pipe located on the right bank of the tributary to Bintliff Ditch. Water within the pipe was 0.125 in. deep and trickling into the segment. The pipe was partially collapsed and rusted through. The substrate that the water was flowing down on the cement was filamentous and light brown in color. There are apartments and commercial buildings located in the area on the right bank. A sample just 0.55 m downstream of the pipe had a bacteria value of 5,290 MPN/100 mL. The ambient sample collected upstream of the pipe had a bacteria value of 3,130 MPN/100 mL. This pipe is a high priority referral site for the proper local authority.

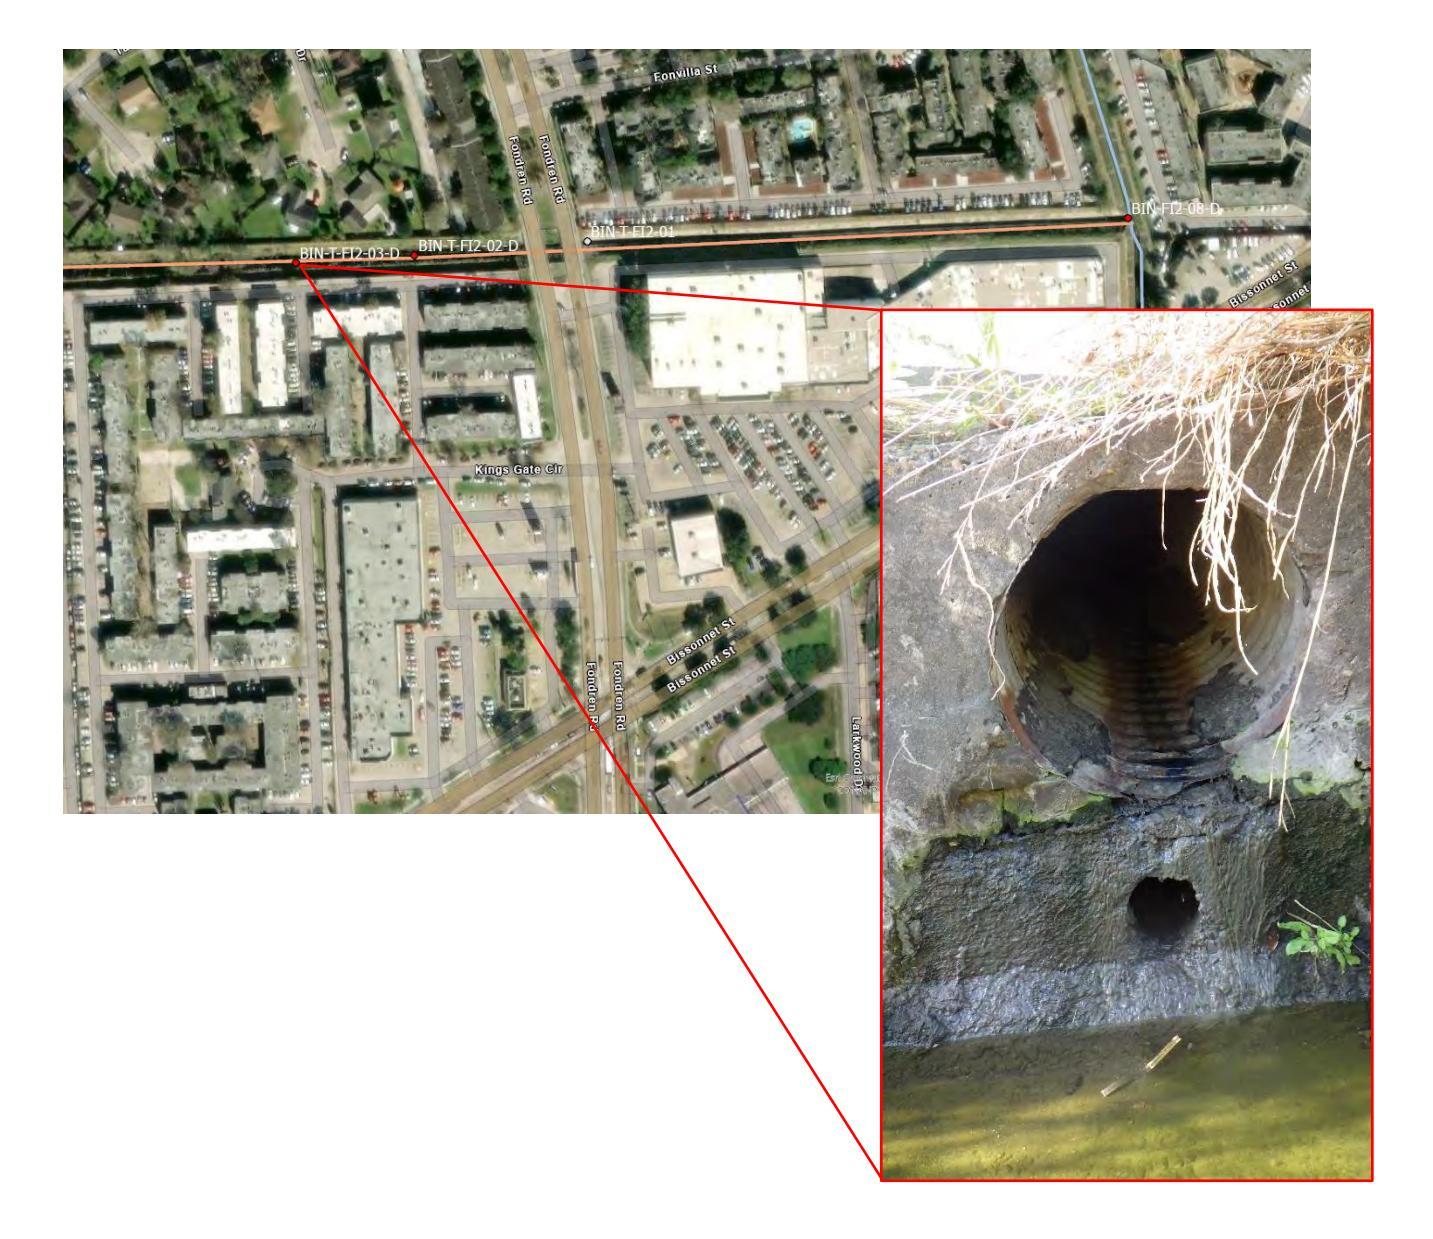
This is a 24 in. diameter metal pipe located on the right bank of the tributary to Bintliff Ditch. Water within the pipe was 0.125 in. deep and trickling into the segment. The pipe was rusted through and leaking behind the cement wall and a filamentous light brown substrate was observed where the water was pouring over the cement. There are apartments and commercial buildings located in the area on the right bank. A sample just 0.5 m downstream of the pipe had a bacteria value of 48,800 MPN/100 mL. The ambient sample collected upstream of the pipe had a bacteria value of 5,650 MPN/100 mL. This pipe is a high priority referral site for the proper local authority.

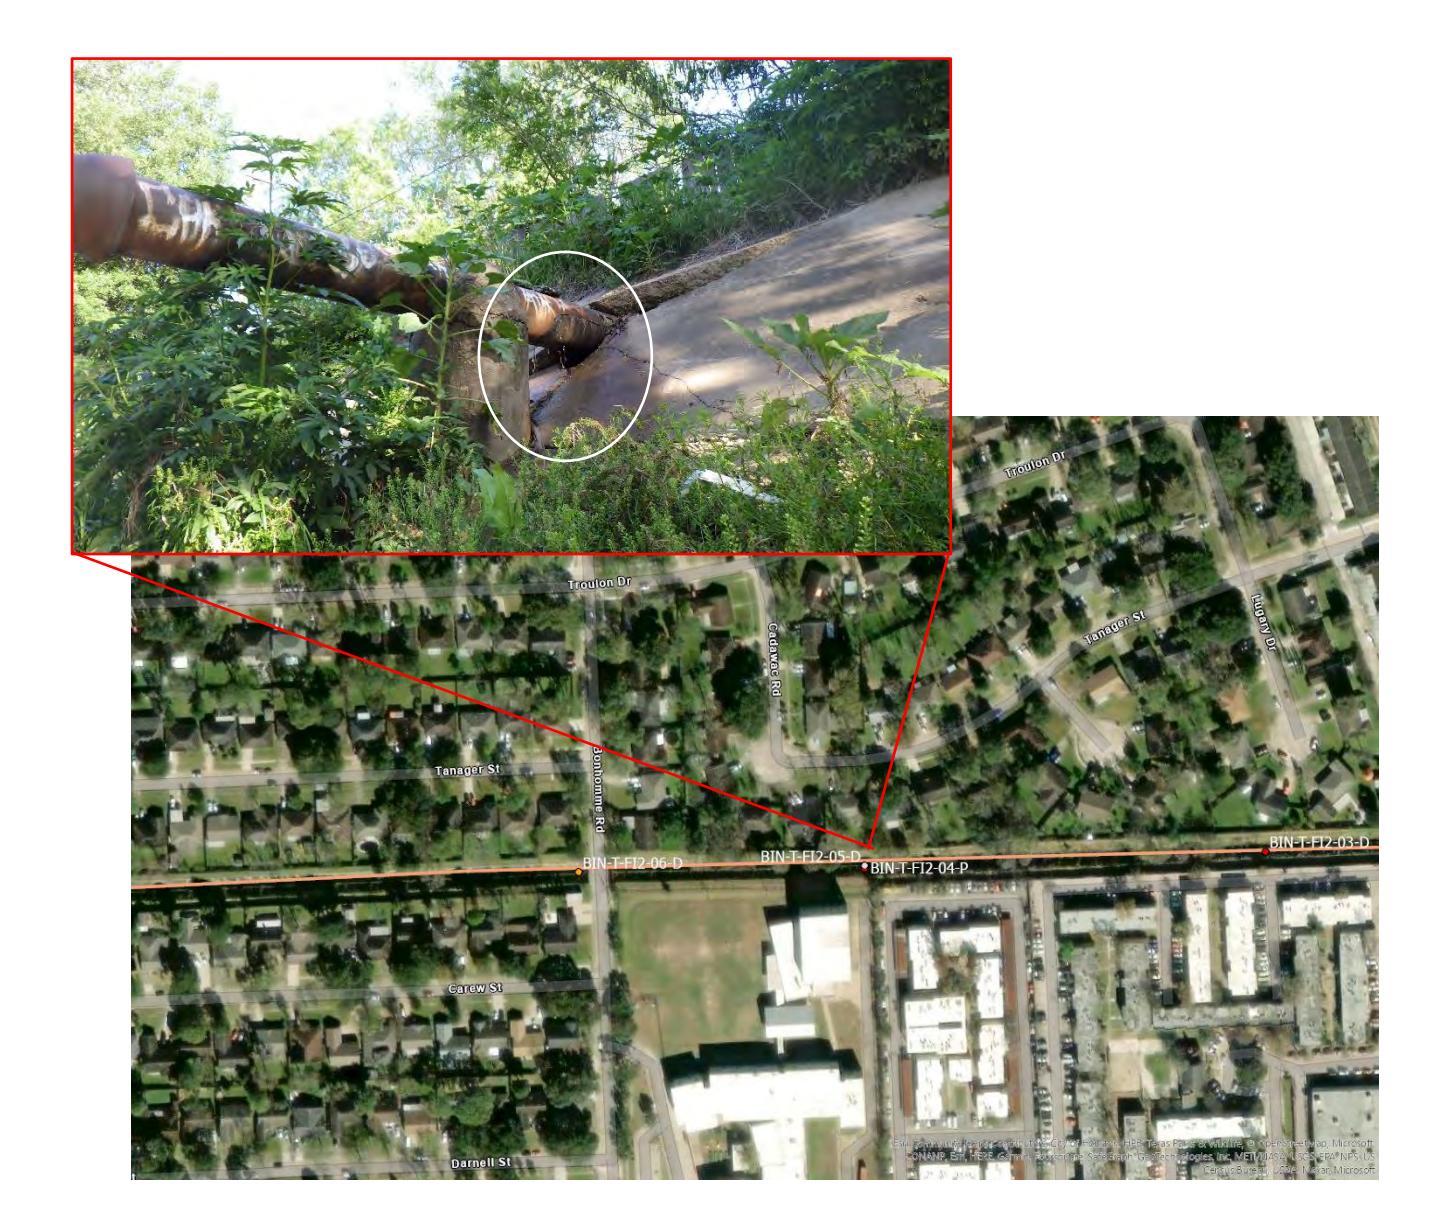
Referral site: BIN-T-FI2-04-P- High Priority

| Sample ID | Lat | Long | DS or Direct <i>E. coli</i> Sample Results (MPN/100 mL) | US <i>E. coli</i> Sample Results (MPN/100 mL) | Difference* DS - US (MPN/100 mL) | Referral | Comments |
|---|---|---|--|---|---|---|---|
| BIN-T-FI2-04-P | 29.68885 | -95.51241 | > 242,000 | NA | NA | Y-H | Water has strong sewage odor; leaking pipe over waterway; leak flowing down left bank. |

This is a 12 in. diameter metal pipe that crosses above the tributary to Bintliff Ditch. It was broken/leaking and flowing down the left bank (white circle in photo below). The crew noted a strong sewage odor from the water leaking from the pipe. There are single-family homes located in the area on the left bank and Sugar Grove Elementary School located on the right bank. A sample taken directly from the leaking pipe had a bacteria value of > 242,000 MPN/100 mL. This pipe is a high priority referral site for the proper local authority.

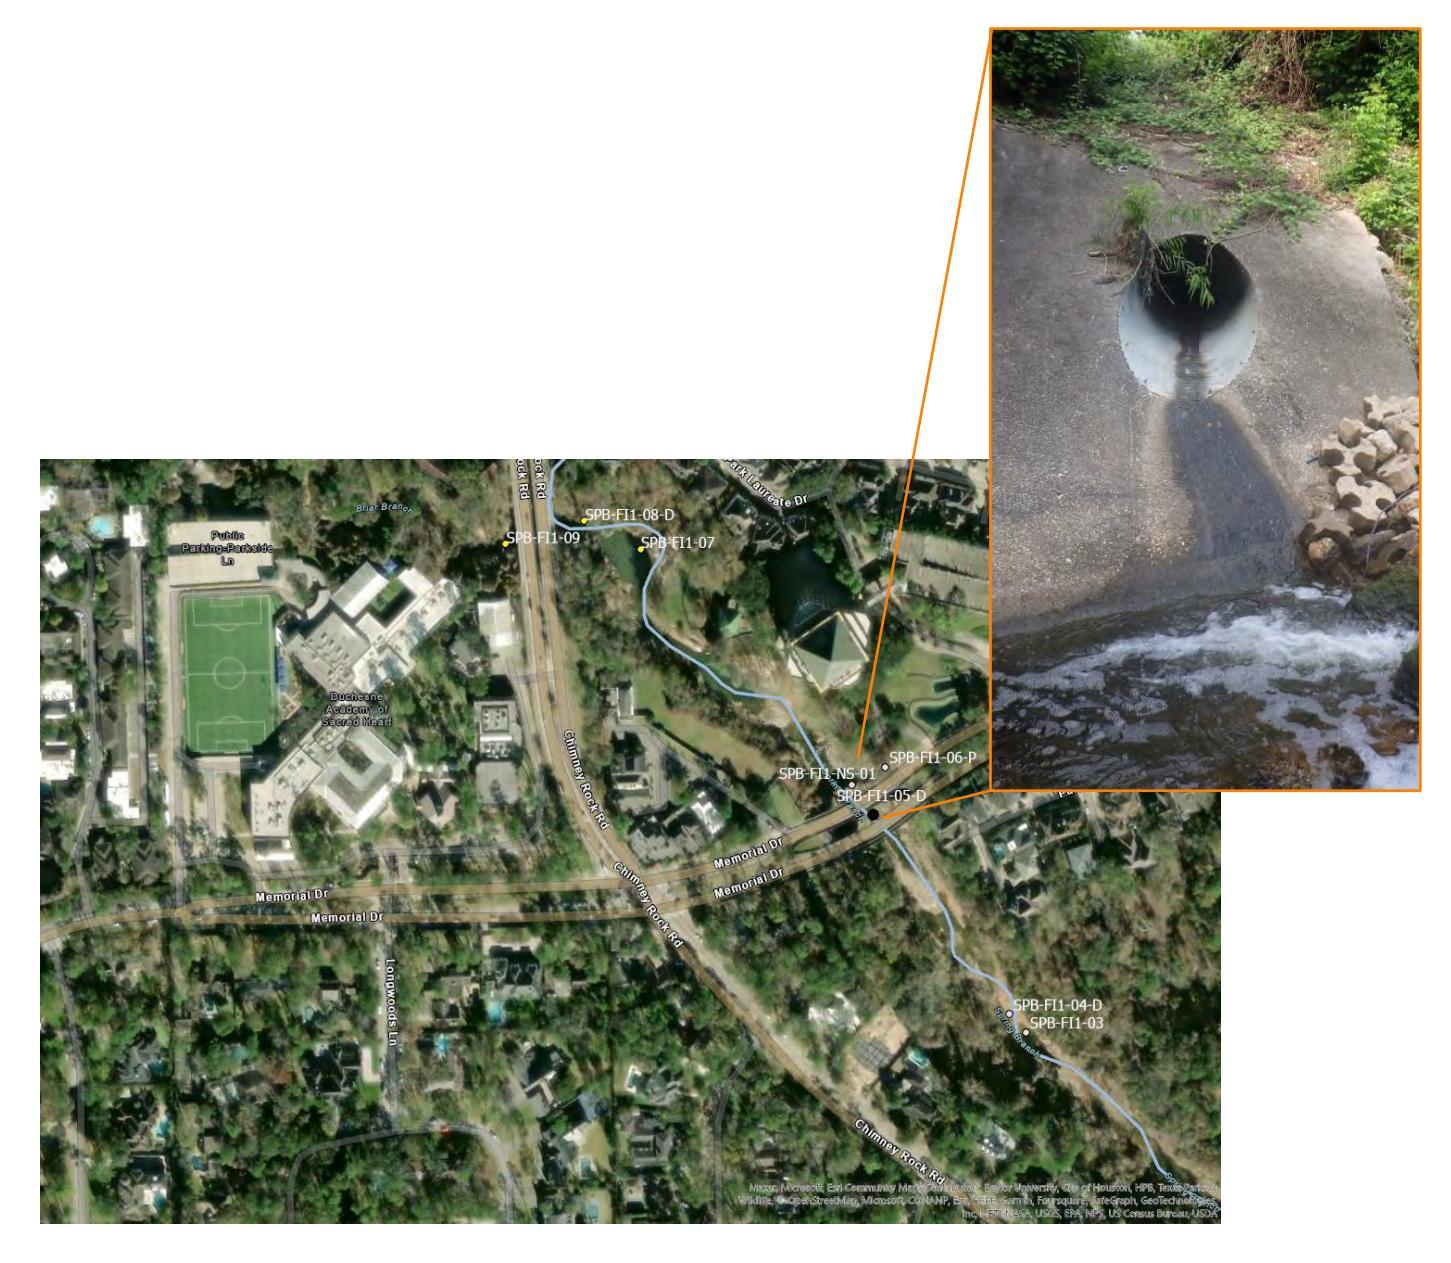
This is a 48 in. diameter metal pipe located on the right bank of Spring Branch where a small waterfall mixes with the outflow of the pipe. Water within the pipe was 0.5 in. deep. There are single family homes in the area and a high school on the right bank. A sample 1.5 m downstream of the pipe had a bacteria value of 740 MPN/100 mL. The ambient sample collected upstream of the pipe had a bacteria value of 410 MPN/100 mL. This pipe is a low priority referral site for the proper local authority.

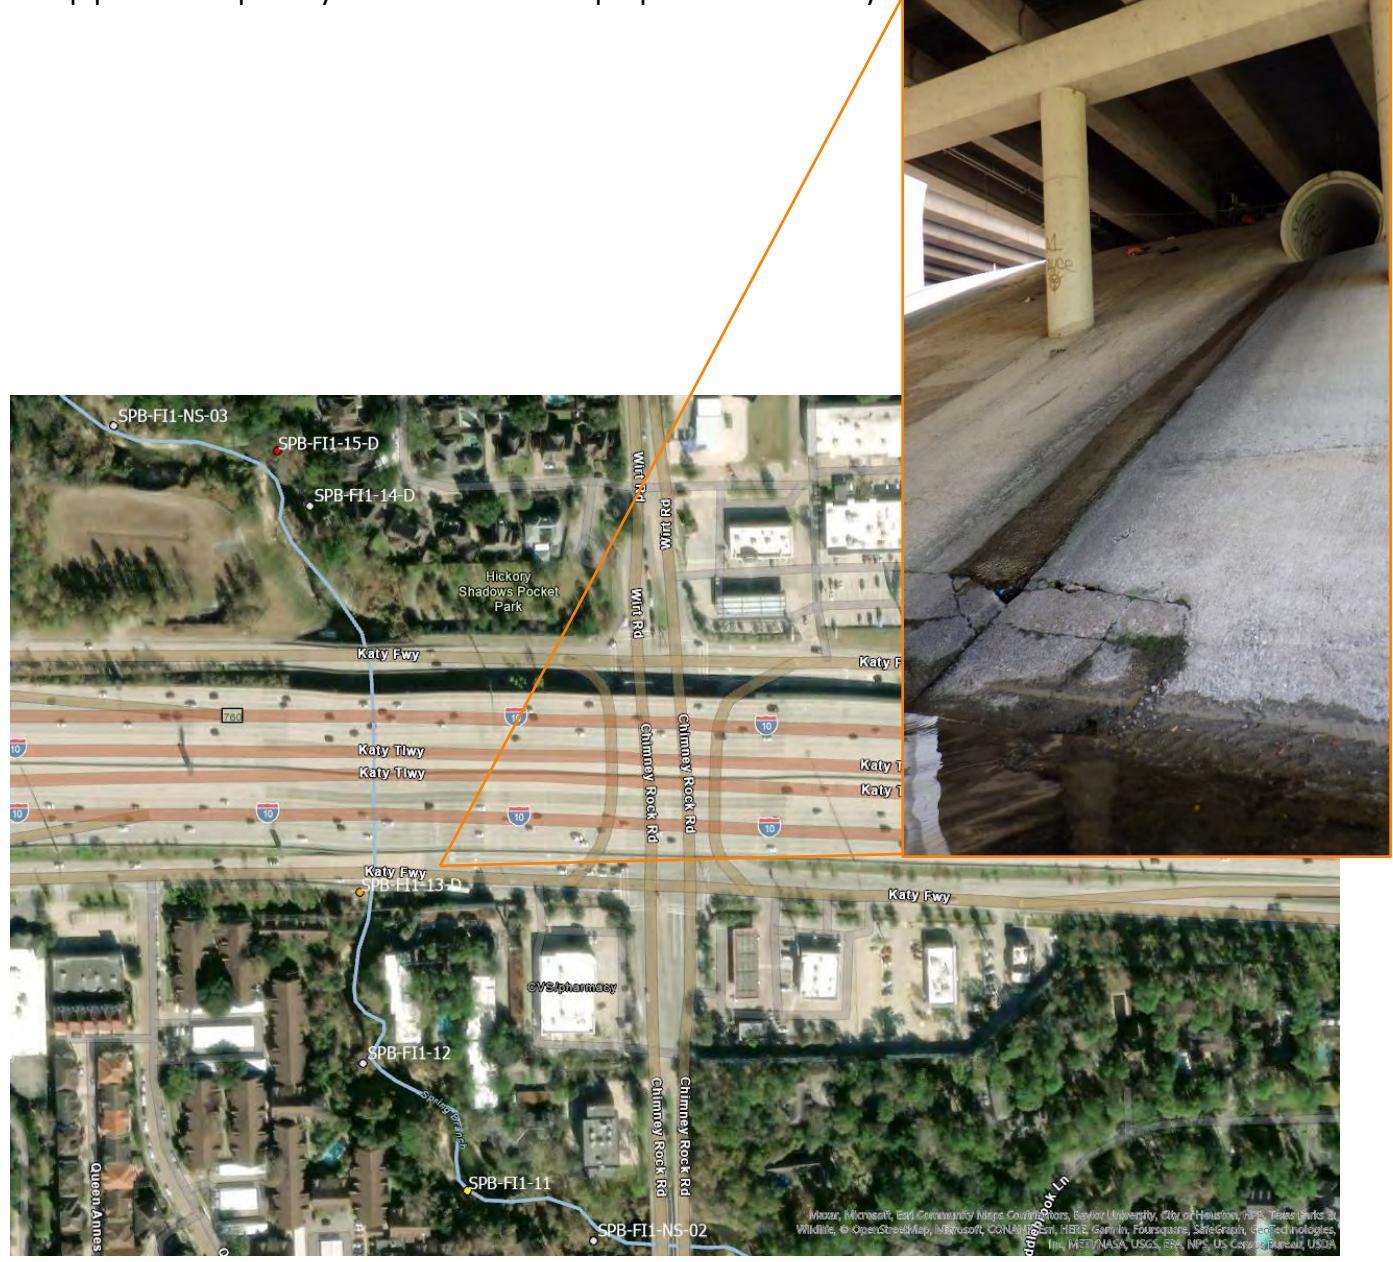
Referral site: SPB-FI1-13-D- Low Priority

This is an approximately 72 in. diameter concrete pipe located on the left bank of Spring Branch. Water within the pipe was estimated to be 0.125 in. The pipe is parallel with Interstate 10 and there are commercial businesses, condos, and single-family homes in the area. Outflow from the pipe runs down approximately 15 m of concrete into cracks before entering the stream. A sample taken downstream of the pipe had a bacteria value of 1,340 MPN/100 mL. The ambient sample collected upstream of the pipe had a bacteria value of 740 MPN/100 mL. This pipe is a low priority referral site for the proper local authority.

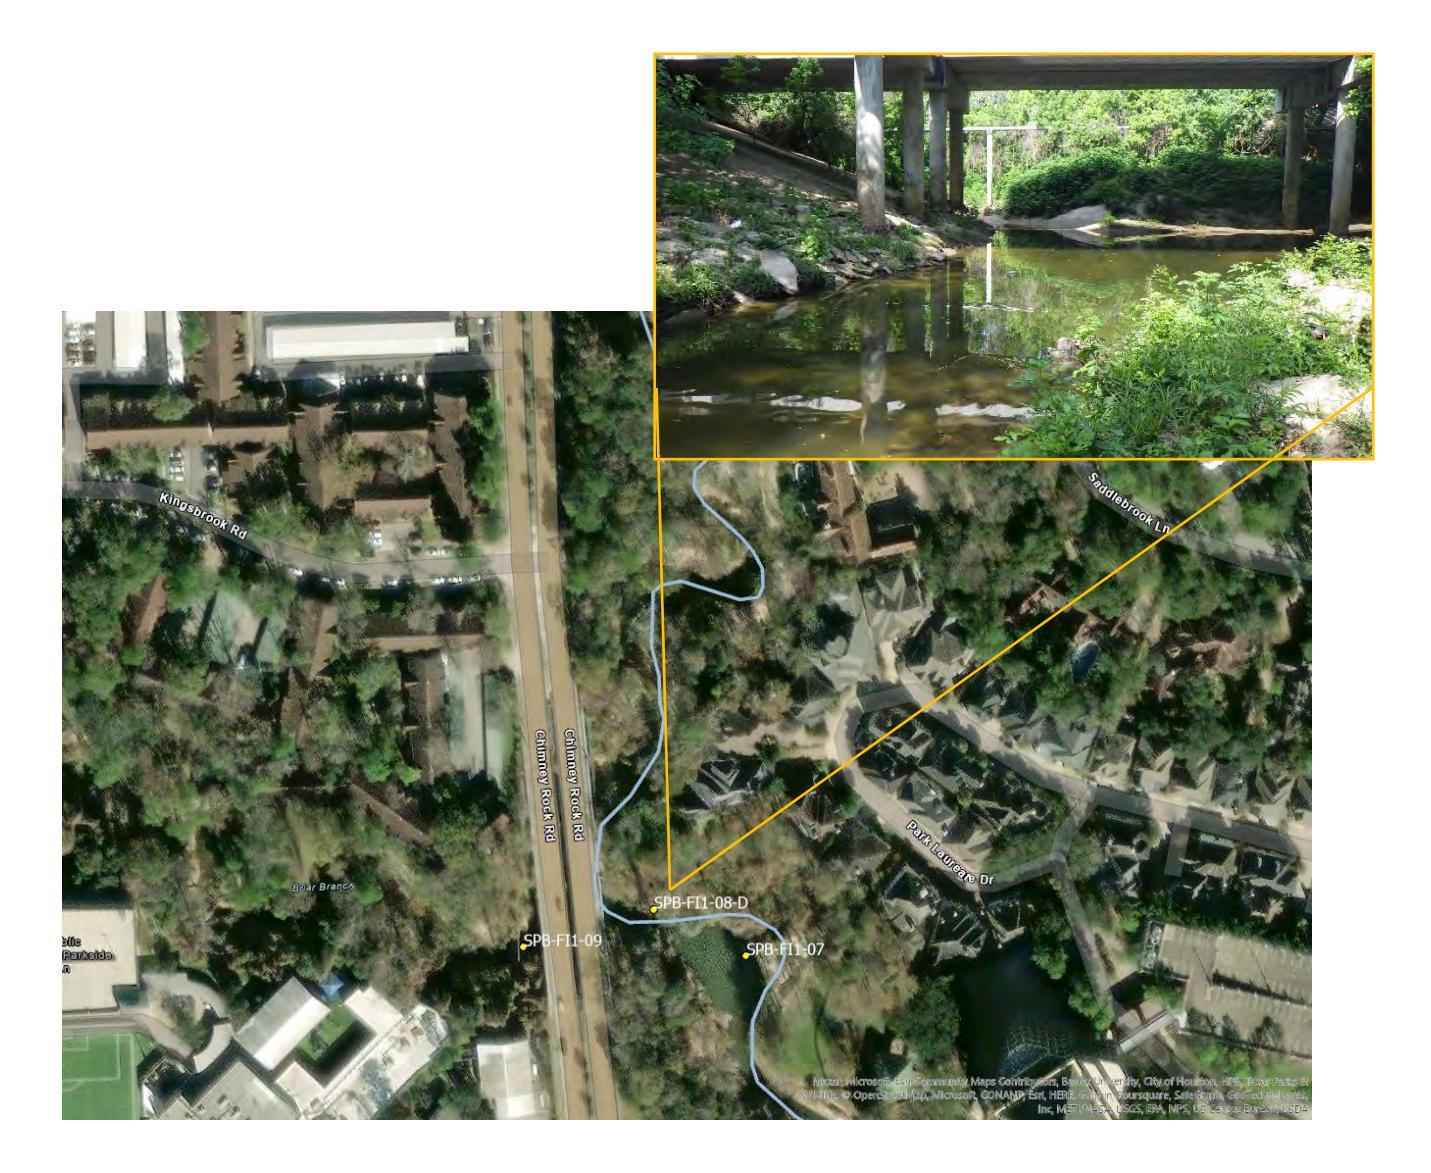
Referral site: SPB-FI1-08-D- Investigate Further

This is a 24 in. metal pipe that was dripping on the left bank of Spring Branch. This sample had a bacteria value of <100 MPN/100 mL but the upstream sample had a bacteria value of 8,390 MPN/100 mL. Bats are present under the bridge upstream of where samples were taken, and a beaver was observed in the water at the site. The next sample taken upstream of this site was SPB-IF1-10D where the upstream sample was 860 MPN/100 mL. There are single-family homes in the area and a high school on the right bank. Further investigation is recommended by the proper local authority to determine the source of elevated bacteria in this section of the segment.

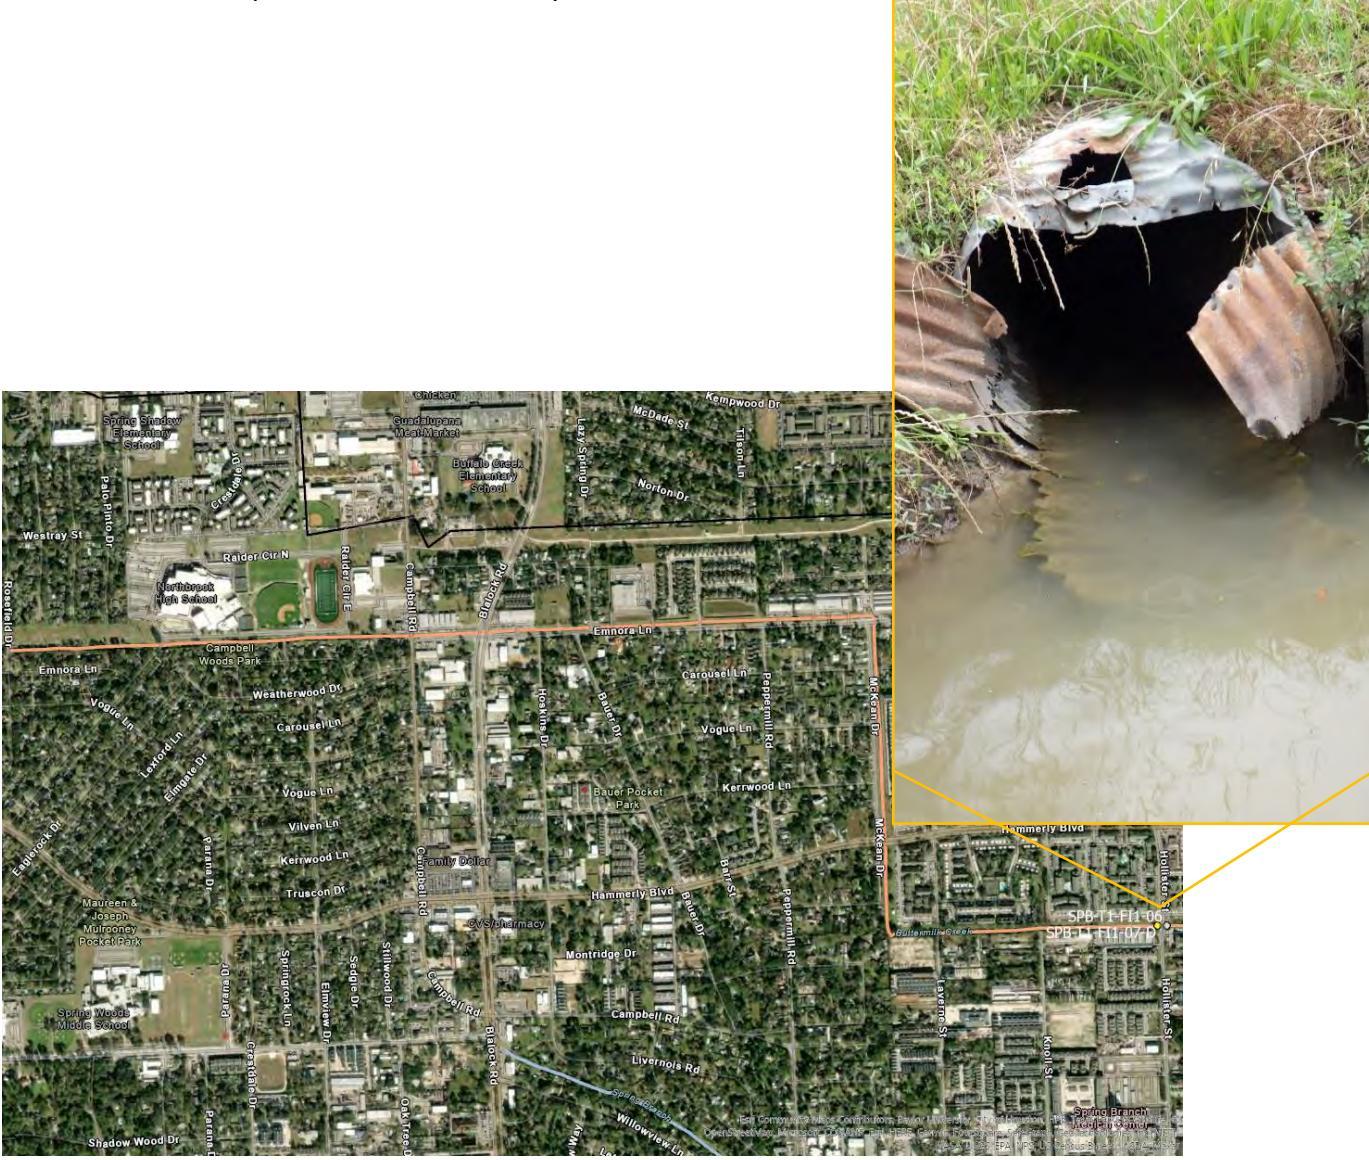
Referral site: SPB-T1-FI1-07- Investigate Further

This is a 36 in. diameter rusted out metal pipe located on the left bank of the tributary of Spring Branch. Water within the partially submerged pipe was 5 in. deep and the team was unable to determine if it was flowing into the tributary. There are apartments and commercial buildings located in the area. Due to the pipe being submerged, the downstream sample was taken within the mixing zone in front of the mouth of the pipe and had a bacteria value of 520 MPN/100 mL. The sample collected upstream of the pipe had a bacteria value of 860 MPN/100 mL. A sample from this location during the WS resulted in a bacteria value of < 100 MPN/100 mL and therefore the FI ended at this site. Due to the higher bacteria levels during the FI, further investigation is recommended by the proper local authority to determine the source of elevated bacteria upstream in the tributary.

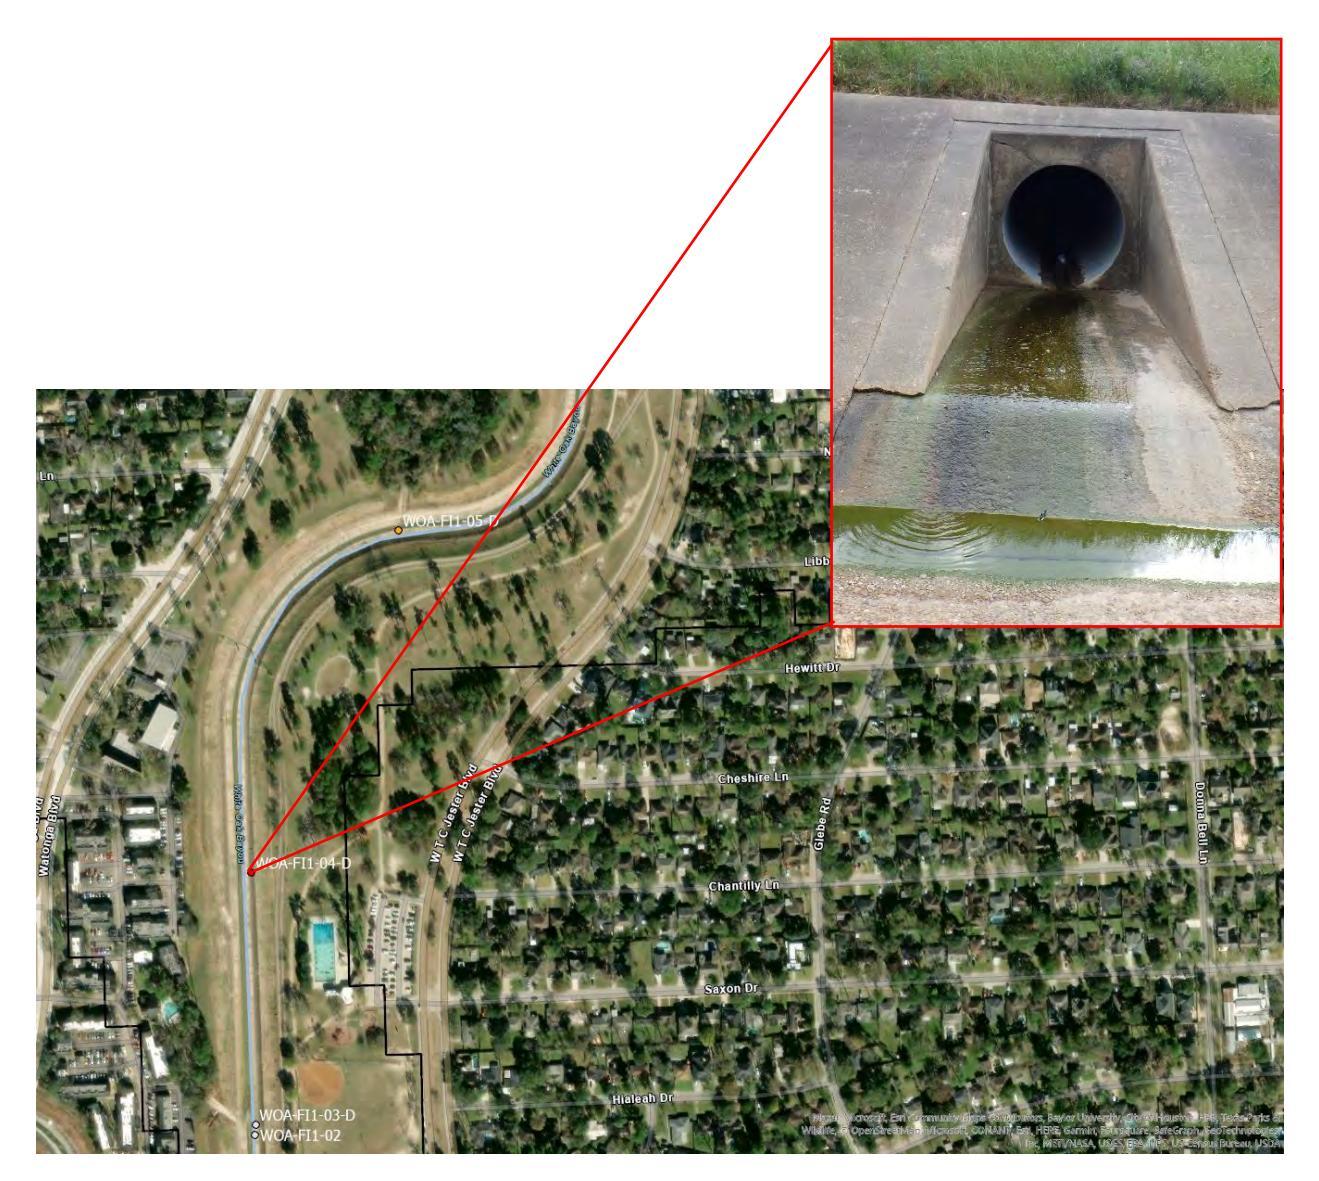
This is a 52 in. diameter metal pipe located on the left bank of White Oak Bayou Above Tidal. Water within the pipe was 0.25 in. deep and discharged onto a concrete lining before entering the AU. There is a walking trail that runs parallel with the bayou located on the left bank of this sampling location. Many joggers with dogs were observed utilizing this trail as the field crew was sampling. There is also a park with a public pool located on the left bank of this site, as well as many residential homes located in the adjacent area on the left bank. The area on the right bank is predominantly residential, with many apartment complexes and several schools. A sample taken 5.0 m downstream of the pipe had a bacteria value of 750 MPN/100 mL. The ambient sample collected upstream of the pipe had a bacteria value of 100 MPN/100 mL. This pipe is a high priority referral site for the proper local authority.

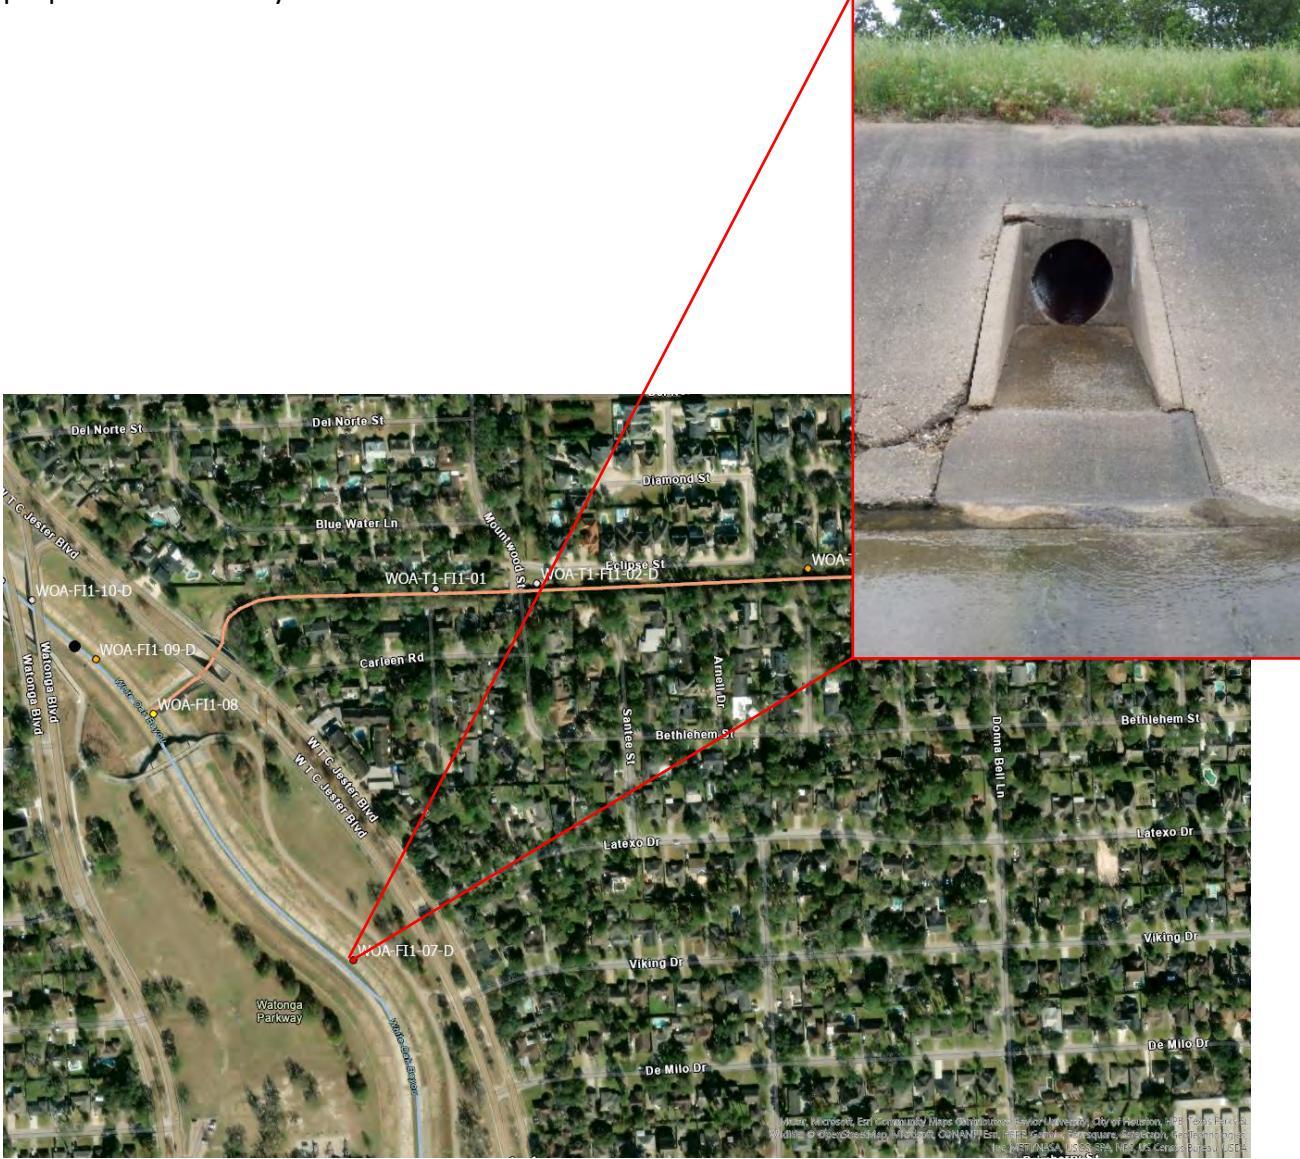
Referral site: WOA-FI1-07-D – High Priority

This is a 32 in. diameter metal pipe located on the left bank of White Oak Bayou Above Tidal. Water within the pipe was 0.6 in. deep and lightly flowing onto the concrete lining and bank before entering the segment. The water coming out of the pipe was noted to be brownish in color. There is a walking trail running parallel to the bayou on the left bank. The area on the left bank is predominately a single-family residential area. A sample taken 4.0 m downstream of the pipe had a bacteria value of 2,430 MPN/100 mL. The ambient sample collected upstream of the pipe had a bacteria value of 300 MPN/100 mL. This pipe is a high priority referral site for the proper local authority.

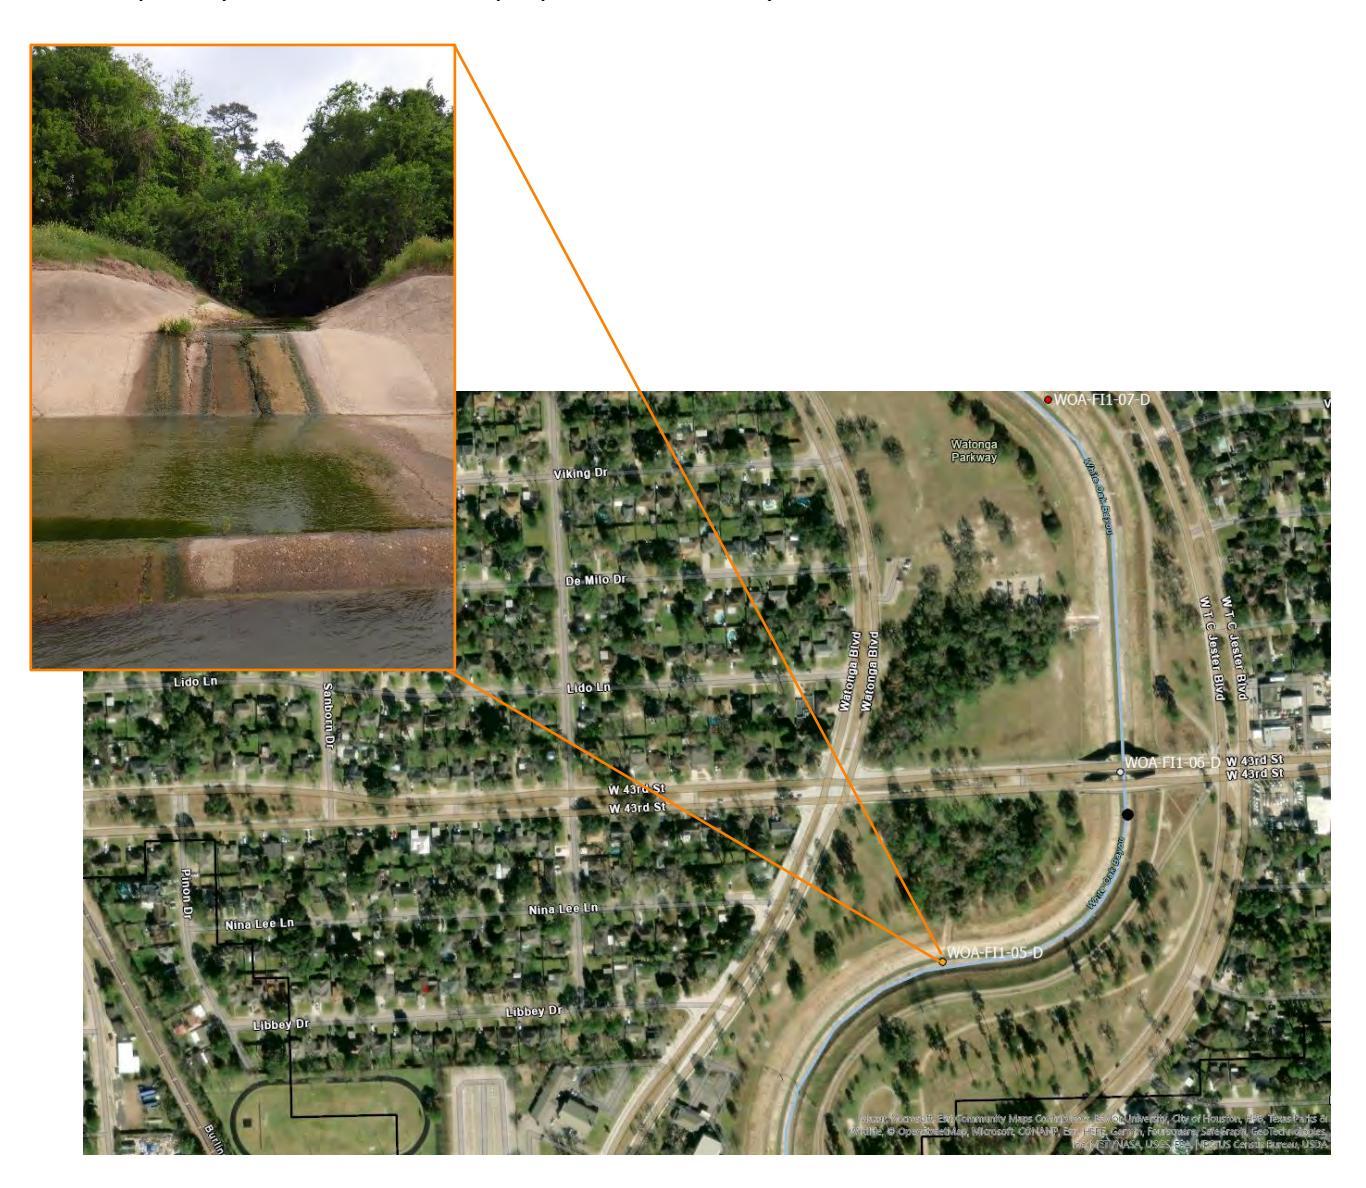
This is a concrete-lined, open-air ditch that flows into White Oak Bayou Above Tidal from the right bank. Water within the ditch was flowing onto the concrete-lined right bank before flowing into the AU. The ditch is located between a small dense wooded area and the main AU. A sample collected from the ditch had a bacteria value of 310 MPN/100 mL. The ambient sample collected upstream of the ditch had a bacteria value of 200 MPN/100 mL. This ditch is a low priority referral site for the proper local authority.
