Targeted Bacteria Monitoring Project Executive Summary

Overview

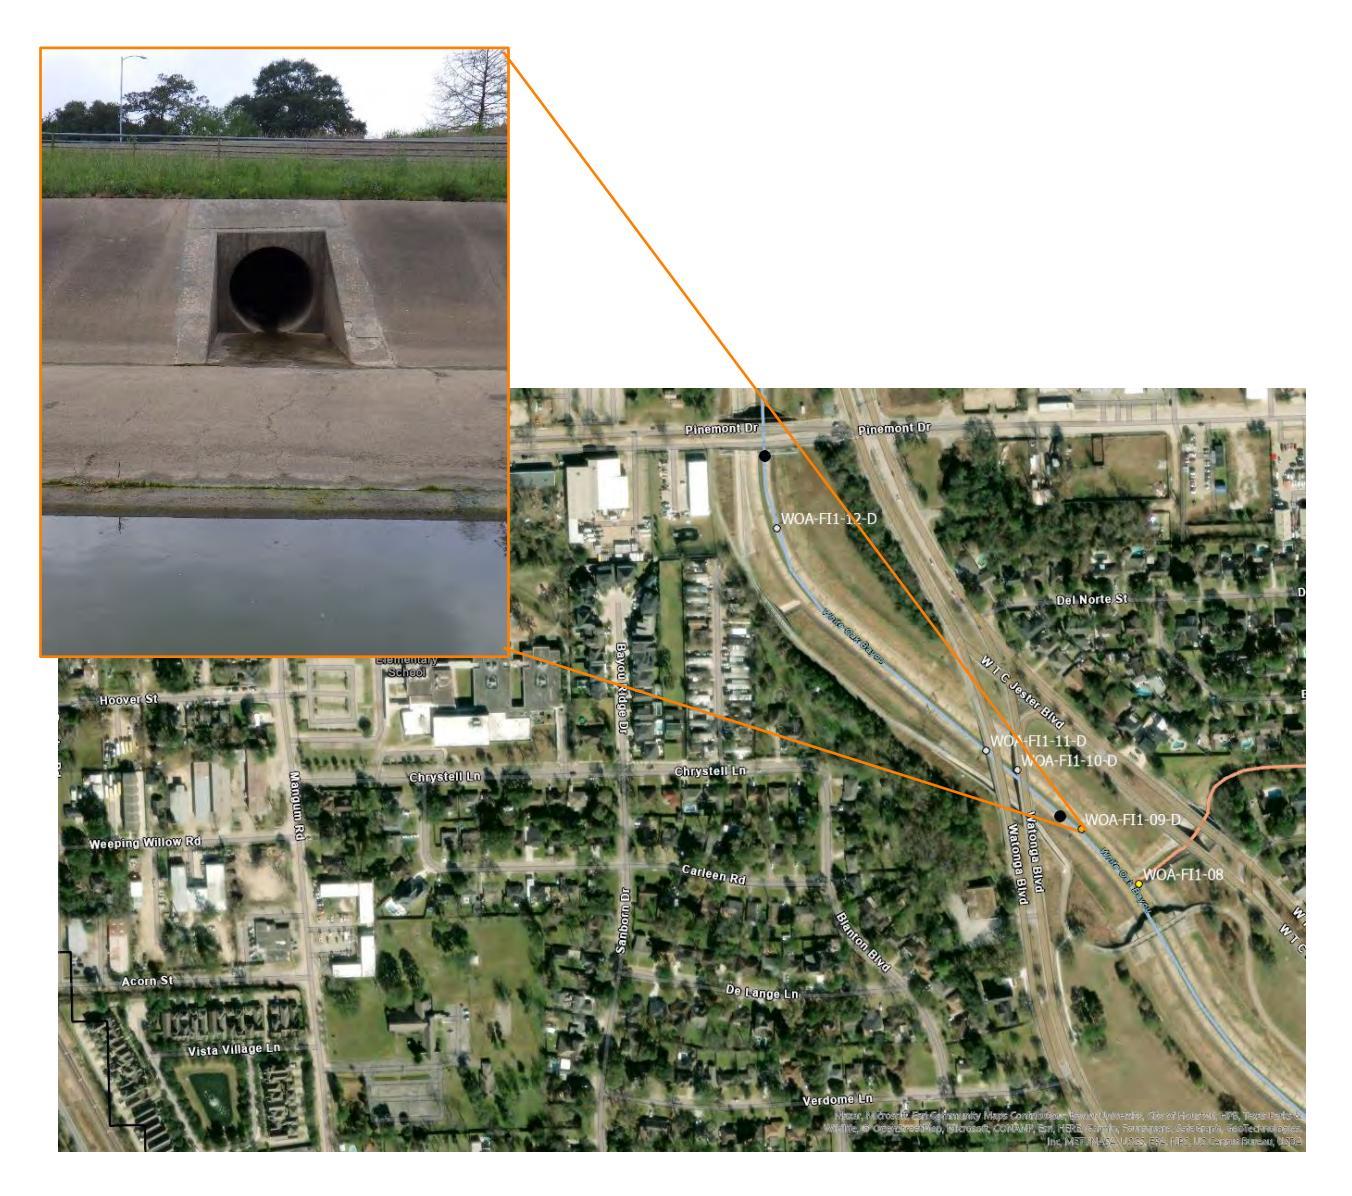
Referral site: WOA-FI1-09-D – Low Priority

This is a 60 in. diameter concrete pipe located on the right bank of White Oak Bayou Above Tidal. Water within the pipe was estimated to be 0.25 in. deep and was slowly flowing down cracks in the concrete-lined bank before entering the segment. There are a small number of commercial buildings located in the area on the right bank, but the area is mostly singleresidence homes. There is a walking trail along the right bank at this site. The right bank was inaccessible to the field crew at this location so the sample was collected within the estimated mixing zone 20 m downstream of the pipe and had a bacteria value of 410 MPN/100 mL. The ambient sample collected upstream of the pipe had a bacteria value of 200 MPN/100 mL. This pipe is a low priority referral site for the proper local authority.

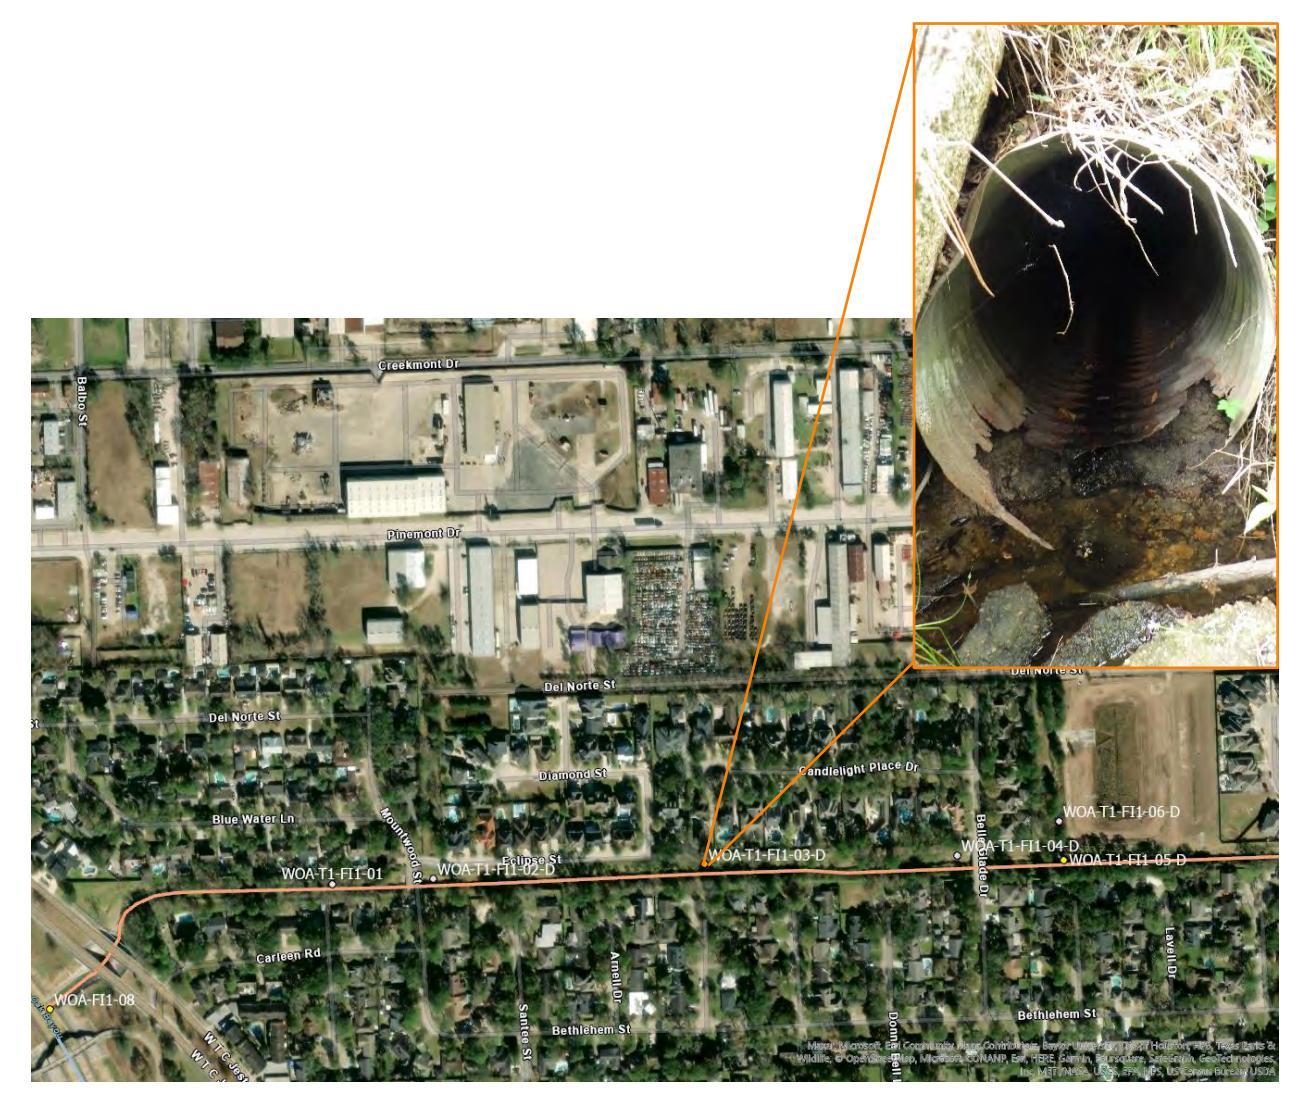
Referral site: WOA-T1-FI1-03-D – Low Priority

This is a 32 in. diameter metal pipe located on the right bank of Tributary 1 of White Oak Bayou Above Tidal. Water within the pipe was 0.25 in. deep and trickling into the AU. The bottom of the pipe was rusted out and the water color was noted to be slightly brown. The area surrounding the site on both banks includes single-family residences with some small industrial properties located on the other side of the residential neighborhood on the right bank. A sample 0.3 m downstream of the pipe had a bacteria value of 410 MPN/100 mL. The ambient sample collected upstream of the pipe had a bacteria value of < 100 MPN/100 mL. This pipe is a low priority referral site for the proper local authority.

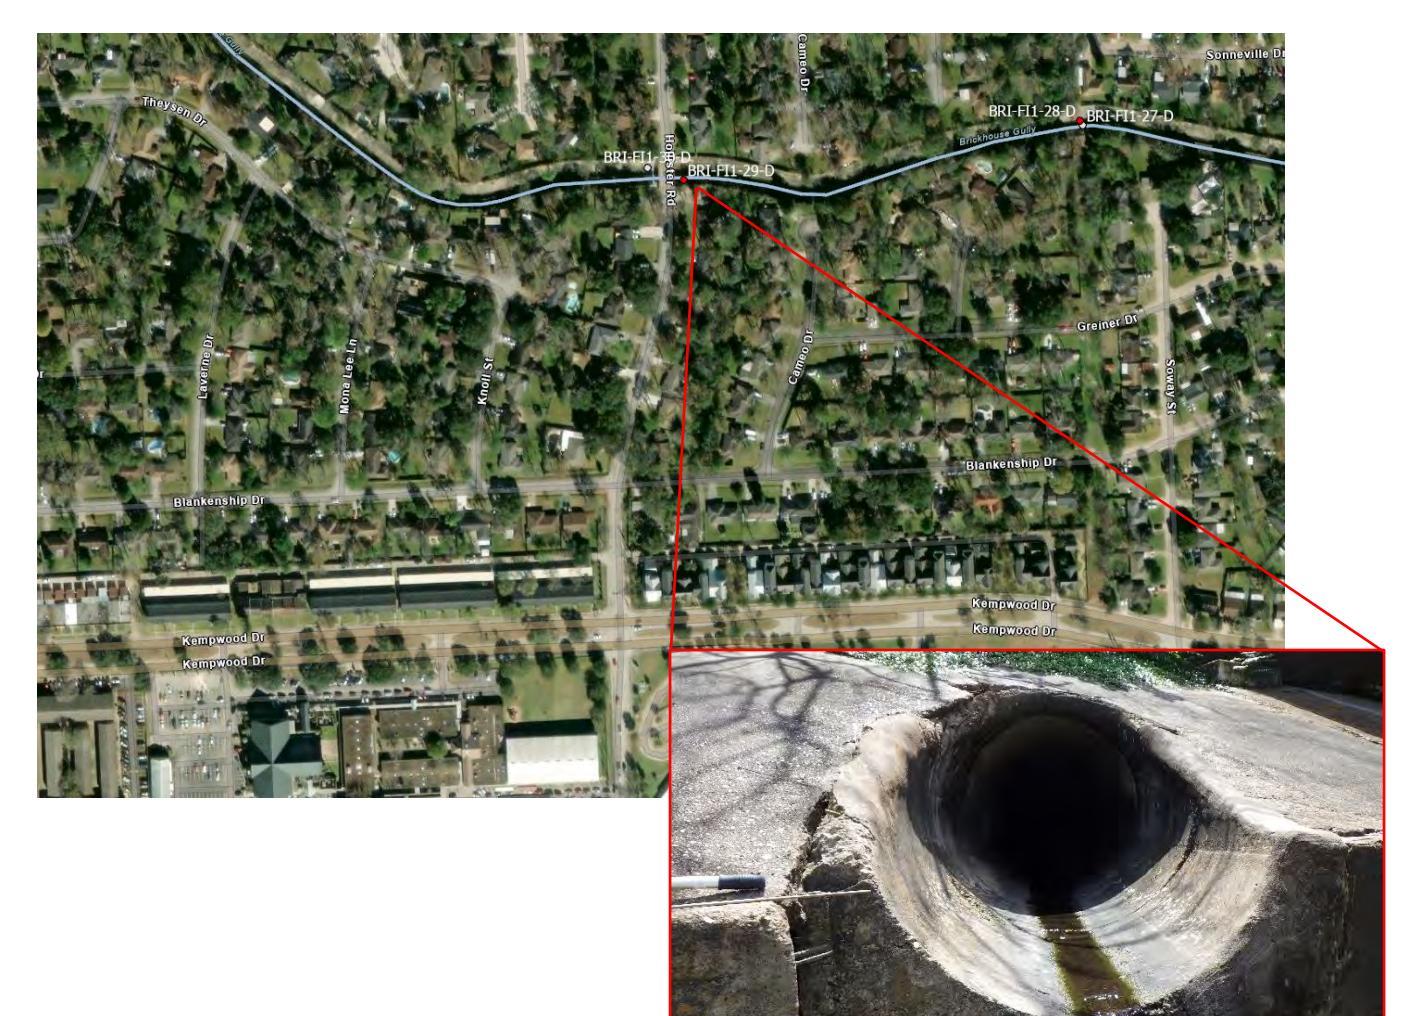
This is a 52 in. diameter concrete pipe located on the right bank of Brickhouse Gully. Water within the pipe was 0.5 in. deep and was flowing into the segment. There are single-family homes in the area. A sample taken 1 m downstream of the pipe had a bacteria value of 1,990 MPN/100 mL. The ambient sample collected upstream of the pipe had a bacteria value of 200 MPN/100 mL. This pipe is a high priority referral site for the proper local authority.

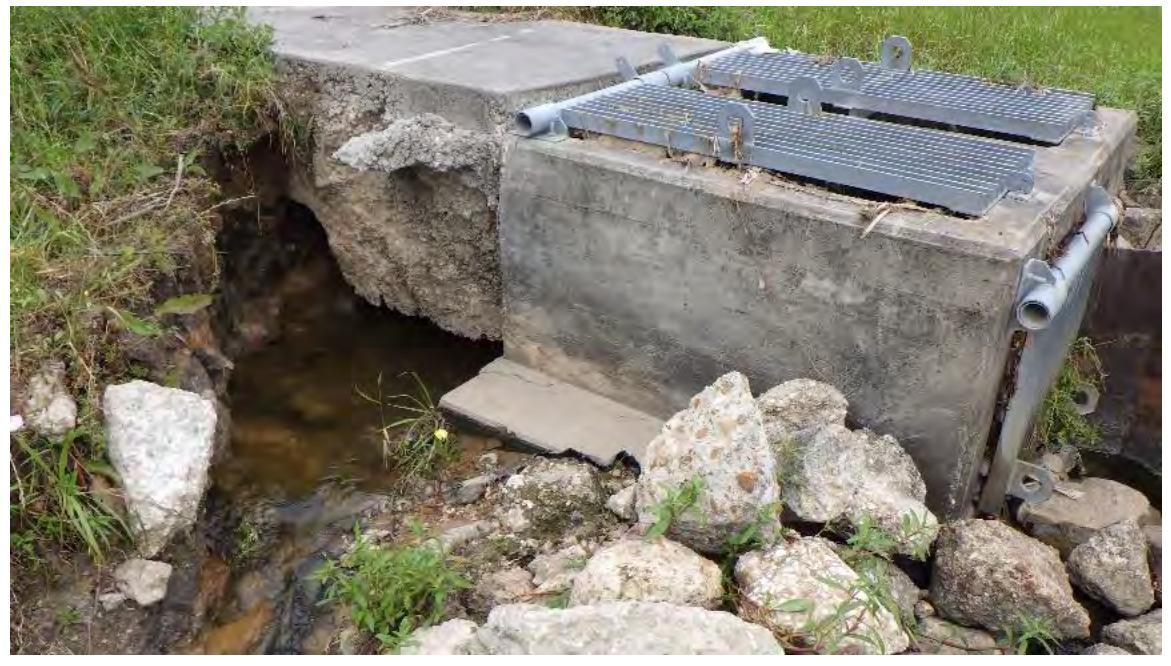
Figure 3: Bank collapse at water diversion

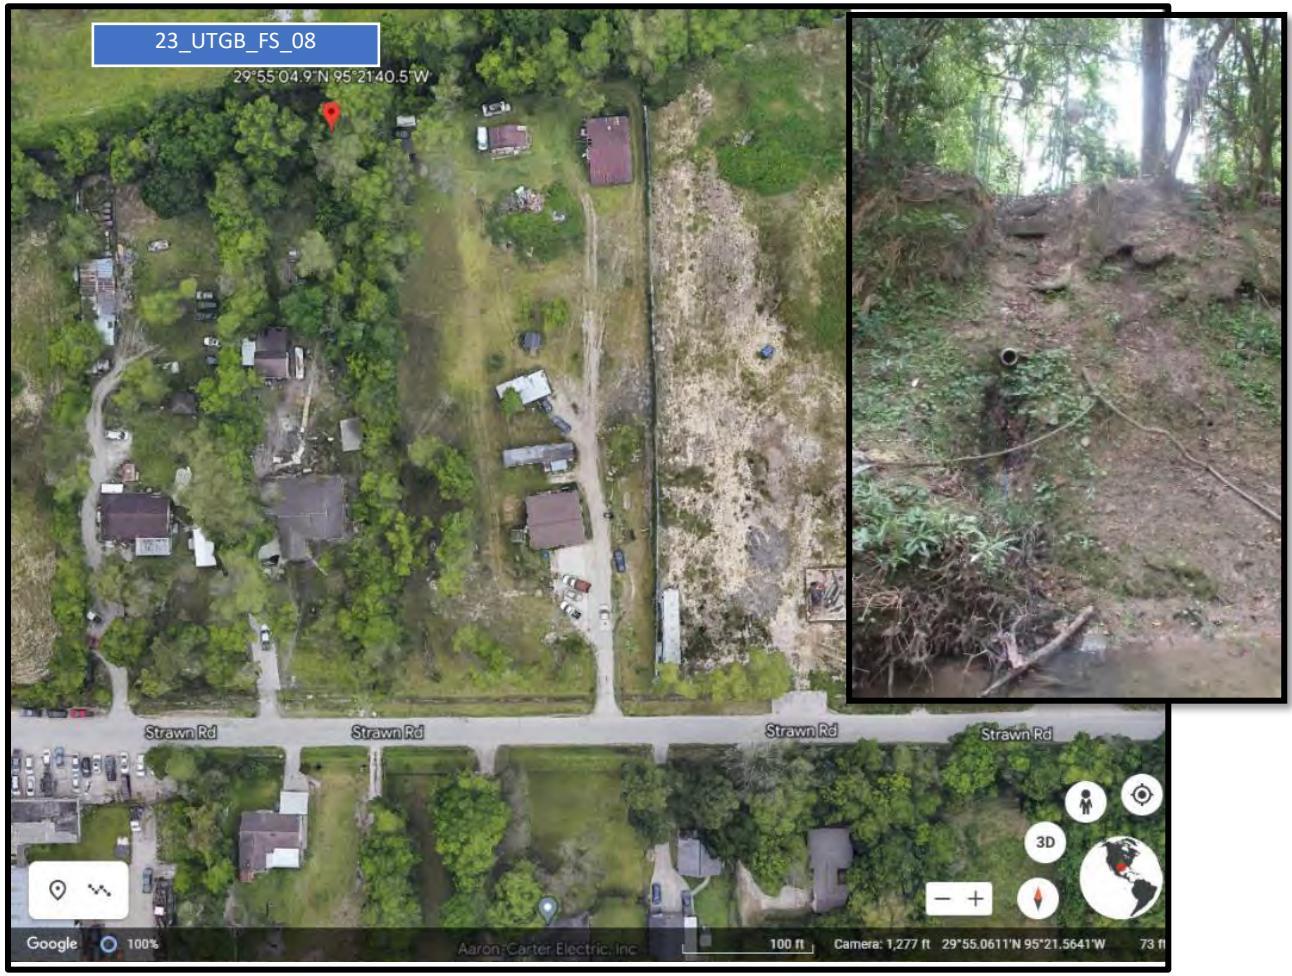
Figure 8: Referral site 23_UTGB_FS_08 with inset photo of dripping pipe into the AU.
