Targeted Bacteria Monitoring Project

FY24 Final Report

Assessment Units: 1007E_01 Willow Waterhole Bayou Above Tidal
and 1007I_01 Plum Creek Above Tidal

Houston-Galveston
Area Council

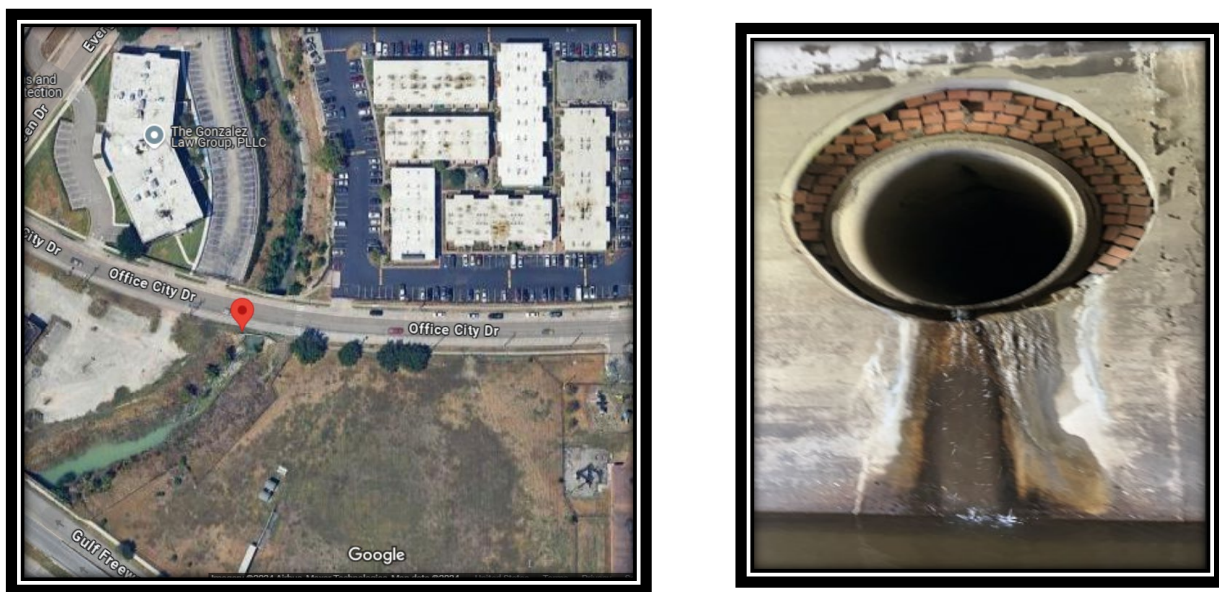
Figure 8. Referral Site 1007I_01_FI_02. Map showing proximity to apartment complex and subset image of tributary view

Sample 1007I_01_FI_02 (2,130 cfu/100 mL) was a grab sample taken at a concrete storm drainpipe on a tributary on the right bank of 1007I_01 (Figure 8). The outfall was under a bridge on Office City Dr near where the AU comes aboveground. This location featured steep banks, extensive riparian overgrowth, and large amounts of litter (more so than during previous WS), making it a bit difficult for field staff to enter the water body and begin their walk. Bacteria levels for this location were spiked from the first grab sample, 1007I_01_FI_01 (1,890 cfu/100 mL), and it is worth noting that there is an apartment complex just downstream from where field staff retrieved the sample.

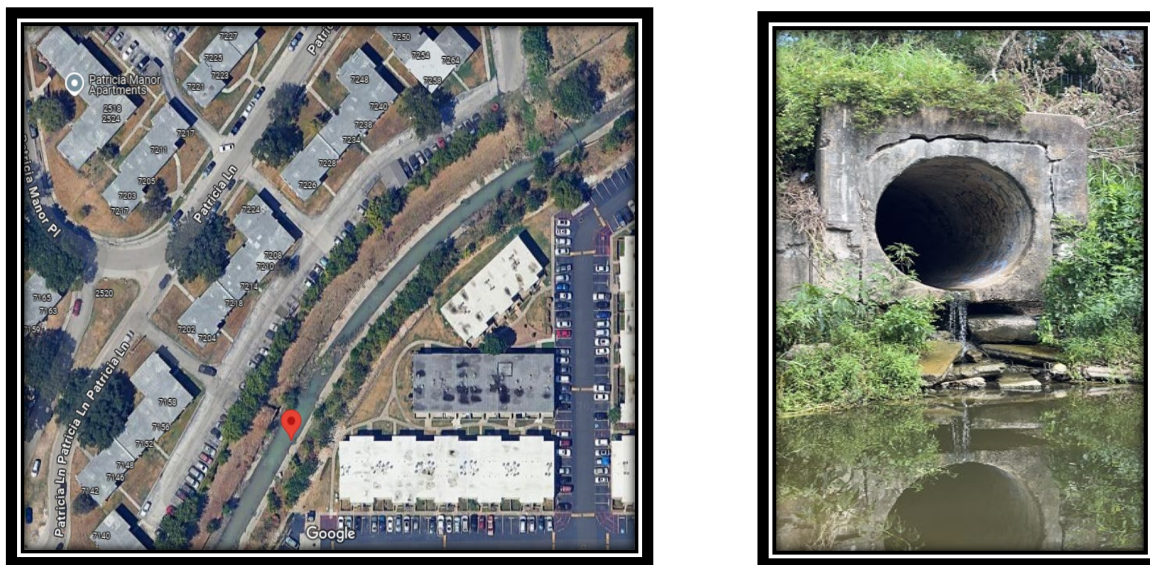
Figure 9. Referral Site 1007I_01_FI_05. Map showing proximity to apartment complex and subset image of tributary view

Sample 1007I_01_FI_05 (98,000 cfu/100 mL) was a grab sample taken from a flowing concrete storm drainpipe on the left bank of the tributary (Figure 9). This outfall was directly below Patricia Manor Apartments. The sample site is located approximately 400 meters downstream from where 1007I_01_FI_02 (2,130 cfu/100 mL) was retrieved and resulted in the highest level of bacteria seen in FI 1. Levels dramatically decreased in the mixing zone sample taken downstream from this site.

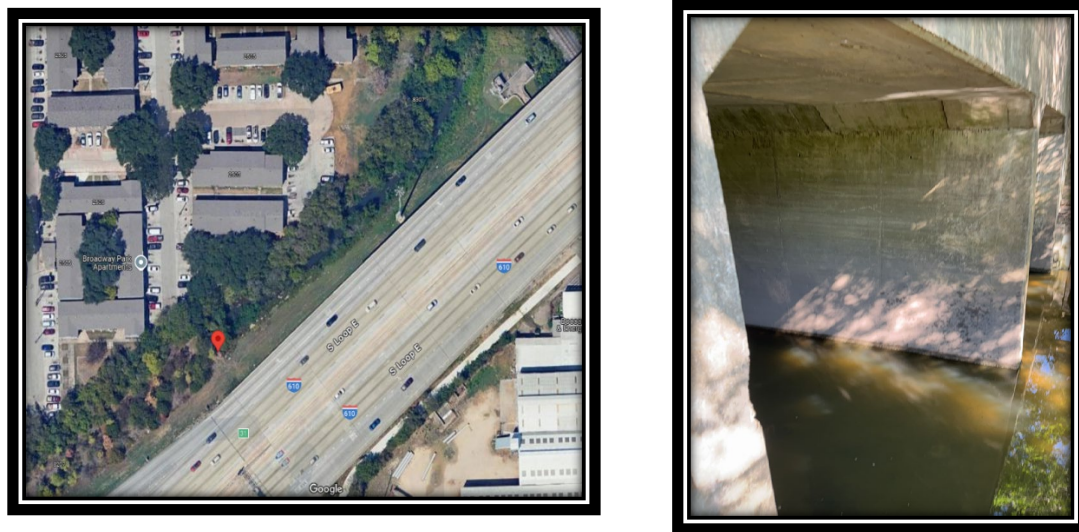
Figure 10. Referral Site 1007I_F2_05. Map showing proximity to apartment complex and lift station and subset image of tributary view

Sample 1007I_F2_05 (1,710 cfu/100 mL) was a bucket sample taken at the right bank of the tributary at an opening of a culvert right off I-610 (Figure 10). The sample was taken 3-5 feet into the tunnel. Bacteria levels spiked for this site in particular, and there is an apartment complex on the left bank if going downstream. A lift station was observed approximately 150 meters downstream from the sample site. After walking downstream towards the lift station from this sample site and towards 1007I_F2_06 (850 cfu/100 mL), field staff observed what appeared to be an outfall pipe under the apartment complex, however there was no evidence of flow or leakage.

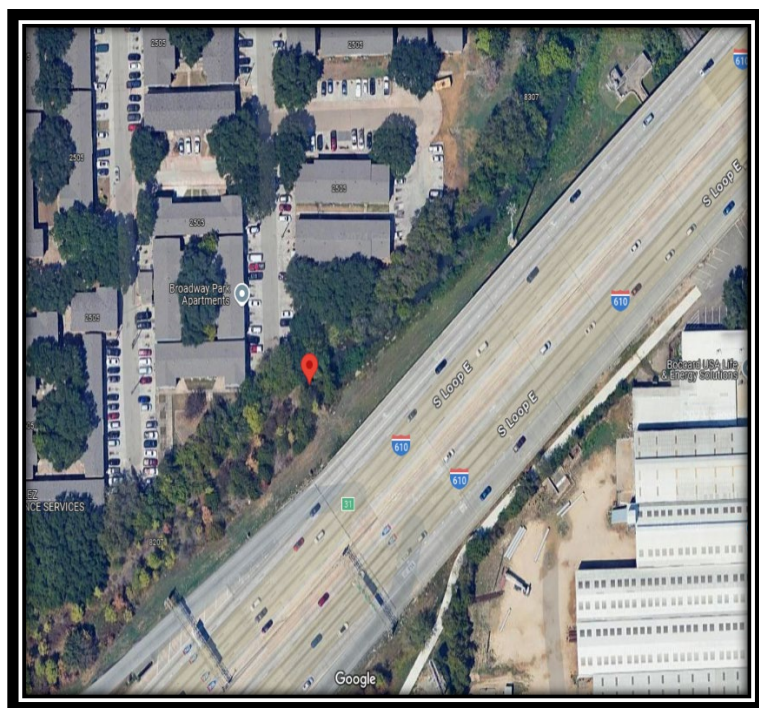
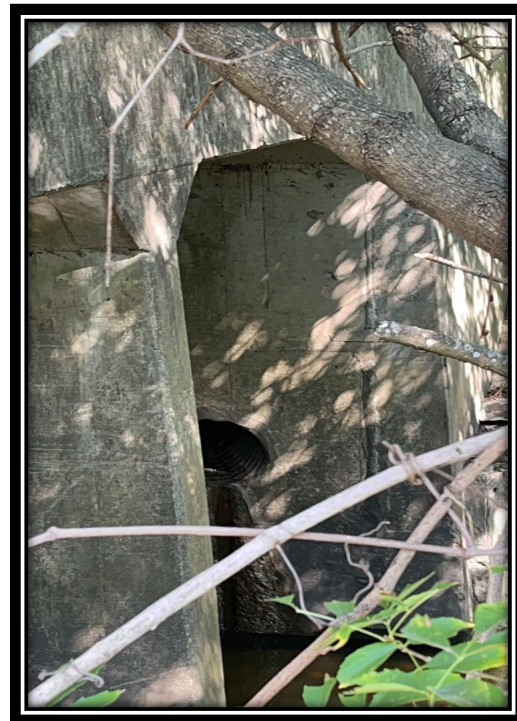
Figure 11. Referral Site 1007I_F2_06. Map showing proximity to apartment complex and lift station and subset image of tributary view.

Sample 1007I_F2_06 (850 cfu/100 mL) was taken on the left bank at the previously mentioned culvert opening (Figure 11). It was here that a storm drainpipe was observed inside the tunnel. There was evidence of past leakage, however no flow or leakage was observed at the time of sampling. As with 1007I_F2_05 (1,710 cfu/100 mL), an apartment complex was observed on the same bank as the sample, and the lift station was approximately 150 meters downstream. It should be noted that there was an excessive amount of litter in the vicinity including shopping carts and trash on trees.

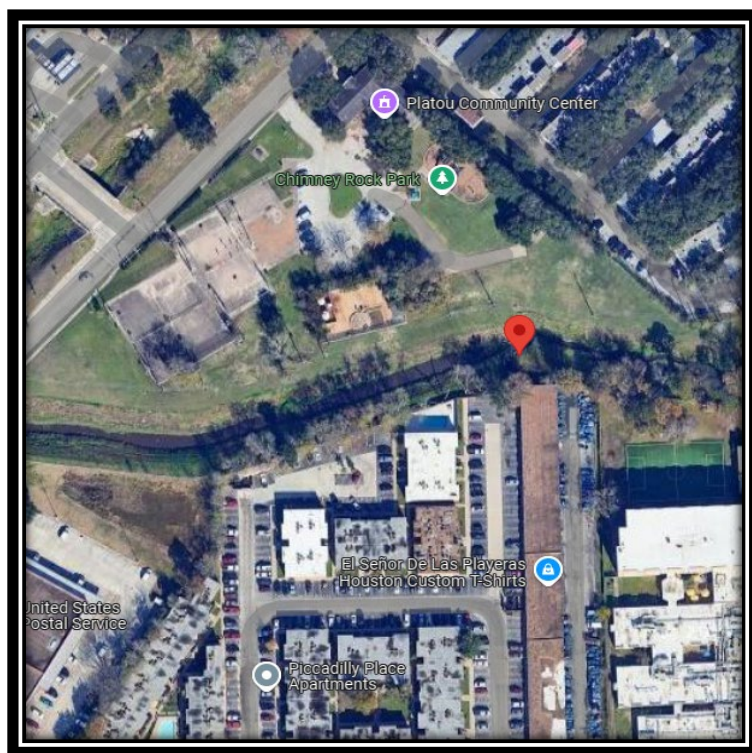
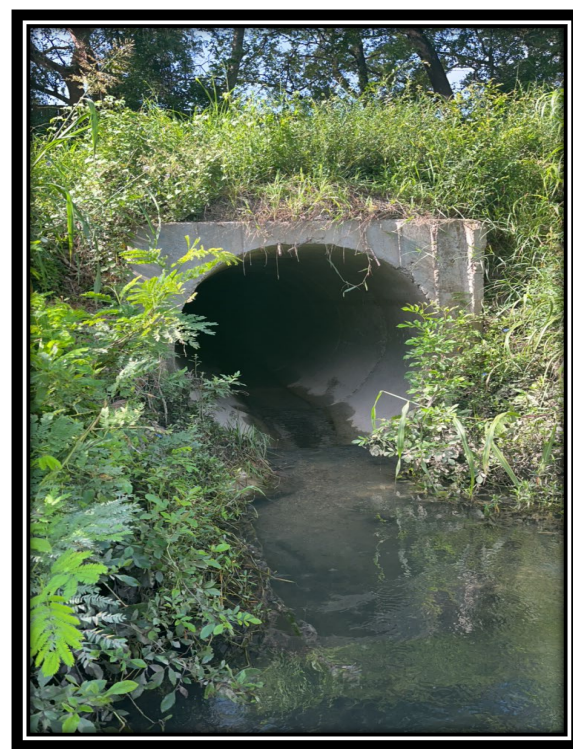
Figure 12. Referral Site 1007E_01_FI_02. Map showing proximity to apartment complex and park and subset image of tributary view.

Sample 1007E_01_FI_02 (>242,000 cfu/100 mL) was a direct sample at an outfall pipe on the right bank of the tributary downstream from Chimney Rock Rd and Chimney Rock Park (Figure 12). Field staff noted a strong sewer smell coming from the pipe and the downstream pool and observed algae and possibly degraded toilet paper in the water. This sample had the highest levels of bacteria seen during the field investigation, with the source likely stemming from the apartment complex on the right bank.

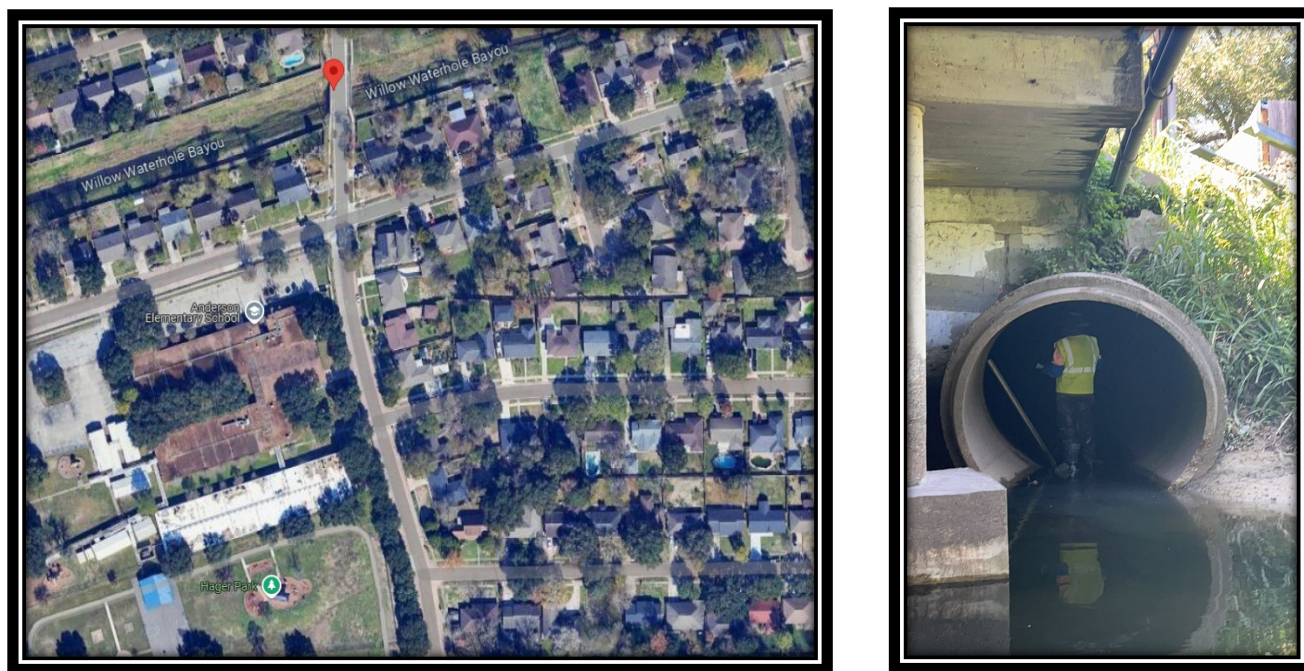
Figure 13. Referral Site 1007E_01_FI_08 and 1007E_01_FI_09. Map showing proximity to elementary school and park and subset image of tributary view.

Samples 1007E_01_FI_08 (750 cfu/100 mL) and 1007E_01_FI_09 (630 cfu/100 mL) were direct samples taken from concrete pipes on the right and left banks of the tributary, respectively (Figure 13). Field staff did not observe flowing water however, they did hear the sound of rushing water from within the culvert. While these samples did not result in the highest values, they were both direct samples entering the waterway at the same location, and an ambient sample downstream spiked at 1,990 cfu/100 mL (1007E_01_FI_06). This location featured extensive riparian overgrowth and was beneath a bridge near the intersection of Landsdowne Dr and Ludington Dr and was approximately 130 meters and 260 meters away from an elementary school and park, respectively.

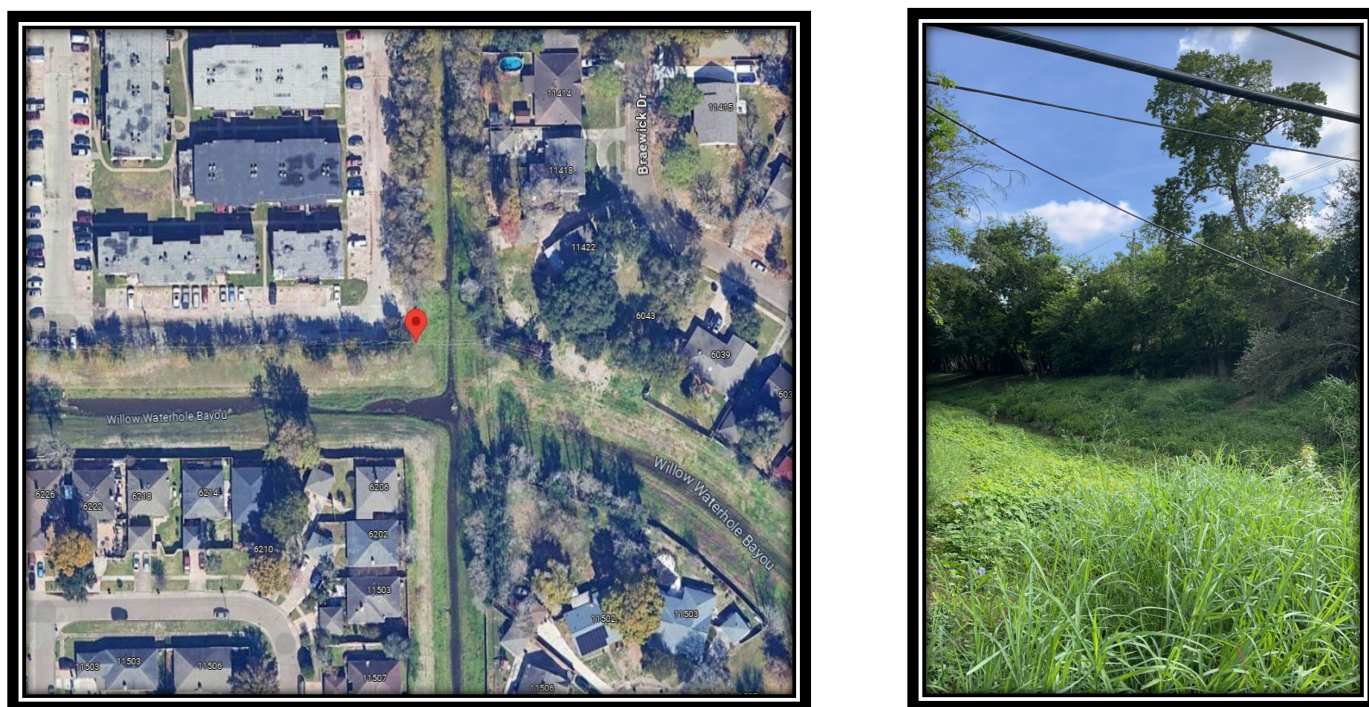
Figure 14. Referral Site 1007E_01_FI_UNC_14. Map showing unnamed channel and proximity to apartment complex and subset image of tributary view

Sample 1007E_01_FI_UNC_14 was an ambient sample taken at an unnamed channel bracketing off north and south from the main tributary near Quail Meadow Dr (Figure 14). At this point on the tributary, field staff observed that there was a berm and the channel choked with vegetation to the east, preventing them from walking further downstream. An apartment complex was observed nearby on the left bank. Since this is an ambient sample, there may not be much to be investigated, however possible SSOs or other complaints, i.e., a trash receptacle may be present, influencing the bacteria result (11,000 cfu/100 mL). Due to the nature of the unnamed channel and flow diversion H-GAC discussed bringing this to the attention of TCEQ for further discussion.

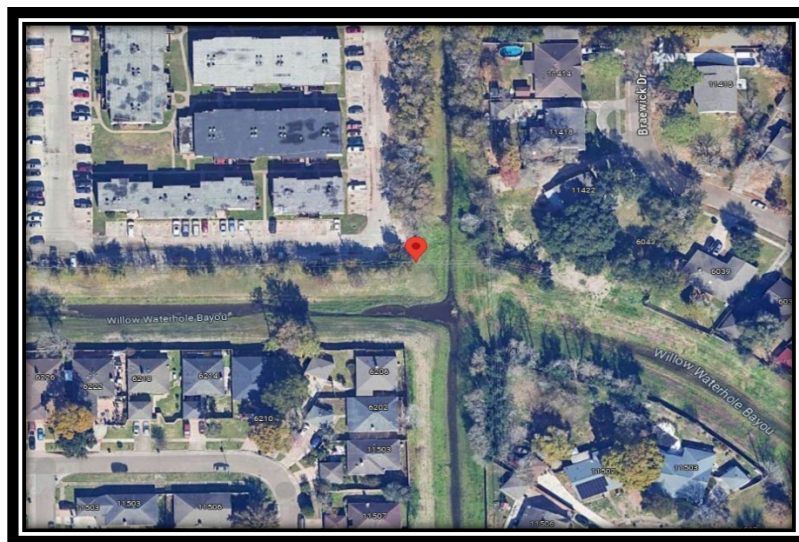
It was explained previously that the location of 1007E_01_FI_UNC_13 was unique, where an unnamed channel bracketing off from 1007E_01 in two directions was discovered near Quail Meadow Dr (Figure 15). H-GAC discussed this with the Harris County Flood Control District. The AU is bisected by numerous ditches to help alleviate flooding. A channel to the west of the figure takes the bulk of the flow north to Brays Bayou. At the "T" in the figure, flow for Willow Waterhole Bayou comes in from the west and turns north. The investigators observed a berm at the top of the "T" that prevents flow from continuing eastward. Based on Google Earth, the flow path is a diversionary channel that returns flow to the east near the Willow Waterhole Detention. H-GAC is considering if these observed diversions might necessitate a discussion with TCEQ assessors on whether the single Willow Waterhole Bayou AU should be broken up to address changes in flow.

Figure 15. The "T" channel in Willow Waterhole Bayou

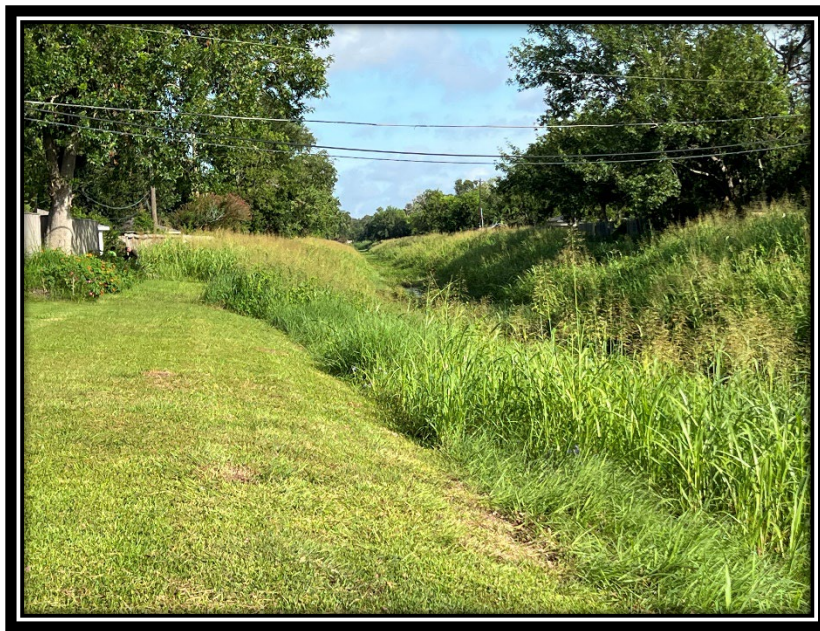
A couple of lessons learned during this investigation was the difficulty with weather and vegetative growth. Starting an investigation in summer can be impacted by tropical rains and high temperatures. Additionally, the riparian vegetation went through its spring growth and if the channel has not been maintained, walking the AU can be difficult and observing outfalls problematic (Figure 16).

Figure 16. Willow Waterhole Bayou riparian cover of 5ft tall Johnson Grass

H-GAC and local jurisdictions explored ideas to address these lessons for future targeted bacteria monitoring. In FY25, amended work planned could include winter investigations removing the impact of summer heat and winter cutting back on vegetative growth. The investigations could be undertaken together with the jurisdictions. Harris County Flood Control District noted they could provide maintenance schedules for the target AUs, helping to avoid excessive riparian overgrowth, and thus making extended investigative walks more manageable for field staff.
