2020 Basin Highlights Report

A Watershed Characterization of Little White Oak Bayou, Clear Creek Tidal, Clear Creek Above Tidal, Mustang Bayou, and Halls Bayou

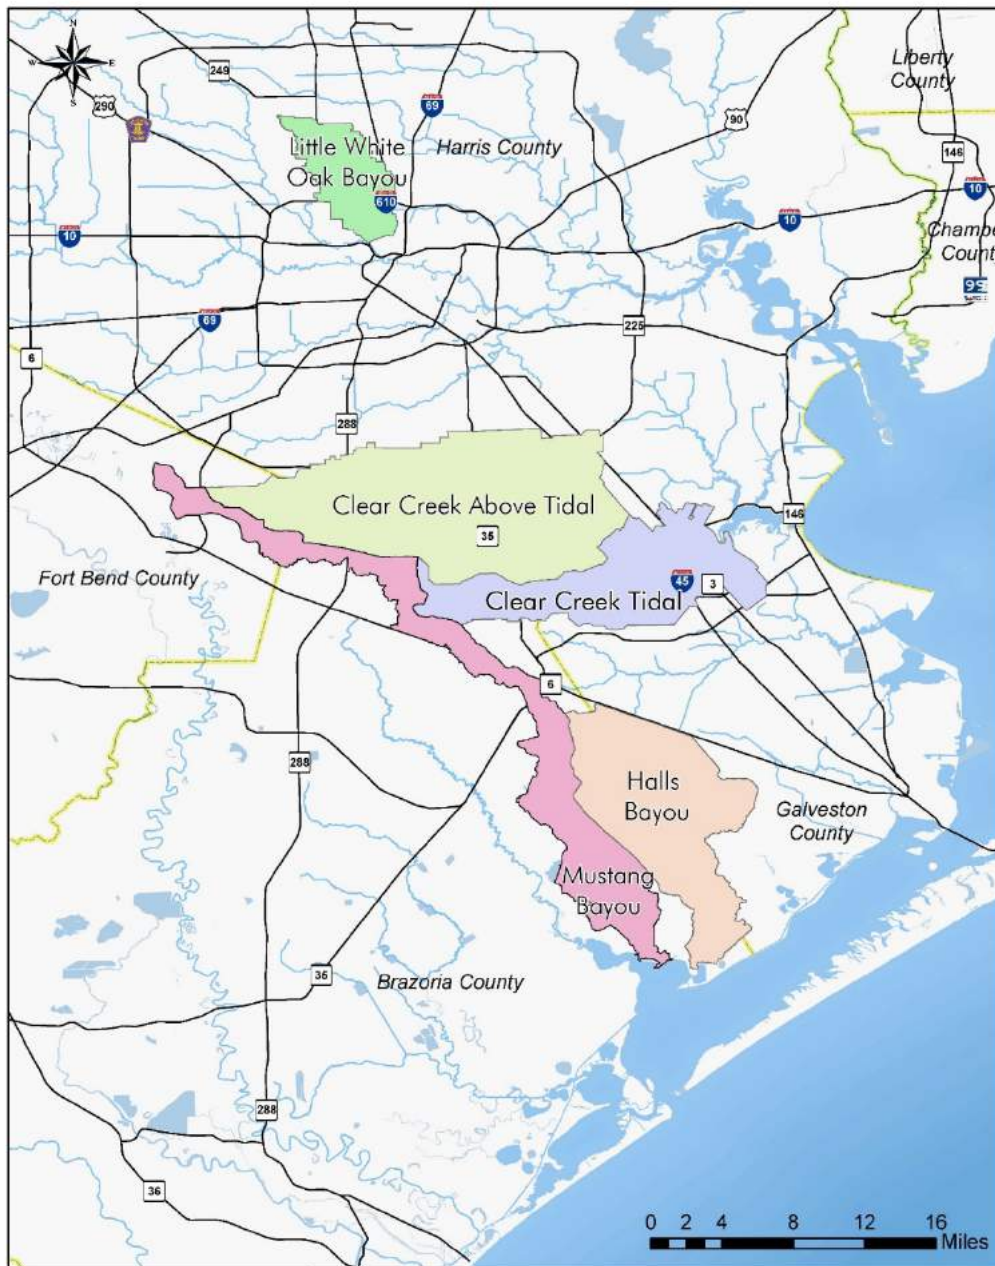
Characterization Sites

The 2020 Basin Highlights Report characterizes select water bodies within the Houston-Galveston region. For this report, H-GAC has chosen to characterize the Little White Oak Bayou (1013A), Clear Creek Tidal (1101), Clear Creek Above Tidal (1102), Mustang Bayou (2432A), and Halls Bayou Tidal (2432C) watersheds. These watershed characterizations may be used to help prioritize monitoring efforts and in the development of watershed-based plans [such as Total Maximum Daily Loads (TMDLs) or watershed protection plans] to improve water quality.

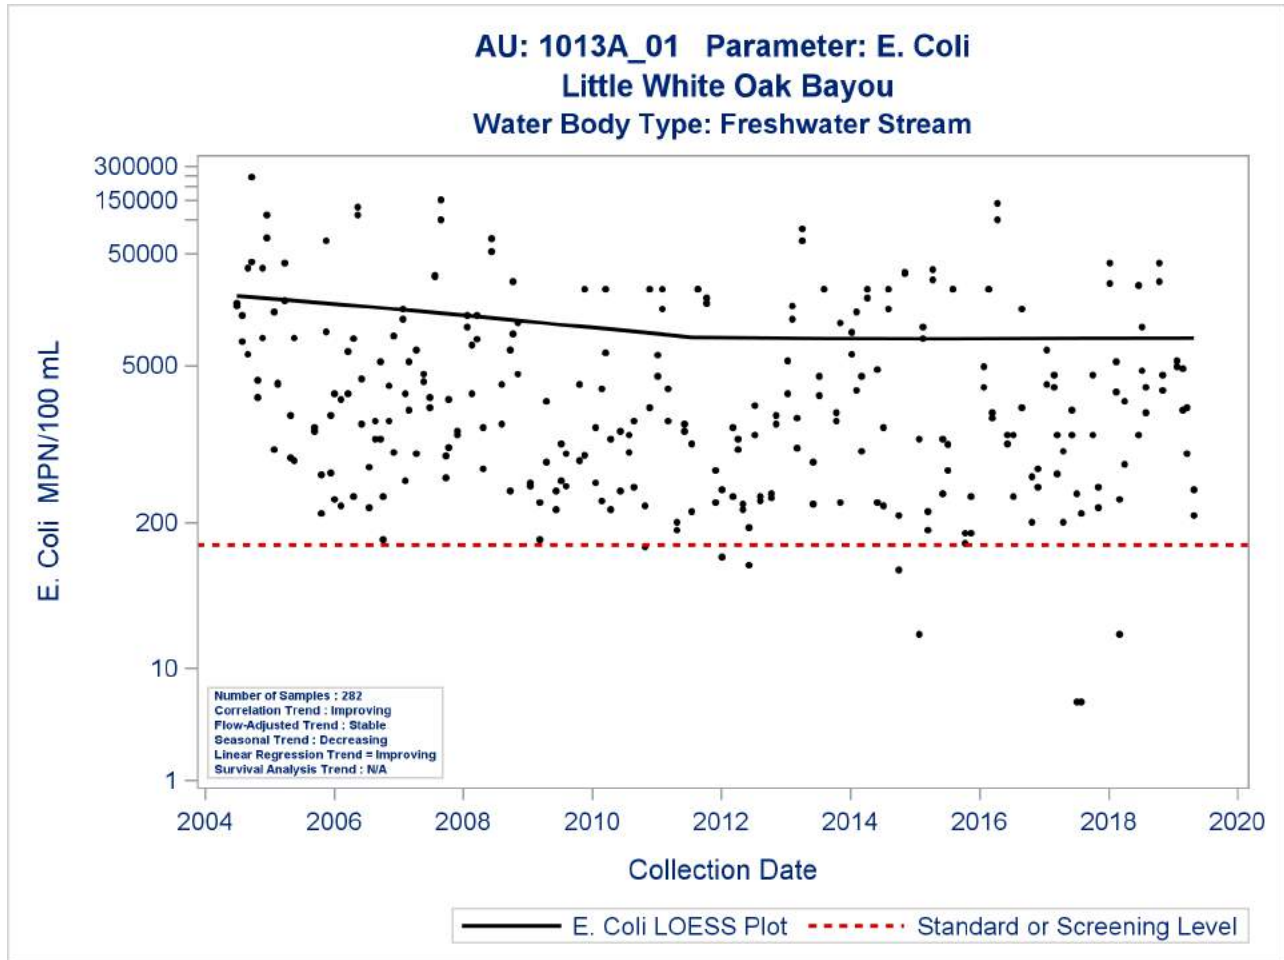
Figure 2 - Grab E. coli sample results of all samples collected from Little White Oak Bayou (2004 - 2019)

Between 2004 and 2011, the trend for grab sample results showed a decline due to fewer single samples being measured at extremely high concentrations of bacteria. While this trend is statistically significant, there is not much evidence of continuing improvement in the watershed. Since 2012, the trend is no longer significantly improving nor deteriorating. The red, dashed line shown in Figure 2 illustrates the *E. coli* geometric mean standard of 126 per 100 mL. In late 2010, individual grabs samples were measured below the geometric mean standard for the first time since 2004. However, the geometric mean remains well above the standard and has remained relatively stable since 2012, as shown in Figure 3.

To examine trends in the data, H-GAC plotted the bacteria grab sample results collected between 2004 and 2019 (Figure 2).

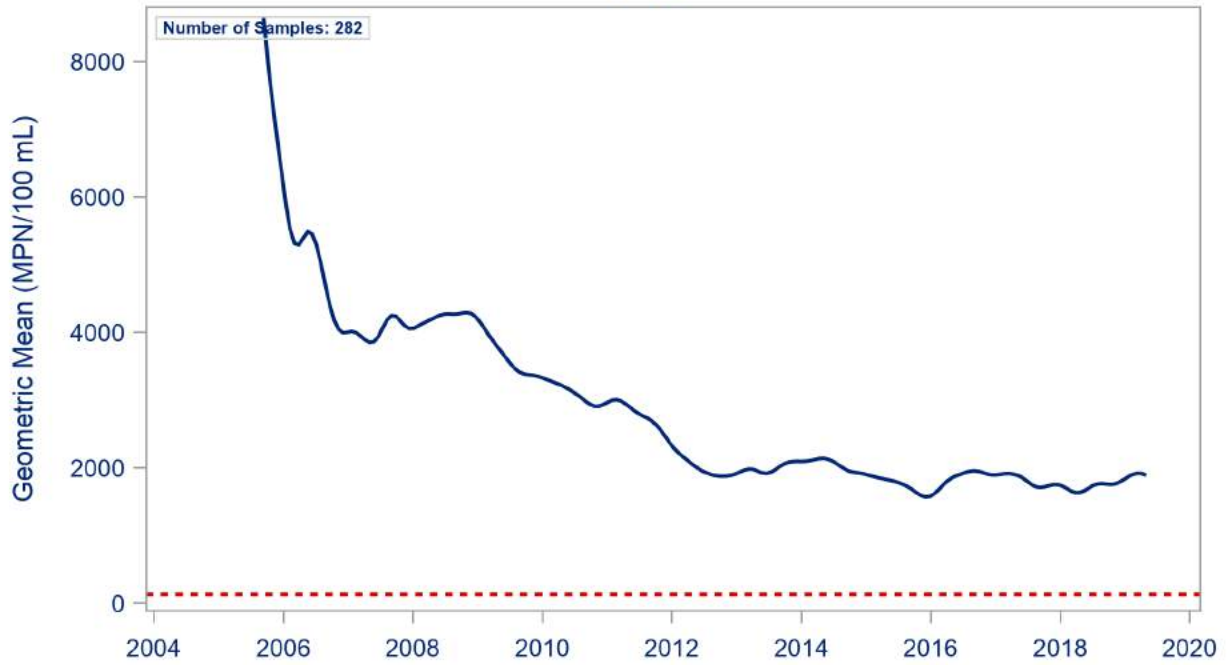
Segment 1013A .
Moving Seven-Year Bacteria Geometric Mean -All Data in Segment
Waterbody Type: Freshwater

Reference Line (if present) represents the Primary Contact Recreation (PCR) Standard
PCR Standard: Freshwater-E. Coli 126 MPN/100 mL; Saltwater-Enterococci 35 MPN/100 mL

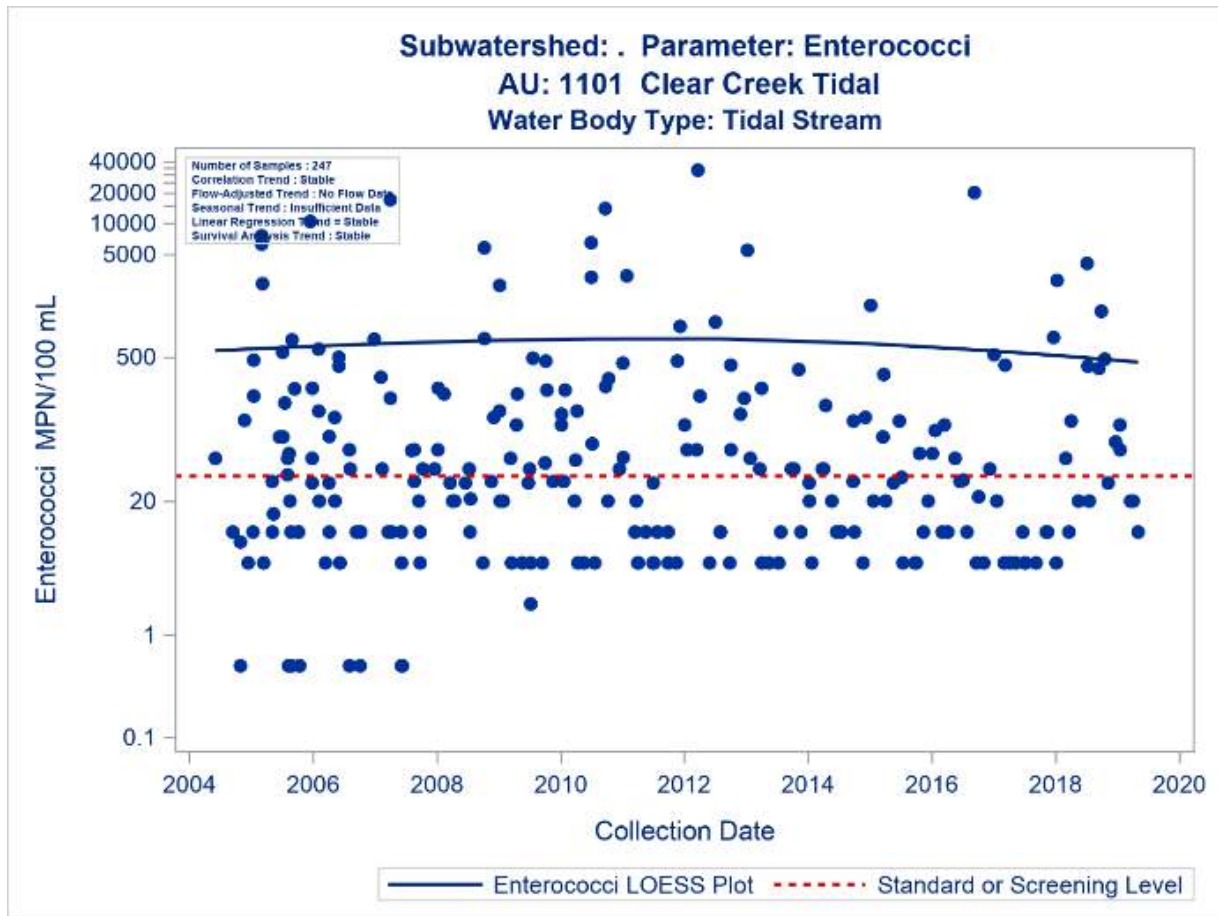
Figure 6 - All enterococcus bacteria sample results for Clear Creek Tidal (1101), 2004 - 2019

Of the four assessment units (AUs) that make up the tidal portion of Clear Creek, only the most downstream AU (1101_04) is fully supportive of the contact recreation standard with an Enterococcus geometric mean of 21 Most Probable Number (MPN) per 100 mL. The geometric mean standard for Enterococcus is 35 MPN per 100 mL. The other three AUs have geometric mean values ranging from 63 to 95 MPN per 100 mL. Bacteria impairments in 1101_01, 1101_02, 1101D_02, and 1101E_01 are carried forward from the previous assessment. There was insufficient data during the assessment period for the most recent Integrated Report to assess these AUs. Figure 2 shows the bacteria results for the period of 2004 – 2019.

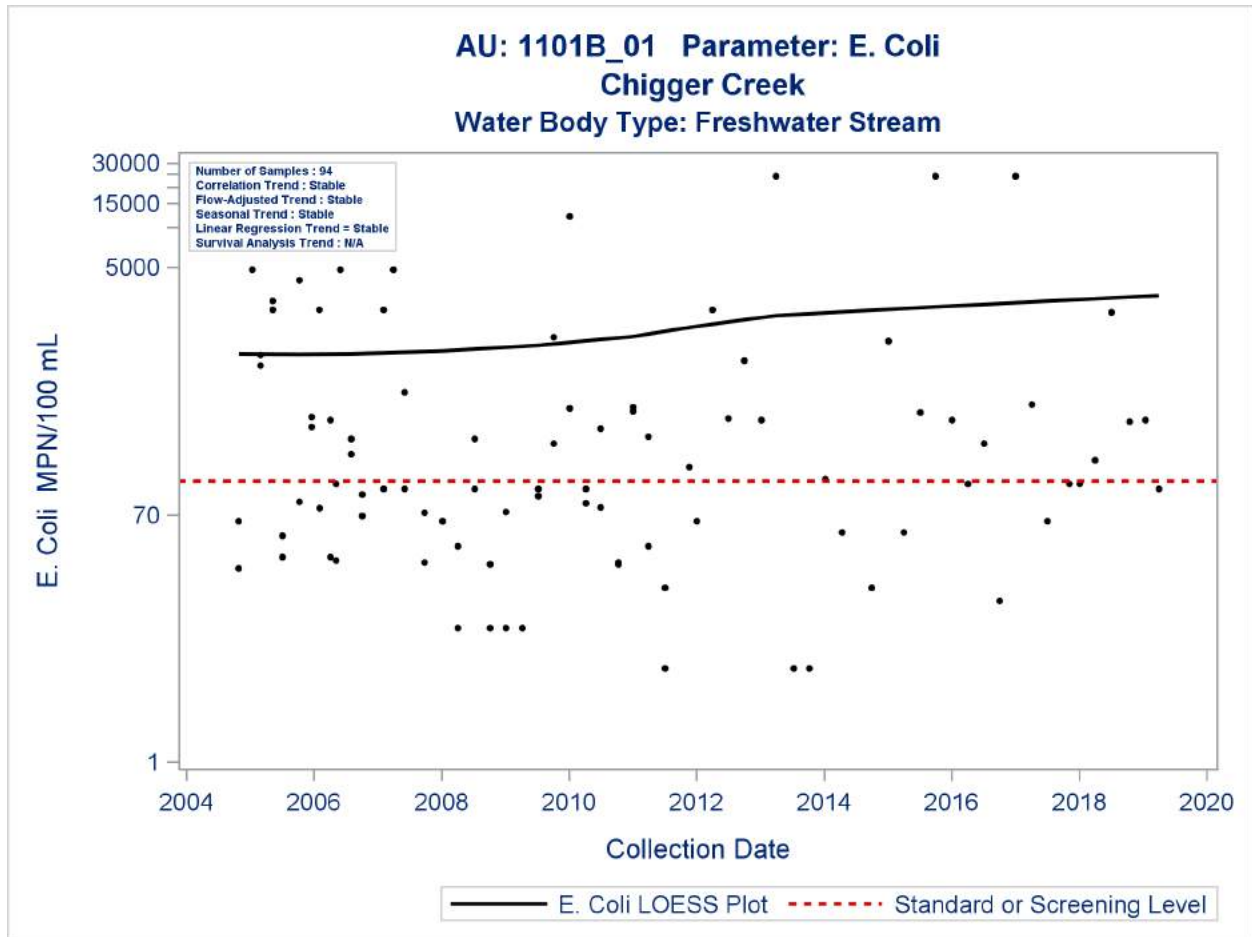
Figure 8 - *E. coli* results for Chigger Creek (1101B_01), 2004 - 2019

Unclassified segment 1101B (Chigger Creek) has two AUs. The upstream AU is freshwater and is sampled for *E. coli* bacteria. The Integrated Report shows a geometric mean of 170 MPN/100 mL versus the freshwater standard of 126 MPN/100 mL. H-GAC's analysis of data from 2012 to 2019 shows an *E. coli* geometric mean of 253 MPN/100 mL. The downstream segment is tidal and is not currently monitored. The downstream AU is listed in the Integrated Report as NA (Not Assessed) as there is not sufficient data to perform an assessment. Figure 4 shows the *E. coli* results for Chigger Creek for the period of 2004 – 2019.

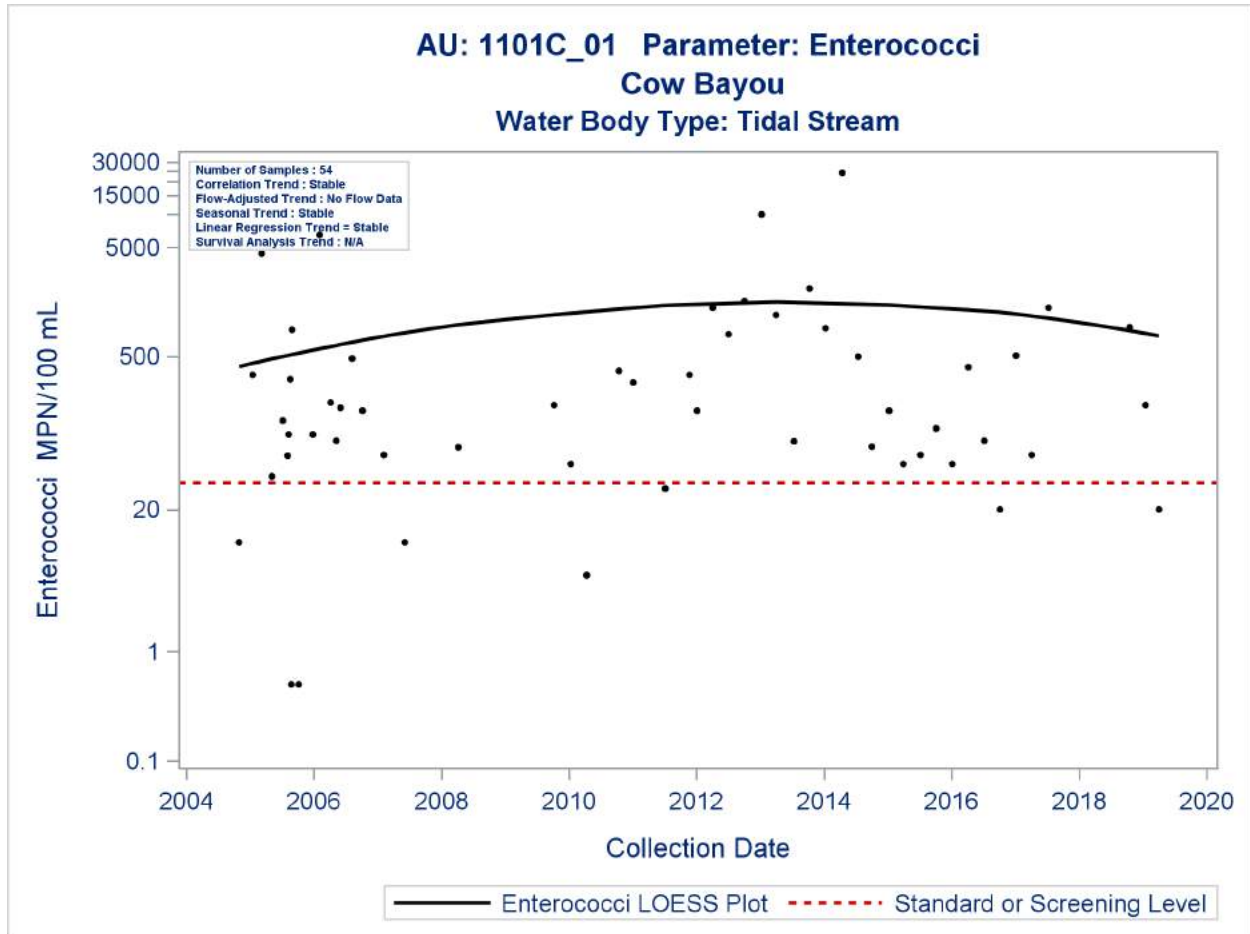
Figure 9 - Enterococci results for Cow Bayou (1101C), 2004 - 2019

Cow Bayou (1101C) has an Enterococcus geometric mean of 253 (2018 Integrated Report) and 311 MPN/100 mL (H-GAC analysis) which greatly exceeds the 35 MPN/100 mL standard. The Enterococci results for this segment for the period of 2004 – 2019 are shown in Figure 5.

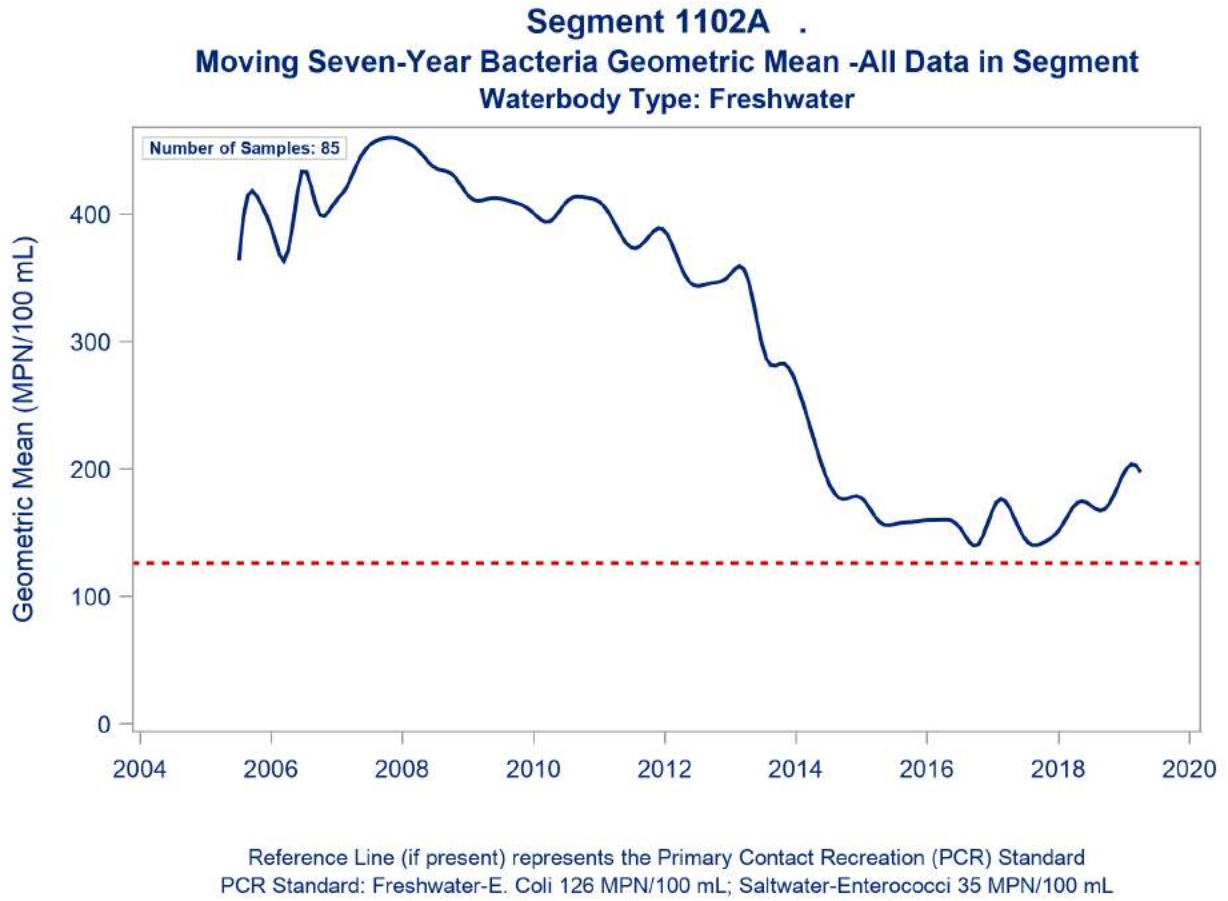
Figure 5 - Moving Seven-Year Bacteria geometric mean for all data collected at Cowart Creek (1102A)

However, if the data from only 1102A (Cowart Creek) is analyzed, there is a significant downward trend where the geometric mean shows improvement over time (Figure 5).
