HOUSTON-GALVESTON AREA COUNCIL

HOW'S THE WATER?

2021

Basin Summary Report

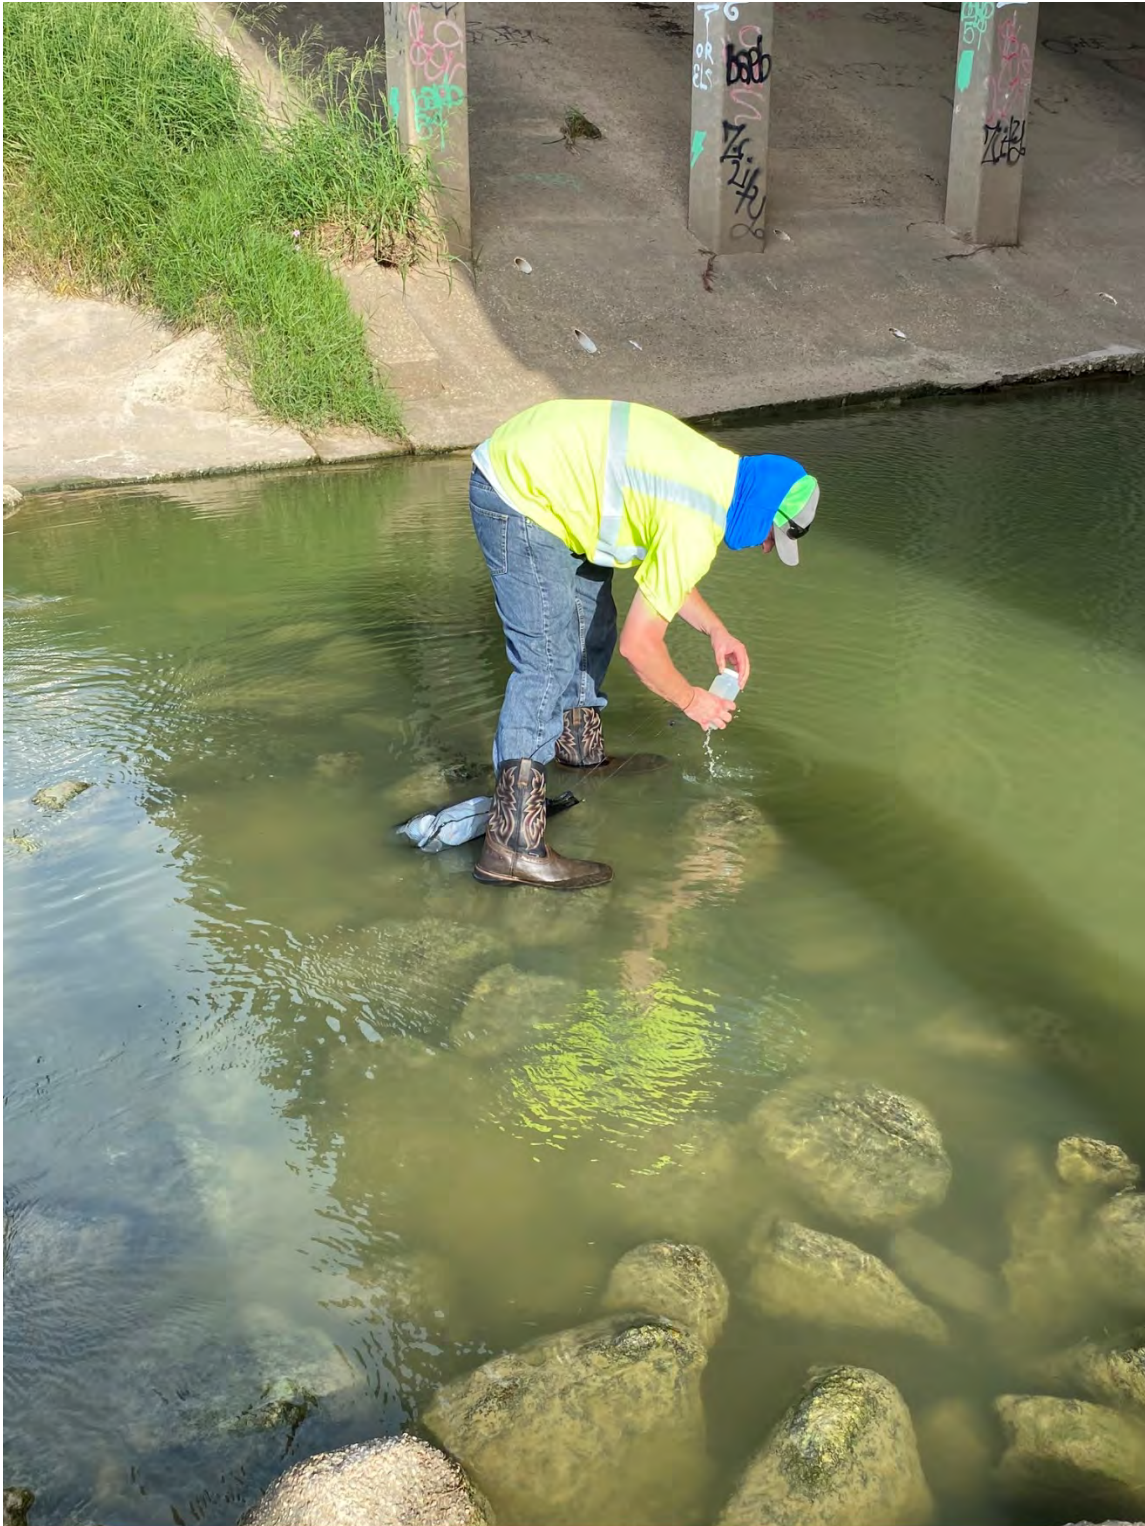
Basins in the H-GAC Region

H-GAC's Clean Rivers Program region includes watersheds in all or a portion of 15 counties. The streams and rivers in the region drain into coastal bays and estuaries that eventually reach the Gulf of Mexico.

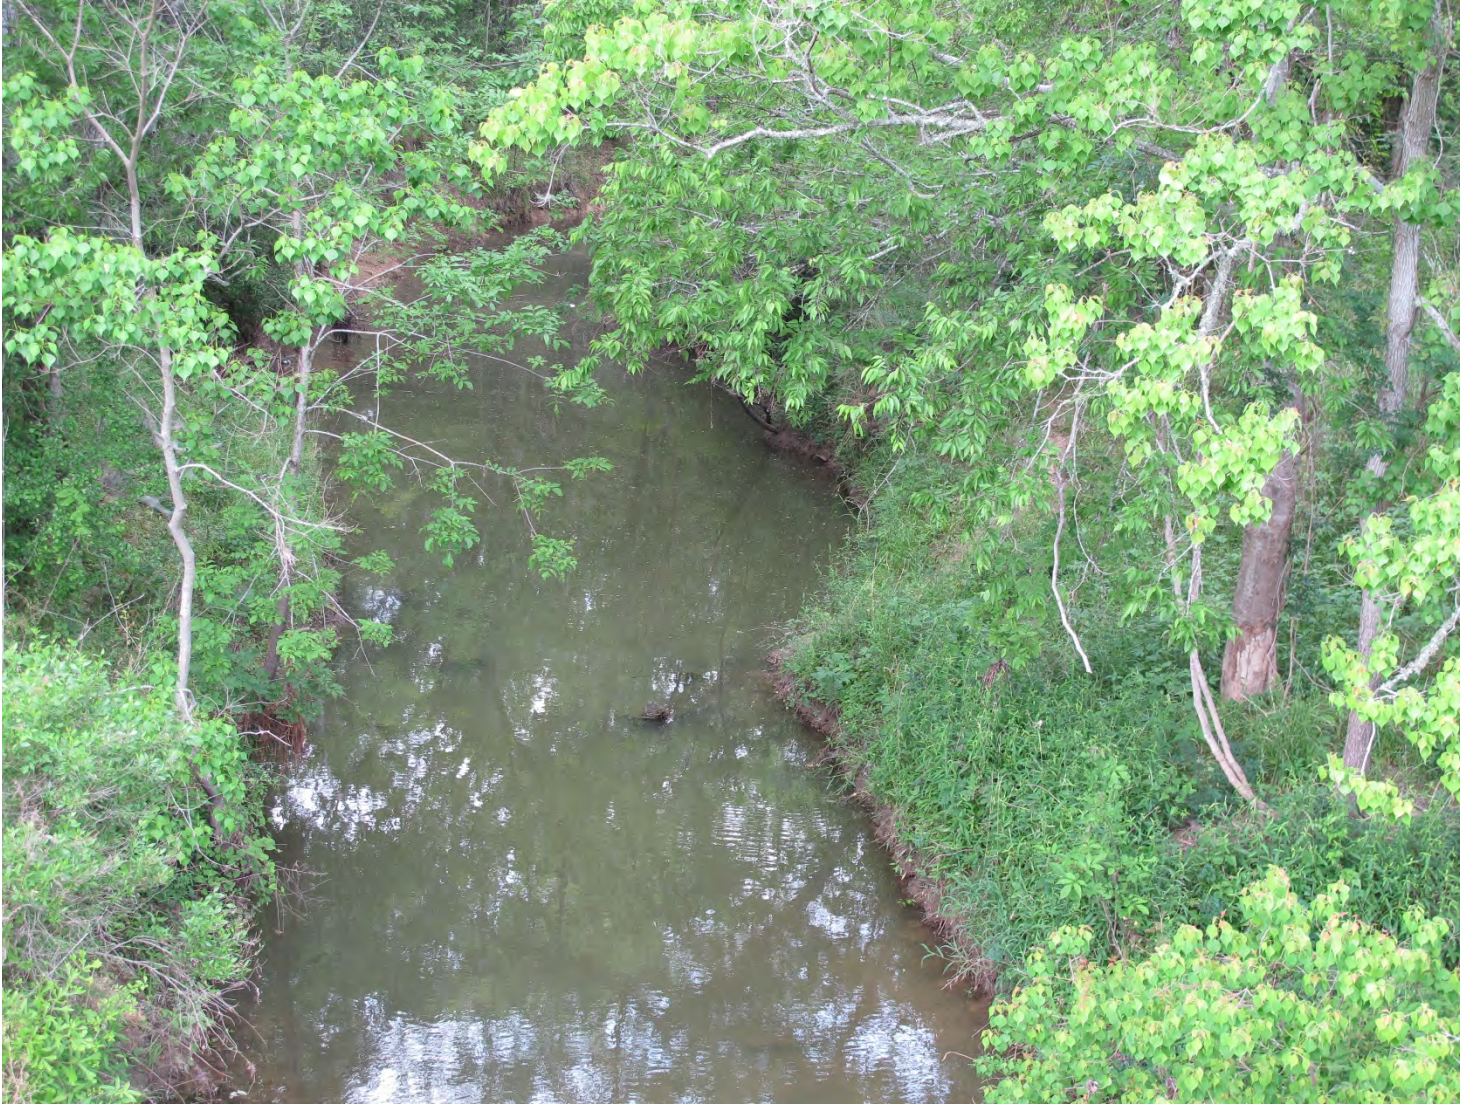
Length: 25 miles **Watershed Area:** 145 square miles **Designated Uses:** Primary Contact Recreation 1; High Aquatic Life

Number of Active Monitoring Stations: 3 **Texas Stream Team Monitoring Stations:** 0 **Permitted WWTF Outfalls:** 29

- Segment 0902 (Perennial Stream w/ High ALU): **Cedar Bayou Above Tidal** (classified water body) – From a point 2.2 km (1.4 miles) upstream of IH 10 in Chambers/Harris County to a point 7.4 km (4.6 miles) upstream of FM 1960 in Liberty County
- Segment 0902A (Perennial Stream w/ Limited ALU): **Adlong Ditch** (unclassified water body) – From the confluence of Cedar Bayou Above Tidal to the intersection of Stoker Rd and Ramsey Rd

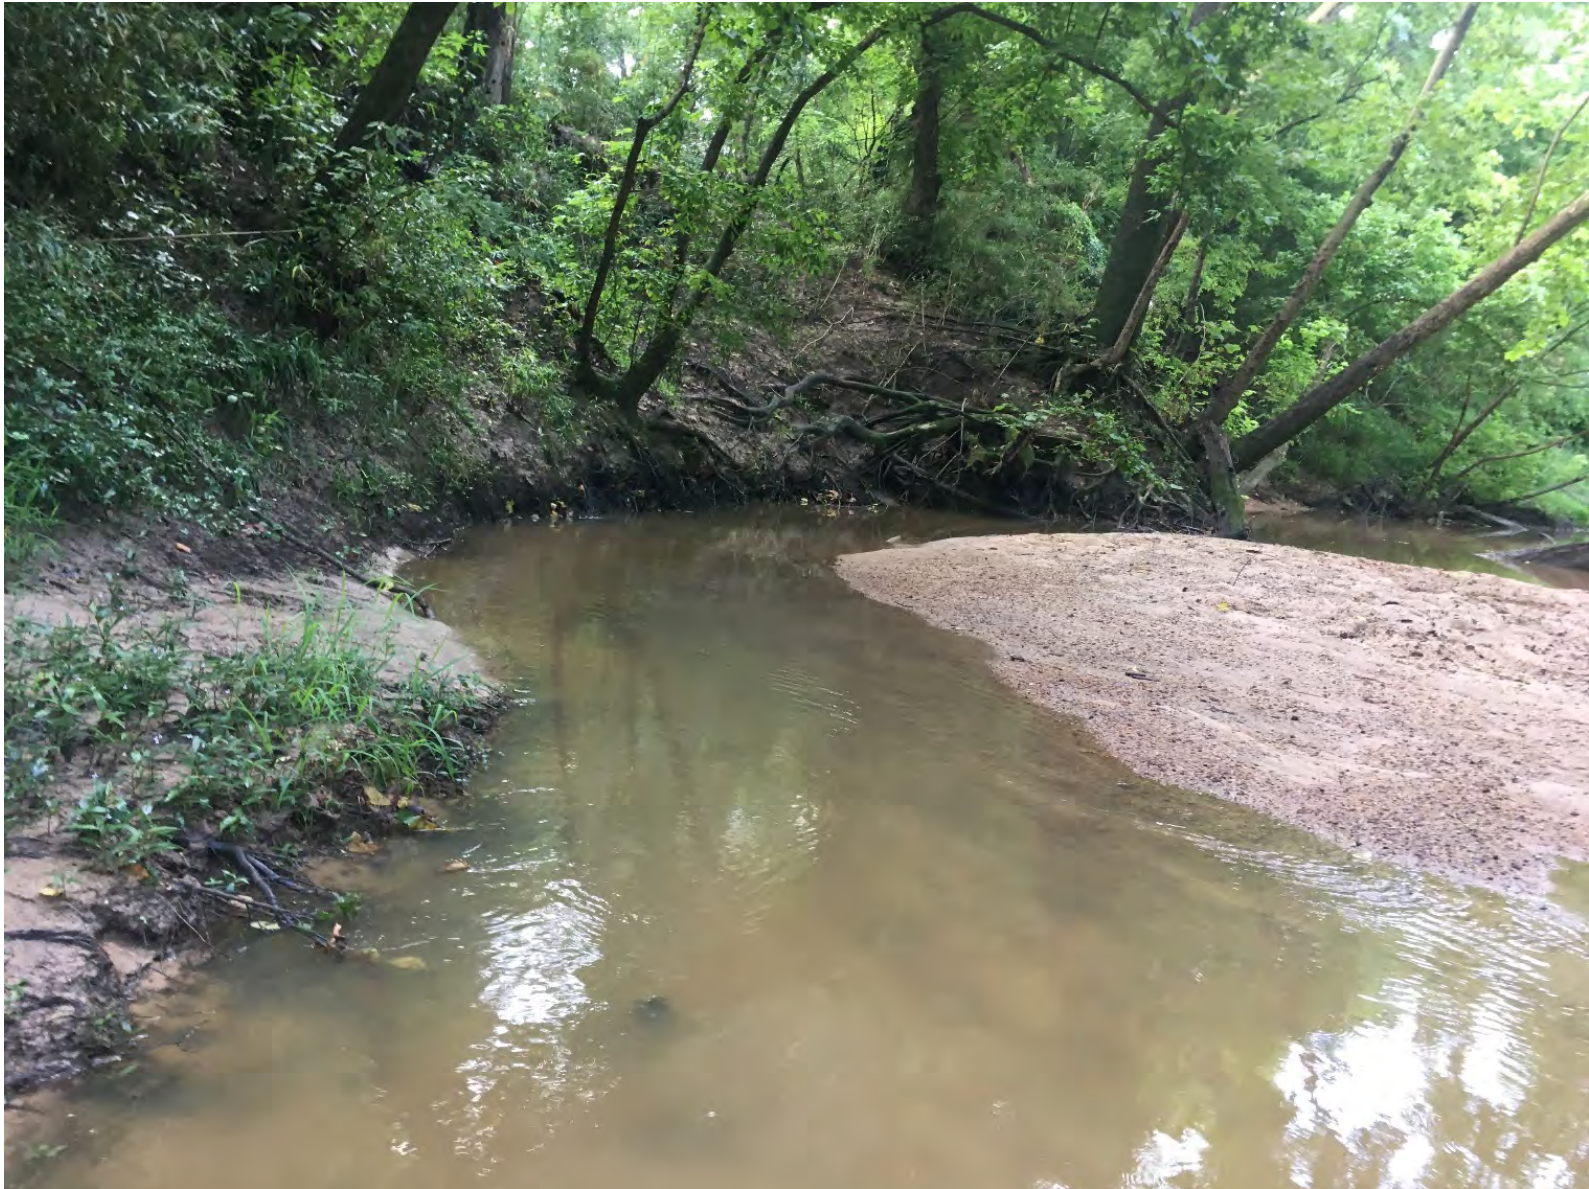
Length: 11 miles **Watershed Area:** 222 square miles **Designated Uses:** Primary Contact Recreation 1; High Aquatic Life; Public Water Supply

Number of Active Monitoring Stations: 6 **Texas Stream Team Monitoring Stations:** 0 **Permitted WWTF Outfalls:** 21

- Segment 1010 (Perennial Stream): **Caney Creek** (classified water body) – From the confluence with the East Fork San Jacinto River in Harris County to SH 150 in Walker County
- Segment 1010A (Intermittent Stream with pools w/ intermediate ALU): **Dry Creek** (unclassified water body) — Intermittent stream with perennial pools from Caney Creek upstream to the confluence with an unnamed tributary approximately 3.6 km upstream of SH 242
- Segment 1010B (Perennial Stream w/ high ALU): **White Oak Creek** (unclassified water body) – Perennial stream from the confluence with Caney Creek upstream to the confluence with an unnamed tributary approximately 2.08 km upstream of US 59
- Segment 1010C (Perennial Stream w/ high ALU): **Spring Branch** (unclassified water body) — From the Caney Creek confluence to a point 0.54 km (0.34 mi) upstream of SH 105

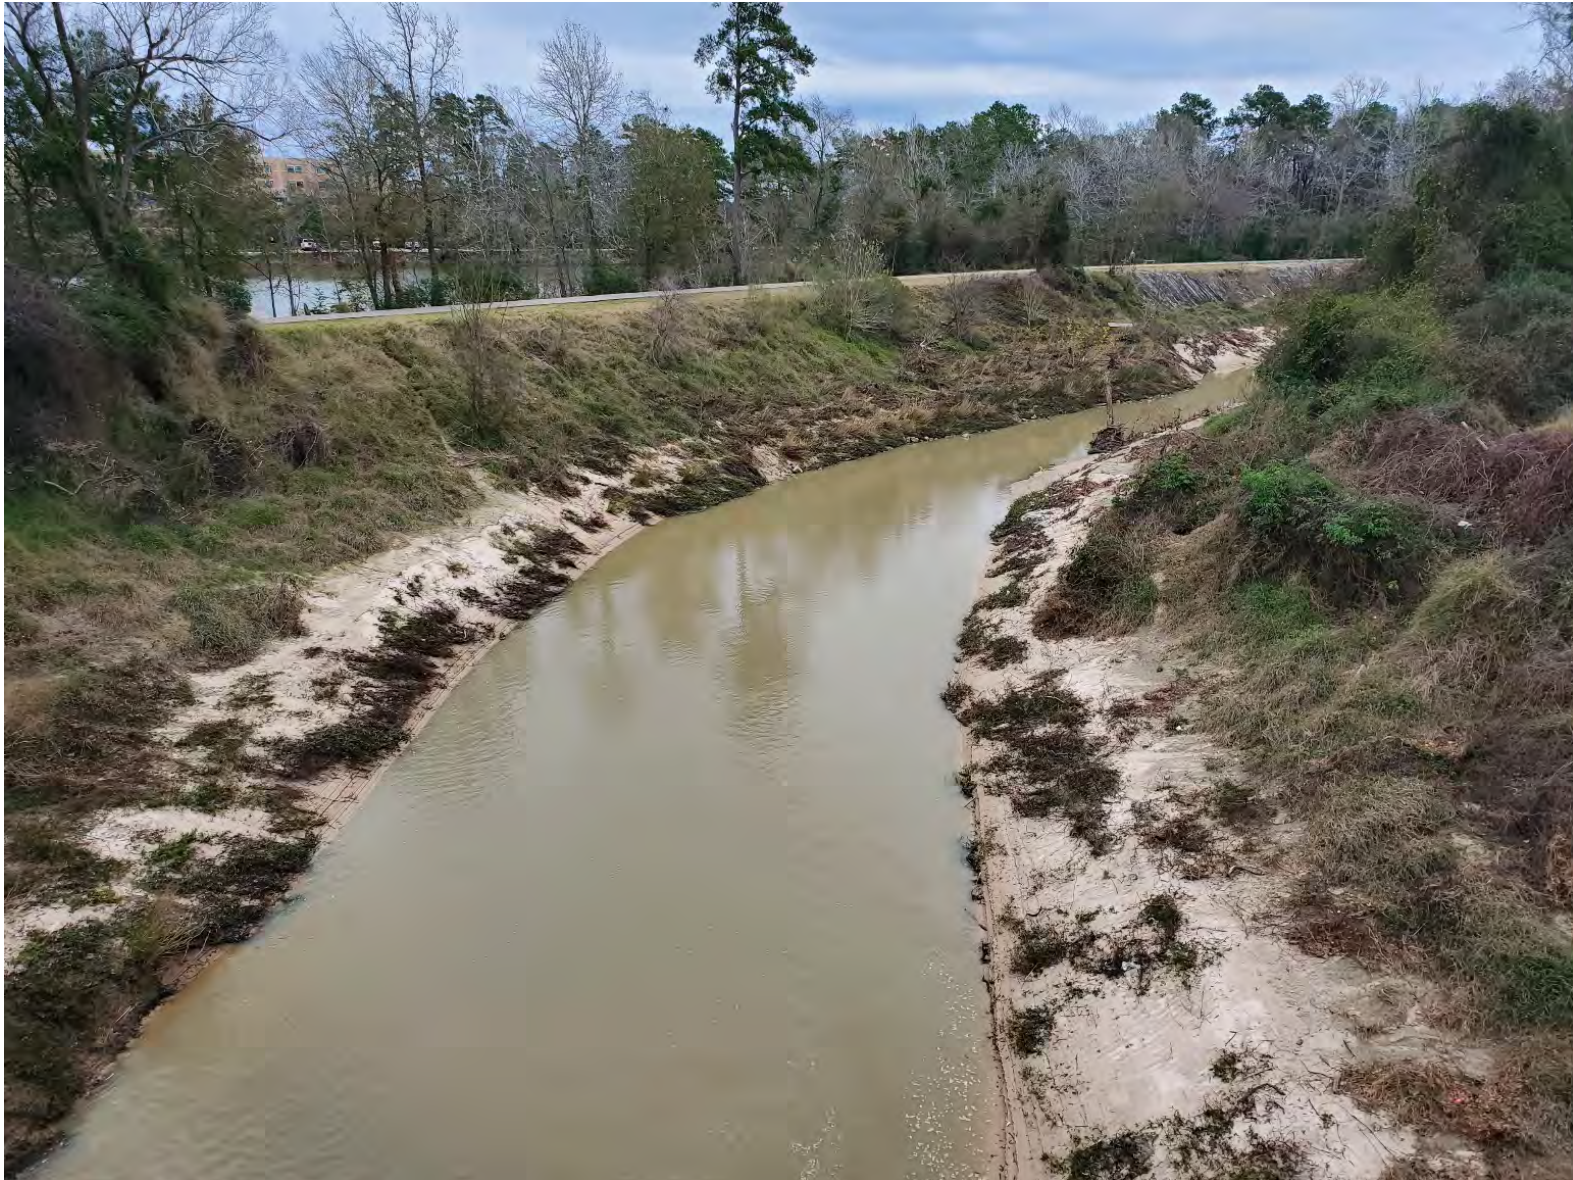
Length: 52 miles **Watershed Area:** 319 square miles **Designated Uses:** Primary Contact Recreation 1; High Aquatic Life; Public Water Supply

Number of Active Monitoring Stations: 11 **Texas Stream Team Monitoring Stations:** 9 **Permitted WWTF Outfalls:** 115

- Segment 1009 (Perennial Stream w/ high ALU): **Cypress Creek** (classified water body) – From the confluence with Spring Creek in Harris County to the confluence of Snake Creek and Mound Creek in Waller County

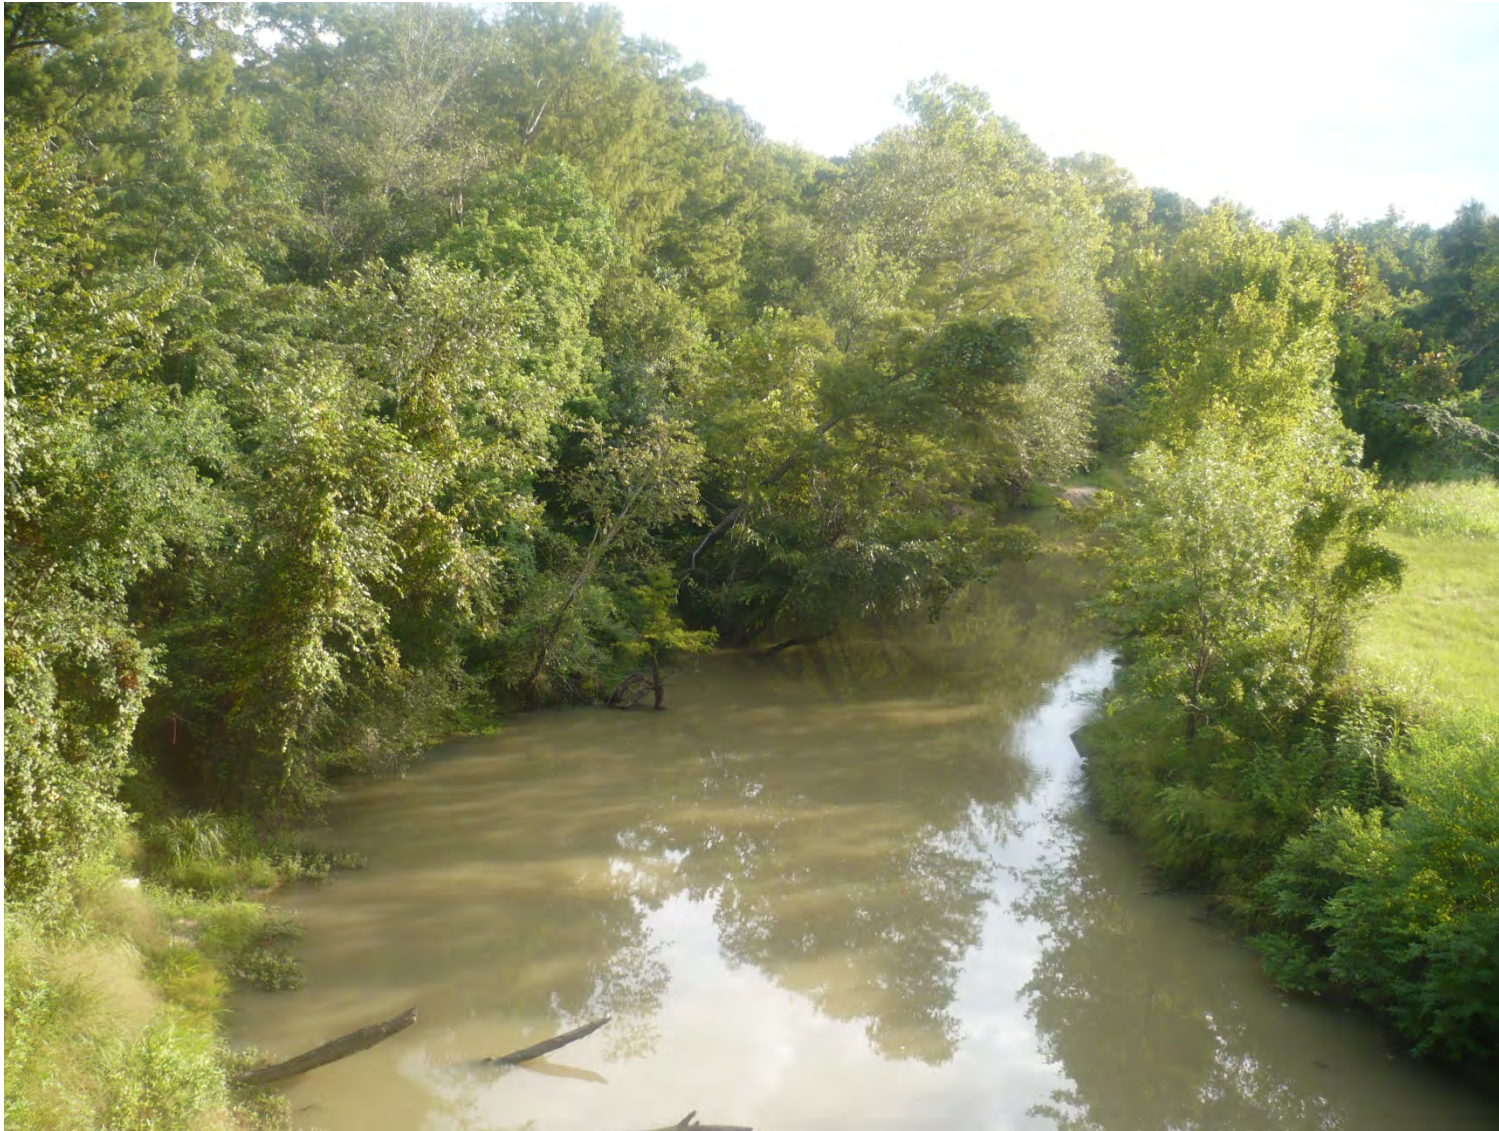
Length: 81 miles **Watershed Area:** 404 square miles **Designated Uses:** Primary Contact Recreation 1; High Aquatic Life; Public Water Supply

Number of Active Monitoring Stations: 14 **Texas Stream Team Monitoring Stations:** 0 **Permitted WWTF Outfalls:** 8

- Segment 1003 (Perennial Stream w/ high ALU): **East Fork San Jacinto River** (classified water body) – From the confluence of Caney Creek in Harris County to US Highway 190 in Walker County
- Segment 1003A (Perennial Stream w/ high ALU): **Winters Bayou** (unclassified water body) – From the confluence with East Fork San Jacinto River to 0.17 mi upstream of Dorrell Road at the confluence of Phelps Creek.
- Segment 1003B (Perennial Stream w/ high ALU): **Nebletts Creek** (unclassified water body) – From the confluence with Winters Bayou near FM 1725 northwest of Cleveland upstream to the headwaters near SH 150 east of New Waverly
- Segment 1003C (Intermittent Stream w/ pools w/ limited ALU): **Boswell Creek** (unclassified water body) - From the confluence with Winters Bayou approximately 11.7 km (7.3 mi) east of New Waverly upstream to the headwaters east of Huntsville

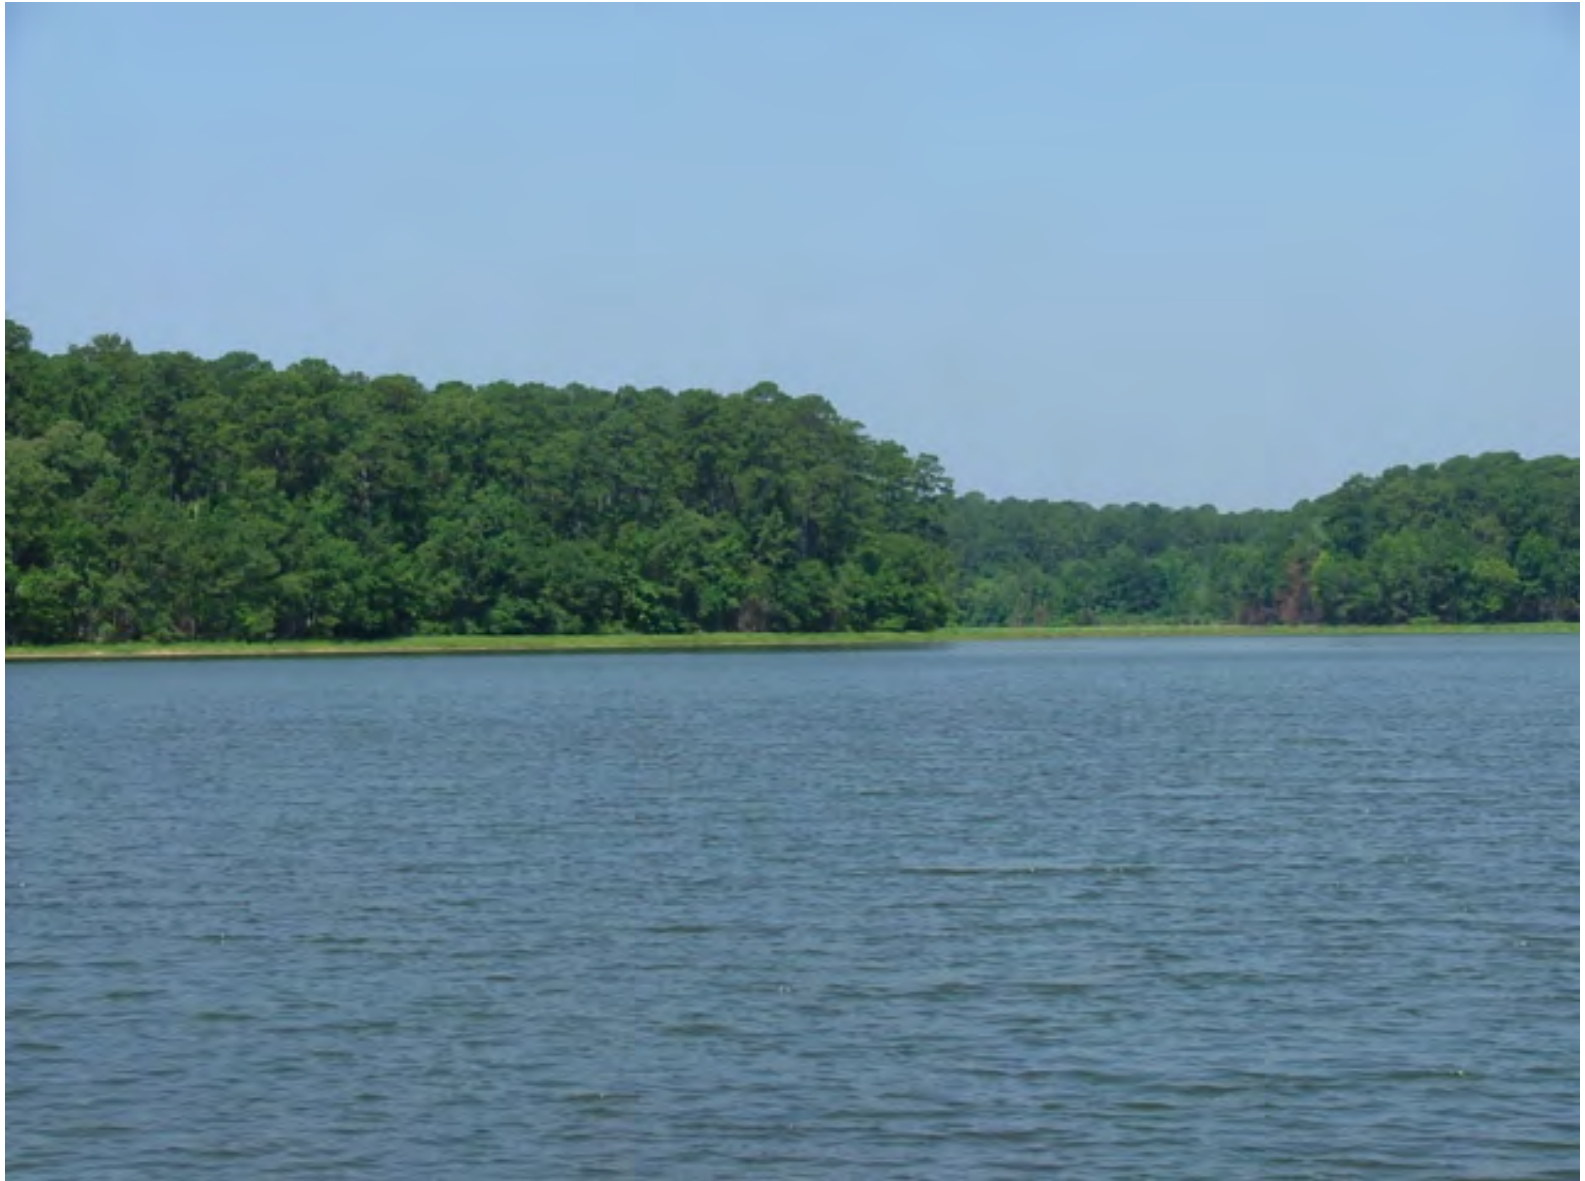
Length: 45 miles **Watershed Area:** 456 square miles **Designated Uses:** Primary Contact Recreation 1; High Aquatic Life; Public Water Supply

Number of Active Monitoring Stations: 17 **Texas Stream Team Monitoring Stations:** 1 **Permitted WWTF Outfalls:** 49

- Segment 1012 (Reservoir w/ high ALU): **Lake Conroe** (classified water body) – From Conroe Dam in Montgomery County up to the normal pool elevation of 201 feet (impounds West Fork San Jacinto River)
- Segment 1012A (Perennial Stream w/ high ALU): **Town Creek** (unclassified water body) – Perennial stream from the confluence with Atkins Creek upstream to the confluence with Carwile Creek
- Segment 1012B (Perennial Stream w/ high ALU): **Robinson Creek** (unclassified water body) – Perennial stream from the confluence with the West Fork San Jacinto River upstream to the confluence with an unnamed second order tributary approximately 0.1 km upstream of Bethel Road
- Segment 1012C (Reservoir w/ high ALU): **Lake Raven** (unclassified water body) – Adjacent to Park Road 40 within the boundaries of Huntsville State Park in Walker County

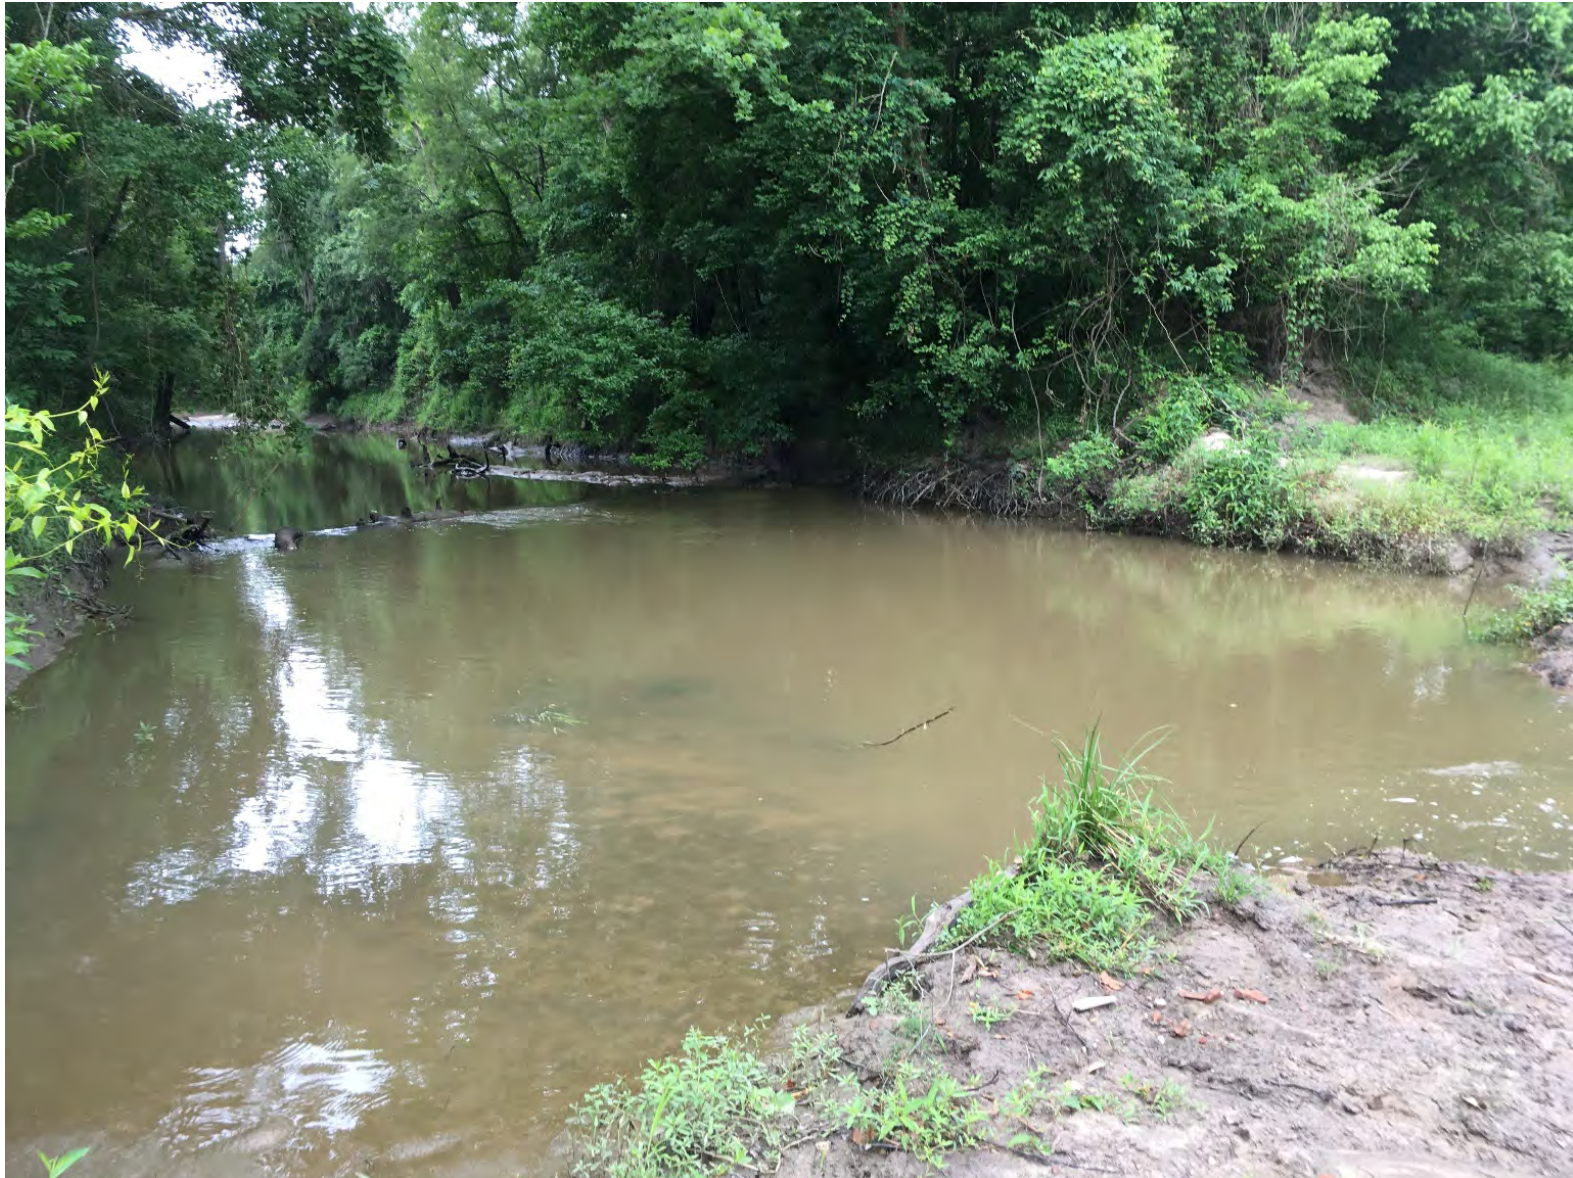
Length: 63 miles **Watershed Area:** 328 square miles **Designated Uses:** Primary Contact Recreation 1; High Aquatic Life; Public Water Supply

Number of Active Monitoring Stations: 3 **Texas Stream Team Monitoring Stations:** 1 **Permitted WWTF Outfalls:** 17

- Segment 1015 (Perennial Stream w/ high ALU): **Lake Creek** (classified water body) – From the confluence with the West Fork San Jacinto River in Montgomery County to a point 4.0 km (2.5 mi) upstream of SH 30 in Grimes County
- Segment 1015A (Perennial Stream w/ high ALU): **Mound Creek** (unclassified water body) – From the Lake Creek confluence upstream to a point 1.1 km (0.69 mi) east of FM 149
- Segment 1015B (Perennial Stream w/ high ALU): **Caney Creek** (unclassified water body) – From the Lake Creek confluence upstream to a point 2.4 km (1.5 mi) south of FM 1774

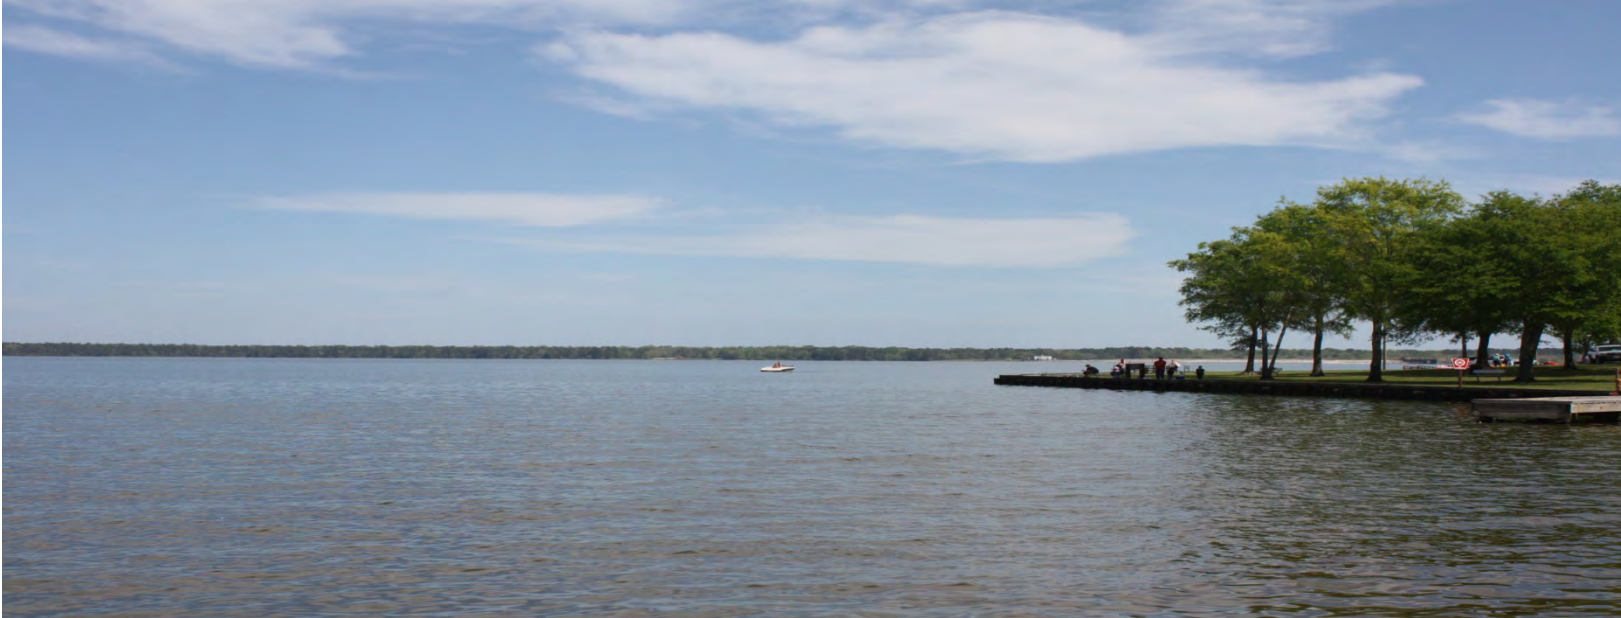
Length: 23 miles **Watershed Area:** 279 square miles **Designated Uses:** Primary Contact Recreation 1; High Aquatic Life; Public Water Supply

Number of Active Monitoring Stations: 13 **Texas Stream Team Monitoring Stations:** 0 **Permitted WWTF Outfalls:** 12

- Segment 1002 (Reservoir): **Lake Houston** (classified water body) – From Lake Houston Dam in Harris County to the confluence of Spring Creek on the West Fork San Jacinto arm in Harris/Montgomery County and to the confluence of Caney Creek on the East Fork San Jacinto arm in Harris County, up to the normal pool elevation of 44.5 feet (impounds San Jacinto River)

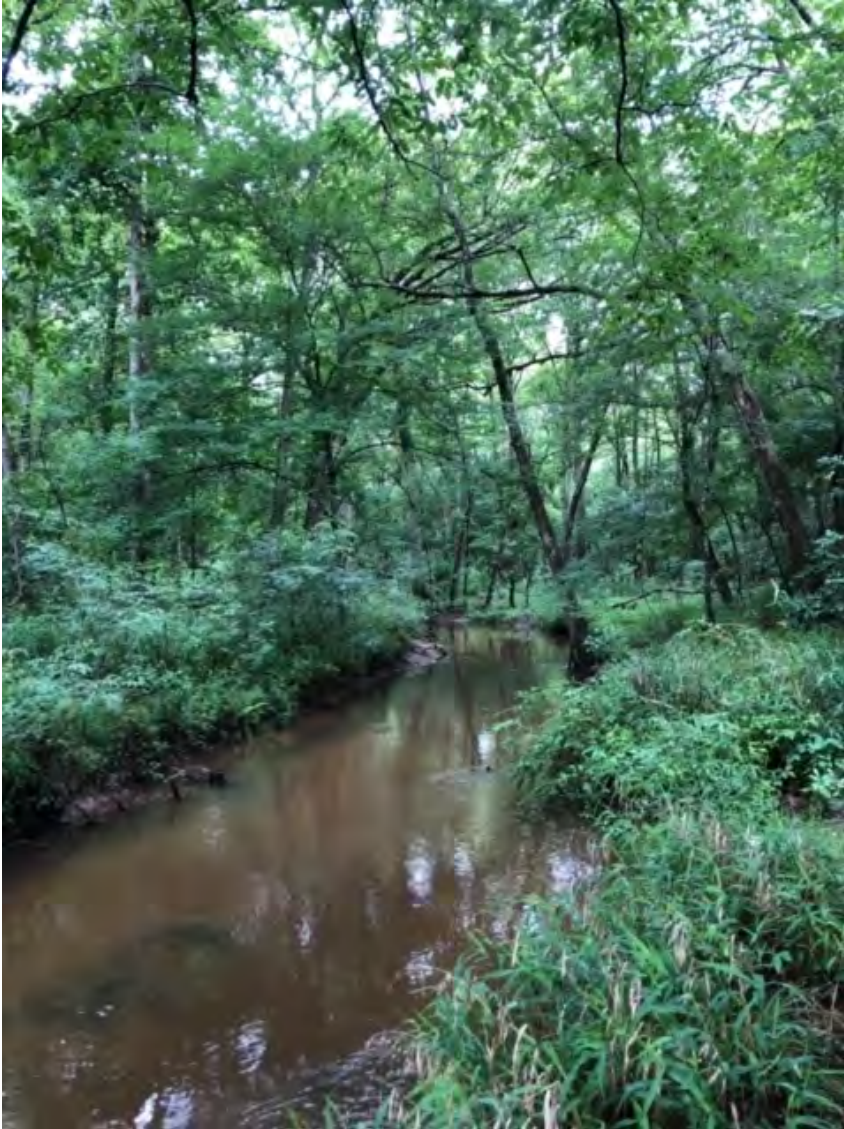
Length: 43 miles **Watershed Area:** 151 square miles **Designated Uses:** Primary Contact Recreation 1; High Aquatic Life; Public Water Supply

Number of Active Monitoring Stations: 4 **Texas Stream Team Monitoring Stations:** 1 **Permitted WWTF Outfalls:** 13

- Segment 1011 (Perennial Stream w/ high ALU): **Peach Creek** (classified water body) – From the confluence with Caney Creek in Montgomery County to SH 150 in Walker County

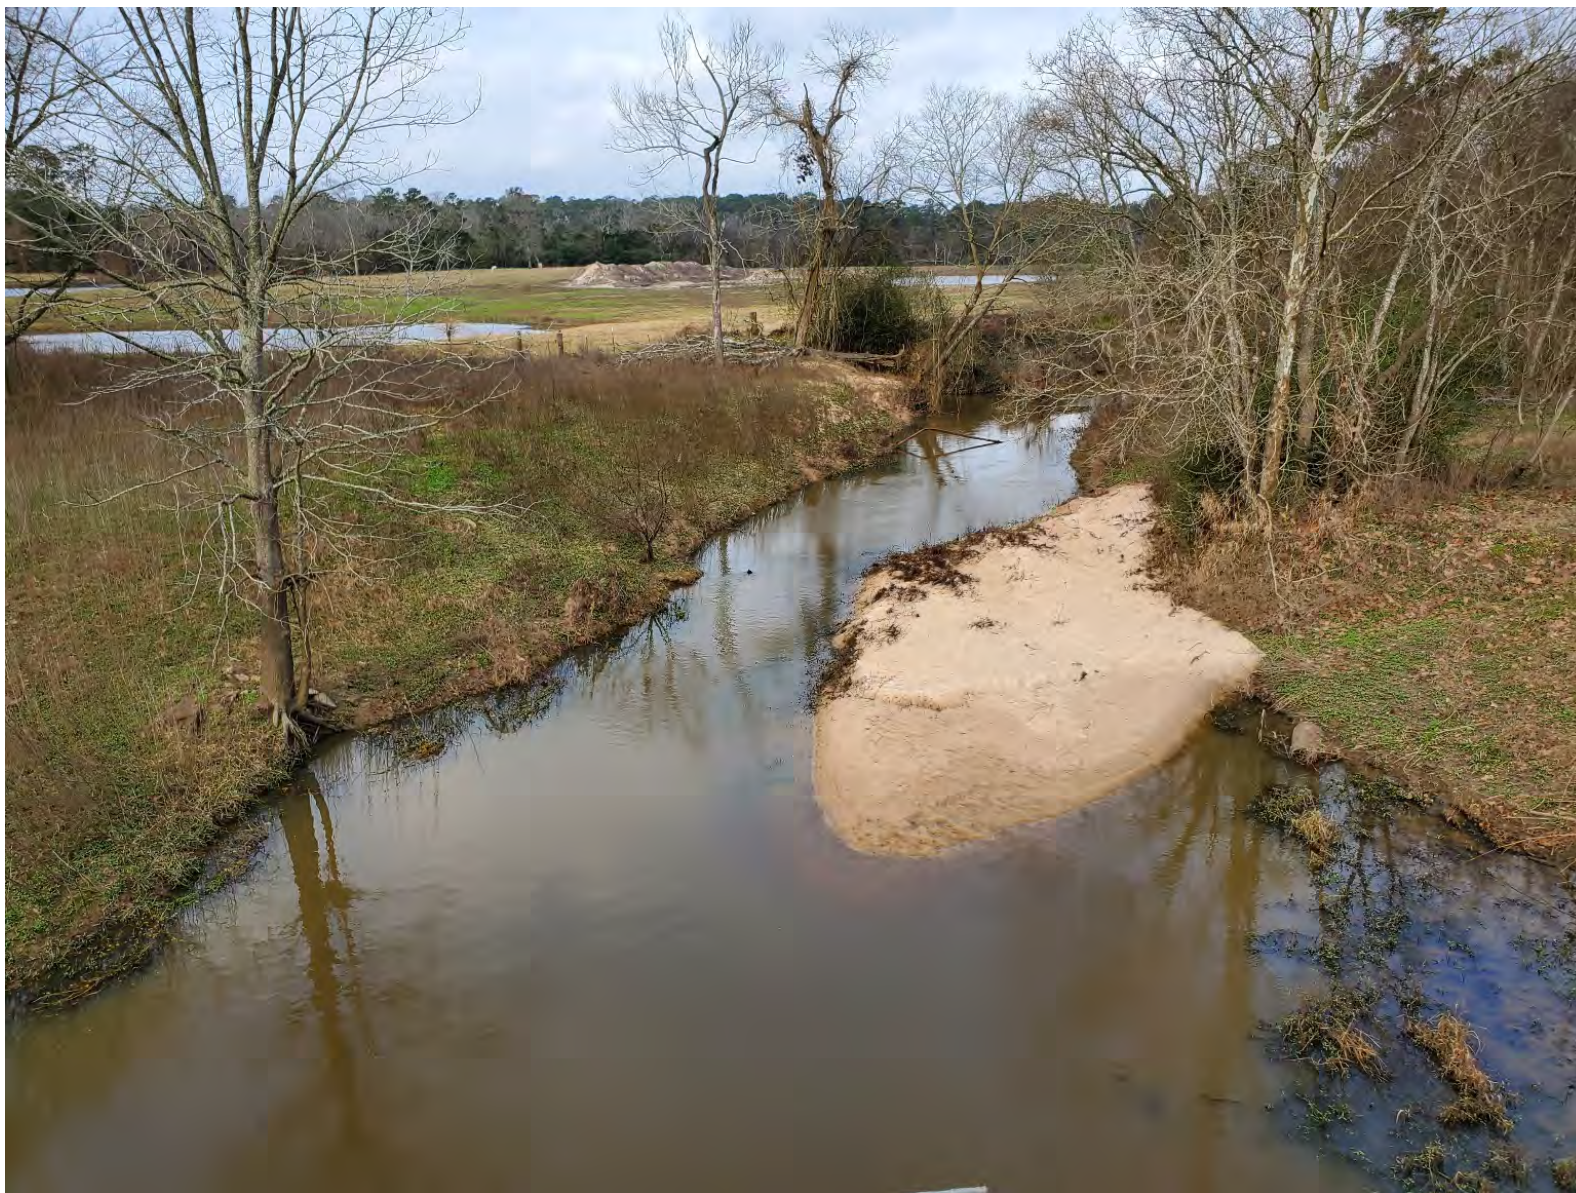
Length: 57 miles **Watershed Area:** 441 square miles **Designated Uses:** Primary Contact Recreation 1; High Aquatic Life; Public Water Supply

Number of Active Monitoring Stations: 20 **Texas Stream Team Monitoring Stations:** 5 **Permitted WWTF Outfalls:** 80

- Segment 1008 (Perennial Stream w/ high ALU) **Spring Creek** (classified water body) – From the confluence with the West Fork San Jacinto River in Harris/Montgomery County to the most upstream crossing of FM 1736 in Waller County

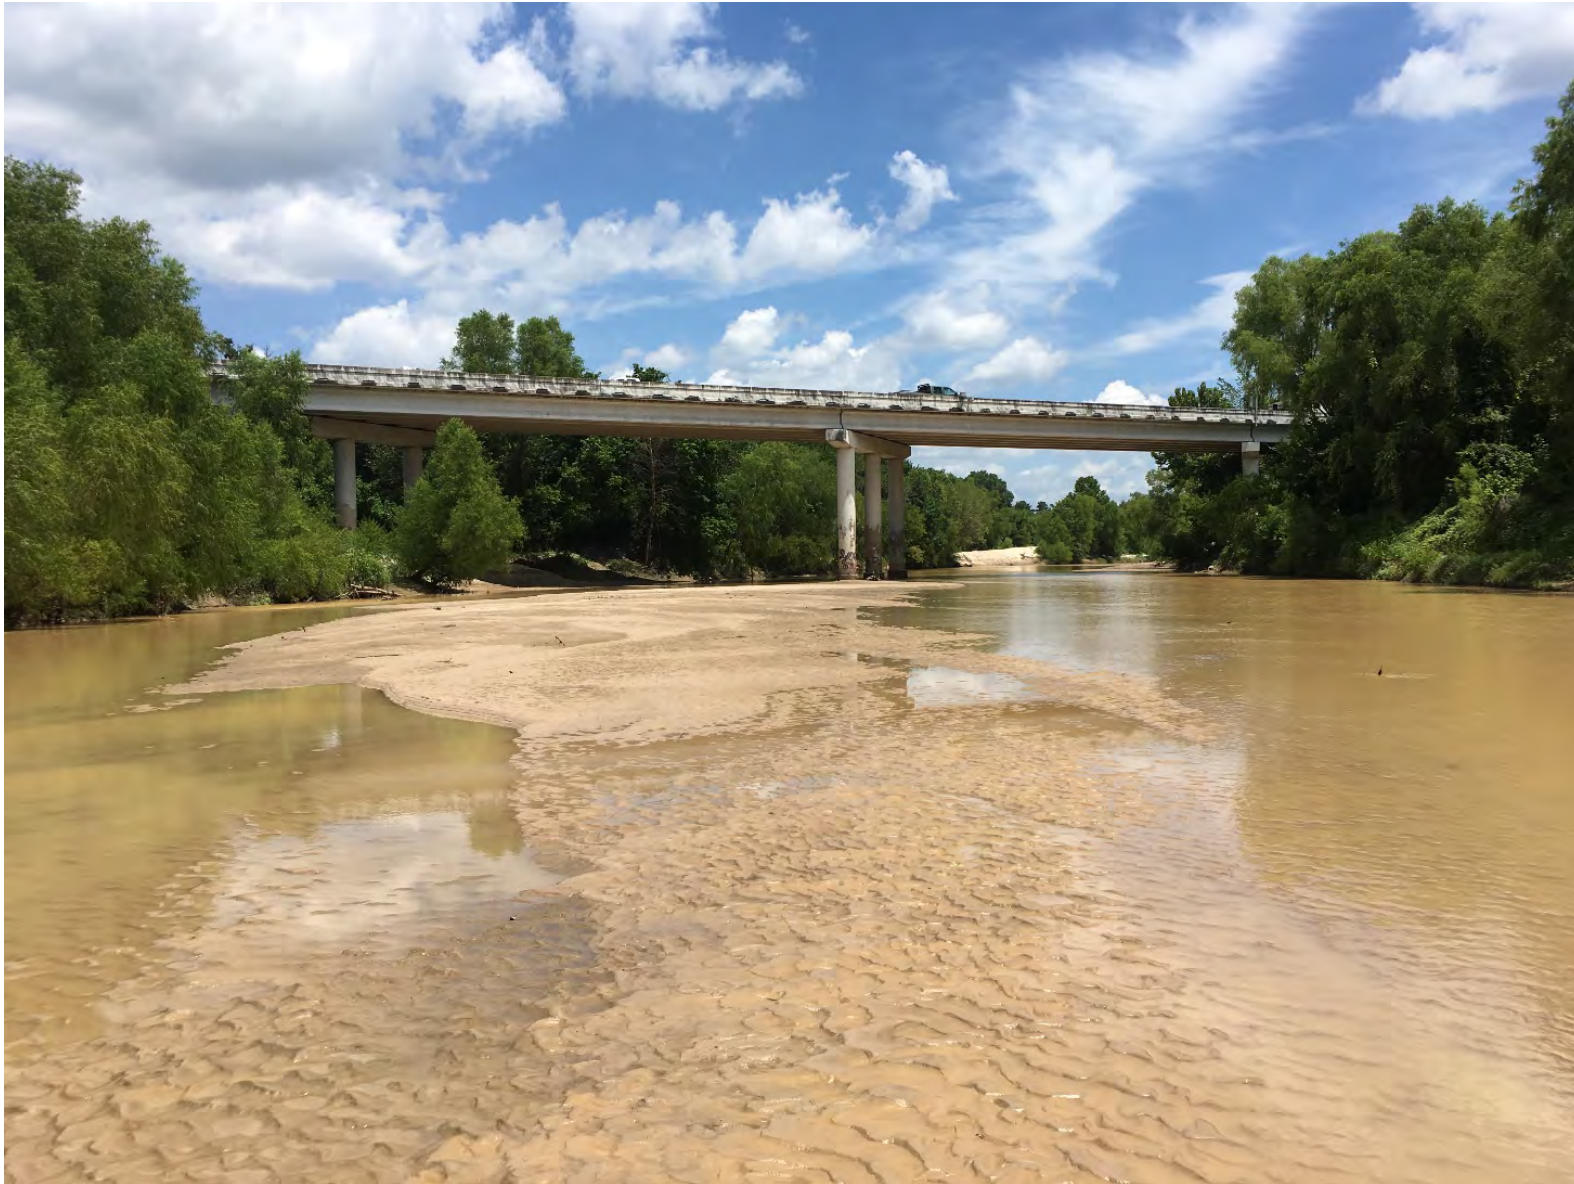
Length: 40 miles **Watershed Area:** 216 square miles **Designated Uses:** Primary Contact Recreation 1; High Aquatic Life; Public Water Supply

Number of Active Monitoring Stations: 6 **Texas Stream Team Monitoring Stations:** 0 **Permitted WWTF Outfalls:** 37

- Segment 1004 (Perennial Stream): **West Fork San Jacinto** (classified water body) – From the confluence of Spring Creek in Harris/Montgomery County to Conroe Dam in Montgomery County

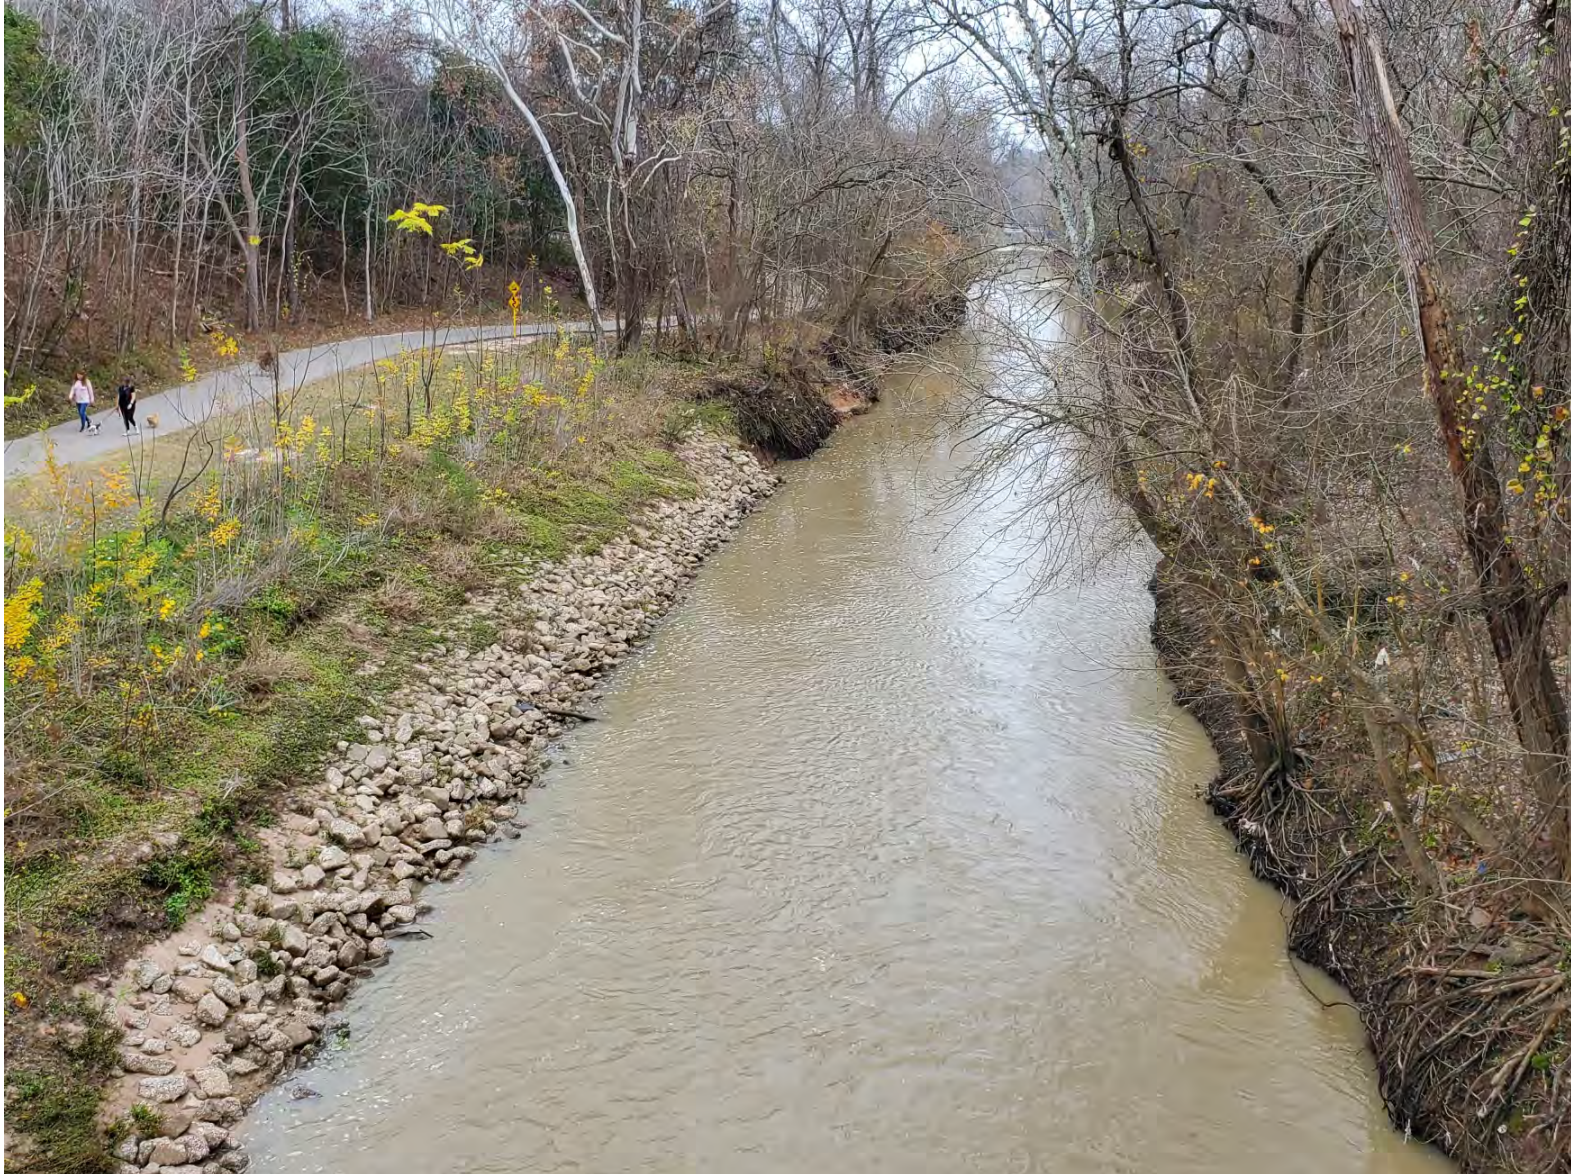
Length: 23 miles **Watershed Area:** 351 square miles **Designated Uses:** Primary Contact Recreation 1; Limited Aquatic Life

Number of Active Monitoring Stations: 23 **Texas Stream Team Monitoring Stations:** 3 **Permitted WWTF Outfalls:** 124

- Segment 1014 (Perennial Stream w/ limited ALU): **Buffalo Bayou Above Tidal** (classified water body) – From a point 400 meters (440 yards) upstream of Shepherd Drive in Harris county to SH 6 in Harris County
