HOUSTON-GALVESTON AREA COUNCIL

HOW'S THE WATER?

2021

Basin Summary Report

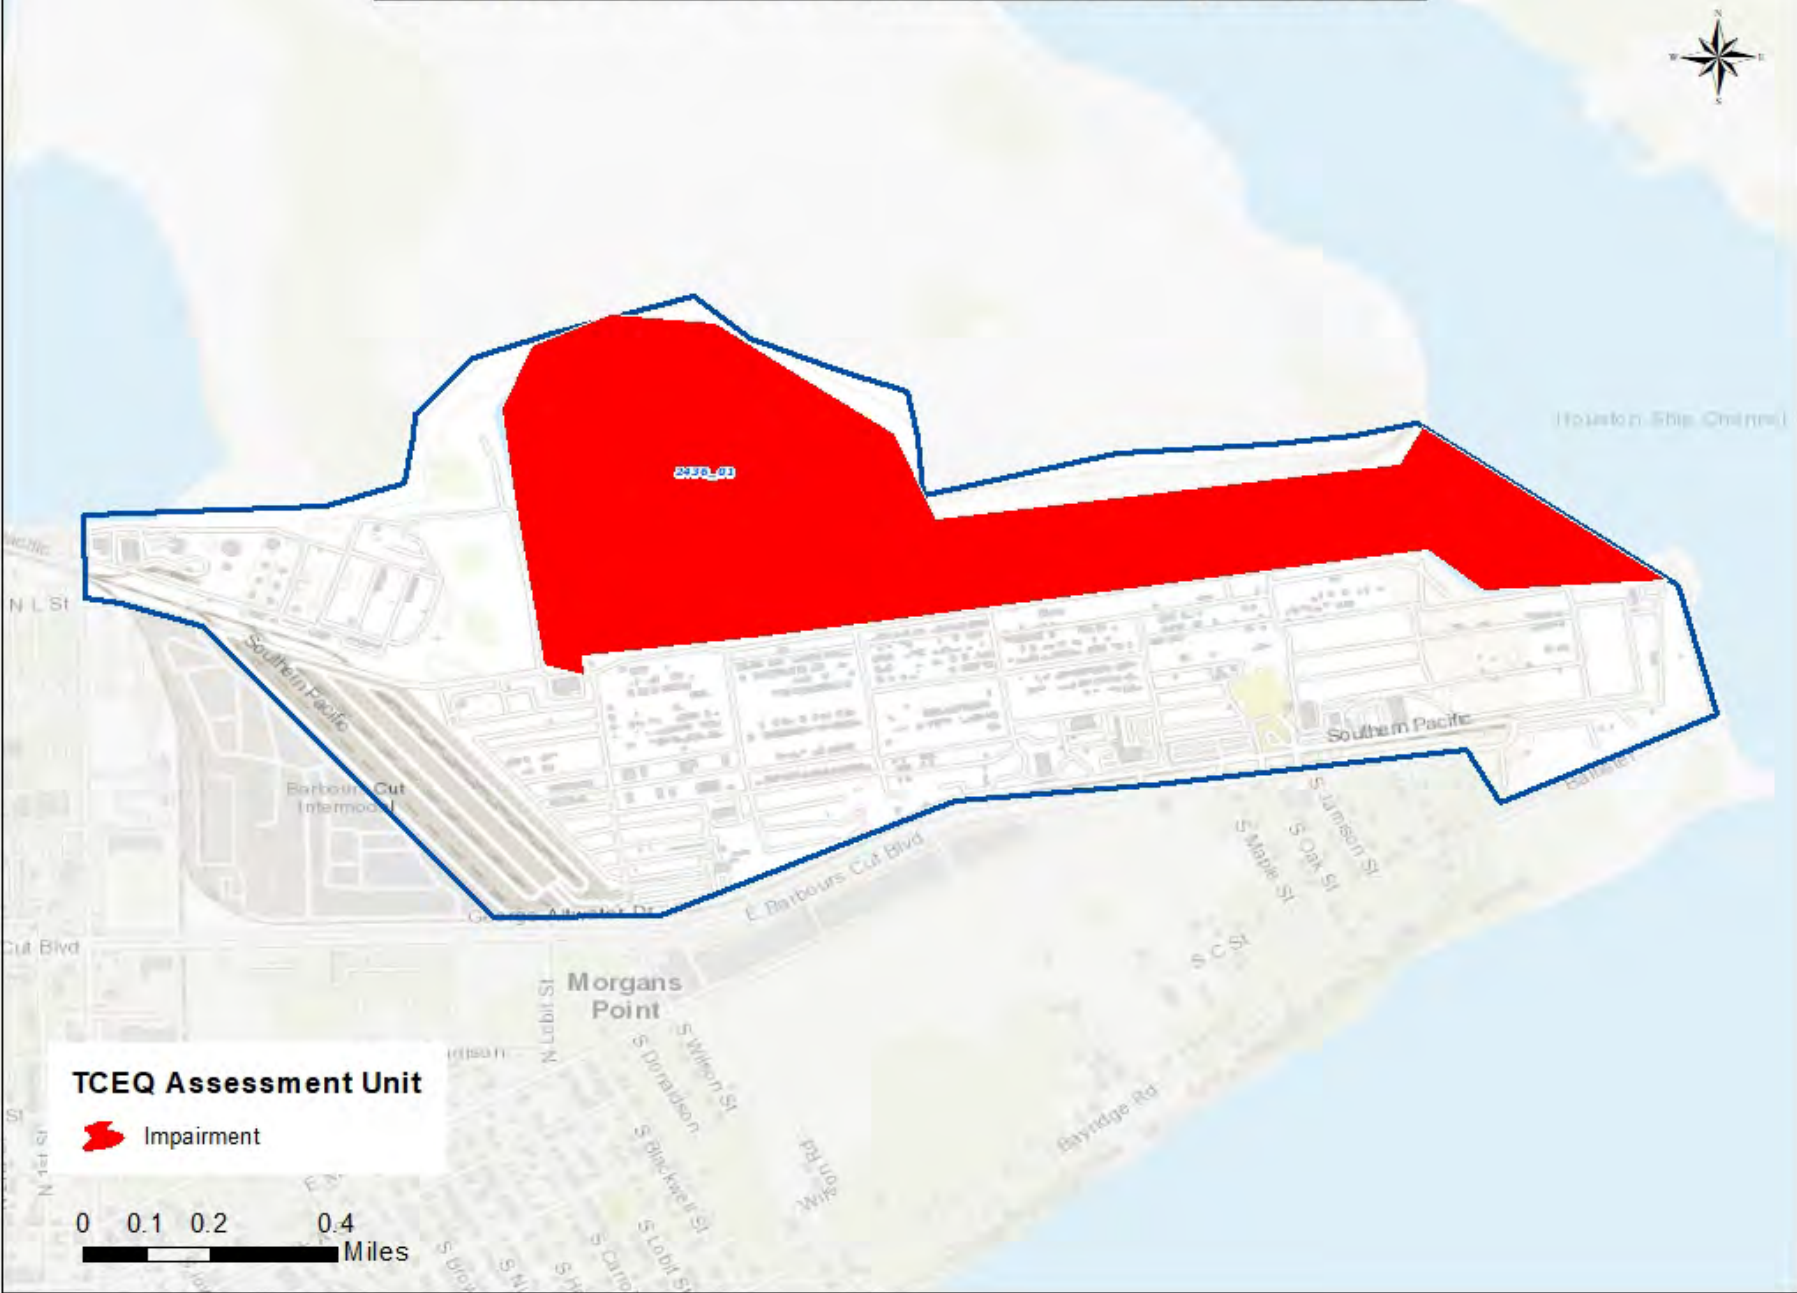
Barbours Cut - PCBs and Dioxins Impairments

There are 3 permitted wastewater outfalls in the Barbours Cut watershed. There are no permitted on-site sewage facilities in the watershed. The wastewater treatment facilities in the watershed are shown in the accompanying map.

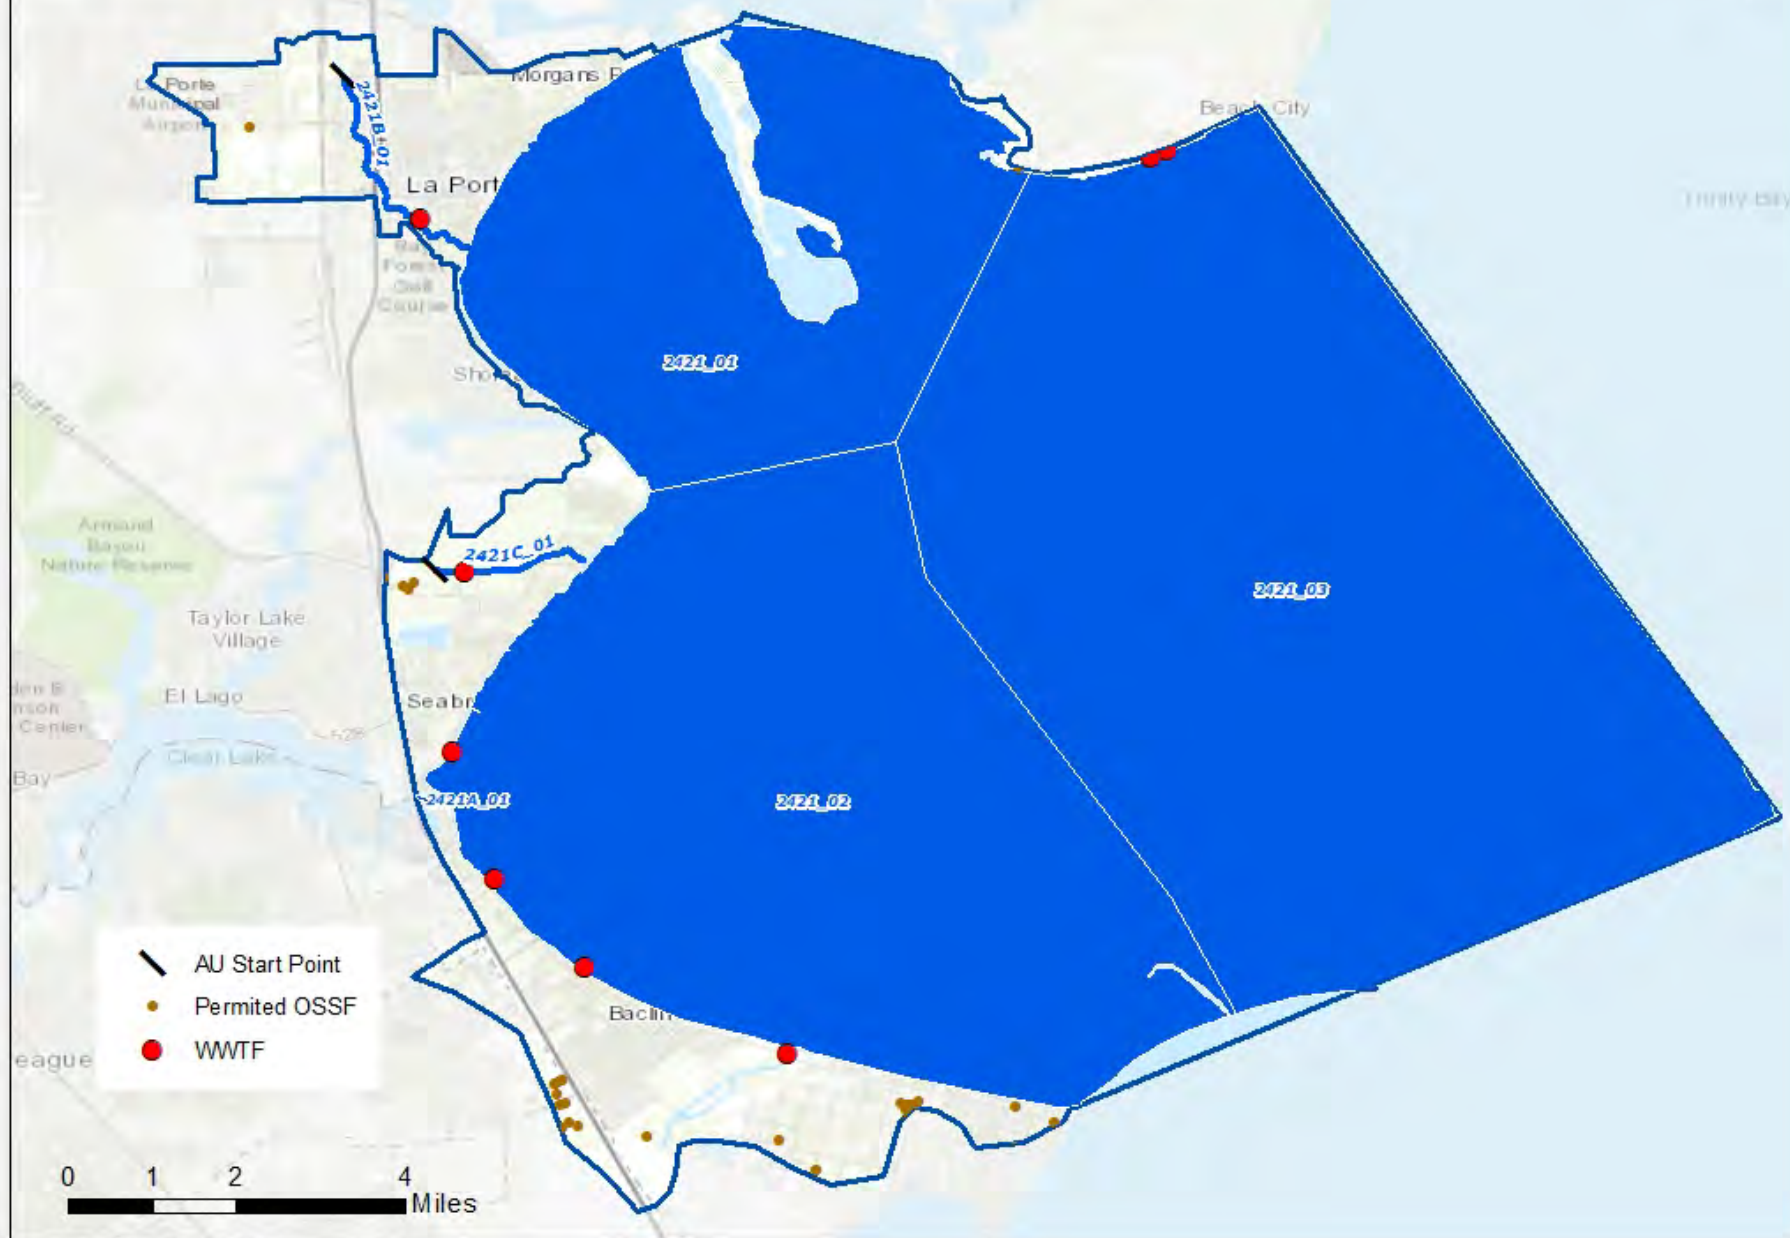
Upper Galveston Bay - 2421

Regression analysis of water quality data identified four parameter trends for Upper Galveston Bay (2421) and four parameter trends in Pine Gully (2421C) including decreasing total phosphorous and TKN. Clear Lake Channel (2421A) and Little Cedar Bayou (2421B), the other two AUs related to Upper Galveston Bay, have no parameter trends identified in their datasets.

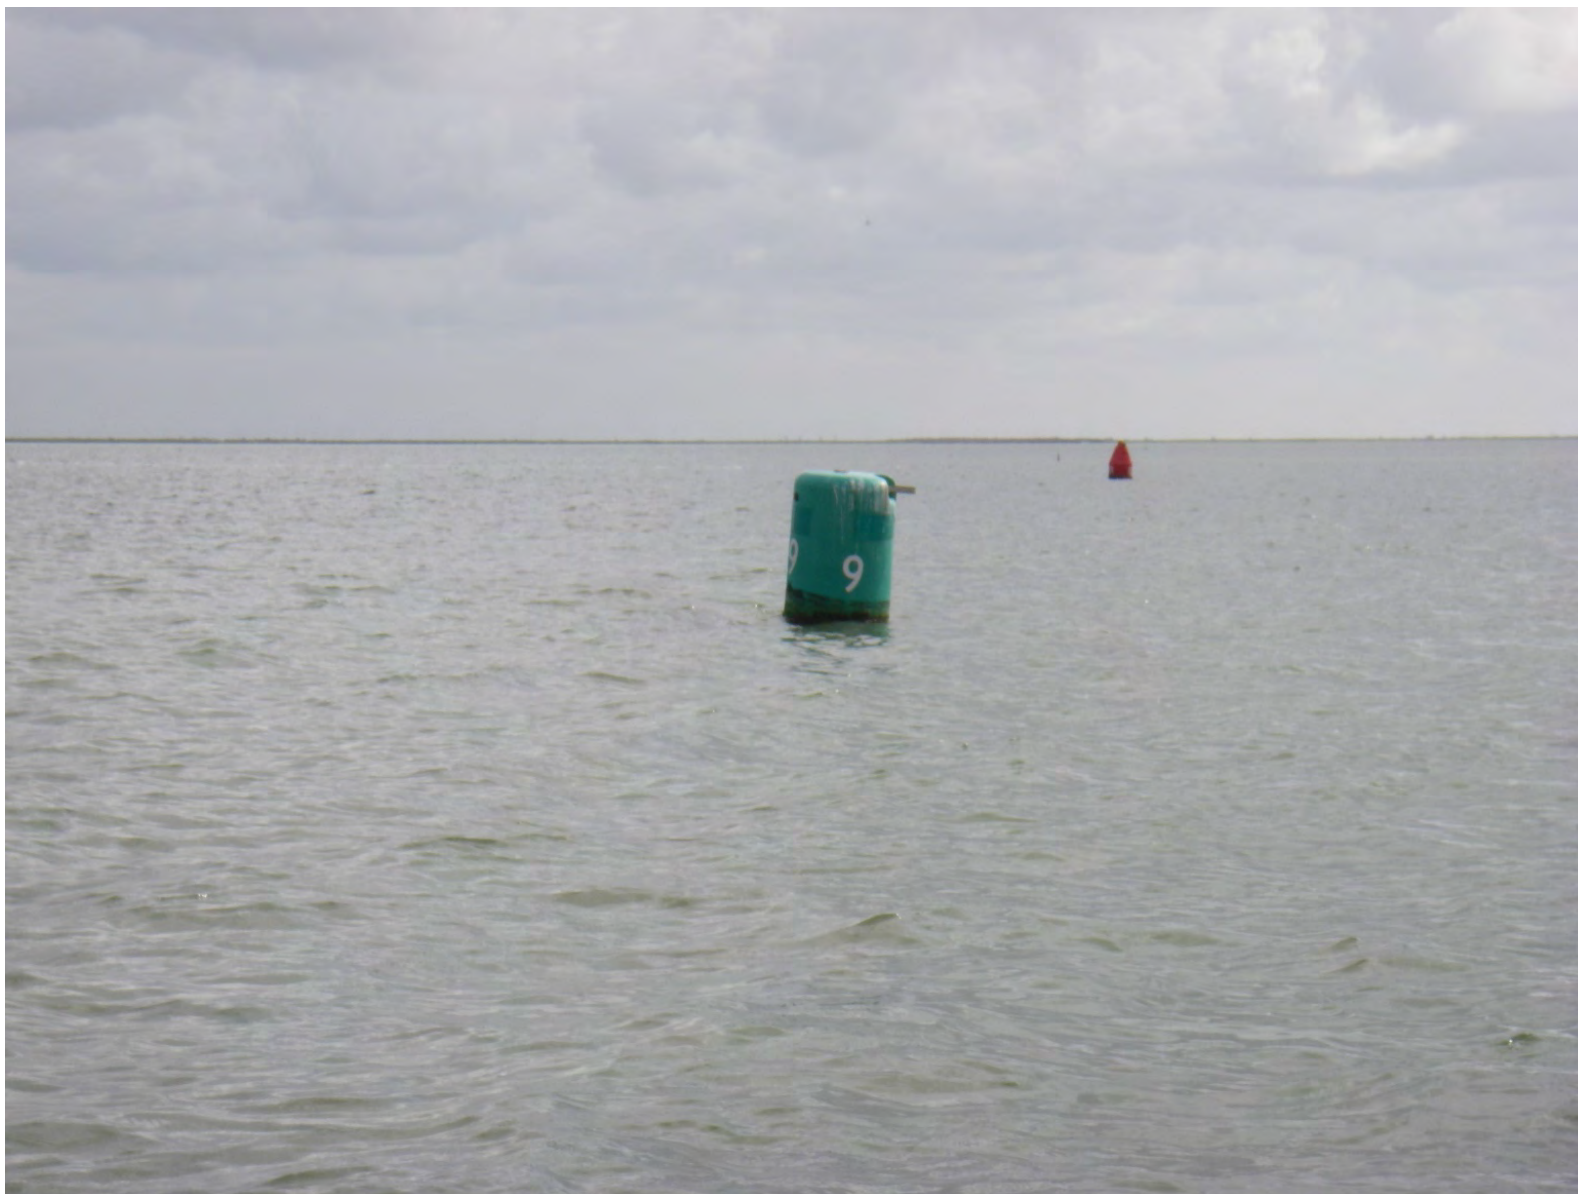
Area: 7.4 square miles **Miles of Shoreline:** 25 miles **Designated Uses:** Primary Contact Recreation 1; High Aquatic Life; Oyster Waters

Number of Active Monitoring Stations: 9 **Texas Stream Team Monitoring Stations:** 0 **Permitted WWTF Outfalls:** 21

- Segment 2432: **Chocolate Bay** (classified water body) – Adjoining the northwest side of West Galveston Bay at the Gulf Intracoastal Waterway and extending upstream to confluence with Chocolate Bayou approximately $\frac{3}{4}$ mile downstream of FM 2004 in southeast Brazoria County

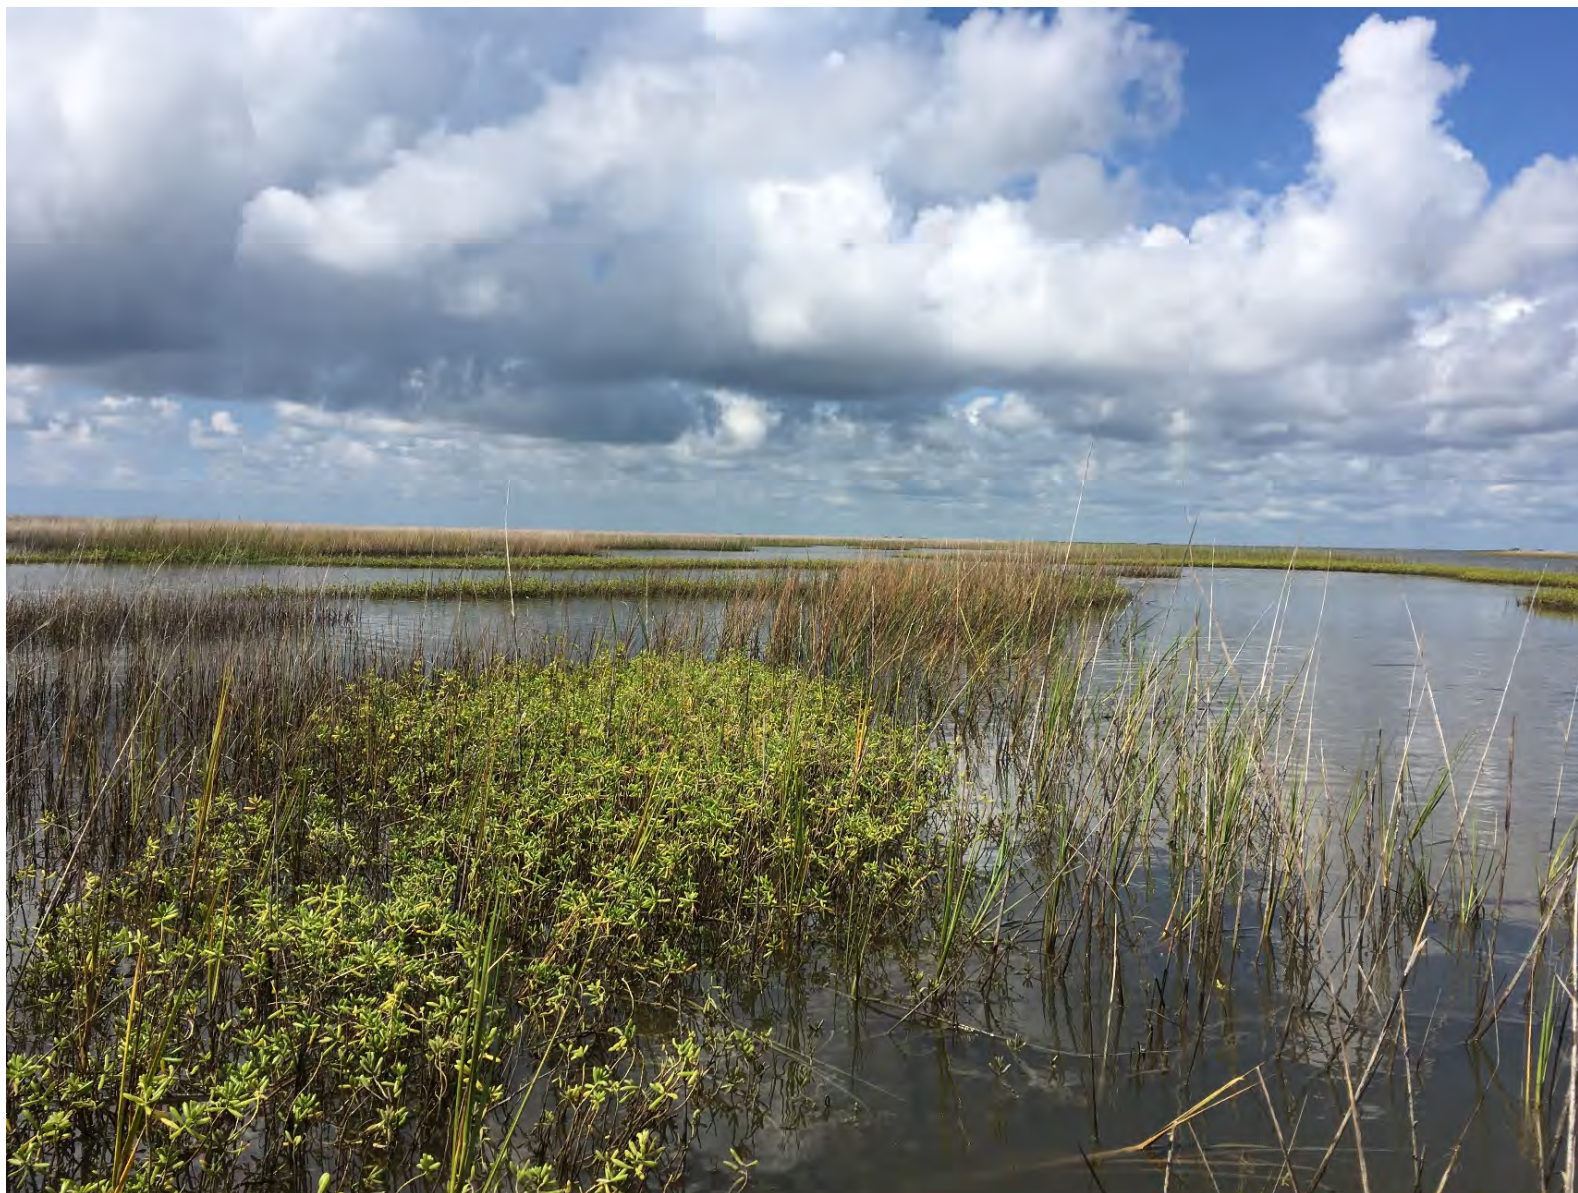
Area: 9.3 square miles **Miles of Shoreline:** 26.1 miles **Designated Uses:** Primary Contact Recreation 1; High Aquatic Life; Oyster Waters

Number of Active Monitoring Stations: 1 **Texas Stream Team Monitoring Stations:** 0 **Permitted WWTF Outfalls:** 2

- Segment 2434: **Christmas Bay** (classified water body) – Located on the landward side of Follet’s Island in Brazoria County and southwest of Mud Island, it drains into Bastrop Bay to the northeast or directly to West Galveston Bay via a channel on the south side of Mud Island.
- Segment 2434OW (Oyster Waters)

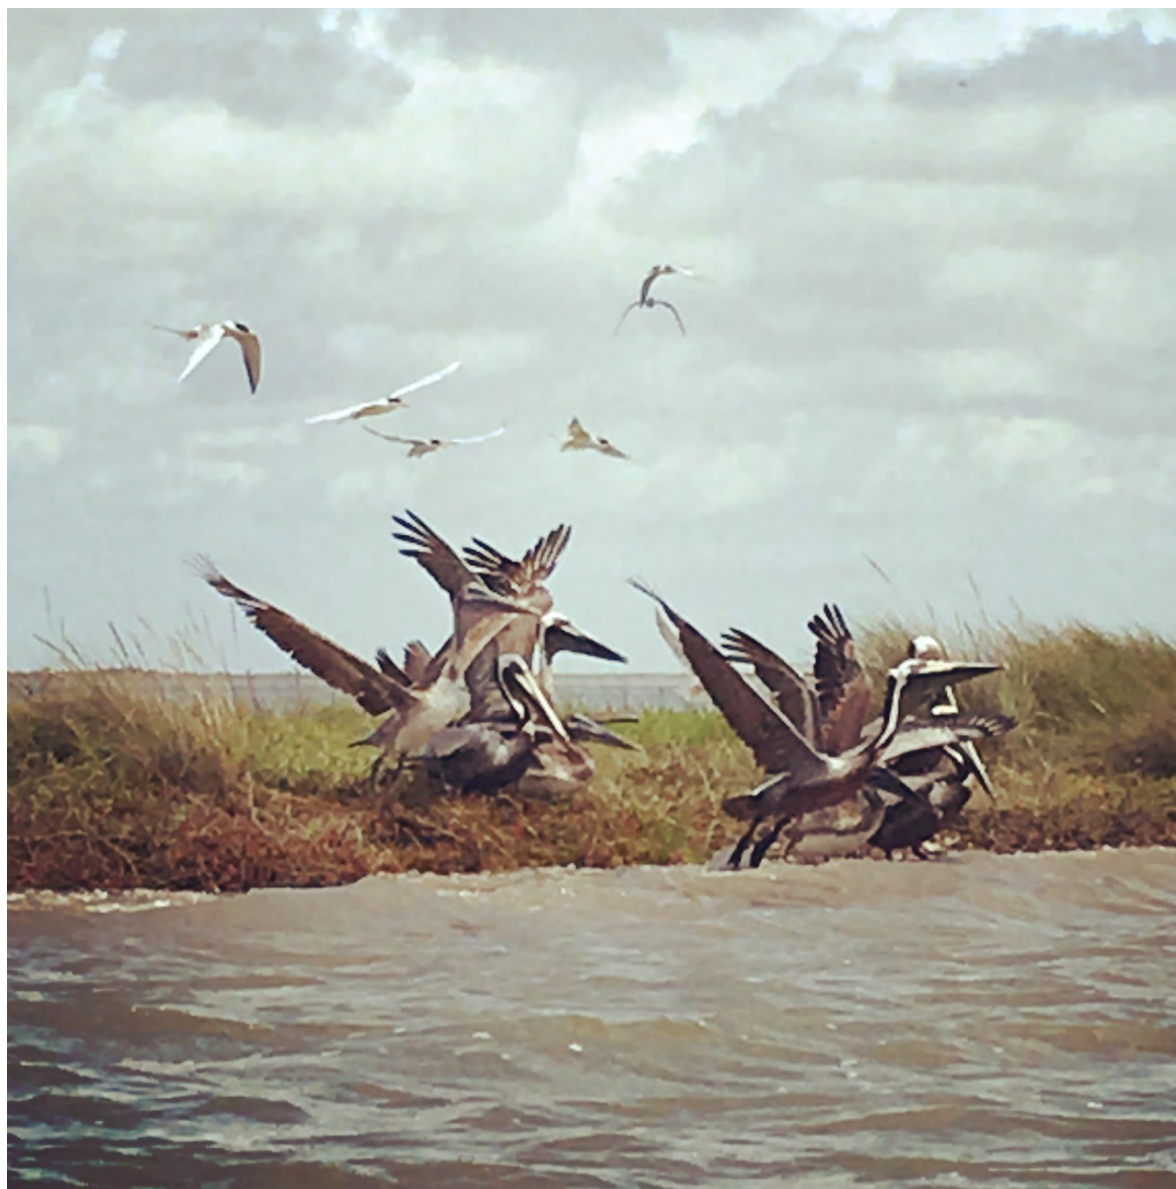
Area: 2 square miles **Miles of Shoreline:** 12.2 miles **Designated Uses:** Primary Contact Recreation 1; High Aquatic Life; Oyster Waters

Number of Active Monitoring Stations: 0 **Texas Stream Team Monitoring Stations:** 1 **Permitted WWTF Outfalls:** 1

- Segment 2435: **Drum Bay** (classified water body) - Located on the landward side of Follet's Island in Brazoria County extending southwest from the confluence with Christmas Bay, it is connected to the Gulf Intracoastal Waterway via a cut on the far western end and via a cut from the north called Nick's Cut.
- Segment 2435A: **Nicks Cut** (unclassified water body) – Cut from Nicks Lake to Gulf Intracoastal Waterway to Drum Bay in Brazoria County.
- Segment 2435OW (Oyster Waters)

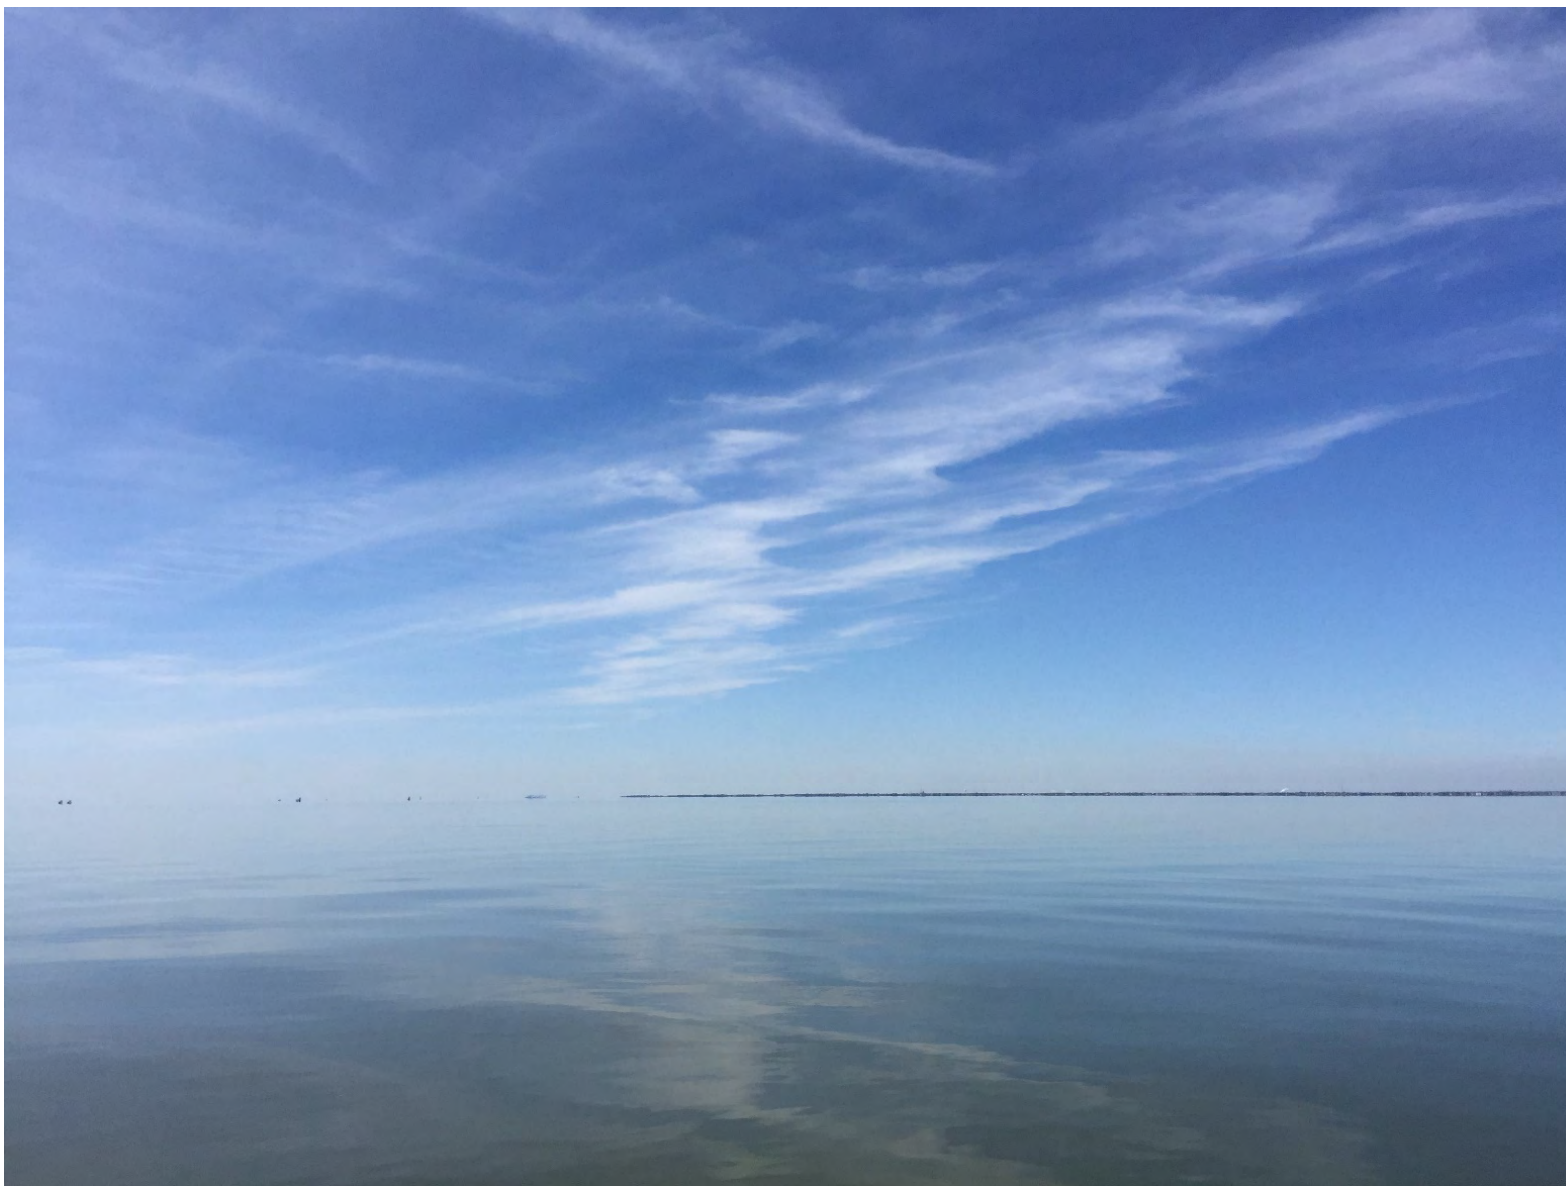
Area: 57 square miles **Miles of Shoreline:** 51 miles **Designated Uses:** Primary Contact Recreation 1; High Aquatic Life; Oyster Waters

Number of Active Monitoring Stations: 5 **Texas Stream Team Monitoring Stations:** 2 **Permitted WWTF Outfalls:** 3

- Segment 2423: **East Galveston Bay** (classified water body) – A 134.9 square kilometer (52.1 square mile) portion of Galveston Bay located on the landward side of Bolivar Peninsula extending westward from the Galveston County line east of High Island to an imaginary north-south line extending from Smith Point southeast to approximately ½ mile east of Pepper Grove Cove on Elm Grove Point and east of Bluewater Subdivision on Bolivar Peninsula
- Segment 2423A (Tidal Stream w/ high ALU): **Oyster Bayou** (unclassified water body) — From the East Bay confluence to a point 2.2 km (1.4 mi) upstream from SH 65 in Chambers County
- Segment 2423OW (Oyster Waters)

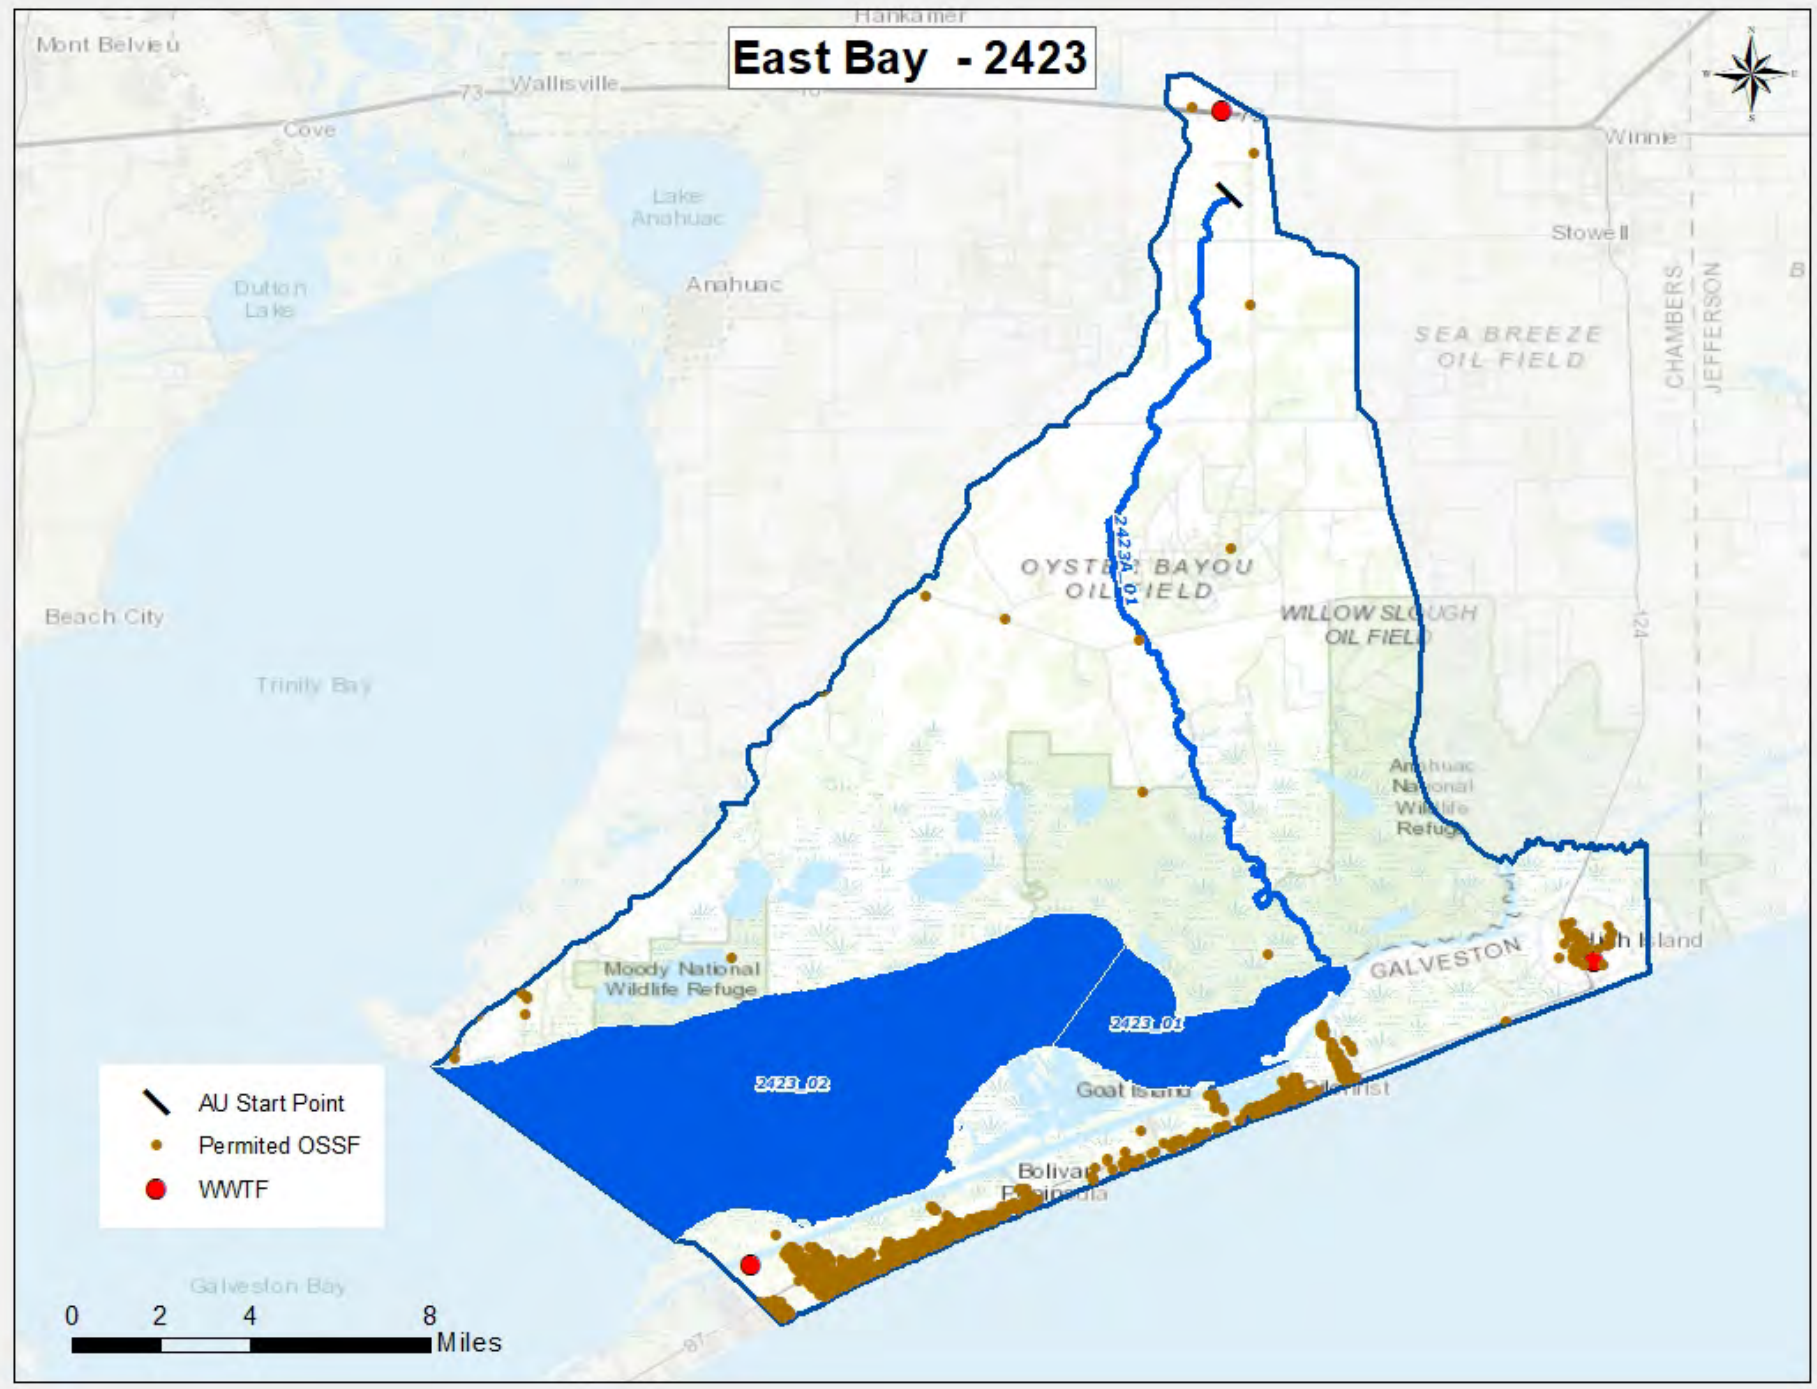
East Bay - 2423

Analysis of water quality data for East Galveston Bay (segment 2423) identified five parameter trends which included decreasing chloride, specific conductance, total phosphorus, and sulfate concentrations while pH was found to be increasing. The pH trend is not problematic at this time because all measurements were found to be in the acceptable range of 6.5 to 9.0 standard units. However, in late 2019 there was one value measured at 9.0 which may or may not point to future excursions of the acceptable pH range.

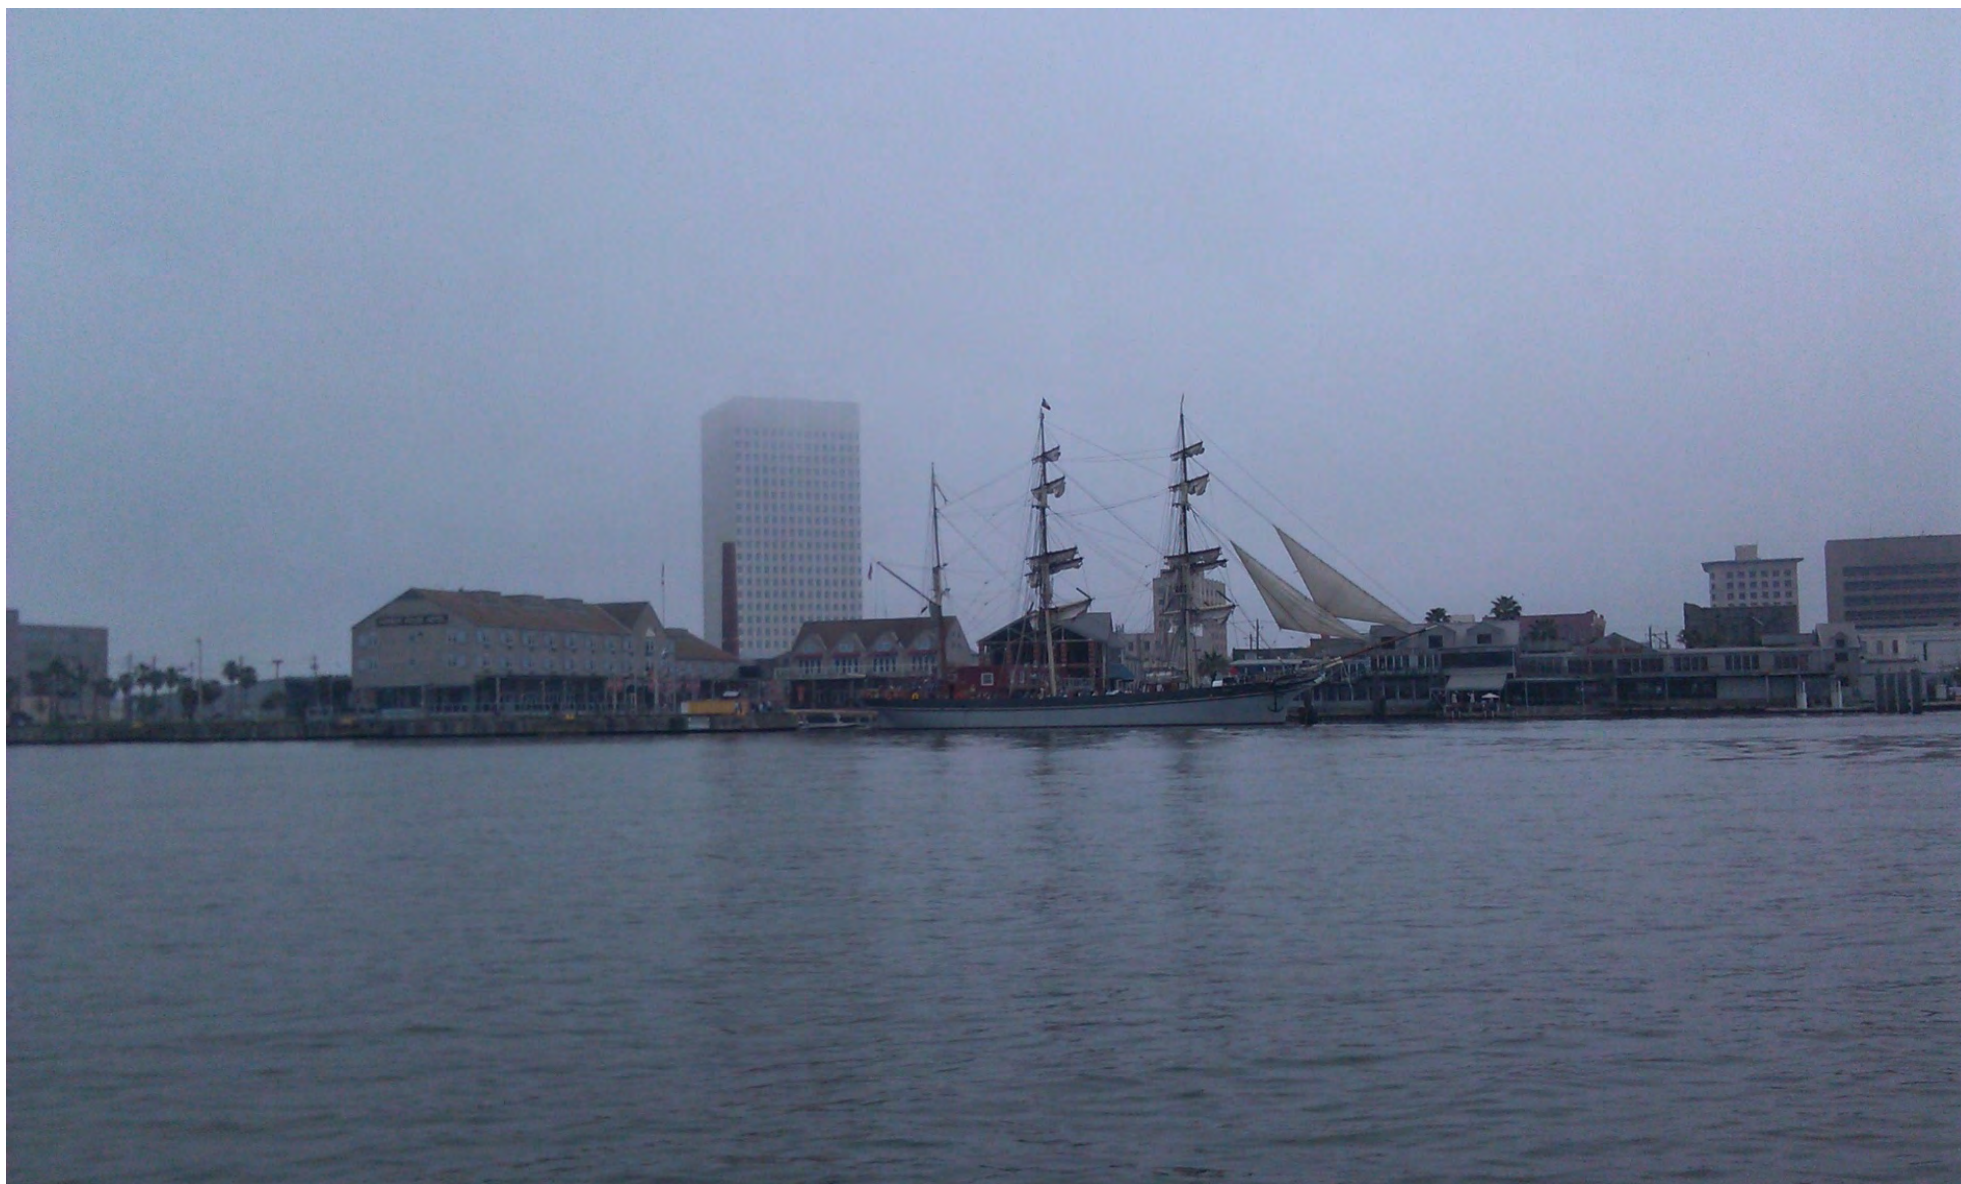
Area: 362 square miles **Miles of Shoreline:** 70 square miles **Designated Uses:** Primary Contact Recreation 1; High Aquatic Life; Oyster Waters

Number of Active Monitoring Stations: 14 **Texas Stream Team Monitoring Stations:** 7 **Permitted WWTF Outfalls:** 13

- Segment 2439: **Lower Galveston Bay** – A 361.6 square kilometer (139.2 square mile) portion of Galveston Bay located entirely within Galveston County extending eastward from the Galveston Causeway (IH-45) past Bolivar Roads (the pass between Galveston Island and Bolivar Peninsula) to an imaginary north-south line from Smith Point to approximately ½ mile east of Pepper Grove Cove on Elm Grove Point and east of Bluewater Subdivision on Bolivar Peninsula. And south of the imaginary line between Eagle Pt and Redfish Reef near the community of San Leon in Galveston County and Smith Point in Chambers County.
- Segment 2439OW (Oyster Waters)

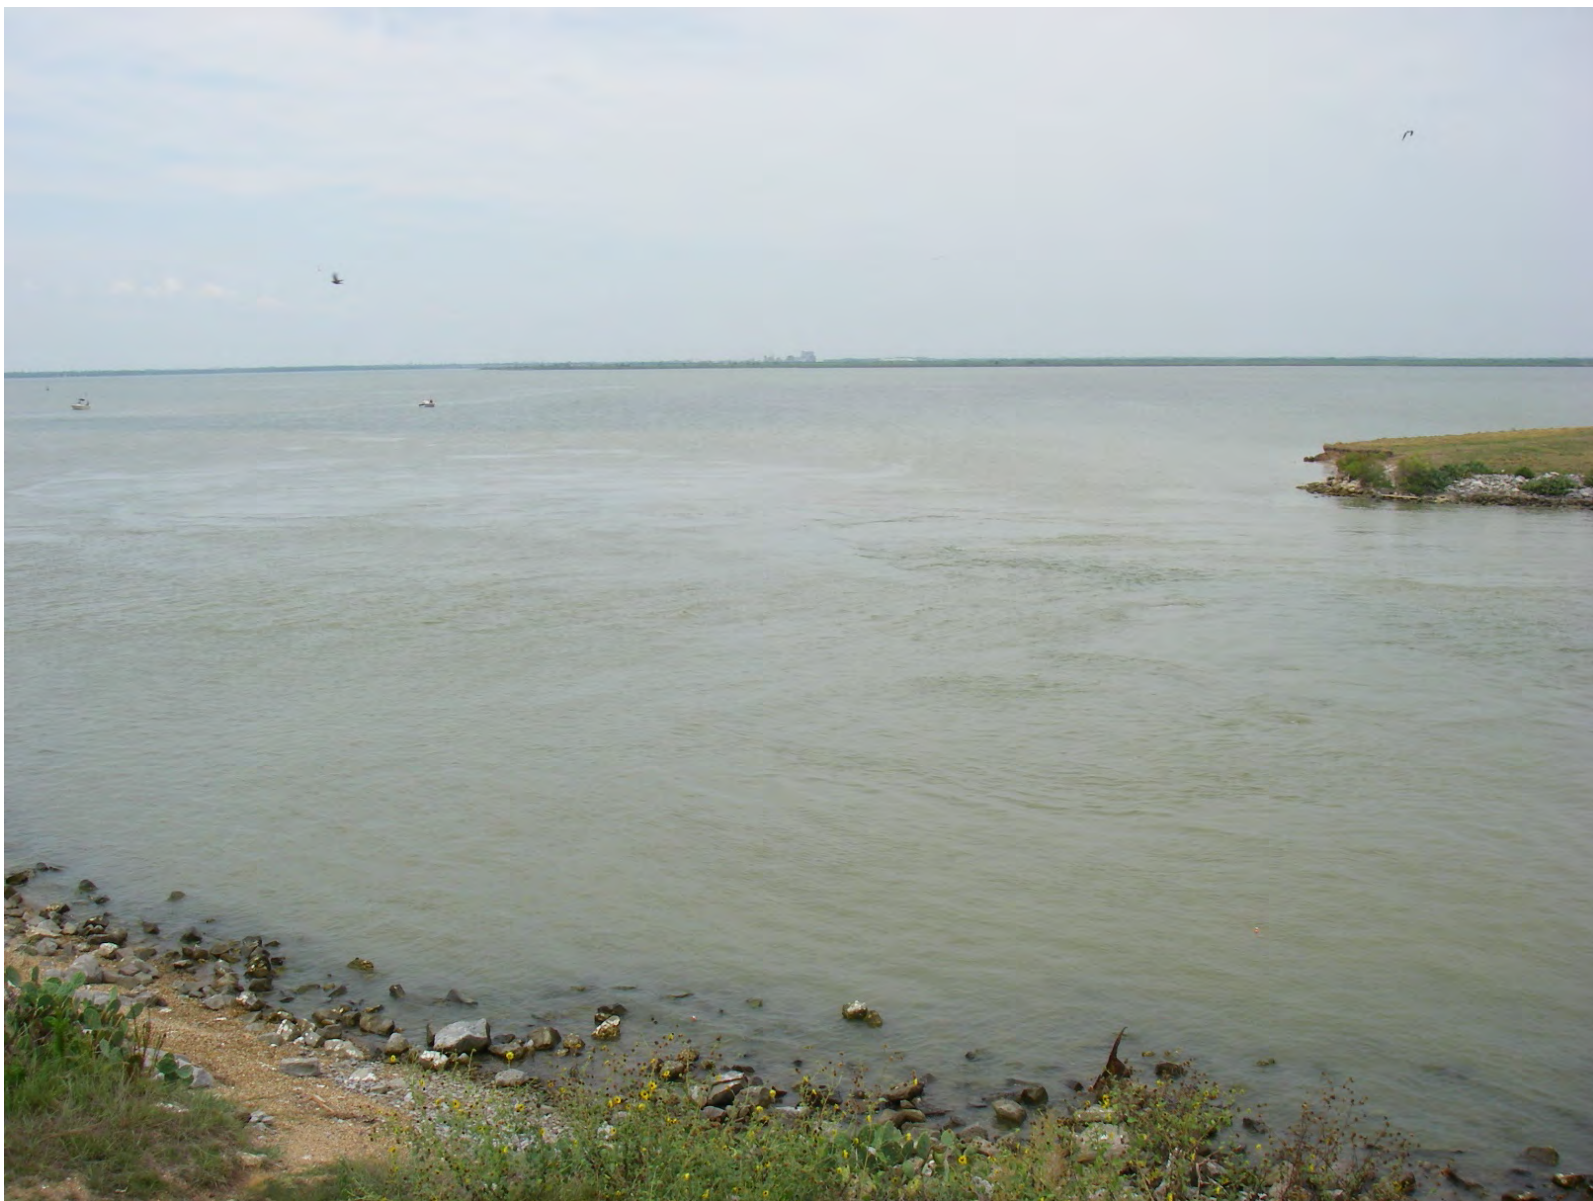
Area: 4 square miles **Miles of Shoreline:** 10.7 miles **Designated Uses:** Primary Contact Recreation 1; High Aquatic Life

Number of Active Monitoring Stations: 4 **Texas Stream Team Monitoring Stations:** 1 **Permitted WWTF Outfalls:** 6

- Segment 2431: **Moses Lake** (classified water body) – An 8.5 square kilometer (3.3 square mile) water body on the western shore of Lower Galveston Bay entirely enclosed by the Texas City levee system immediately north of the urbanized portion of the City of Texas City, south of and adjacent to Dickinson Bay in Galveston County

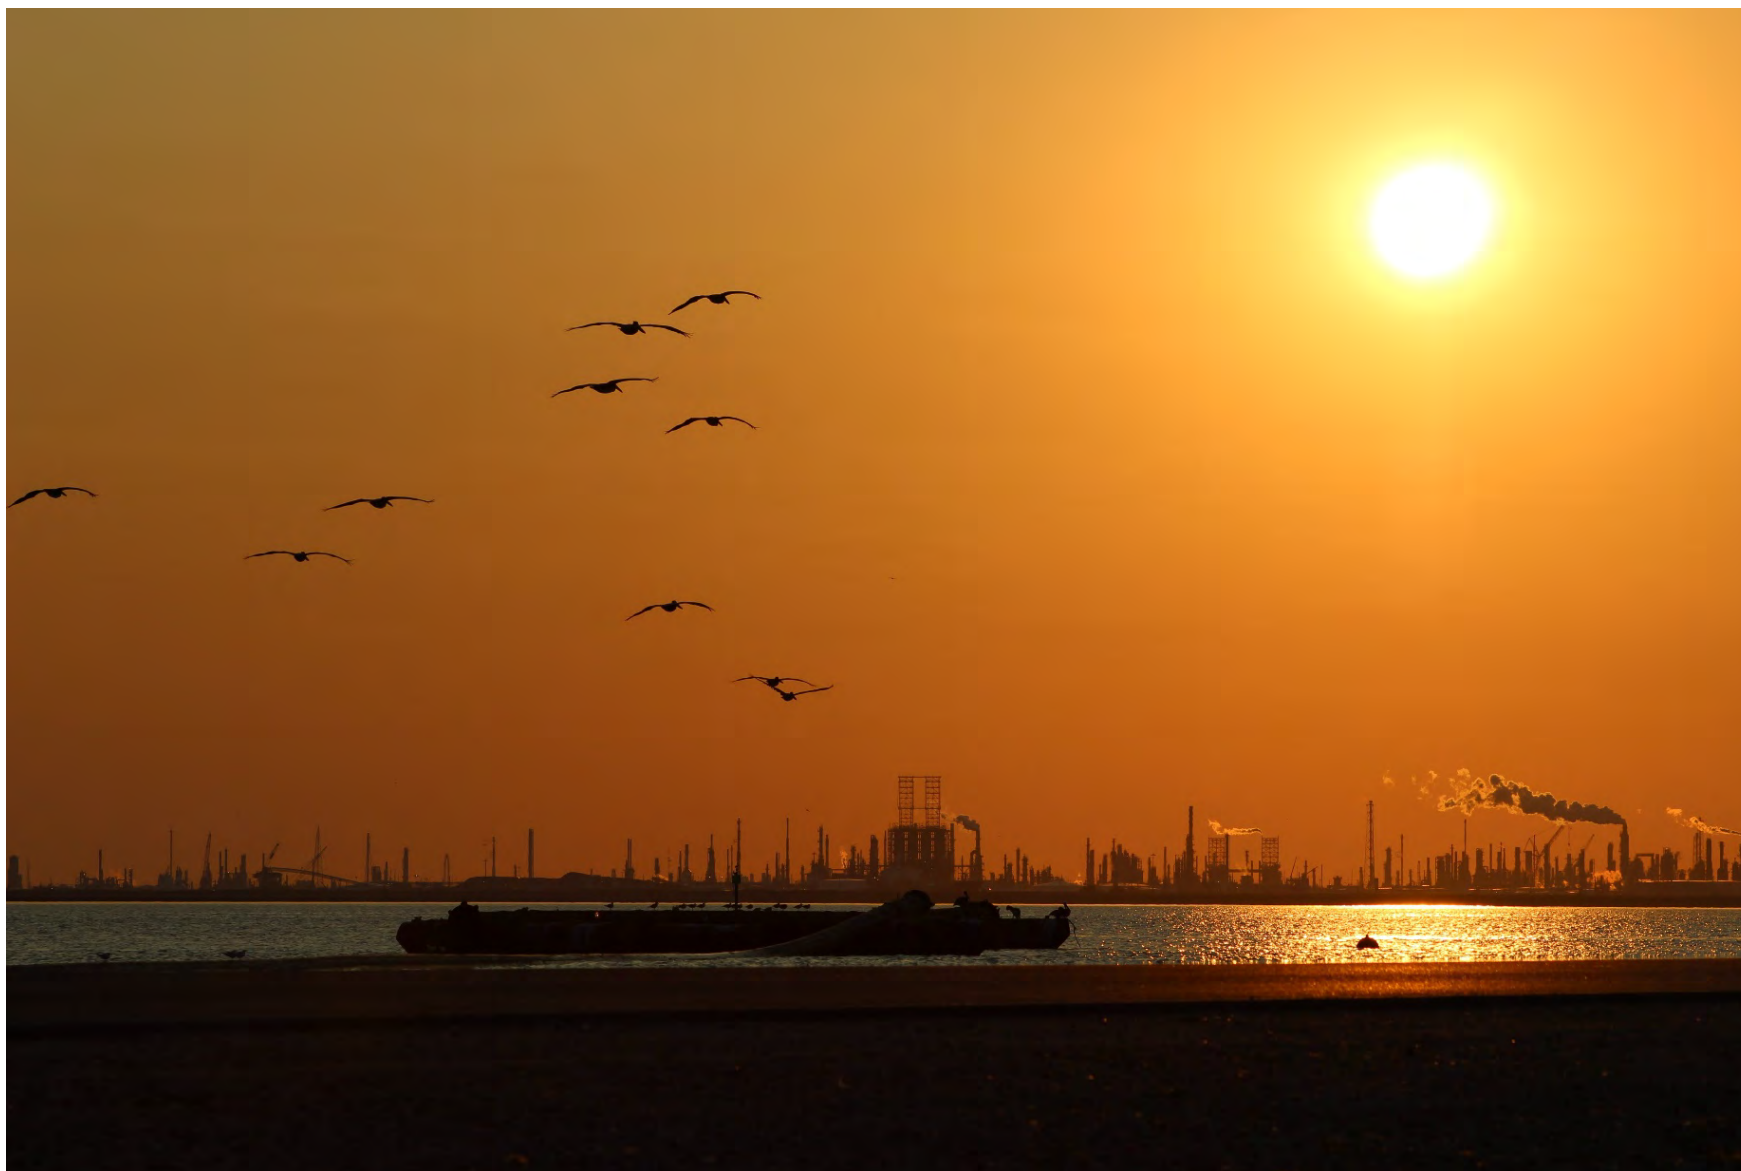
Area: 0.7 square miles **Miles of Shoreline:** 9 miles **Designated Uses:** Noncontact Recreation; High Aquatic Life

Number of Active Monitoring Stations: 1 **Texas Stream Team Monitoring Stations:** 0 **Permitted WWTF Outfalls:** 34

- Segment 2437: **Texas City Ship Channel** (classified water body) – A 1.6 square kilometer (0.6 square mile) navigation channel immediately south of the Texas City Dike on the western shore of Lower Galveston Bay in Galveston
