HOUSTON-GALVESTON AREA COUNCIL

HOW'S THE WATER?

2021

Basin Summary Report

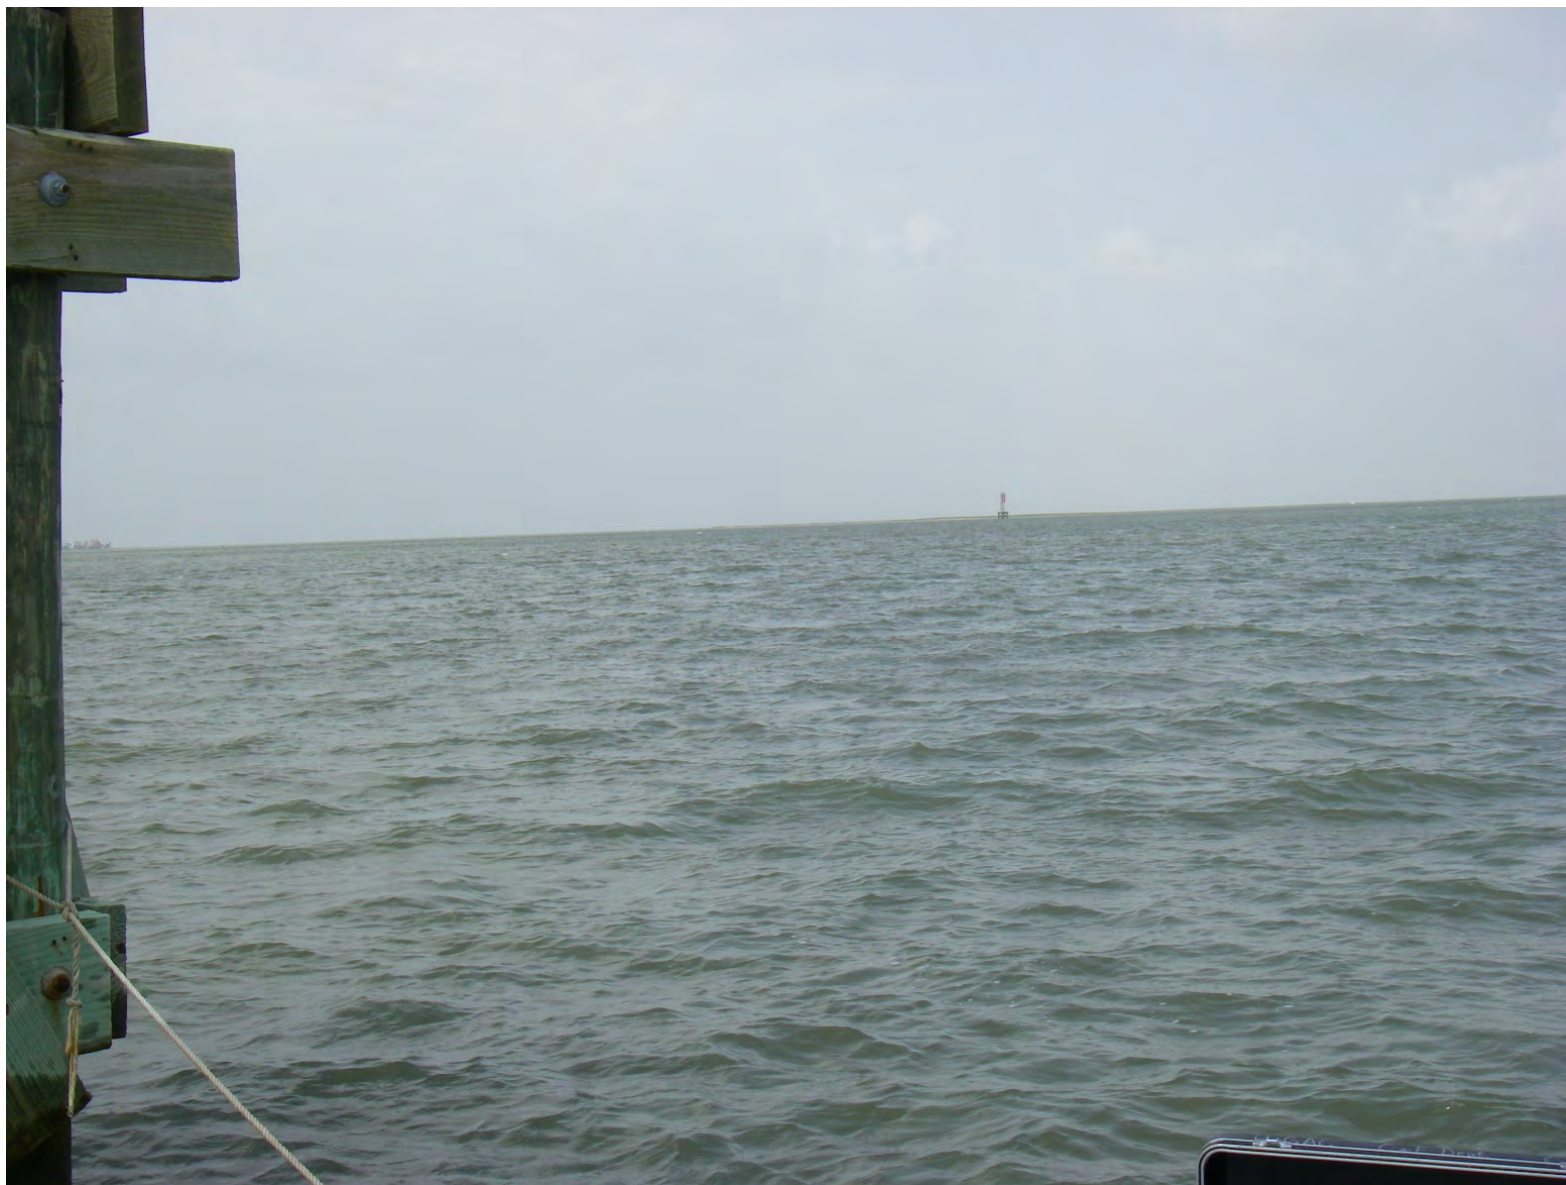
Area: 74 square miles **Miles of Shoreline:** 172 miles **Designated Uses:** Primary Contact Recreation 1; High Aquatic Life; Oyster Waters

Number of Active Monitoring Stations: 18 **Texas Stream Team Monitoring Stations:** 13 **Permitted WWTF Outfalls:** 6

- Segment 2424: **West Galveston Bay** (classified water body) – A 179.5 square kilometer (69.3 square mile) portion of the Galveston Bay system located on the landward side of Galveston Island, extending from the Galveston Causeway (IH-45) in Galveston County to the western side of San Luis Pass and the eastern shore of Mud Island in Brazoria County

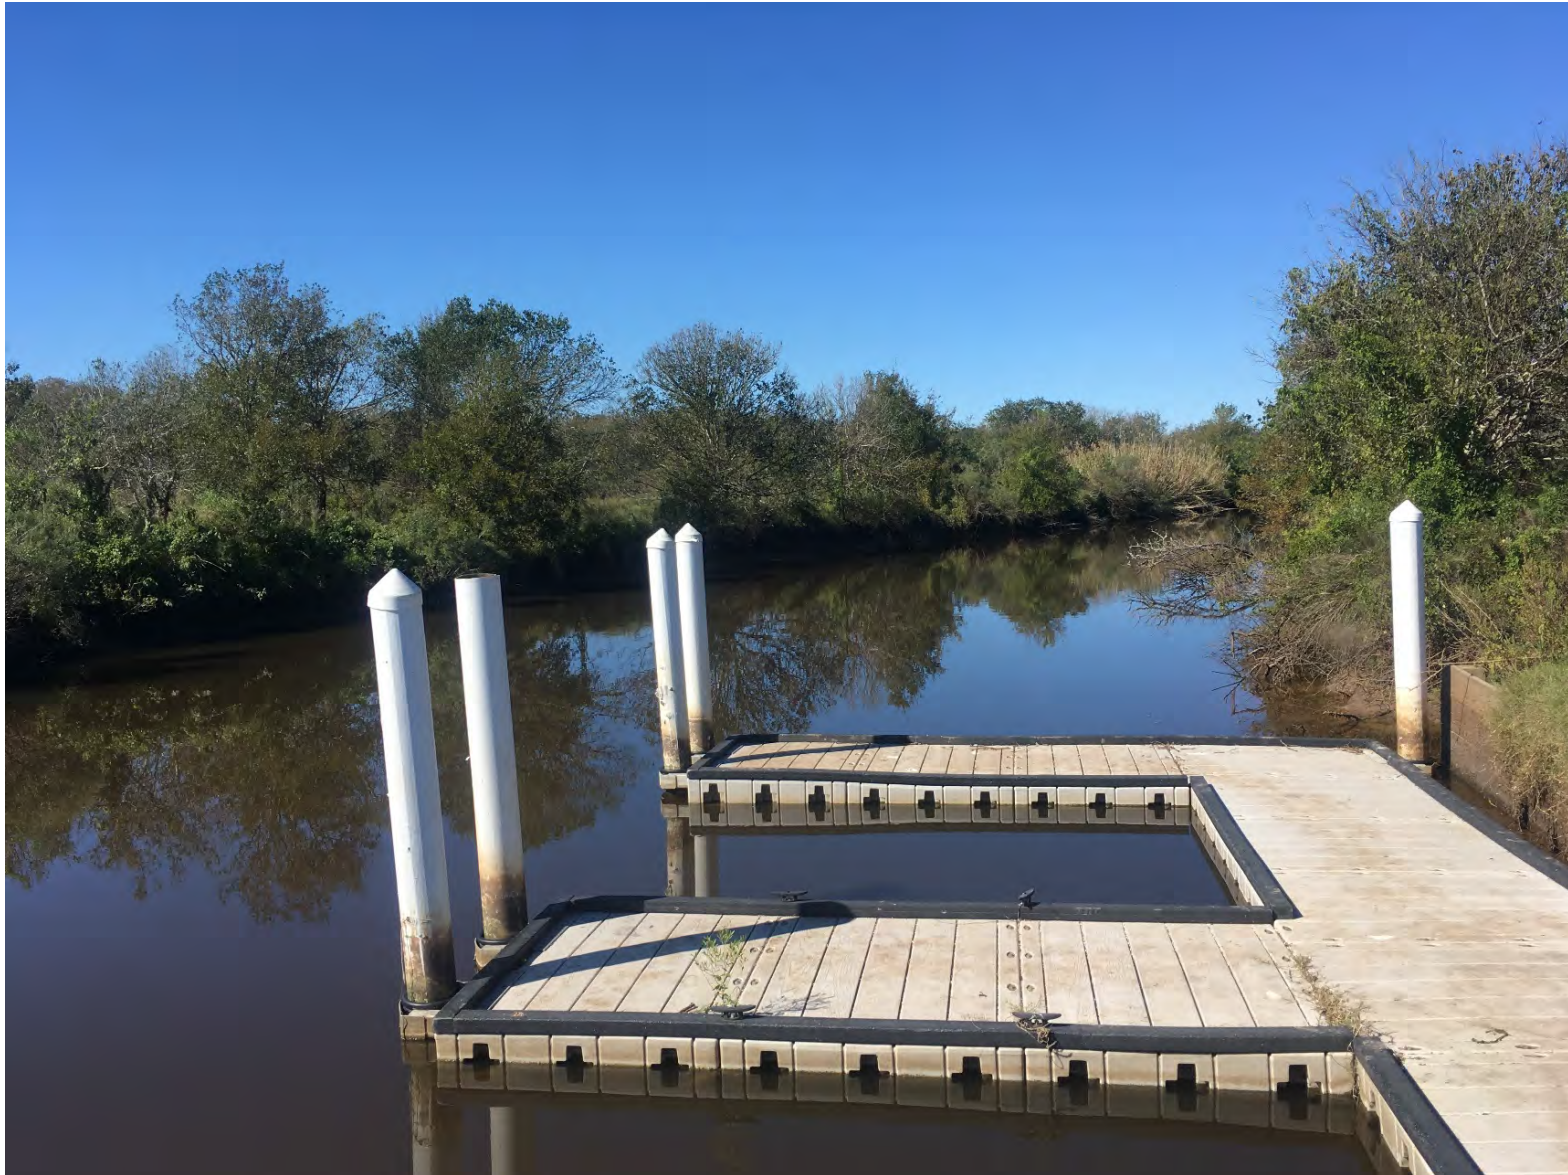
Texas Stream Team Monitoring Stations: 0

Permitted WWTF Outfalls: 7

- Segment 2442: **Cedar Lakes** is located down the coast from and southwest of the San Bernard River, the Cedar Lakes lie between the Gulf Intercoastal Waterway on the north and a barrier island and the Gulf of Mexico to the southeast.
- Segment 2442OW: Oyster Waters
