A Preliminary
Total Maximum Daily Load (TMDL)
Study on
Dickinson Bayou

Galveston County Health District
Pollution Control Division

August 31, 2001

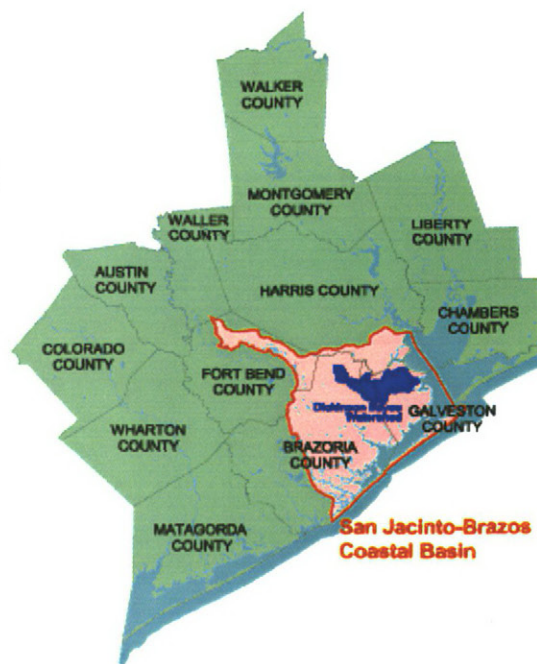
Figure 1 - Dickinson Bayou Watershed in Southeast Texas

Dickinson Bayou is located in southeast Texas in the San Jacinto-Brazos Coastal Basin (Figure 1). The

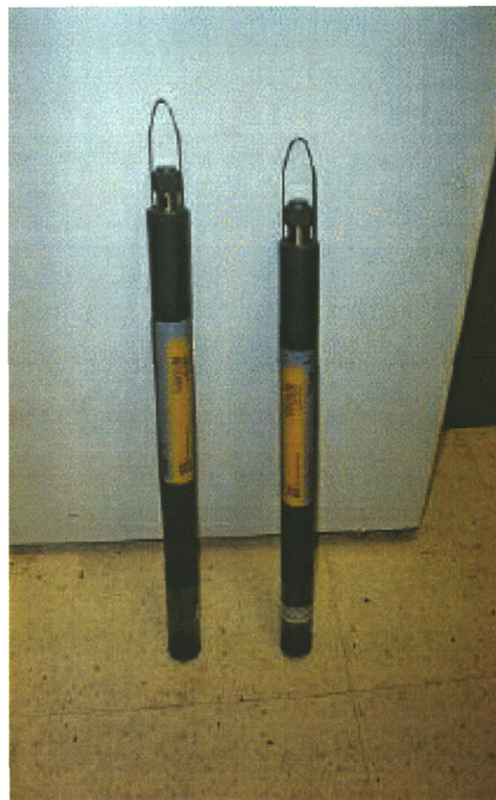
Photo 1 - YSI datasondes used in study.

The Yellow Springs Instrument (YSI) multi-parameter data logger, model YSI-600XLM was chosen for this project because of its reliability, the technical support system in place and, ultimately, because the investigation team was able to gather the most YSI sondes. Photo 1

shows two of the sondes. They are the same model but from two (2) different production years. For consistency in the study, a decision was made to use the same brand and model of equipment. A total of 12 YSI-600XLM data sondes were acquired for use in this project. Eight (8) sondes were carried to the deployment sites by way of a sonde transport bucket (Photo 2).

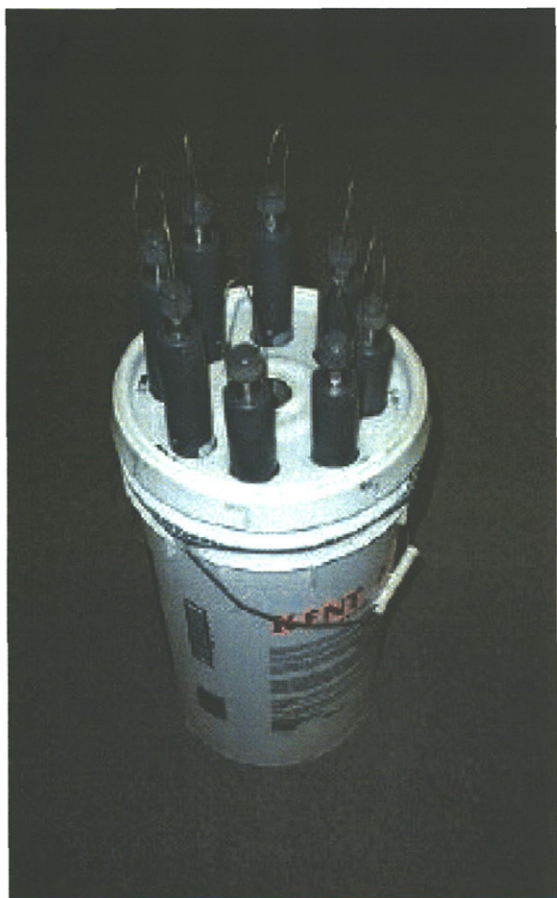
Photo 2 - Datasonde transport bucket.

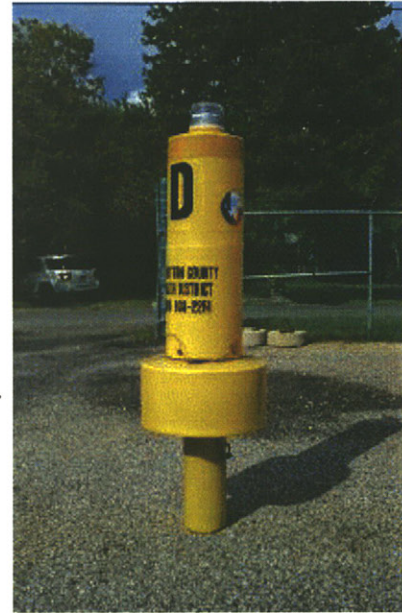
Photo 3 - Yellow research buoy.

and, in some instances, lighted. GCHD selected cylinder buoys made of yellow plastic (Photo 3). They are easy to maintain and light weight enough for one person to carry. They float high in the water and provide a good attachment point for the sondes. The buoys are anchored to a 225 pound (lb.), molded concrete weight connected via ¼ inch, galvanized chain and locking shackles (Photo 4). Lastly, a snap shackle deployment system was developed for safe placement of the buoy weights in the water (Photo 5).

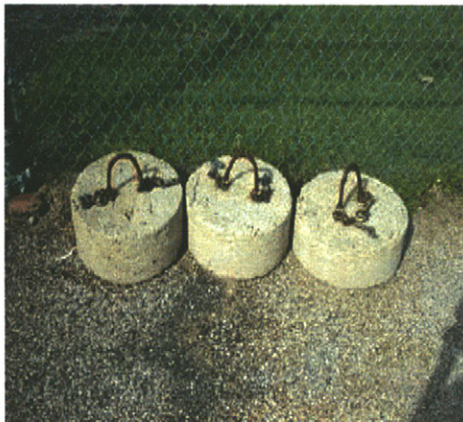
Photo 4 - Concrete weights showing chain and locking shackles.

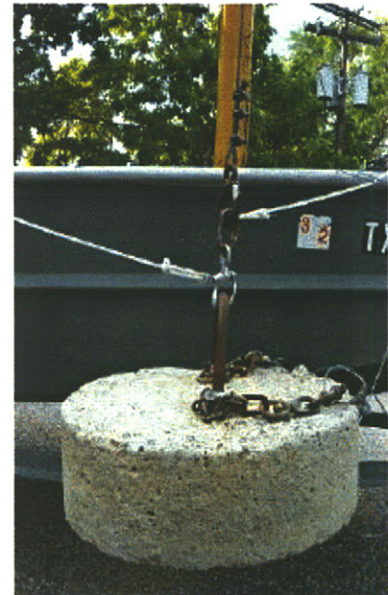
Photo 5 - Concrete weight suspended from crane by deployment assembly.

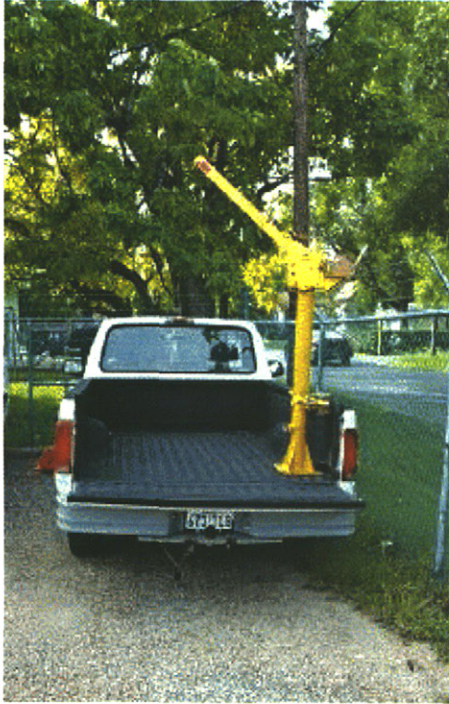
Photo 6 - Crane mounted on bed of pick-up truck.

crane was installed in both the bed of a pick-up truck and on the deck of the boat, then an interchangeable, 500 pound capacity crane was purchased (Photos 6 & 7). To protect the truck and boat surfaces, sprayed-in protective coatings were applied.

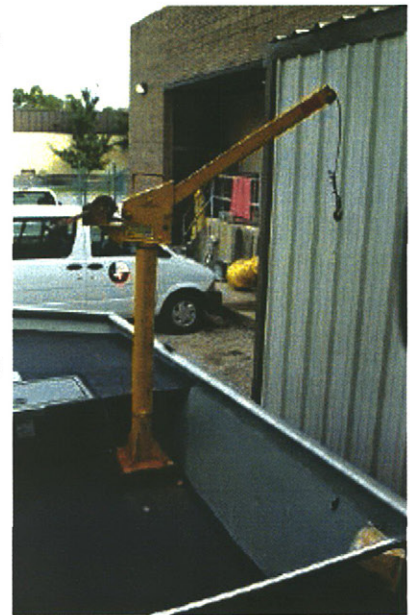
Photo 7 - Crane mounted on deck of boat.

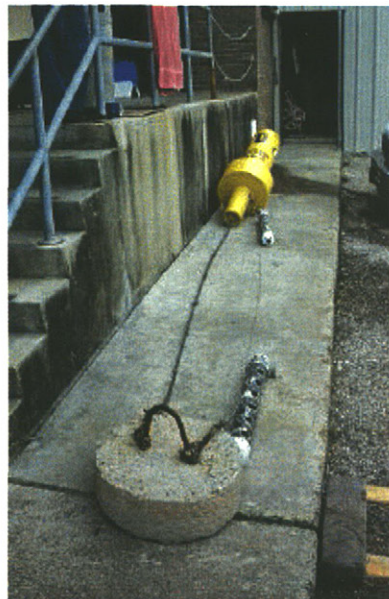
Photo 8 - Buoy and weight assembly with attached sondes.

The system also had to allow the sondes to be safely and efficiently connected and disconnected from the buoys and weights while they were in the water. Initially, GCHD found that trying to deploy a weight, buoy, and sondes at the same time was too difficult. A galvanized wire cable system, connected to both the weight and the buoy, but independent of the anchor chain, was made for each site (Photo 8). The sondes could now be raised or

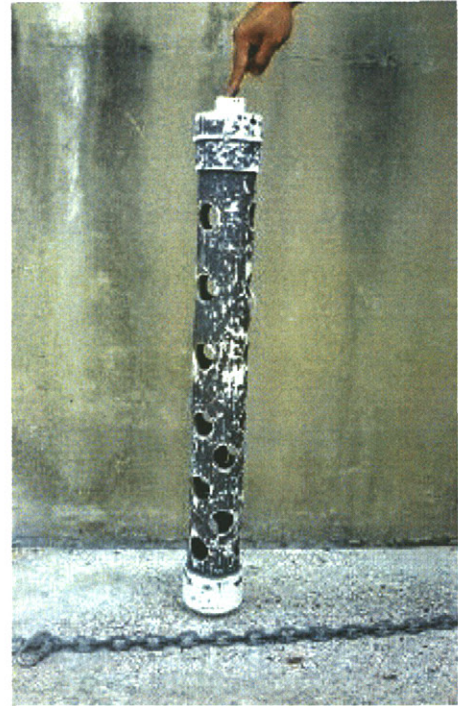
Photo 9 - Protective PVC cover for sonde deployment.

Dickinson Bayou is a popular recreation area which means lots of traffic from water crafts. Protective covers were designed and constructed for each sonde to minimize the chance of loss, tampering, theft, and/or damage. YSI representatives confirmed that our design of using three inch (3"), Schedule 80 PVC pipe with numerous 1" holes bored into the lower half of the tubes would allow for adequate water circulation around the sonde probes. Additionally, the anti-fouling paint which was used on the covers to minimize the amount of aquatic growth on the units would not interfere with the probe operations (Photo 9) .

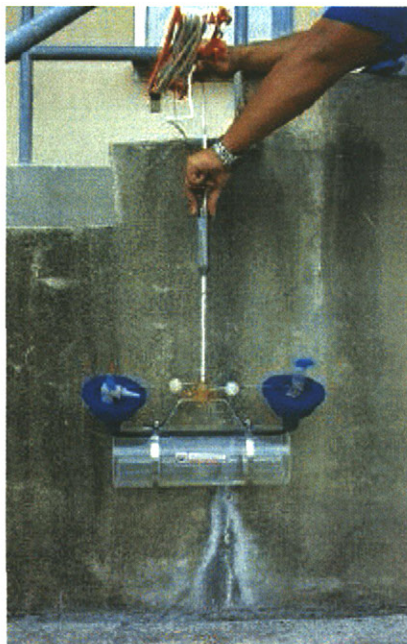
Photo 10 - Van Dorn bottle used to collect stratified water samples.

Vertical field data profiles were first collected at every site in one foot (1') increments from top to bottom using a Hydrolab 4a MiniSonde multi-probe hand held meter. All information was recorded and taken back to the office for data entry. Appendix 15 contains examples of the profile data field sheet, SOP for operating the Hydrolab. Water samples from various depths were collected using 2 liter, clear acrylic Van Dorn bottles (Photo 10). The sampler was lowered over the side of the boat to the appropriate depth, then discrete samples of water were collected. More than two (2) gallons of water were needed to perform the number of analytical tests required, so a 5 gallon mixing bucket was used to composite every sample. See Appendix 16 for a list of containers and preservation methods.

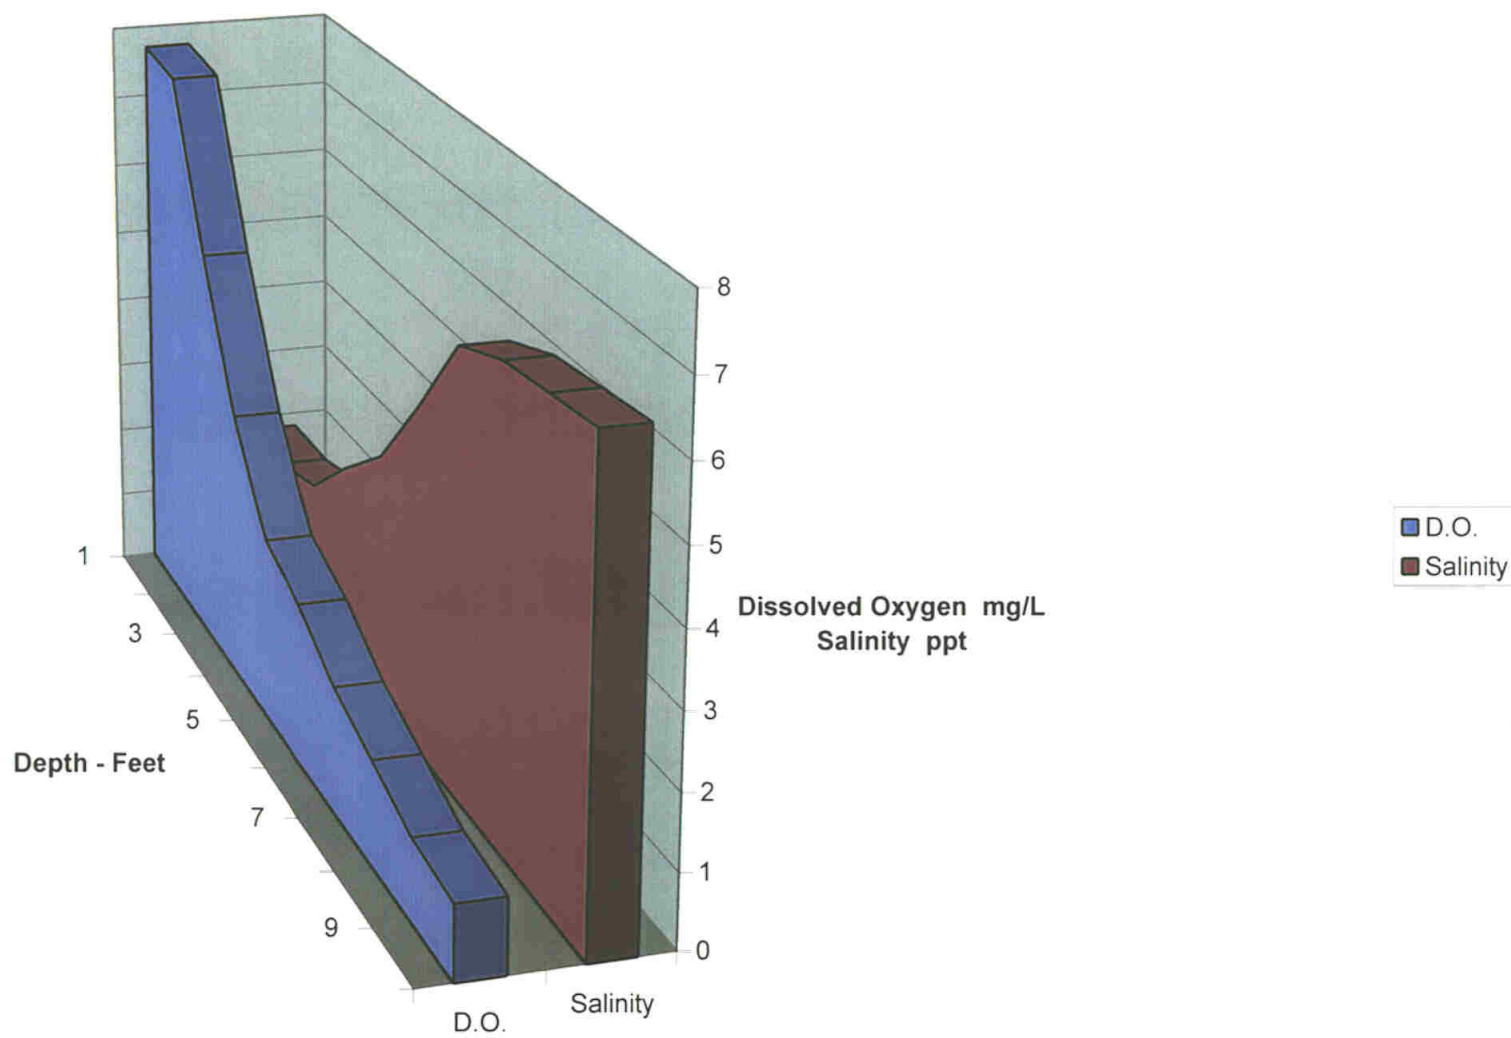
Figure 6 - DB5 Gum Bayou 12 July 2001

change from fresh/brackish water to saline waters in less than a one foot (1') increment. DO levels also declined drastically at and below this halocline boundary while the DO levels remain higher above. This phenomenon is illustrated by the stratified profiling at site DB5 and continuing upstream to DB1. Figure 6 illustrates a comparison between DO levels and salinity at site DB5.

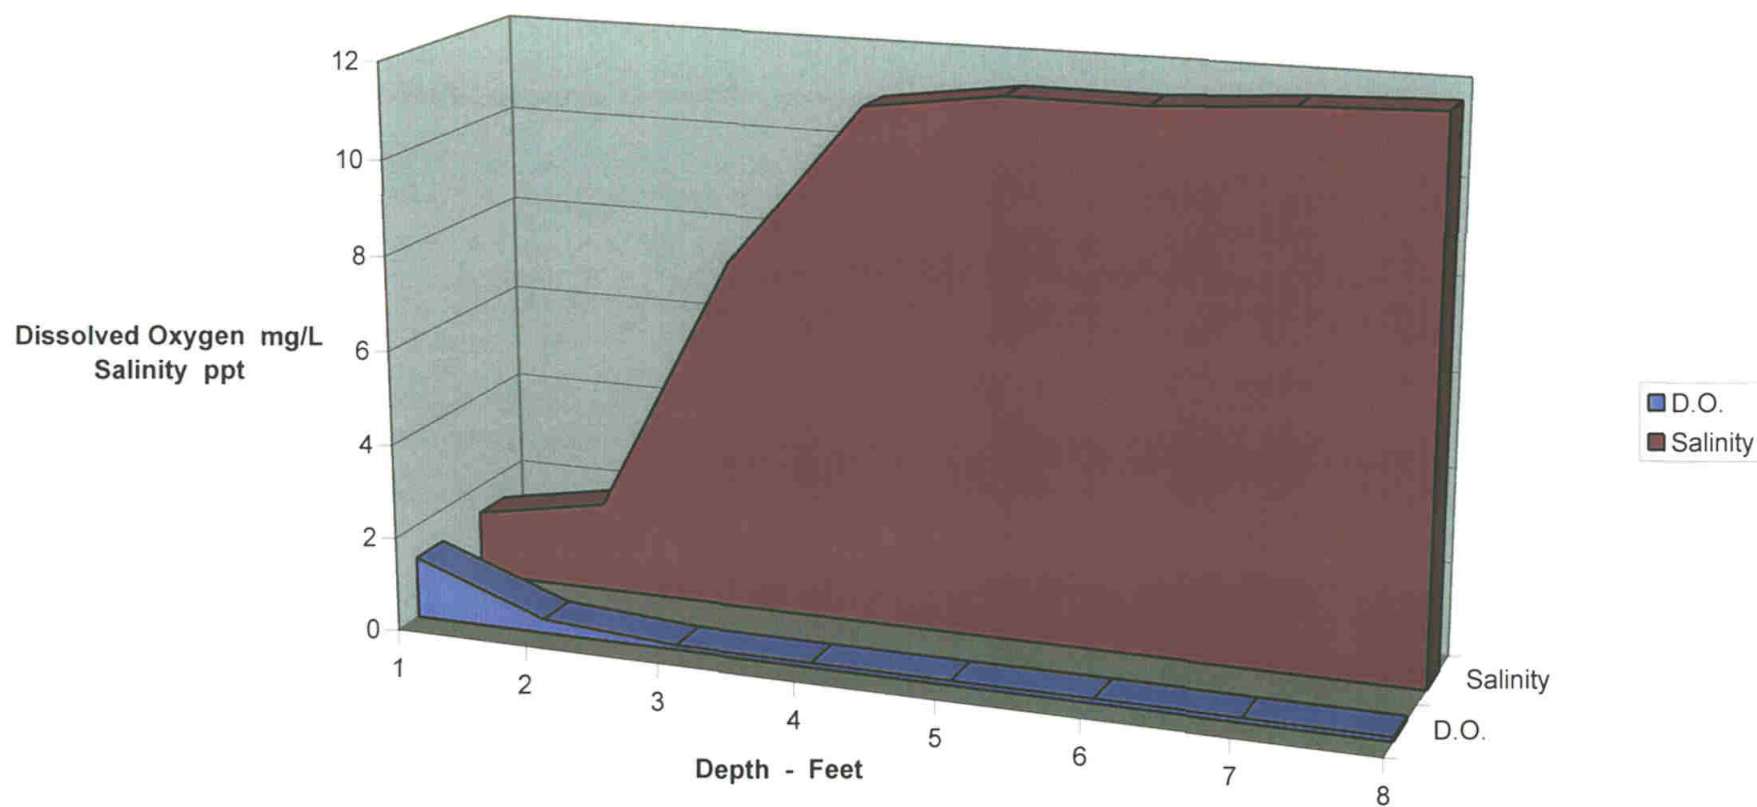
Figure 7 - DB1 Cemetery Road Bridge 12 September 2000

An example of dry weather, saltwater encroachment can be seen in Figure 7. The saltwater wedge was easily tracked upstream from DB5 to DB1 exhibiting an excellent example of the DO/halocline boundary. Figures 8 - 10 illustrate three (3) wet weather event examples when the saltwater wedge was present at DB5, but had disappeared at the next upstream site. Appendix 22 contains additional graphs illustrating several examples.

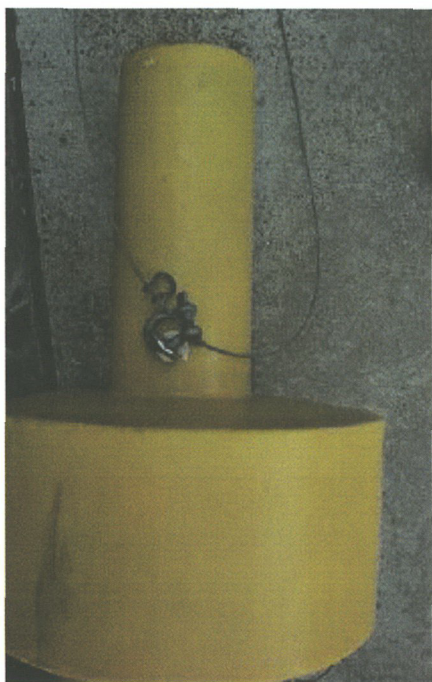
Photo 11 - D-rings shackled directly to the "eye" of the buoy.

The buoys are deployed using galvanized chain and 225 lb. weights. The sondes are deployed by locking them in protective covers and securing both to an independent cabling system which operates similar to a flag pole. Originally, the cable was shackled directly to the “eye” of the buoy and anchor weight, but the D-rings which secure the sondes would not slide through the shackle. The size and shape of the shackle created an obstacle for the cable D-rings, preventing

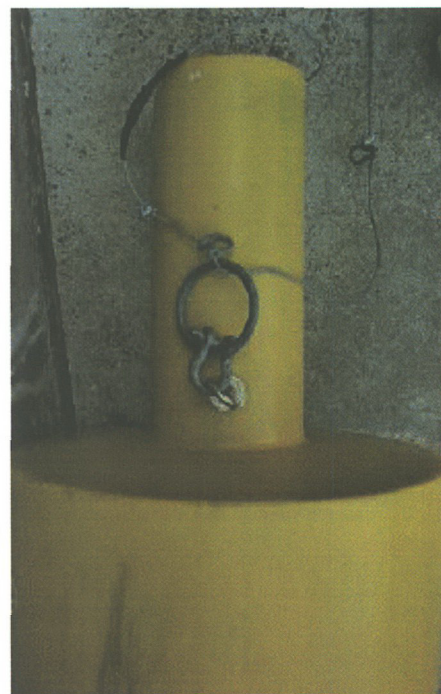
Photo 12 - Four inch (4") galvanized ring attached to "eye" of buoy.

the sondes from being raised or lowered. Investigators shackled four-inch (4") diameter galvanized rings to both the top and bottom "eyes," then ran the cable through the rings attaining a smooth operating cable system. The cable D-rings no longer snag on the smaller opening of the shackles (Photos

Lesson Learned #3: Shackle a four-inch (4") galvanized steel ring to the "eye" of the buoy and anchor weight to allow the cable and d-rings to pass through unrestricted.
