Clean Rivers Program

2013 Houston-Galveston Area Council Basin Highlights Report

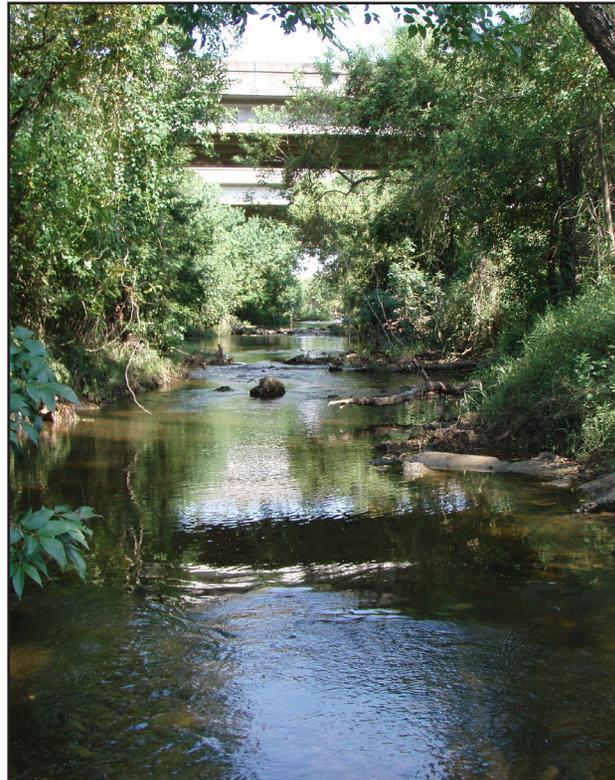
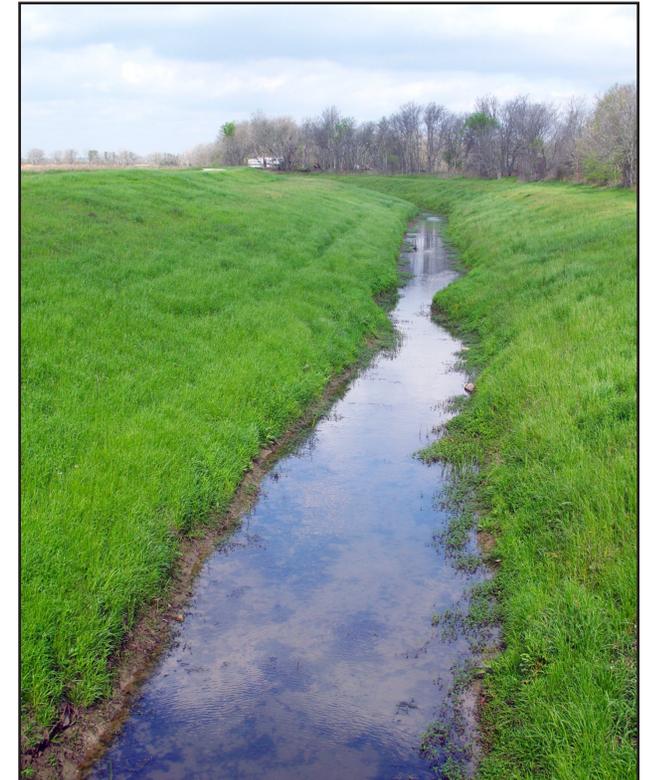
SEGMENT 0902 CEDAR BAYOU ABOVE TIDAL LAND USE

Industrial/Commercial: small manufacturing facilities, pipe yards, assembling yards, railroad trestle yards. WWTFs are included in the category. Refer to the land cover map for the actual location of the WWTFs.

Oil & Gas: natural gas well pads, gathering facilities, obvious footprints of units associated with the oil and gas industry.

The majority of this watershed is used for agricultural purposes with sod/ grass farms being the dominant crop today. Row crops, rice and hay production occur to a lesser extent. While there are no concentrated animal operations in the watershed, cattle are common throughout, especially where fields have been allowed to go fallow. See Figure - 6 on page 13 for more details.

In the upper half of the watershed, the waterway has been modified or channelized. Beginning 0.4 miles upstream of FM 1960, mowed grass banks are the only vegetated buffer between the water and the agricultural fields. Conversely, the downstream half of the waterway has wide riparian buffers composed of forests and woody wetlands on both sides of the stream. See Figure - 6 on page 13.

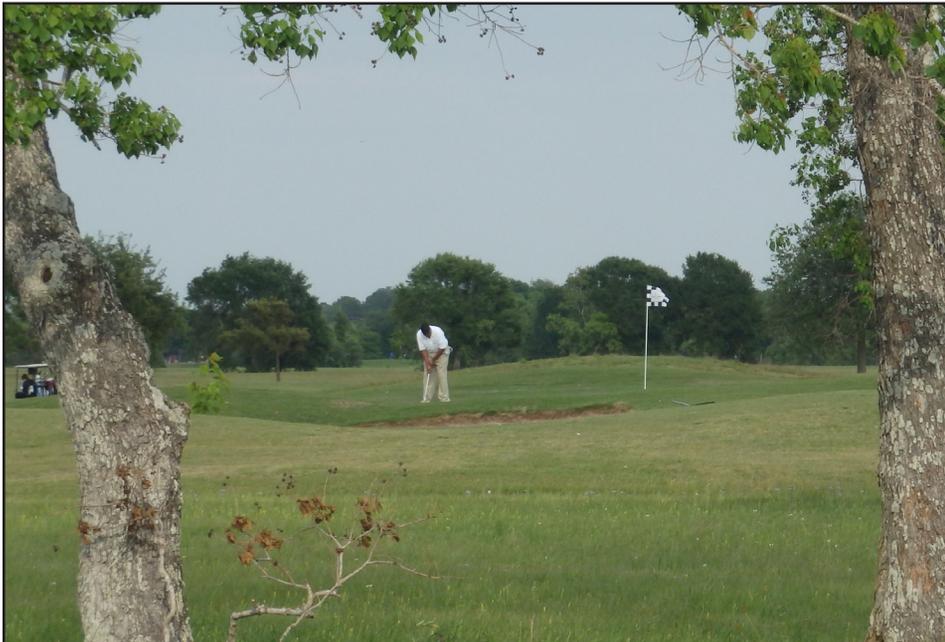
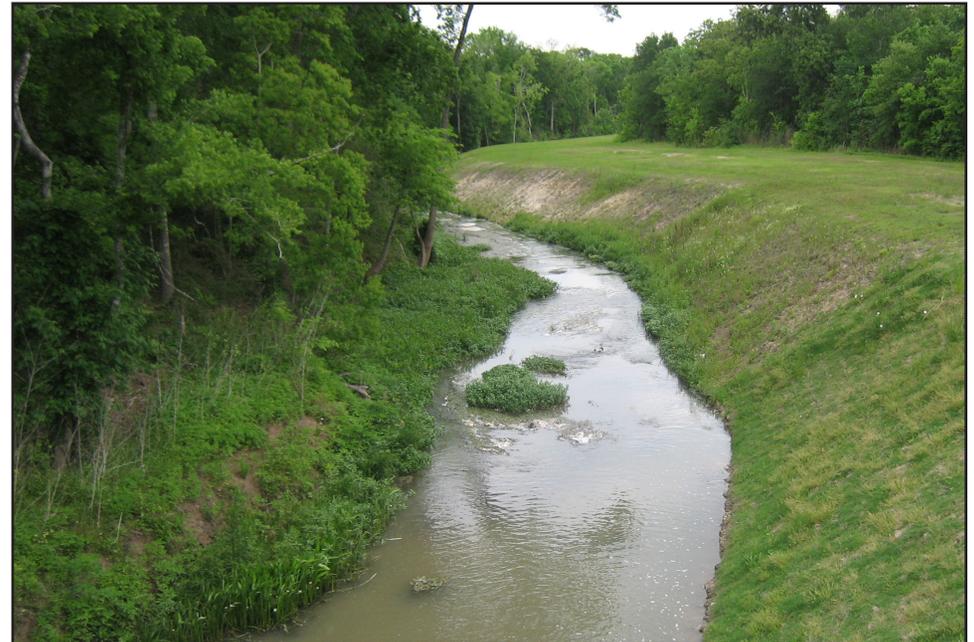
SEGMENT 1102 CLEAR CREEK ABOVE TIDAL LAND USE

There are six monitoring stations located throughout the segment. Samples are collected on a quarterly basis by TCEQ at two stations and at four stations by H-GAC’s CRP partner, EIH. Three of the stations are on the main water body while three are on the downstream end of three major tributaries – Cowart Creek, Mary’s Creek and Hickory Slough. See Figure - 60 on page 73 for a full description of all monitoring stations. See Figure - 61 on page 74 for the locations of the stations.

Past urban development has been concentrated along FM 518, but more recent developments have occurred along the major north-south corridors in the watershed. While there are still large tracts of agricultural lands in the far west, south central and north center areas, subdivisions and commercial properties are being built at an accelerated pace. The Texas Highway 288 corridor near FM 518 has been one of the fastest growing areas in the greater Houston region. In the far eastern area of the watershed there is a large tract of land that is still relatively natural. Wildlife and cattle are the primary uses of the land. See Figure - 61 on page 74 for greater detail.
