# Final Report for the West Lake Houston Basin Implementation Project (West Fork San Jacinto River, Lake Creek, Cypress Creek, and Spring Creek Watersheds)

September 2025

**This document was prepared by the Houston-Galveston Area Council for the stakeholders of the West Lake Houston Basin. It was prepared in cooperation with the Texas Commission on Environmental Quality and the United States Environmental Protection Agency.**

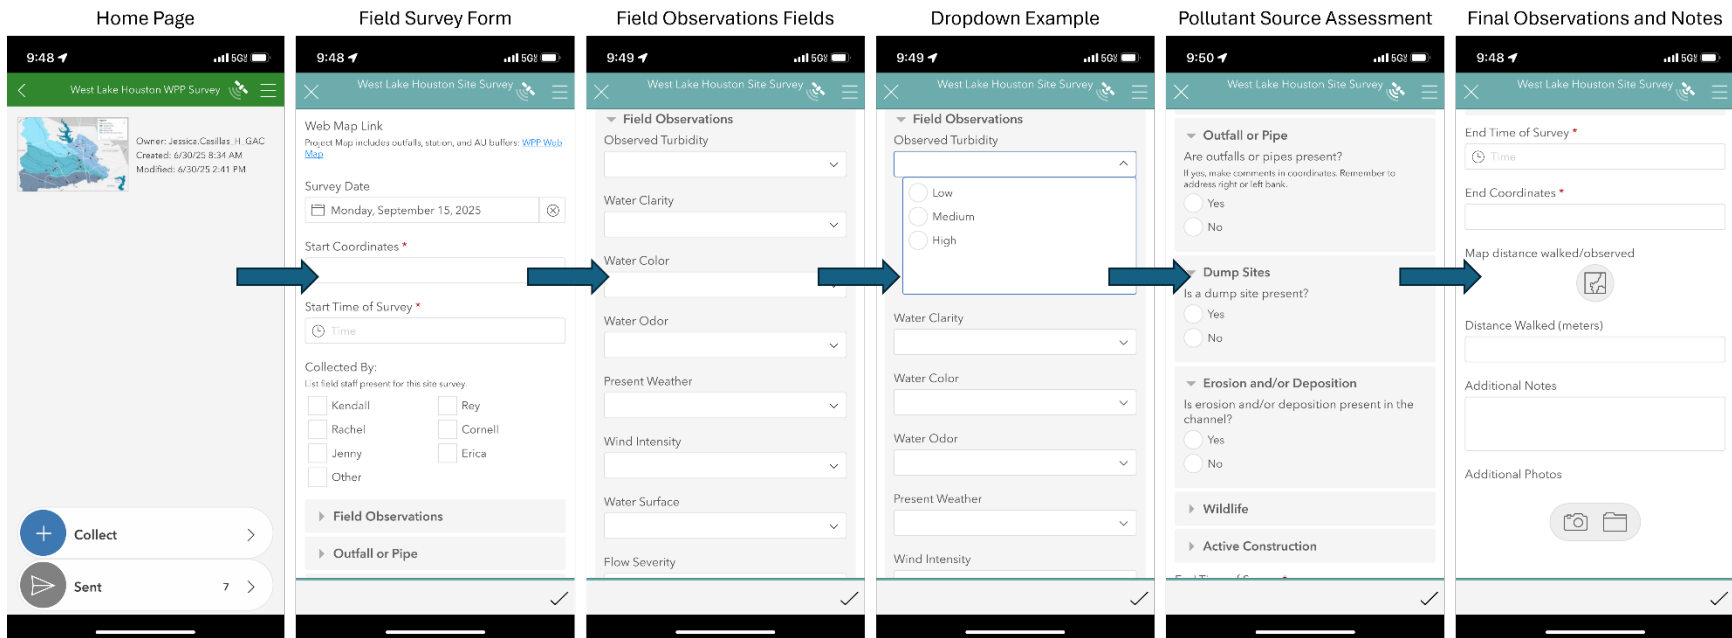
Figure 7. ArcGIS Survey 123 Field Survey Form Example

Next, H-GAC developed a form-centric application in ArcGIS Survey 123 to record and geolocate observations. The application is hosted on mobile phones and tablets which offered an easily portable solution for recording data in the field. This form was programed to have required fields, meaning that data such as the date, time, staff, and necessary observations had to be completed before the field collector could save the data and progress to the next site. For qualitative observations, drop down choices limited responses to those listed in the TCEQ *Surface Water Quality Monitoring Procedures, Volume 1: Physical and Chemical Monitoring Methods, 2012*<sup>3</sup>. The application also offered mapping functions and the ability to attach and view photos, videos, and audio files. An example of the form layout and records flow is shown in Figure 7.

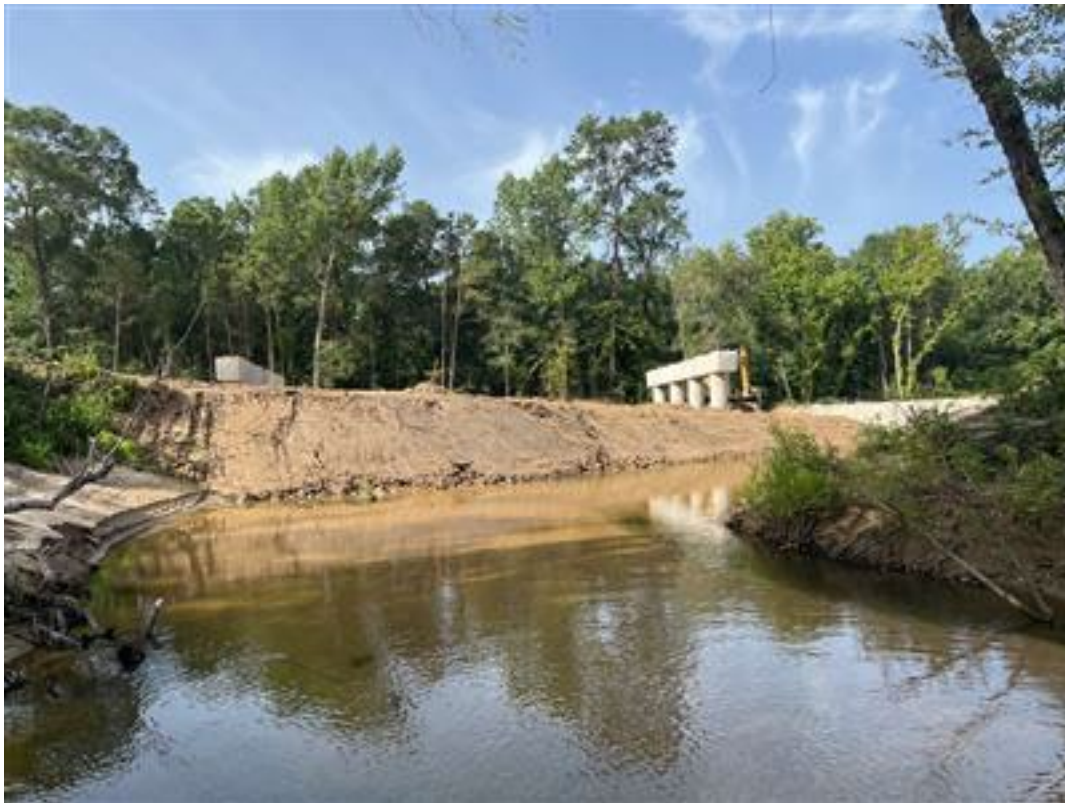
Segments in the West Fork San Jacinto watershed were characterized by their sandy, eroded banks. Wildlife tracks were observed at all sites though the only active wildlife observed were birds nesting under overpasses located near the sites. Specific to site 20731 on White Oak Creek (1004J), signs of human recreation were observed around the banks. This site was located in a quiet, residential area. Though no dump sites were observed, general trash accumulation was widespread throughout the watershed. The unifying observation for all sites in this watershed was the presence of construction and growing development of residential areas and roadway expansion (**Figure 8**).

*Figure 8. Roadway Construction on Stewarts Creek*

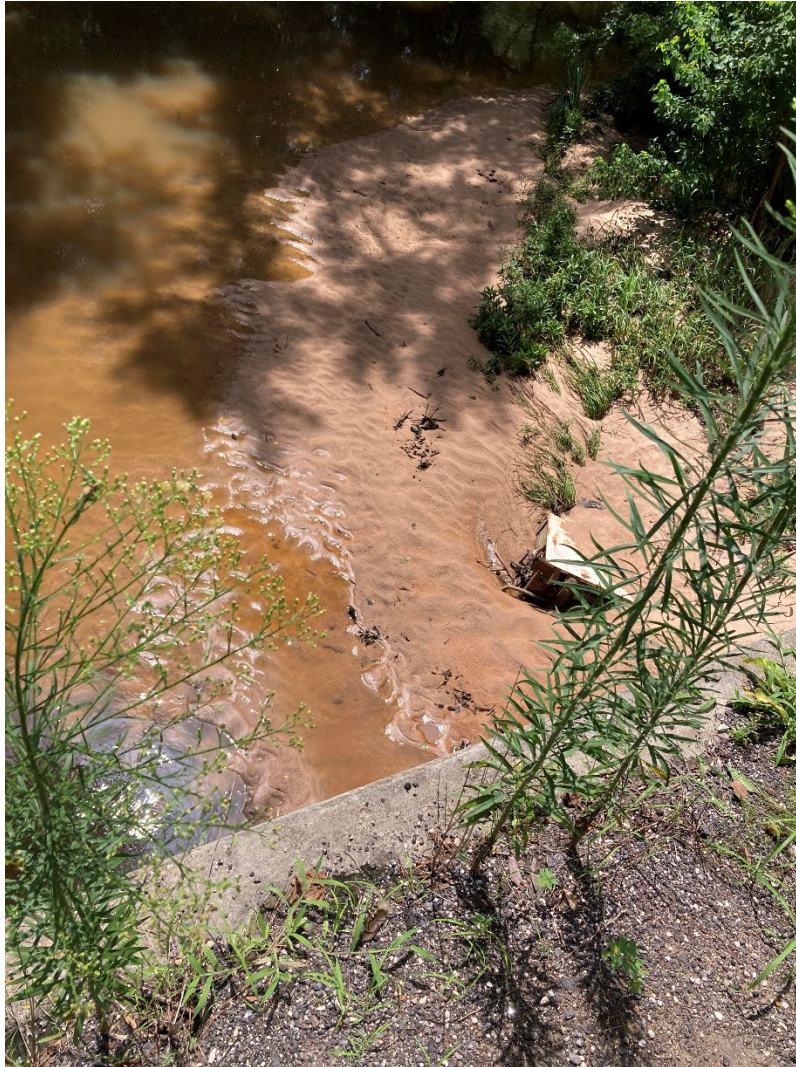
Like the West Fork San Jacinto River segments, segments in the Spring Creek watershed were largely sandy and eroded leading to frequent observations of sediment deposition which impeded flow. Some of this sedimentation may be naturally occurring, but much of it is likely the result of construction efforts in the watershed. Despite this, signs of wildlife were observed throughout the watershed. Evidence of regular dumping was recorded at site 11323 on Spring Creek (1008) (**Figure 9**). Invasive species such as elephant ear and apple snails were also noted at points throughout the watershed (**Figure 10**).

*Figure 9. Dump Site on Spring Creek (1008)*

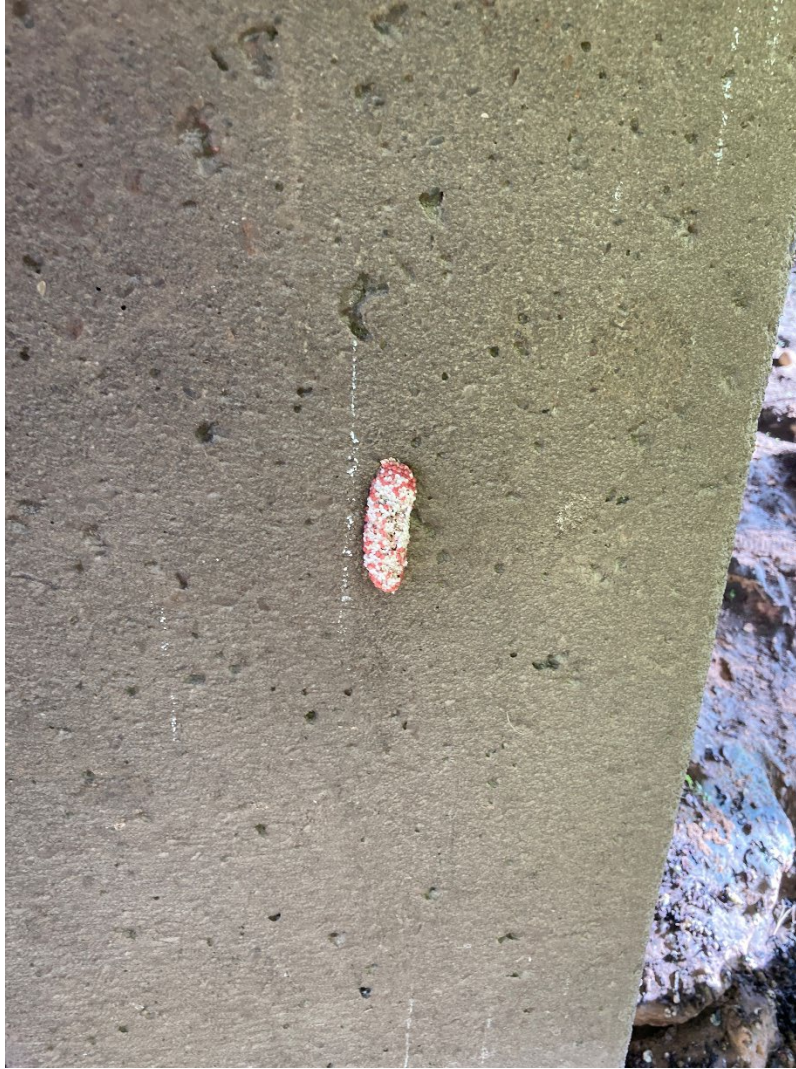
*Figure 10. Apple Snail Eggs at Bear Branch (1008E)*

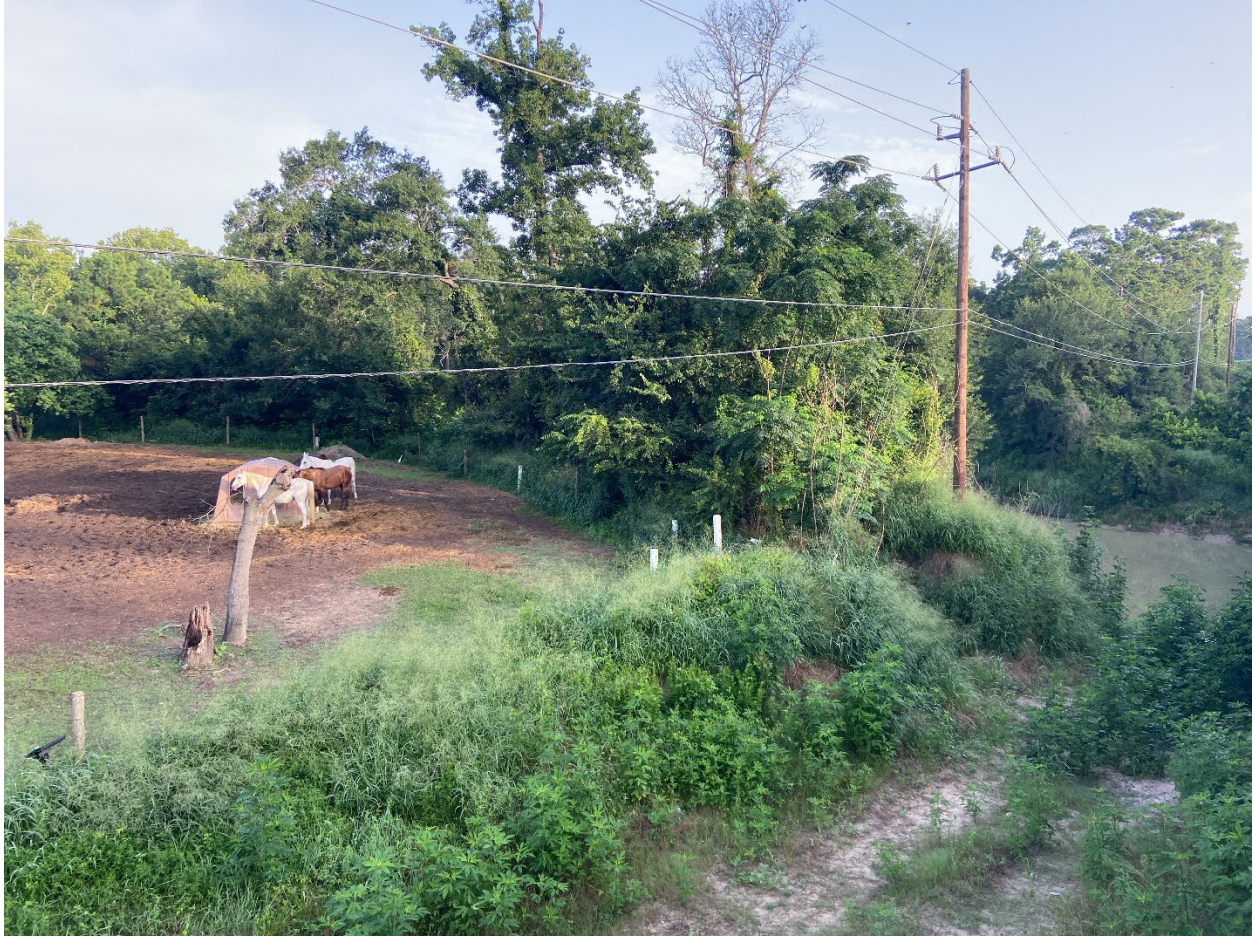
*Figure 11. Horses on Cypress Creek (1009)*

Similar to segments in the Spring Creek watershed, segments in the Cypress Creek watershed were characterized by sandy banks and frequent observations of sedimentation and deposition. Multiple notes were made about debris, and the riparian forest at site 11324 on Cypress Creek (1009) appeared to have been trimmed back or cleared in some areas. Another observation recorded at site 11324 included the presence of horses near the waterway and evidence of a trail riding business (**Figure 11**). One other notable observation was recorded at site 17496 on Faulkey Gully regarding a manhole cover with a broken cap ring (**Figure 12**).

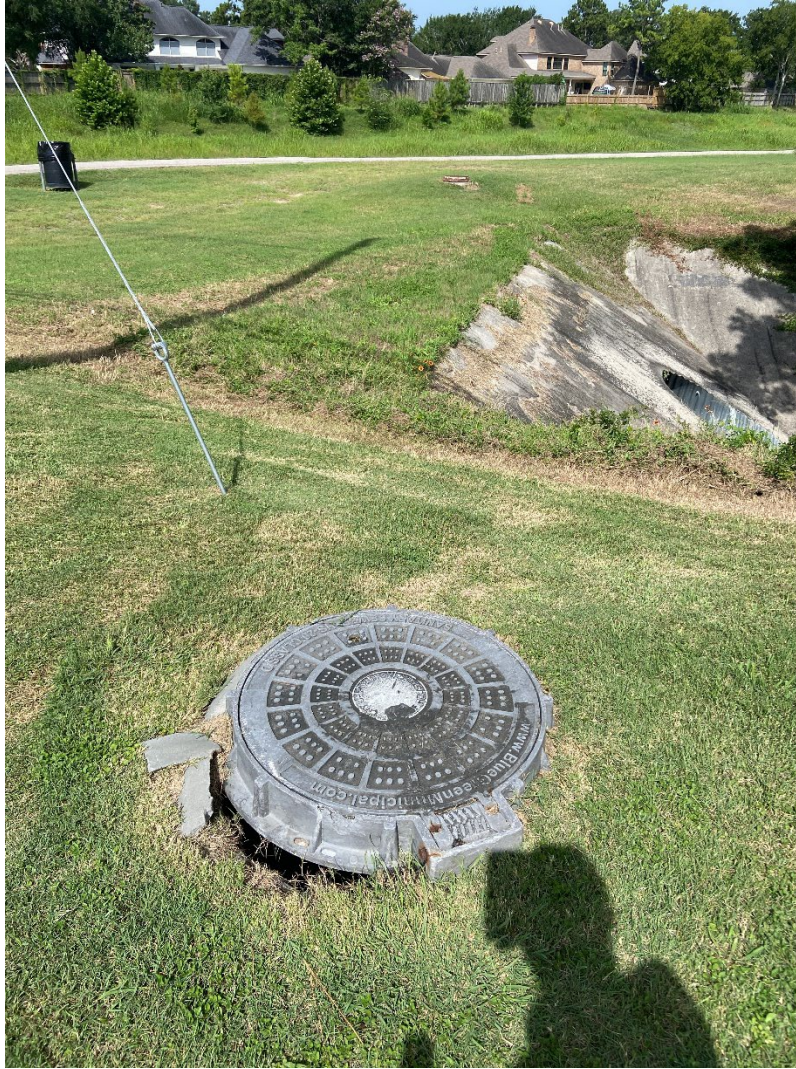
*Figure 12. Broken Manhole Cover at Faulkey Gully (1009C)*

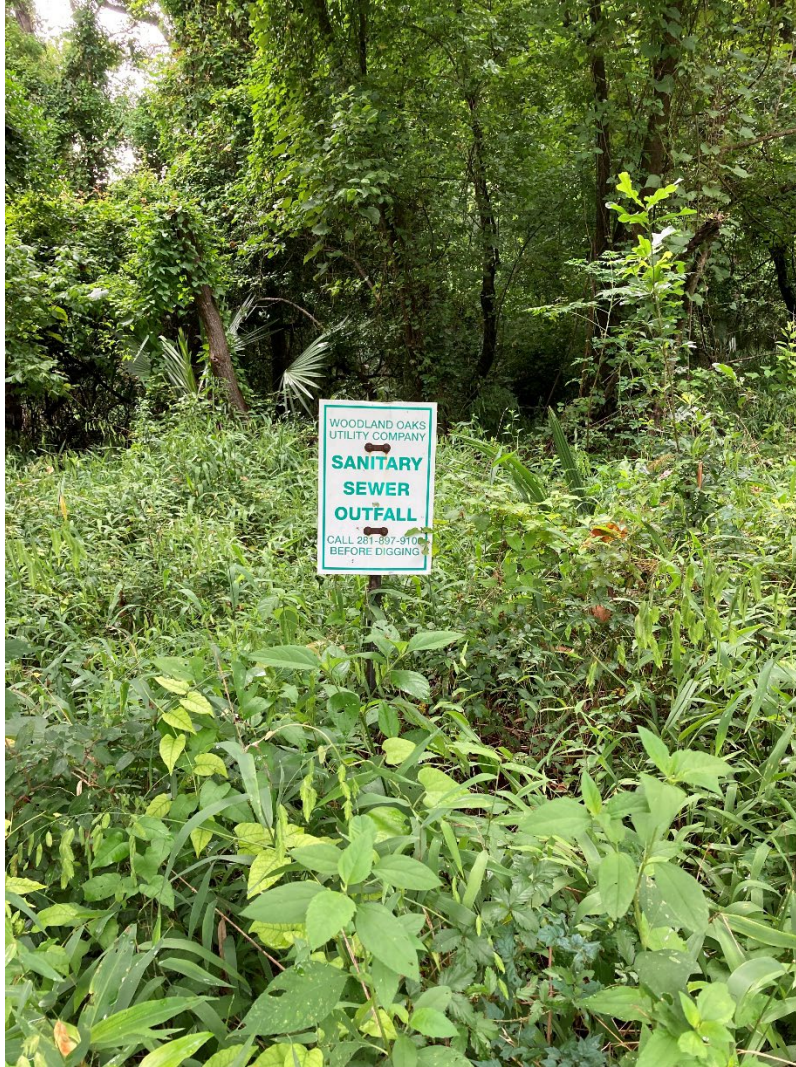
Segments in the Lake Creek watershed are among the least developed areas relative to other watersheds in the West Lake Houston Basin. However, as seen in other watersheds, development is on the rise on Lake Creek segments as well. Wildlife or their tracks were observed at both sites. Residents near site 11367 shared anecdotes of an alligator that has been observed in Lake Creek (1015) near their neighborhood, but it was not sighted by H-GAC staff during the survey. The most likely source pressures in this watershed included development and potentially effluent from the RV park located at the Lake Creek site (**Figure 13**).

*Figure 13. Outfall Signage at Site 11367 on Lake Creek (1015)*
