BACTERIA IMPLEMENTATION GROUP'S TOP FIVE MOST AND TOP FIVE LEAST IMPAIRED WATER BODIES

Final Report
May 31, 2017

Prepared by the Houston-Galveston Area Council in cooperation with the Texas Commission on Environmental Quality's Galveston Bay Estuary Program and U.S. Environmental Protection Agency.

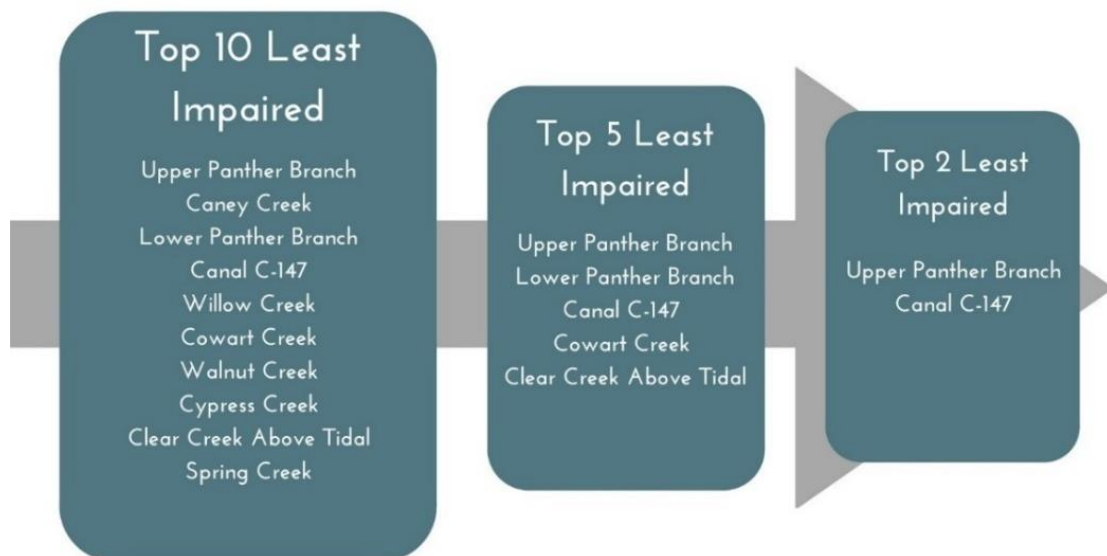
Figure 4. Prioritization of the least bacteria-impaired stream segments by the Technical Workgroup

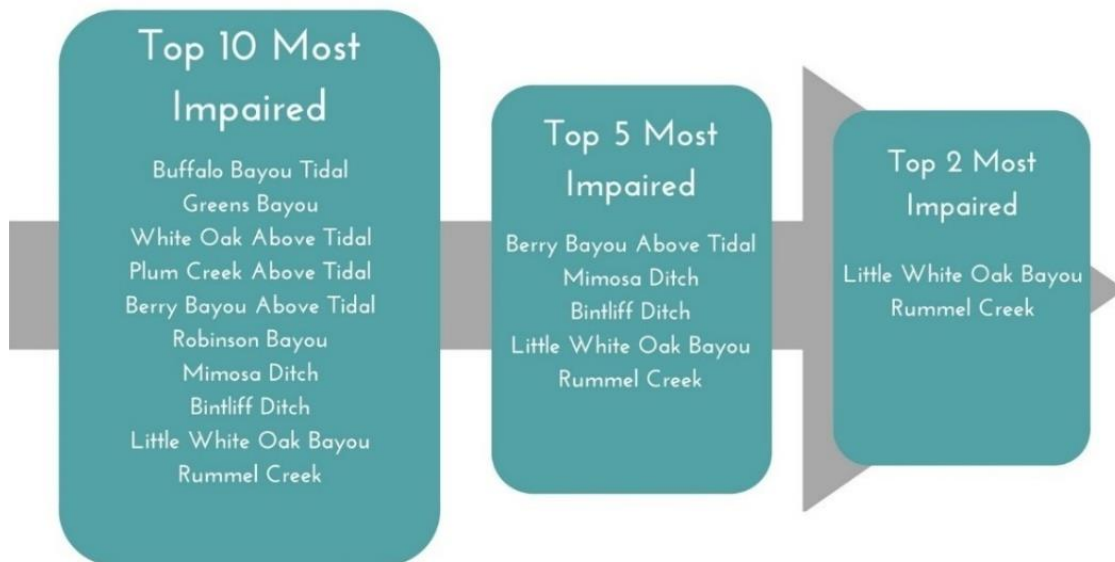
Figure 5. Prioritization of the most bacteria-impaired stream segments by the Technical Workgroup

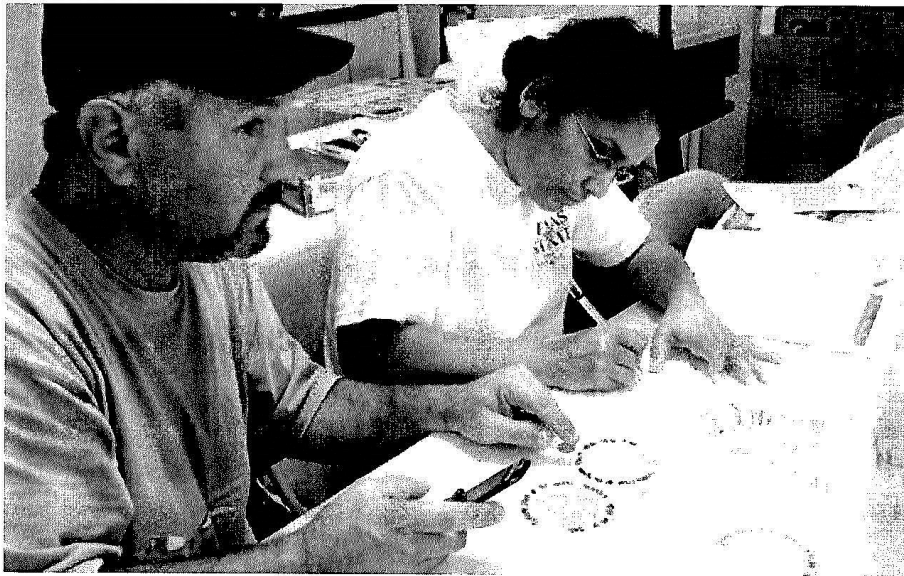
The Coliscan Easygel test can detect as little as one bacterial colony per sample, and can be used to identify up to 200 colonies per sample. Concentrations exceeding 200 colonies per

sample are recorded as too numerous to count (TNTC). A black and a white grid, which is the same size as the petri dishes, is provided to assist monitors in counting *E. coli* colonies.

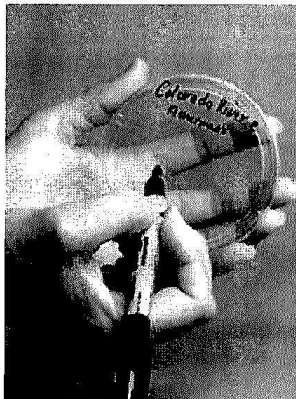
Figure A

- **Figure A** depicts a monitor holding a Whirlpak bag.
- **Figure B** portrays a monitor labeling a petri dish with the appropriate monitoring information .
- **Figure C** shows a monitor using a 5 mL pipette to remove a sample from the Whirlpak bag.
- **Figure D** shows the monitor placing the stream sample into the Coliscan Easygel bottle media.
- **Figure E** shows a monitor pouring the media, which includes the stream sample, onto the petri dish.

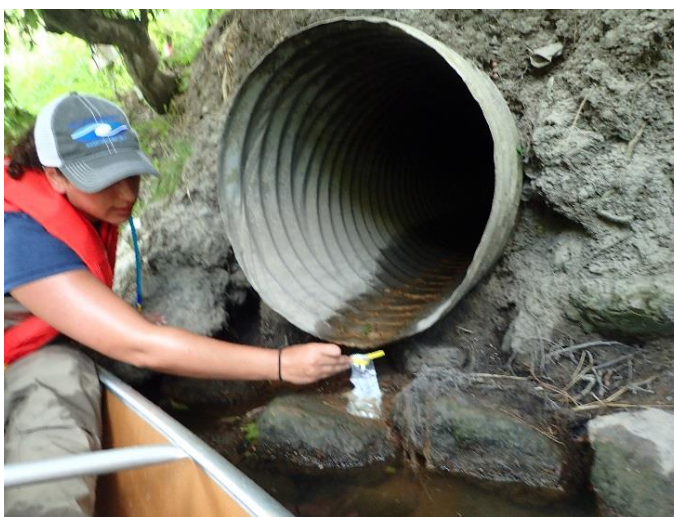
Figure 7. Collecting sample from discharging outfall

A total of 25 bacteria screening samples were collected along Little White Oak Bayou during the on-the -round surveys July 13, 18, and 20, 2016. Samples were collected at eight discharging outfalls (Figure 7) and one tributary, while the rest of the samples were surface water samples collected in an effort to better identify hot spots and trace bacteria sources back to their origin. It should be noted that a significant rain event occurred on July 19, 2016, making the samples collected on July 20, 2016, wet weather samples. Sample sites from July 20, 2016, will be re-visited during Phase II to collect dry weather samples for comparison.

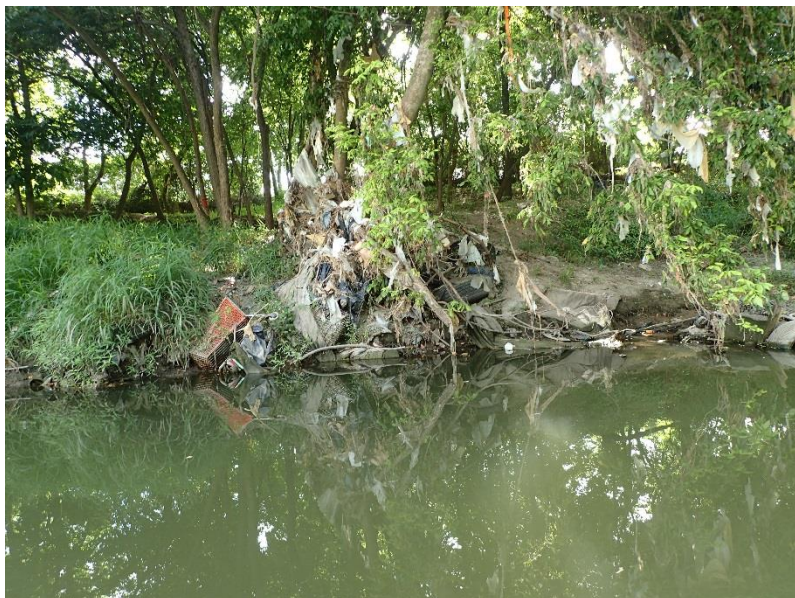
Figure 11. Shopping cart and litter on water bank

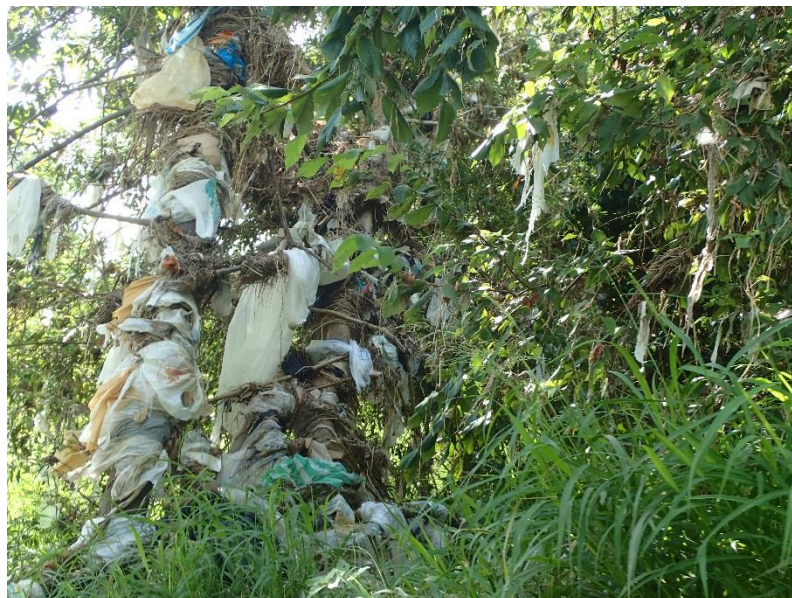
Figure 12. Trash wrapped around tree trunks in lower portion of Little White Oak

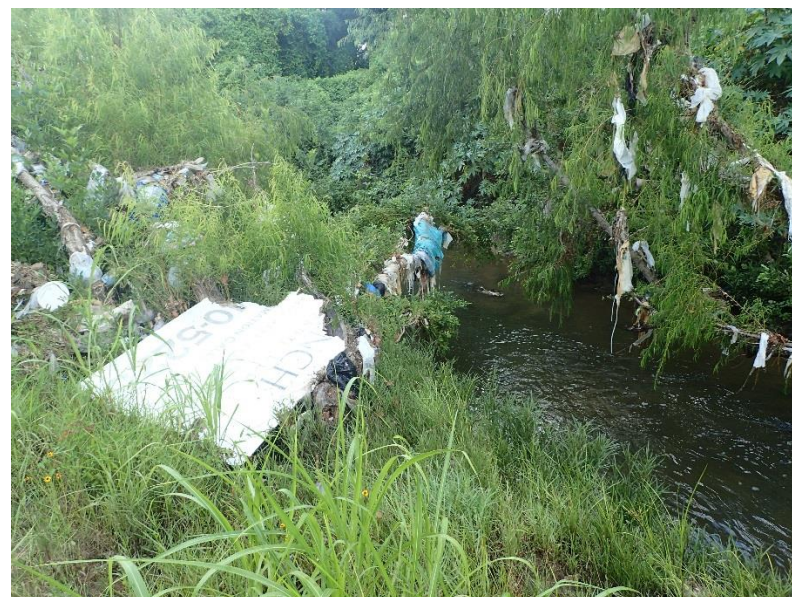
Figure 14. Washed up trash trapped by tree branches

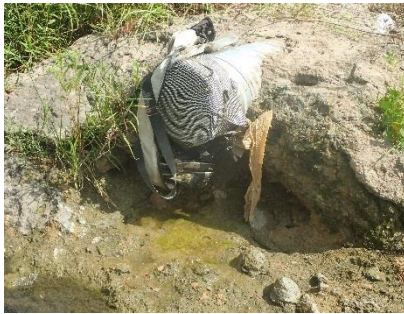
Figure 11. Phase II bacteria source identification monitoring stations for Canal C-147, Segment 1007A_01, from the Top 2 Least Impaired list.

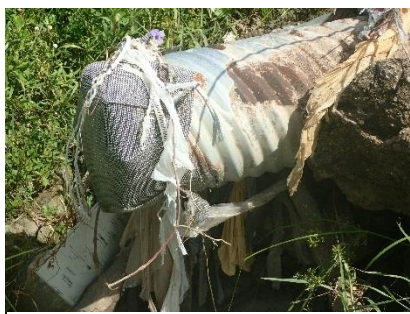
Figure 16. Outfall Tier II ID 035

- 1) Three suspicious outfall pipes adjacent to the Moody Park area had metal screened covers attached to the ends. One of the three pipes had a small amount of discharge dripping from the outfall, but not enough for sample collection and bacteria screening. Locations for the screened outfalls can be found in Table 3 (Tier II ID 033, 035, and 040). Refer to Figures 15-17 for images of the three suspicious outfall pipes.

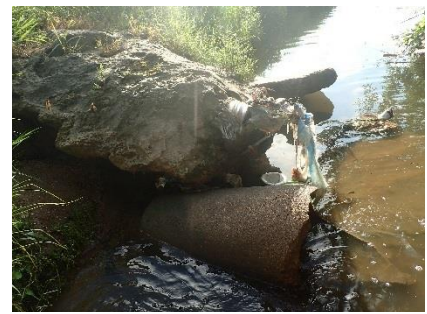
Figure 13. Phase II bacteria source identification monitoring stations for Rummel Creek, Segment 1014N_01, from the Top 2 Most Impaired list.

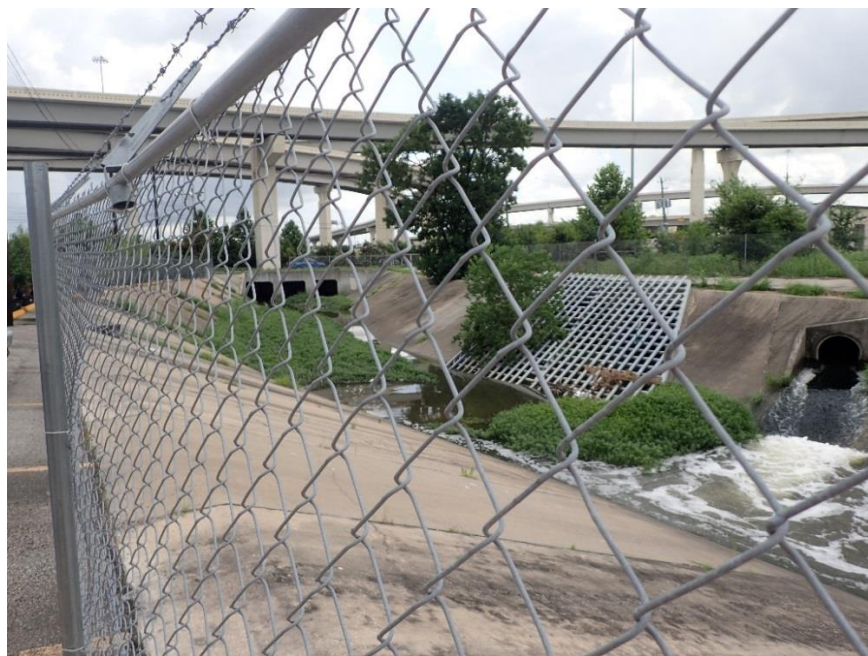
Figure 28. Stormwater detention outfall adjacent to plant nursery at southwest corner of I-10 and Beltway 8 intersection

The windshield survey for Rummel Creek was June 22, 2016. The waterway was investigated by vehicle, and points of access and potential pollution sources were noted. Primary land use is residential throughout the catchment area with commercial and industrial land uses present primarily north of Beltway 8 and at the intersection of I-10 and Beltway 8. Several industrial stormwater outfalls are adjacent to the I-10 corridor north of Beltway 8 before the stream goes underground. Nearby facilities include a hospital and various flooring distribution and furniture warehouses. A large plant nursery is on the southwest corner of the I-10 and Beltway 8 intersection adjacent to where Rummel Creek emerges from underground. A large discharging outfall appeared to be coming from the stormwater detention area adjacent to the nursery. A significant amount of vegetation was growing through the cement-lined channel adjacent to the nursery and stormwater detention outfall (Figure 28). Refer to Figure D1 in Appendix D for a map of the windshield survey route.

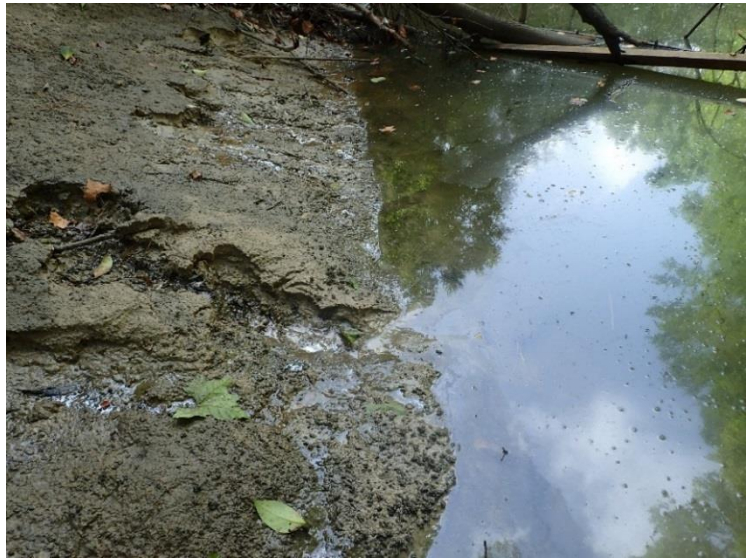
Noteworthy findings include sample 033 collected at a bend in the stream segment where trash accumulation was observed and apparent groundwater discharge was present. A slight sheen was visible on the water surface at the same location disturbed by the groundwater movement in the otherwise stagnant water (Figure 31). Two dilapidated pipes were observed at sample location 034 where high bacteria levels were detected. One pipe was bored under the waterway (Figure 32) while the other crossed above the water at street level. A concrete slab was found on the floor of Rummel Creek just downstream of the Rummel Creek Road bridge (Figure 33). The concrete was impeding water flow and creating high algae accumulation on the upstream side of the slab. Samples were taken upstream and downstream of the concrete slab, and bacteria levels were higher upstream where water flow was slower (sample 039). Algae was common throughout the waterway but appeared particularly dense north of Memorial Drive near Rummel Creek Elementary School (Figures 34-35). The sample collected at this location (sample 036) had the highest bacteria concentration collected during the Rummel Creek survey.

Figure 31. Groundwater discharge and surface sheen at sample 033

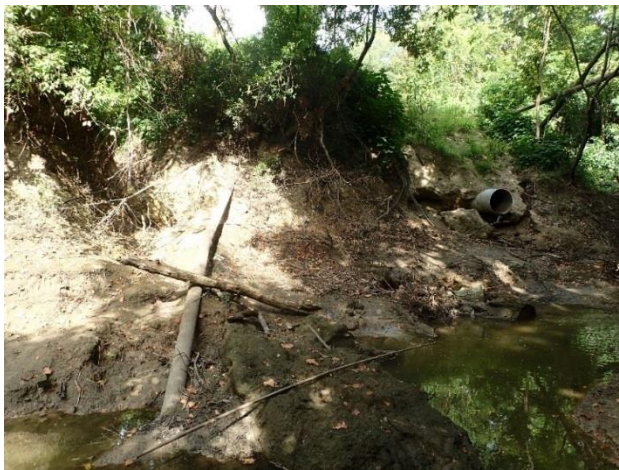
Figure 32. Pipe and outfall near sample 034

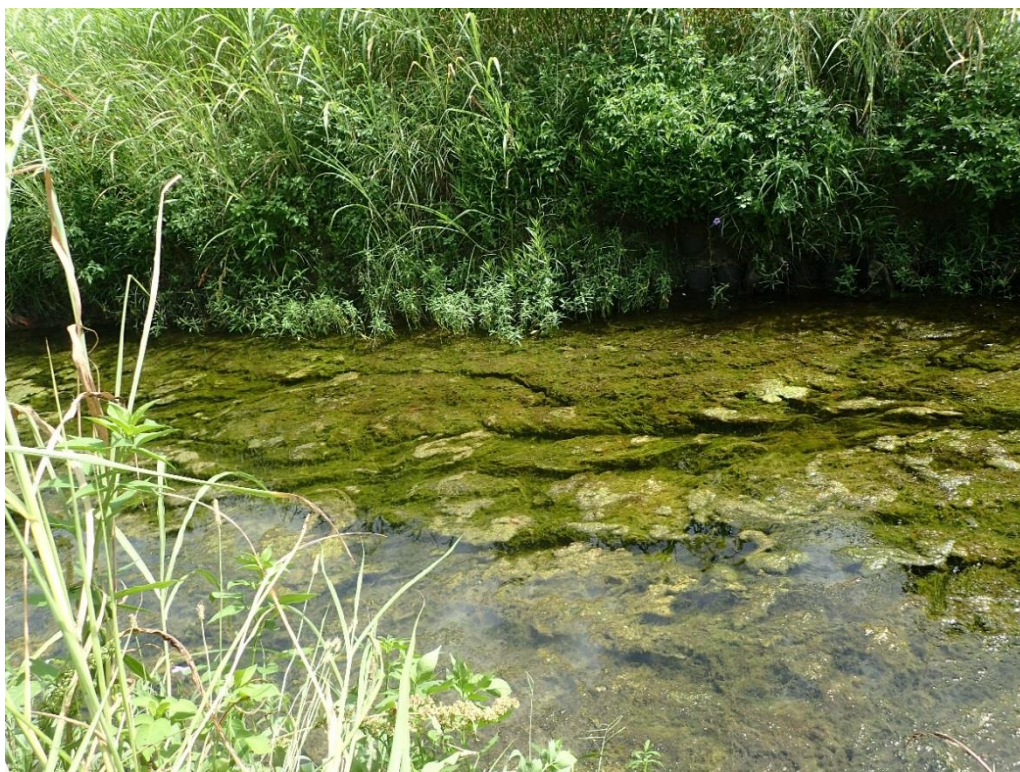
Figure 35. Dense algal blooms near Rummel Creek Elementary School (sample 036)

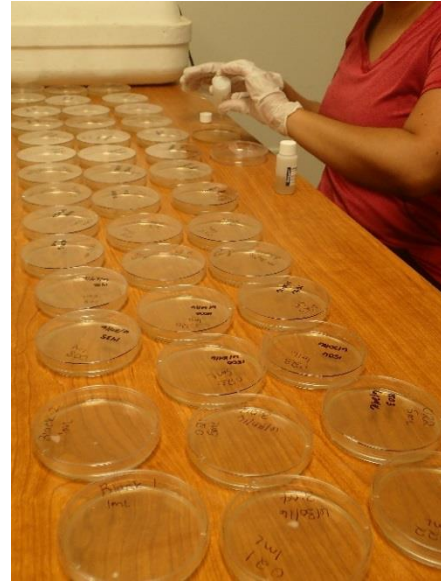
Samples were analyzed using the Coliscan Easygel method to test for *E.coli* concentrations (Figure 43). Two dilutions were measured for each sample and the average concentration is reported in Table 5. Refer to Figure 44 for a station map illustrating the location and sample type for each sample collected during the Canal C-147 survey, and to Figure 45 for a map illustrating the bacteria results for each sample collected. Additional information about sample locations and descriptions can be found in Table E1 in Appendix E.

Figure 43. Plating Canal C-147 samples using Coliscan Easygel methodology

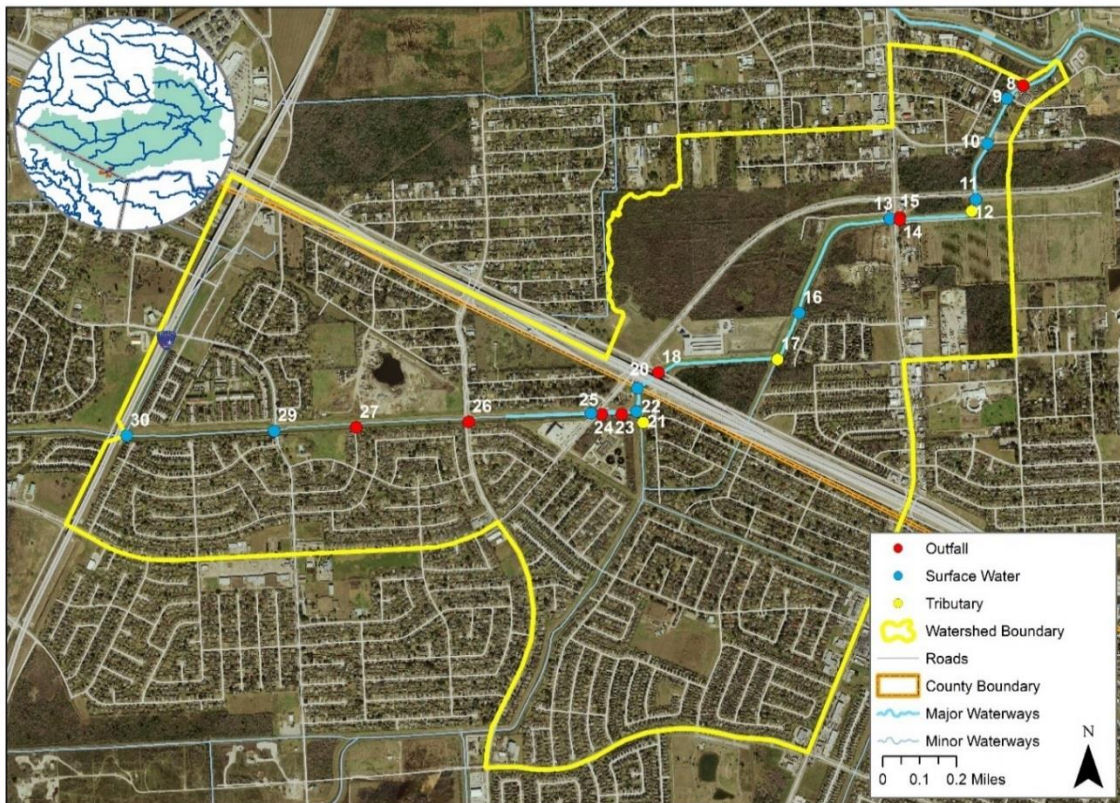
Figure 44. Station map for Canal C-147 survey June 30, 2016

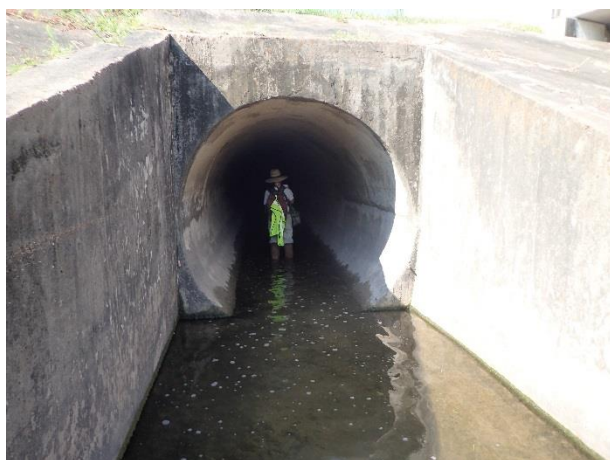
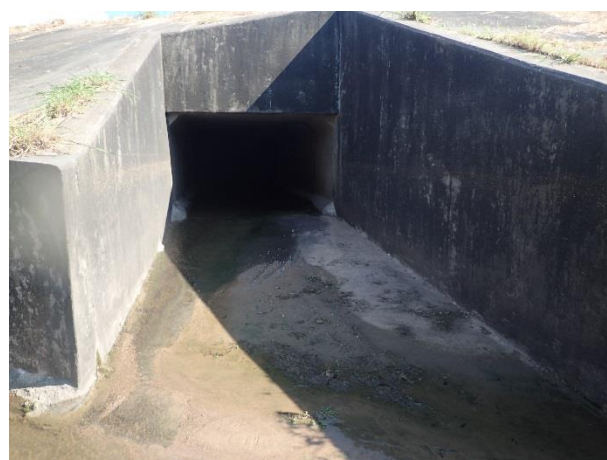
Figures 45 and 46. Storm drains downstream of the S. Post Oak Road bridge (samples 013 and 014)

Noteworthy findings include the high bacteria loading from an outfall (sample 008) directly downstream of the CRP monitoring station off Tiffany Drive (Figure 46). Discharges from this outfall would not be captured in routine CRP monitoring due to its location. Two large concrete storm drains directly downstream of the South Post Oak Road bridge (Figure 47-48) had high *E.coli* concentrations (samples 013 and 014). Another high bacteria source discharging into the canal was a small tributary north of Beltway 8, sample 021 (Figure 49).

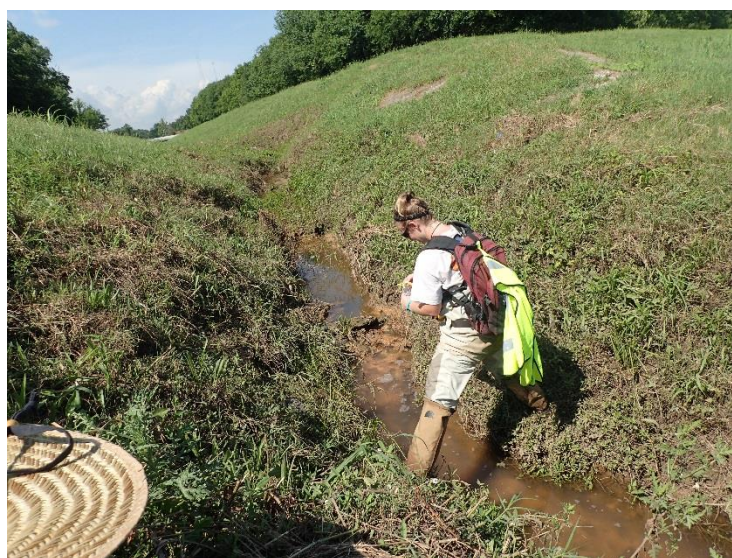
Figure 47. Tributary north of Beltway 8 with high bacteria concentration (sample 021)

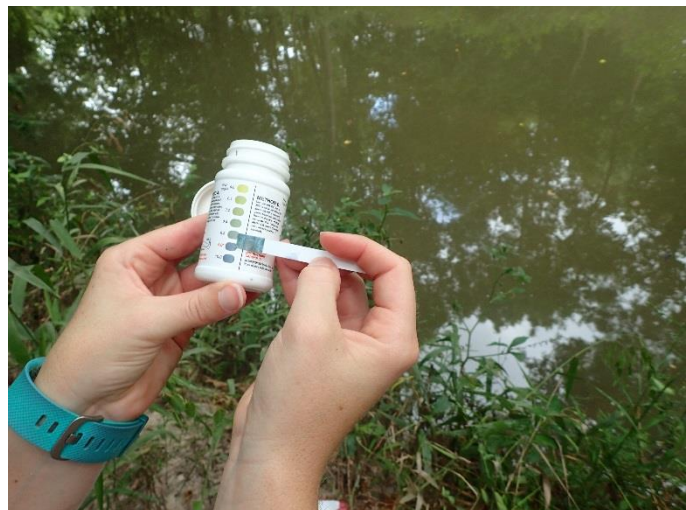
The most significant observation recorded during the Upper Panther Branch surveys was the strong odor and presence of chlorine throughout the waterway. Chlorine test strips were used at the majority of sample locations to detect estimated chlorine levels. All chlorine test strips tested positive for chlorine with *at least* 1.0 mg/L present for every sample tested (Figure 55). Many of the stormwater drainage tributaries had lower levels of chlorine and higher bacteria concentrations compared to the main stem of Upper Panther Branch. Further investigation is recommended in order to identify where the chlorine was originating.

Figure 55. Chlorine test strip result for Upper Panther Branch sample 004

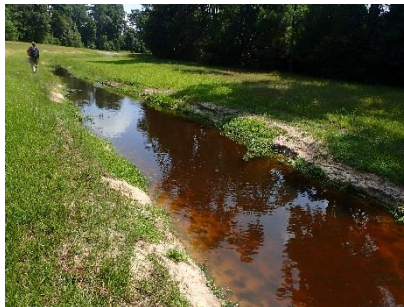
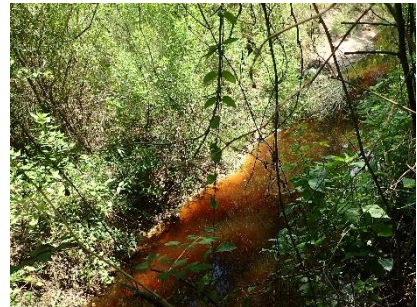
Figures 58-60. Red tinted waters in the tributaries of Upper Panther Branch

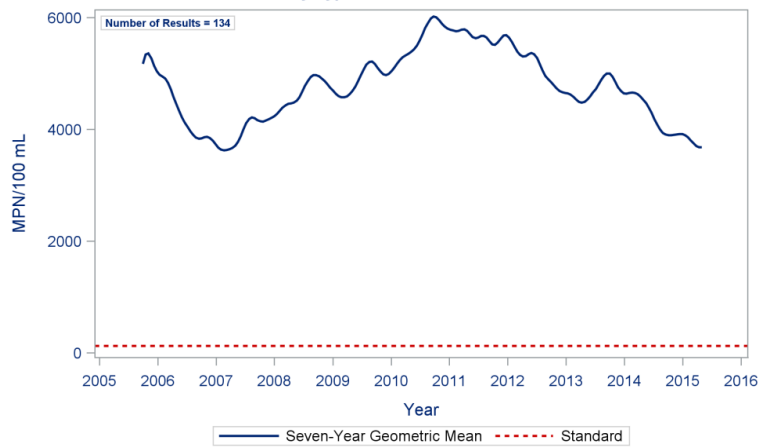
1. Buffalo Bayou Tidal

**Segment 1013C Unnamed Non-Tidal Tributary of Buffalo Bayou
Moving Seven-Year Bacteria Geometric Mean -All Data in Segment
Waterbody Type: Unclassified Freshwater Stream**

Reference Line represents the Primary Contact Recreation (PCR) Standard
PCR Standard: Freshwater-E. Coli 126 MPN/100 mL; Saltwater-Enterococci 35 MPN/100 mL

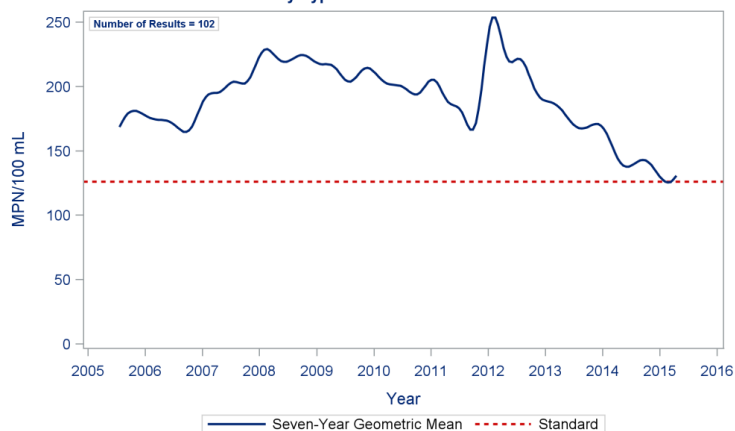
1. Upper Panther Branch

Segment 1008B Upper Panther Branch
Moving Seven-Year Bacteria Geometric Mean -All Data in Segment
Waterbody Type: Unclassified Freshwater Stream

Reference Line represents the Primary Contact Recreation (PCR) Standard
PCR Standard: Freshwater-E. Coli 126 MPN/100 mL; Saltwater-Enterococci 35 MPN/100 mL

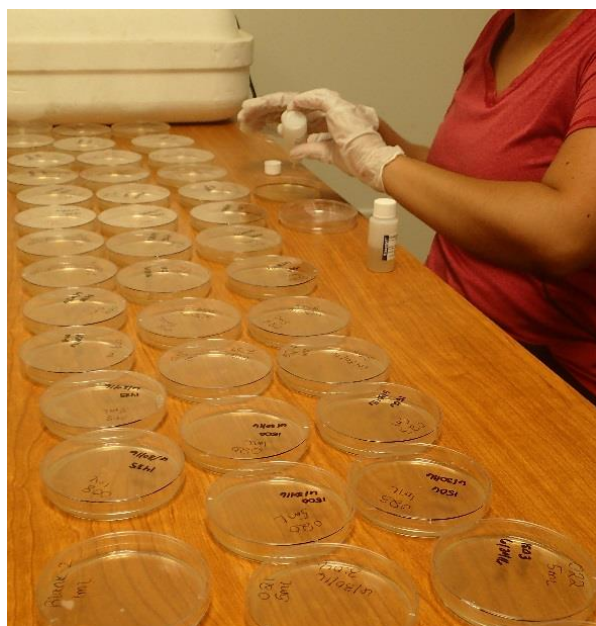
Figure 9. Coliscan Easygel set up

Phase I samples were analyzed using the Coliscan Easygel petri dish method to test for *E.coli* concentrations by counting the number of bacteria colonies that form on the Easygel medium (Figures 1 and 2). Two dilutions of each sample were tested using this methodology and the average bacteria concentration was reported. However, colony counting using this method provides limited measurement capability for *E.coli* due to the possibility of too numerous to count (TNTC) results that occur if greater than 200 colonies are formed on a dish. Results and findings from the bacteria screening process were used as a precursor to Phase II assessments where only the stations with the highest bacteria screening concentrations from Phase I were subject to follow up investigation. The following is a summary of Phase I bacteria screening results for the four selected AUs and details on the station selection process for Phase II investigations.

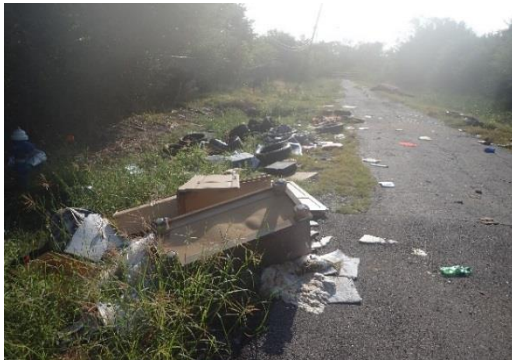
Figure 12

Station 8 is a metal outfall located at the downstream end of the Canal C-147 watershed boundary adjacent to a residential neighborhood and a number of auto body junk yards. Illegal dumping of trash, tires, and large debris was common in the area (Figure 5). Figures 6 and 7 are photos of the outfall taken during the dry weather sampling event. Based on these results, the City of Houston initiated an investigation at this outfall location in September 2016 and detected a potable water leak. Information about corrective actions related to the potable leak are unknown. However, Phase II investigations resulted in wet and dry weather samples with *E.coli* concentrations that are now in compliance with state standards (Table 6).

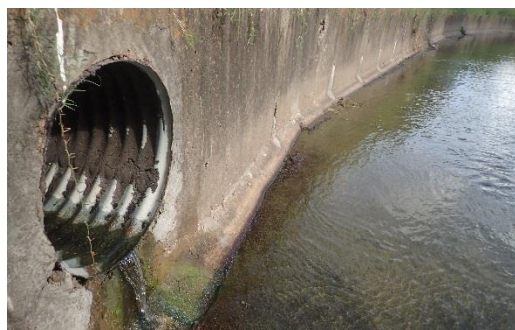
Figure 15

Samples were collected directly from the discharging outfall during both wet and dry weather events. Only the wet weather sample had an *E.coli* concentration that exceeded the state water quality standard of 126 MPN/100mL (Table 7).

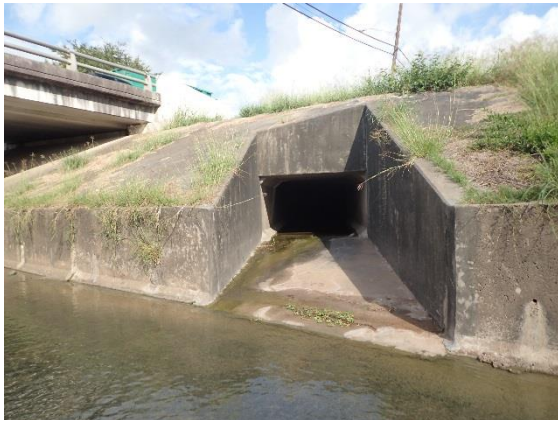
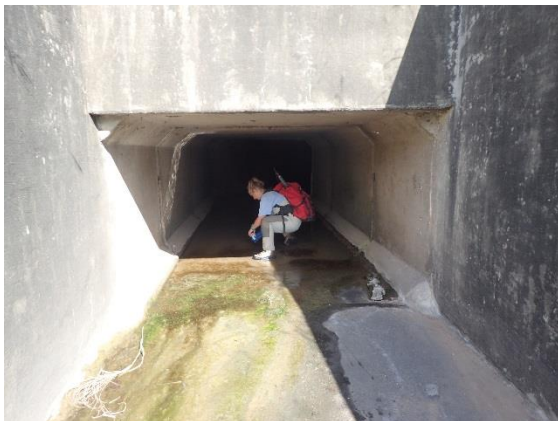
Figure 21

Station 14 is a large square storm drain located on the left side of Canal C-147 at the South Post Oak Street bridge directly across from station 13. A tire shop and car dealership are located adjacent to Canal C-147 at this location.

During the dry weather event, there was only a shallow trickle of water discharging from the storm drain (Figures 13 and 14). The water appeared clean and colorless with no particular odor, but was too shallow for the collection of field water quality data using the multiparameter data sonde. There was a significant difference in *E.coli* concentrations between the wet weather and dry weather sampling events (Table 9). Further investigation is recommended at this location to identify the cause for this variation during different weather conditions.

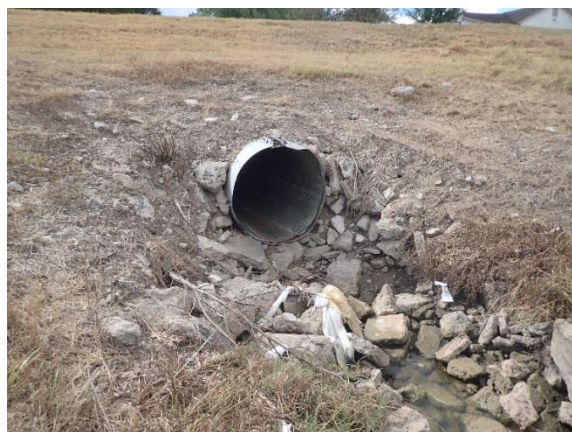
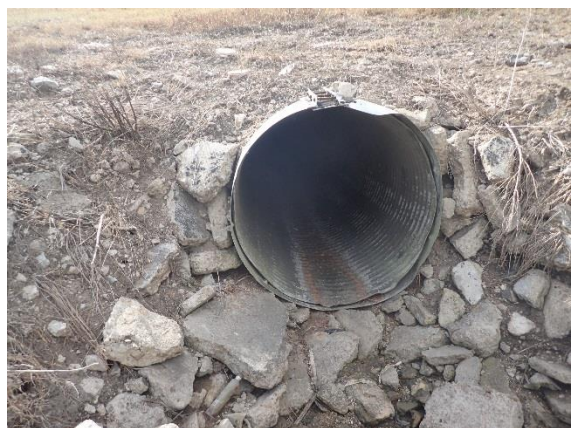
Figure 25

Station 27 is a metal outfall located on the right bank of Canal C-147 between Blue Ridge Road and Chimney Rock Road. The easiest access point is through a residential neighborhood at the end of Ohara Drive.

There was no discharge observed during the dry weather event conducted on October 19, 2016 (Figures 17 and 18) resulting in no dry weather samples collected at this location during Phase II investigations. A wet weather sample was collected on November 7, 2016. A sample was collected directly from the outfall and field water quality data from the data sonde were taken from the shallow pool of water accumulated in front of the outfall. The resulting bacteria concentration was 3,650 MPN/100mL which is significantly greater than the state water quality standard for *E.coli* (Table 11).

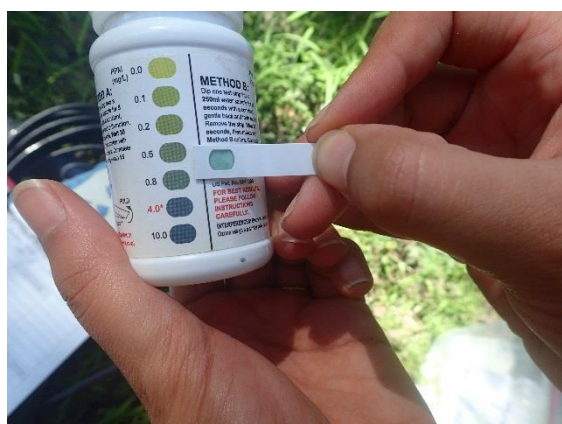
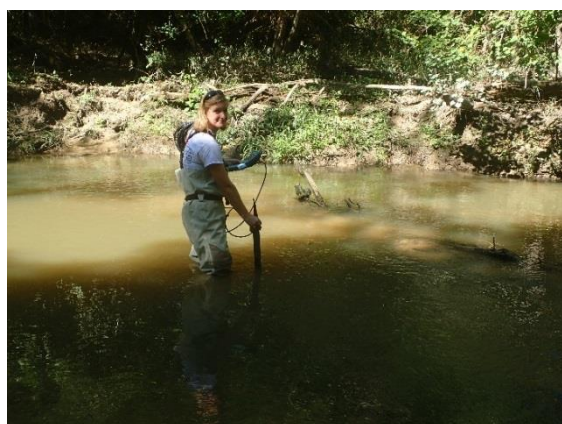
Figure 28

A chlorine odor was detected during the Upper Panther Branch Phase I and Phase II investigations. Chlorine test strips detected concentrations measuring greater than 0.5 mg/L at this location during the dry weather sampling event (Figure 21). The local wastewater treatment facility was notified, but a source for the chlorine is still unknown.

A dry weather sample was collected on September 28, 2016 (Figure 22) resulting in an *E.coli* concentration of 121 MPN/100mL which is just below the state water quality standard of 126 MPN/100mL. The wet weather sample collected on February 15, 2017 had a much greater *E.coli* concentration measuring at 9,800 MPN/100mL (Table 12).

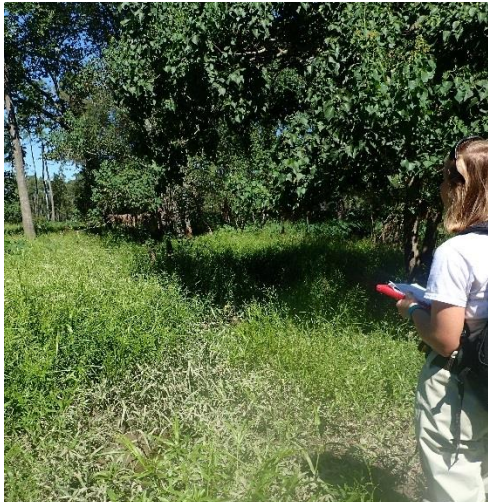
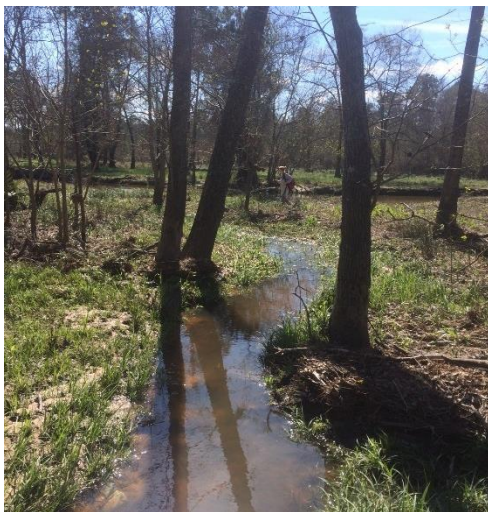
Figure 34

Station 9 is a tributary of Upper Panther Branch located adjacent to a sporting facility off Marisco Place. The tributary's confluence with Upper Panther Branch is approximately 250 meters south of the facility which includes tennis courts, soccer and baseball fields, and concession stands. The tributary continues to the north of the sporting facility into a neighborhood that is serviced through on-site sewage facilities (OSSFs).

The dry weather sample collected on September 28 (Figure 27) was in compliance with state water quality standards for bacteria (Table 15). The water had a strong chemical odor during this sampling event and chlorine test strips detected a chlorine concentration of approximately 0.1 mg/L. The wet weather event conducted on February 15, 2017 (Figure 28) resulted in a bacteria concentration of 5,790 MPN/100mL (Table 15).

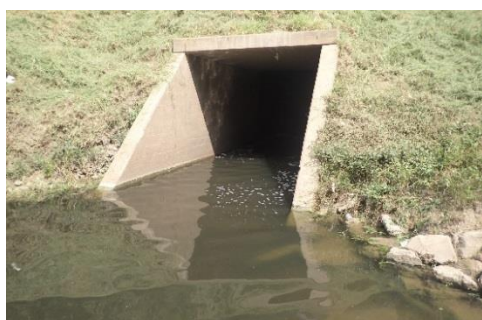
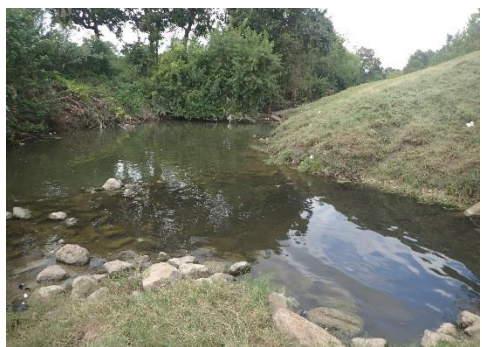
Figure 38

Station 8 is a large outfall located at the southern end of Moody Park adjacent to a parking lot off Fulton Street. The outfall was consistently discharging large volumes of water into Little White Oak Bayou during all Phase I and II investigations (Figures 31-32). Homeless activity was commonly observed at this location.

Samples were collected directly downstream of the outfall during Phase II investigations (Figure 33). The dry weather sample collected on October 11, 2016 was just over the state water quality standard for bacteria measuring at 199 MPN/100mL (Table 16). However, the wet weather sample collected on February 15, 2017 resulted in the much higher bacteria concentration of 24,200 MPN/100mL.

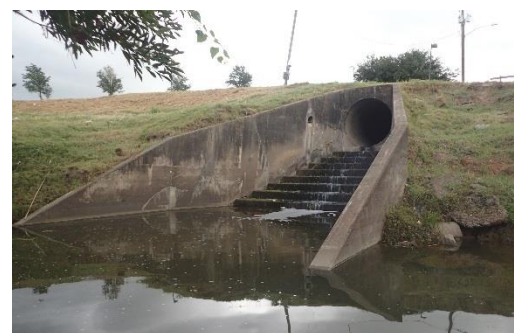
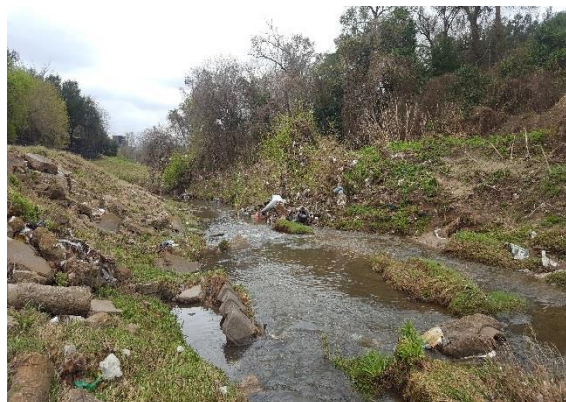
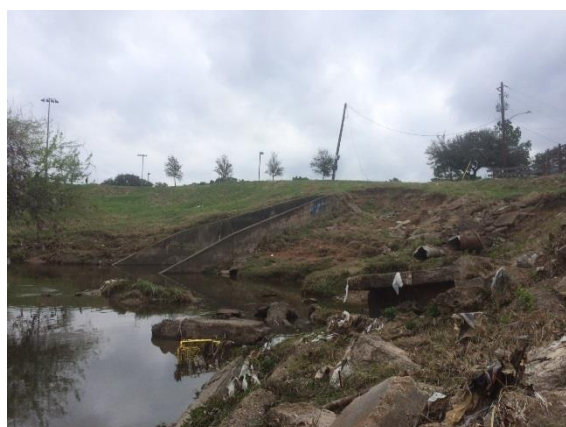
Figure 41

Station 10 is a large storm drain located at Hays Street next to an apartment complex (Figure 34). Litter and debris build up is significant at this location, especially after rain events, with trash from upstream getting trapped at the bend in Little White Oak Bayou located at this station (Figure 35-36).

Samples were collected directly downstream of the storm drain during Phase II investigations. The dry weather sample collected on October 11, 2016 resulted in an *E.coli* concentration of 1,080 MPN/100mL, making it one of the highest bacteria sources to Little White Oak Bayou during

the dry weather event (Table 17). However, the wet weather sample collected on February 15, 2017 resulted in a much higher bacteria concentration of 24,200 MPN/100mL.

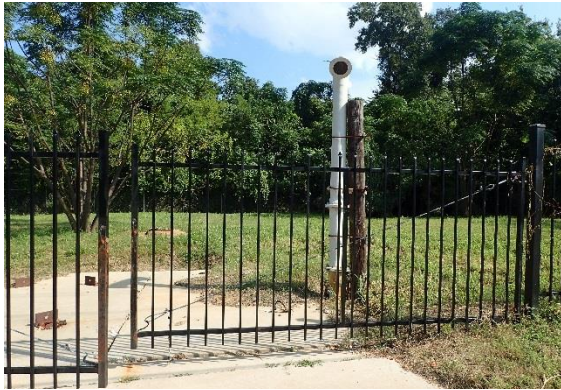
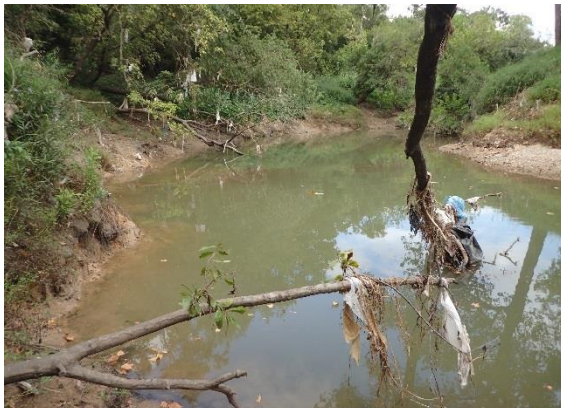
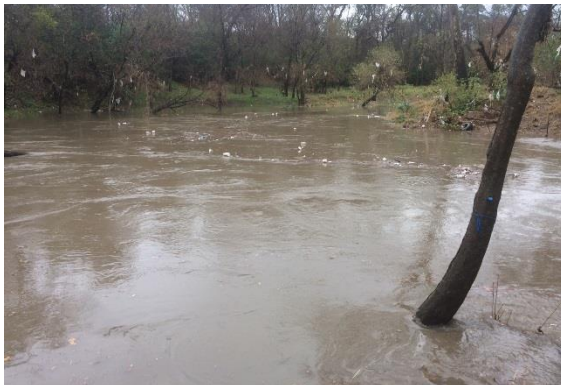
Figure 44

Station 15.1 is located approximately 110 meters upstream of Wrightwood Street. A sewer system junction box is located at Wrightwood Street at Little White Oak Bayou that has had several overflow incidents during wet weather events. Stations 15.1 and 16.1 were investigated to identify the extent of contamination originating from this junction box (Figure 37).

The dry weather sample collected at this location on October 11, 2016 (Figure 38) resulted in an *E.coli* concentration of 161 MPN/100mL, slightly exceeding the state water quality standard. The wet weather sample collected approximately 20 minutes after a significant rain event on February 14, 2017. The water level was high and large amounts of trash and debris were flowing with the water downstream (Figure 39). The *E.coli* concentration for the wet weather event was 24,200 MPN/100 mL, significantly higher than the dry weather concentration (Table 18).

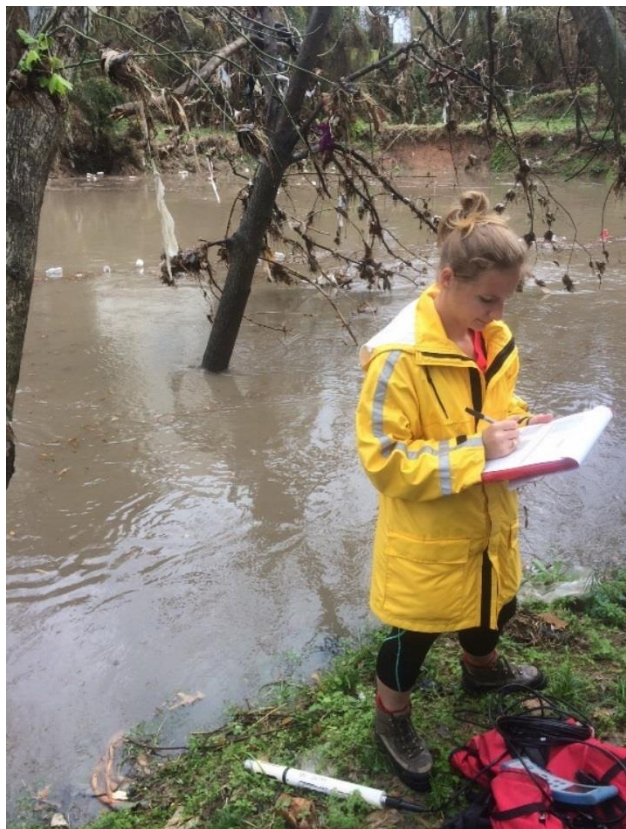
Figure 48

A dry weather sample was collected on October 11, 2016. At the time of sample collection, a strong odor of diesel was detected and an oily sheen was observed on the surface of the water (Figure 48). The *E.coli* concentration was 7,700 MPN/100mL which was the highest bacteria concentration collected during the dry weather event at Little White Oak Bayou. The wet weather sample collected on February 15, 2017 (Figure 49) resulted in a significantly higher bacteria concentration of 24,200 MPN/100mL. The same *E.coli* concentration was detected for all surface water samples collected on February 15, 2017 that were located downstream of this station. Further investigation upstream of this location is recommended to better evaluate specific bacteria sources impacting Little White Oak Bayou.

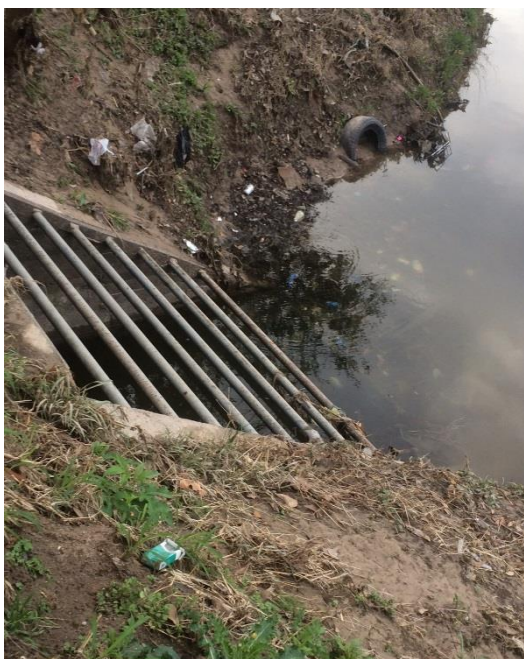
Figure 52

Station 34 is located at the southern end of the Rummel Creek watershed boundary downstream of the Edith L Jones Nature Conservancy. The station can be accessed through dense vegetation at the end of Hermitage Lane in a residential neighborhood. Old pipelines were observed along the stream bottom, although it was unclear if they were still operating or not (Figure 52).

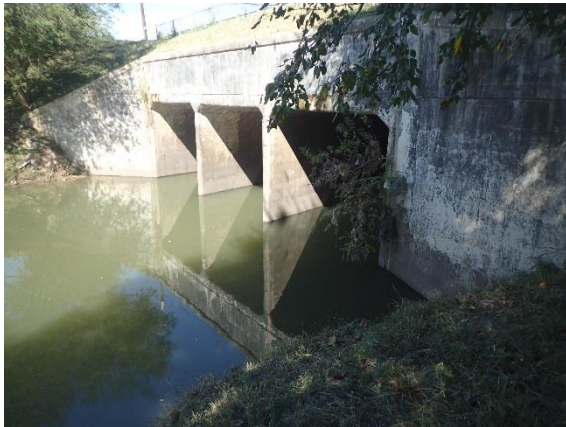
Figure 53

A dry weather sample was collected on December 14, 2016 resulting in a bacteria concentration slightly exceeding the state water quality standard (Table 24). The wet weather sample was collected on February 14, 2017 immediately following a significant rain event (Figure 53). The bacteria concentration for the wet weather sample was 8,660 MPN/100mL which was significantly higher than the dry weather sample, but was the lowest wet weather concentration observed in Rummel Creek.

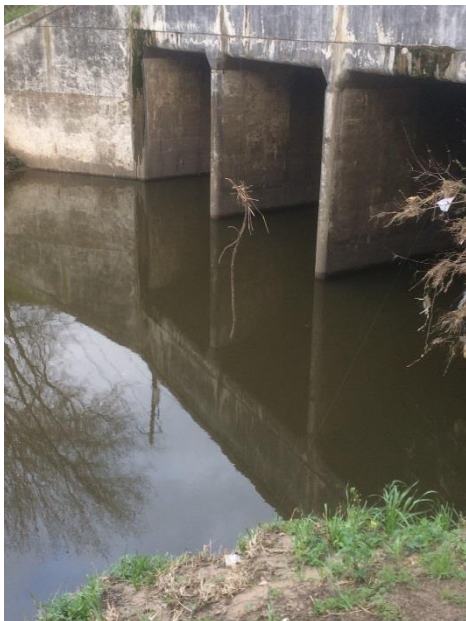
Figure 54

Station 36 is an outfall located downstream of Rummel Creek Elementary directly upstream of the bridge at Memorial Drive (Figure 54). This station is one of the highest contributors of bacteria into Rummel Creek during both Phase I and Phase II investigations. The outfall was discharging during all station visits, regardless of weather conditions.

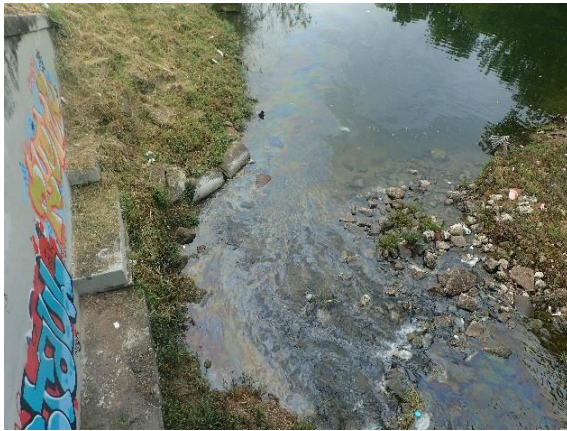
Figure 56

Station 40 is located directly downstream of where Rummel Creek emerges from I-10 underground. This portion of Rummel Creek is concrete lined but sediment has settled on the surface of the concrete downstream where vegetation is now growing (Figure 56). Additionally, a plant nursery and large detention basin are located on either side of the concrete lined canal at this location.

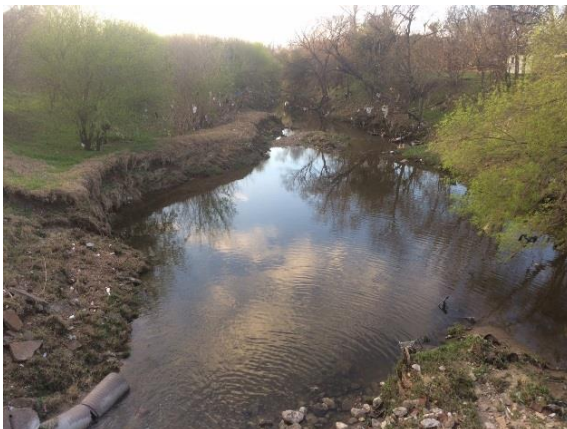
Figure 55

The dry weather sample collected on December 14, 2016 resulted in an *E.coli* concentration of 1,860 MPN/100mL. The wet weather sample collected immediately following a significant rain event on February 14, 2017 (Figure 55) was significantly higher measuring at 24,200 MPN/100mL.
