**PRELIMINARY RESULTS OF A RECREATIONAL USE
ATTAINABILITY ANALYSIS OF THE BUFFALO BAYOU/WHITE
OAK BAYOU STREAM SYSTEM IN HOUSTON, TEXAS**

**TEXAS A & M UNIVERSITY
COLLEGE STATION, TEXAS**

August 2008

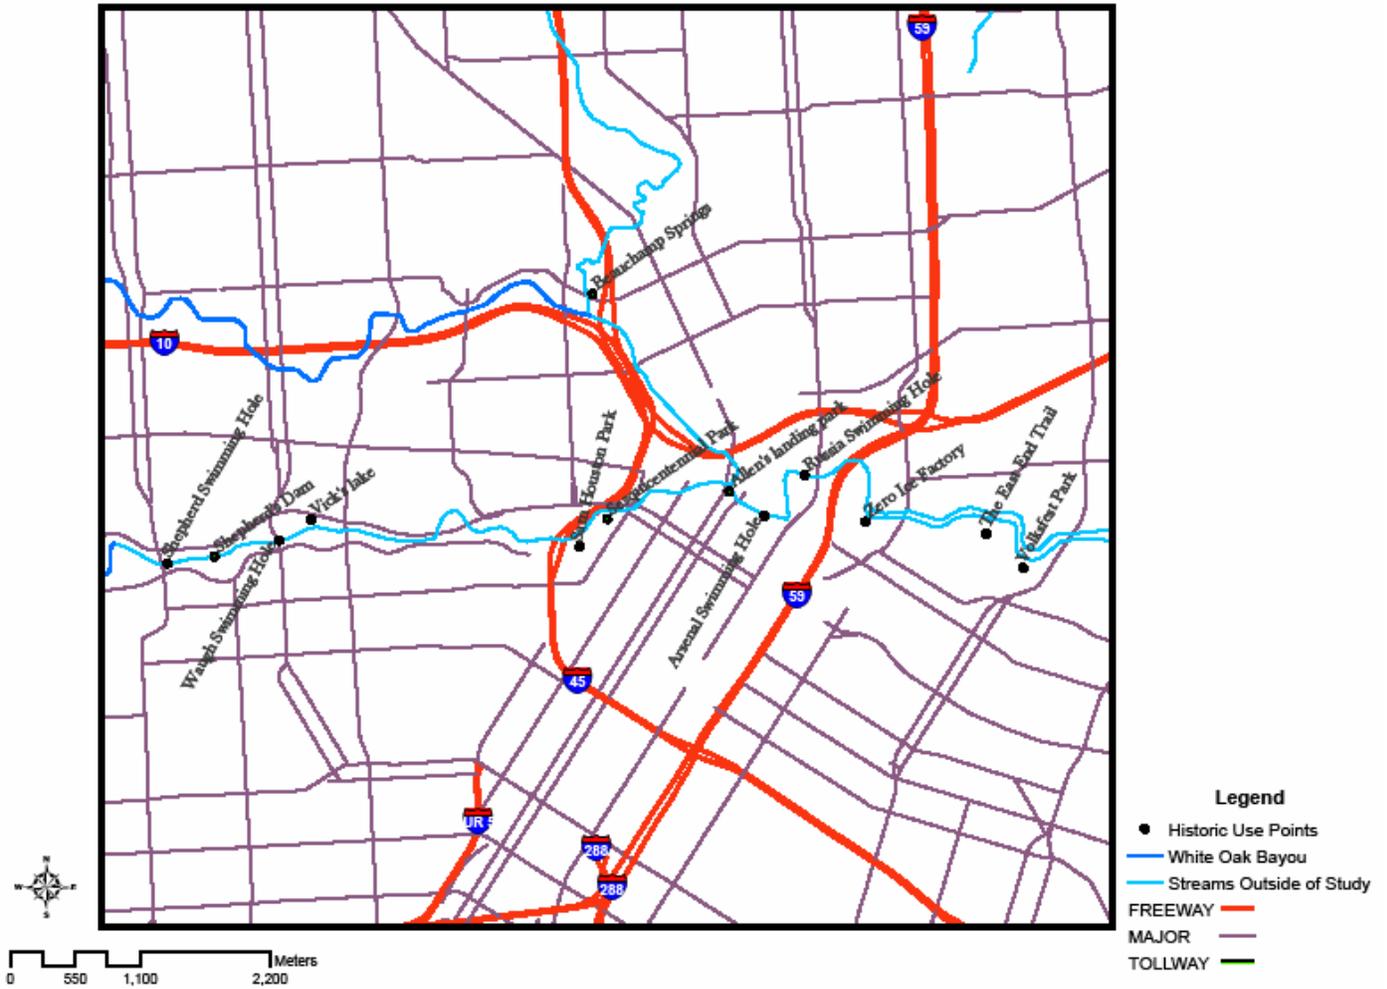
Figure 5. Areas of Historic use along Buffalo Bayou.

Locations of the parks are shown on Figure 5. In addition to water-based recreational activities, Buffalo Bayou also provided water sources for industrial uses, public fountains, and fire hydrants (Johnston, 1991). However, increased traffic on the waterway, industrial activities, and sewage discharged from residential areas contributed to the deterioration of the Bayou's water quality. Concern about pollution of the Bayou can be traced back to 1841 when sawmills were the major source of pollution (Aulbach, 2004). In the early 1970s, water pollution became the focus of attention, and the city of Houston was identified as the major source partly due to inadequate and overloaded sewage treatment plants (Miller, 1992). Unrestricted development and pollution along with occasionally severe flooding had impaired Houstonians' perception of Buffalo Bayou and the quality of recreation that it supported (Fuller, 1987).

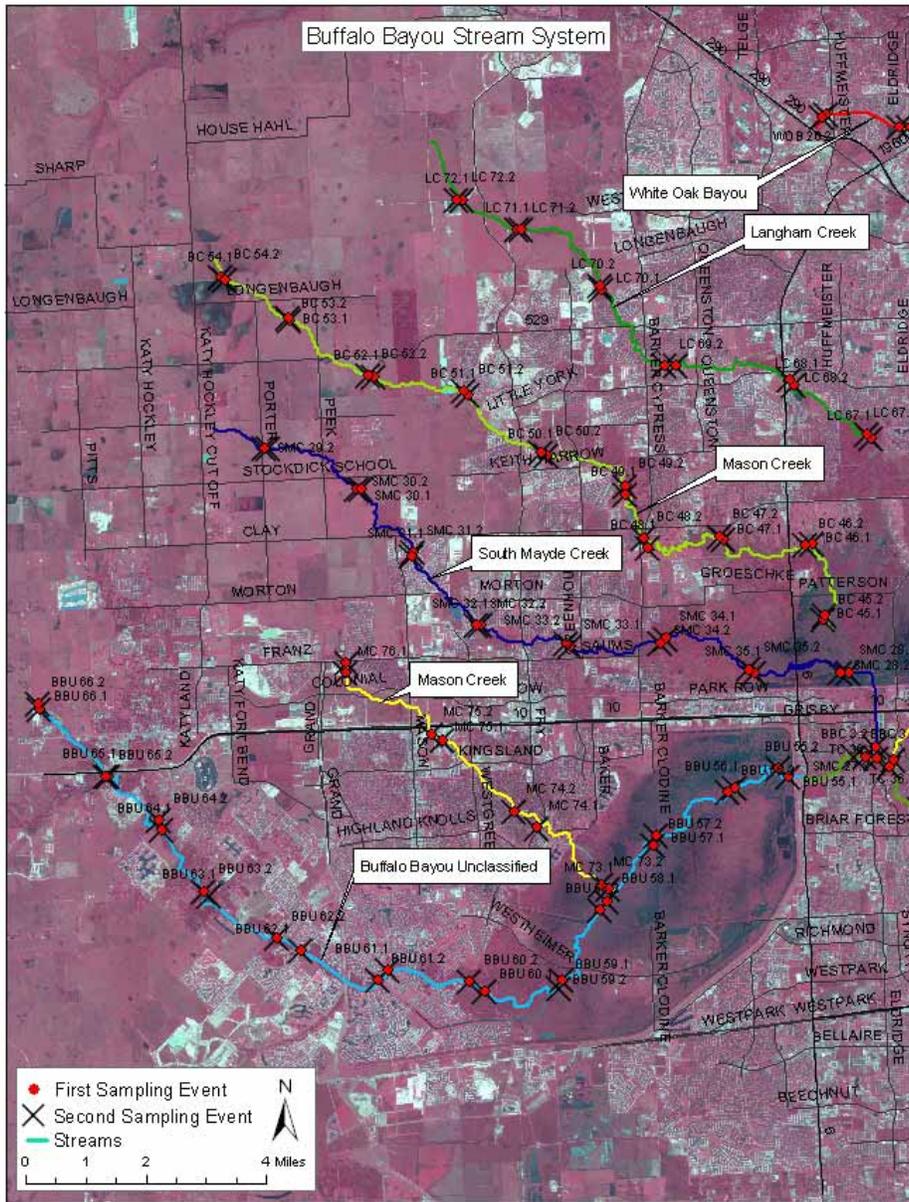
Figure 8. Location of sampling stations along Buffalo Bayou and its tributaries.

A total of 85 stations were sampled between June 6 and August 10, 2008 (Figure 8 and 9). In addition to proximity to recreation areas (Table 5) and maximum depth (Table 3), street location, county location, general surroundings, riparian zone description, and point source information were collected for each station (Table 4).

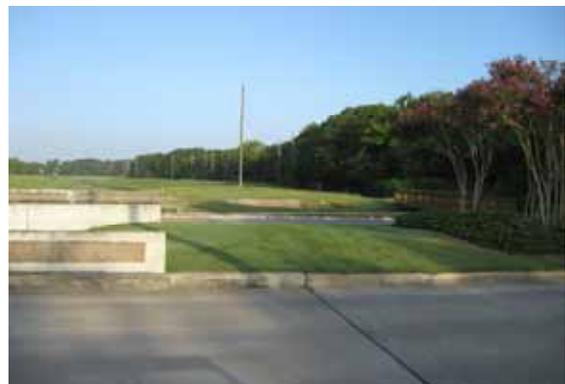
Photo 5. Trail along a channelized section of Buffalo Bayou
