Clean Rivers Program

2015 Houston-Galveston Area Council
Basin Highlights Report

2015 BASIN HIGHLIGHTS REPORT

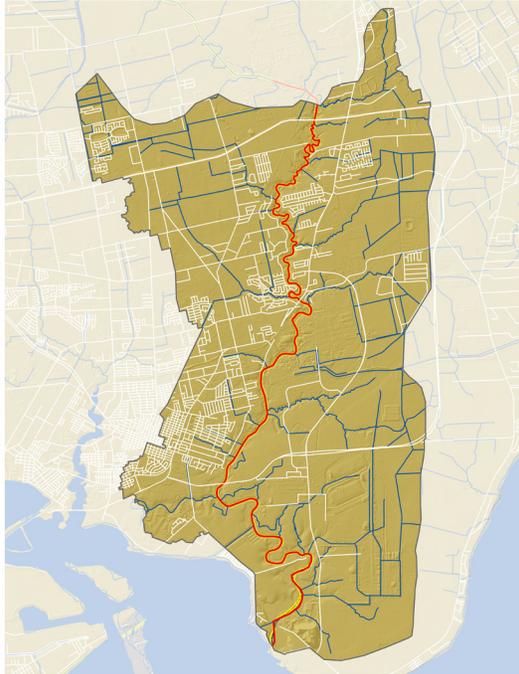
BACTERIA

No Change

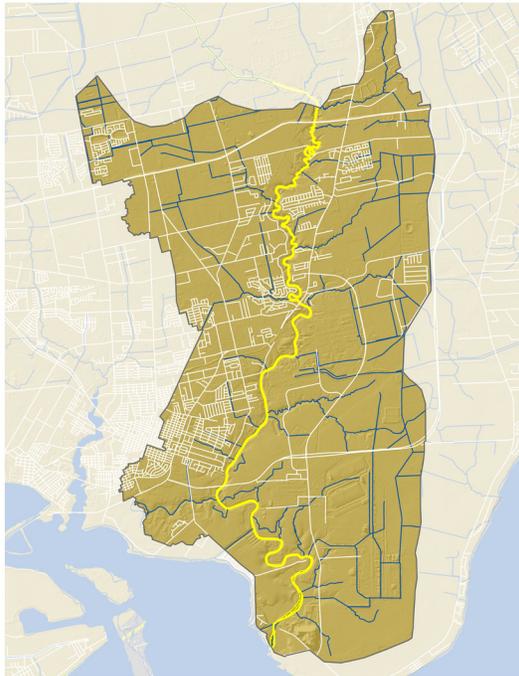
NUTRIENTS

Improving

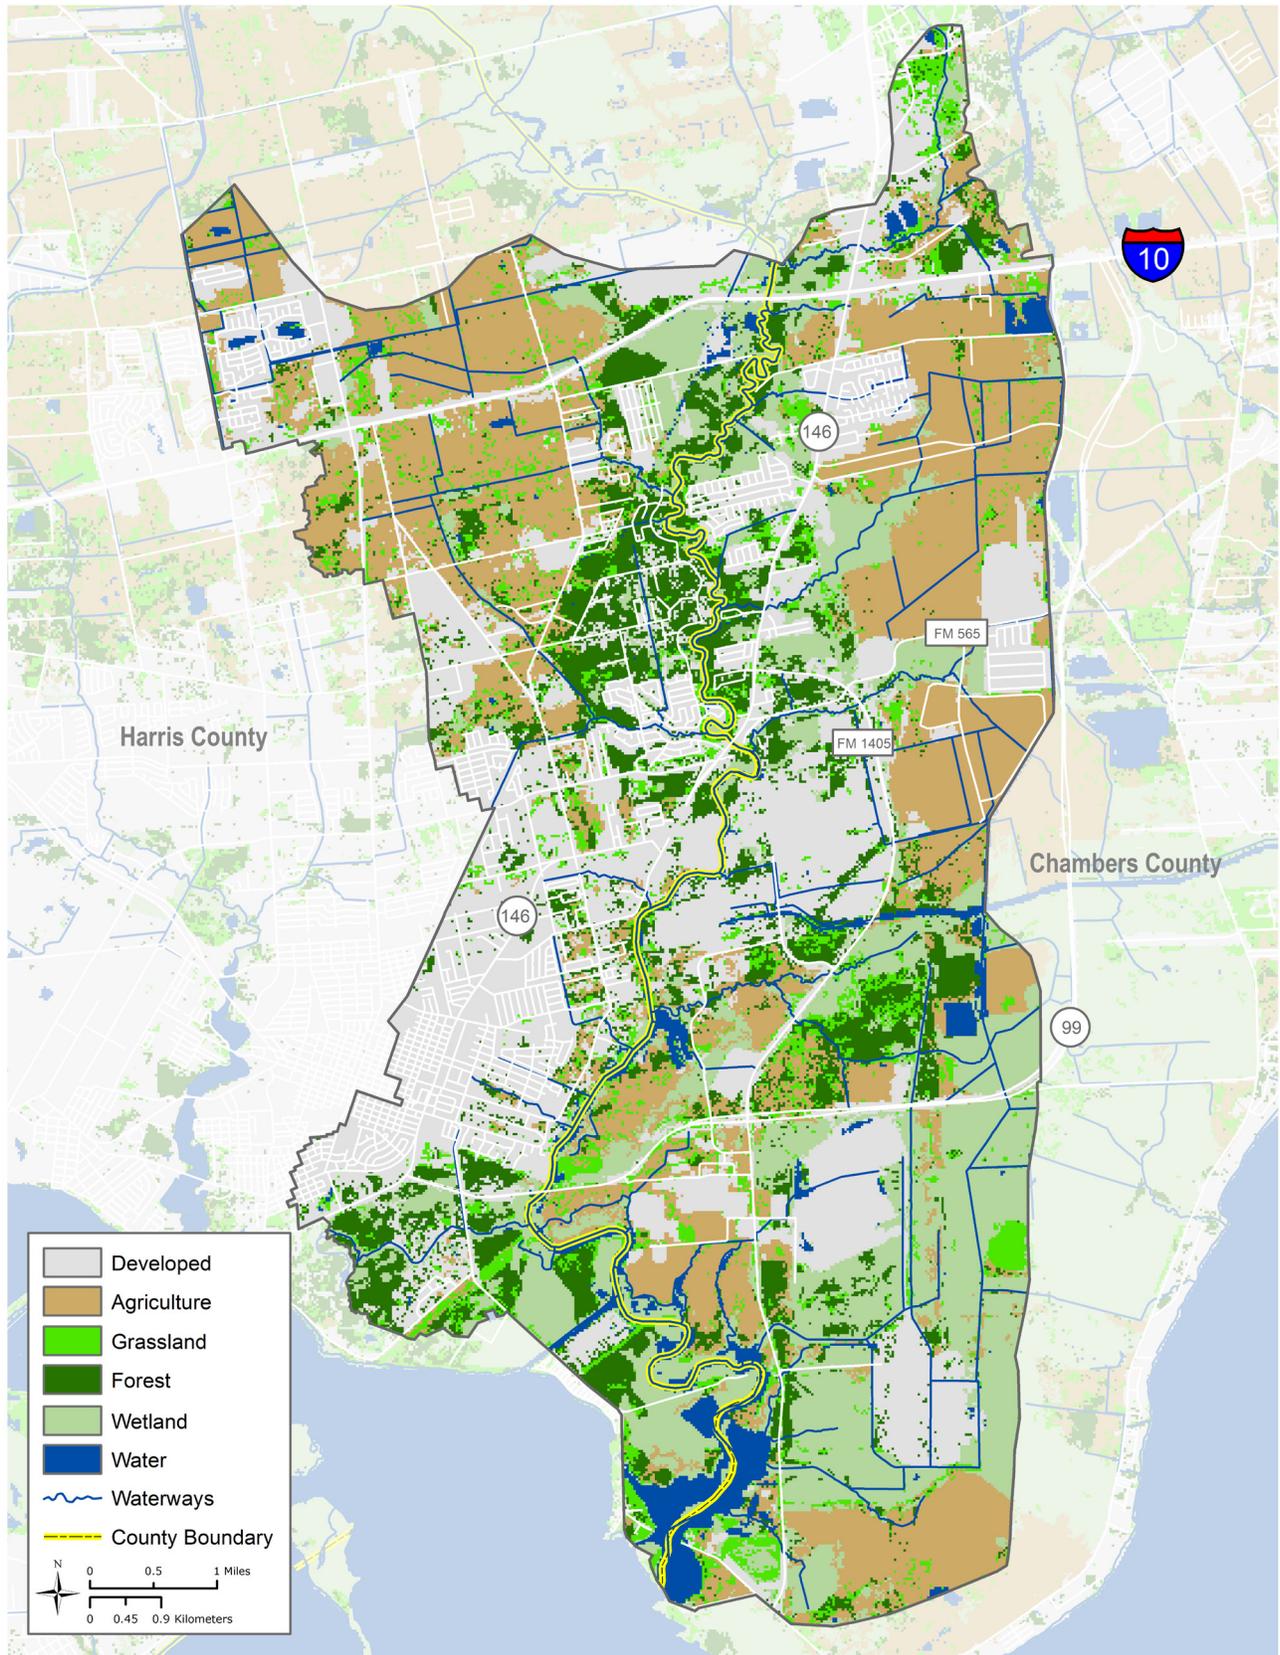
LAND USE

South of the Baytown area, the land uses include a variety of wetland and undeveloped land cover types. Specific uses of note in this area include a large solid waste landfill site adjacent to Cedar Bayou's east shore north of the mouth. Blocks of undeveloped bottomland forest, tidal wetland and coastal prairie can be found at the mouth of Cedar Bayou near its confluence with Upper Galveston Bay. Highly salt-tolerant plants are common to the coastal marshes and estuarine lakes in the lower reach.

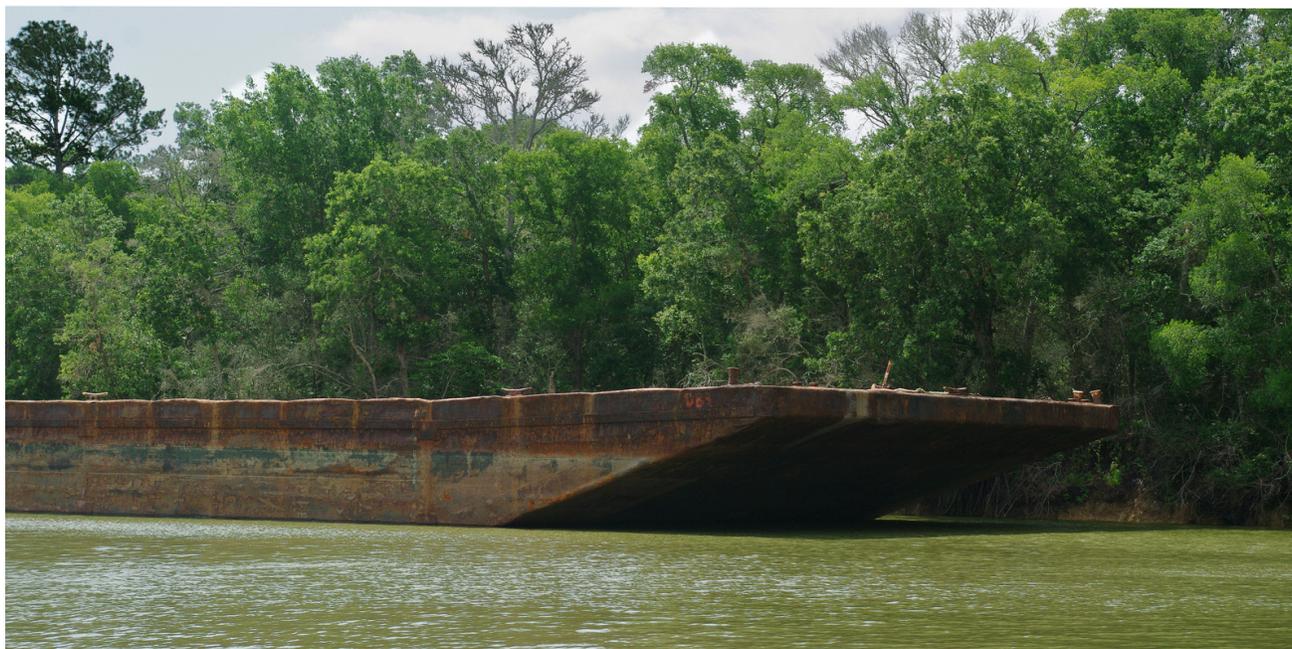
Recent efforts by WPP stakeholders and other local organizations resulted in removal of more than a dozen abandoned vessels from the segment, eliminating them as impediments to safety, sediment transport and as sources of legacy contamination. The photo below is of one vessel.

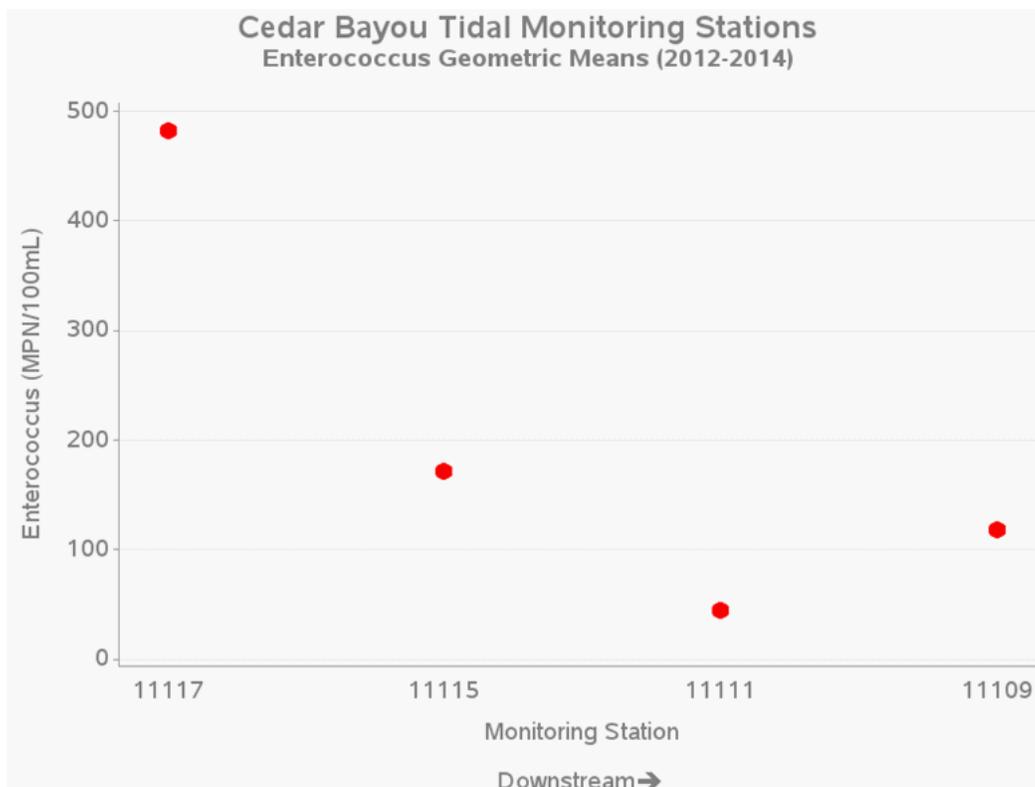
FIGURE 1

The tidal segment of Cedar Bayou is highly susceptible to bacterial contamination through wastewater and stormwater outfalls and aging collection systems; failing on-site sewage facilities (OSSF); and sheet flow from residential, agricultural and undeveloped areas. Monitoring data displays decreasing levels further downstream from I-10 showing the highest concentration of enterococci near the tidal/above tidal segment boundary at station ID 11117 (see Figure 1).

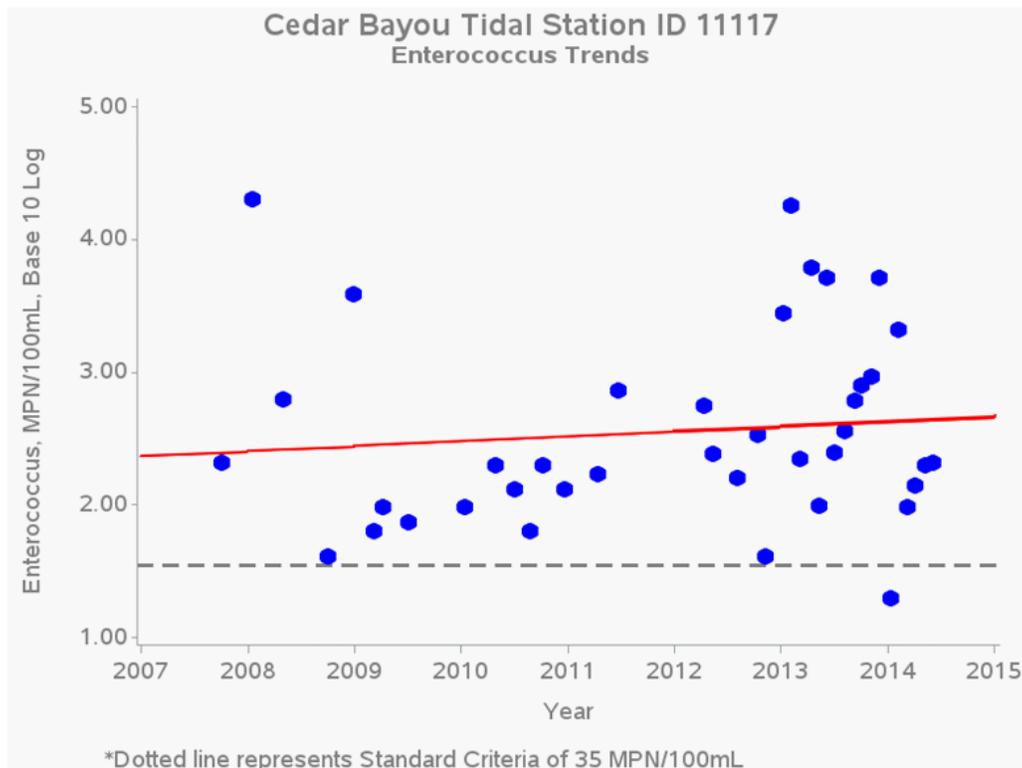
FIGURE 2

This trend is likely due in part to the widening channel and increased tidal influences as the stream approaches its confluence with Upper Galveston Bay. H-GAC’s analysis of enterococci data shows station ID 11117 to be the only station with a deteriorating bacteria trend (see Figure 2).

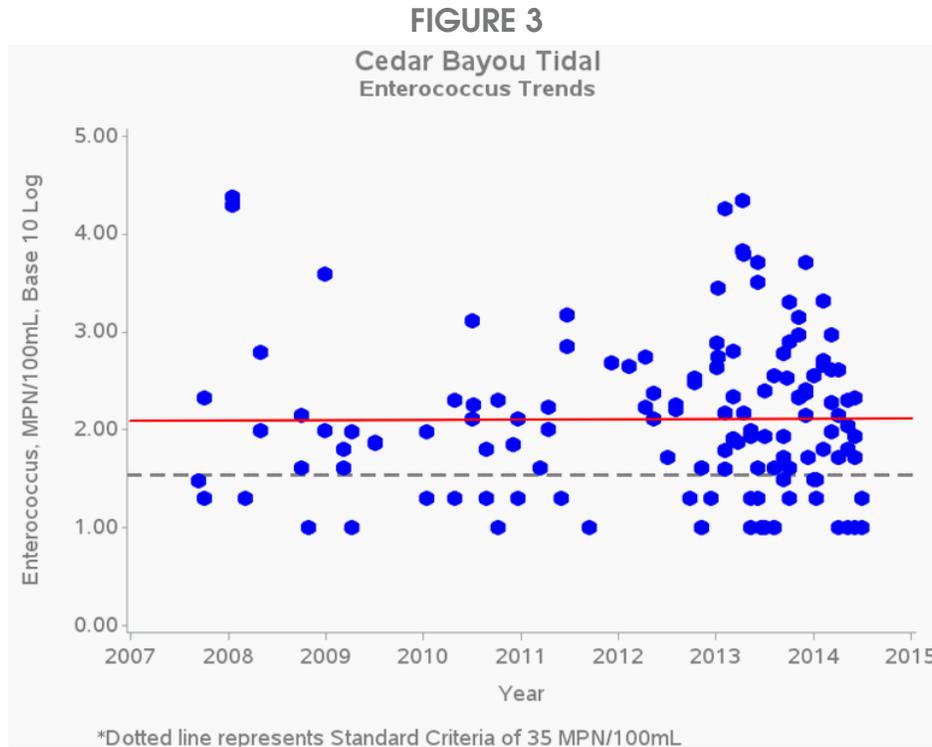
However, the majority of ambient data collected is still significantly higher than the 35 MPN/100mL standard set for Enterococcus (see Figure 3).

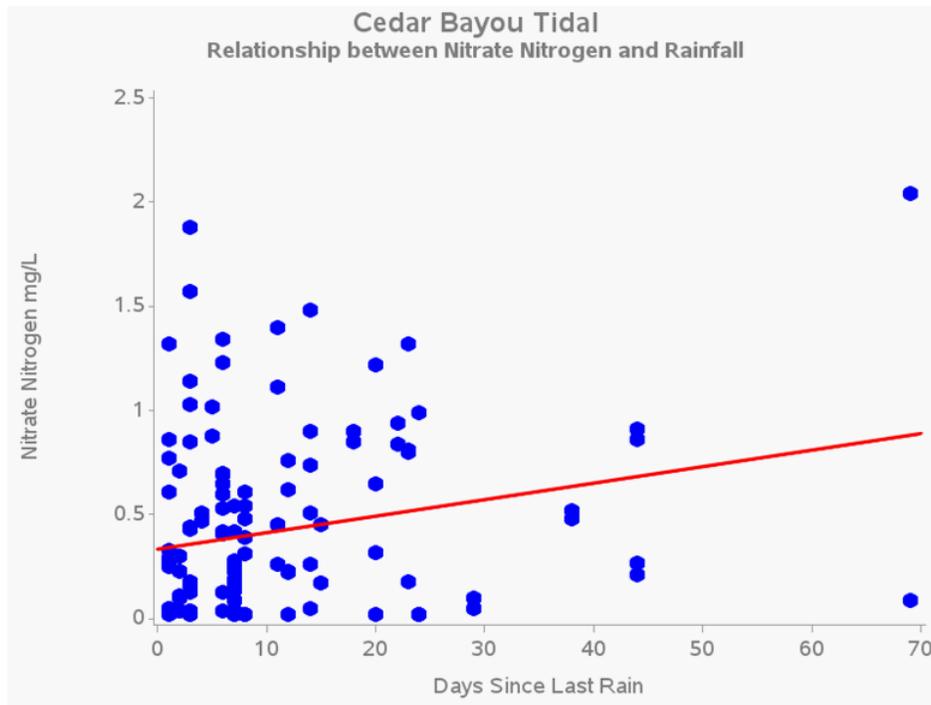
FIGURE 4

While the focus of current efforts under the WPP is on bacterial contamination, best management practices (reduction of human and pet waste, protection of riparian corridors, etc.) and concurrent efforts (implementation of Texas Pollutant Discharge Elimination System {TPDES} stormwater permits) may also affect nutrient levels.

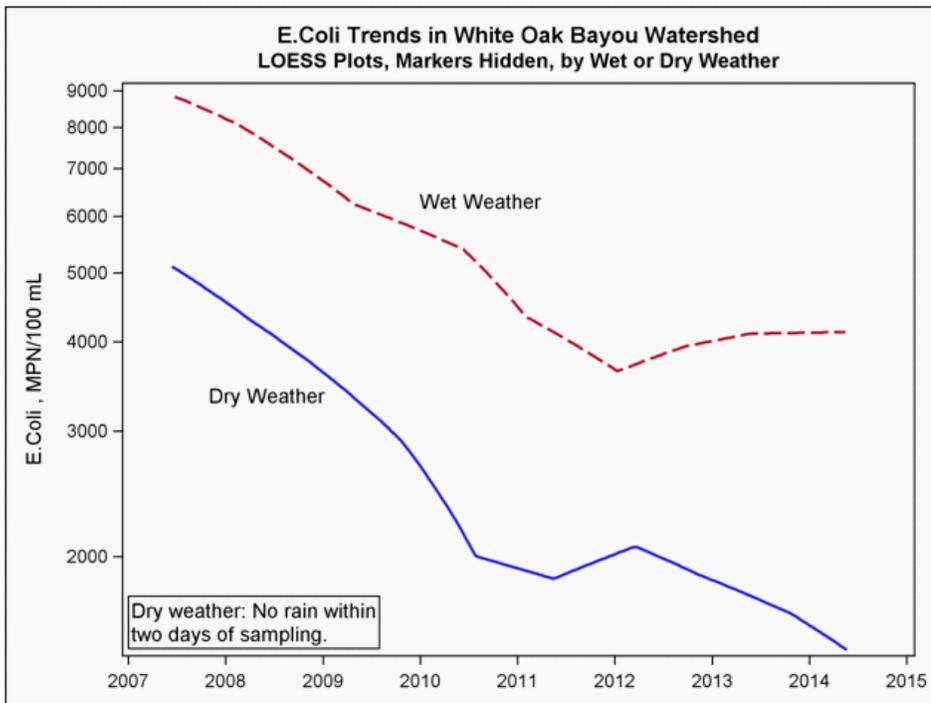
FIGURE 10

The data suggest that most bacteria measured in this watershed are introduced during wet weather. Although the dry weather levels are about five times the water quality standard, *E. coli* density is highest in wet weather. The geometric mean from all stations in the watershed is roughly 2200 MPN/100 mL during wet periods and 570 MPN/100 mL during dry periods. The good news is bacteria concentrations are declining over time during both wet and dry periods as seen in Figure 10.
