Executive Summary

The Houston-Galveston Area Council's (H-GAC) Targeted Monitoring Project focuses on the region's most prevalent pollutant – bacteria. The goal is to examine ten watersheds in various land cover types to identify bacteria sources (Table 1). A seven-year geometric mean analysis defining the severity of impairment was performed on each assessment unit (AU) within the region. H-GAC ranked waterways using the highest geomean relative to the state standards for contact recreation. Assessment units were selected by 1) highest geomean identified, 2) land cover type, and 3) accessibility and feasibility of the waterway for field investigations (Figure 1).

Bintliff Ditch (1007T_01)

Bacteria Monitoring Report

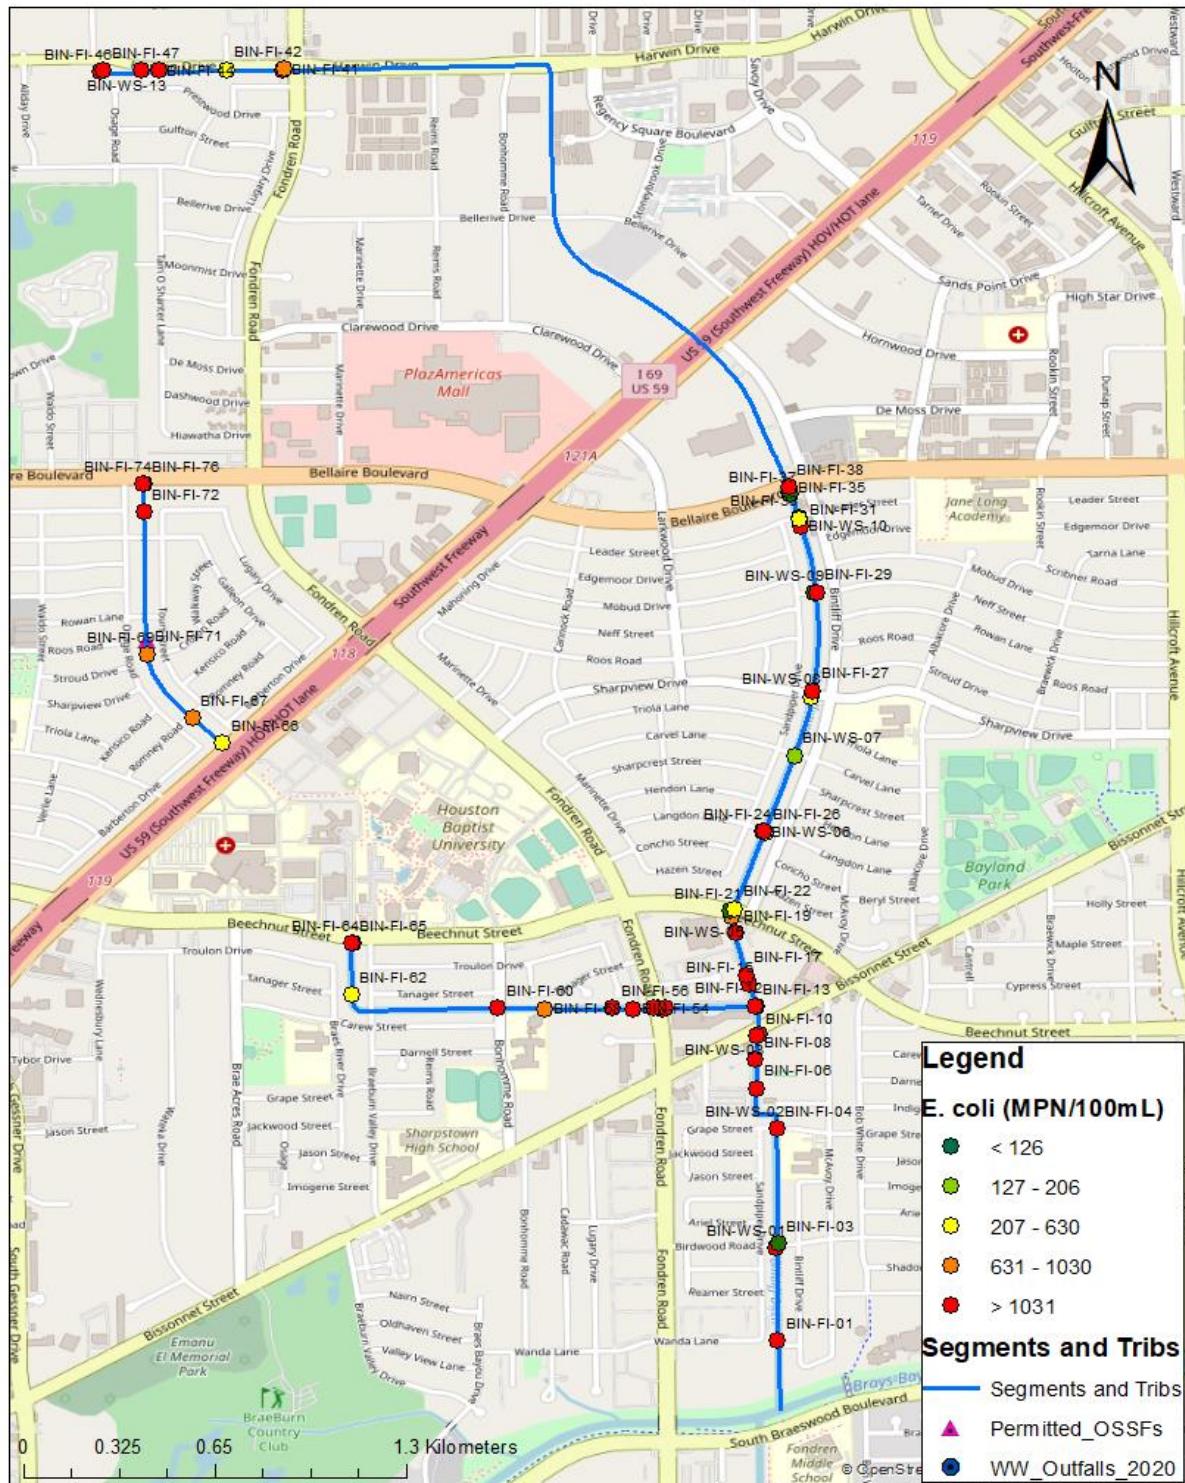
Figure 2. Map of Field Investigation bacteria results from April 6, 2021. Results displayed are the raw bacteria levels from the samples collected downstream of permitted outfalls, or directly from un-permitted outfalls.

The FI of the main stream and tributary was conducted on April 6, 2021 (9 days since last significant rainfall) and a total of 76 bacteria samples were collected. The values of the bacteria samples collected from downstream of permitted outfalls, or directly from un-permitted outfalls are illustrated in Figure 2. A total of eight referral locations with elevated *E. coli* bacteria levels measured during the FI are recommended for further investigation by the proper authorities. These locations are summarized in Table 1. Each of these referrals are summarized by site herein. Much of the segment had ambient samples with bacteria levels at or greater than 24,200 MPN/100mL (cells highlighted in yellow in Table 1). A segment-wide investigation by the authorities or a second field investigation on this segment is recommended.

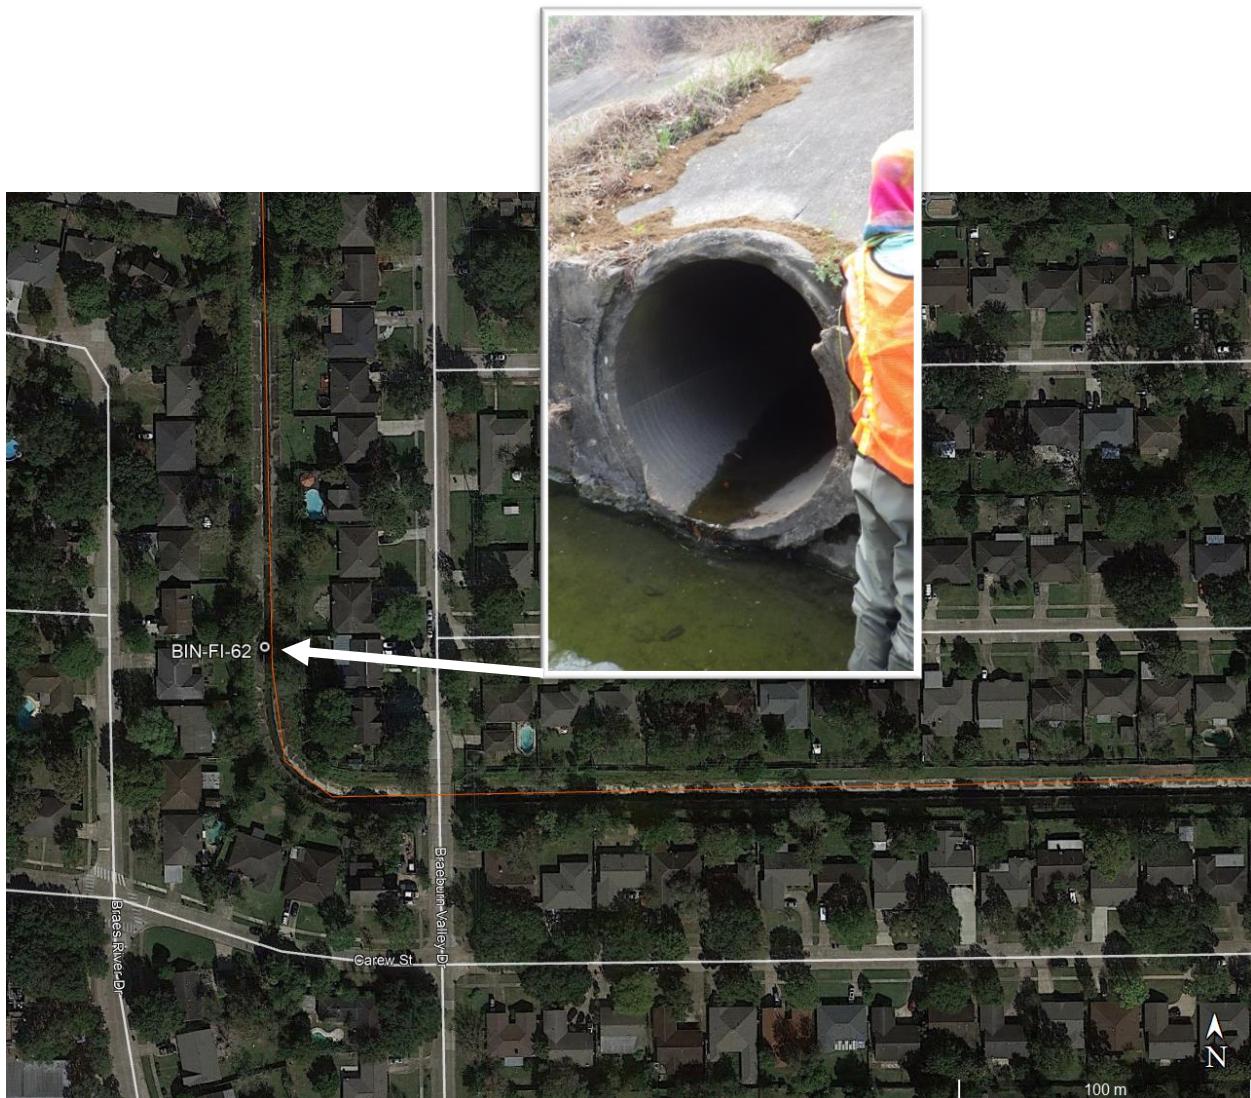
Referral site: BIN-FI-62

This site is located along the tributary of the Bintliff Ditch assessment unit. The outflow pipe on the right bank was made of concrete and had an inner diameter of 40 inches. The water flowing from the pipe had a depth of 0.25 inches. The sample collected from upstream of the outflow had a low *E. coli* bacteria value of 10 MPN/100ML while the downstream value was 471 MPN/100ML. This means the drainage exiting this pipe was adding bacteria to the stream, increasing the detected value by 461 MPN/100ML. Photo taken shows the concrete drainage pipe.

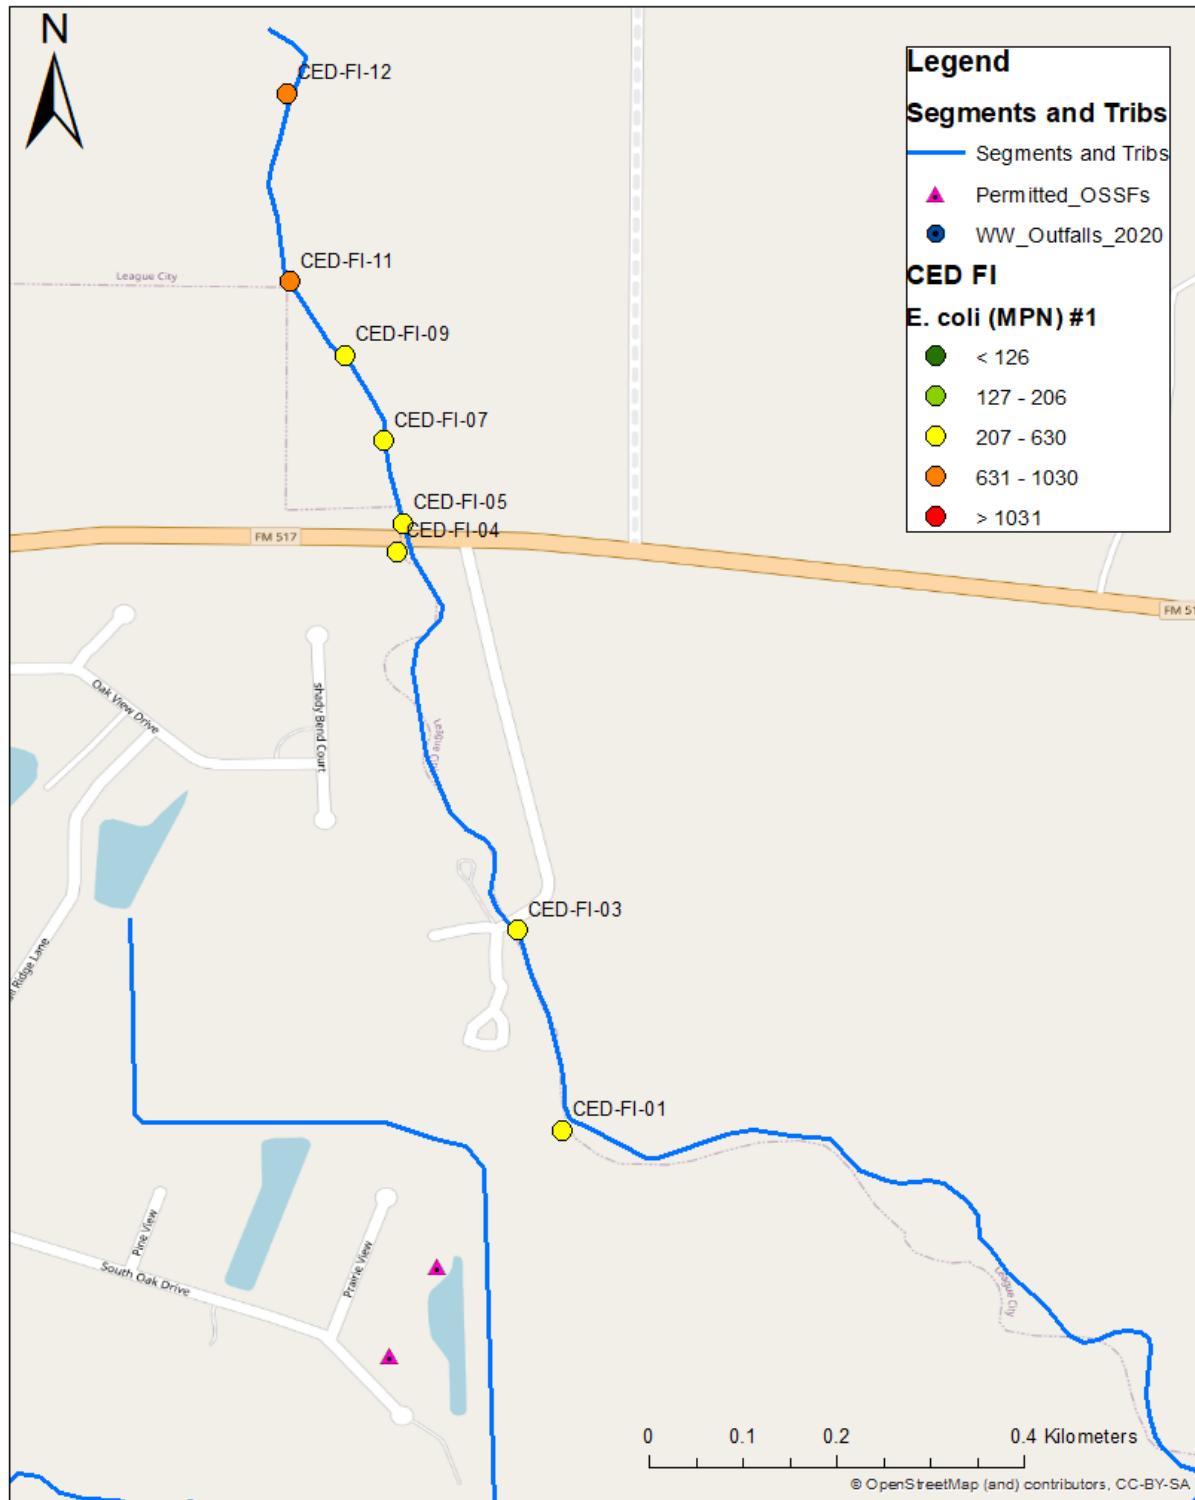
Figure 2. Map of Field Investigation bacteria results from April 7, 2021. The color of the sample location relates to the raw bacteria levels from the samples collected downstream of permitted outfalls, or directly from un-permitted outfalls.

The FI was conducted on April 7, 2021 (14 days since last significant rainfall) and a total of 12 bacteria samples were collected. The values of the bacteria samples collected from downstream of permitted outfalls, or directly from un-permitted outfalls are illustrated in Figure 2 and Table 1. Only one location with elevated *E. coli* bacteria levels measured during the FI is recommended for further investigation by the proper authorities. This site is not an outfall, but an ambient sample taken at the most upstream site of the assessment unit. This referral location is summarized on page 7.

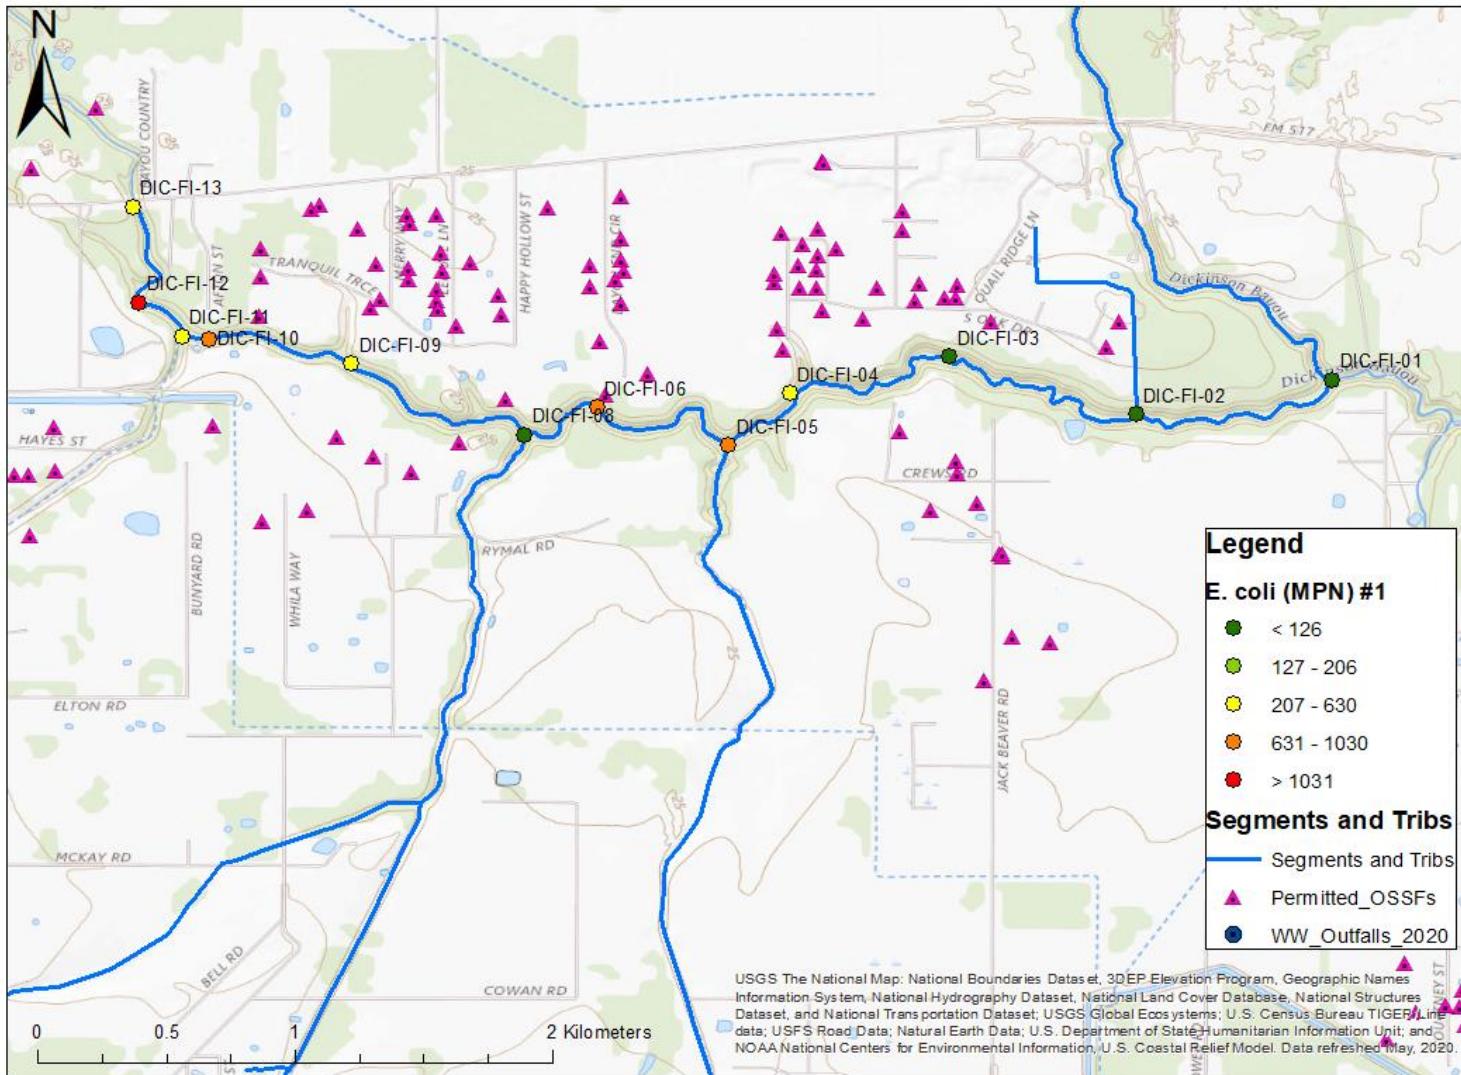
Figure 2. Map of Field Investigation bacteria results from April 12, 2021. Results displayed are the raw bacteria levels from the samples collected downstream of permitted outfalls, or directly from un-permitted outfalls.

The FI was conducted on April 12, 2021 (15 days since last significant rainfall) and a total of 13 bacteria samples were collected. The values of the bacteria samples collected from downstream of permitted outfalls, or directly from un-permitted outfalls are illustrated in Figure 2. A total of five locations with elevated *E. coli* bacteria levels measured during the FI are recommended for further investigation by the proper authorities. These locations are summarized in Table 1 and each of these referrals are summarized by site herein.

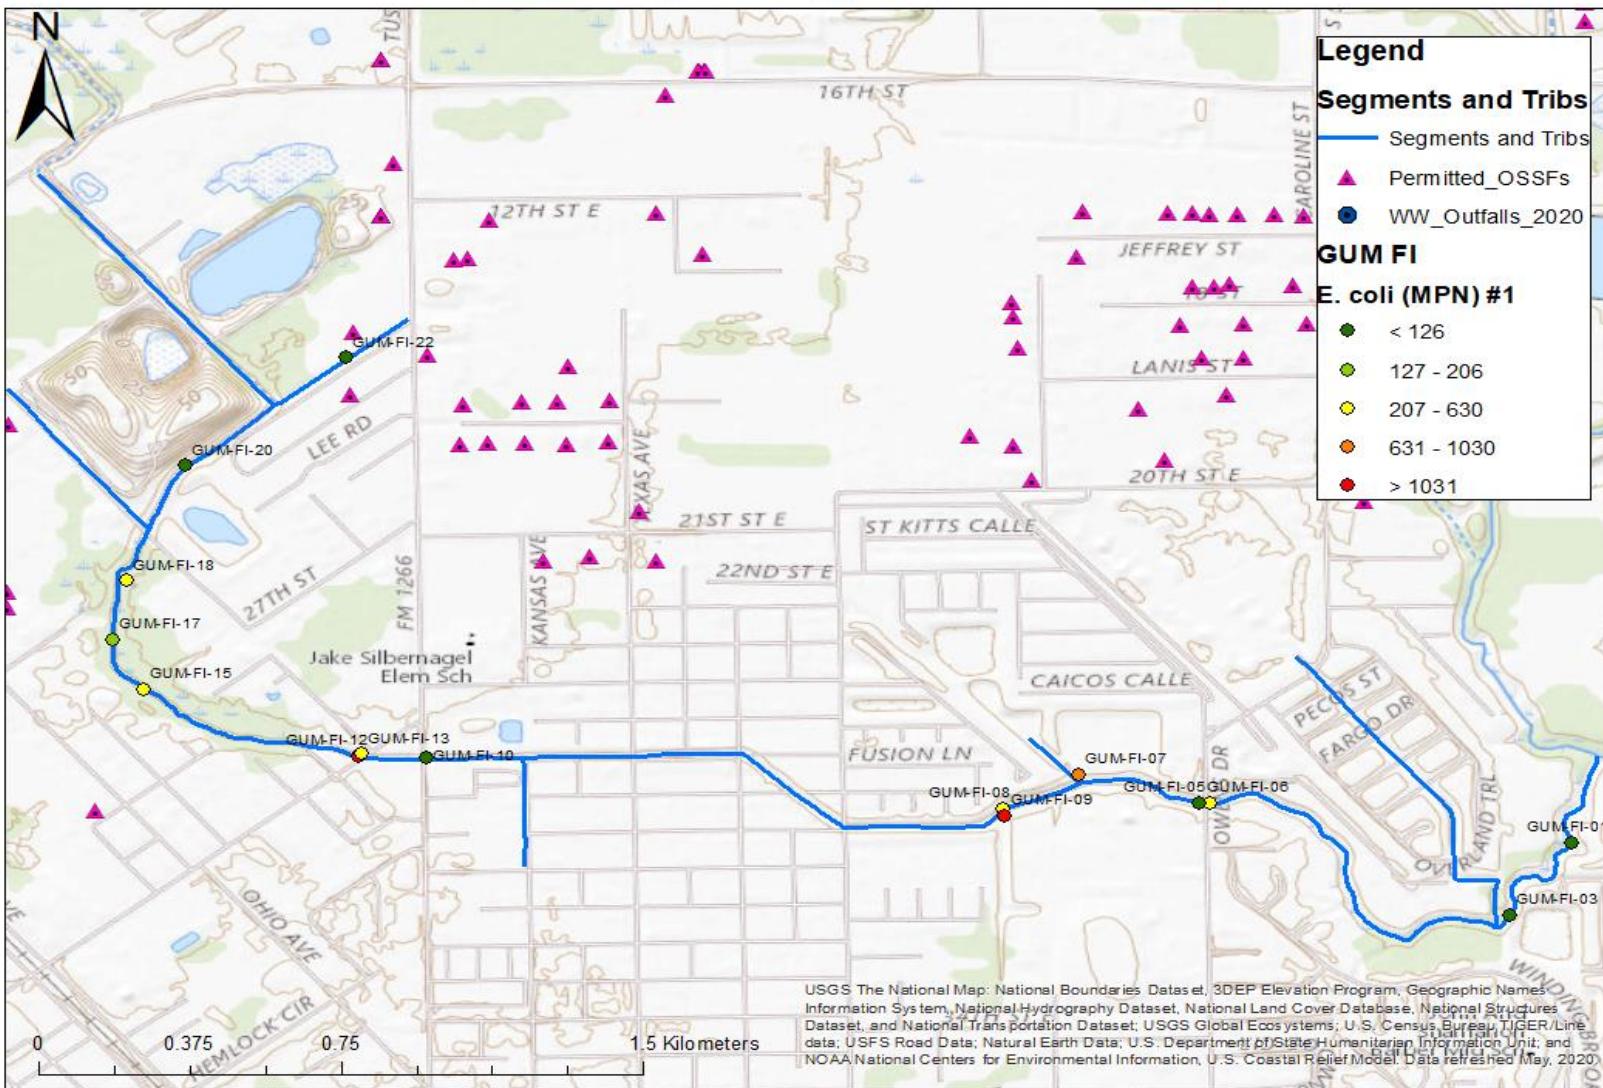
Figure 2. Map of Field Investigation bacteria results from April 5, 2021. Results displayed are the raw bacteria levels from the samples collected downstream of permitted outfalls, or directly from un-permitted outfalls.

Based on the results of the windshield survey, focus during the field investigation was placed on the main AU and three previously unsampled tributaries. The FI was conducted on April 5, 2021 (6 days since last significant rainfall) and a total of 22 bacteria samples were collected. The values of the bacteria samples collected from downstream of permitted outfalls, or directly from un-permitted outfalls are illustrated in Figure 2. A total of 4 locations with elevated *E. coli* bacteria levels measured during the FI are recommended for further investigation by the proper authorities. These locations are summarized in Table 1 (gray rows). Each of these referrals are summarized by site herein.

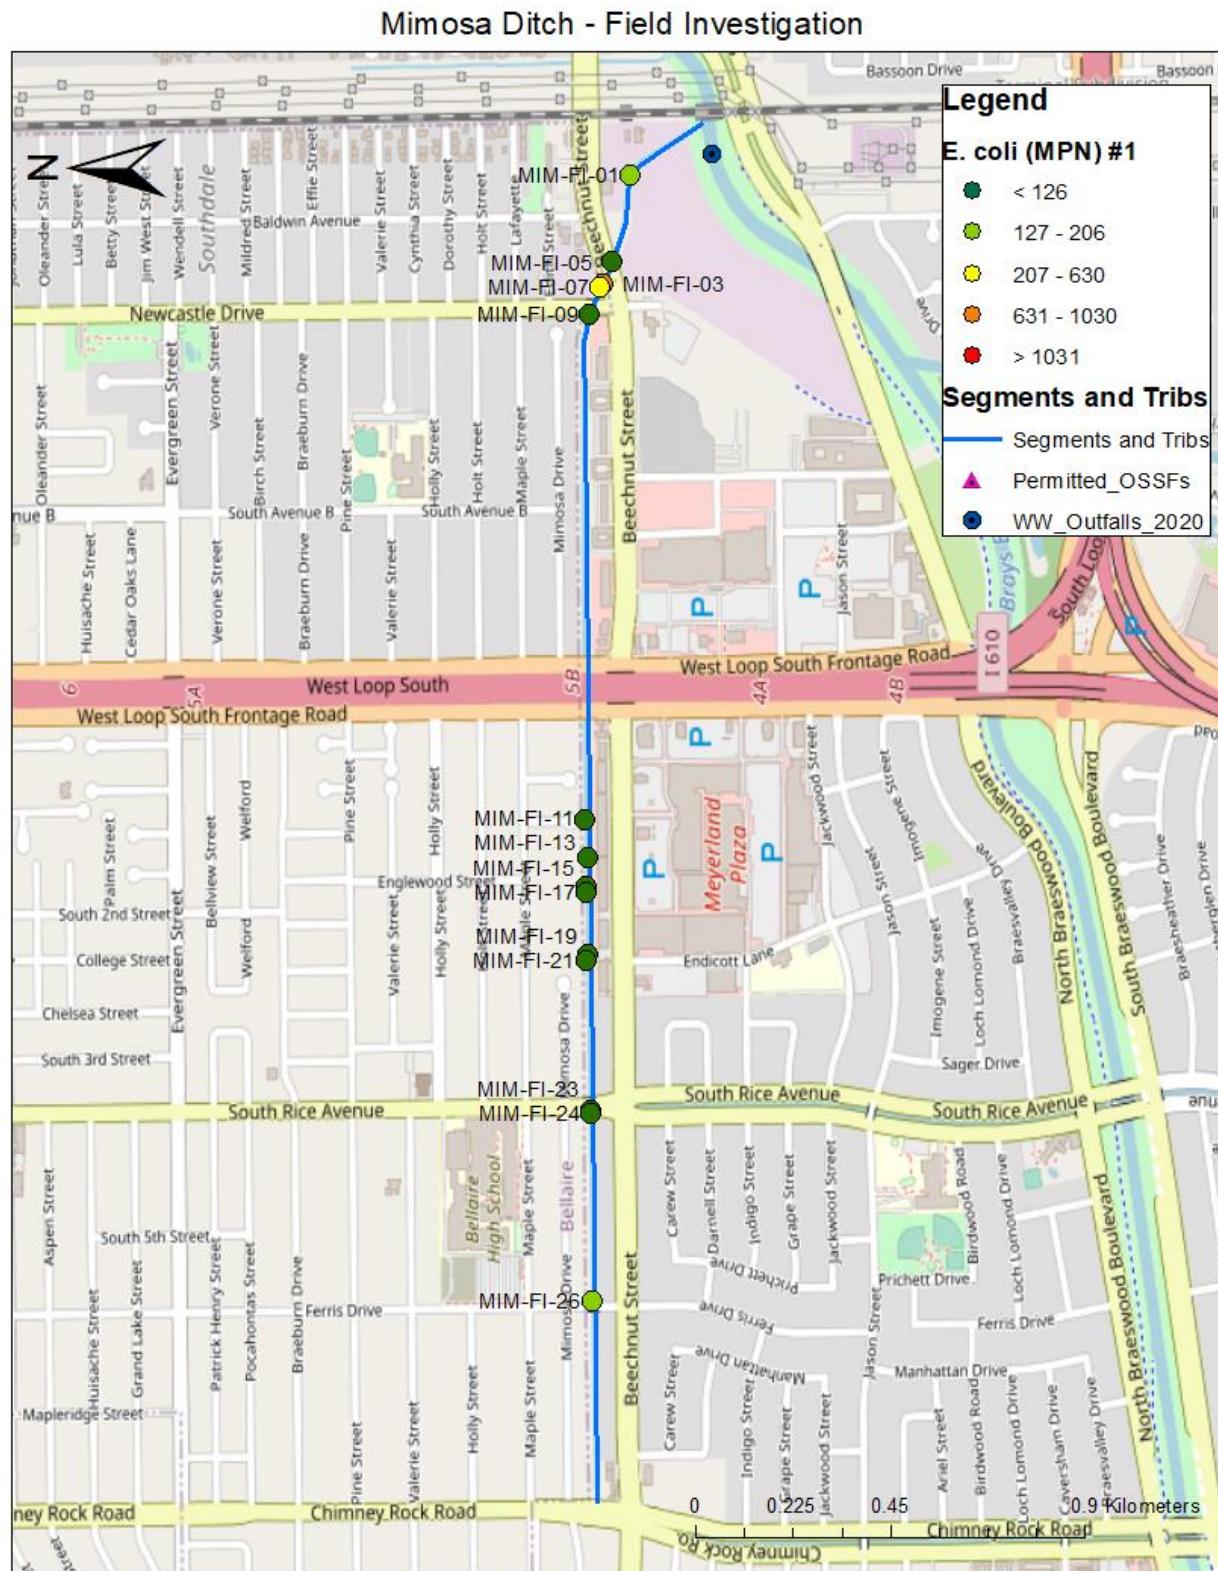
Figure 2. Map of Field Investigation bacteria results from March 12, 2021. Results displayed are the raw bacteria levels from the samples collected downstream of permitted outfalls, or directly from un-permitted outfalls.

The FI was conducted on March 12, 2021 (11 days since last significant rainfall) and a total of 26 bacteria samples were collected. The values of the bacteria samples collected from downstream of permitted outfalls, or directly from un-permitted outfalls are illustrated in Figure 2. A total of 4 locations with elevated *E. coli* bacteria levels measured during the FI are recommended for further investigation by the proper authorities. These locations are summarized in Table 1. Each of these referrals are summarized by site herein.

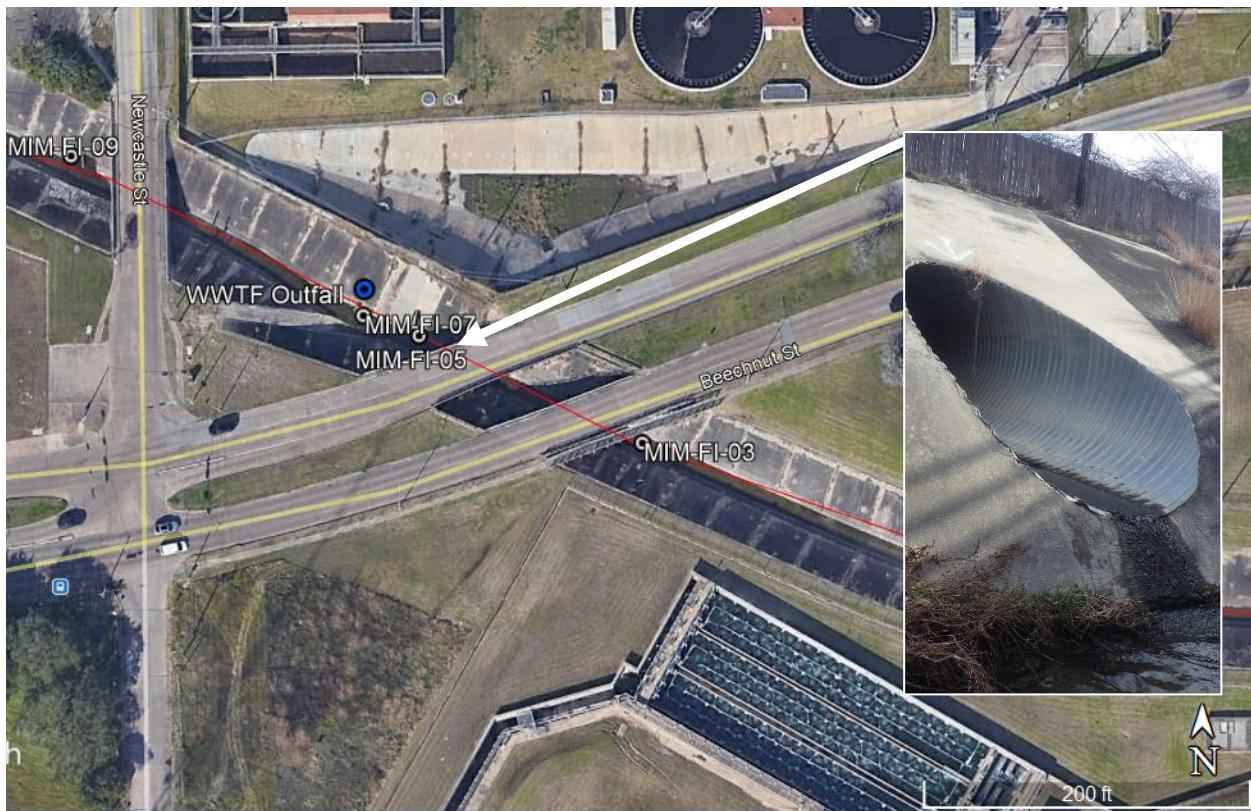
Referral site: MIM-FI-05

This site is a metal pipe, ~ 70 inches in diameter coming out of the left bank located just downstream of the permitted waste water treatment facility outfall between Newcastle St. and Beechnut St. The sample collected in the mixing zone, just downstream of the outfall had a bacteria value of 683 MPN/100ML, and the ambient sample collected just upstream of the outfall (mid channel) had a bacteria value of 119 MPN/100ML (MIM-FI-06) indicating that the outfall is likely a source of elevated bacteria. Photo of pipe taken looking onto the left bank from slightly upstream.

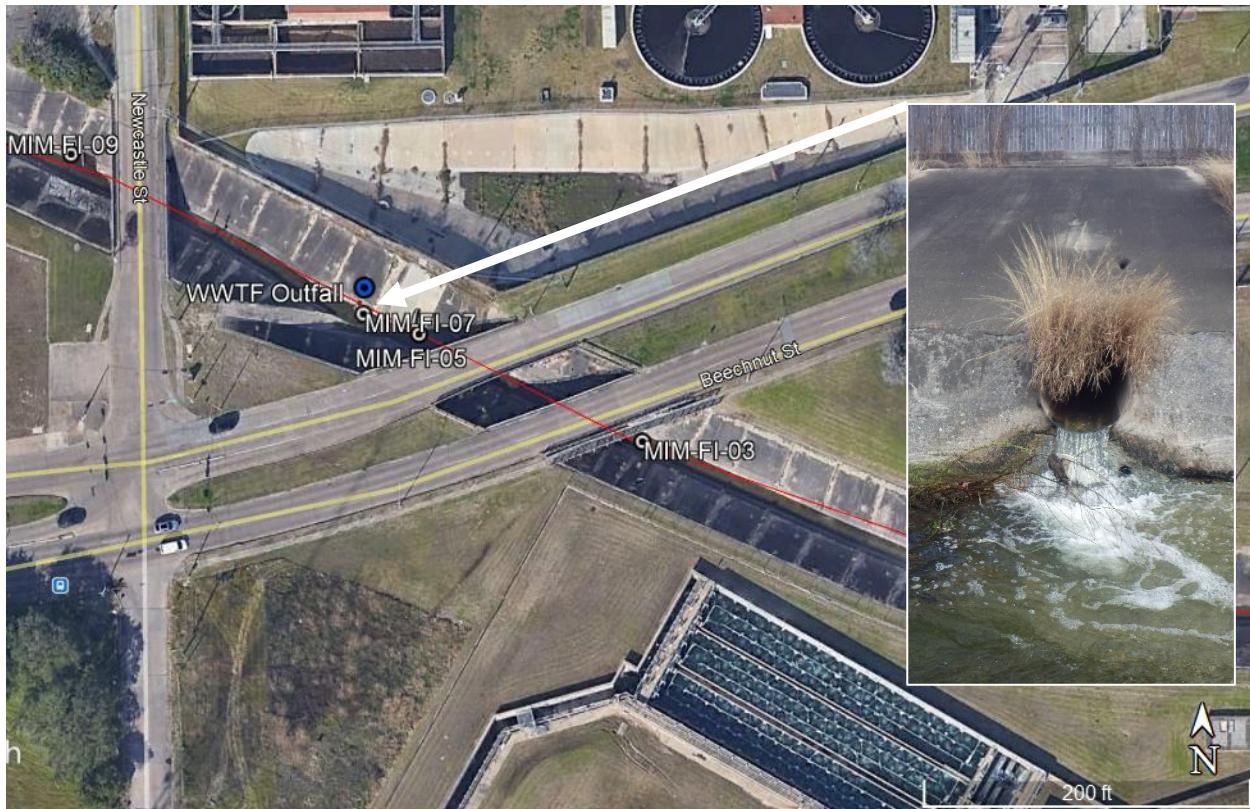
Referral site: MIM-FI-07

This site is a metal pipe, ~ 37 inches in diameter coming out of the left bank and is believed to be the permitted waste water treatment facility outfall between Newcastle St. and Beechnut St. The sample collected in the mixing zone, just downstream of the outfall had a bacteria value of 313 MPN/100ML, and the ambient sample collected just upstream of the outfall (mid channel) had a bacteria value of 160 MPN/100ML (MIM-FI-08) indicating that the outfall is likely a source of elevated bacteria. Photo of pipe taken looking onto the left bank from mid-channel. It is important to note that the field crew made a remark on the field datasheet that they did not observe any aquatic vegetation, fish, or invertebrates in the downstream of the permitted waste water treatment facility outfall, but that all of those things were observed upstream of it. Chlorine levels were not tested.

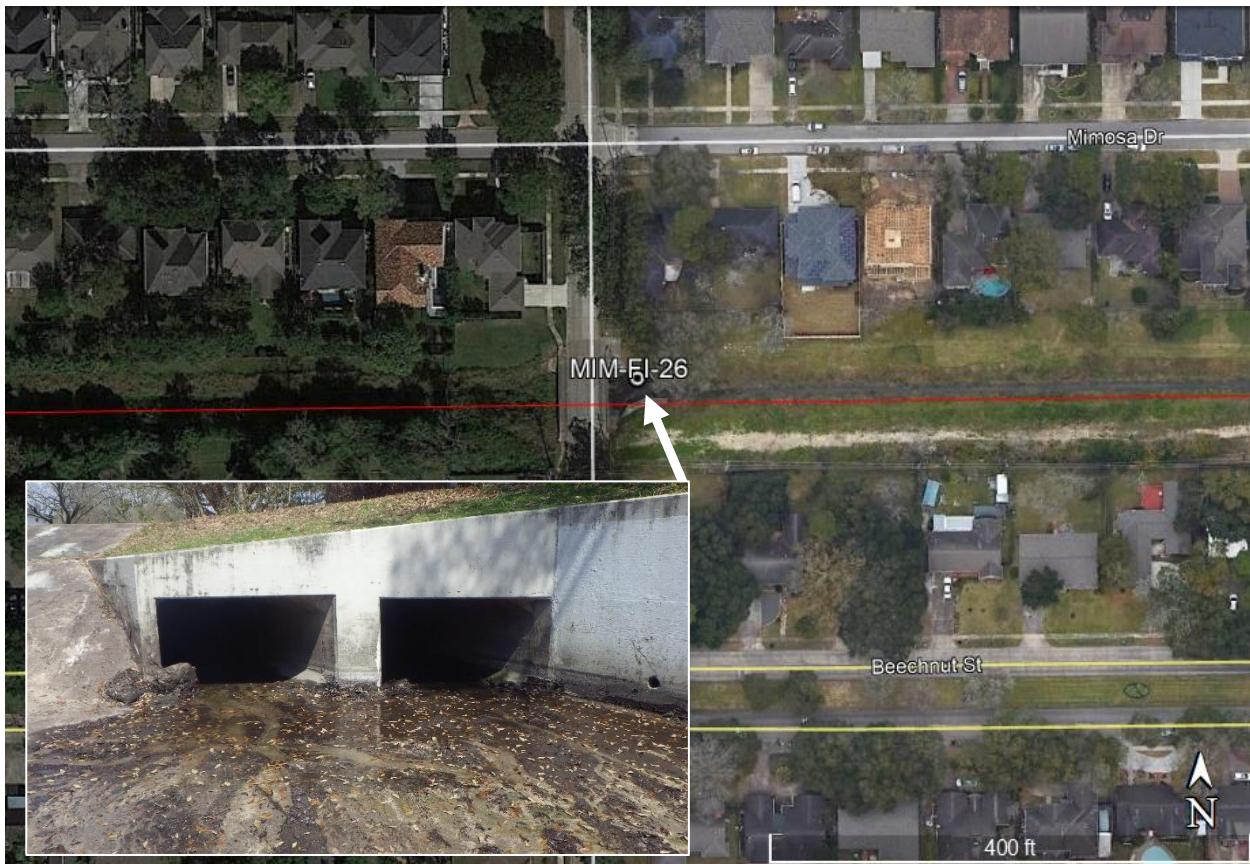
Referral site: MIM-FI-26

This site is at the top of the segment where two ~60 inch tall square concrete culverts enter from the left bank at the bridge crossing of Ferris Dr. The sample taken just downstream of the culverts was 132 MPN/100ML indicating that there is likely a bacteria source upstream of this location. The ambient sample taken further downstream at Rice Ave was also elevated (199 MPN/100ML). Note, the segment upstream of this bridge crossing on Mimosa Ditch was dry. Photo of culverts taken looking onto the left bank.

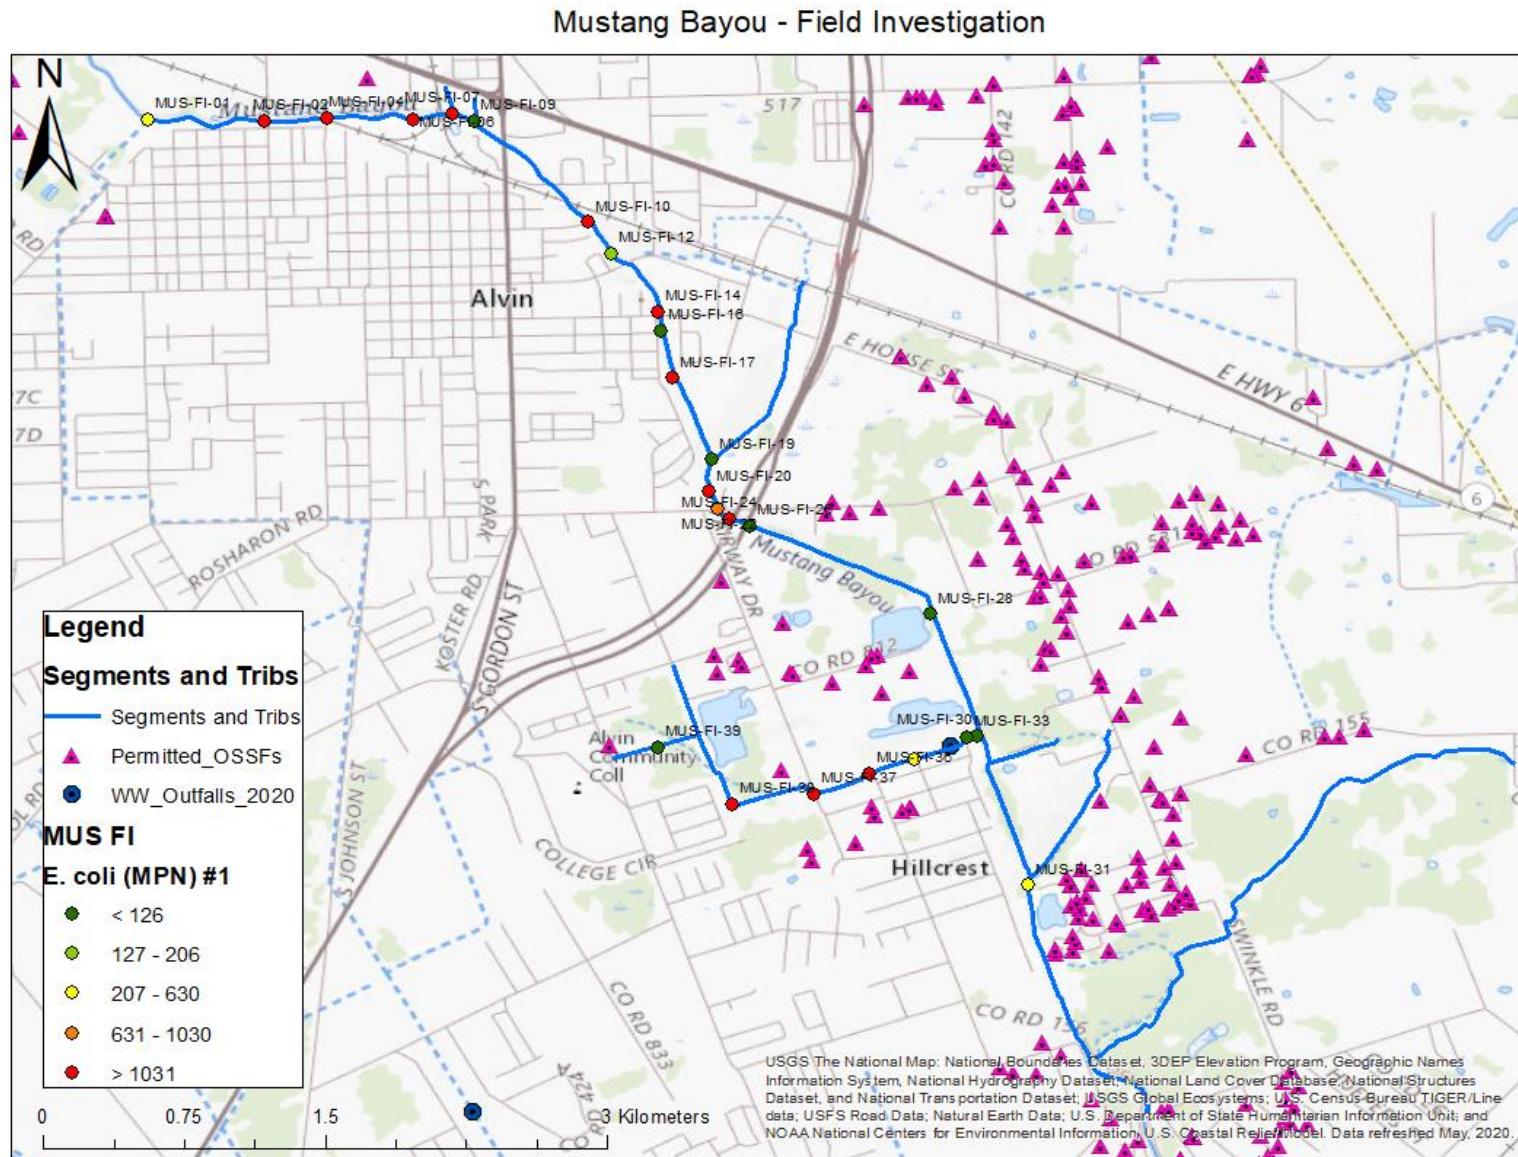
Figure 2. Map of Field Investigation bacteria results from April 5 and April 6, 2021. Results displayed are the raw bacteria levels from the samples collected downstream of permitted outfalls, or directly from un-permitted outfalls

The FI was also conducted across two days, April 5 and April 6, 2021 (8 and 9 days respectively since last significant rainfall) due to time constraints on the first day. A total of 39 bacteria samples were collected, 32 on the first day of sampling and 7 on the second. The values of the bacteria samples collected from downstream of permitted outfalls, or directly from un-permitted outfalls are illustrated in Figure 2. A total of ten locations with elevated *E. coli* bacteria levels measured during the FI are recommended for further investigation by the proper authorities. These locations are summarized in Table 1. Each of these referrals are summarized by site herein.

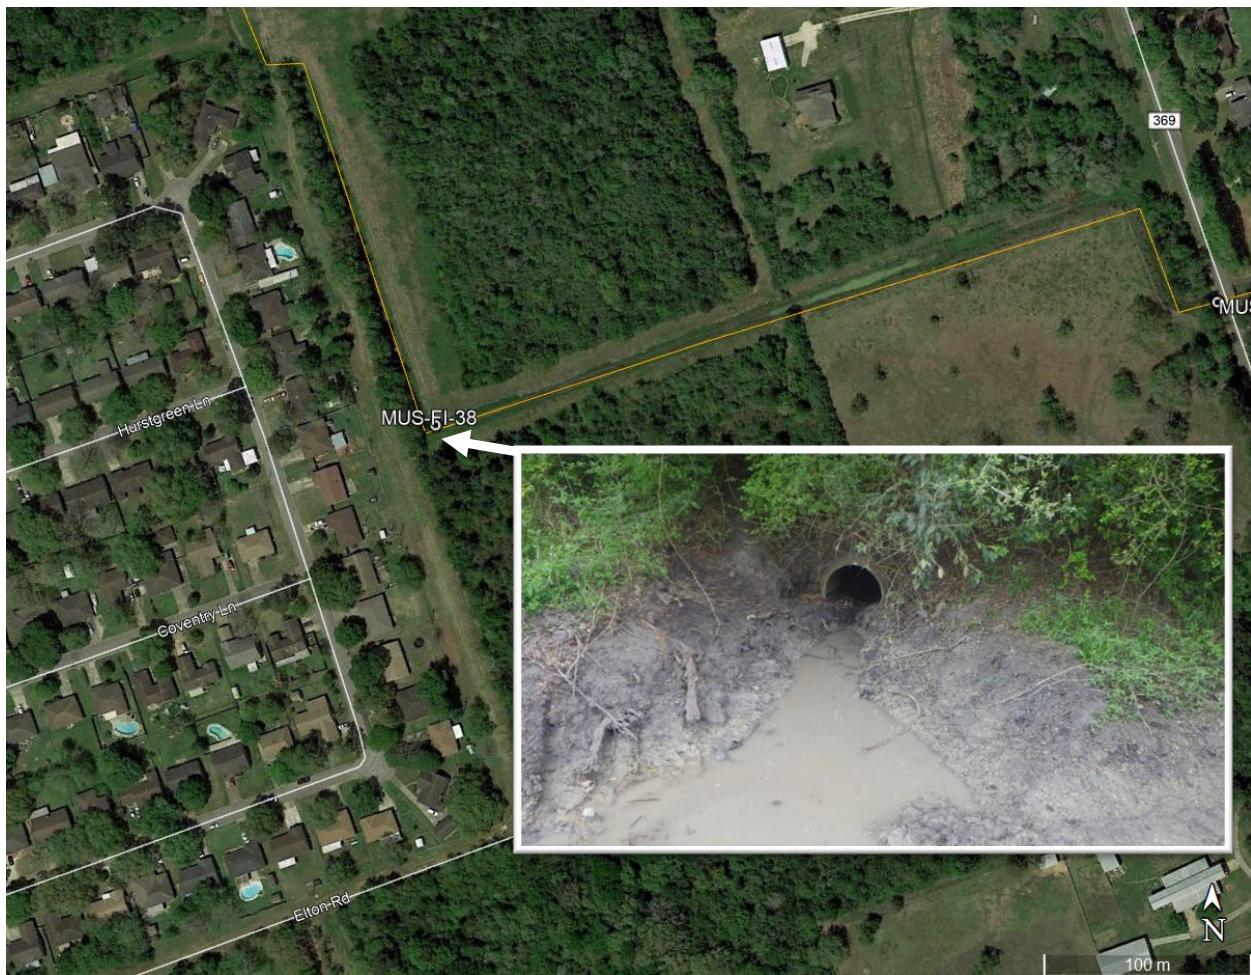
Referral site: MUS-FI-38

This site is located along the fourth tributary of Mustang Bayou near a neighborhood. The pipe located at this site was concrete and 20 inches in diameter. There was about 0.25 inches of water in the pipe at the time of sampling. The sample was collected from a pool outside the pipe where the water sits before flowing into the stream. The stream looked recently dredged along this portion of the tributary. The sample collected at this location had an *E. coli* bacteria value of 3,650 MPN/100ML. Further investigation is suggested. Photo taken shows pipe and pooling in recently dredged area.

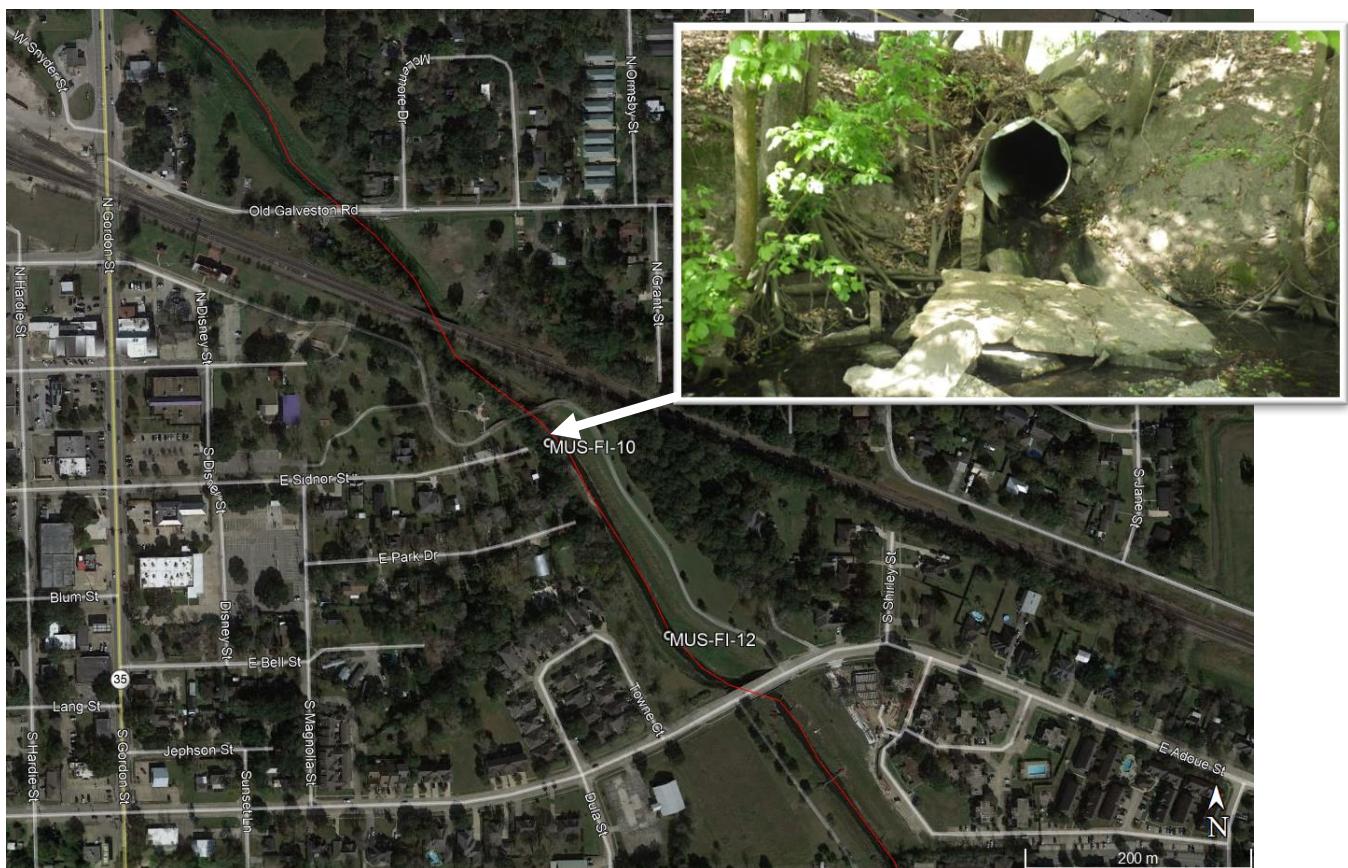
Referral site: MUS-FI-10

This site is located in a residential area and the pipe was located along the right bank. The pipe is metal with a 40-inch diameter and 0.5 inches of water within. The pipe was broken with water flowing straight down into the stream. The downstream sample was taken in this mixing zone, which had a bacteria value of 3,260 MPN/100ML. The upstream sample had a bacteria value of 933 MPN/100ML, with a difference of 2,327 MPN/100ML. This site is located just downstream of a park. Further investigation is suggested. Photo taken of the pipe on the right bank with rusted out bottom.

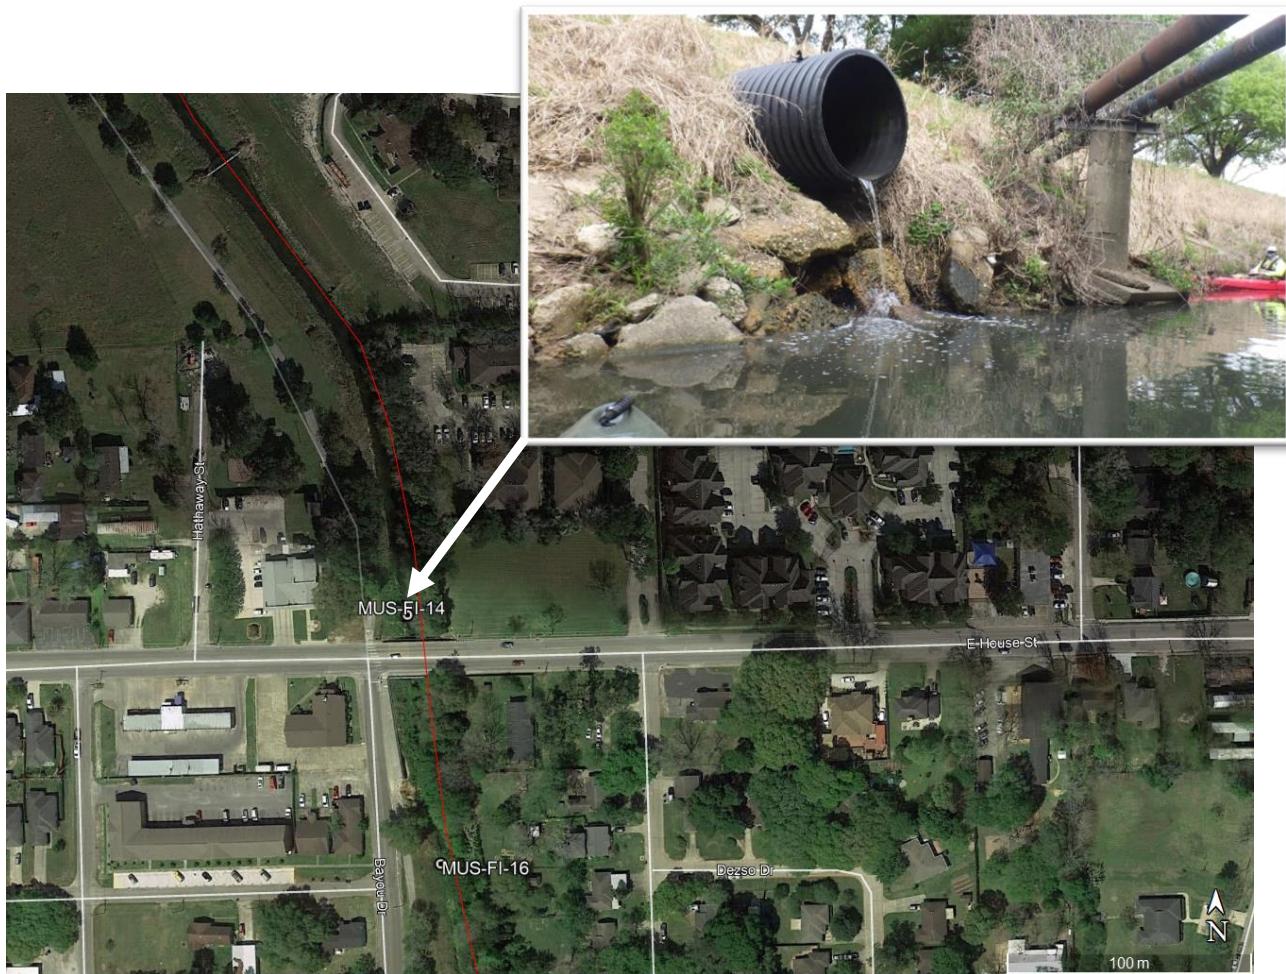
Referral site: MUS-FI-14

This site is located on the right bank in an area with many townhomes and a dog park. The corrugated plastic/plastic coated pipe had a diameter of 56-inches with consistent water flow, about 1.5 inches within the pipe. The sample collected from the mixing zone had an *E. coli* bacteria value of 2,380 MPN/100ML. The upstream sample was 504 MPN/100ML, giving a difference of 1,876 MPN/100ML. This site is downstream of a dog park which could be contributing bacteria, but further investigation is necessary. Photo taken of the plastic pipe on the right bank.
