Executive Summary

The Houston-Galveston Area Council's (H-GAC) Targeted Monitoring Project focuses on the region's most prevalent pollutant – bacteria. The goal is to examine ten watersheds in various land cover types to identify bacteria sources (Table 1). A seven-year geometric mean analysis defining the severity of impairment was performed on each assessment unit (AU) within the region. H-GAC ranked waterways using the highest geomean relative to the state standards for contact recreation. Assessment units were selected by 1) highest geomean identified, 2) land cover type, and 3) accessibility and feasibility of the waterway for field investigations (Figure 1).

Bintliff Ditch (1007T_01)

Bacteria Monitoring Report

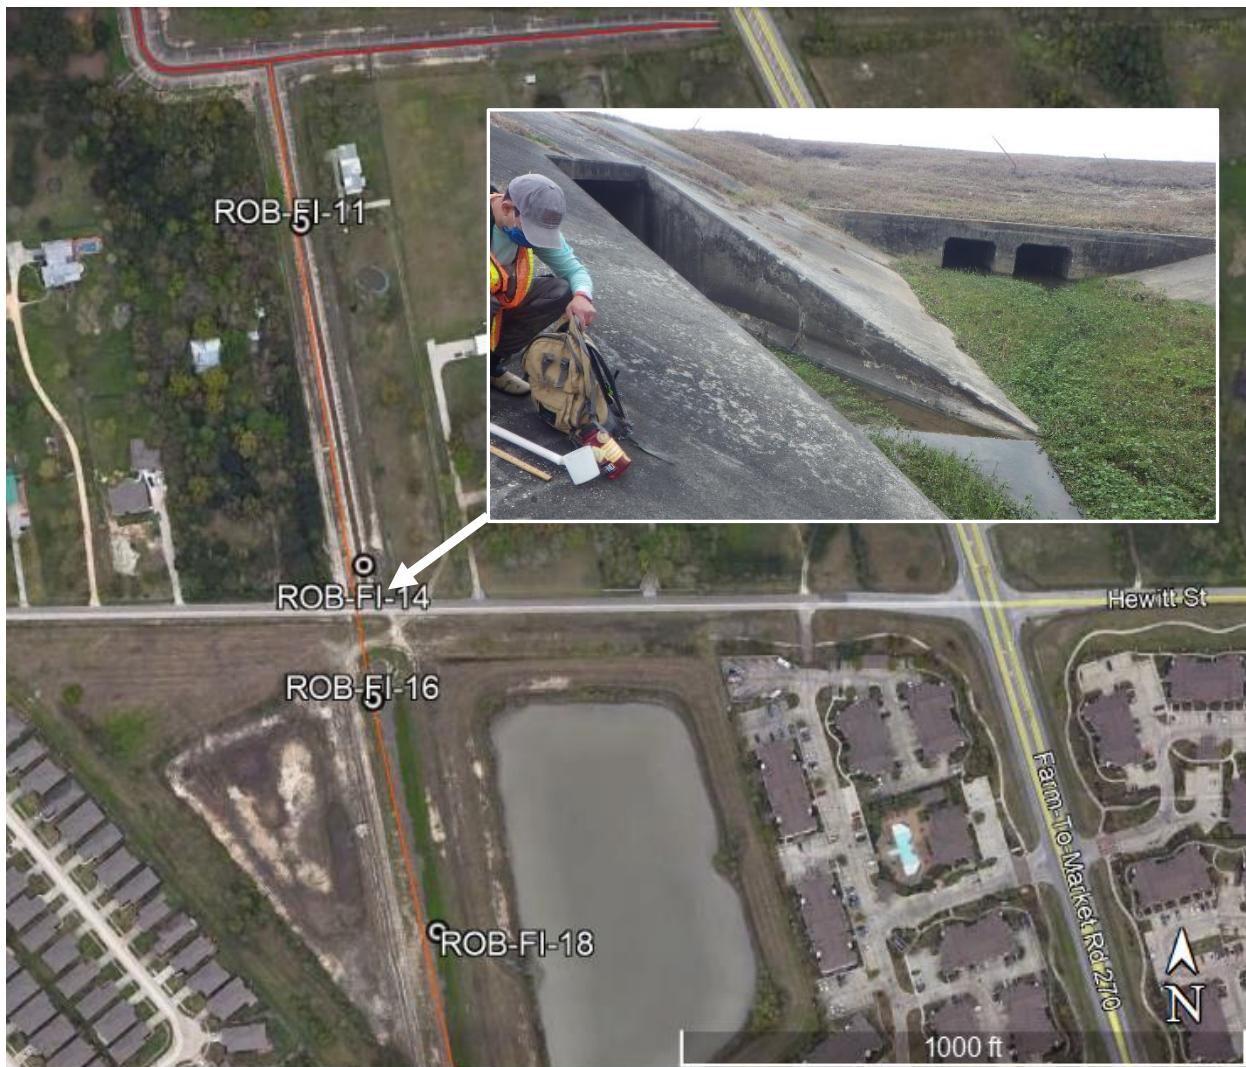
Referral site: ROB-FI-14 (Upstream sample from sites ROB-FI-12 and -13)

This site is located at the fourth unnamed tributary to Robinson Bayou and Hewitt St. The highest bacteria value of 7700 MPN/100ML was collected just downstream of the bridge crossing, with another high value (3650 MPN/100ML) collected just below the flowing culvert on the right bank. The ambient sample taken immediately upstream of the bridge (ROB-FI-16) had a low bacteria value (20 MPN/100ML) and the next sample downstream (ROB-FI-11) also had a relatively low bacteria value (122) indicating that there is likely a source somewhere under the bridge. It appeared that the culvert on the right bank as well as the two culverts directly under the bridge (pictured below) all connect through to the upstream side of the bridge. The field crew did not enter the culverts at the time of the FI. Photo taken downstream of bridge facing upstream. The right bank culvert and bridge culverts are in the field of view.

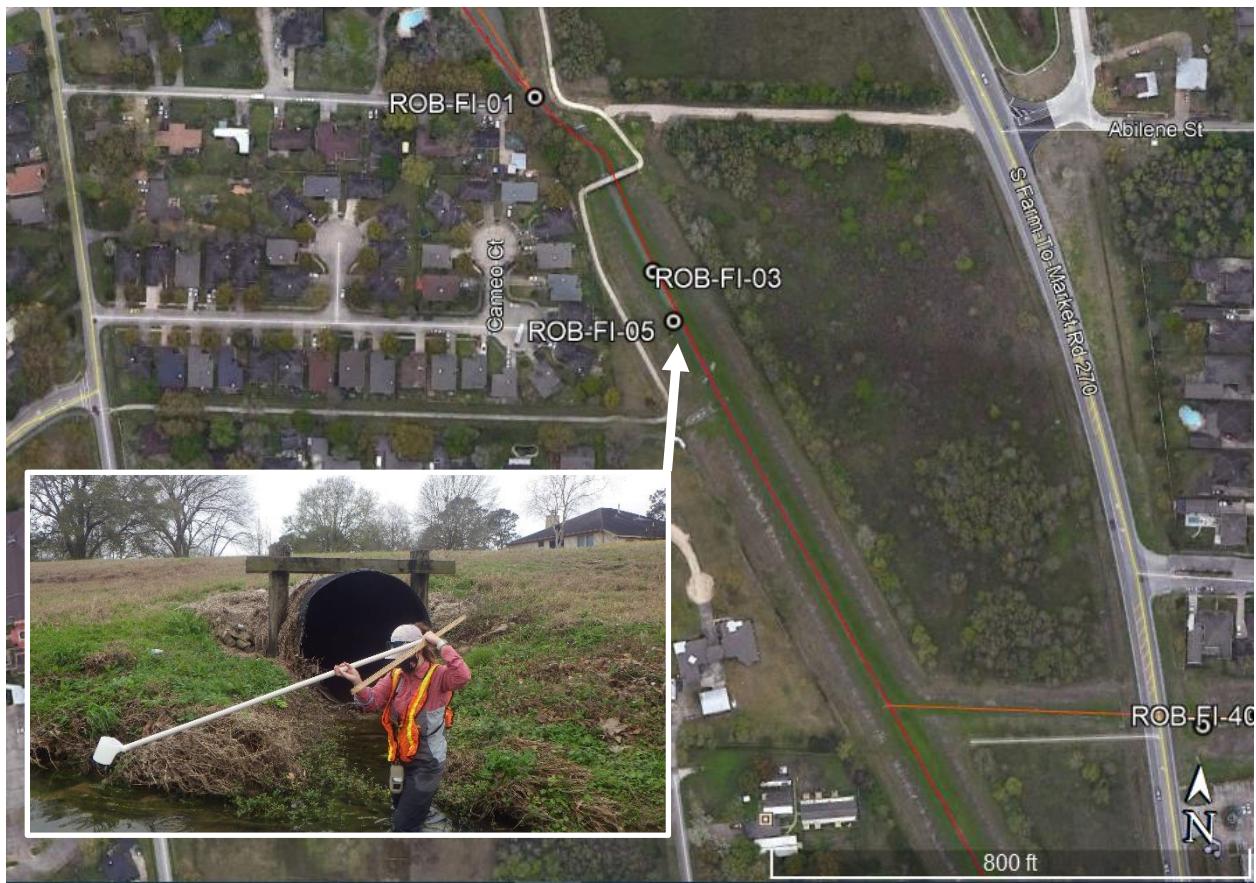
Referral site: ROB-FI-05

This site is a large ~70inch diameter corrugated plastic pipe protruding from the left bank located on the main assessment unit of Robinson Bayou near the end of Cameo Ct. The sample taken just downstream of the outfall pipe was 1400 MPN/100ML. The ambient sample taken immediately upstream of the outfall had a relatively lower bacteria value (132 MPN/100ML) indicating that there is likely a bacteria source contributing to this outfall pipe. Photo of pipe taken looking onto the left bank.

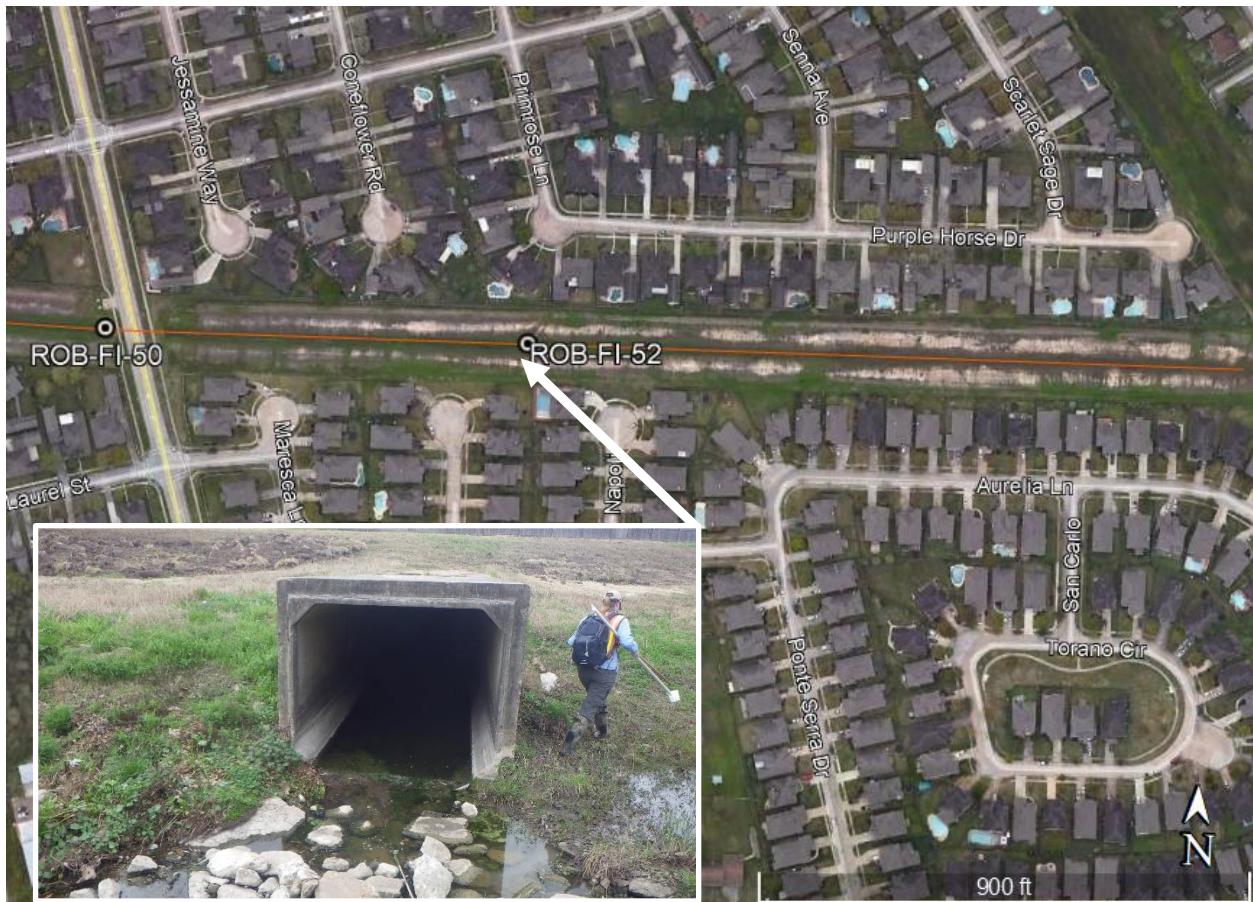
Referral site: ROB-FI-52

This site is a large ~70inch diameter concrete square culvert protruding from the right bank located near the top of the unnamed tributary 1 to Robinson Bayou near the intersection of Primrose Ln and Purple Horse Dr. The sample taken just downstream of the outfall pipe was 1100 MPN/100ML. The ambient sample taken immediately upstream of the outfall had a low bacteria value (31 MPN/100ML) indicating that there is likely a source feeding this outfall pipe. Photo of culvert taken looking onto the right bank.

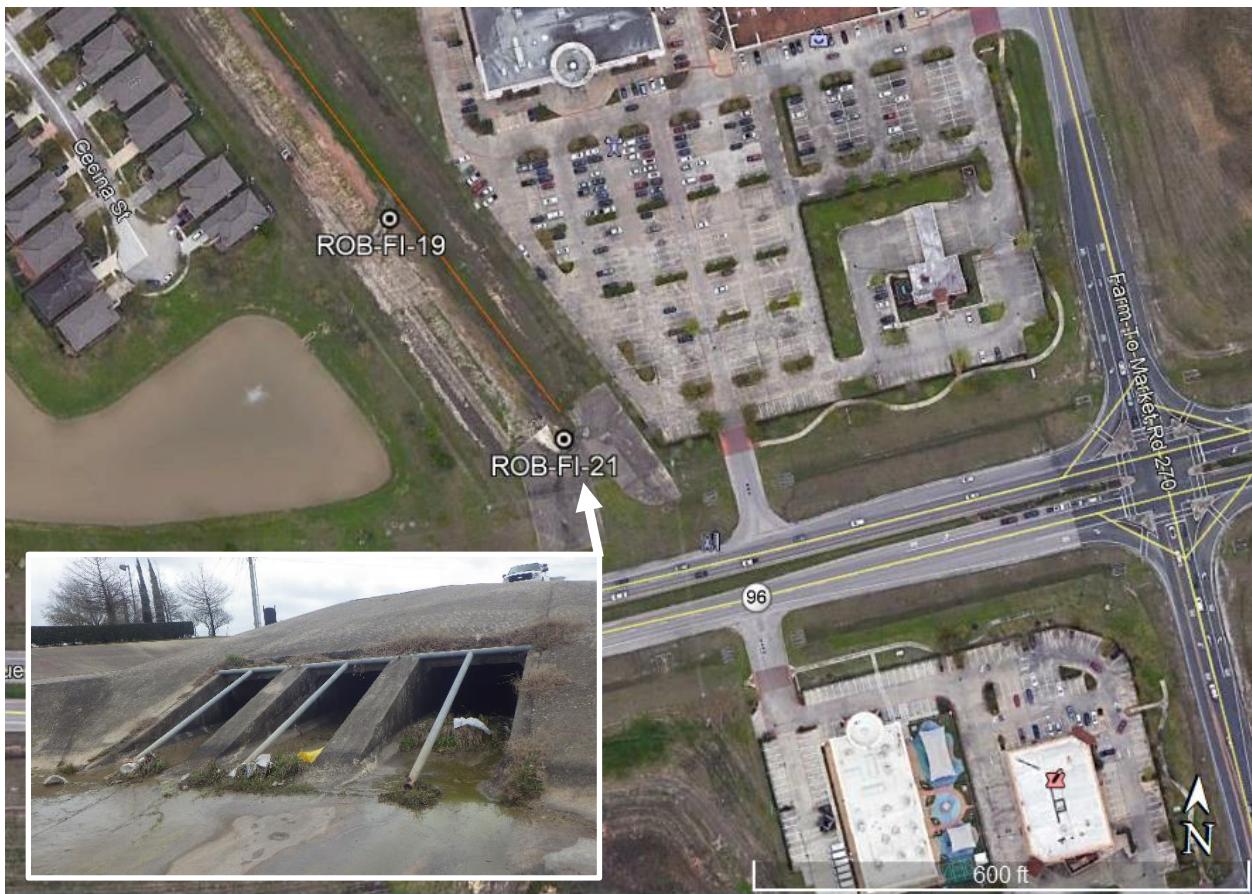
Referral site: ROB-FI-21

This site is the top of the unnamed tributary 4 to Robinson Bayou and consists of three large ~58inch diameter concrete square culverts from under League City Parkway/96. The sample taken just downstream of the culverts was 613 MPN/100ML. The ambient sample taken downstream (ROB-FI-19) had a relatively low bacteria value (121 MPN/100ML) indicating that there is likely a source upstream of the sampled culverts. Photo of the culverts facing upstream from the sample location.

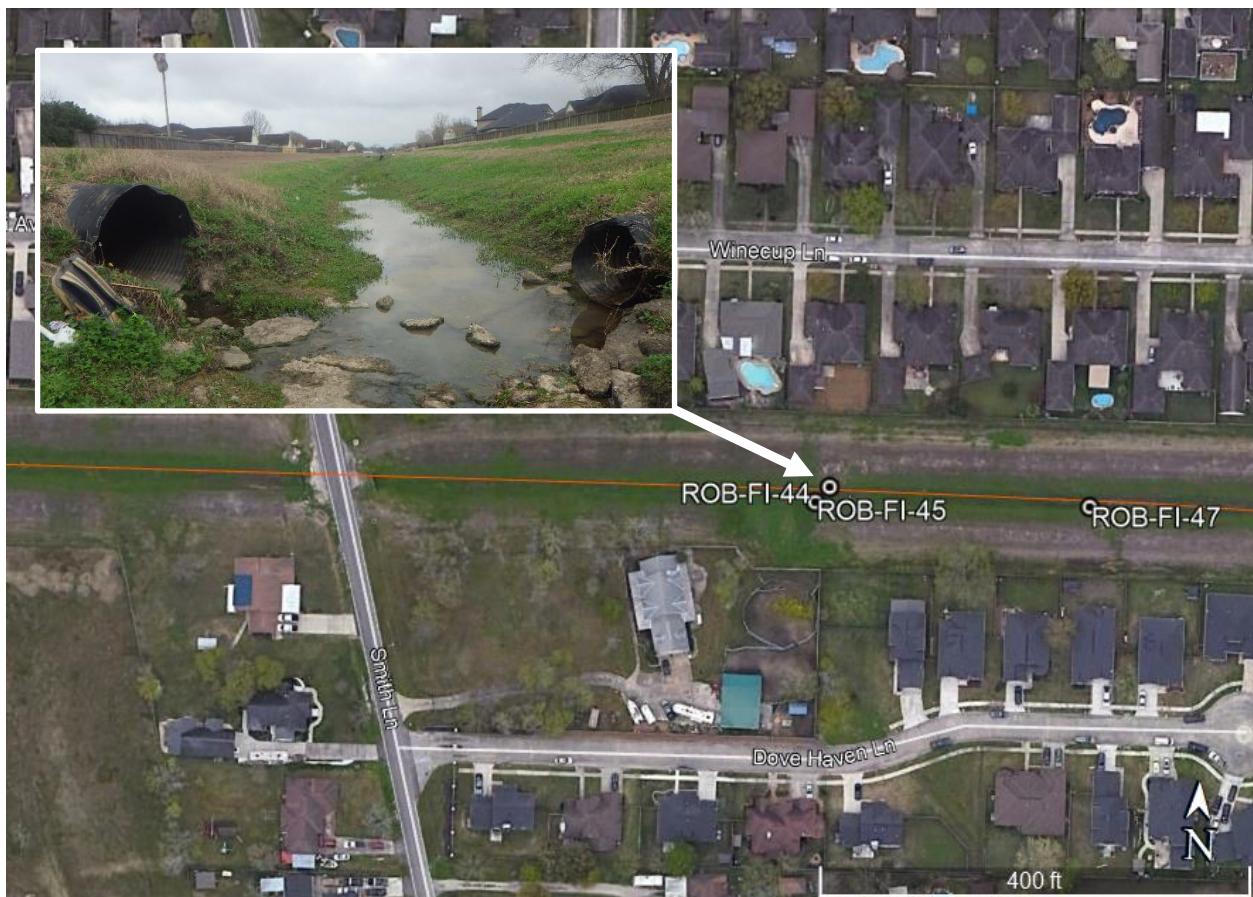
Referral site: ROB-FI-45

This site is on the unnamed tributary 1 to Robinson Bayou and consists of one ~23inch diameter corrugated metal pipe coated in plastic protruding from the left bank upstream of Smith Ln. The sample taken just downstream of the culverts was 5480 MPN/100ML, while the ambient sample taken upstream of the pipe was high as well (4880 MPN/100ML) but still nearly 600MPN/100ML less than the downstream sample. The downstream sample taken at the pipe in the same vicinity but on the right bank was significantly lower (121 MPN/100ML). The ambient sample taken upstream (ROB-FI-47) had a relatively lower bacteria value (309 MPN/100ML) indicating that there is likely a source in or near the identified pipe. Photo of the two pipes facing upstream (pipe in question is on the right-hand side of the photo).

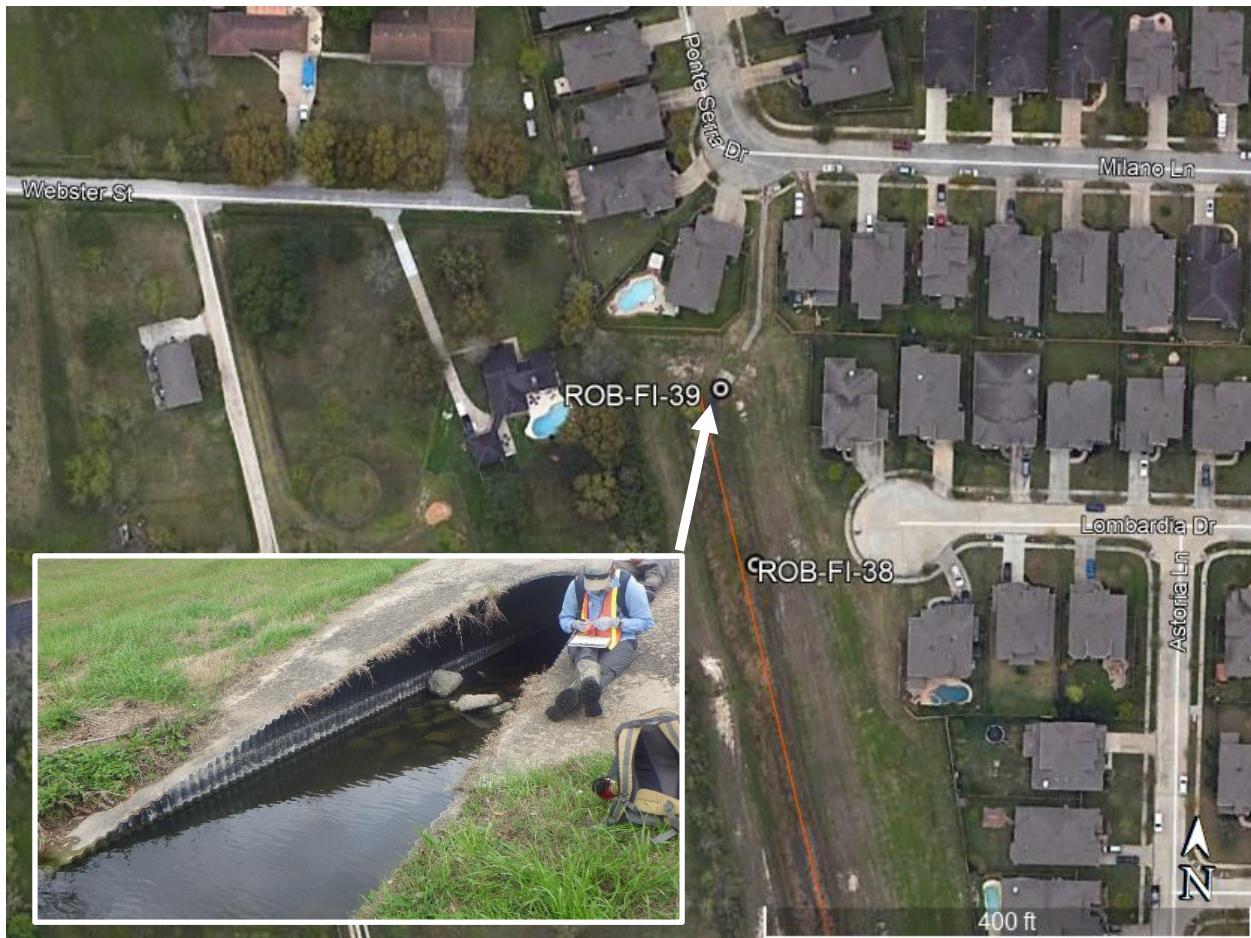
Referral site: ROB-FI-39

This site is the top of the unnamed tributary 2 to Robinson Bayou and consists of one ~57inch diameter corrugated plastic pipe near the cul-de-sac intersection of Ponte Serra Dr. and Milano Ln. The sample taken just downstream of the culvert was 383 MPN/100ML. There is likely a source upstream of the segment that drains into this pipe. Photo of the pipe facing upstream from the sample location.

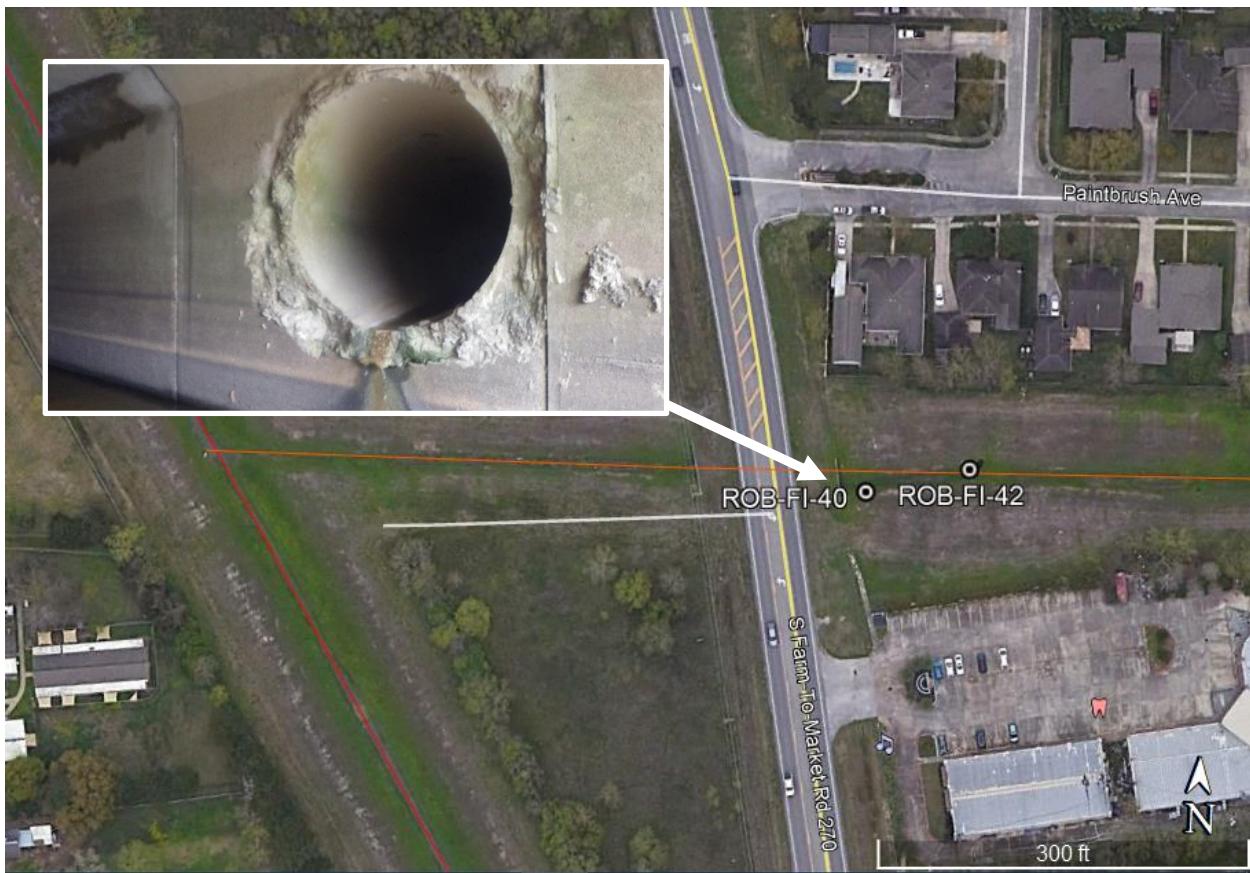
Referral site: ROB-FI-40

This site is on the unnamed tributary 1 to Robinson Bayou and consists of one ~45 inch diameter cement pipe protruding from the right bank under the bridge crossing of FM 270. The sample taken just downstream of the culvert was 691 MPN/100ML, while the ambient sample taken upstream of the bridge was only 315 MPN/100ML indicating that there is likely a source contributing to the identified pipe. Photo of the pipe from under the bridge. NOTE: the latitude, longitude was taken approx. 4 m upstream of the bridge.

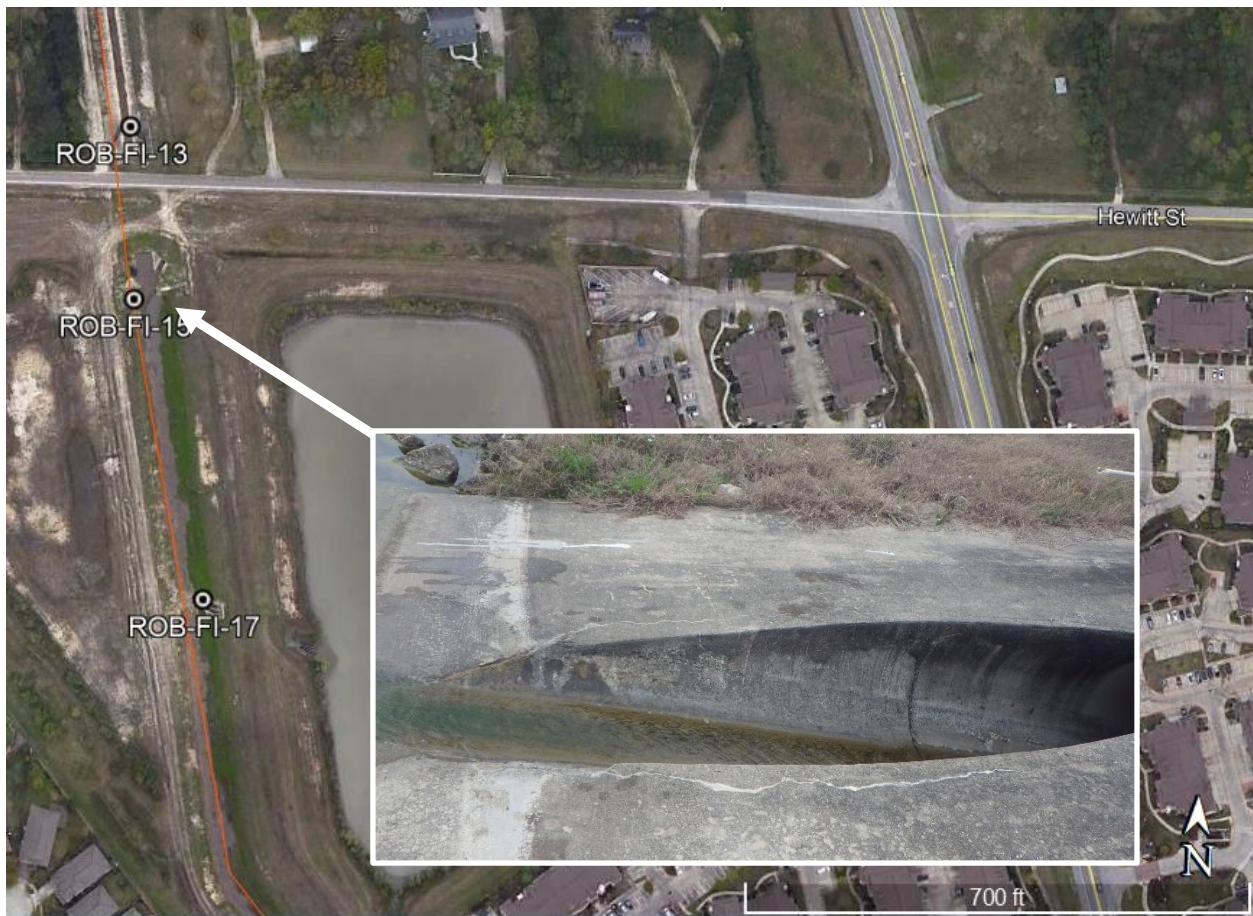
Referral site: ROB-FI-15

This site is just upstream of the highest priority referral (ROB-FI-14), on the unnamed tributary 4 to Robinson Bayou and consists of one ~37 inch diameter cement pipe protruding from the left bank just upstream of the Hewitt St. bridge. The sample taken just downstream of the culvert was 189 MPN/100ML, while the ambient sample taken upstream of the site was only 20 MPN/100ML indicating that there may be a source contributing to the identified pipe. Note: ducks were observed near the site just prior to sampling. Photo of the pipe from left bank, looking upstream.

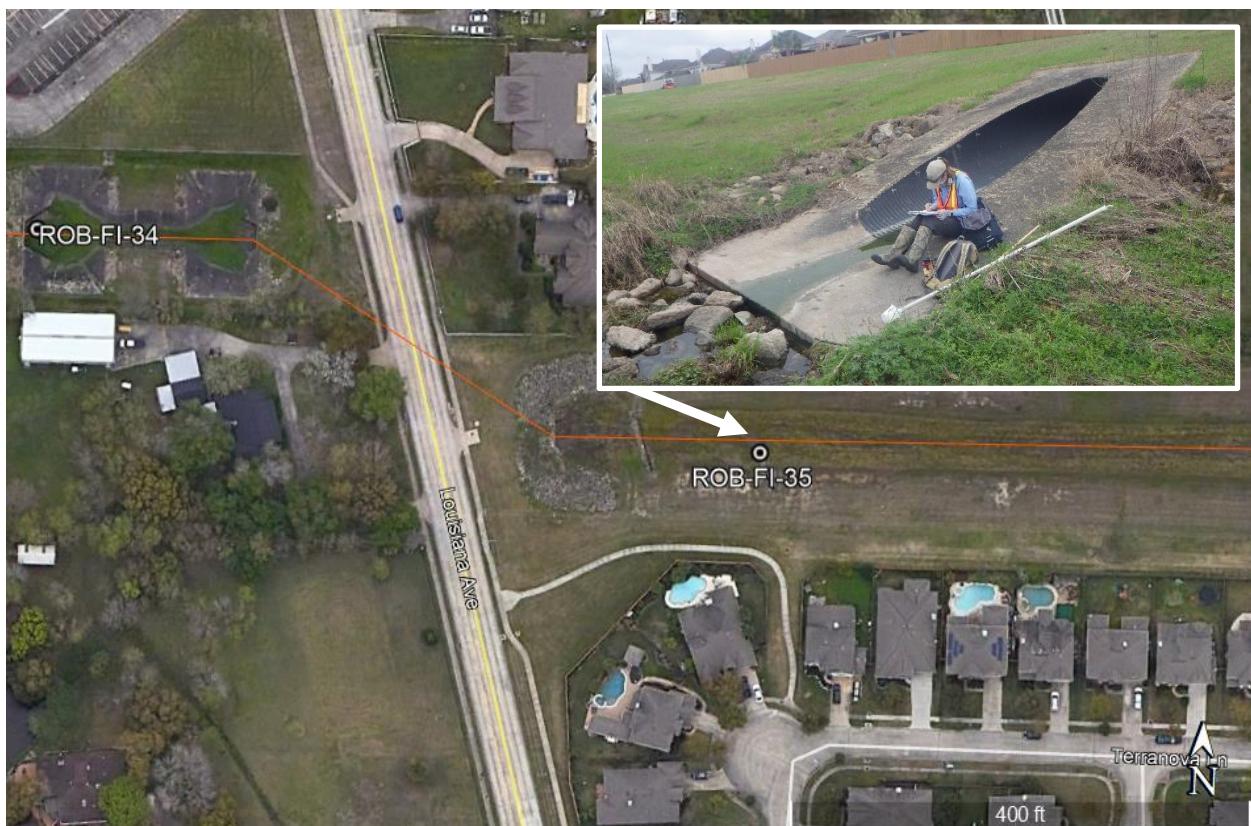
Referral site: ROB-FI-35

This site is just upstream of Louisiana Ave. on the unnamed tributary 2 to Robinson Bayou and consists of one ~60 inch diameter corrugated plastic pipe protruding from the left bank. The sample taken just downstream of the culvert was 146 MPN/100ML, while the ambient sample taken upstream of the site was only 20 MPN/100ML indicating that there may be a source contributing to the identified pipe. Photo of the pipe looking upstream.

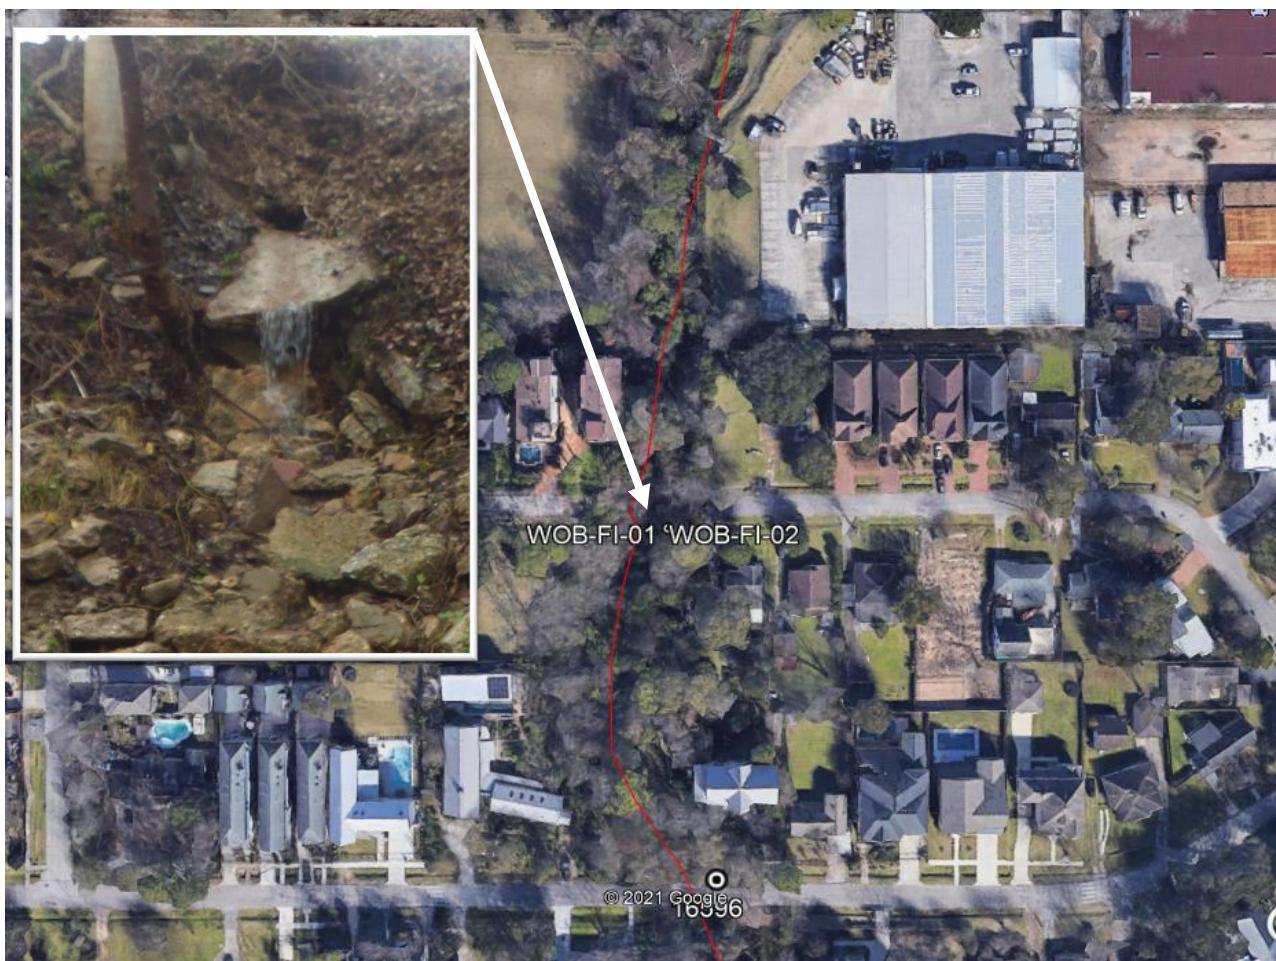
Referral site: WOB-FI-01

This site is located where the main assessment unit intersects with W 14 ½ Street, between Beall Street and Dian Street. This pipe is located on the left bank and is a metal pipe with an inner diameter of 9 inches. Just one sample was taken here from the broken concrete apron leading from the pipe with a bacteria value of 4350 MPN/100ML. This site, WOB-FI-01 was located just downstream of site WOB-FI-02, which is also recommended for referral. Photo taken looking at left bank, showing pipe in the bank with a broken concrete apron.

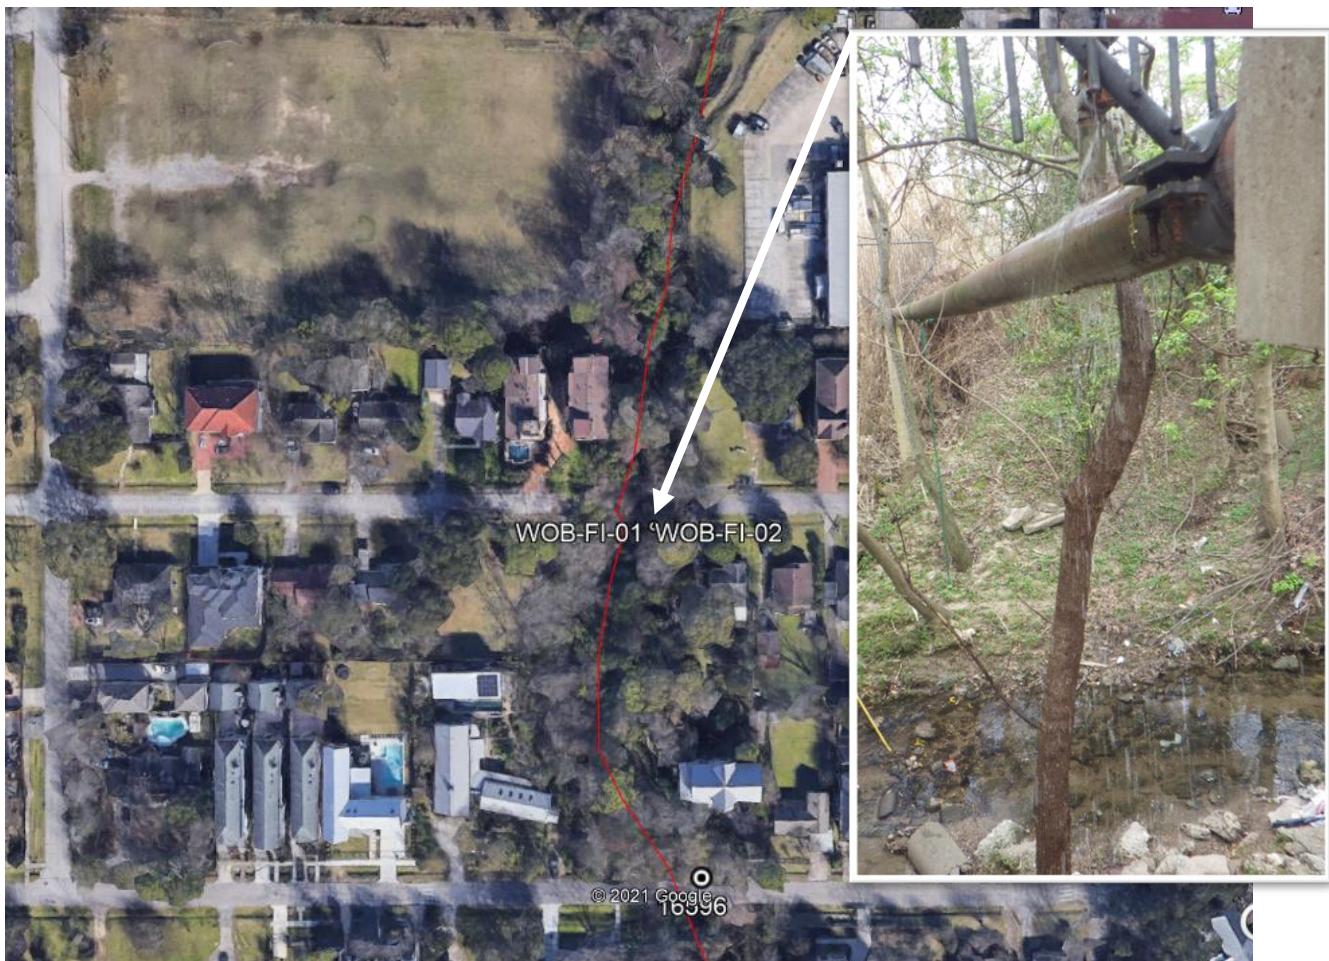
Referral site: WOB-FI-02

This site describes a sealed, permitted metal pipe with an inner diameter of about 6 inches that runs about the main assessment unit of this tributary of White Oak Bayou. It is just upstream of site WOB-FI-01. Connected to the main pipe is a holding pump that is broken and leaking water into the stream along the left bank, see photo. One direct sample was taken here from the leaking pipe with a bacteria value of 3870 MPN/100ML. It appears that this permitted pipe is in need of repair and has been leaking high bacteria water into the stream. Photos were taken from the left bank and show the broken area of the pipe and where the leaking water has been running into the stream bed.

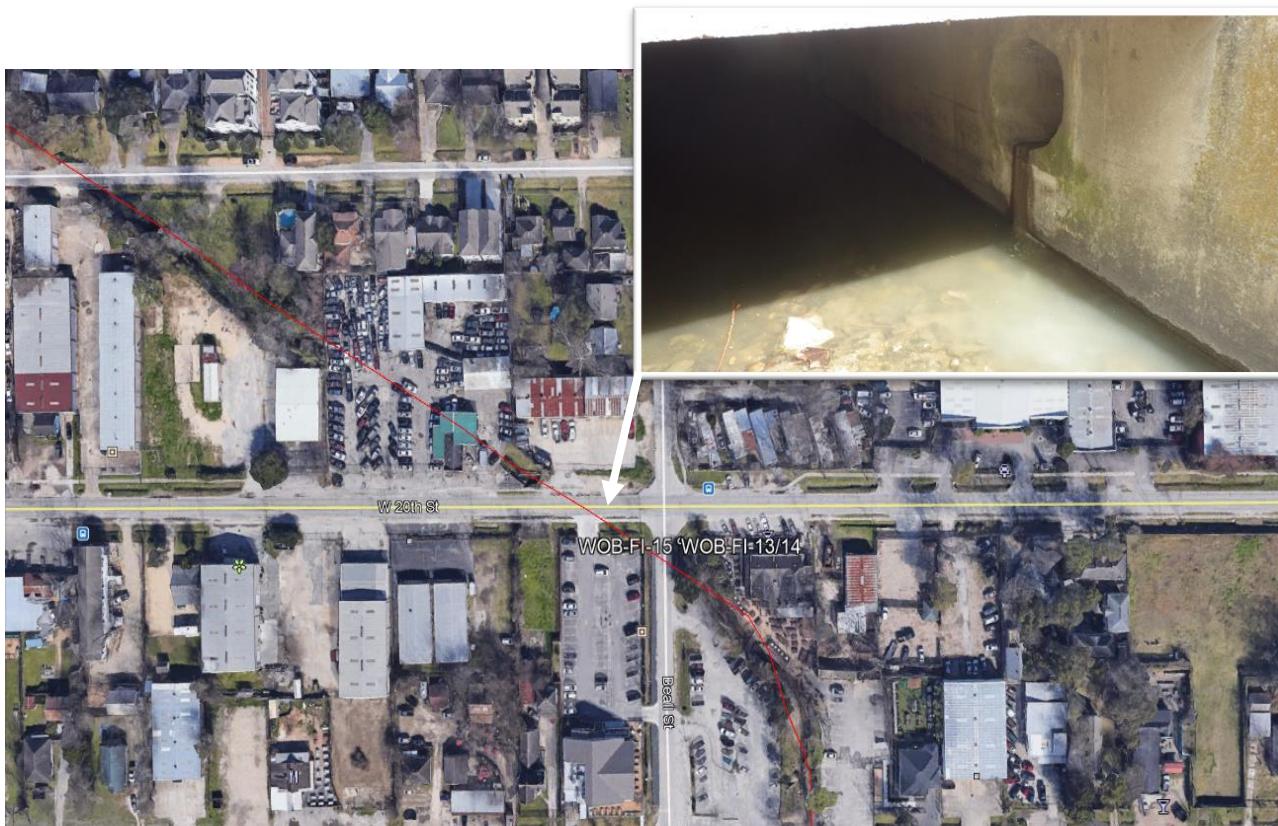
Referral site: WOB-FI-15

This site is located under the road at the intersection of W 20th Street and Beall Street. It is downstream of a car dealership and many townhouses. The pipe located under the street is concrete and has an inner diameter of about 30 inches. The sample taken just downstream of the outfall pipe was 1620 MPN/100ML. The ambient sample taken upstream of the outfall had a relatively low bacteria value (109 MPN/100ML) indicating that this outfall is likely a source contributing to the elevated *E. coli* levels in this assessment unit. When initially passing this pipe, there was no water observed, but it began to flow while the team was sampling another area. The water coming from the pipe was sudsy and cloudy. Photo taken from downstream shows pipe location on the left bank under the road.

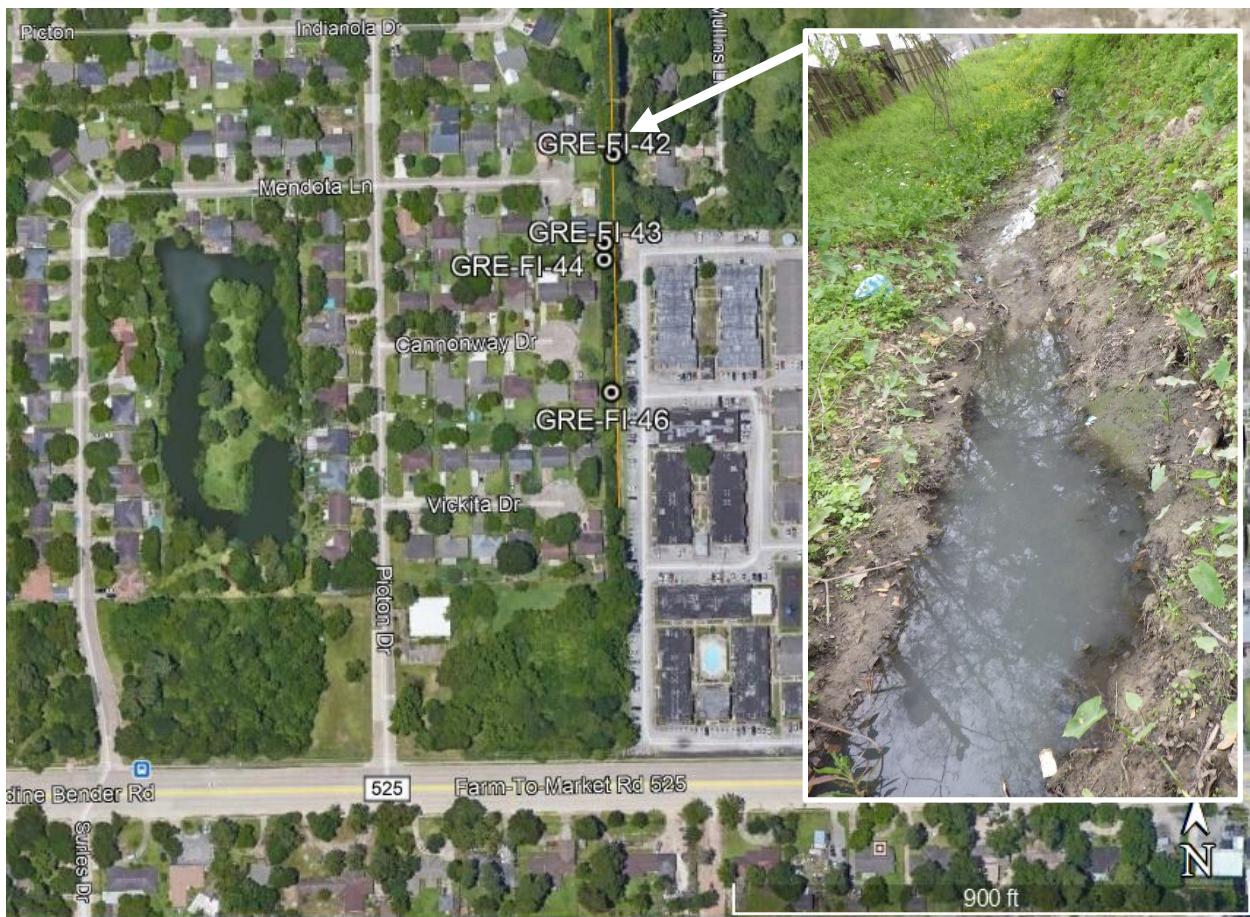
Referral site: GRE-FI-42

This site is located in the center of Tributary #4 to the main segment near Mendota Ln cul-de-sac. There are fences along each bank. Access must be from the nearest downstream bridge crossing at McCrackin Road. A change in water color in the ditch was observed. Water in this area appeared cloudy/milky but there was no apparent flowing source in the direct vicinity, so an ambient sample was collected mid-channel in the earthen tributary and had a bacteria value of >24,200 MPN/100ML. The ambient sample collected downstream of the site near McCracken Rd had a bacteria value of 46,10 MPN/100ML and the sample taken upstream of this location (GRE-FI-43) was taken near a submerged pipe, but had a bacteria value of 1600 MPN/100ML. This suggests that there may be a leak somewhere under the tributary in this area which may be a source of elevated bacteria. Photo of section of tributary with discolored water where sample was taken.

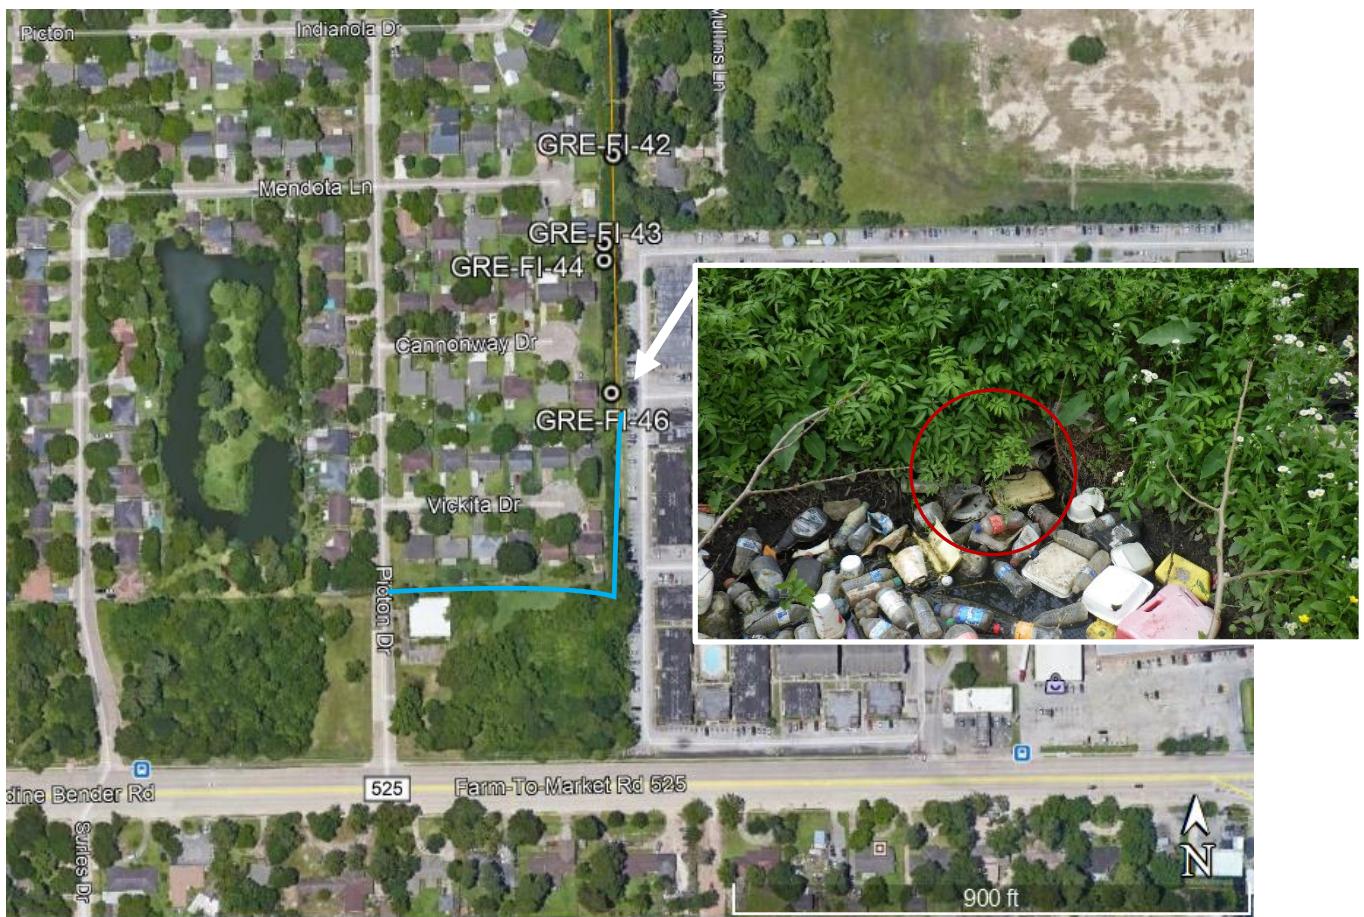
Referral site: GRE-FI-46

This site is a metal pipe, ~ 24 inches in diameter coming out of the right bank located near the top of the tributary #4 of the segment. The pipe is difficult to see (indicated in red circle below) due to bank vegetation, trash in the water, and the fact that it is partially collapsed. The sample collected in the mixing zone, just downstream of the outfall had a bacteria value of >24,200 MPN/100ML, and the ambient sample collected just upstream of the outfall (mid channel) had a bacteria value of 171 MPN/100ML indicating that the outfall is likely a source of elevated bacteria. Photo of pipe taken looking onto the right bank. NOTE: further upstream there was an isolated pool that should also be investigated, although no samples were taken at the time of the FI. It appeared that there was a water source coming up from the ground in this area. The banks are fenced on both sides. The best access to this site is in the grass “ally” behind the southern houses on Vickita Dr (Blue Pathway marked on map)

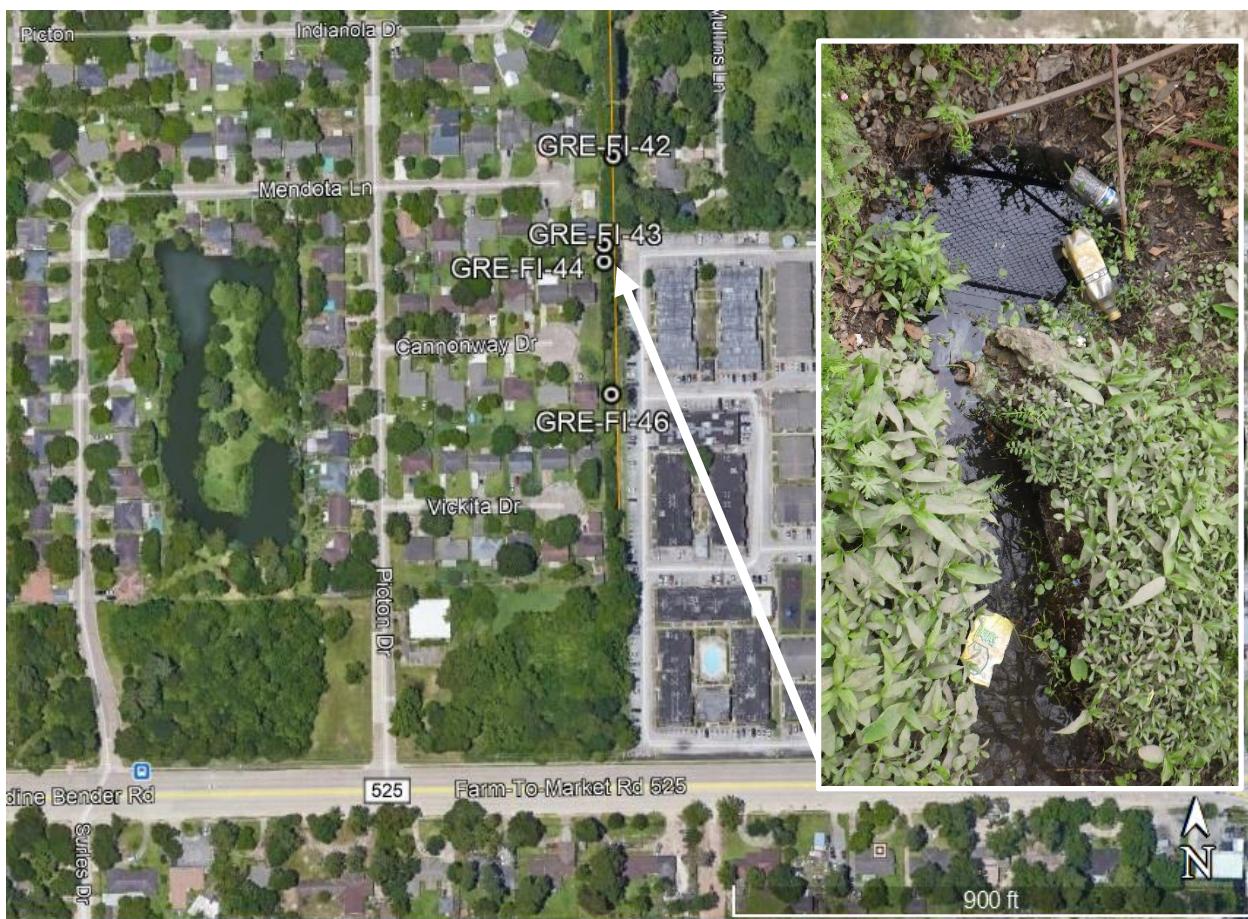
Referral site: GRE-FI-44

This site is a deeper pool (hole) with very dark (black/grey) water just upstream of GRE-FI-43 near the left bank on the Tributary #4. There are fences along each bank. Access must be from the nearest downstream bridge crossing at McCrackin Road. The sample collected in the pool of dark water had a bacteria value of 19,900 MPN/100ML, and the ambient sample collected just upstream of the area (mid channel) had a bacteria value of 288 MPN/100ML indicating that the outfall is likely a source of elevated bacteria. Photo of dark pool taken looking onto the right bank.

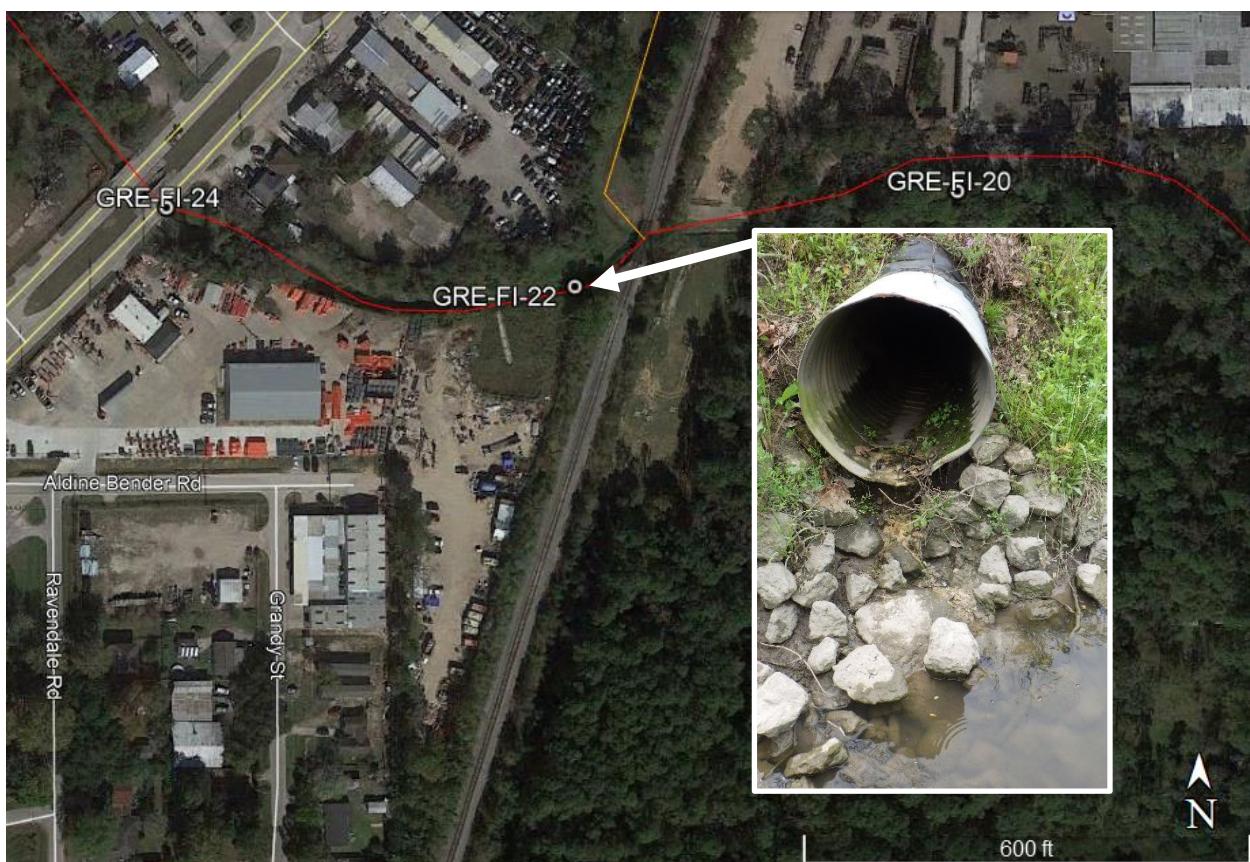
Referral site: GRE-FI-22

This site is a metal pipe, ~ 24 inches in diameter coming out of the right bank of the main stem of the Unnamed Tributary to Greens Bayou, located just upstream of the rail-road track crossing between Old Humble Road and Smith Rd. The water flowing from the pipe was cloudy and the ground around the pipe was “stained” a milky white color. The sample collected in the mixing zone, just downstream of the outfall had a bacteria value of 6130 MPN/100ML, and the ambient sample collected just upstream of the outfall (mid channel) had a bacteria value of 933 MPN/100ML indicating that the outfall is likely a source of elevated bacteria. Photo of pipe taken looking onto the right bank.

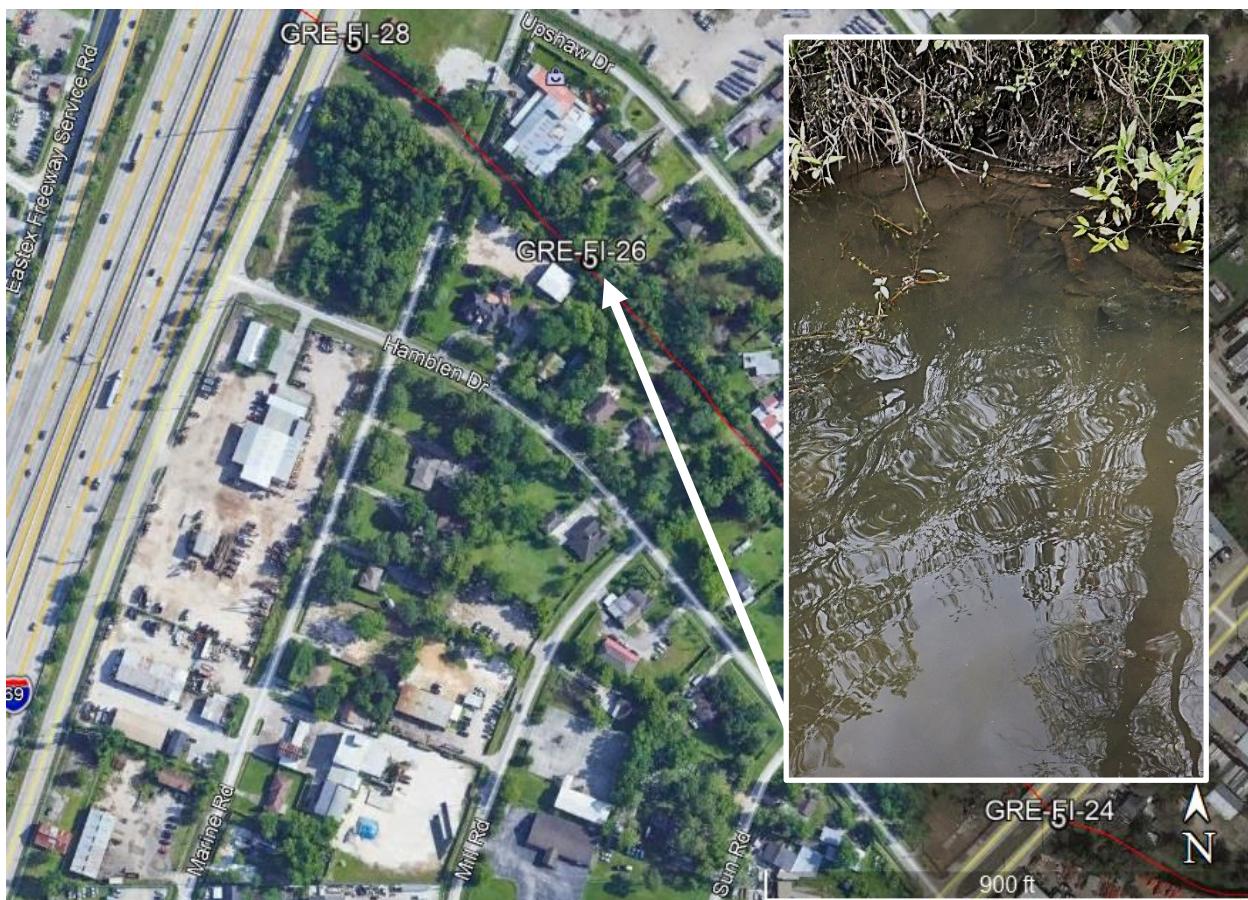
Referral site: GRE-FI-26

This site is a small pvc pipe, ~ 4 inches in diameter coming out of the left bank and extending into mid-channel, fully submerged. It is located on the main segment of the Unnamed Tributary of Greens Bayou between Old Humble Rd. and the Eastex Freeway frontage road. The field team could not tell if water was flowing from the pipe and could not lift the pipe above the water to aid in that determination. Therefore, a sample was collected in the mixing zone, just downstream of the potential outfall and had a bacteria value of 554 MPN/100ML, and the ambient sample collected just upstream of the outfall (mid channel) had a bacteria value of <10 MPN/100ML indicating that the outfall is likely a source of elevated bacteria. Photo of pipe taken looking down into the water, difficult to see, but running up and down in the right half of the image.
