Executive Summary

The Houston-Galveston Area Council's (H-GAC) Targeted Monitoring Project focuses on the region's most prevalent pollutant – bacteria. The goal is to examine ten watersheds in various land cover types to identify bacteria sources (Table 1). A seven-year geometric mean analysis defining the severity of impairment was performed on each assessment unit (AU) within the region. H-GAC ranked waterways using the highest geomean relative to the state standards for contact recreation. Assessment units were selected by 1) highest geomean identified, 2) land cover type, and 3) accessibility and feasibility of the waterway for field investigations (Figure 1).

Bintliff Ditch (1007T_01)

Bacteria Monitoring Report

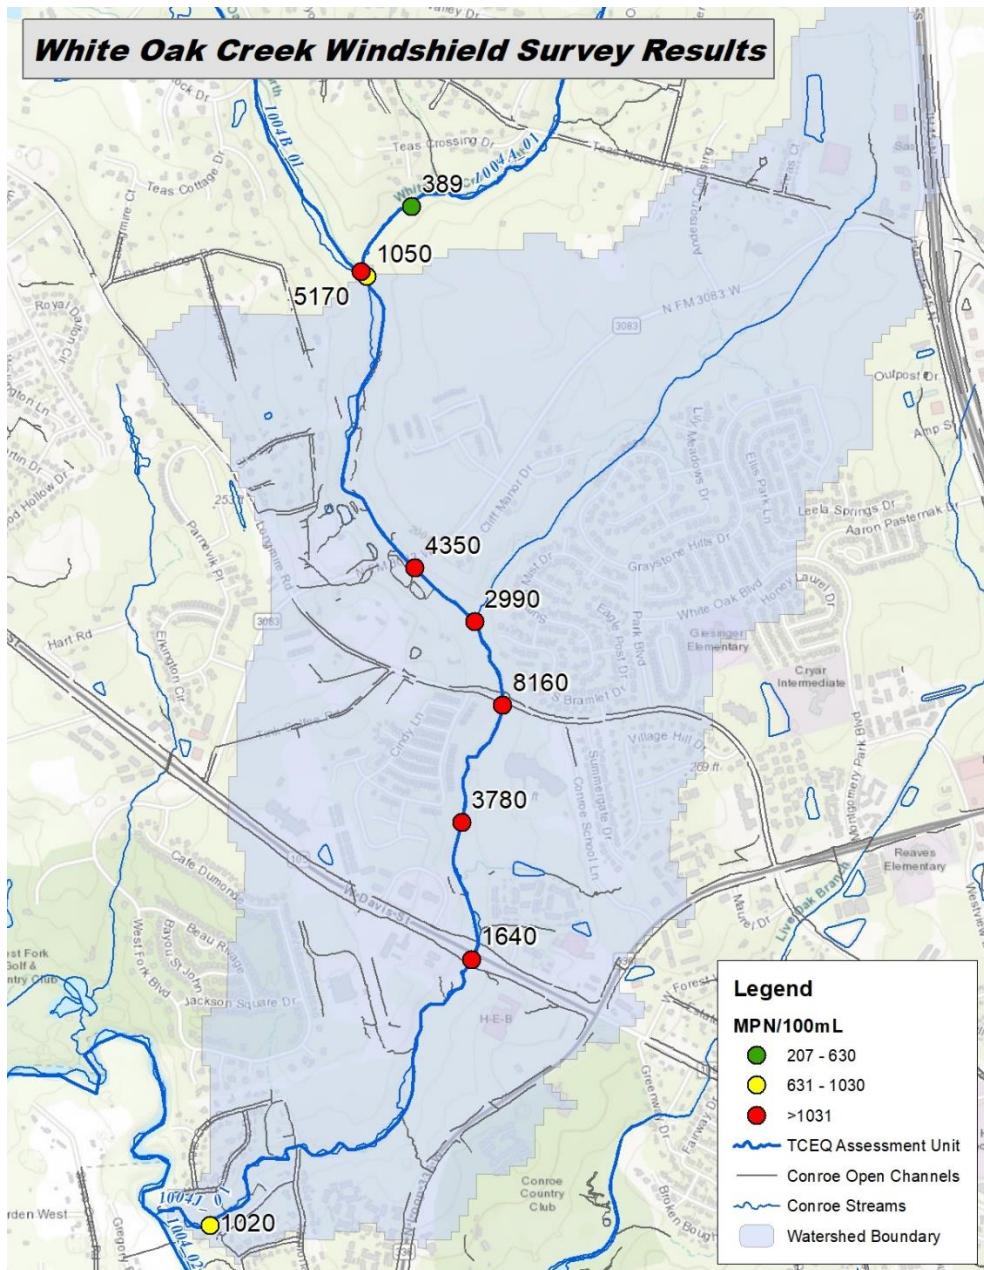
Figure 2. White Oak Creek Watershed Survey Results Mapped

Bacteria concentrations from the WS ranged from 389 to 8,160 MPN/100mL, though all results were greater than the standard of 126 MPN/100mL. A spike in *E. coli* levels was noted between sample 05 (2,990 MPN/100mL) and the downstream sample 04 (8,160 MPN/100mL), though a strong flow originating from under a residential cul-de-sac was noted

between the two samples. Another increase in *E. coli* levels was noted between samples 07 (1,050 MPN/100mL) downstream of the confluence of the two forks and the downstream sample 06 (4,350 MPN/100mL) at FM 3083. Much of the area between the two is under construction for a new or expanded residential area. One key finding of the WS was that while the sample upstream on the East Fork of White Oak Creek (1004A_01) was 389 MPN/100mL, the sample on the West Fork of White Oak Creek (1004B_01) was significantly higher at 5,170 MPN/100mL. The West Fork sample was taken closer to the confluence than the East Fork because no public access was found within a reasonable distance, so the field crew walked upstream from the confluence to a point where no mixing would occur.

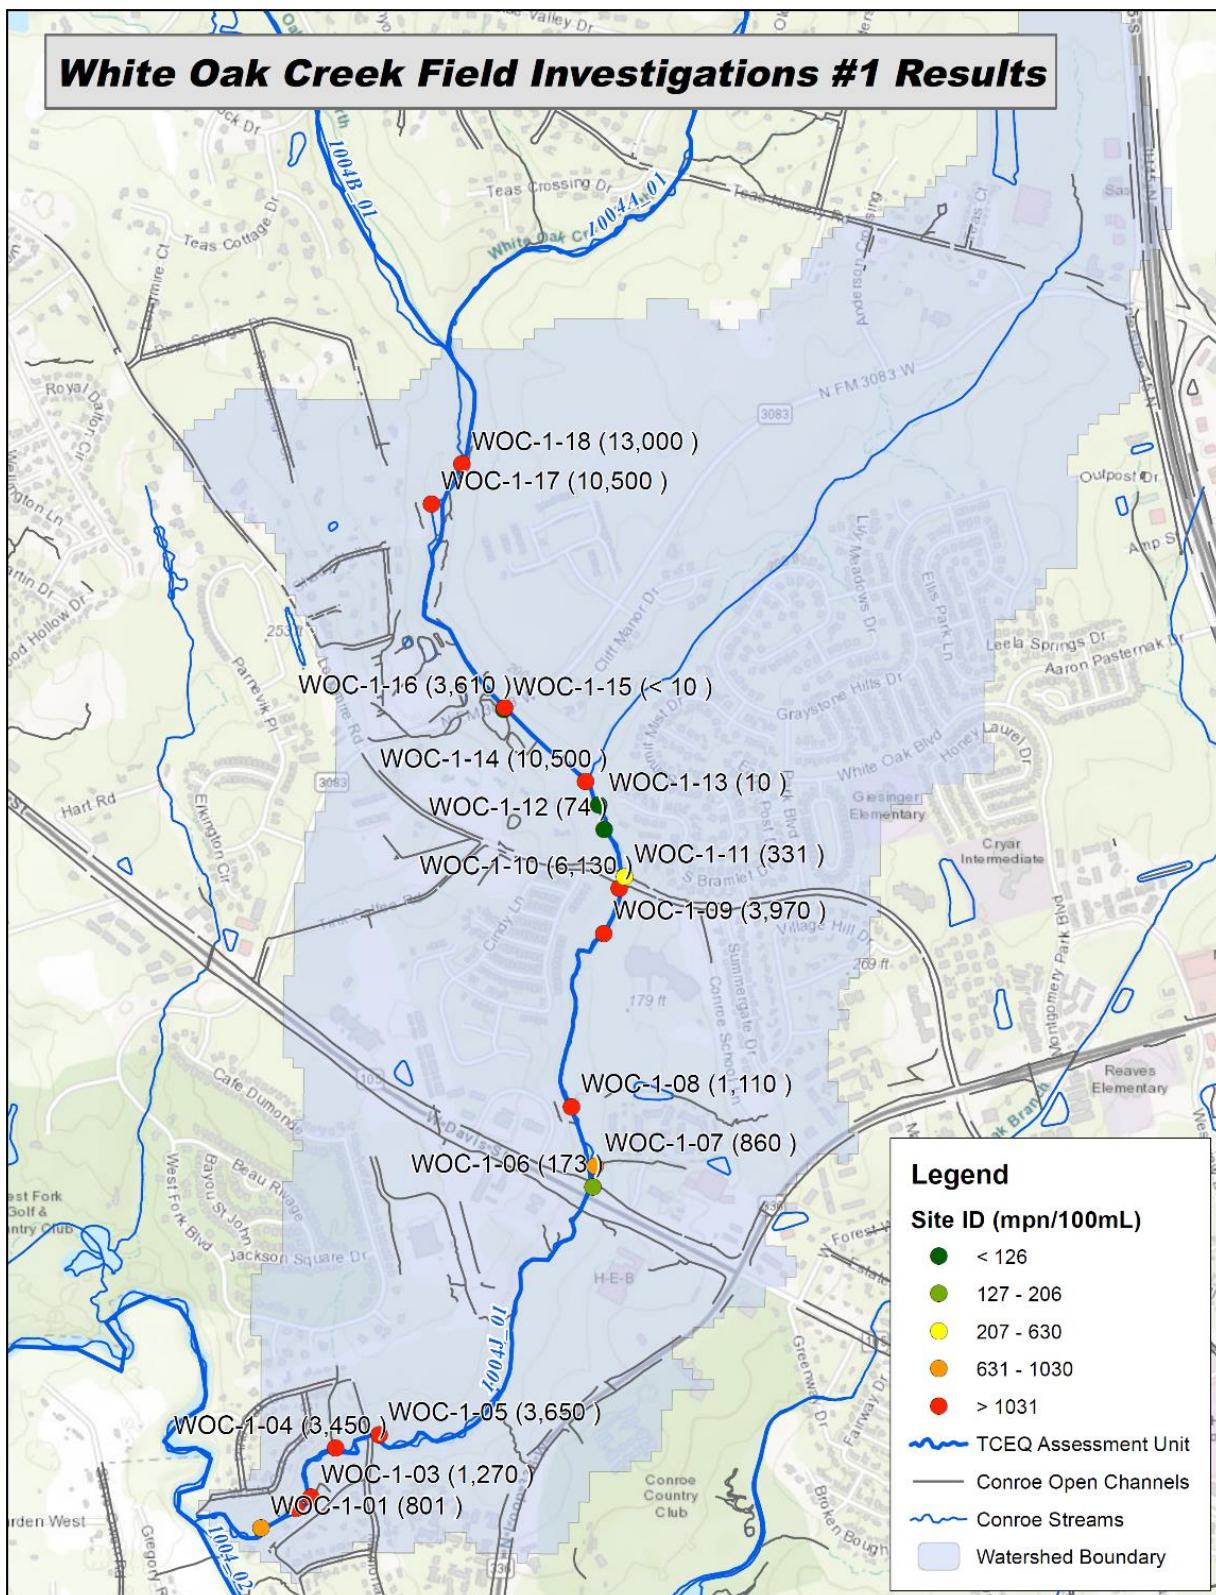
Figure 3. Results from the White Oak Creek Field Investigation

Due to time constraints during the FI, the H-GAC field crew was unable to sample upstream of WOC-1-18. However, this sample contributes to the highest bacteria concentrations (13,000 MPN/100mL) found throughout the entire watershed (Figure 3). Since the WS survey suggested large bacteria contributions from 1004B_01, H-GAC recommends targeting the West Fork of White Oak Creek (1004B_01) as the impairment source may be in the upstream assessment unit and reflected in the receiving waters of 1004J_01.

There was a large spike in the bacteria concentrations in samples between FM 3083 (WOC-1-16) and the dam outfall from a large drainage area downstream (WOC-1-14), but field crews did not find any other sources between the two to sample. It is worth noting that there was also a large spike in bacteria concentrations near FM 3083 during the WS. There are several large ponds on the right bank immediately downstream and upstream of the bridge on FM 3083, but no flow source was noted during the FI.

In addition, the two furthest upstream samples (WOC-1-17 and WOC-1-18) had significantly higher bacteria concentrations than anywhere else on the waterway besides the sample mentioned above near FM 3083 (WOC-1-16). The furthest upstream sample taken during the FI was near the bottom of a new subdivision under construction and had a result of 17,300 MPN/100mL. There was still approximately 0.25 to 0.5 miles upstream of the final sample site to the top of the AU where the West and East Forks of White Oak Creek diverge. As noted in the section 2.1, the WS results indicated a much higher bacteria concentration coming from West Fork than the East Fork, but that result was still just a fraction of the 17,300 MPN/100mL coming from upstream of the final sample point of the FI.

Potential sources could not be identified for these higher bacteria concentrations; therefore, no referrals could be made for correction. Further investigations are recommended to identify sources for future referral. These investigations would focus on the area around FM 3083 and upstream to the confluence of the two forks (1004B_01 and 1004A_01). It is recommended to sample both upstream assessment units to determine which waterway is contributing the most bacteria concentrations. Since the results in the upstream portion of the AU were significantly higher in the WS samples, it is also recommended to determine if the City of Conroe has reports of any Sanitary Sewer Overflows (SSOs) during the period leading up to the FI that could explain the increase.

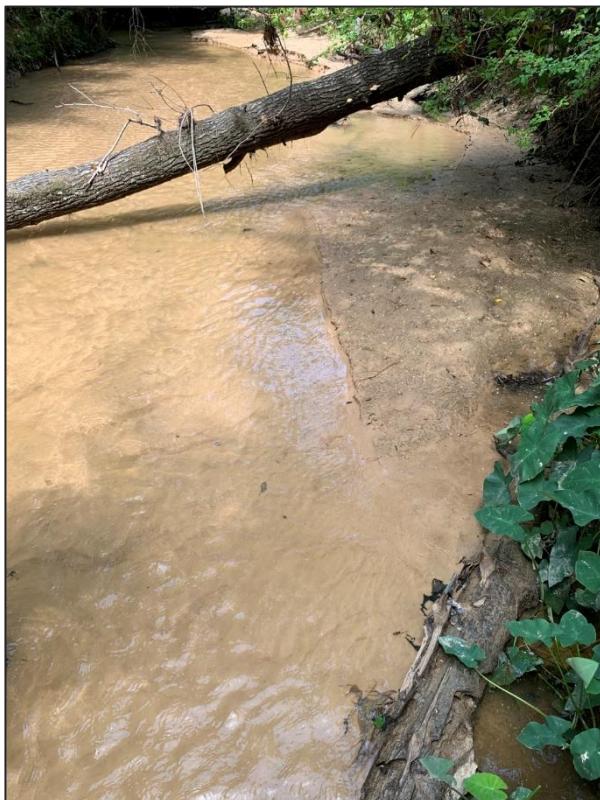
Figure 4. WOC-1-07; Tributary into White Oak Creek

Two small tributaries on the right and left bank of White Oak Creek upstream of SH 105/W Davis Street are listed for referral (Figures 4 and Figure 5). The sites are downstream of an apartment complex and upstream of a shopping center. The tributaries have a low flow, but the exact origin of one of the tributaries is unknown (WOC-1-08). The City of Conroe provided GIS layers that indicate an open channel is found at WOC-1-07, which collects stormwater from a nearby residential community (Figure 6). The field crew took samples directly from the tributaries, upstream of the mixing zone with White Oak Creek, during the FI on April 28, 2021. The *E. coli* results were 860 MPN/100mL at site 07 and 1,110 MPN/100mL at site 08. Since both tributaries were sampled directly, it indicates that both are contributing bacteria to White Oak Creek at levels above the state standard.

During the WS in January, samples were taken upstream and downstream of the tributaries. The upstream sample WS-03 (upstream behind school) showed a bacteria concentration of 3,780 MPN/100mL, and the downstream sample WS-02 (downstream near bridge on SH 105/W Davis St) results were 1,640 MPN/100mL. Since there was a high dilution rate, this indicates the tributaries were not contributing a large number of bacteria during the WS, however, further investigation is recommended based upon FI results.

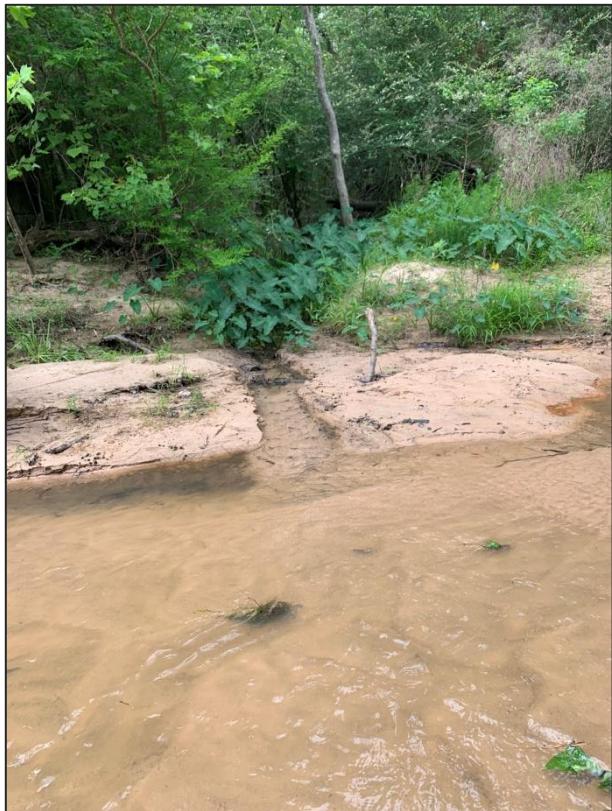
Figure 7. View of shallow sandy tributary

This referral site is located on a tributary on the right bank of White Oak Creek upstream of FM 3083 and downstream of the confluence of the two forks. The site is somewhat downstream of a new subdivision under construction and immediately upstream of a property with a bulkhead on the creek. The tributary is flowing enough to cut a shallow channel through the sandy bank, though the exact origin of the tributary is unknown (Figure 7 and Figure 8). The area around the tributary appears to be residential, with several properties nearby or adjacent to it. These properties have suspected unpermitted OSSFs and while others have known permitted systems (Figure 9). When the field crew sampled the site on April 28, 2021, the downstream sample *E. coli* results were 1,290 MPN/100mL higher than the upstream sample, indicating that the tributary is contributing high bacteria numbers to White Oak Creek, at a level ten times higher than the state standard for contact recreation.
