Pasadena Intersection Safety Study

**Final Report
by the**

**Center for Transportation Safety
Texas Transportation Institute
Texas A&M University System**

Pasadena Safety Study Revised Intersection Report

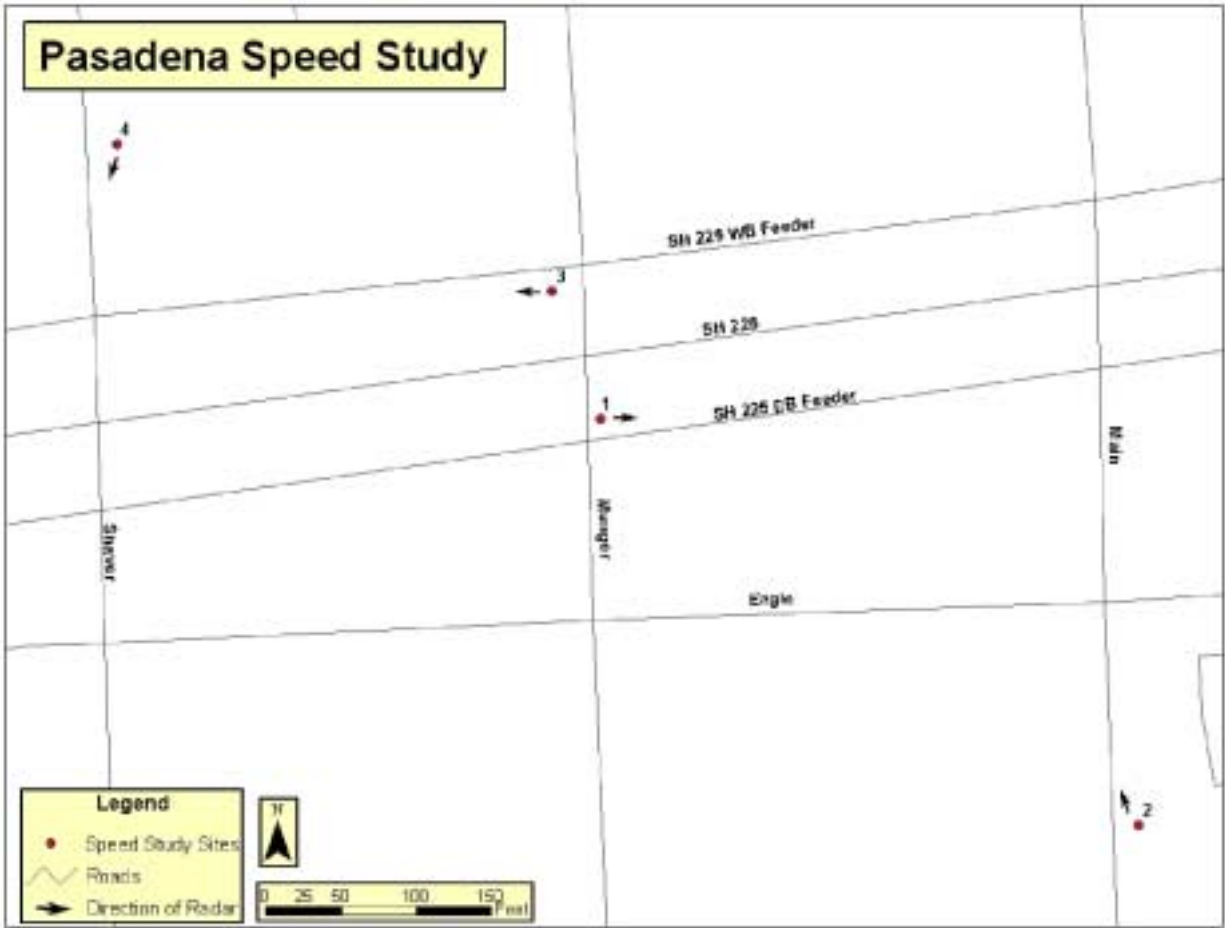
Figure 6. Spot Speed Study Locations on SH 225 at Main and Shaver.

There were two speed studies for this location, previously shown in Figure 6, sites 1 and 2. All of the 85th percentile speeds at these locations, with the exception of NB Main, were below the speed limit. Thus, speeding did not seem to be an issue during the time the speed study was conducted. NB Main had a 37 mph 85th percentile speed while the speed limit was 35 mph. This indicated that a fair number of people tend to speed on this approach. Increased police enforcement is suggested at this location. Increasing the speed limit to 40 mph could be done, but it would require adjusting the signal timing in the area. A more detailed study would be needed to determine the impact of increasing the speed limit. See Appendix B for the specifics on the speed studies performed at this location.

There were two speed studies for this location, shown as sites 3 and 4 in Figure 6. All of the 85th percentile speeds at these locations were below the speed limit. Thus, speeding did not seem to be an issue during the time the speed study was conducted. See Appendix B for the specifics on these studies.

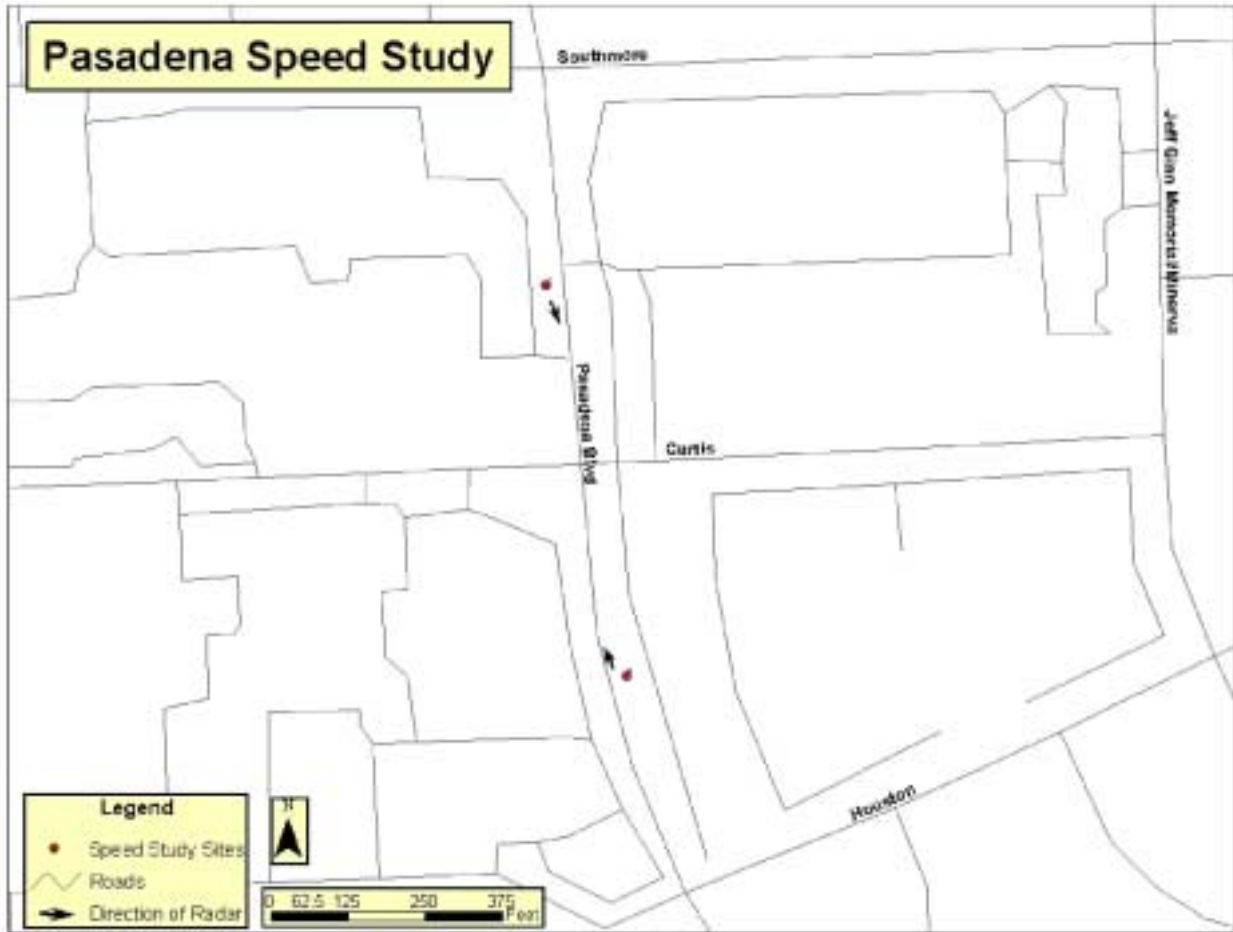
Figure 7. Spot Speed Study Locations on Pasadena at Curtis.

There were two speed studies for this location, shown previously in Figure 7. The posted speed limit on Pasadena was 30 mph on both approaches to the intersection. However, the SB traffic on Pasadena had a 31 mph 85th percentile speed and the NB traffic had a 35 mph 85th percentile speed. This indicated that a fair number of people tend to speed through this intersection. Increased police enforcement is suggested, not only to slow down speeding vehicles but to catch the red-light violators. Of the right angle crashes, 15 of the 18 (or 83 percent) were due to a disregard of the red light. While police may not write tickets for people going slightly over the speed limit, their presence alone in the area may help to reduce these driving behaviors. Increasing the speed limit to 35 mph could be done, but it would require adjusting the signal timing in the area, and its effect on the clearance interval would be negligible. A more detailed study would be needed to determine the impact of this increase. See Appendix B for the rest of the information pertaining to the speed study conducted at this location.

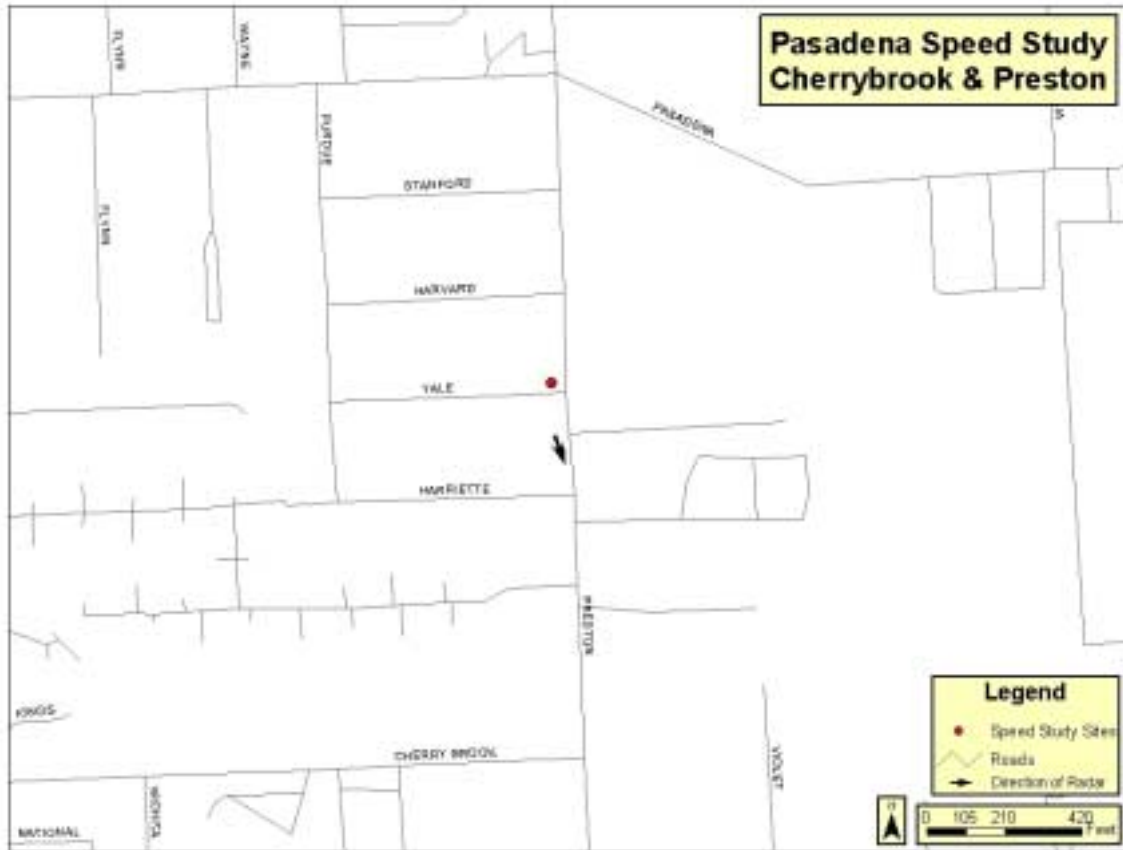
Figure 8. Spot Speed Study Location at Preston at Cherry Brook.

One speed study was conducted at this location, previously shown in Figure 8, site 7. It was conducted for the SB approach to the intersection on Preston, the approach with the highest rate of rear-end collisions. The 85th percentile speed was 41 mph while the speed limit was 35 mph. This indicated that many people tend to speed on this approach, 75% of those recorded in the study (see Appendix B for more specifics on the speed study performed at this location). Increased police presence is suggested at this intersection to reduce both speeding and red-light running behaviors that may be leading to rear-end and right-angle crashes. Increasing the speed limit to 40 mph could be done, but it would require adjusting the signal timing in the area. A more detailed study would be needed to determine the impact of increasing the speed limit.

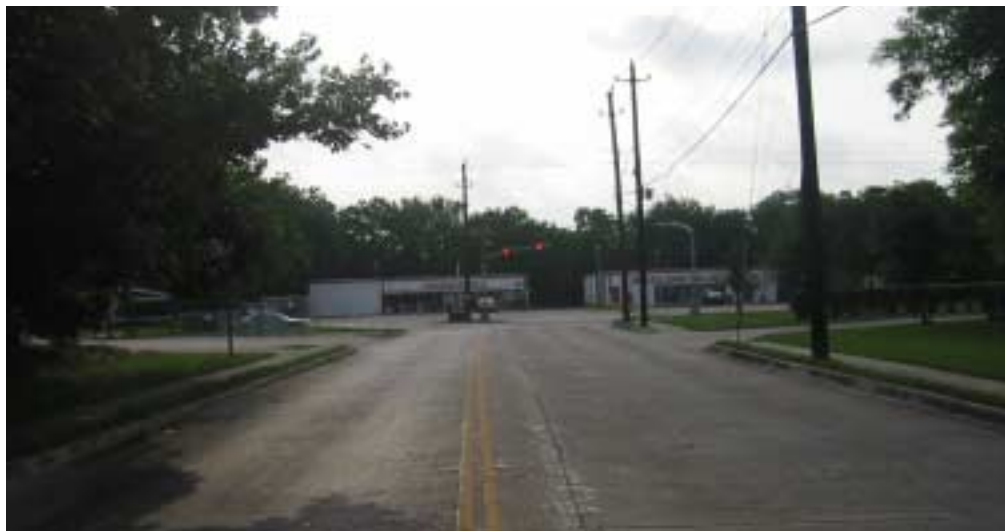
Figure 15. View of Preston @ Cherry Brook from the Eastbound Approach.

General traffic counts from the area were provided by the City of Pasadena. Intersection turning movement counts were also provided for each intersection for the AM peak, Midday, and PM peak periods, shown in Figure A-5 in Appendix A. The predominant movement is northbound and southbound along Preston with a large number of vehicles turning WB on Cherry Brook during the AM peak period (see Figure 15). In addition to traffic count data, signal timings were also provided. All red and yellow clearance intervals were adequate based on standard practice.
