Targeted Bacteria Monitoring Project

FY25 Final Report – Assessment Unit: 1006D_02 Halls Bayou

Houston-Galveston Area Council
3555 Timmons Lane, Suite 100 Houston,
TX 77027

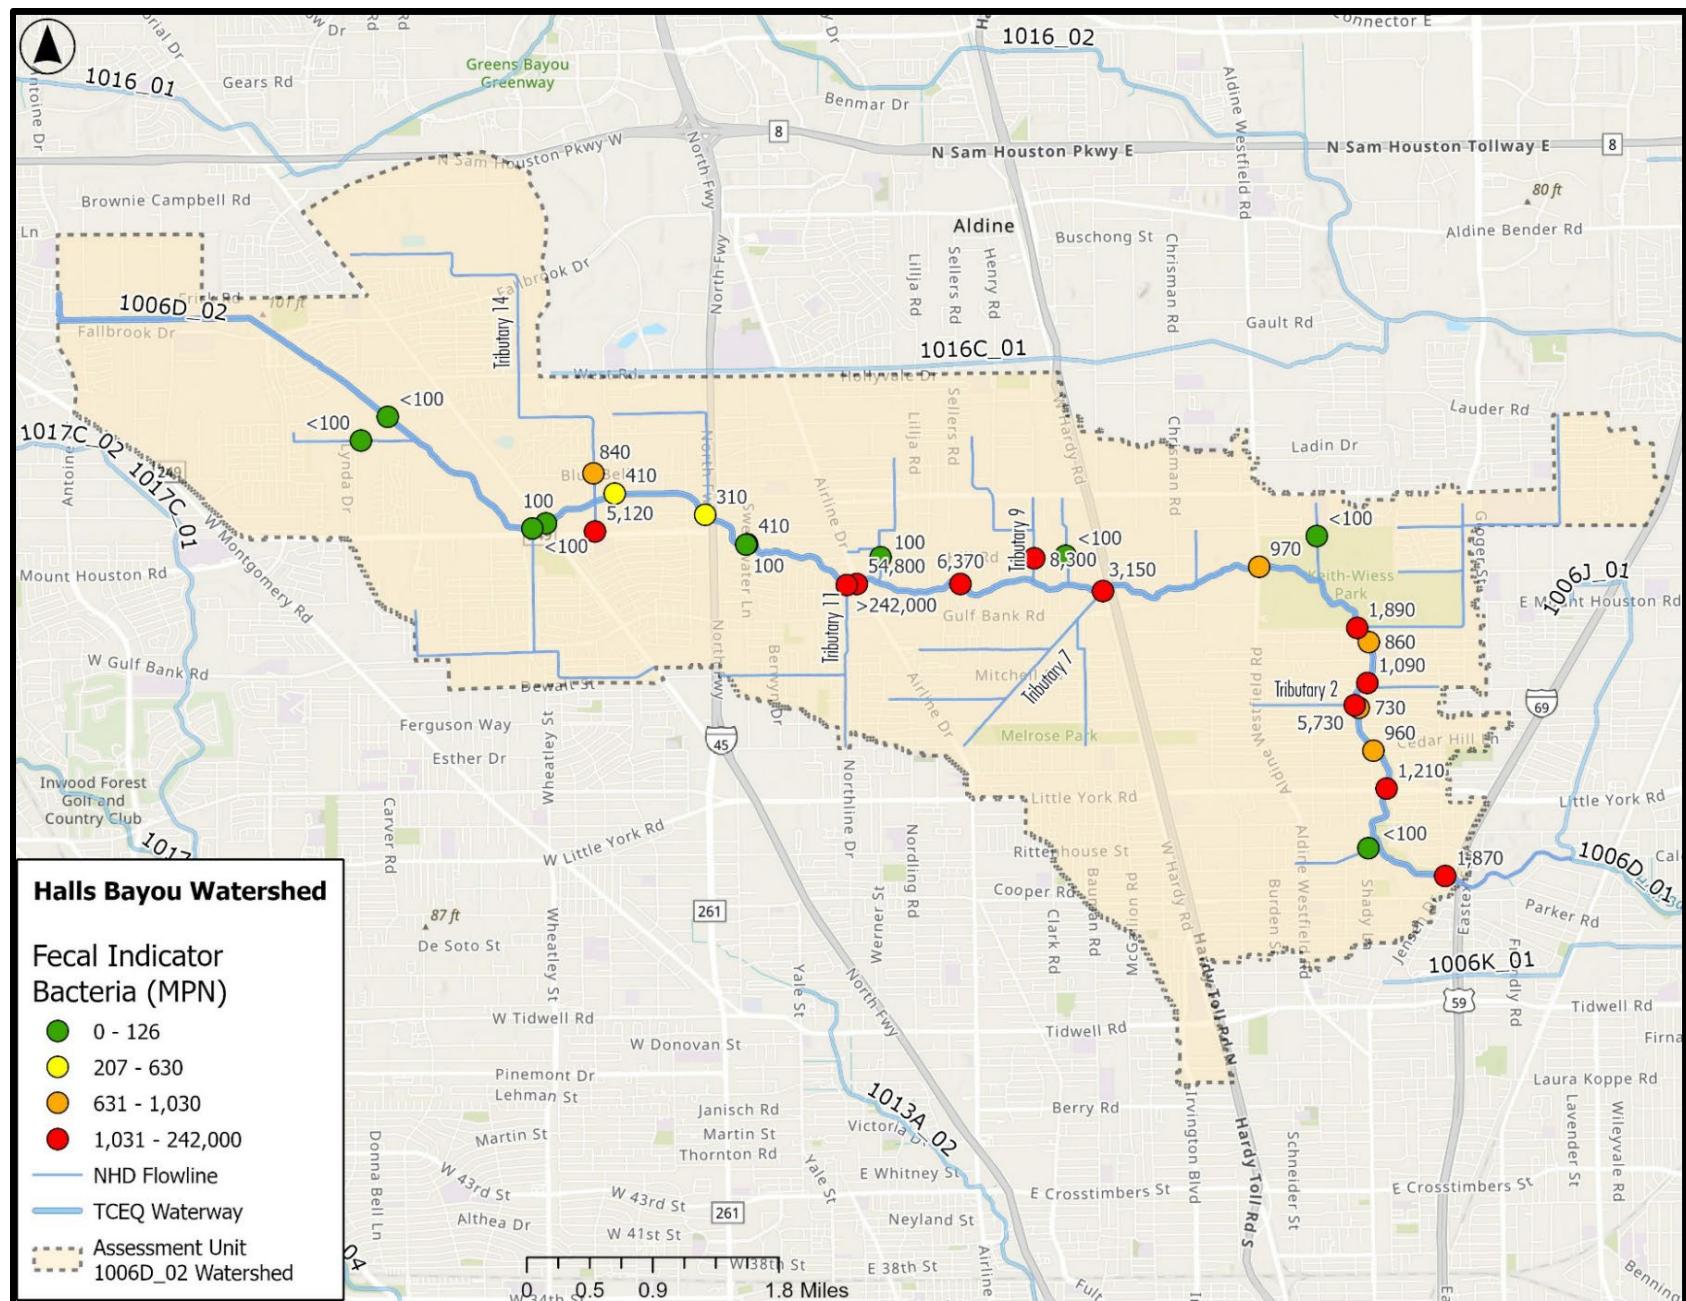
Figure 4. Halls Bayou (1006D 02) windshield survey results. Sampling was conducted on 02/04/2025.

The WS for Halls Bayou was conducted on February 4th, 2025, five days after the last significant rainfall in the watershed (0.16 inches). A total of 28 samples were collected across the 31 WS sites identified during the desktop review. Seven of the WS sites were not sampled due to dry conditions and accessibility issues. Bacteria results from the ambient water samples collected ranged from less than 100 colonies/100 mL to greater than 242,000 colonies/100 mL (Figure 4, Table 1). The highest values were samples collected at the most easily accessible downstream locations of 5 tributaries that flow into Halls Bayou (gray rows indicated in Table 1). These values ranged from 3,150 colonies/100 mL at tributary 7 to greater than 242,000 colonies/100 mL at tributary 11. Two samples collected on the main AU had elevated values believed to result from discharge from the tributaries identified for field investigation which include values of 54,800 colonies/100 mL approximately 0.06 mi downstream of Tributary 11 and 6,370 colonies/100 mL approximately 0.78 mi downstream of Tributary 11. These results informed the decision to focus the intensified field investigation to these five tributaries with the highest indicator bacteria results. All other samples collected on the main AU range from less than 100 colonies/100mL to 1,890 colonies/100mL. Observations during the WS include areas with large amounts of litter and areas where livestock have open access to the water body.

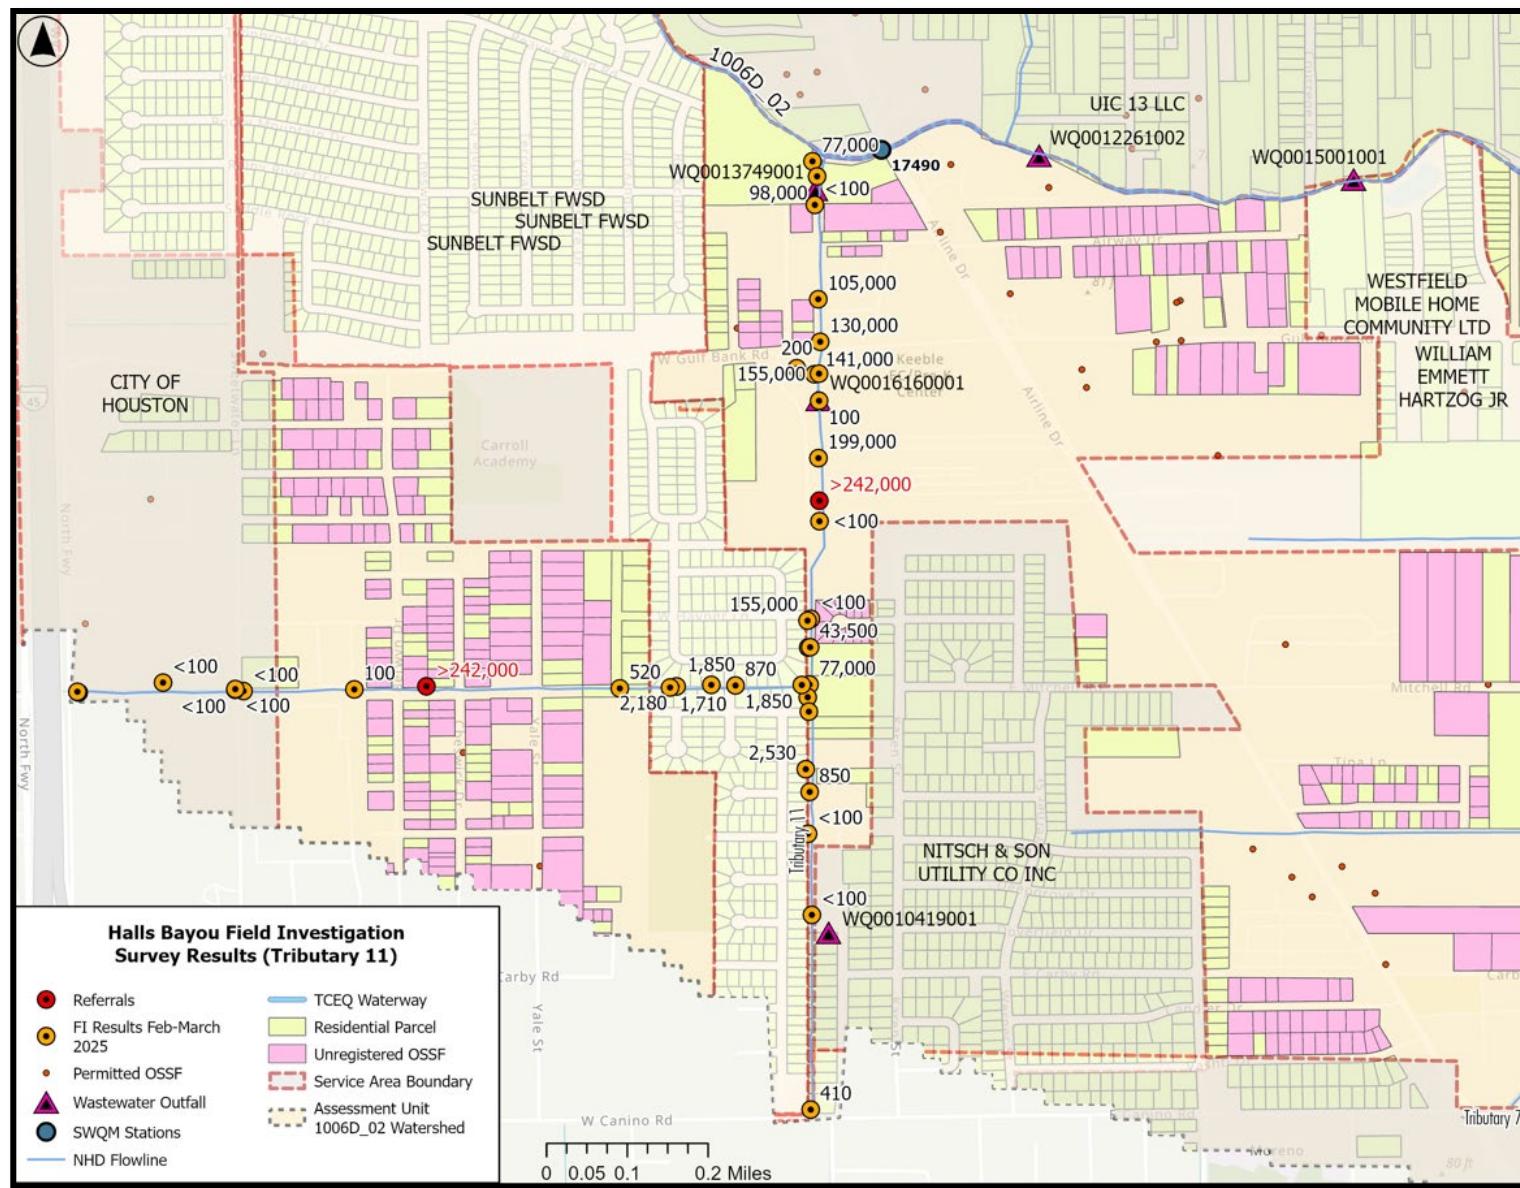
Figure 6. Tributary 11 field investigation results from 2/27/2025 on Halls Bayou (1006D_02).

The initial access point on tributary 11 featured a small WWTF in Pine Oak Mobile Home Community. Tributary 11 is located around 3 main service area boundaries: Sunbelt FWSD, City of Houston, and NITSCH & Son Utility Co., Inc. There are various clusters of permitted and non-registered OSSFs in this area. An active SWQM station, 17490, is located to the east of the sampling location on the main AU. Field staff made their way down into the water body and took their first sample in front of two culvert openings before beginning their extended walk. A total of 38 samples were collected (Figure 6 and Table 2). Of the samples collected, 26 reflected a bacteria level greater than the primary contact recreation single sample criterion of 399 colonies/100 mL. Although these samples were all higher than the single sample criterion, there were only two locations (FI-T11-11P and FI-T11-31P) that were recommended for further investigation as they had the highest bacteria levels seen for this tributary. Areas suggested for further investigation are detailed in the Referrals to Local Jurisdictions section of the report.

For each of the tributaries, field staff took ambient samples at the initial access points as close to the previous WS sample as possible to compare results and to note whether there were any significant changes. For Tributary 11, the *E. coli* levels seen for sample FI-T11-01A (77,000 colonies/100mL) decreased from the previous sample WS-21 (>242,000 colonies/100 mL) but was still well above the single sample criterion.

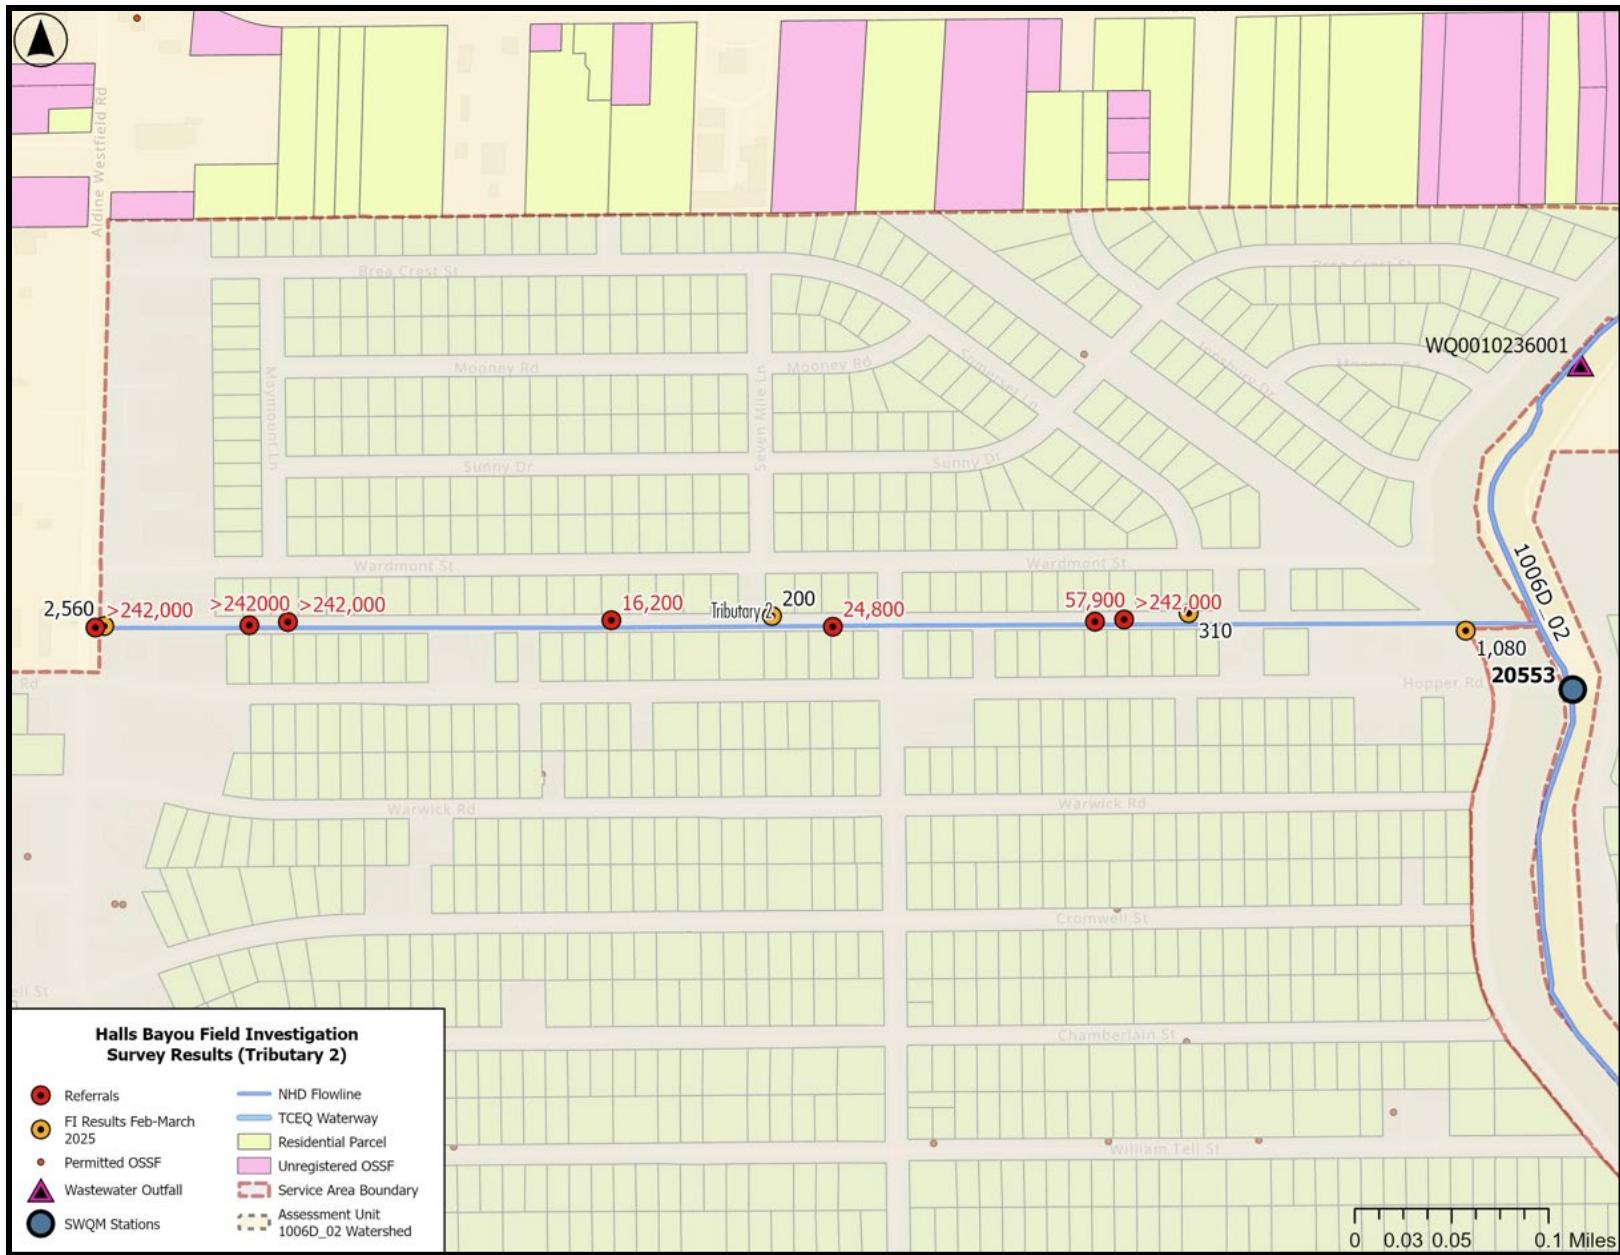
Figure 7. Tributary 2 field investigation results from 2/27/2025 on Halls Bayou (1006D_02).

Tributary 2's initial access point was at the most downstream location before an outfall leading out to the main AU. A historical SWQM station, 20553, is located to the east of the first sampling location on the main AU, and a permitted WWTF is observed upstream (Figure 7). A considerable amount of litter was observed in the outfall near where field staff collected the first sample. A total of 11 samples were collected (Table 3). Field staff noted that throughout this survey, multiple PVC pipes with water flowing into the tributary were observed coming from residential properties. This tributary falls within the Sunbelt FWSD service area boundary, and it appears that the tributary does not directly intersect with permitted and non-registered OSFFs.

Of the samples collected, 9 reflected a bacteria level greater than the primary contact recreation single sample criterion of 399 colonies/100 mL. Seven locations were recommended for further investigation as they had the highest bacteria levels seen for this tributary. Areas suggested for further investigation are detailed in the Referrals to Local Jurisdictions section of the report.

For comparison, the ambient sample, FI-T2-39A, collected during the field investigation *E. coli* result was 1,080 colonies/100 mL, while the ambient sample collected at approximately the same location during the WS, WS-6, had a result of 5,730 colonies/100 mL.

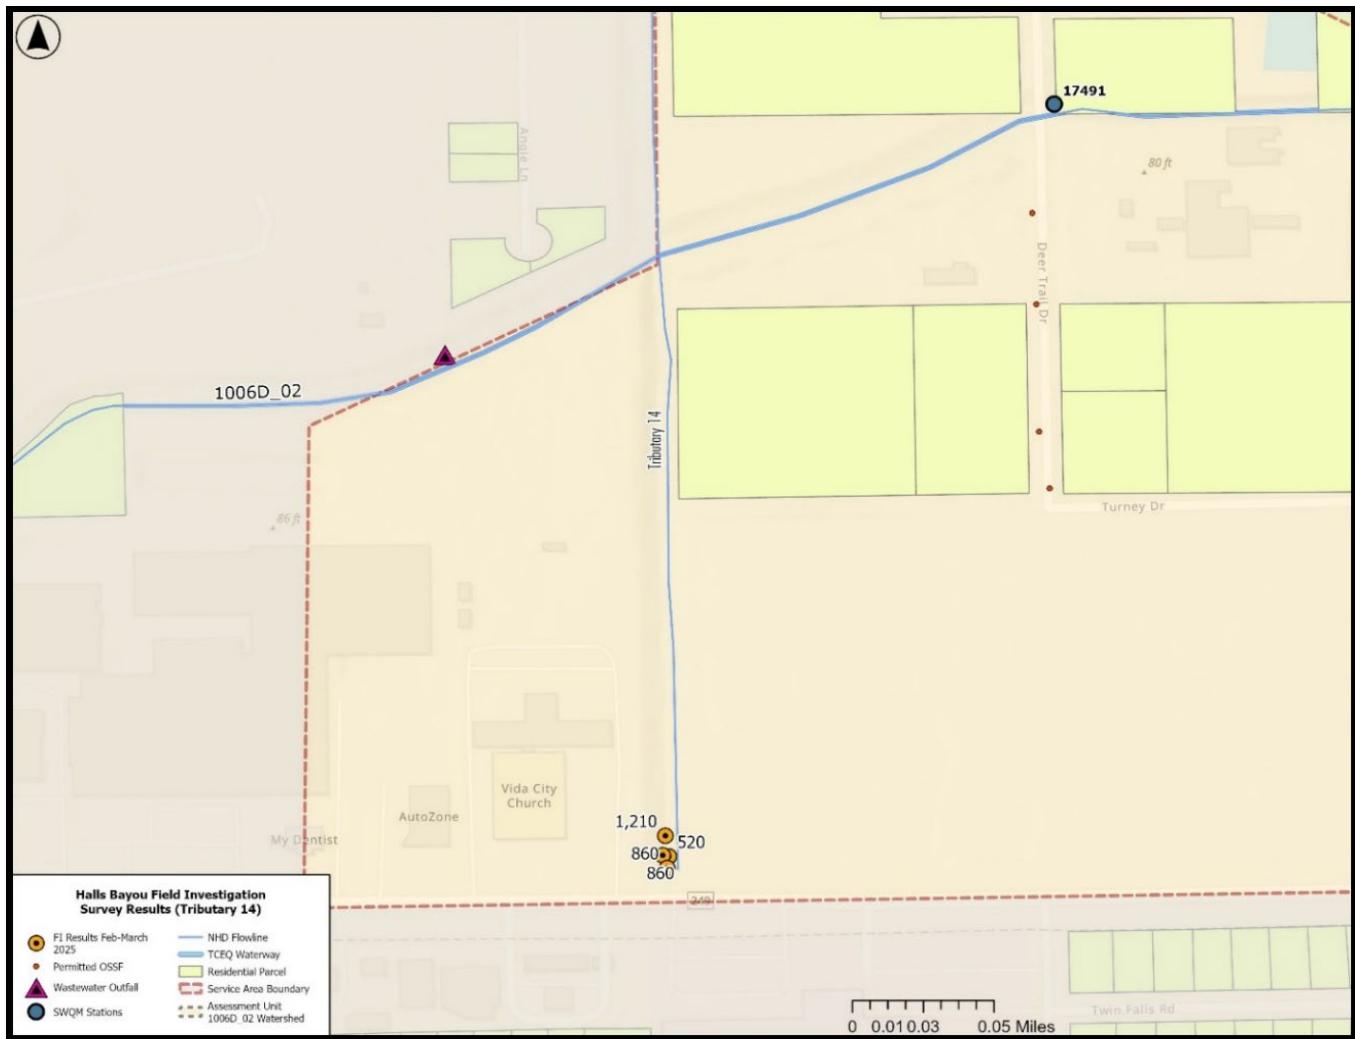
Figure 8. Tributary 14 field investigation sampling locations of 3 outfall pipes sampled on 3/18/2025.

Sample collection for tributary 14 was at a singular area, featuring four samples in total (Figure 8 and Table 4). The initial sample obtained was an ambient grab just downstream of three outfalls located near the property of Vida City Church. Field staff took note of the stagnant water and what appeared to be an oil sheen on the water's surface. Due to the prioritization of the other four tributaries based on their significantly higher *E. coli* levels, no referrals were recommended for tributary 14 at this time. All samples had bacteria results greater than the primary contact recreation single sample criterion of 399 colonies/100 mL.

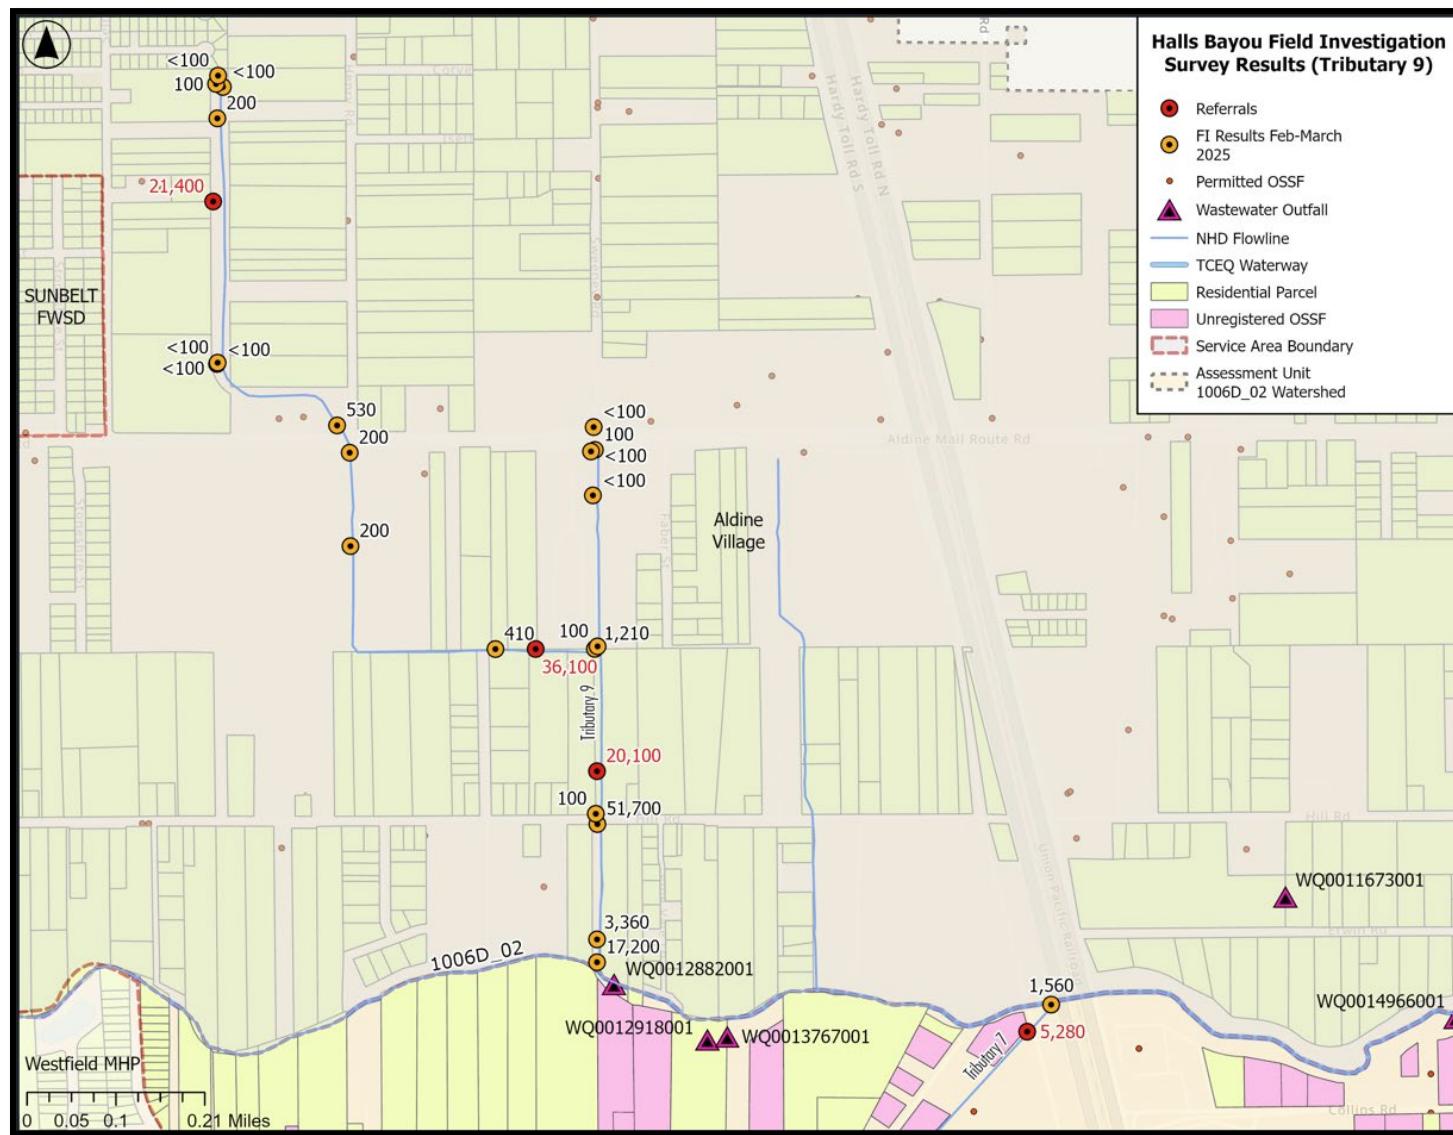
Figure 9. Tributary 9 field investigation results from 3/18/2025 on Halls Bayou (1006D_02).

Tributary 9 flows into Halls Bayou approximately 0.53 mi west of Hardy Toll Road and continues upstream (northwest) past Aldine Mail Route Road for 1.40 mi. A total of 24 samples were collected with *E. coli* results ranging from less than 100 colonies/100mL to 51,700 colonies/100mL (Figure 9 and Table 5). Two referrals are recommended for this tributary, both were samples collected directly from pipes. The field staff noted an oil sheen in the tributary near site FI-T9-12P and a white film on the surface with a strong sewage smell at FI-T9-05P. The third referral (FI-T9-20A) was collected from an earthen ditch where field staff observed a horse stable on the left bank. Although one sample (FI-T9-03A) had the highest bacteria levels in this tributary, it was not recommended for referral since it was an ambient sample taken with no observed sources nearby. This tributary is located in the Aldine Village residential area in the UIC 13 LLC (Utilities Investment) service area boundary.

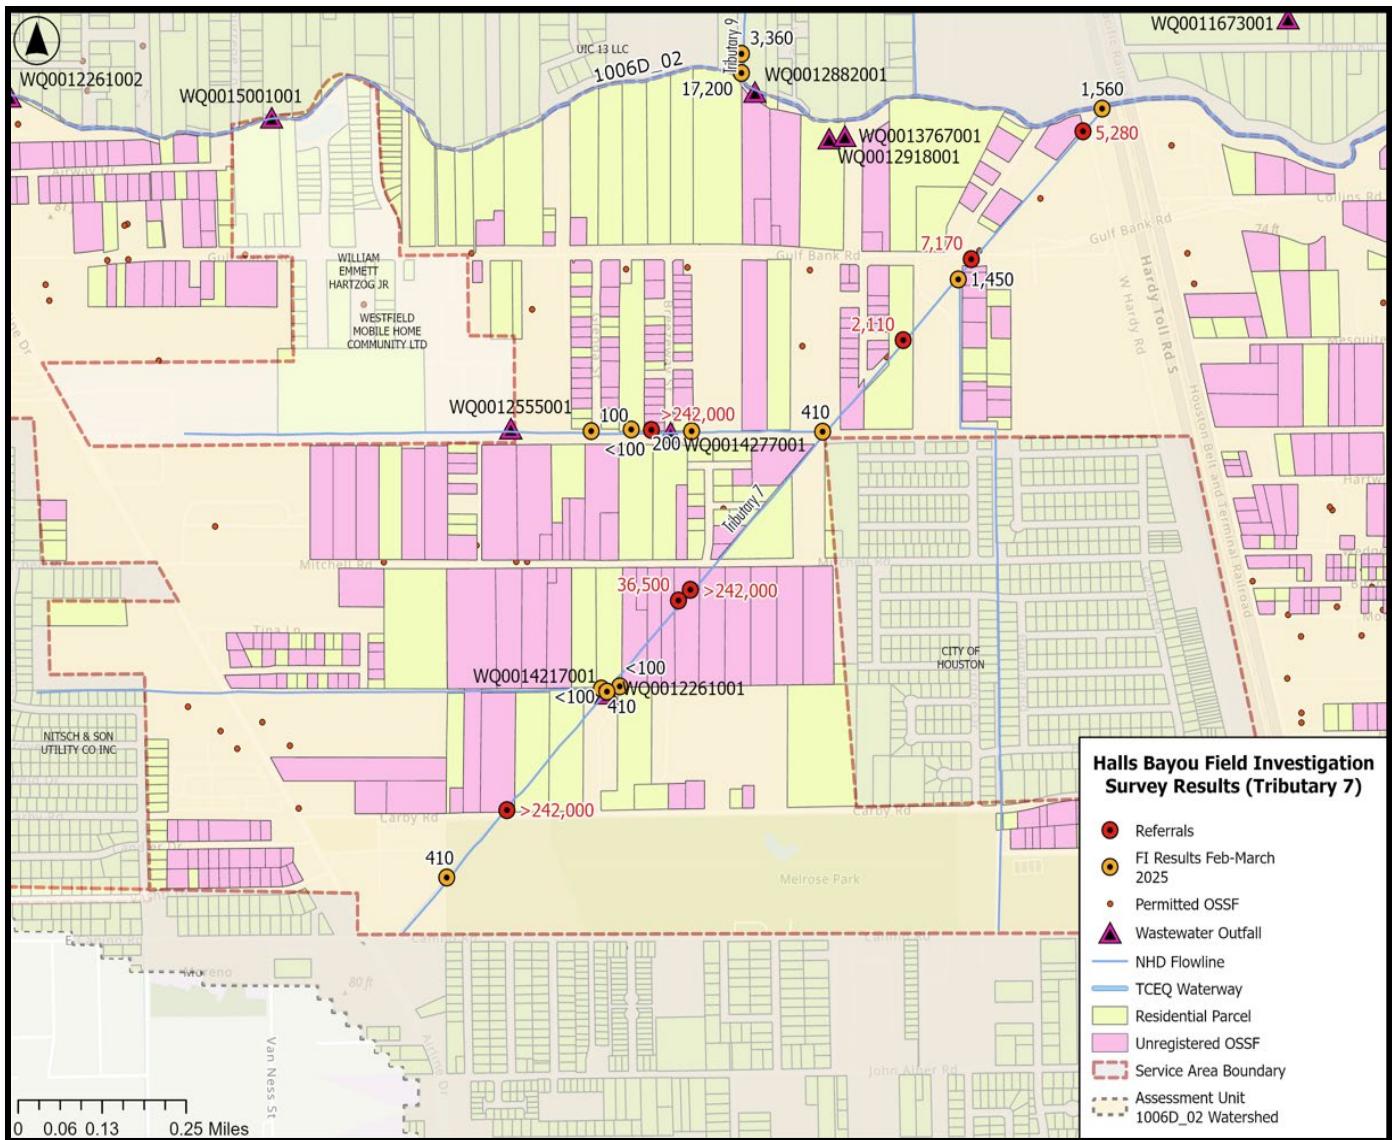
Figure 10. Tributary 7 field investigation results from 3/18/2025 on Halls Bayou (1006D_02).

Tributary 7 flows into Halls Bayou near Hardy Toll Road and continues upstream (southwest) near Airline Drive for approximately 1.46 mi. A total of 17 samples were collected with *E. coli* results ranging from less than 100 colonies/100mL to > 242,000 colonies/100mL (Figure 10 and Table 6). Out of all samples collected, there are a total of 7 referrals. All referrals were samples collected directly from pipes ranging from 2 inches to 72 inches in diameter with ≤ 0.25 inches of water flowing out. This tributary does not intersect with any service area boundaries and flows through residential parcels with potentially unregistered OSSF.
