# Bacteria Source Identification Report

## BIG's Top Five Most and Top Five Least Impaired Water Bodies Project

Project is funded through grants from the U.S. Environmental Protection Agency through the Texas Commission on Environmental Quality's (TCEQ) Galveston Bay Estuary Program (GBEP)

Paniz Miesen  
Senior Environmental Planner  
Houston-Galveston Area Council  
3555 Timmons Lane Suite 100  
Houston, TX 77027  
(832) 681-2523  
[Paniz.miesen@h-gac.com](mailto:Paniz.miesen@h-gac.com)

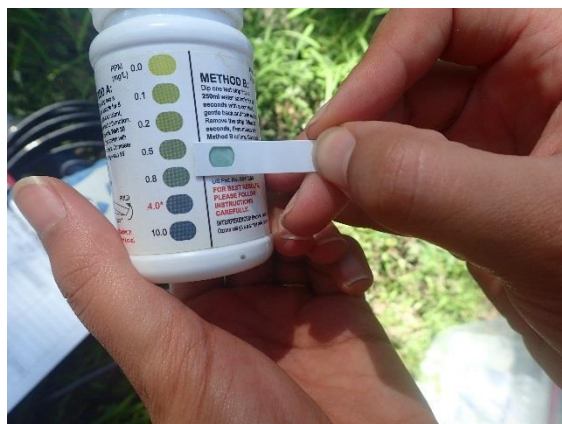
**FIGURE 21**

A chlorine odor was detected during the Upper Panther Branch Phase I and Phase II investigations. Chlorine test strips detected concentrations measuring greater than 0.5 mg/L at this location during the dry weather sampling event (Figure 21). The local wastewater treatment facility was notified, but a source for the chlorine is still unknown.

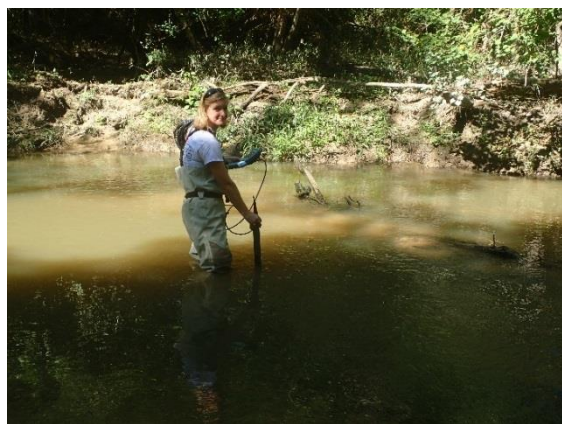
**FIGURE 22**

A dry weather sample was collected on September 28, 2016 (Figure 22) resulting in an *E.coli* concentration of 121 MPN/100mL which is just below the state water quality standard of 126 MPN/100mL. The wet weather sample collected on February 15, 2017 had a much greater *E.coli* concentration measuring at 9,800 MPN/100mL (Table 12).

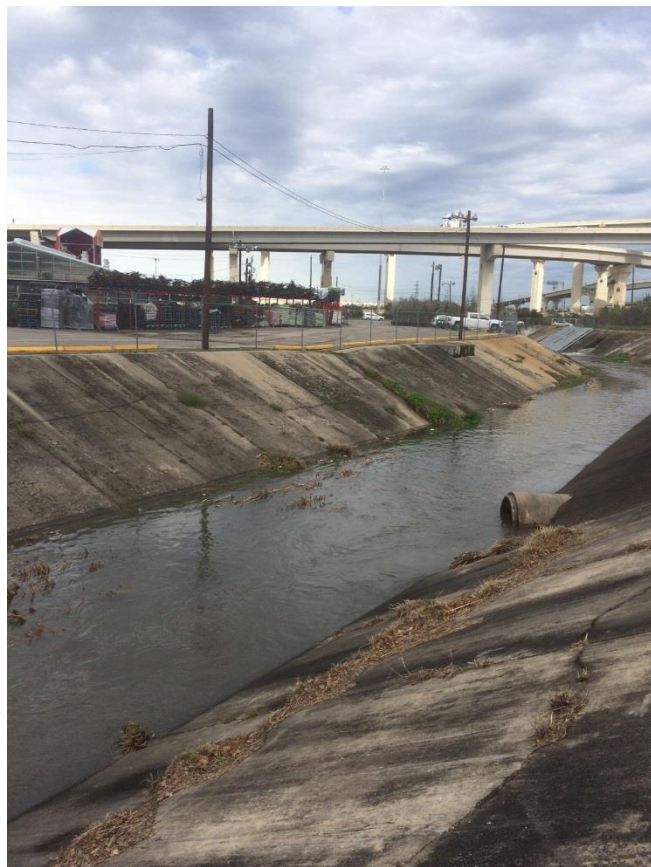
**FIGURE 58**

Station 41 is located approximately 160 meters downstream of station 40 near where the concrete lining ends (Figure 58). There are several outfalls located between stations 40 and 41, most of which are storm water outfalls originating from the detention basin to the east of Rummel Creek at this location. There is also a weather emergency alert facility located adjacent to the detention basin that has some type of on-site sewage facility (OSSF) on location.

During the dry weather event conducted on December 14, 2016, a strong odor of sewage was detected at one of the large outfalls directly upstream of station 41. Toilet paper was also observed at the outfall, although no water was discharging at that time. The dry weather sample resulted in a bacteria concentration of 369 MPN/100mL. The wet weather sample collected on February 14, 2017 was 24,200 MPN/100mL making station 41 one of the highest contributors of bacteria during wet weather conditions.
