Targeted Bacteria Monitoring Project Executive Summary

Overview

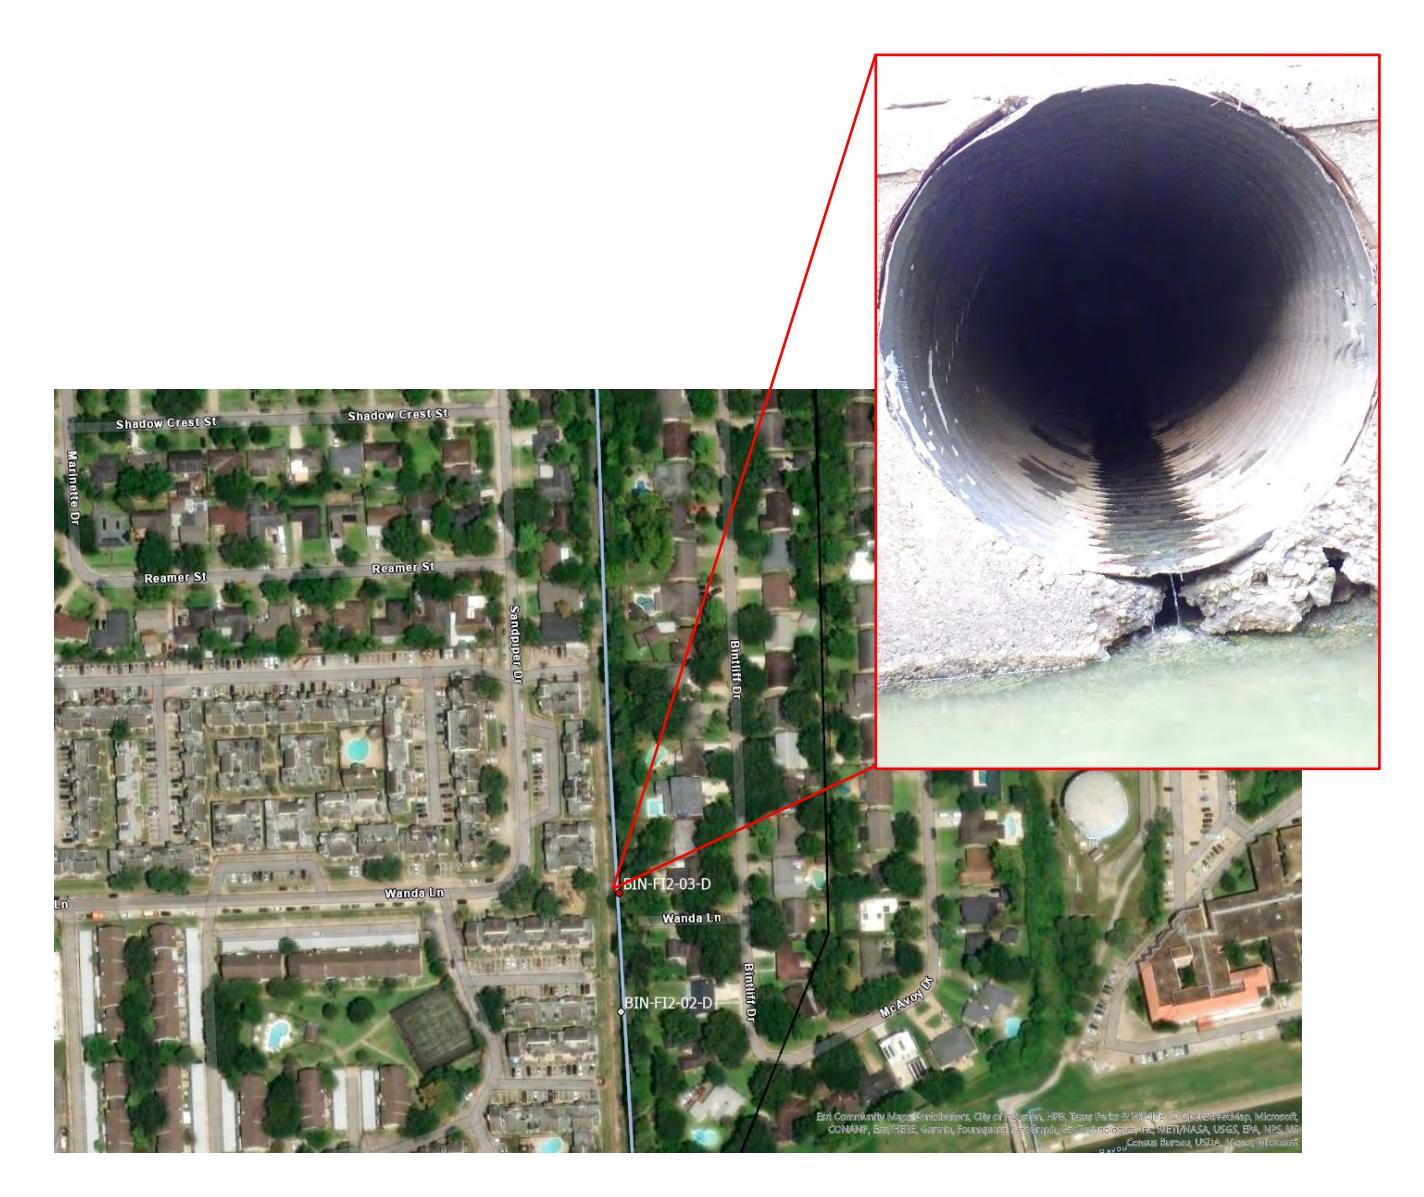
Referral site: BIN-FI2-03-D- High Priority

This is a 35 in. diameter metal pipe located on the right bank of Bintliff Ditch. Water within the pipe was 0.5 in. deep and trickling into the segment. There was a smell of effluent in the ambient air. There are apartments located in the area on the right bank. A sample taken 0.1 m downstream of the pipe had a bacteria value of 5,210 MPN/100 mL. The ambient sample collected upstream of the pipe had a bacteria value of 1,830 MPN/100 mL. This pipe is a high priority referral site for the proper local authority.

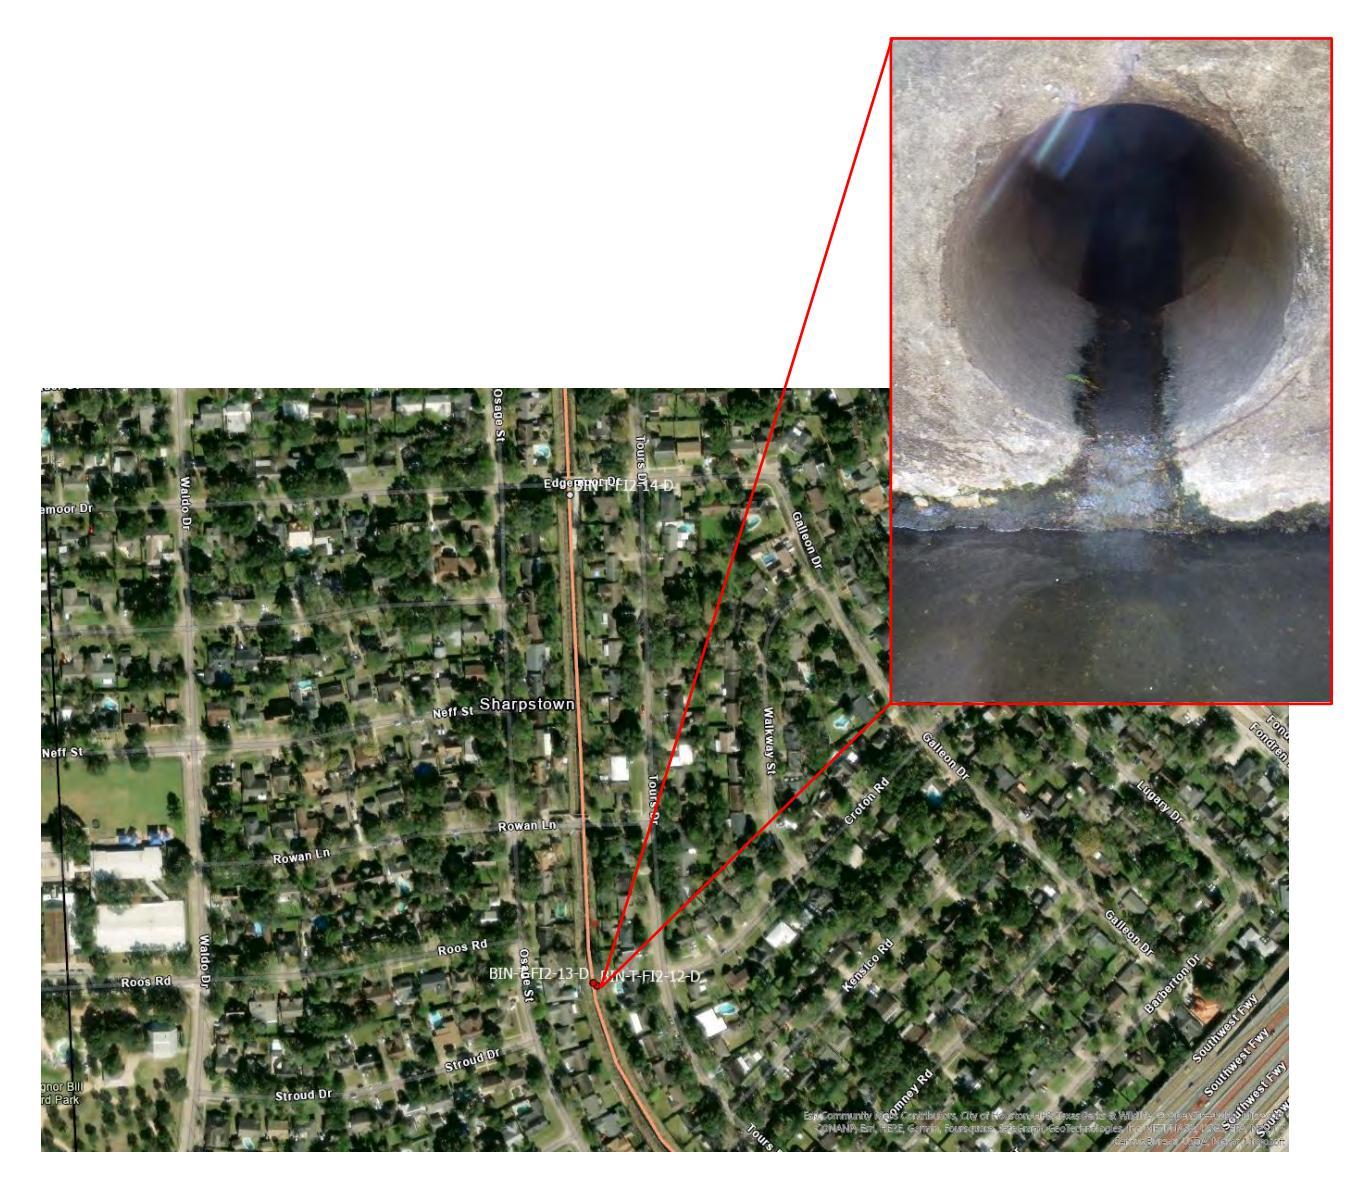
Referral site: BIN-T-FI2-12-D- High Priority

This is a 26 in. diameter cement pipe located on the left bank of the tributary to Bintliff Ditch. Water within the pipe was 0.125 in. deep and trickling into the segment. There are single-family homes located in the area on the left bank. A sample just 0.2 m downstream of the pipe had a bacteria value of > 242,000 MPN/100 mL. The ambient sample collected upstream of the pipe had a bacteria value of 1,580 MPN/100 mL. This pipe is a high priority referral site for the proper local authority. Note: the next referral site (BIN-T-FI2-13-D) is immediately upstream (approximately 1 m) of this pipe on the same bank.

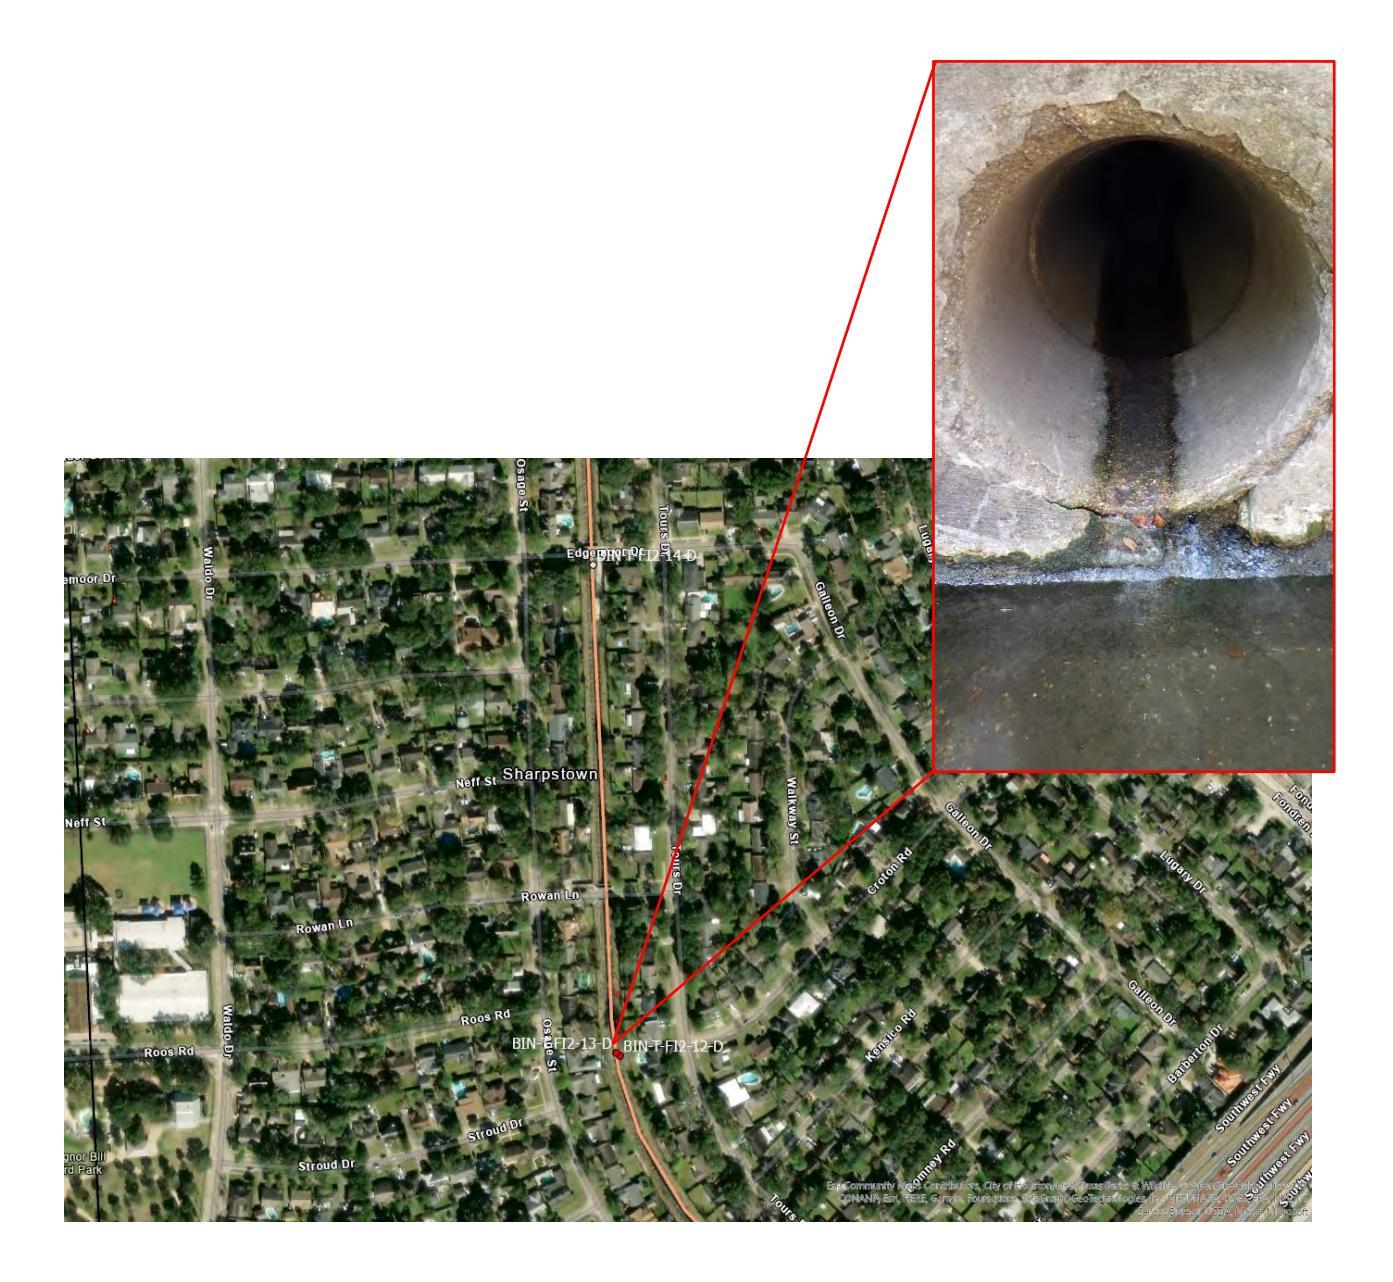
Referral site: BIN-T-FI2-13-D- High Priority

This is a 26 in. diameter cement pipe located on the left bank of the tributary to Bintliff Ditch, approximately 1 m upstream of the last referral site (BIN-T-FI2-12-D). Water within the pipe was 0.125 in. deep and trickling into the segment. There are single-family homes located in the area on the left bank. A sample just 0.2m downstream of the pipe had a bacteria value of > 242,000 MPN/100 mL. The ambient sample collected upstream of the pipe had a bacteria value of 1,580 MPN/100 mL. This pipe is a high priority referral site for the proper local authority.

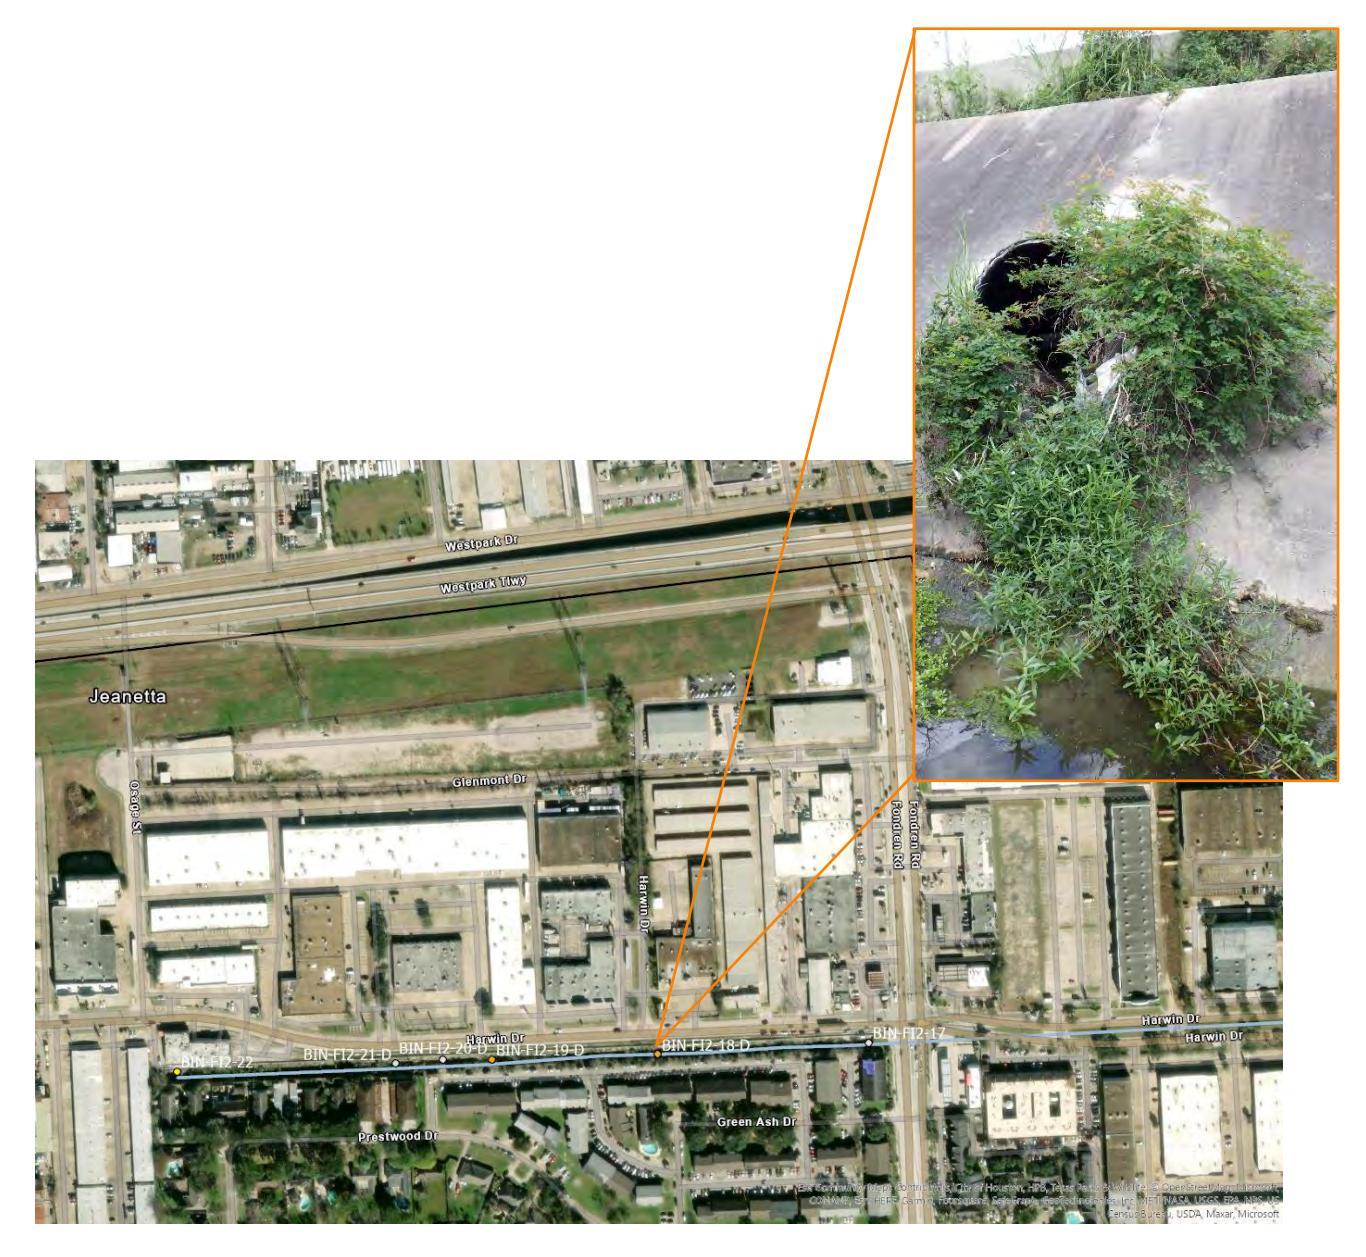
Referral site: BIN-FI2-18-D- Low Priority

This is a 36 in. diameter metal pipe located on the left bank of Bintliff Ditch. Water within the pipe was 0.25 in. deep and trickling into the segment through significant vegetation. There are commercial buildings located in the area on the left bank. A sample just 0.7 m downstream of the pipe had a bacteria value of 520 MPN/100 mL. The ambient sample collected upstream of the pipe had a bacteria value of 100 MPN/100 mL. This pipe is a low priority referral site for the proper local authority.

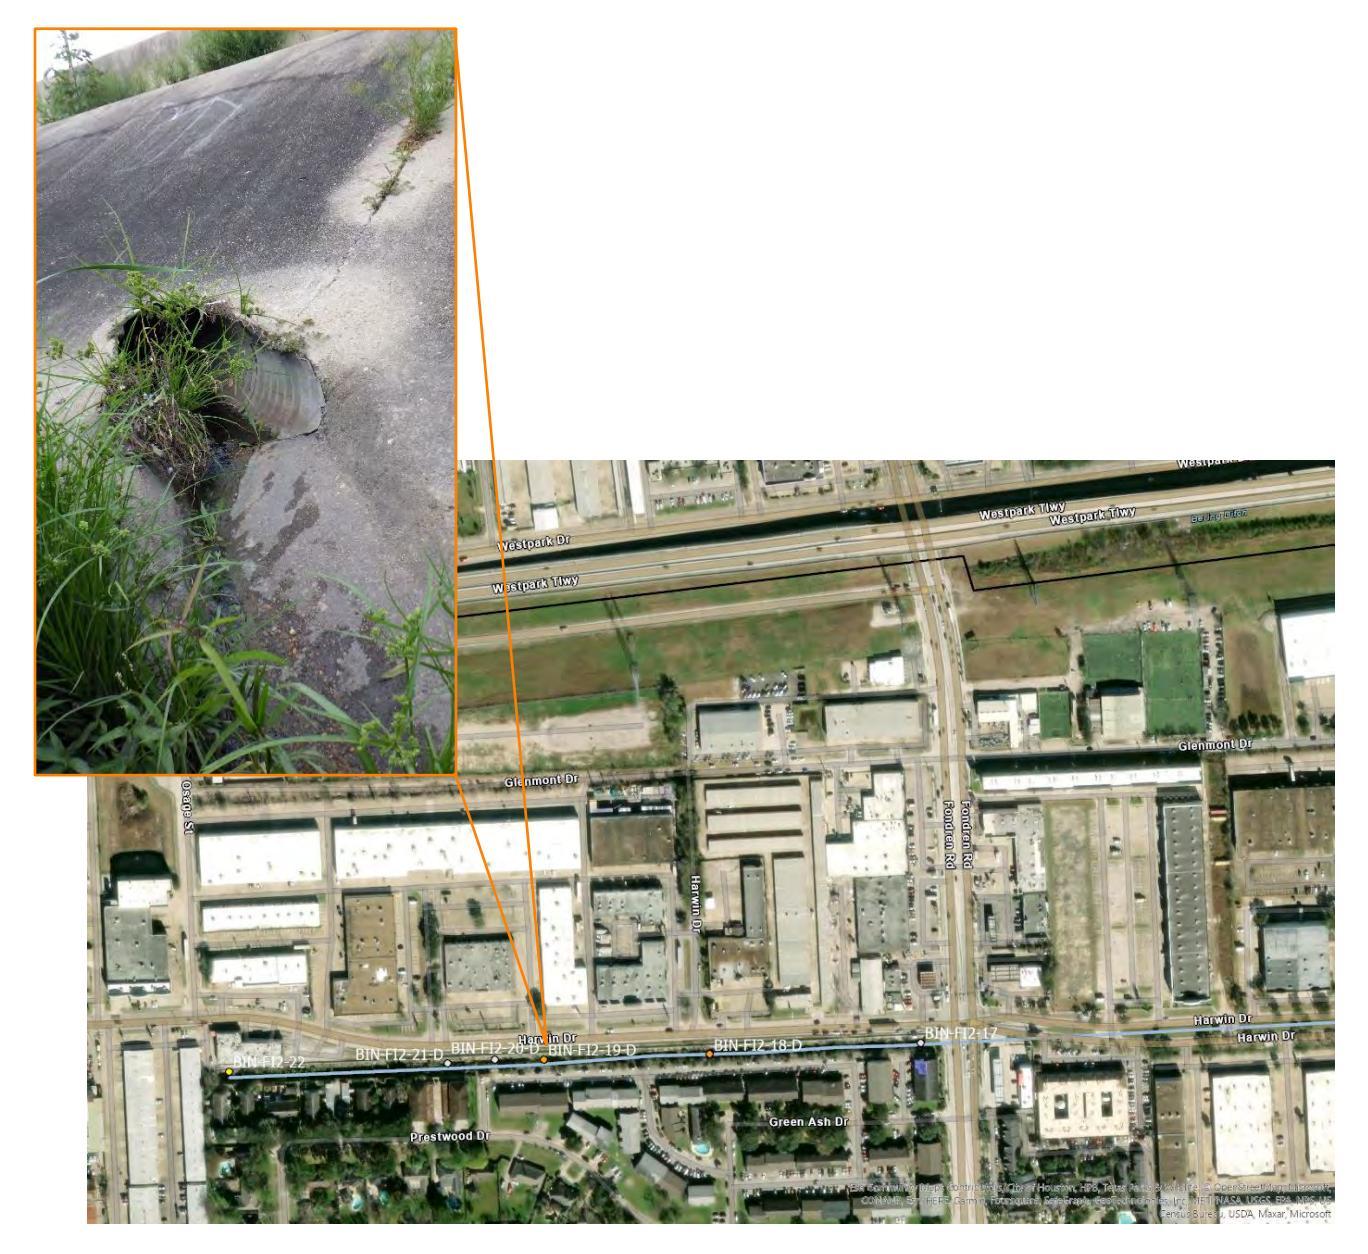
Referral site: BIN-FI2-19-D- Low Priority

This is a 21 in. diameter metal pipe located on the left bank of Bintliff Ditch. Water within the pipe was 2 in. deep and flowing into the segment over the cement wall through some vegetation. There are commercial buildings located in the area on the left bank. A sample just 1.3 m downstream of the pipe had a bacteria value of 630 MPN/100 mL. The ambient sample collected upstream of the pipe had a bacteria value of 300 MPN/100 mL. This pipe is a low priority referral site for the proper local authority.

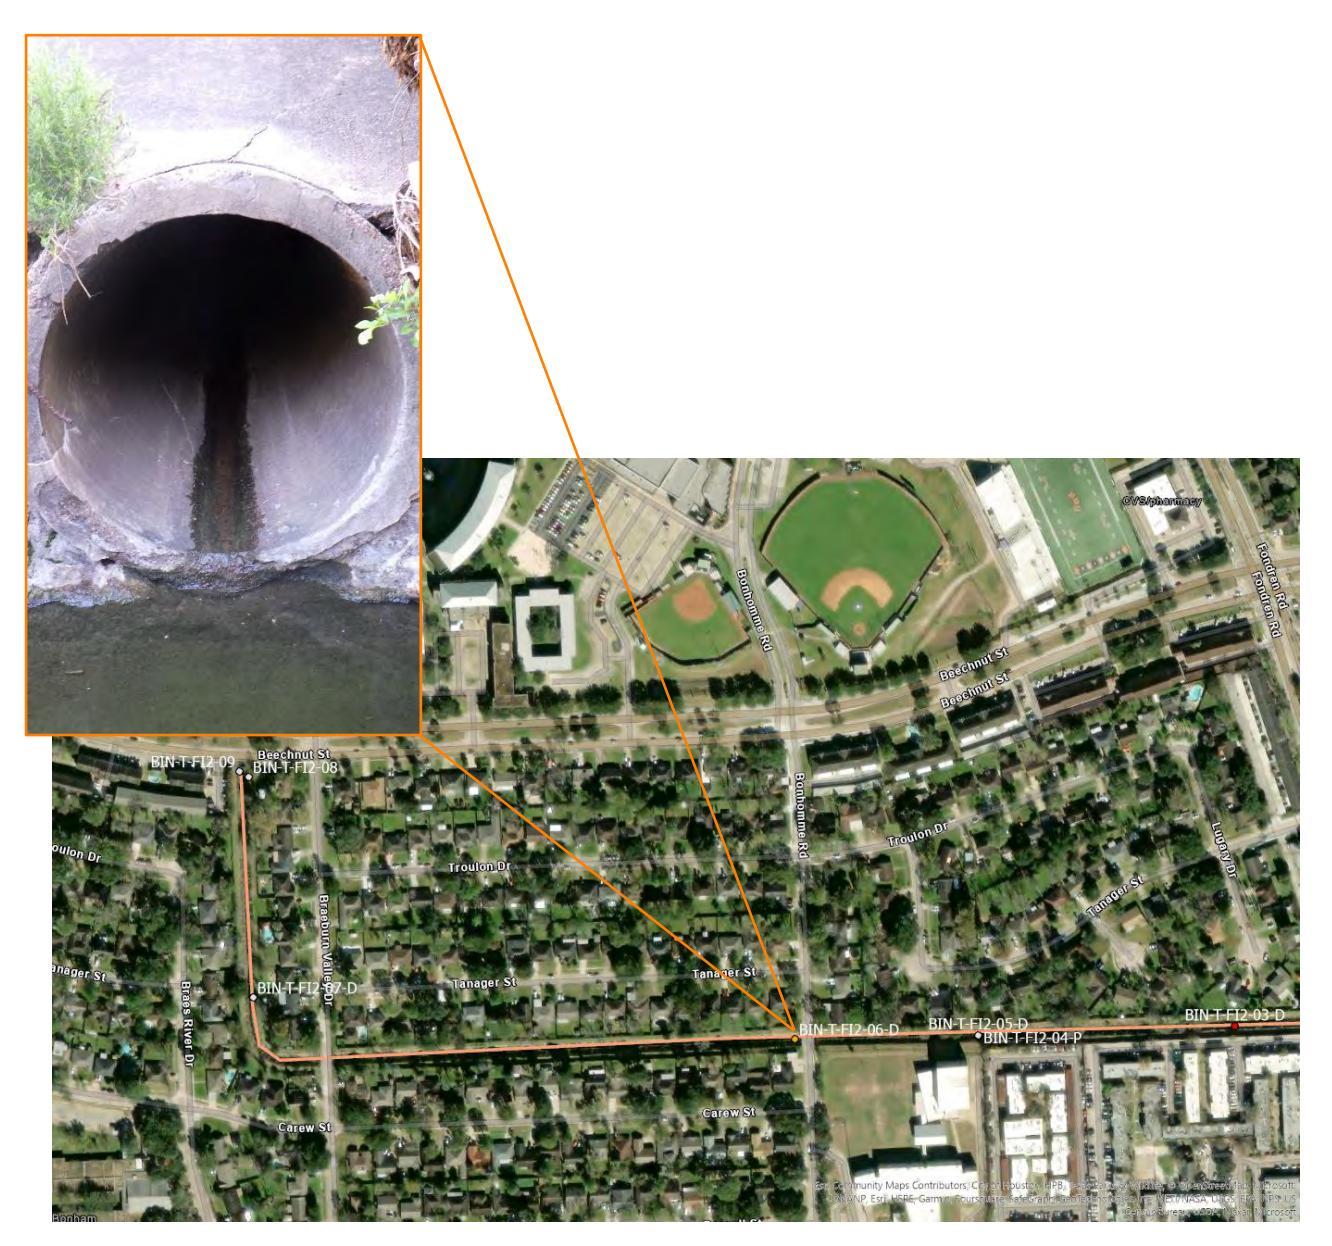
Referral site: BIN-T-FI2-06-D- Low Priority

This is a 42 in. diameter cement pipe located on the left bank of the tributary to Bintliff Ditch. Water within the pipe was 0.5 in. deep and trickling into the segment. There are single-family homes located in the area on the left bank. A sample just 0.2 m downstream of the pipe had a bacteria value of 520 MPN/100 mL. The ambient sample collected upstream of the pipe had a bacteria value of < 100 MPN/100 mL. This pipe is a low priority referral site for the proper local authority.

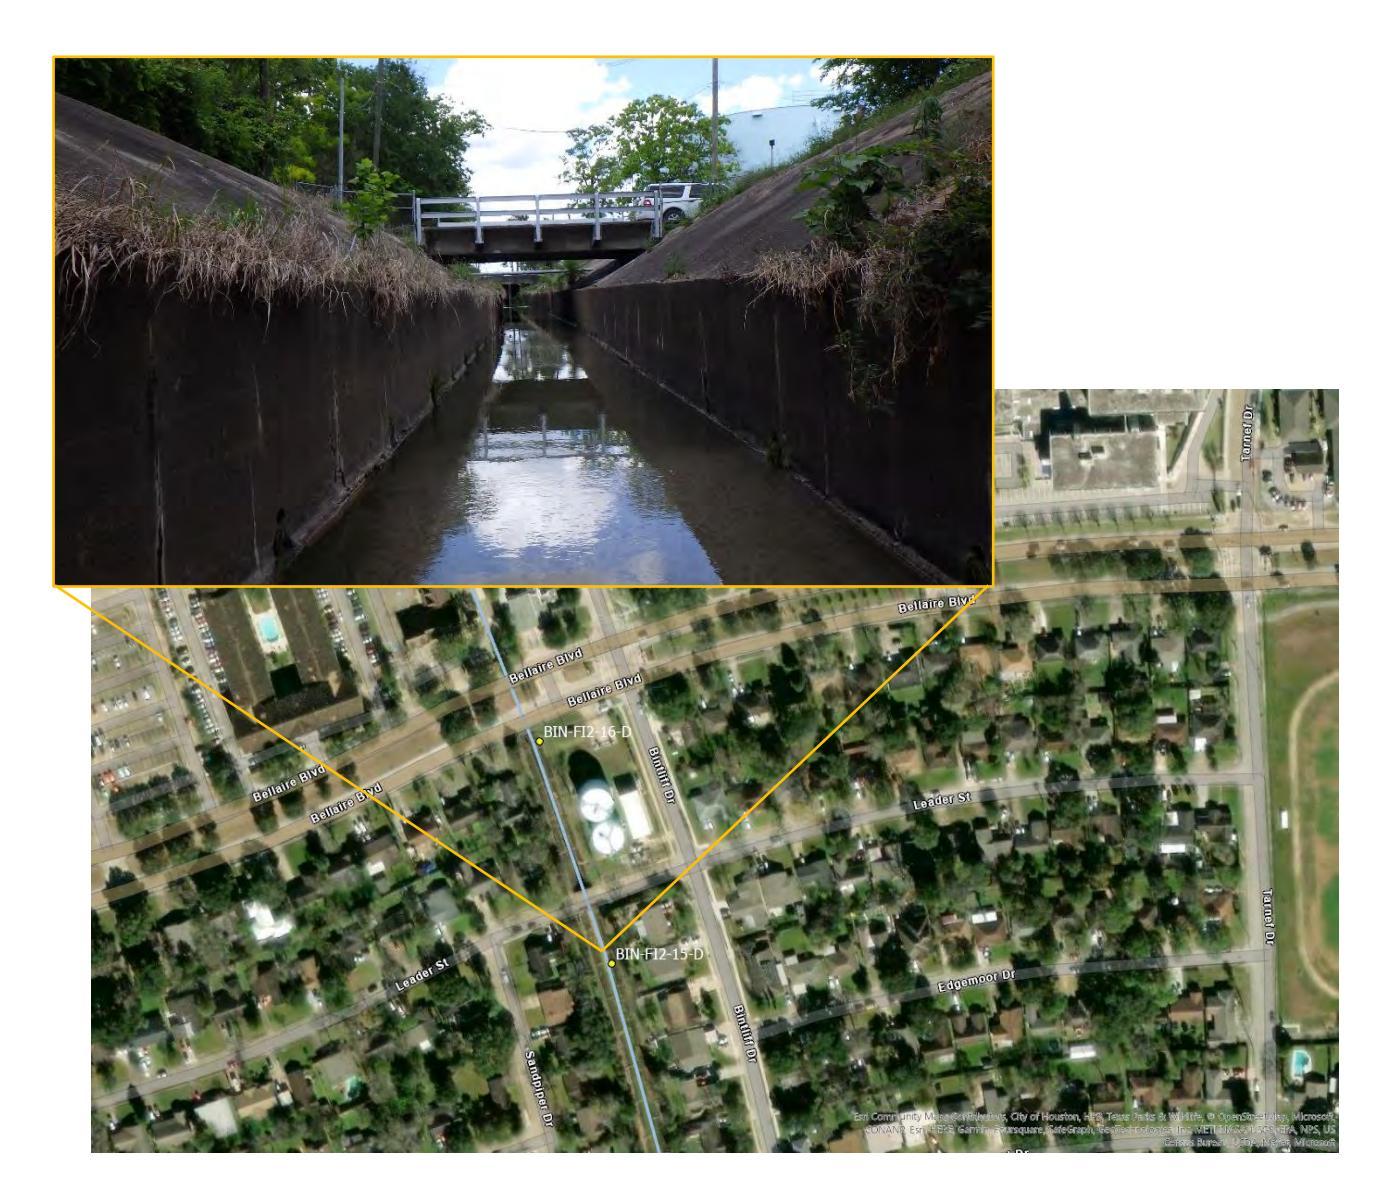
Referral site: BIN-FI2-15-U – Investigate Further

This was an ambient (upstream) sample taken to accompany a sample taken at a trickling weep hole (BIN-FI2-15-D) on Bintliff Ditch. The ambient sample had a bacteria value of > 242,000 MPN/100 mL. The next upstream ambient sample taken at site BIN-FI2-16-U, just before the segment continues underground, had a bacteria value of 850 MPN/100 mL. While there were no obvious pipes flowing into the segment between these two sample points, there is a source of elevated bacteria. There are some kind of large tanks located along the left bank between these two sites as seen in the map and photo facing upstream from site BIN-FI2-15-U below. Further investigation is recommended by the proper local authority to determine the source of elevated bacteria in this small stretch of the segment.

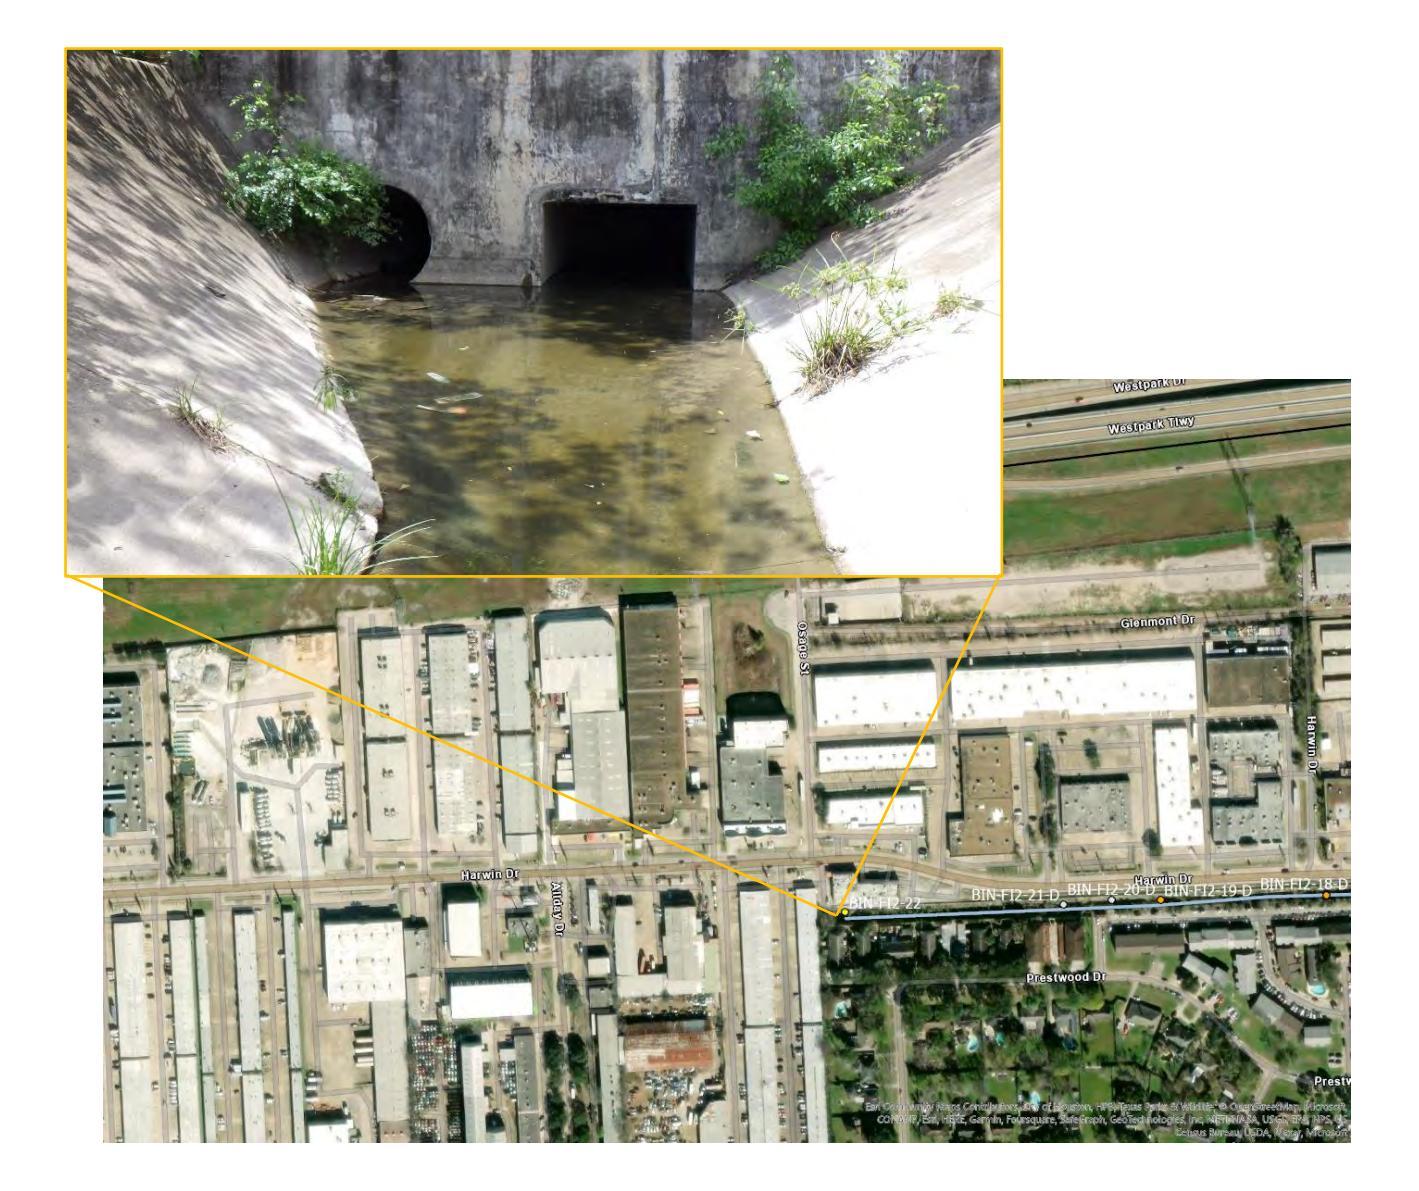
Referral site: BIN-FI2-22 – Investigate Further

This was an ambient sample taken at the most upstream portion of the Bintliff Ditch segment before it goes underground around Osage St. A sample just downstream of the two cement pipes had a bacteria value of > 46,100 MPN/100 mL. Further investigation is recommended by the proper local authority to determine the source of elevated bacteria underground and upstream of the segment.

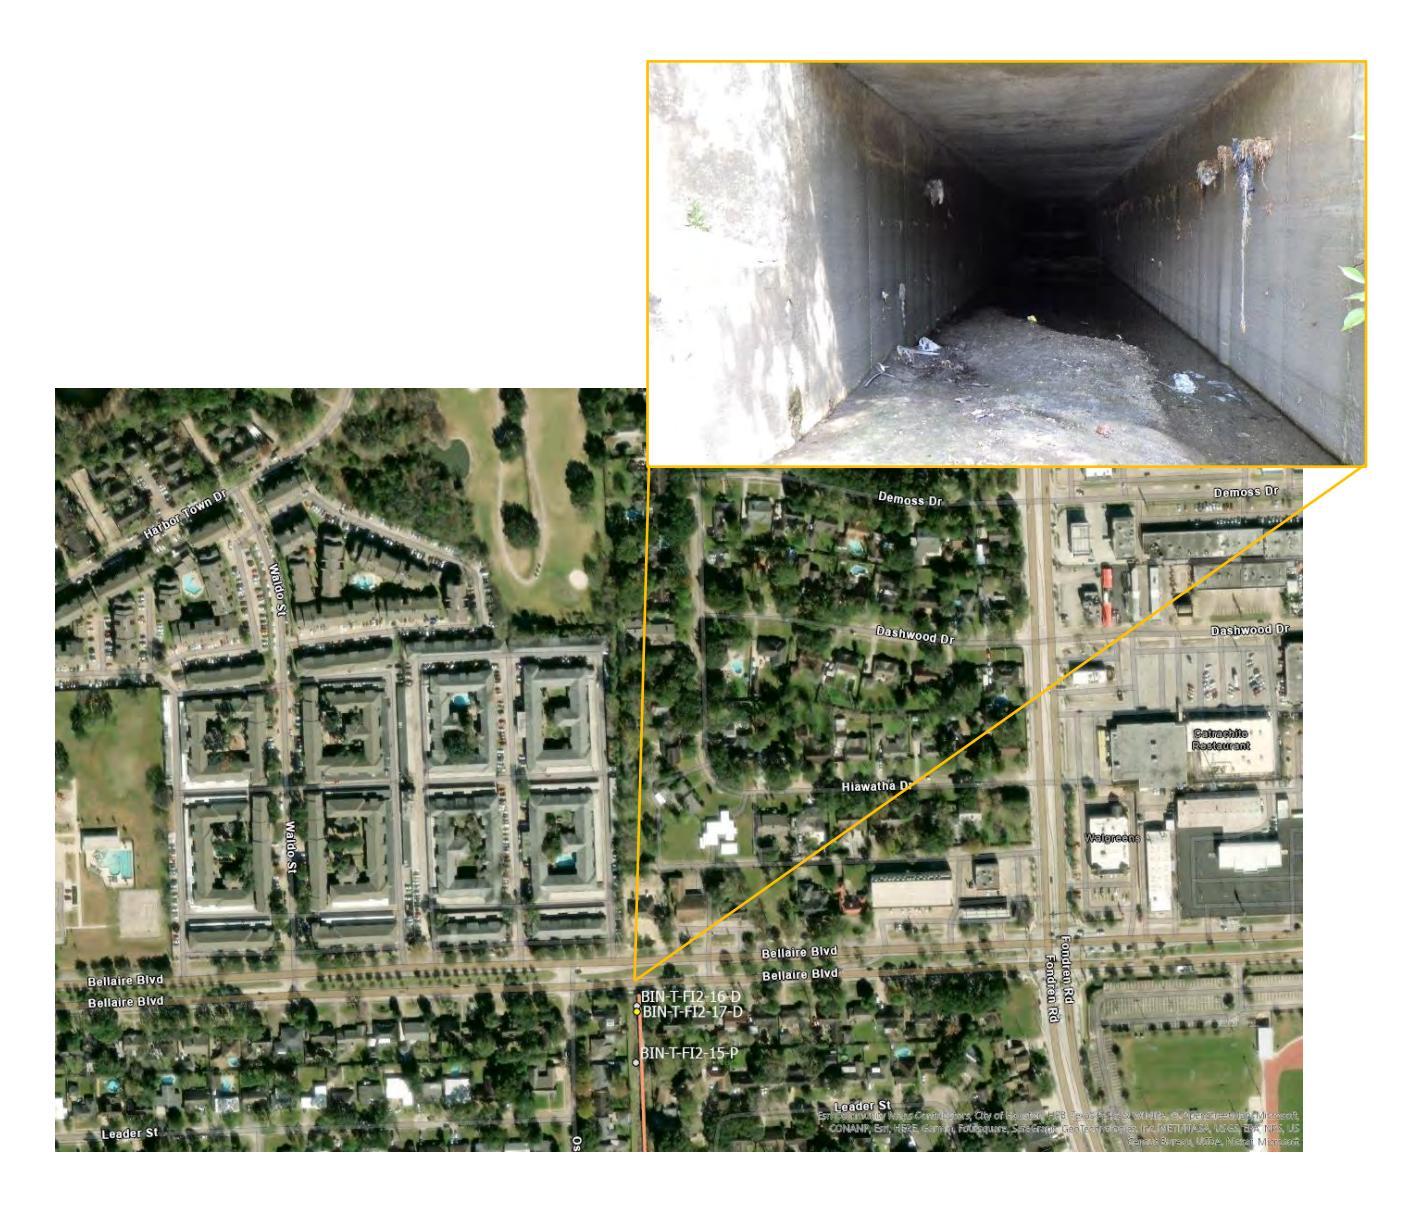
Referral site: BIN-T-FI2-16-U - Investigate Further

This was an ambient upstream sample which accompanied samples BIN-T-FI2-16-D and BIN-T-FI2-17-D, taken at the most upstream portion of the tributary to Bintliff Ditch before it goes underground at Bellaire Blvd. The ambient sample taken just in front of the bridge crossing had a bacteria value of 5,040 MPN/100 mL. Further investigation is recommended by the proper local authority to determine the source of elevated bacteria underground and upstream of the segment. There are apartment and single-family homes located upstream of the site as well as a golf course.

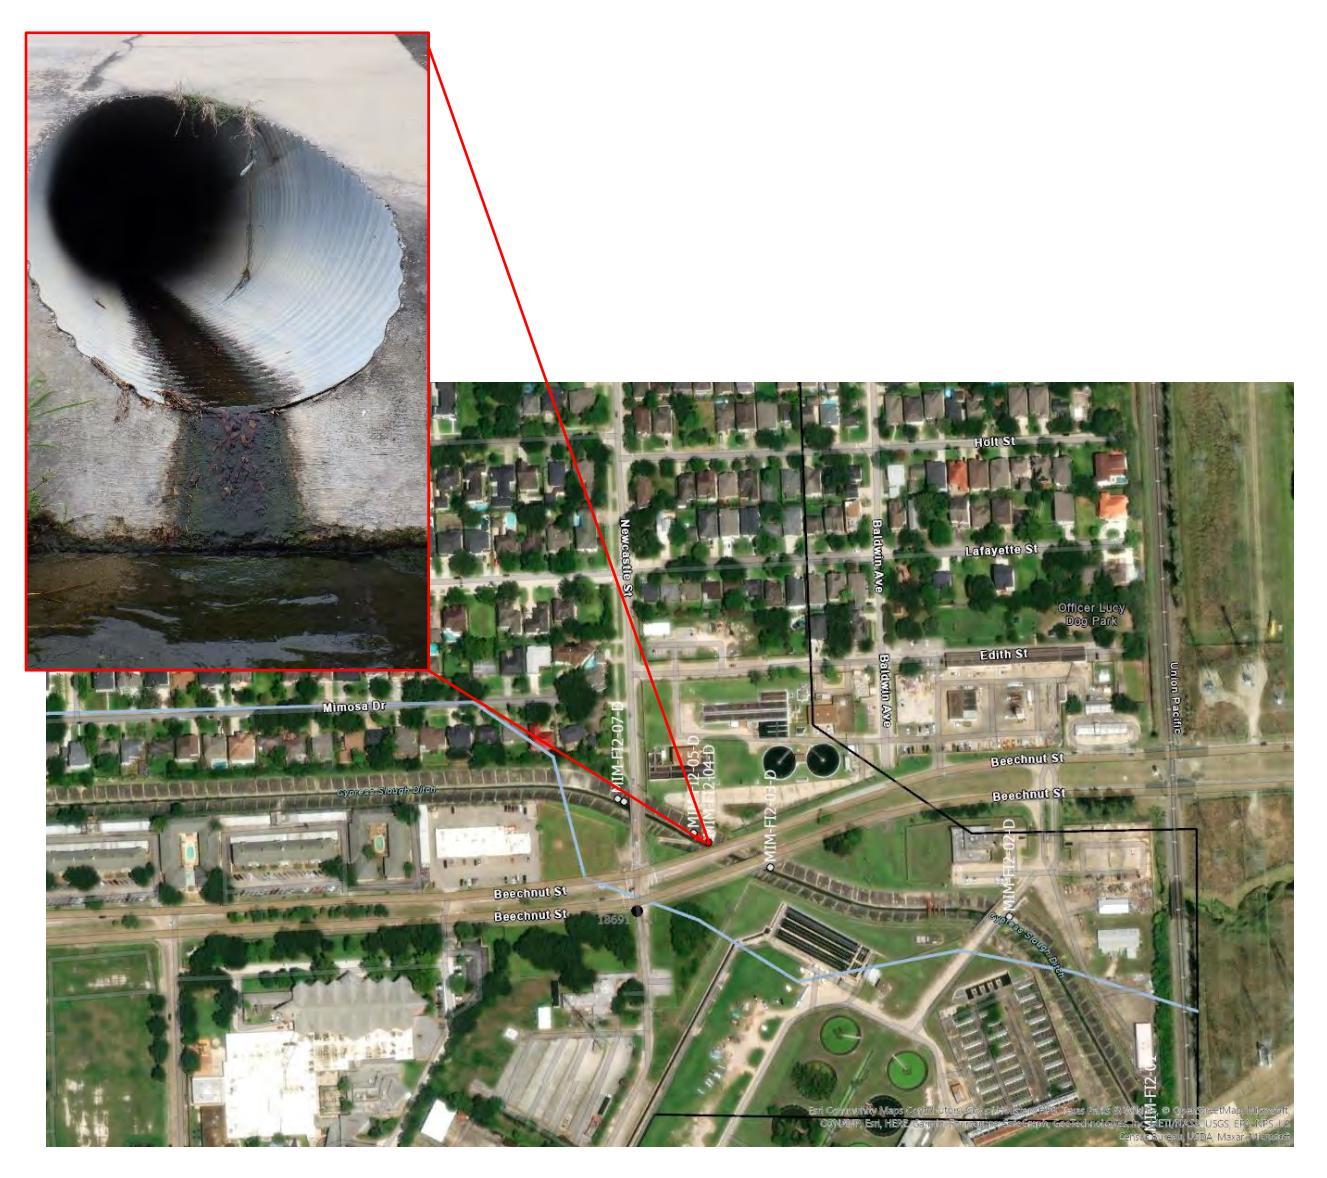
Referral site: MIM-FI2-04-D – High Priority

This is a 78 in. diameter metal pipe located on the left bank of Mimosa Ditch. Water within the pipe was 1.0 in. deep and flowing down algae-coated concrete before entering the segment. There is a permitted wastewater treatment discharge located in the area on the left bank. A sample taken 0.2 m downstream of the pipe had a bacteria value of 1,690 MPN/100 mL. The ambient sample collected upstream of the pipe had a bacteria value of 100 MPN/100 mL. This pipe is a high priority referral site for the proper local authority.

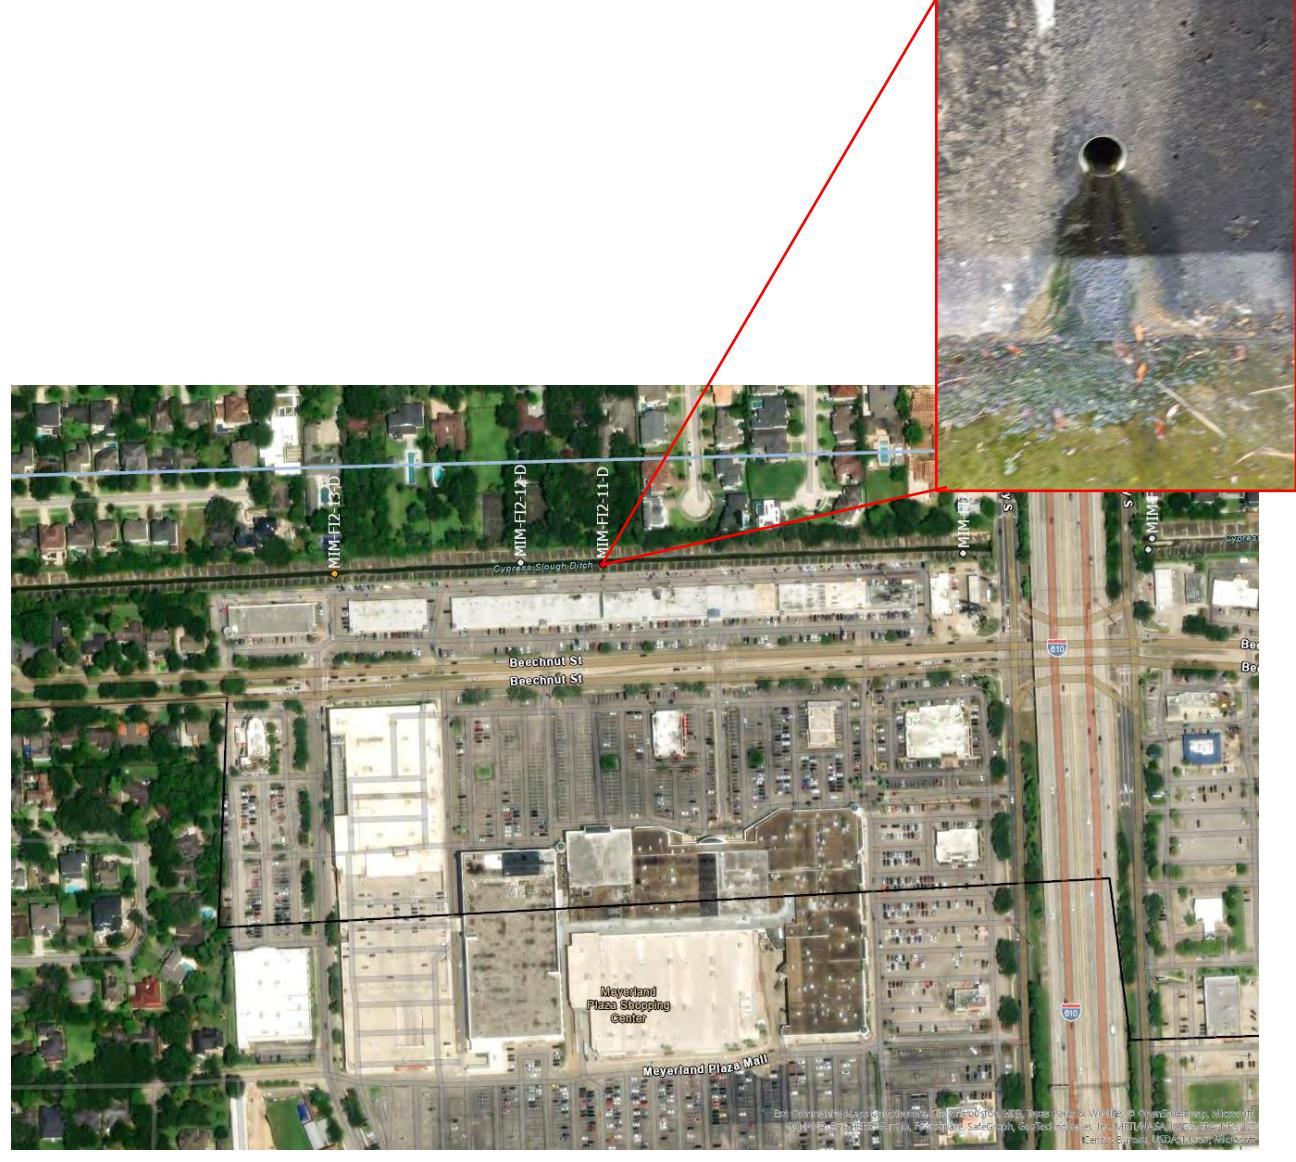
Referral site: MIM-FI2-11-D – High Priority

This is a 4 in. diameter PVC pipe located on the right bank of Mimosa Ditch. Water within the pipe was 0.25 in. deep and flowing down algae-coated concrete before entering the segment. There are multiple restaurants and a shopping plaza located in the area on the right bank. A sample taken 1.0 m downstream of the pipe had a bacteria value of 970 MPN/100 mL. The ambient sample collected upstream of the pipe had a bacteria value of 100 MPN/100 mL. This pipe is a high priority referral site for the proper local authority.

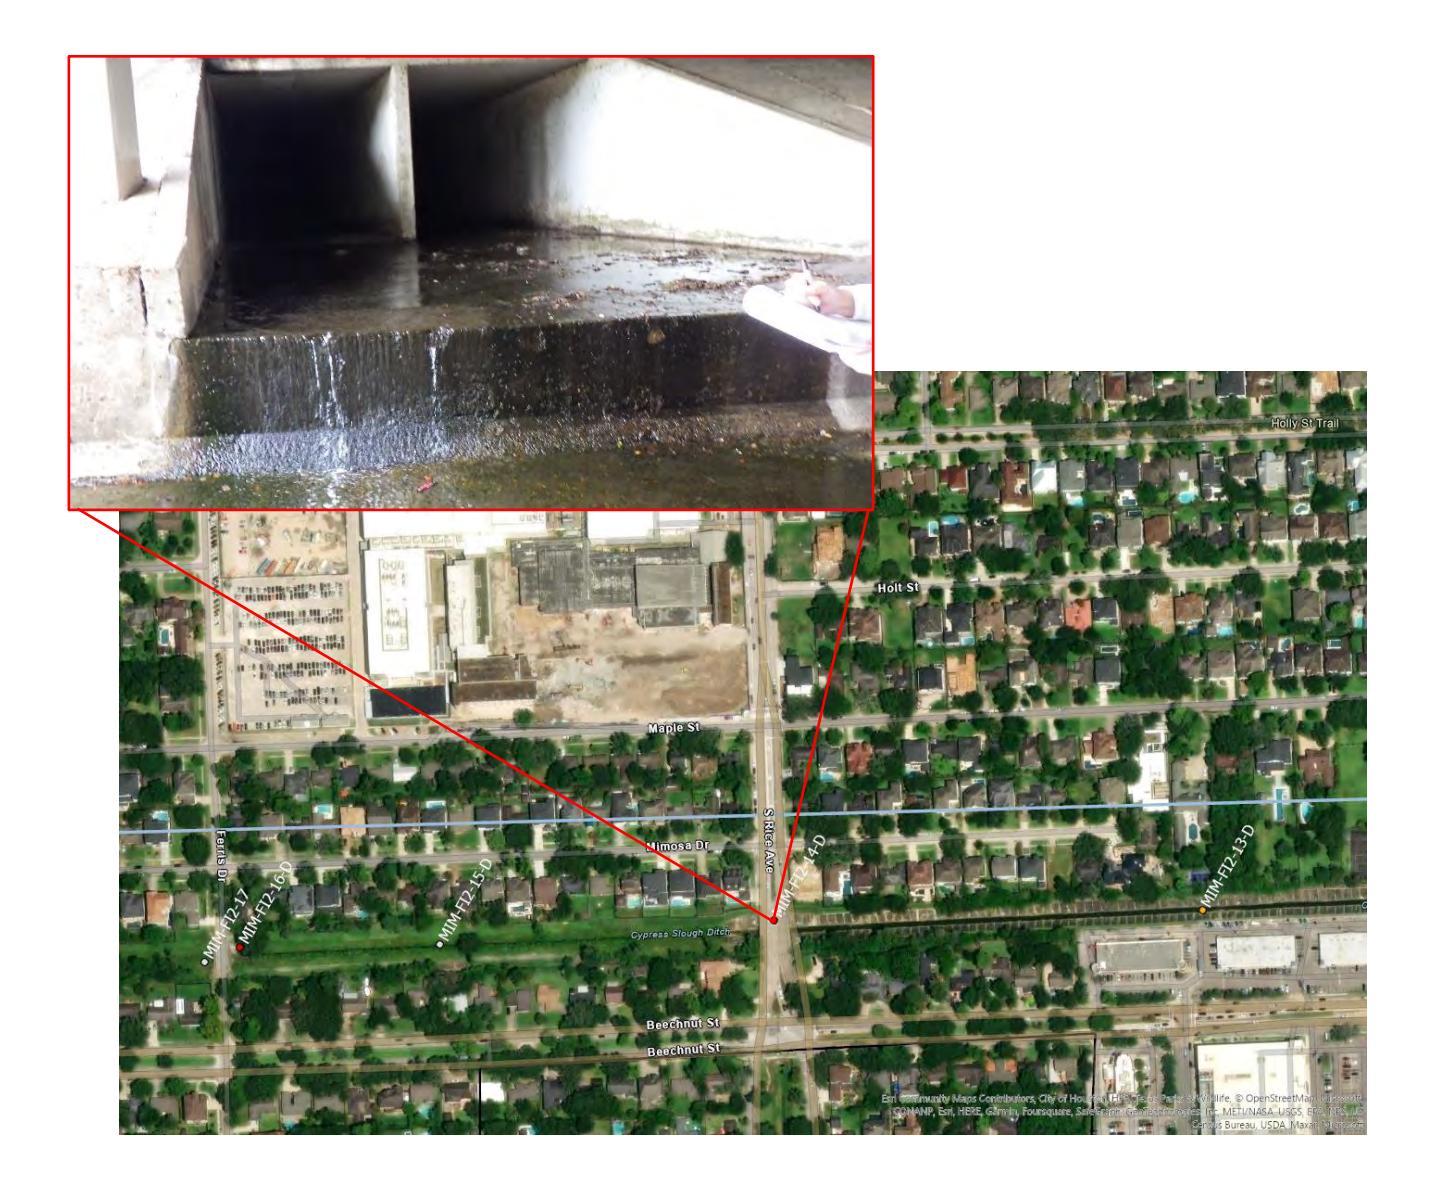
Referral site: MIM-FI2-14-D – High Priority

This is a 98 in. wide, square concrete culvert located under the bridge of S. Rice Avenue on the left bank of Mimosa Ditch. Water within the culvert was 0.25 in. deep and flowing into the segment. The area is mostly residential around this site, but there is a high school undergoing construction about 200 m north of the bridge on S. Rice Avenue. A sample taken 0.6 m downstream of the culvert had a bacteria value of 9,330 MPN/100 mL. The ambient sample collected upstream of the culvert had a bacteria value of 630 MPN/100 mL. This culvert is a high priority referral site for the proper local authority.
