Targeted Bacteria Monitoring Project Executive Summary

Overview

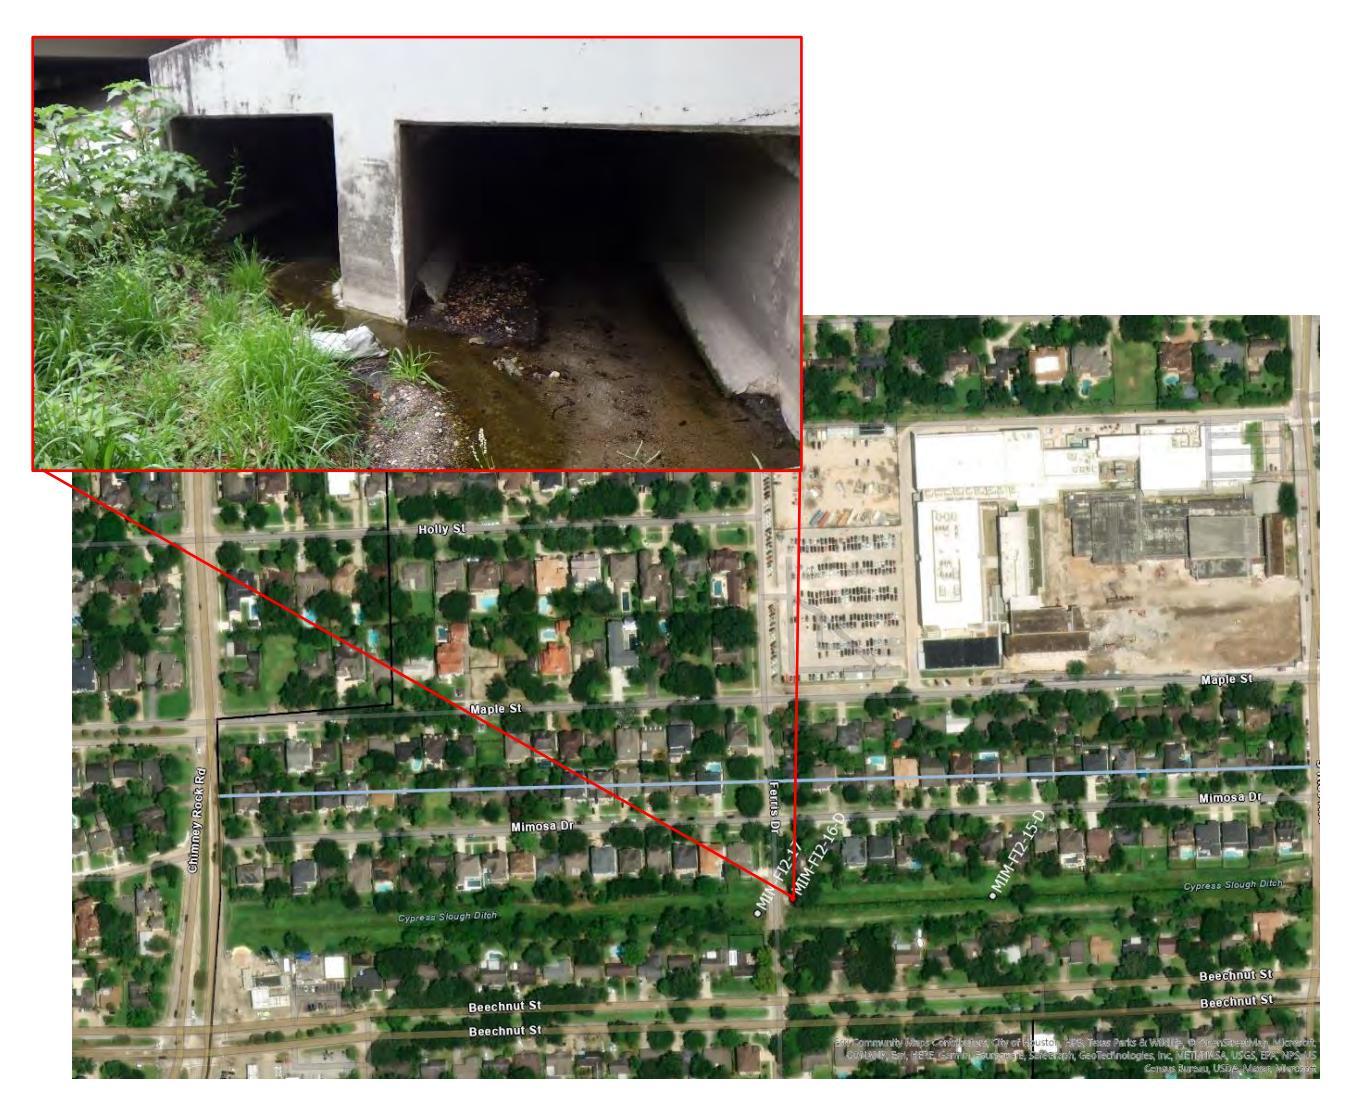
Referral site: MIM-FI2-16-D – High Priority

This is a 72 in. diameter square cement culvert located on the left bank of Mimosa Ditch. Water within the culvert was 0.13 in. deep and flowing into the AU. The culvert that was flowing at the time of sampling was the most upstream of the two culverts at this location. A sample taken 0.1 m downstream of the culvert had a bacteria value of 2,990 MPN/100 mL. The ambient sample collected upstream of the culvert had a bacteria value of 1,200 MPN/100 mL. This culvert is a high priority referral site for the proper local authority.

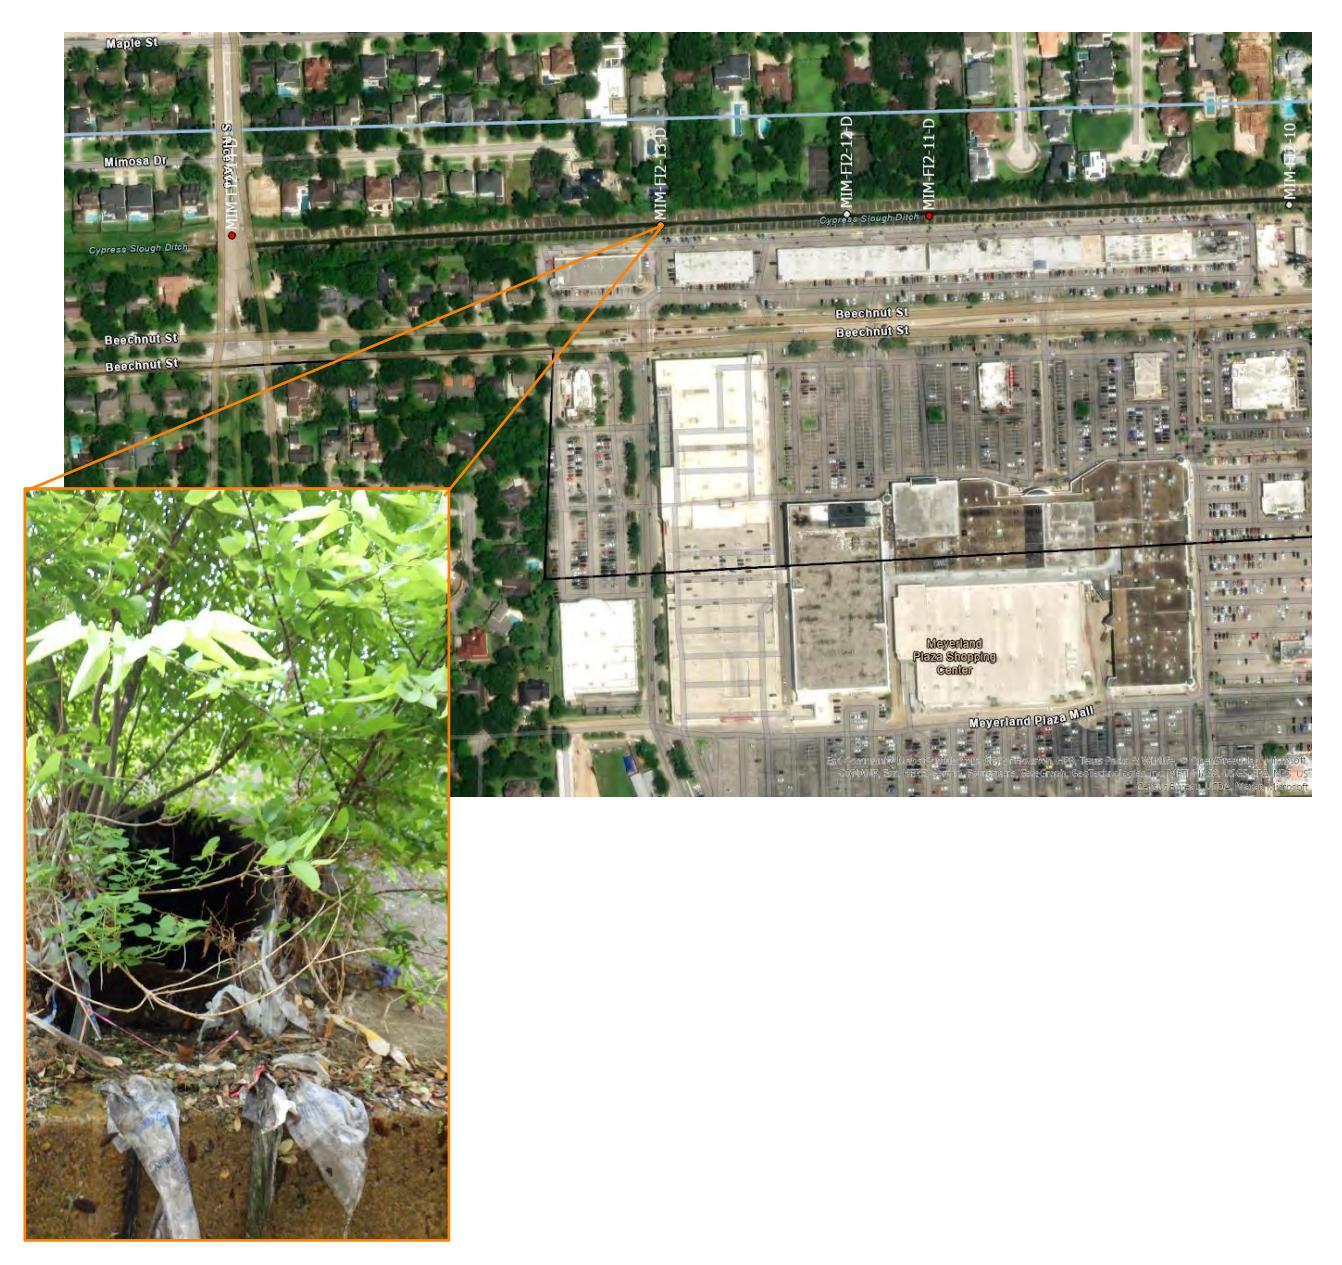
Referral site: MIM-FI2-13-D- Low Priority

This is a 36 in. diameter metal pipe located on the right bank of Mimosa Ditch. Water within the pipe was 6.0 in. deep and flowing down the vertical concrete bank and into the segment. There was vegetation growing and trash around the pipe at the time of sampling. There are several restaurants and a shopping plaza located in the area on the right bank. A sample 1.25 m downstream of the pipe had a bacteria value of 410 MPN/100 mL. The ambient sample collected upstream of the pipe had a bacteria value of 200 MPN/100 mL. This pipe is a low priority referral site for the proper local authority.

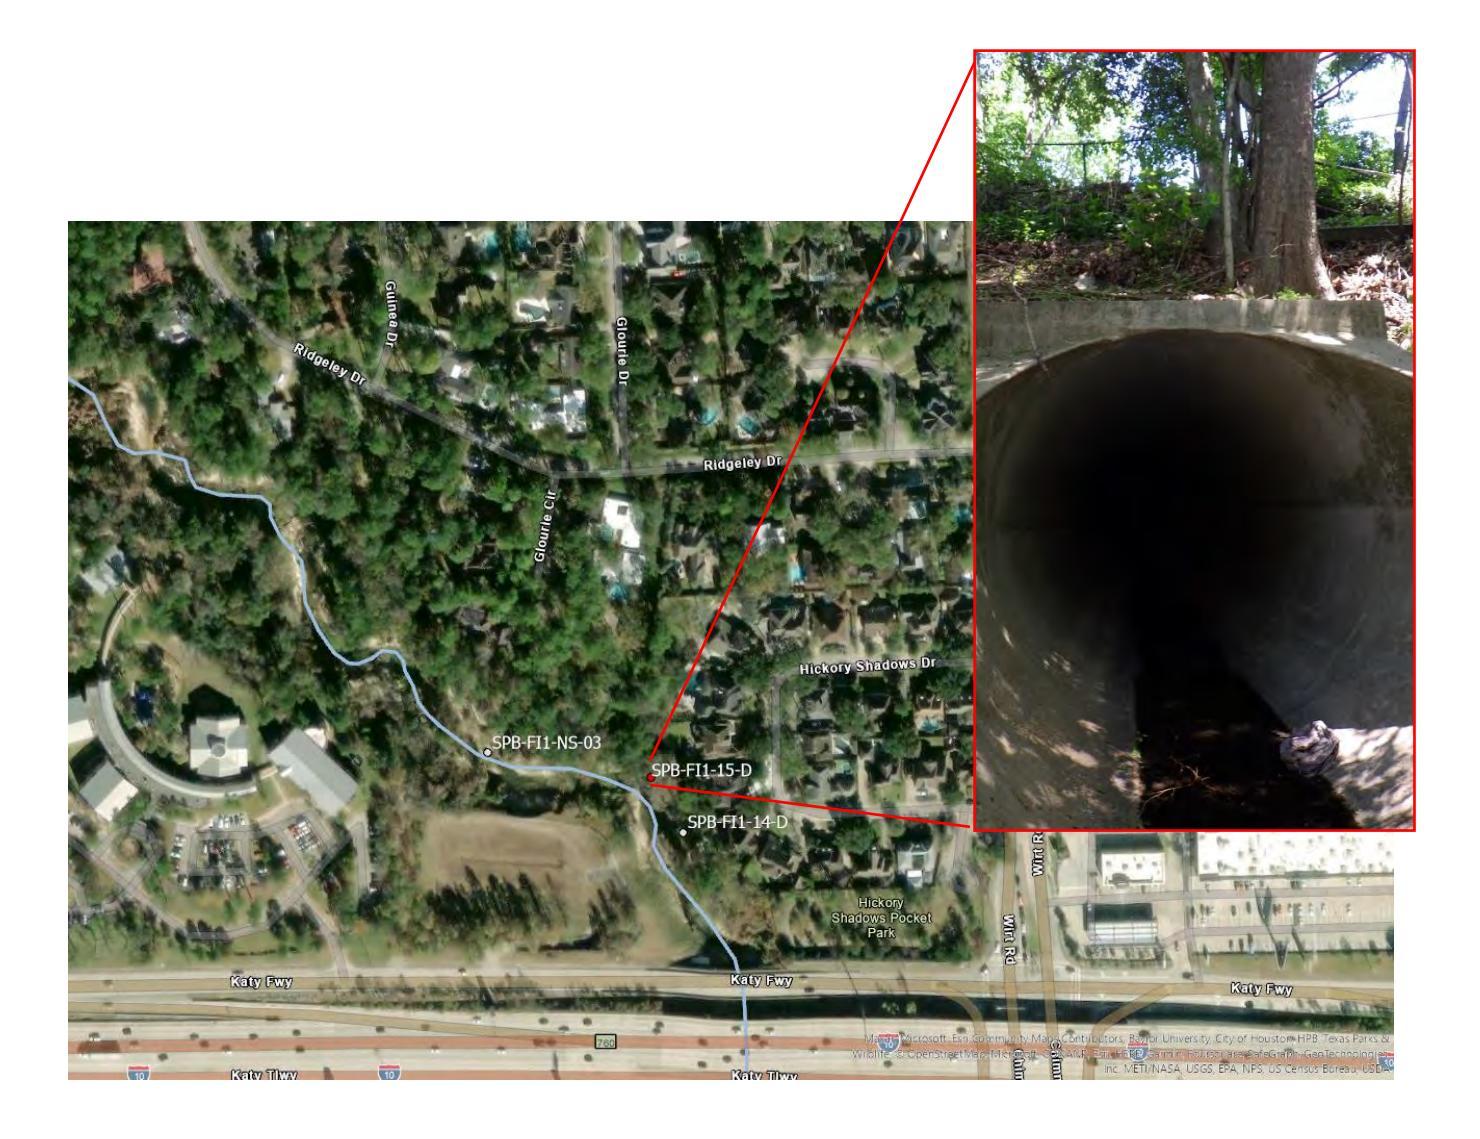
Referral site: SPB-FI1-15-D- High Priority

This is a 124 in. diameter concrete pipe located on the left bank of Spring Branch. Water within the pipe was 2 in. deep with a substantial flow into the segment. There are single family homes in the area. A sample taken 0.25 m downstream of the pipe had a bacteria value of 1,210 MPN/100 mL. The ambient sample collected upstream of the pipe had a bacteria value of 100 MPN/100 mL. This pipe is a high priority referral site for the proper local authority.

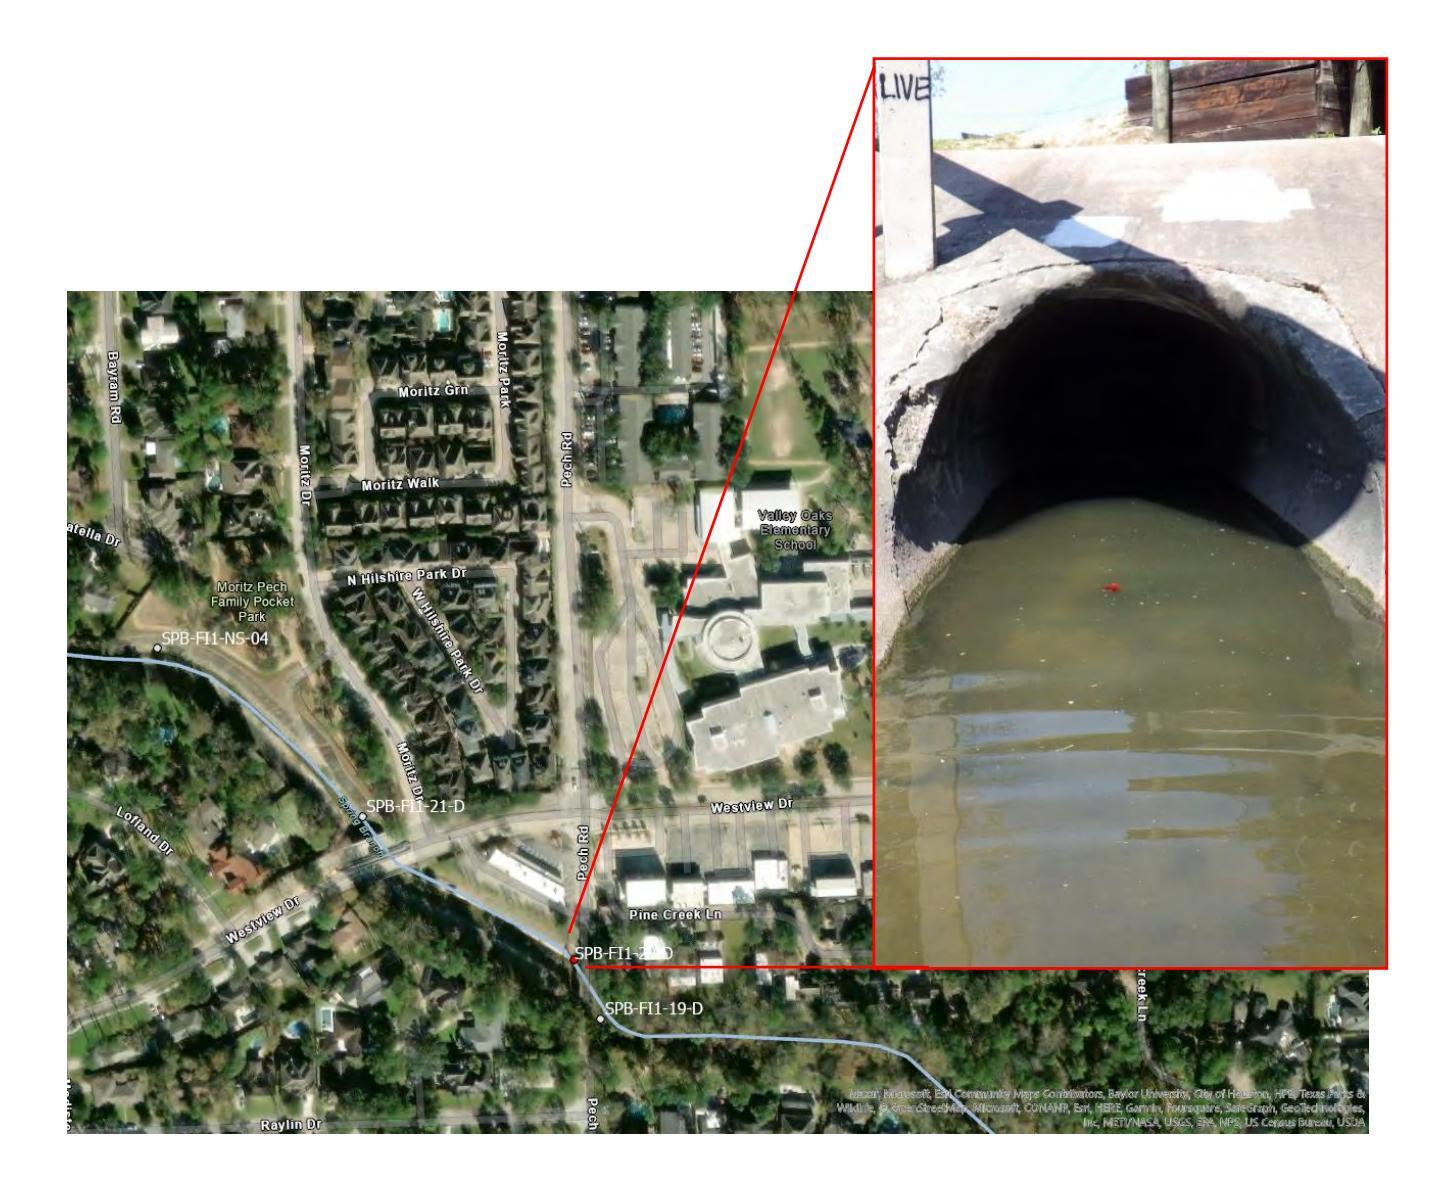
Referral site: SPB-FI1-20-D- High Priority

This is a 104 in. diameter concrete pipe located on the left bank of Spring Branch. Water within the partially submerged pipe was 22 in. deep. Bats are present under the bridge upstream of where these samples were taken. There are single family homes, commercial businesses, schools, and parks in the area. Due to the pipe being submerged, the downstream sample was taken within the mixing zone in front of the mouth of the pipe and had a bacteria value of > 242,000 MPN/100 mL. The ambient sample collected upstream of the pipe had a bacteria value of 17,800 MPN/100 mL. This pipe is a high priority referral site for the proper local authority.

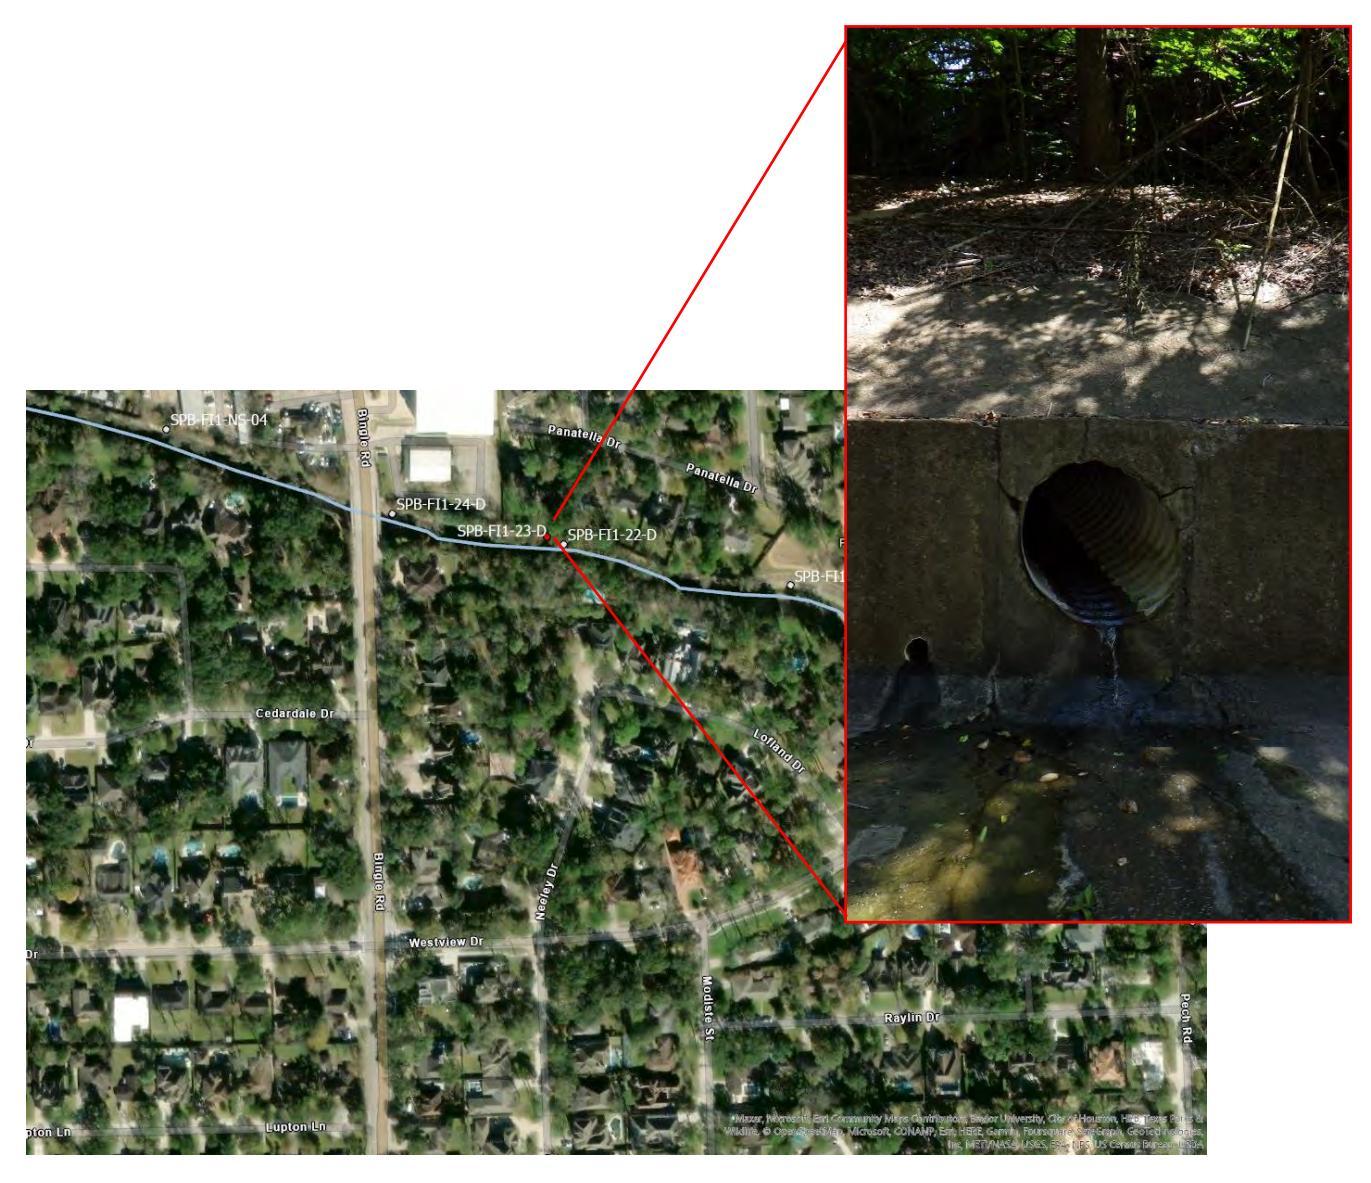
Referral site: SPB-FI1-23-D- High Priority

This is a 32 in. diameter metal pipe located on the right bank of Spring Branch. Water within the pipe was 0.5 in. deep. While the pipe was not flowing initially, water started flowing out of the pipe while the team was present and it smelled of effluent. There are single-family homes in the area and commercial businesses on the left bank. A sample was taken 1.8 m downstream of the pipe and it had a bacteria value of 1,340 MPN/100 mL. The ambient sample collected upstream of the pipe had a bacteria value of 100 MPN/100 mL. This pipe is a high priority referral site for the proper local authority.

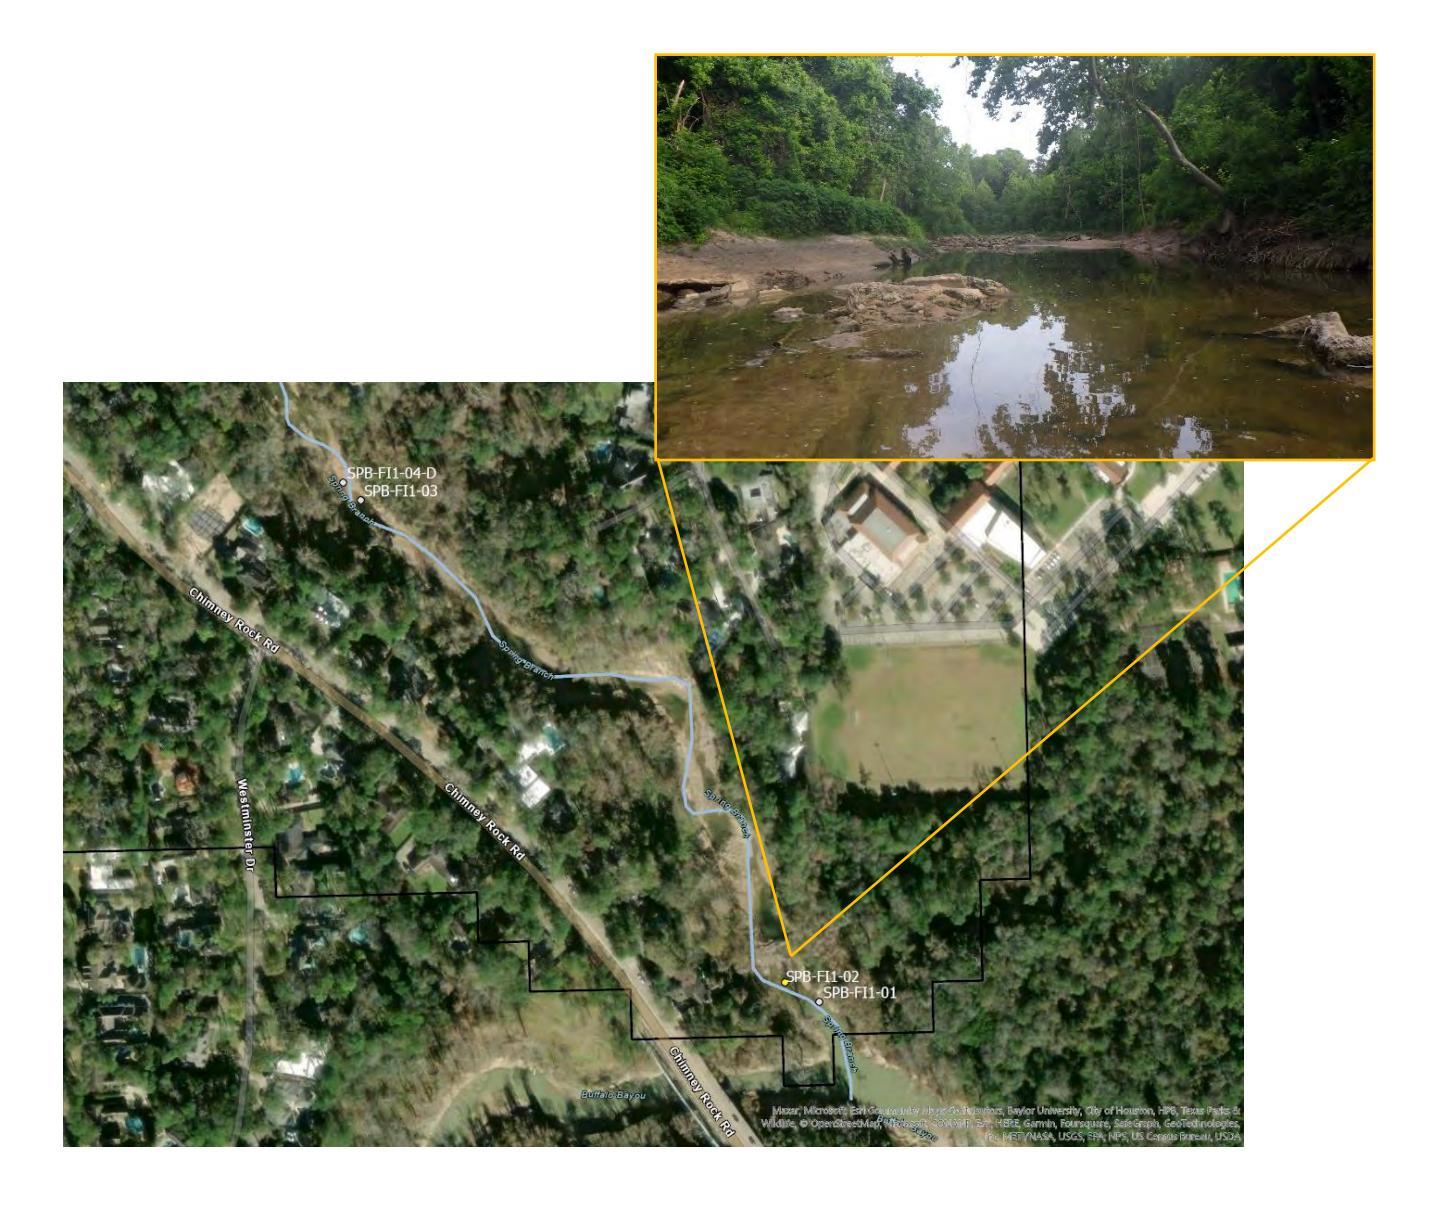
Referral site: SPB-FI1-02- Investigate Further

This was an ambient sample taken upstream of the estimated mixing zone of the confluence of Spring Branch and Buffalo Bayou. The ambient sample had a bacteria value of 980 MPN/100 mL while another ambient sample taken approximately 400 m further upstream had a bacteria value of 410 MPN/100 mL. Further investigation is recommended by the proper local authority to determine the source of elevated bacteria in this section of the segment. There are single-family homes and a seminary in the area.

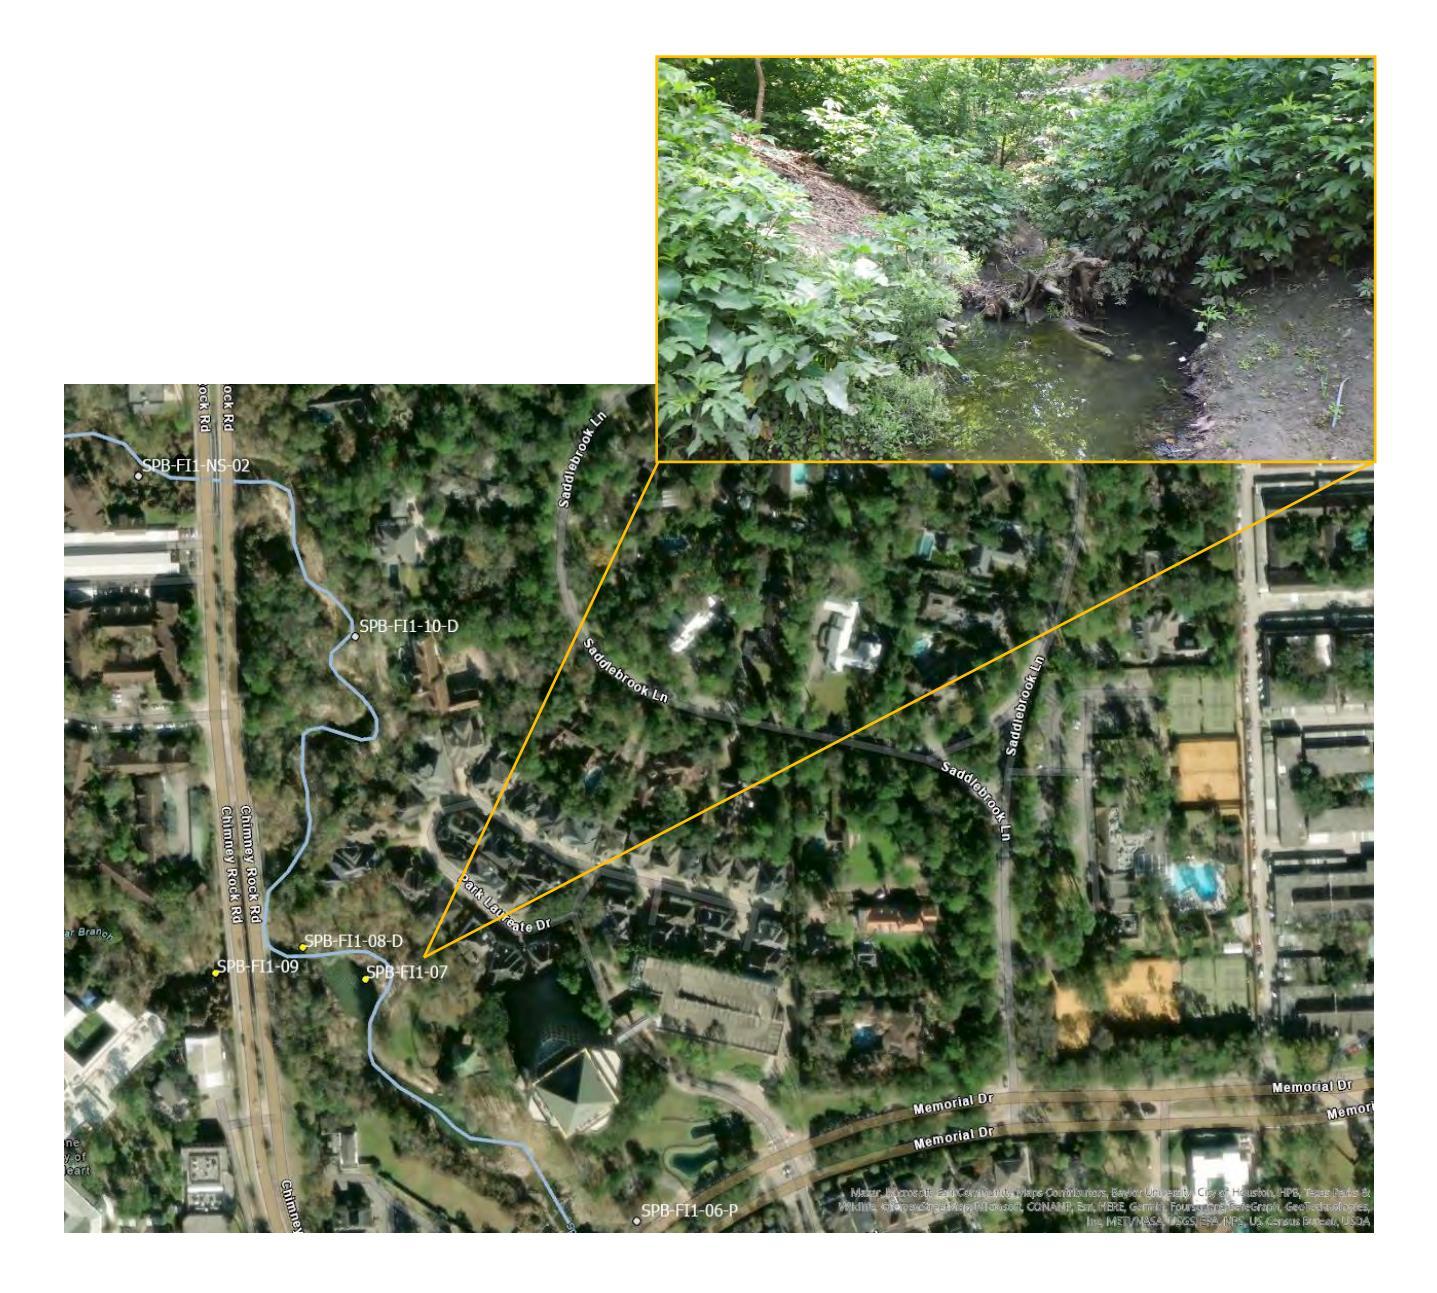
Referral site: SPB-FI1-07- Investigate Further

This was an ambient sample taken from a tributary to Spring Branch on the left bank. The ambient sample had a bacteria value of 1,460 MPN/100 mL. Further investigation is recommended by the proper local authority to determine the source of elevated bacteria in this tributary. There are single-family homes and commercial buildings in the area.

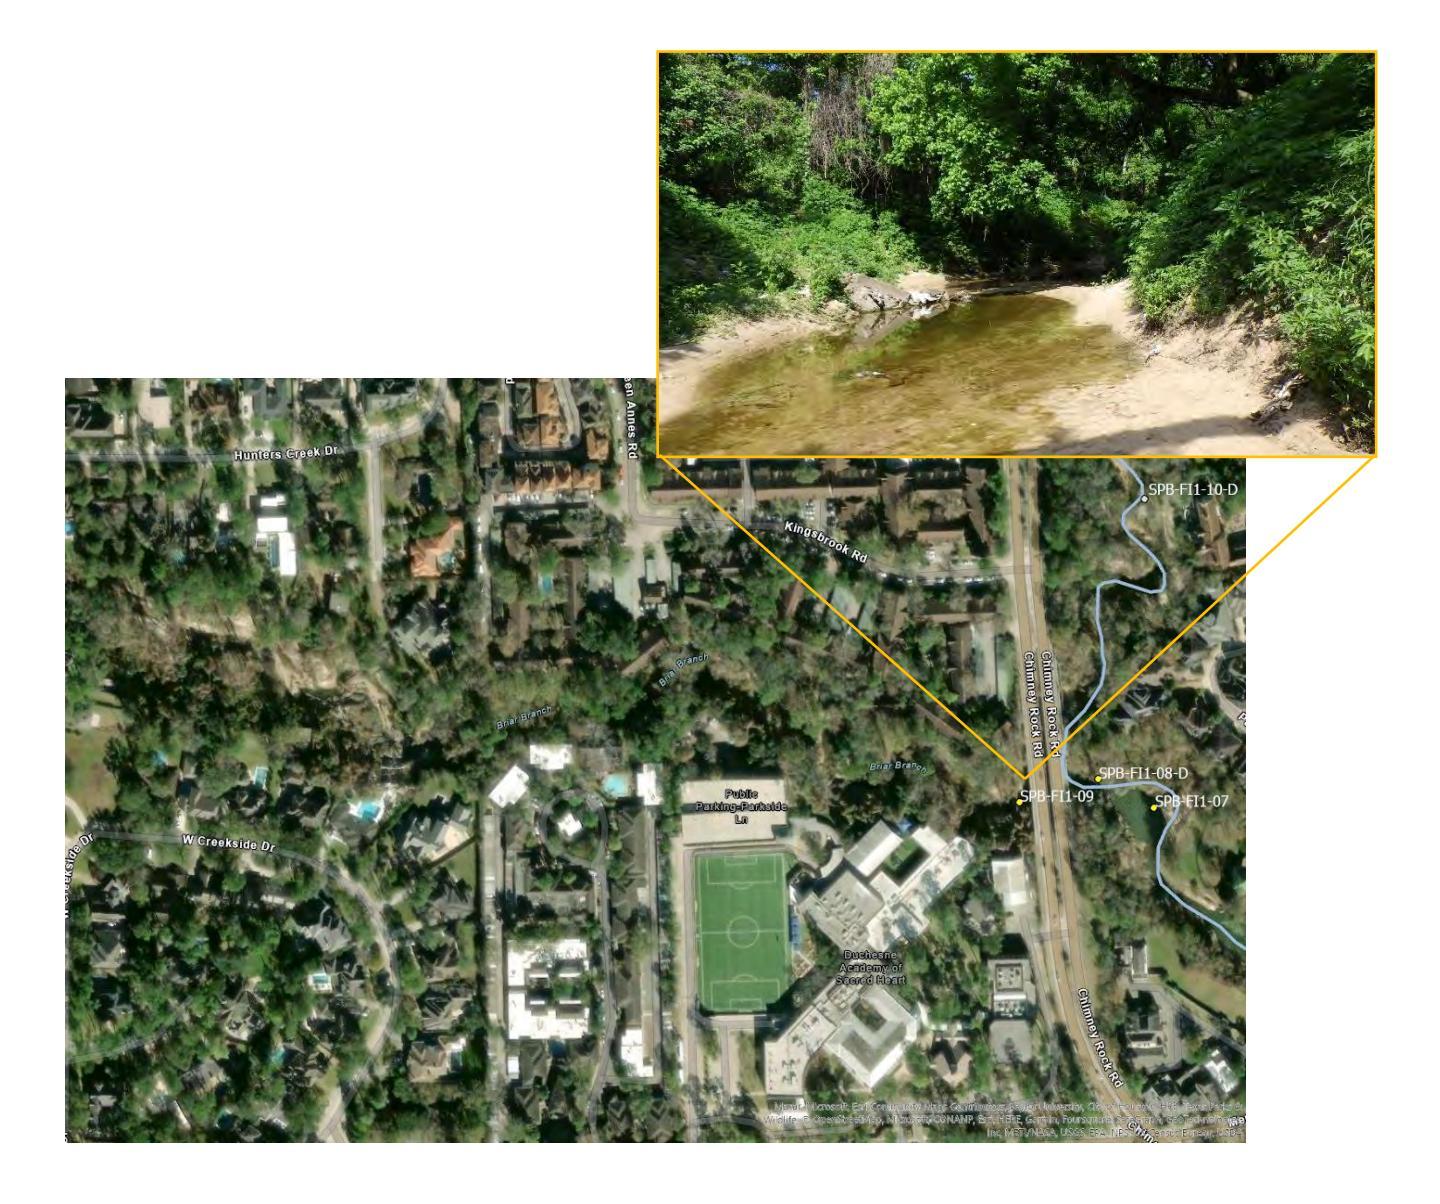
Referral site: SPB-FI1-09- Investigate Further

This was an ambient sample taken from a tributary of Spring Branch (Briar Branch) upstream of the Chimney Rock Bridge. This sample had a bacteria value of 630 MPN/100 mL. A FI or further investigation of this tributary is recommended. There are single-family homes in the area and a high school on the right bank of this tributary.

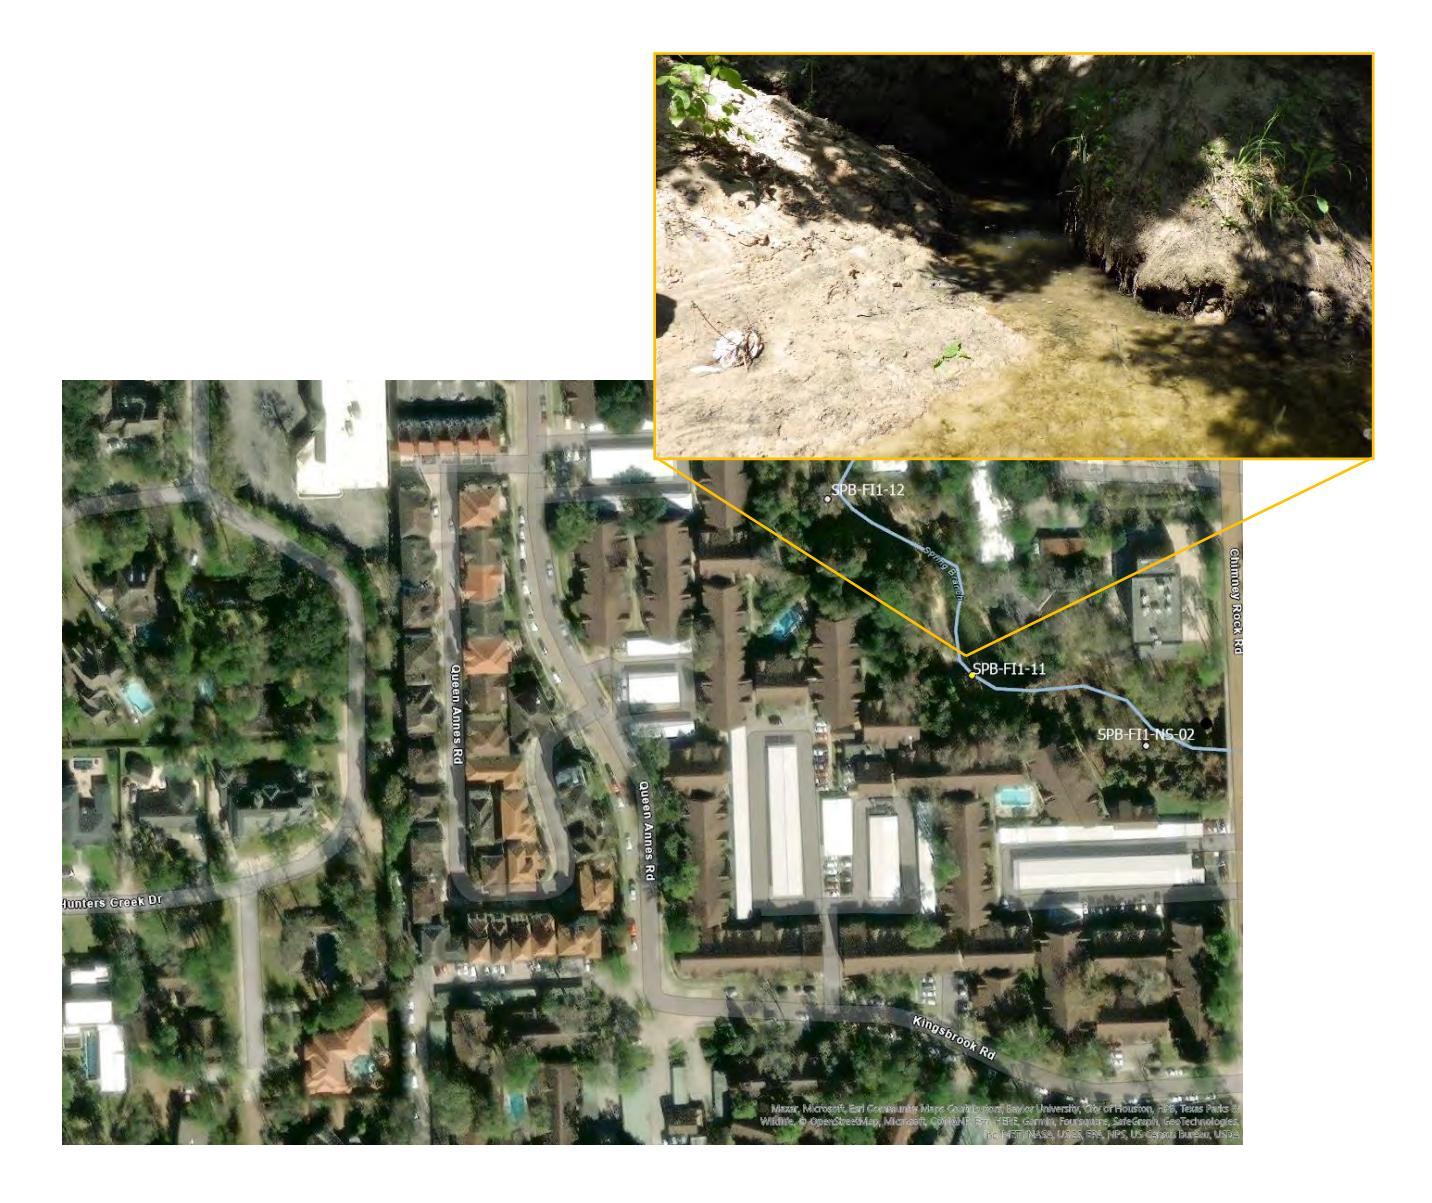
Referral site: SPB-FI1-11- Investigate Further

This was an ambient sample taken from a small tributary located on the right bank of Spring Branch. This sample had a bacteria value of 410 MPN/100 mL. Further investigation is recommended by the proper local authority to determine the source of elevated bacteria in this tributary. There are apartments on the right bank where it looks like this tributary originates.

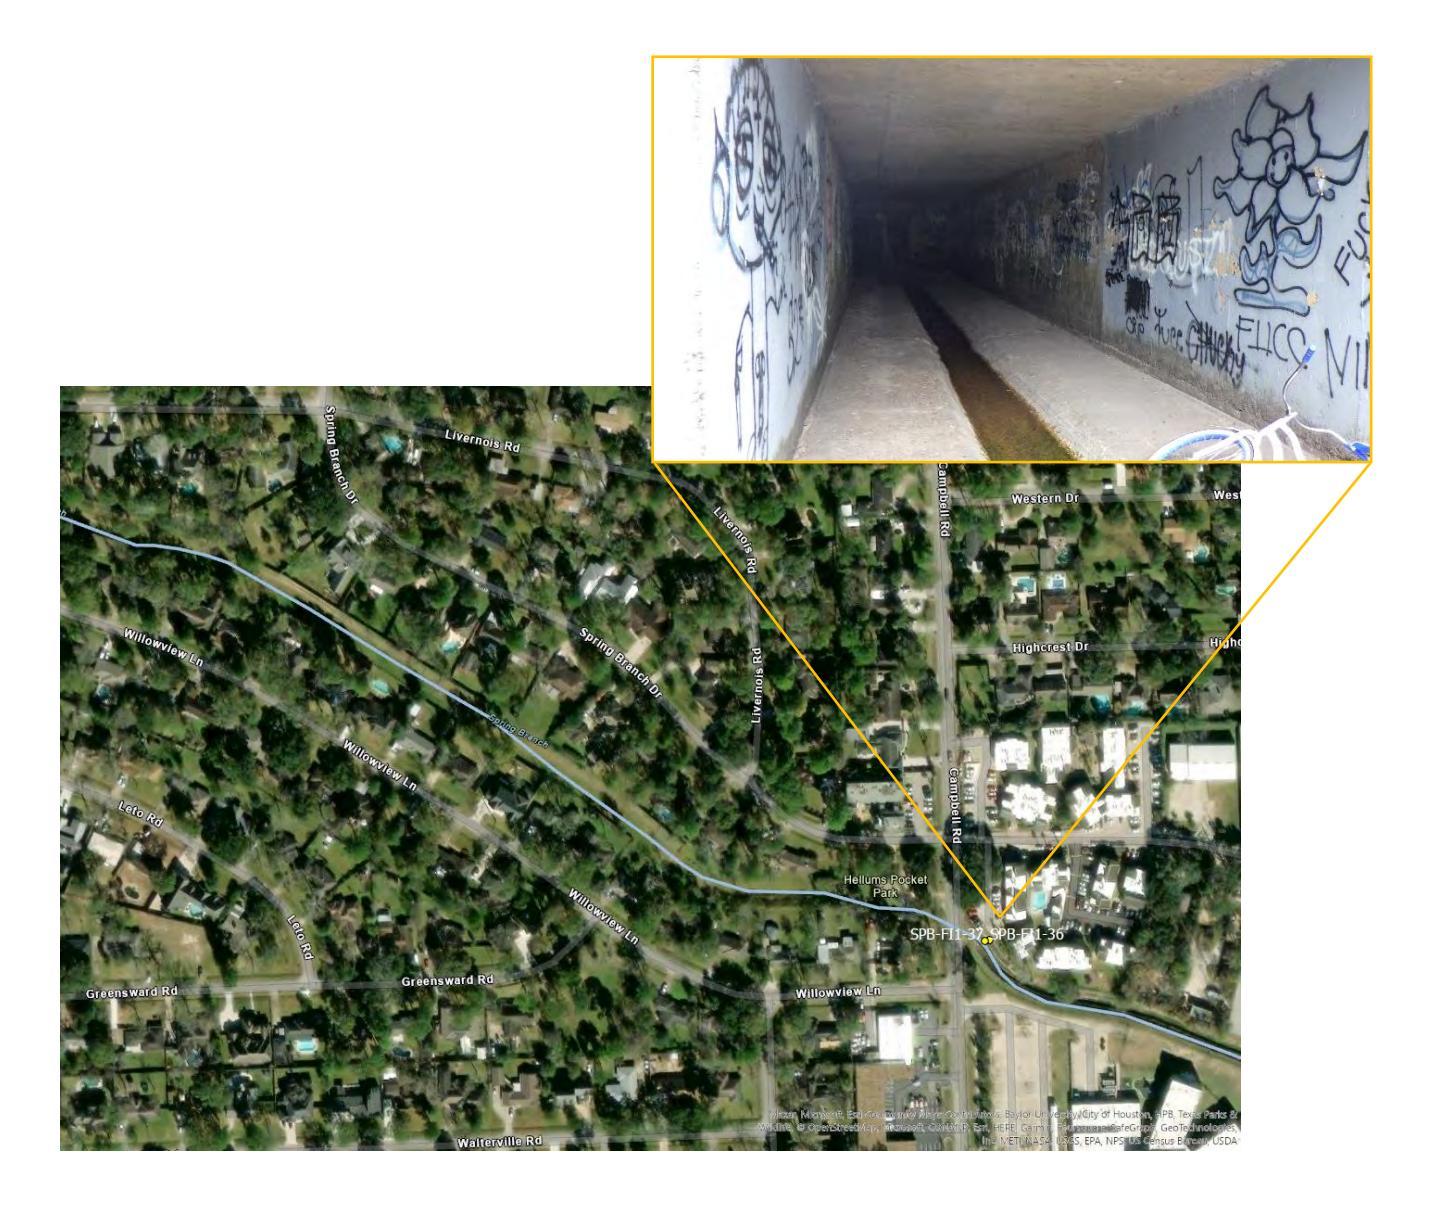
Referral site: SPB-FI1-36- Investigate Further

This was a sample taken from the opening of the left bank culvert at the top of the segment that had a bacteria value of 410 MPN/100 mL. The segment goes underground after this point and flow could be heard entering the culvert somewhere further upstream. Further investigation is recommended by the proper local authority to determine the source of elevated bacteria underground and upstream of the segment. There are apartments in the area and a park is located upstream on the right bank.

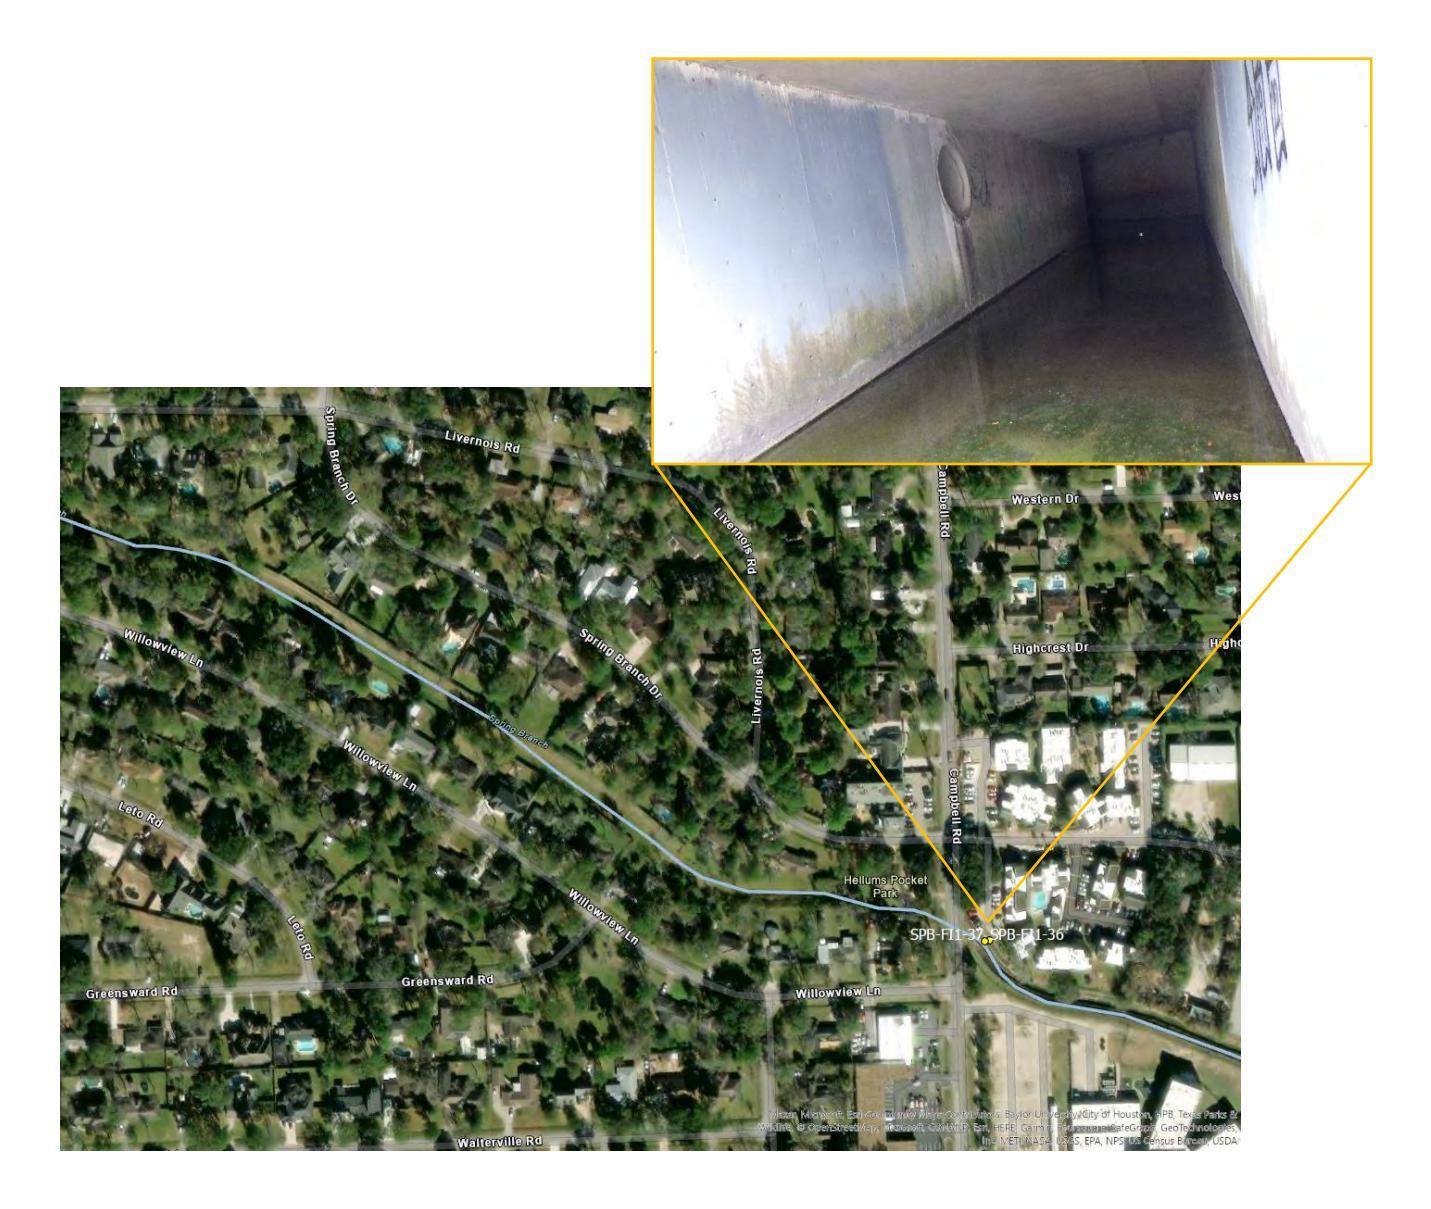
Referral site: SPB-FI1-37- Investigate Further

This was a sample taken from the opening of the right bank culvert at the top of the segment that had a bacteria value of 750 MPN/100 mL. The segment goes underground after this point. Further investigation is recommended by the proper local authority to determine the source of elevated bacteria underground and upstream of the segment. There are apartments in the area and a park is located upstream on the right bank.

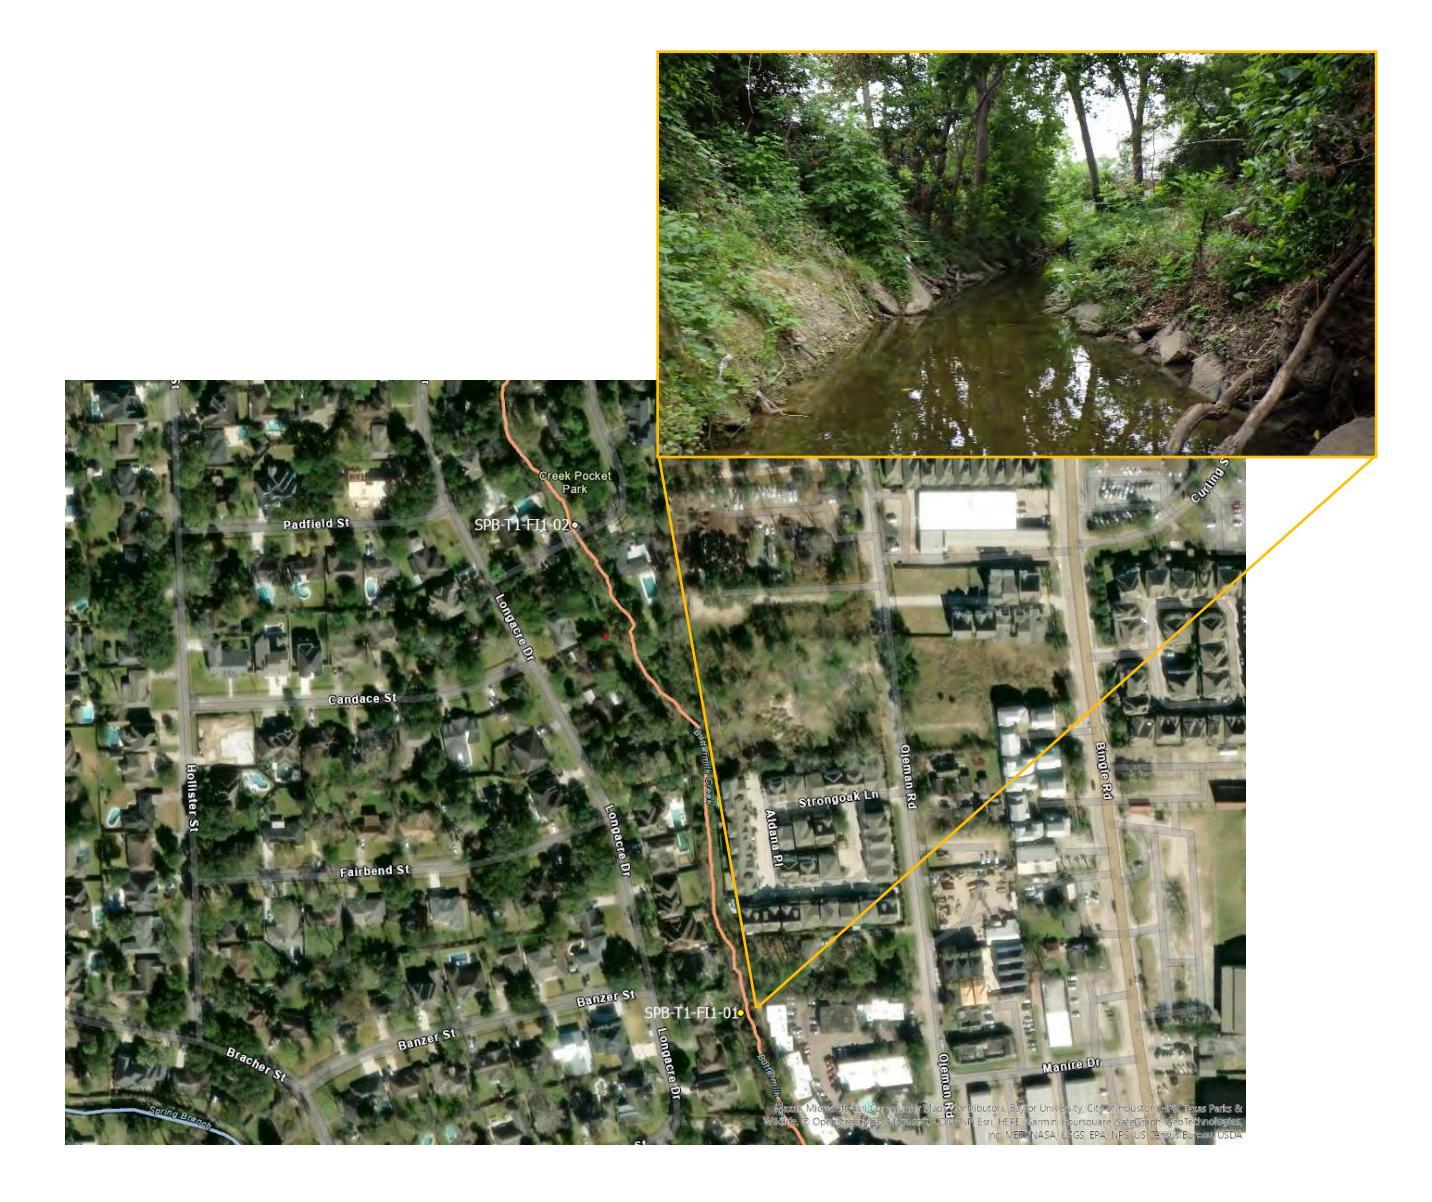
Referral site: SPB-T1-FI1-01- Investigate Further

This was an ambient sample taken from a tributary of Spring Branch that had a bacteria value of 34,500 MPN/100 mL. Another ambient sample taken approximately 300 m further upstream in the tributary had a bacteria value of 310 MPN/100 mL. No evidence of flow entering the stream was observed between the two samples. Further investigation is recommended by the proper local authority to determine the source of elevated bacteria in this section of the tributary. There are apartments and single-family homes located in the area.
