Targeted Bacteria Monitoring Project Executive Summary

Overview

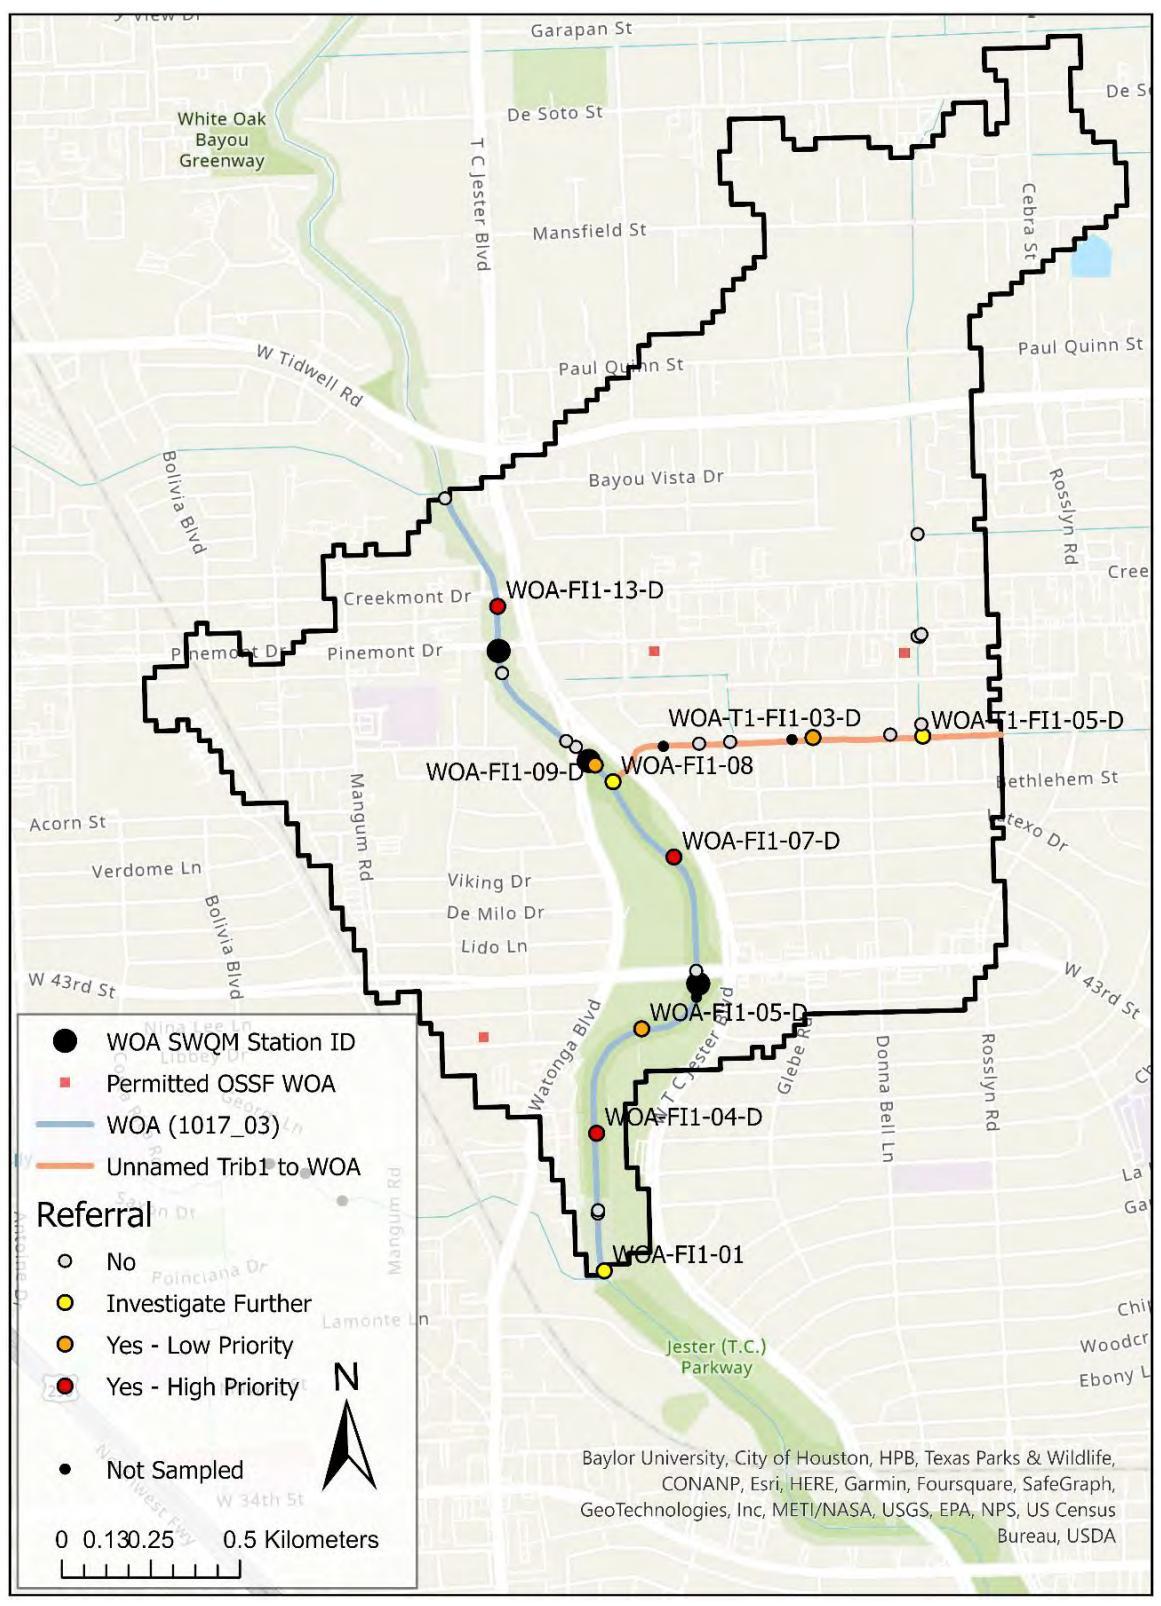
Figure 4: Field investigation sites sampled on 4/3/23 and identified for referral to the proper authorities on White Oak Bayou Above Tidal (Assessment Unit 1017_03).

Referral site: WOA-FI1-04-D - High Priority

This is a 52 in. diameter metal pipe located on the left bank of White Oak Bayou Above Tidal. Water within the pipe was 0.25 in. deep and discharged onto a concrete lining before entering the AU. There is a walking trail that runs parallel with the bayou located on the left bank of this sampling location. Many joggers with dogs were observed utilizing this trail as the field crew was sampling. There is also a park with a public pool located on the left bank of this site, as well as many residential homes located in the adjacent area on the left bank. The area on the right bank is predominantly residential, with many apartment complexes and several schools. A sample taken 5.0 m downstream of the pipe had a bacteria value of 750 MPN/100 mL. The ambient sample collected upstream of the pipe had a bacteria value of 100 MPN/100 mL. This pipe is a high priority referral site for the proper local authority.

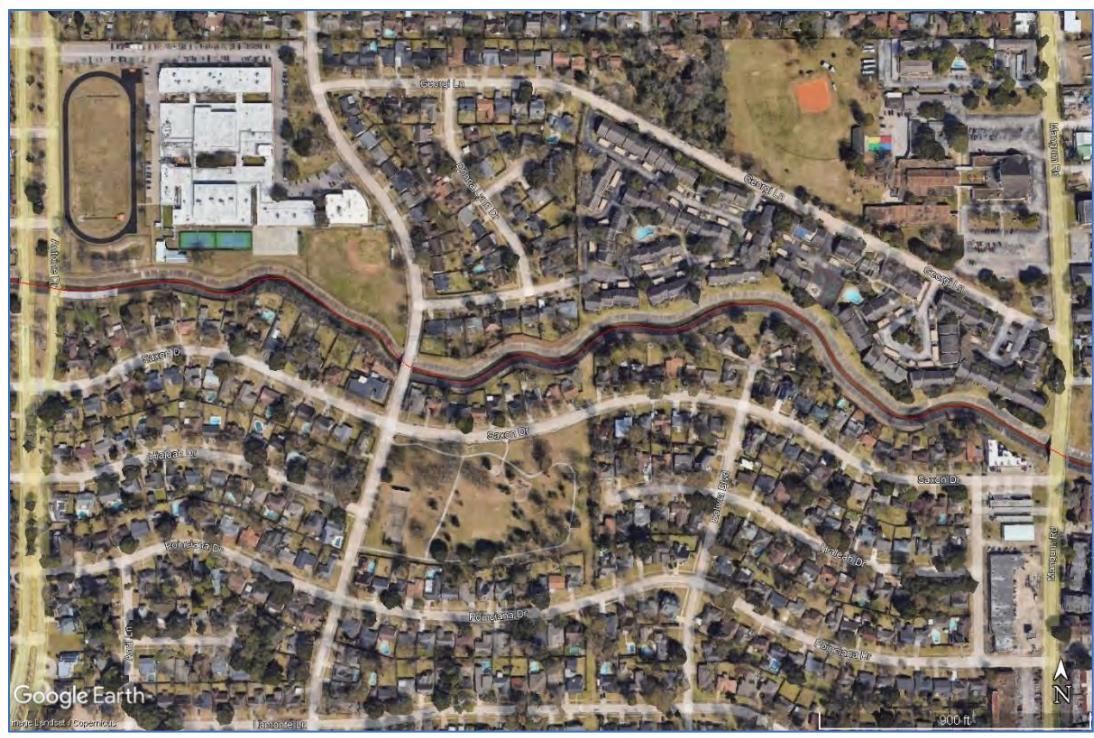
Figure 2: Stretch of the AU bordered by many parks and schoolgrounds. Identified during desktop review as a possible source.

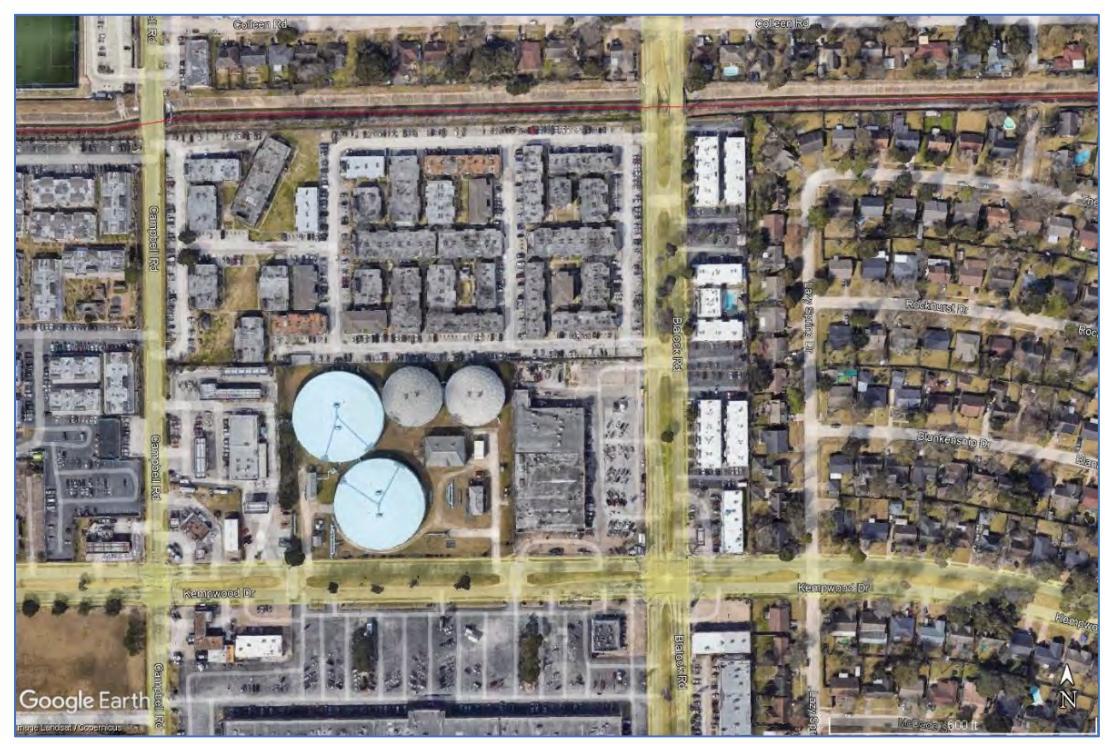
Figure 3: A city water facility near the AU that was not listed under the permitted/unpermitted outfalls provided by H-GAC. Identified during desktop review as a possible source.

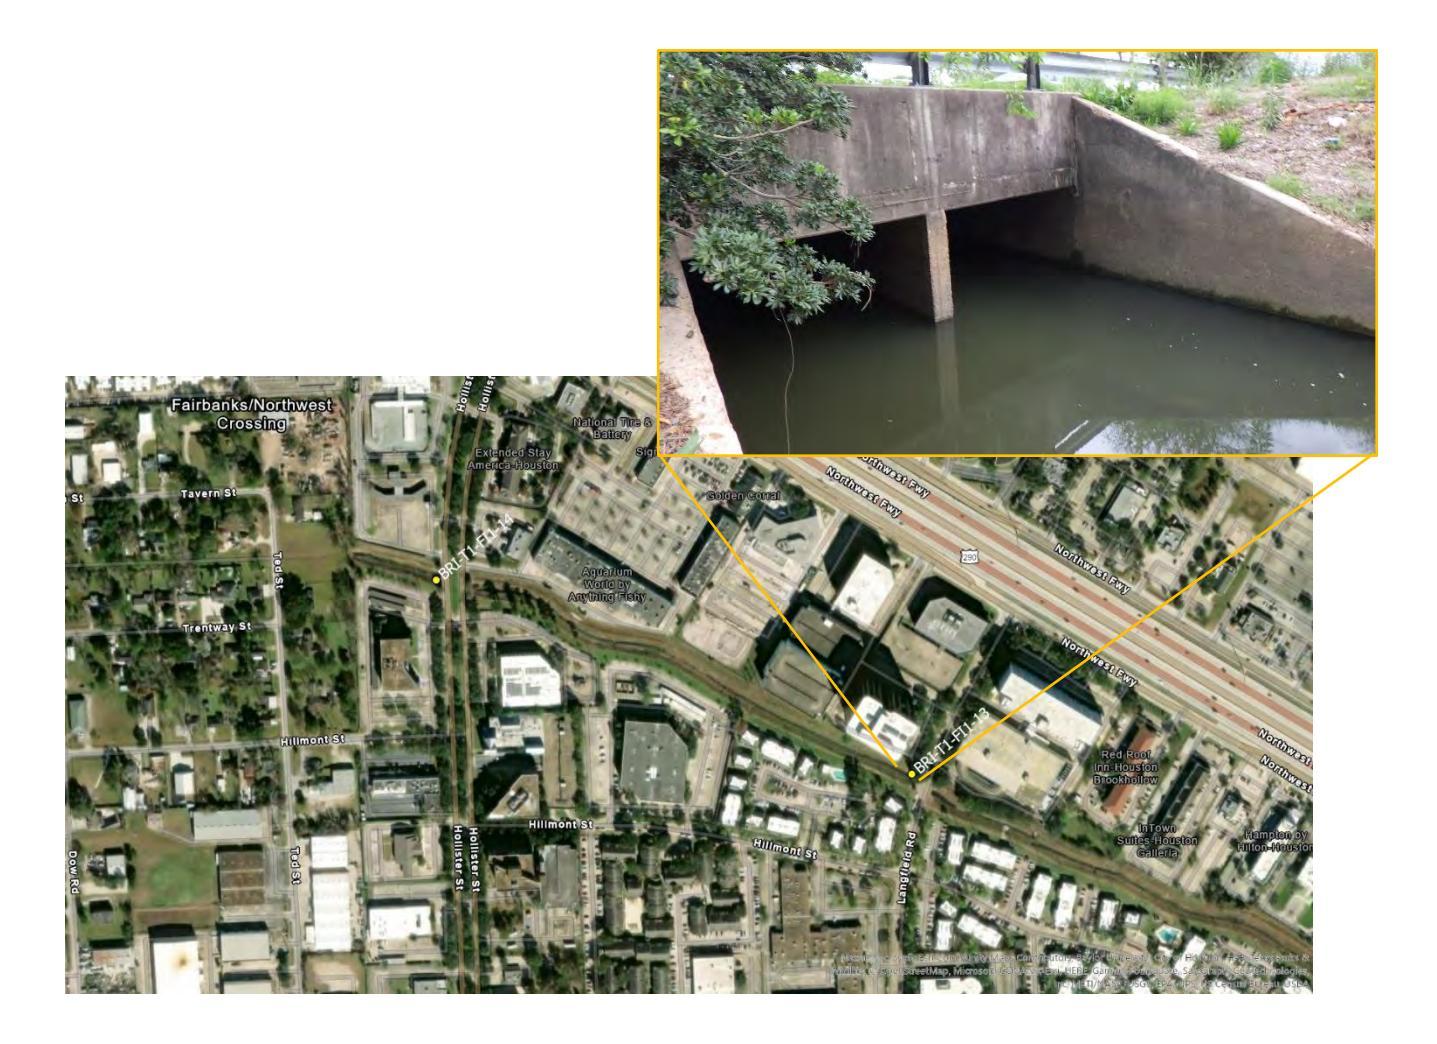
Referral site: BRI-T1-FI1-14 – Investigate Further

This was an ambient sample taken upstream of the Hollister Road bridge on the tributary of Brickhouse Gully. The ambient sample taken just in front of the bridge crossing had a bacteria value of < 100 MPN/100 mL while the sample taken downstream at Langfield Road had a bacteria value of > 242,000 MPN/100 mL. Further investigation is recommended by the proper local authority to determine the source of elevated bacteria between these two locations as the field crew was unable to walk this portion due to oncoming thunderstorms. There are apartments and commercial businesses located between this location and BRI-T1-FI1-13.

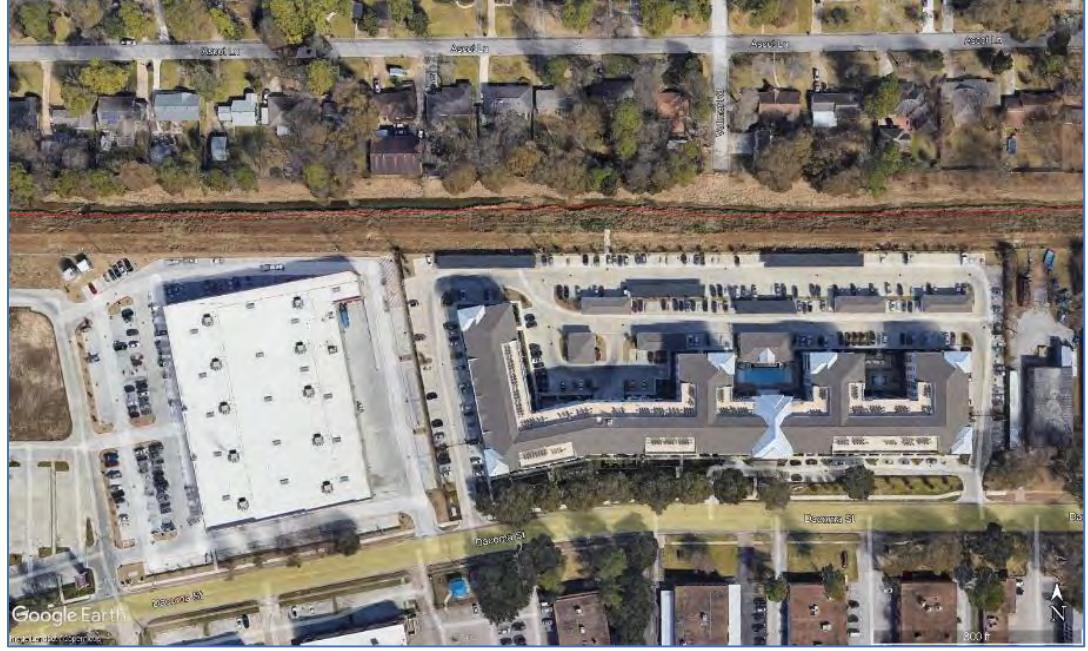
- newly constructed apartments on Dacoma St. near US 290 that border the unnamed tributary (Figure 2)
- a small (0.45 acre) farm that may have runoff into the AU (Figure 3)

Figure 2. Possible source identified during desktop review.

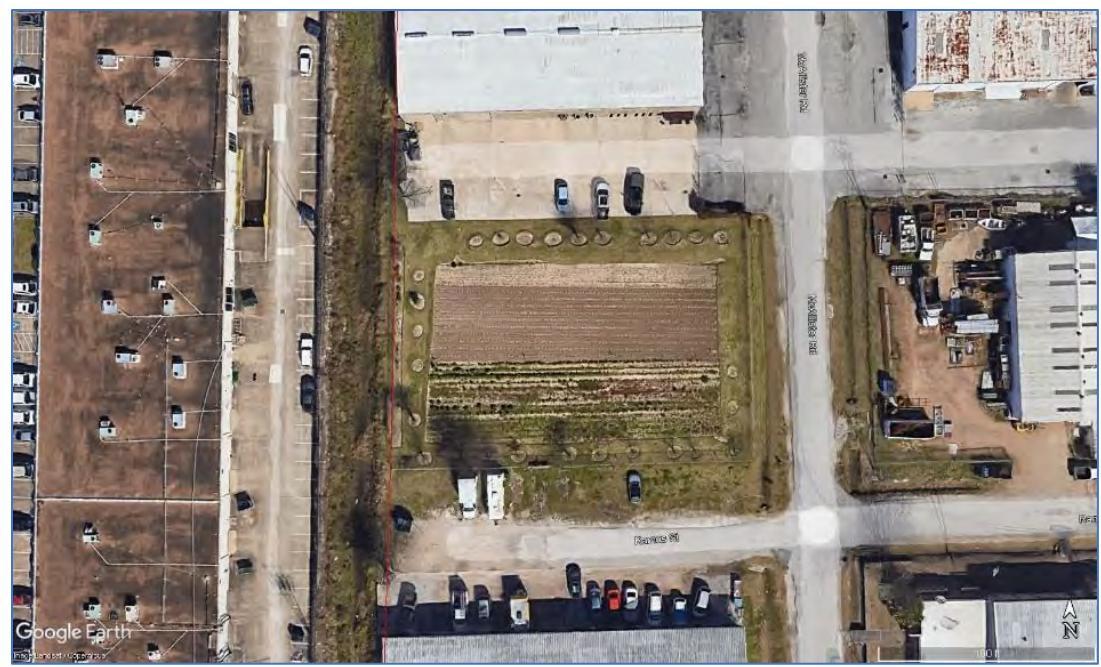
Figure 3. Possible source identified during desktop review.

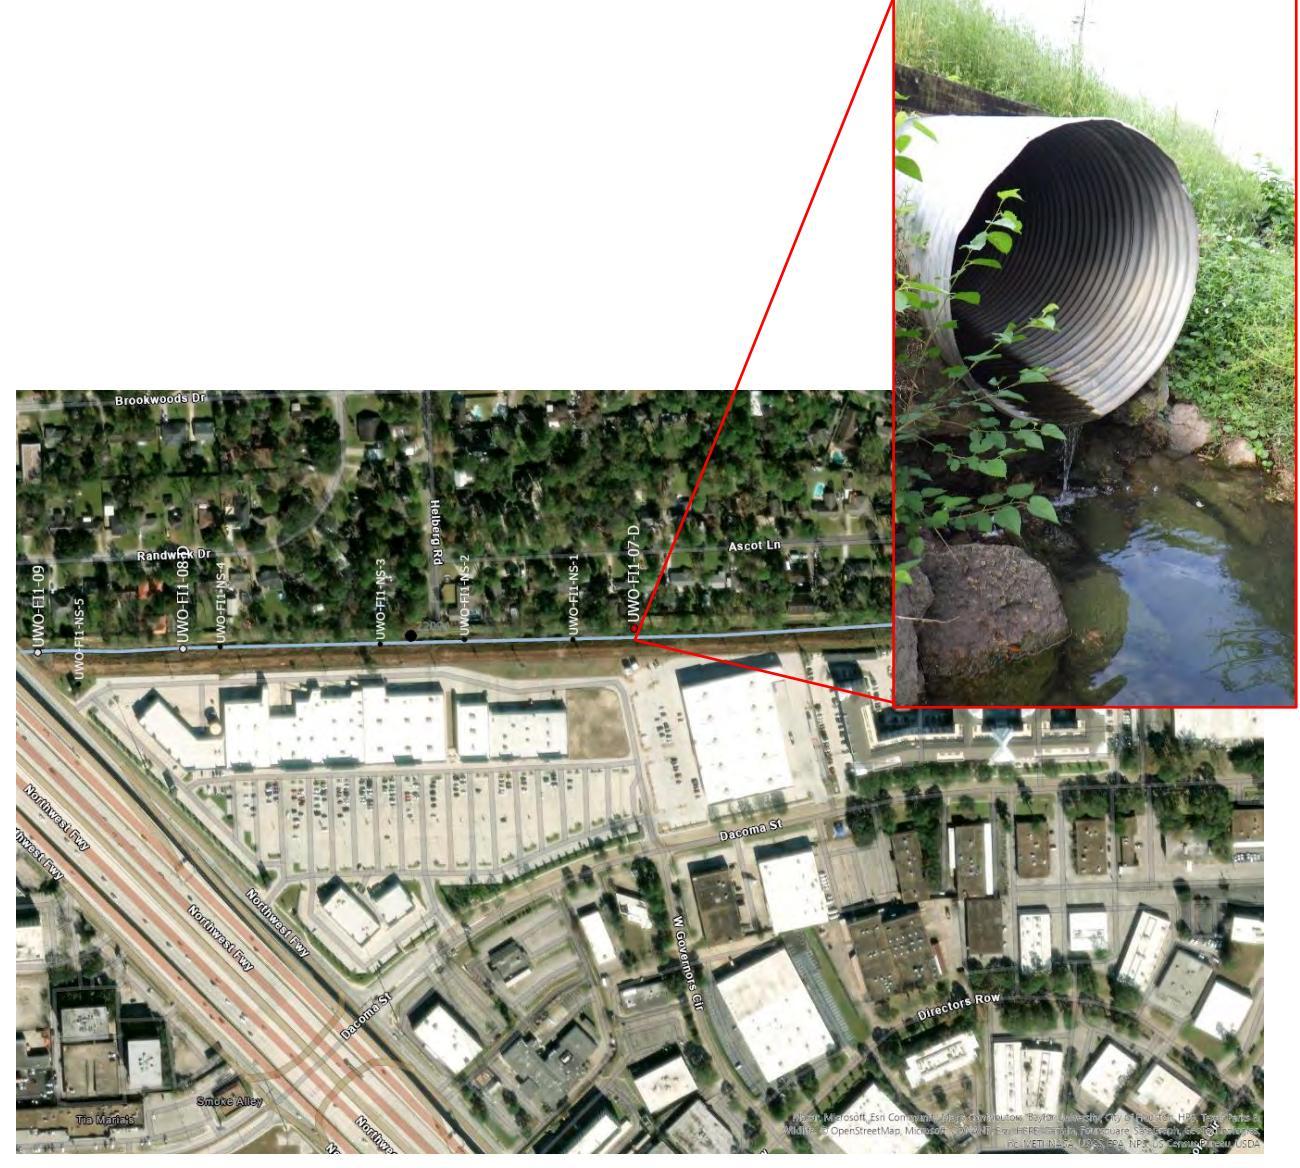
Referral site: UWO-FI1-07-D- High Priority

This is a 48 in. diameter metal pipe located on the right bank of the Unnamed Tributary to White Oak Bayou. Water within the pipe was 0.33 in. deep and flowing into a pooled area of the segment. There are commercial buildings located in the area on the right bank. A sample taken 0.3 m downstream of the pipe had a bacteria value of 3,990 MPN/100 mL. The ambient sample collected upstream of the pipe had a bacteria value of < 100 MPN/100 mL. This pipe is a high priority referral site for the proper local authority.

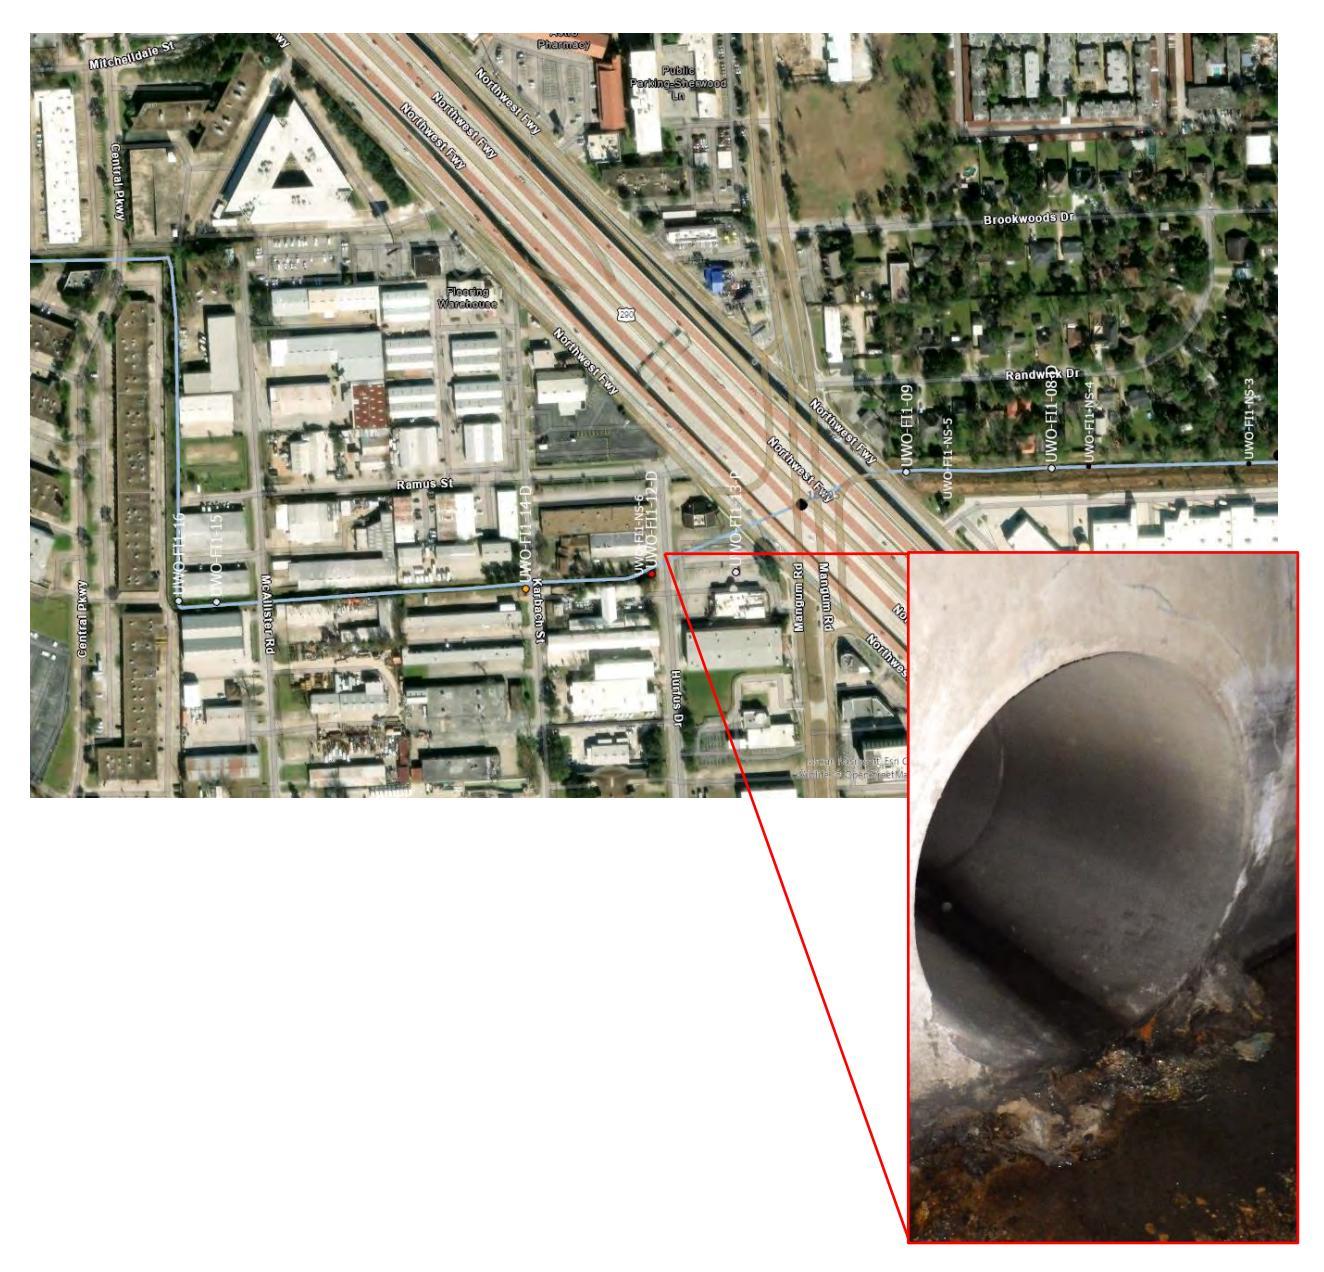
Referral site: UWO-FI1-12-D- High Priority

This is a 54 in. diameter cement pipe located on the left bank approximately 15 m downstream of the upstream side of the bridge on the Unnamed Tributary to White Oak Bayou. Water within the pipe was 0.6 in. deep and flowing into the segment. There was a pipe across from the sampled pipe that was barely trickling and not sampled. There are commercial buildings located in the area on the left bank. A sample taken 0.1 m downstream of the pipe had a bacteria value of 520 MPN/100 mL. The ambient sample collected upstream of the pipe had a bacteria value of < 100 MPN/100 mL. This pipe is a high priority referral site for the proper local authority.

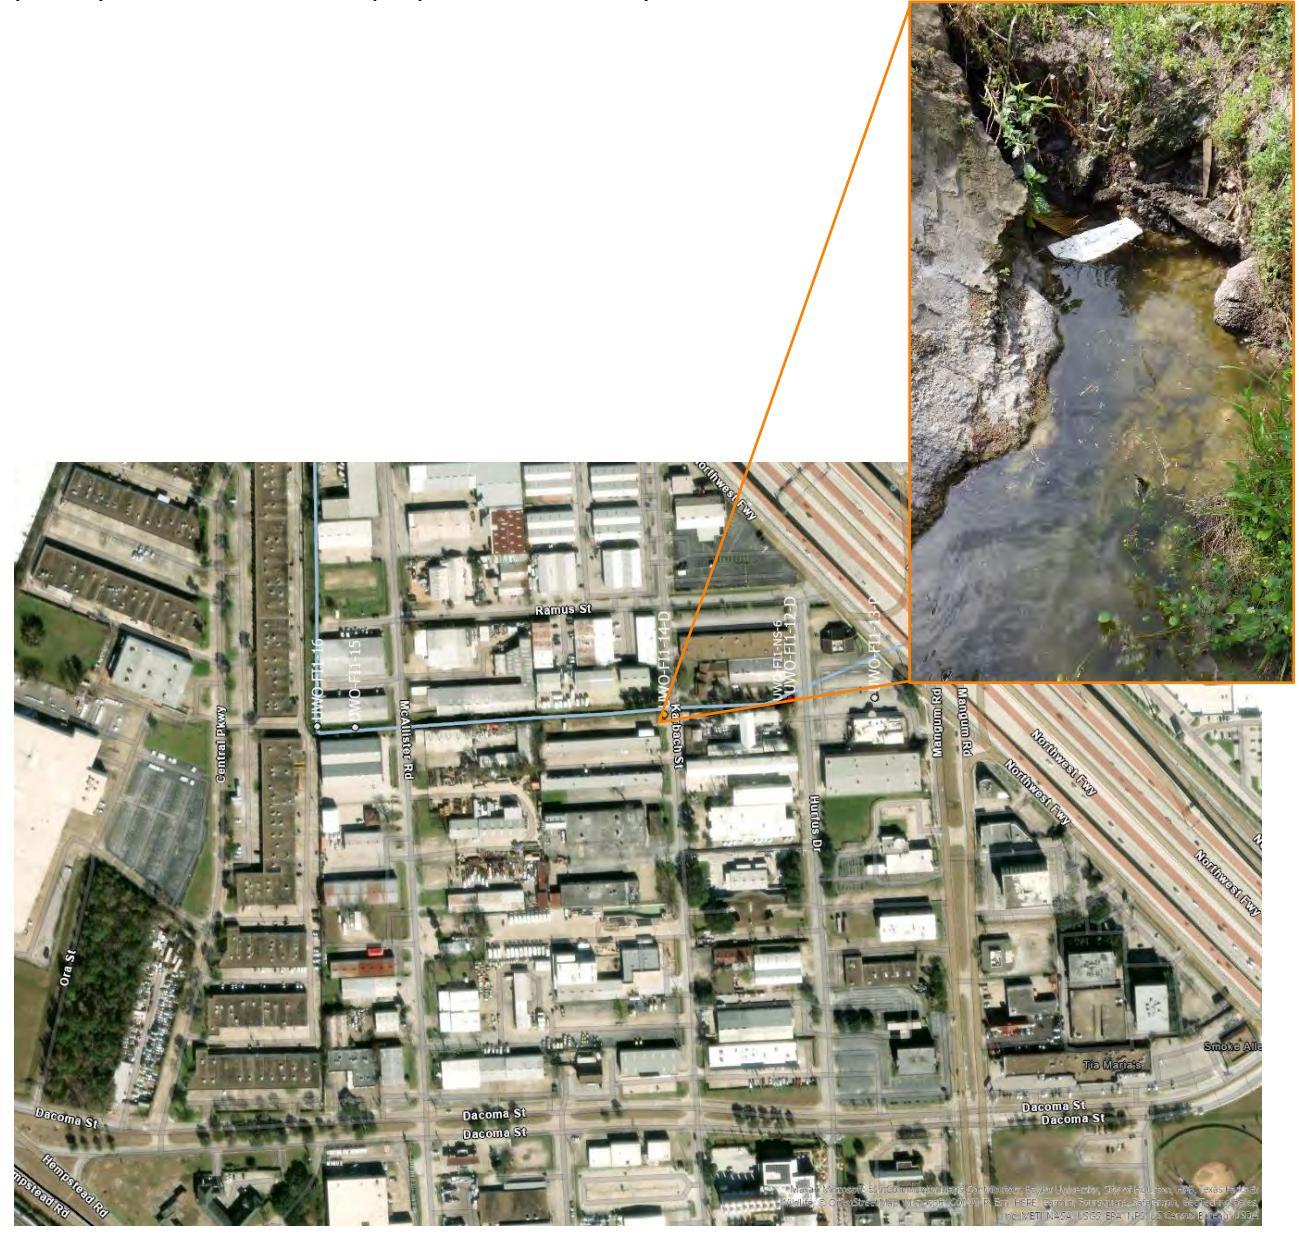
Referral site: UWO-FI1-14-D- Low Priority

This is a 12 in. diameter cement pipe located on the right bank of the Unnamed Tributary to White Oak Bayou. The pipe is completely submerged and the field crew was unable to tell if it was flowing, but the cement bank around it was collapsed and there is a pool under it. There are commercial buildings located in the area on the right bank. A sample taken 1 m downstream of the pipe had a bacteria value of 410 MPN/100 mL. The ambient sample collected upstream of the pipe had a bacteria value of 100 MPN/100 mL. This pipe is a low priority referral site for the proper local authority.

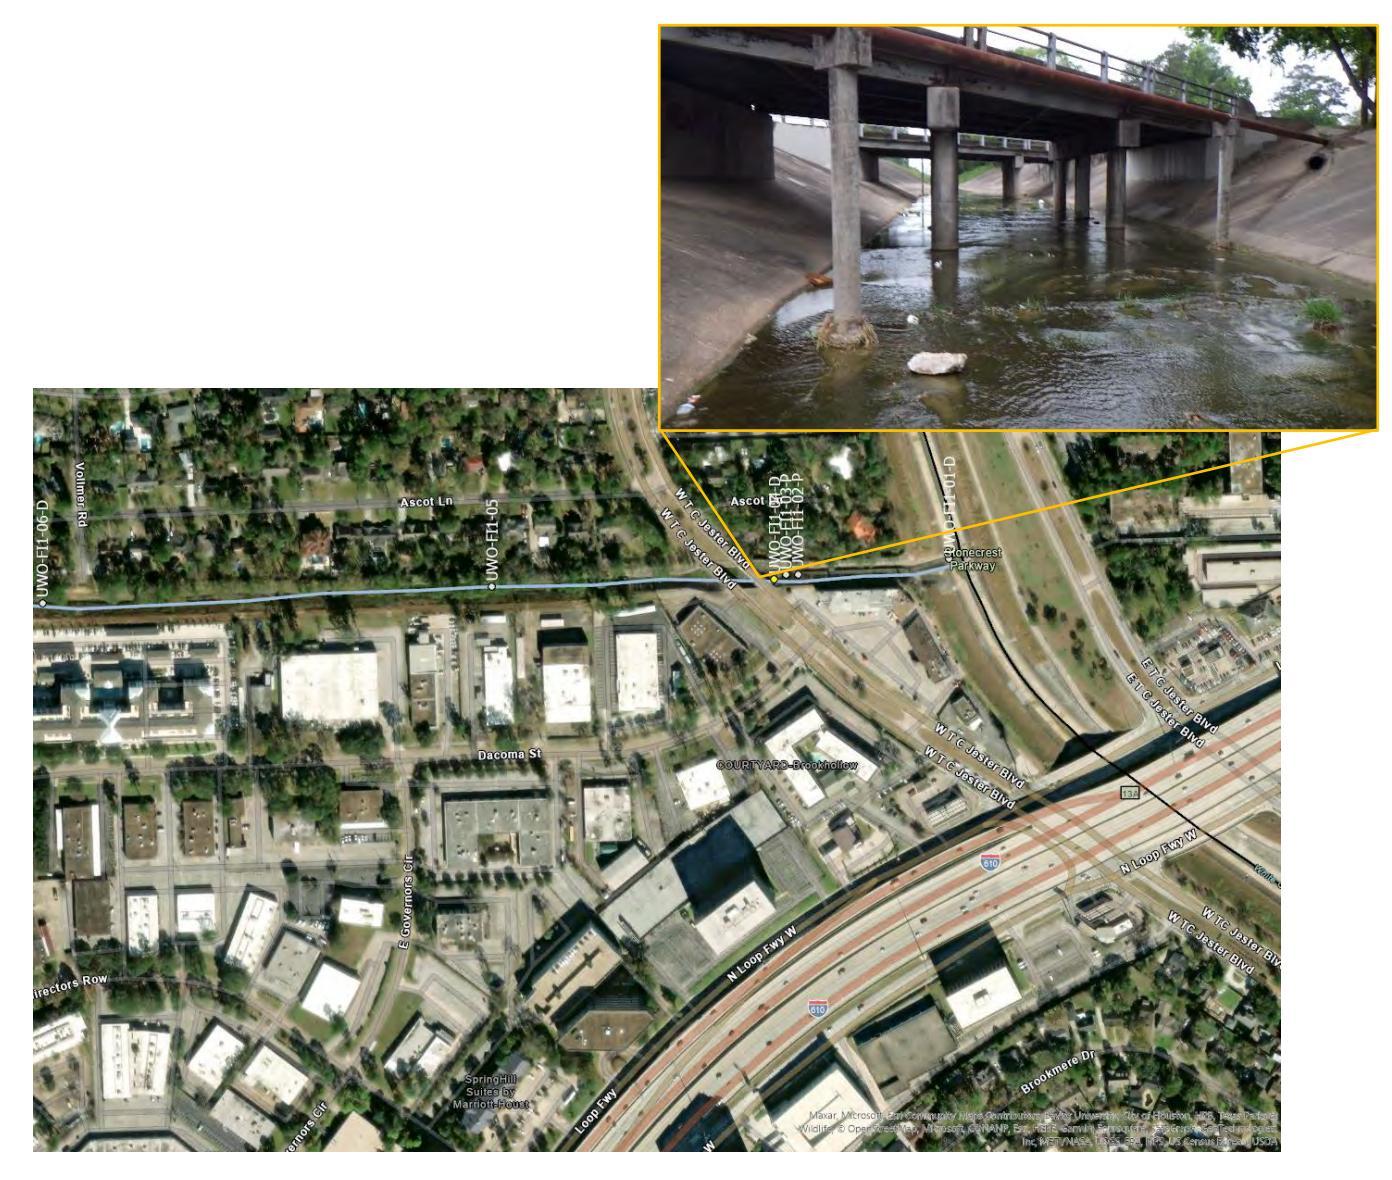
Referral site: UWO-FI1-04-U – Investigate Further

This was an ambient upstream sample taken on the Unnamed Tributary of White Oak Bayou for reference with the sample UWO FI1-04-D taken at a pipe on the right bank near the TC Jester bridge crossing. The ambient sample taken just downstream of the bridge crossing had a bacteria value of 3,320 MPN/100 mL. Another ambient sample was taken approximately 235 m further upstream and had a bacteria value of < 100 MPN/100 mL. No potential point sources were observed within this reach. Further investigation is recommended by the proper local authority to determine the source of elevated bacteria in this section of the segment. There are single-family homes located on the left bank and commercial building located on the right bank in this section of the segment.

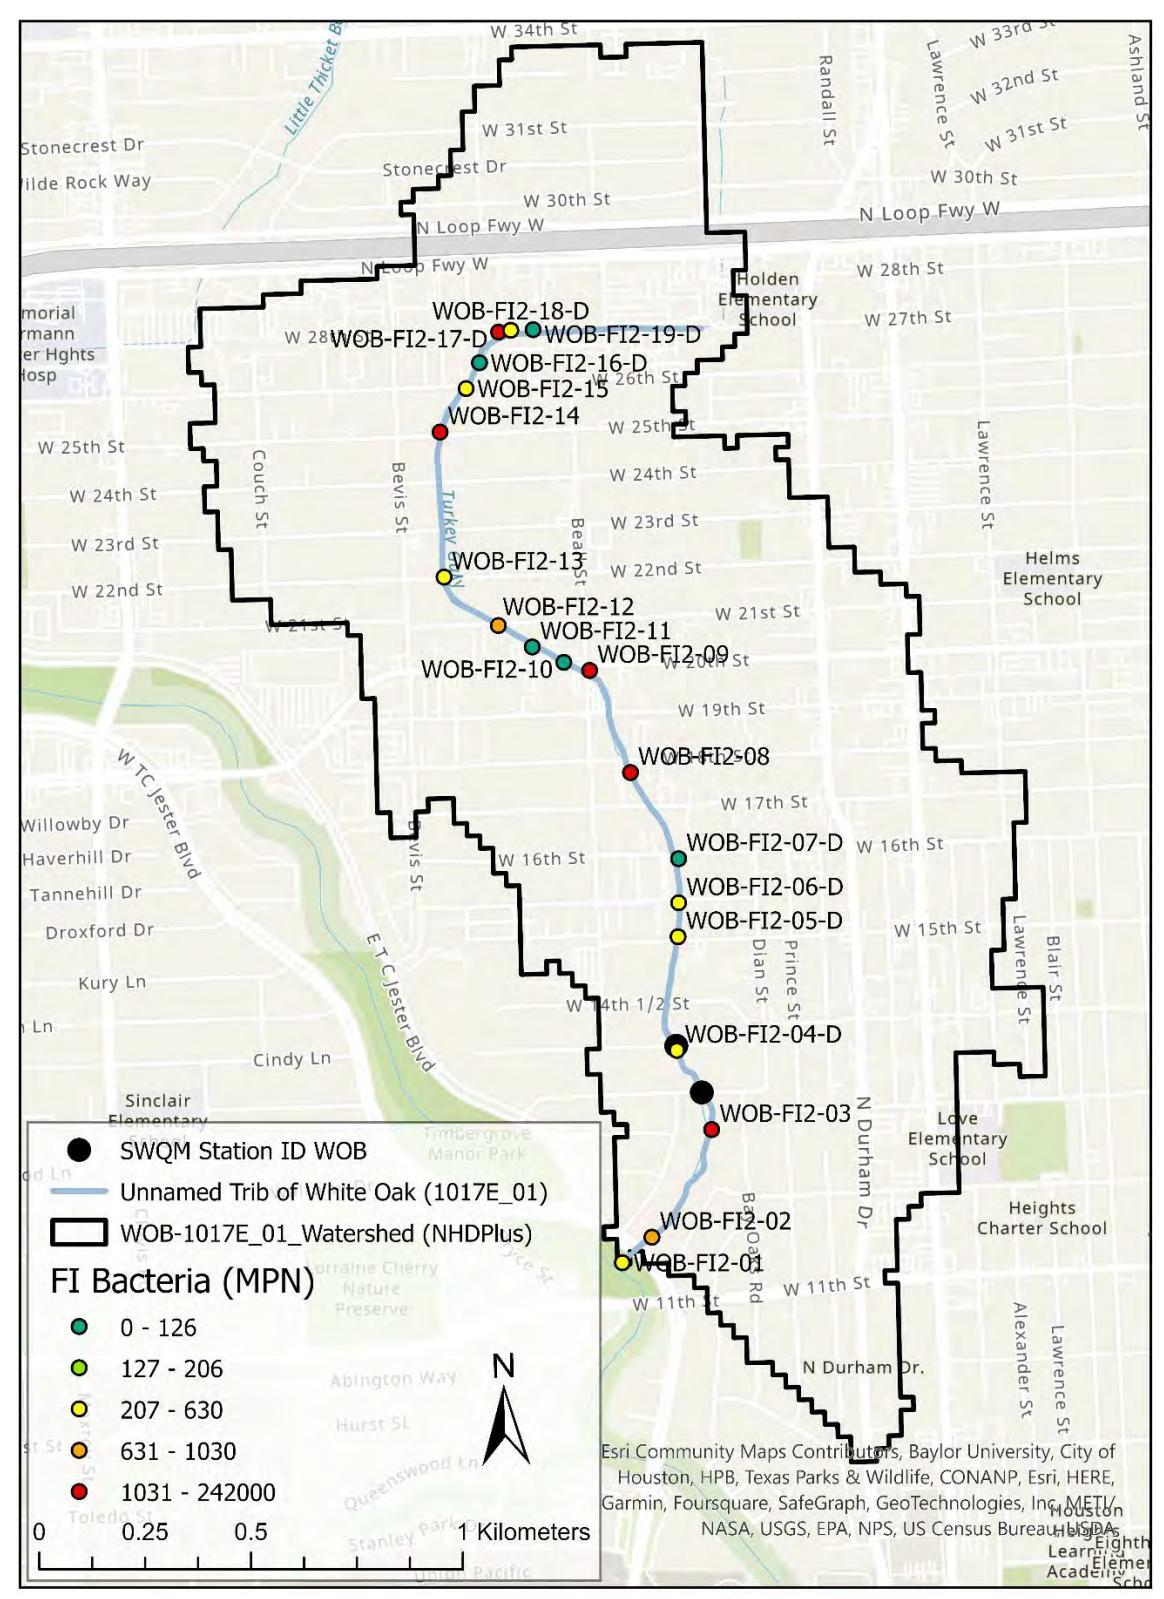
Figure 3: Field investigation bacteria sampling Results from 03/30/2023 on the Unnamed Tributary of White Oak Bayou (Assessment Unit 1017E_01).

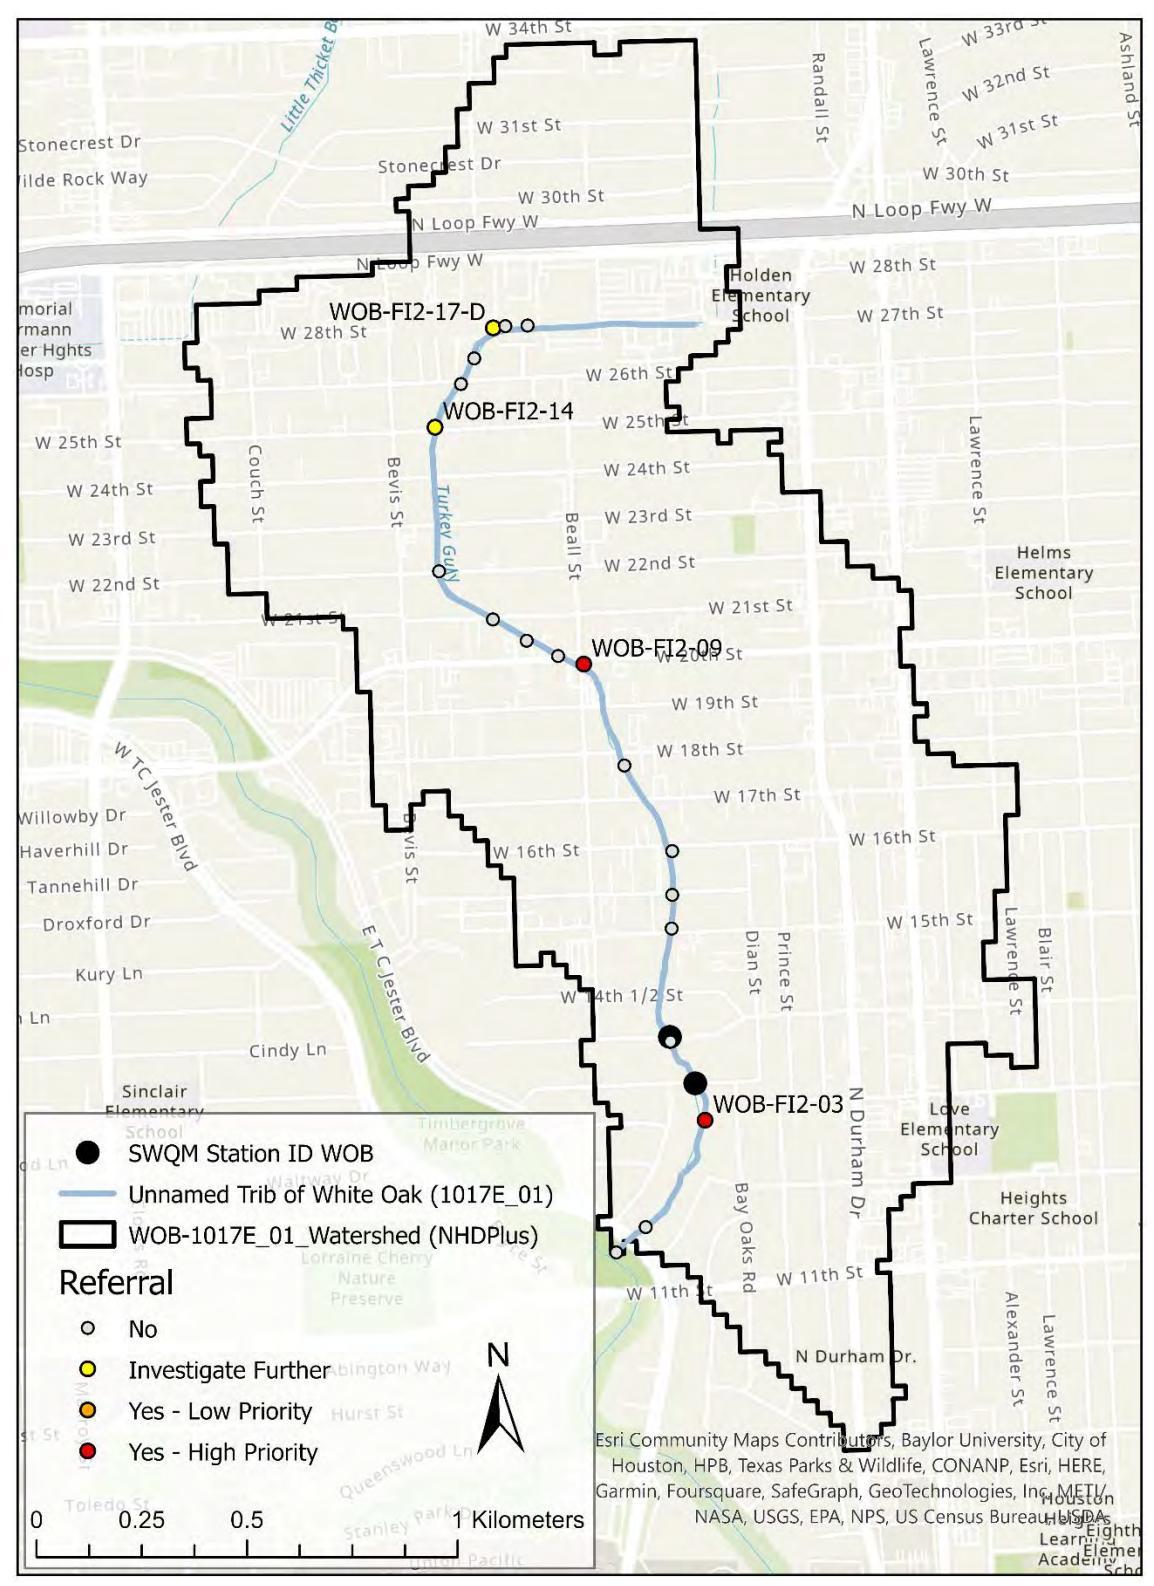
Figure 4: Field investigation sites sampled on 03/30/2023 and identified for referral to the proper authorities on the Unnamed Tributary of White Oak Bayou (Assessment Unit 1017E_01).

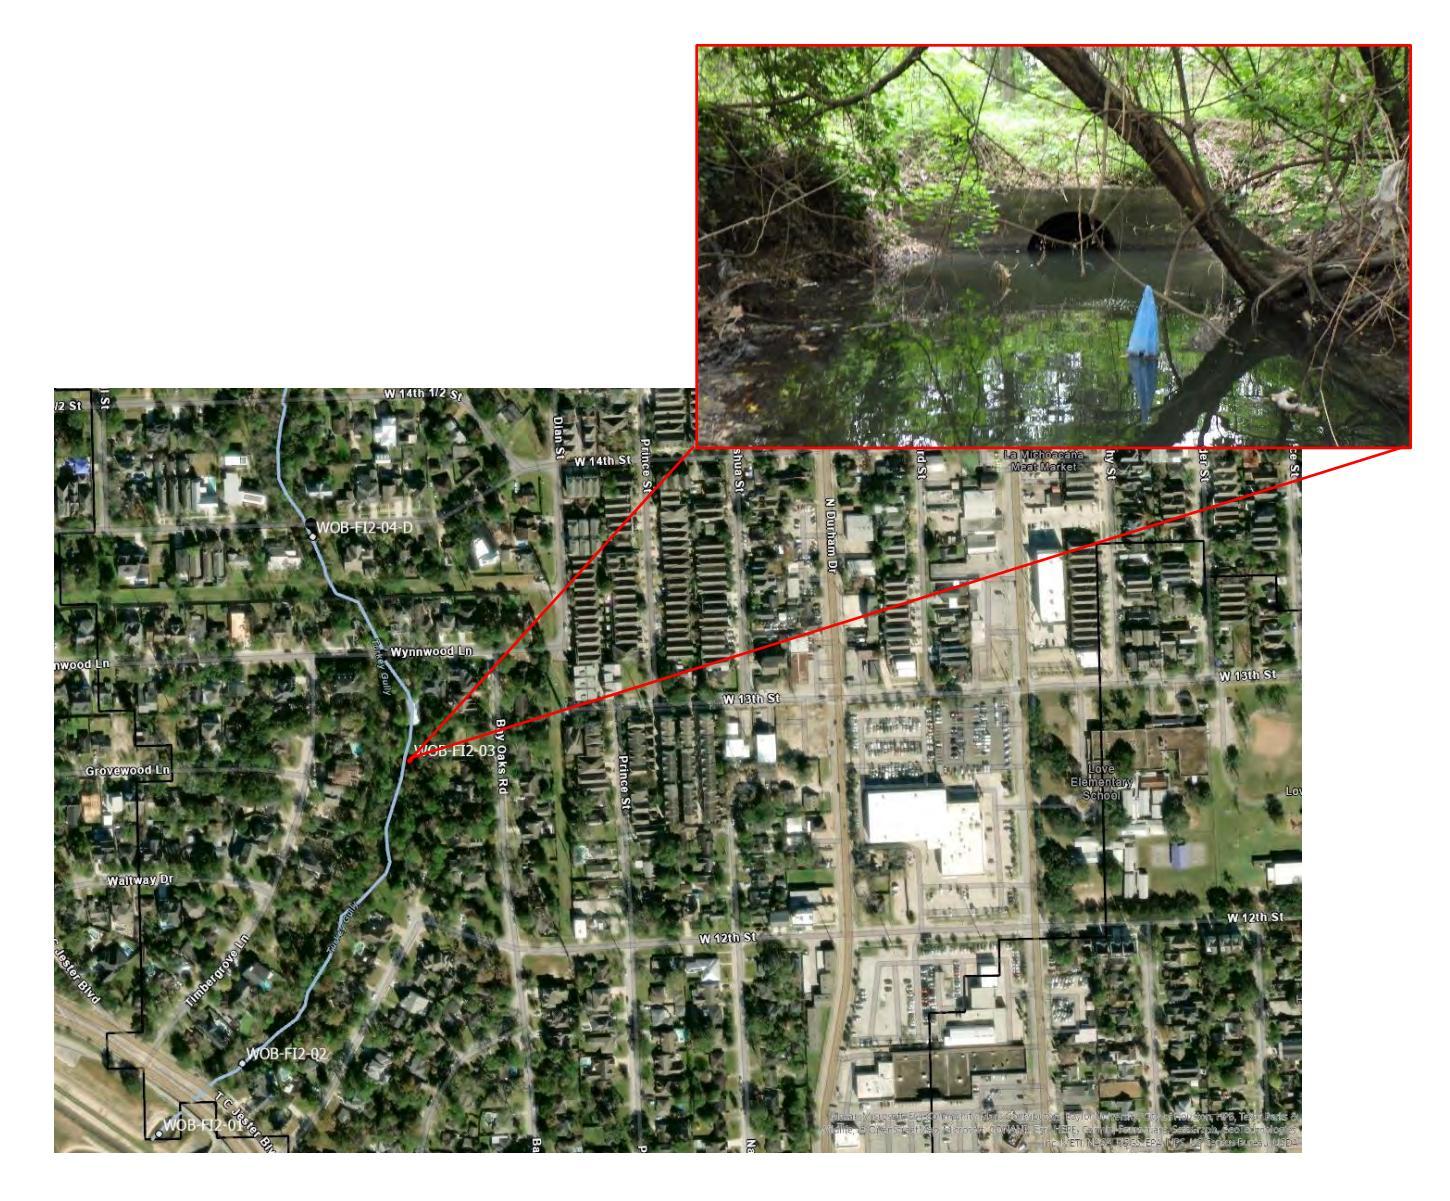
Referral site: WOB-FI2-03 - High Priority

This is a 51 in. diameter concrete pipe that was partially submerged on the left bank of the Unnamed Tributary of White Oak Bayou. Water within the pipe was 36 in. deep and the field crew was unable to tell if it was flowing into the segment due to it being submerged. The area in front of the pipe was a stagnant pool and the substrate appeared to be black in color with a white film on top. When disturbed, the substrate gave off an anoxic odor. Due to the pipe being submerged, the downstream sample was taken within the mixing zone in front of the mouth of the pipe and had a bacteria value of 5,200 MPN/100 mL. An ambient sample was not collected directly upstream of this pool, but the next ambient sample collected approximately 200 m upstream of the pipe had a bacteria value of 850 MPN/100 mL. This pipe is a high priority referral site for the proper local authority.

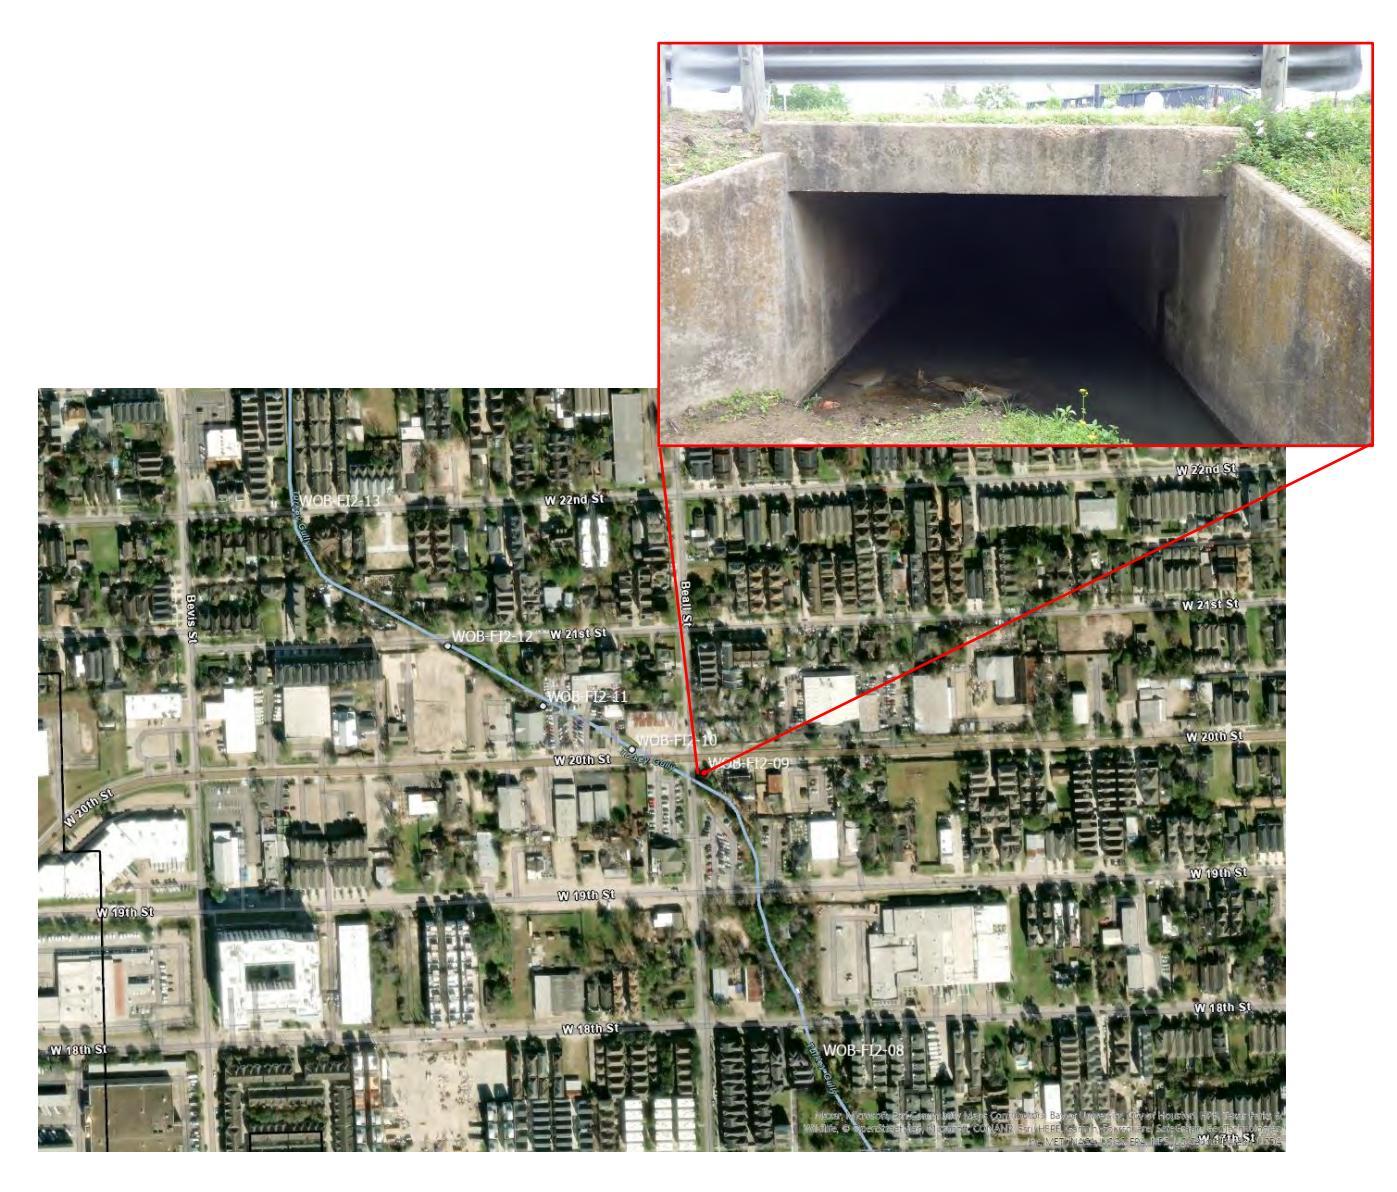
Referral site: WOB-FI2-09 – High Priority

This is where the Unnamed Tributary of White Oak Bayou goes underground. An ambient sample was collected just downstream of this bridge and had a bacteria value of 173,000 MPN/100 mL. The next ambient sample collected approximately 460 m upstream had a bacteria value of 100 MPN/100 mL. There were no pipes between these two ambient samples that were observed to be flowing into the AU at the time of sampling. This portion of the AU runs through a mix of restaurants, clubs, and residences. This section of the AU is a high priority referral site for the proper local authority.
