Targeted Bacteria Monitoring Project Executive Summary

Overview

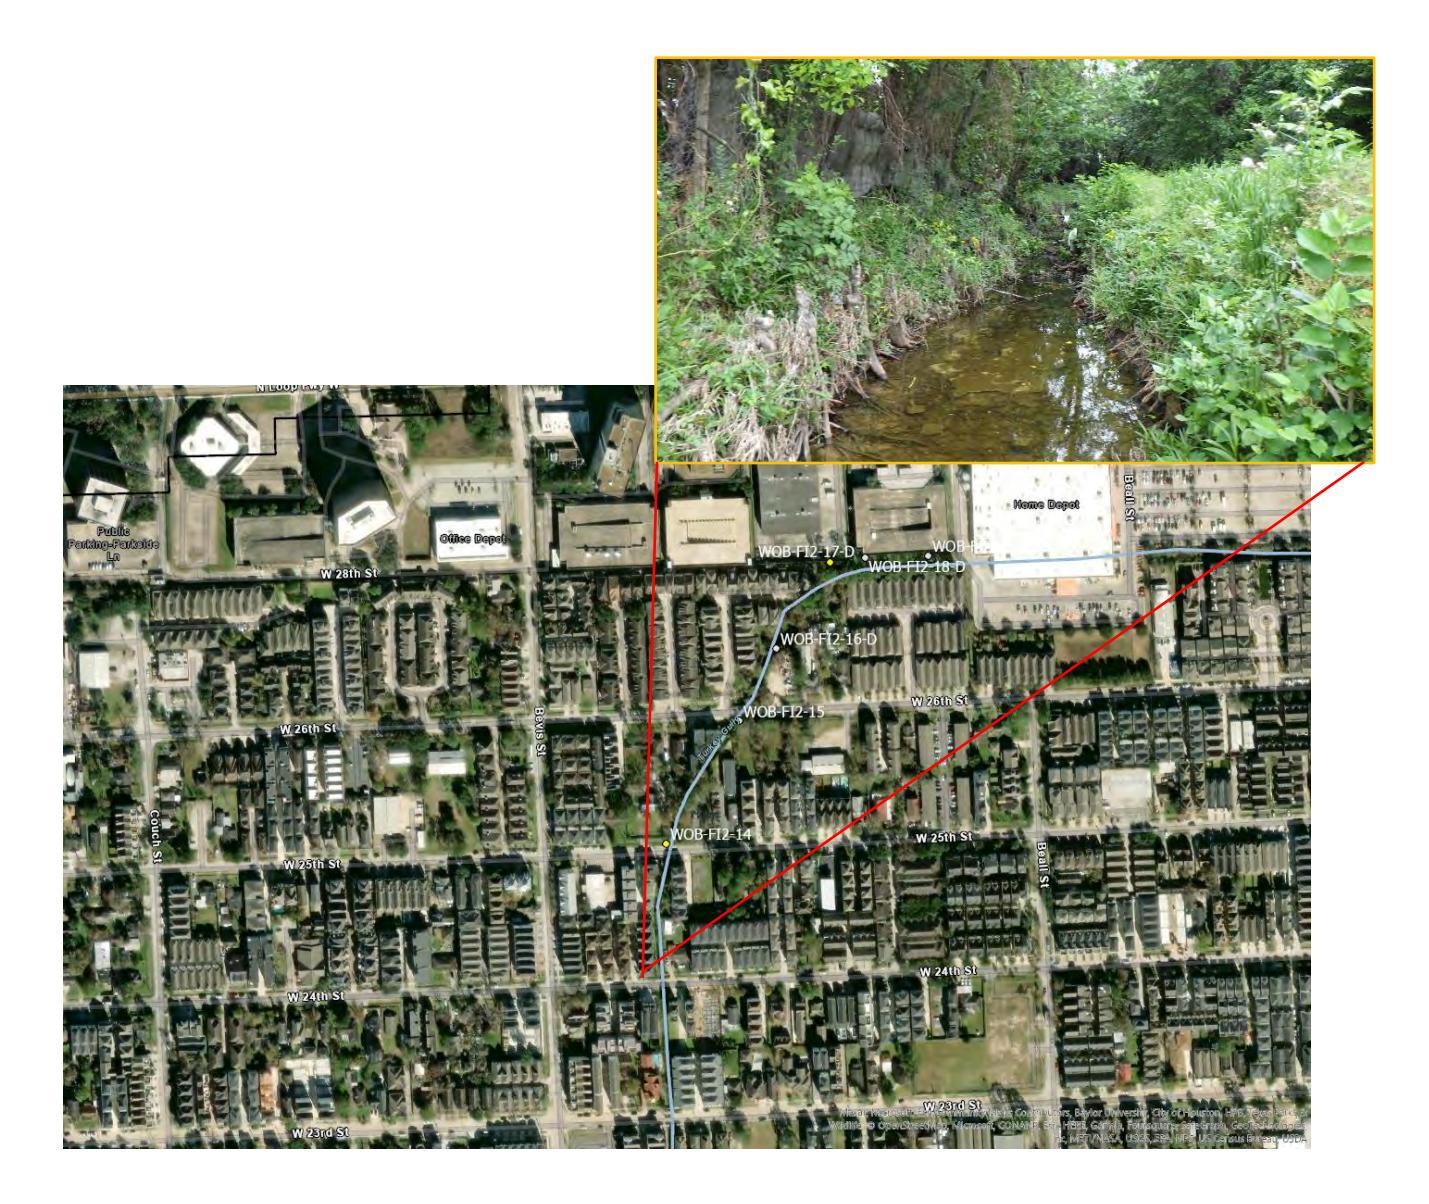
Referral site: WOB-FI2-14 - Investigate Further

This was an ambient sample taken just upstream of the bridge of W 25th St. on the Unnamed Tributary of White Oak Bayou. This ambient sample had a bacteria value of 6,130 MPN/100 mL. The next ambient sample was collected 115 m upstream and had a bacteria value of 310 MPN/100 mL. No pipes were observed to be flowing between these two sampling locations during the time of sampling. Further investigation is recommended by the proper local authority to determine the source of elevated bacteria in this section of the AU. There are apartment and single-family homes located upstream of the site.

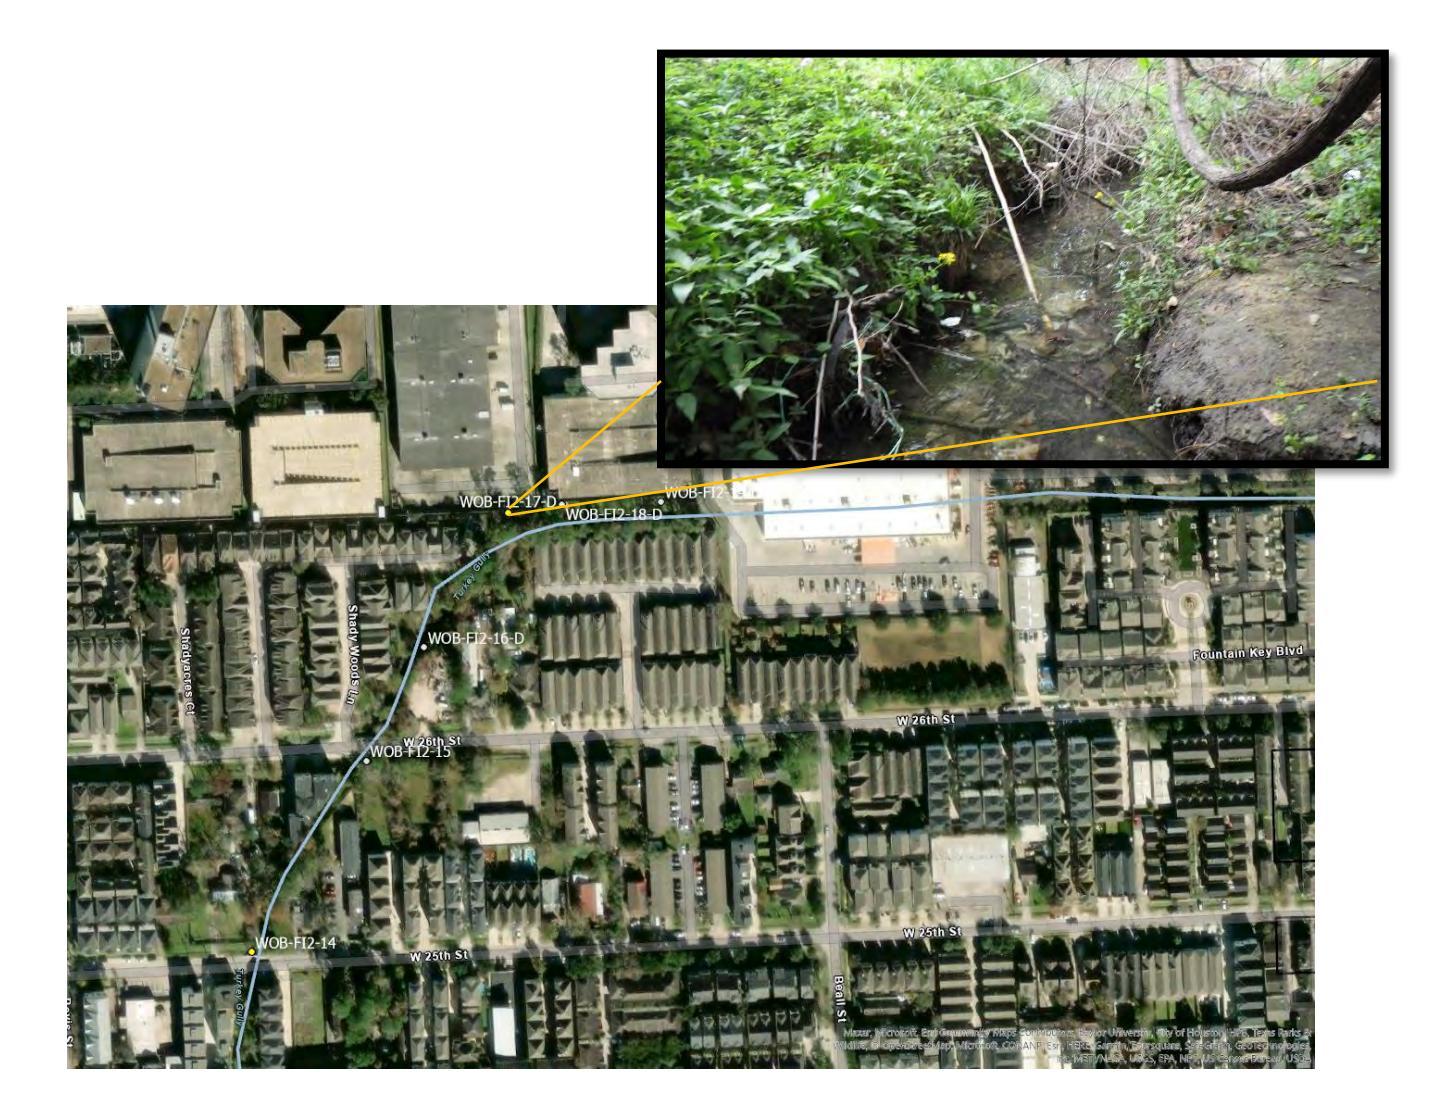
Referral site: WOB-FI2-17-U – Investigate Further

This portion between two pipes had suspect levels of bacteria. The ambient sample taken just upstream of this pipe had a bacteria value of 11,800 MPN/100 mL yet the sample collected downstream of the next pipe (18-D), which was only 30 m upstream, had a bacteria value of 630 MPN/100 mL. There were no pipes that were observed to be flowing into the AU between pipes 17-D and 18-D at the time of sampling. Further investigation is recommended by the proper local authority to determine the source of elevated bacteria in this section of the AU. There are apartments and single-family homes located upstream of the site, as well as commercial properties.

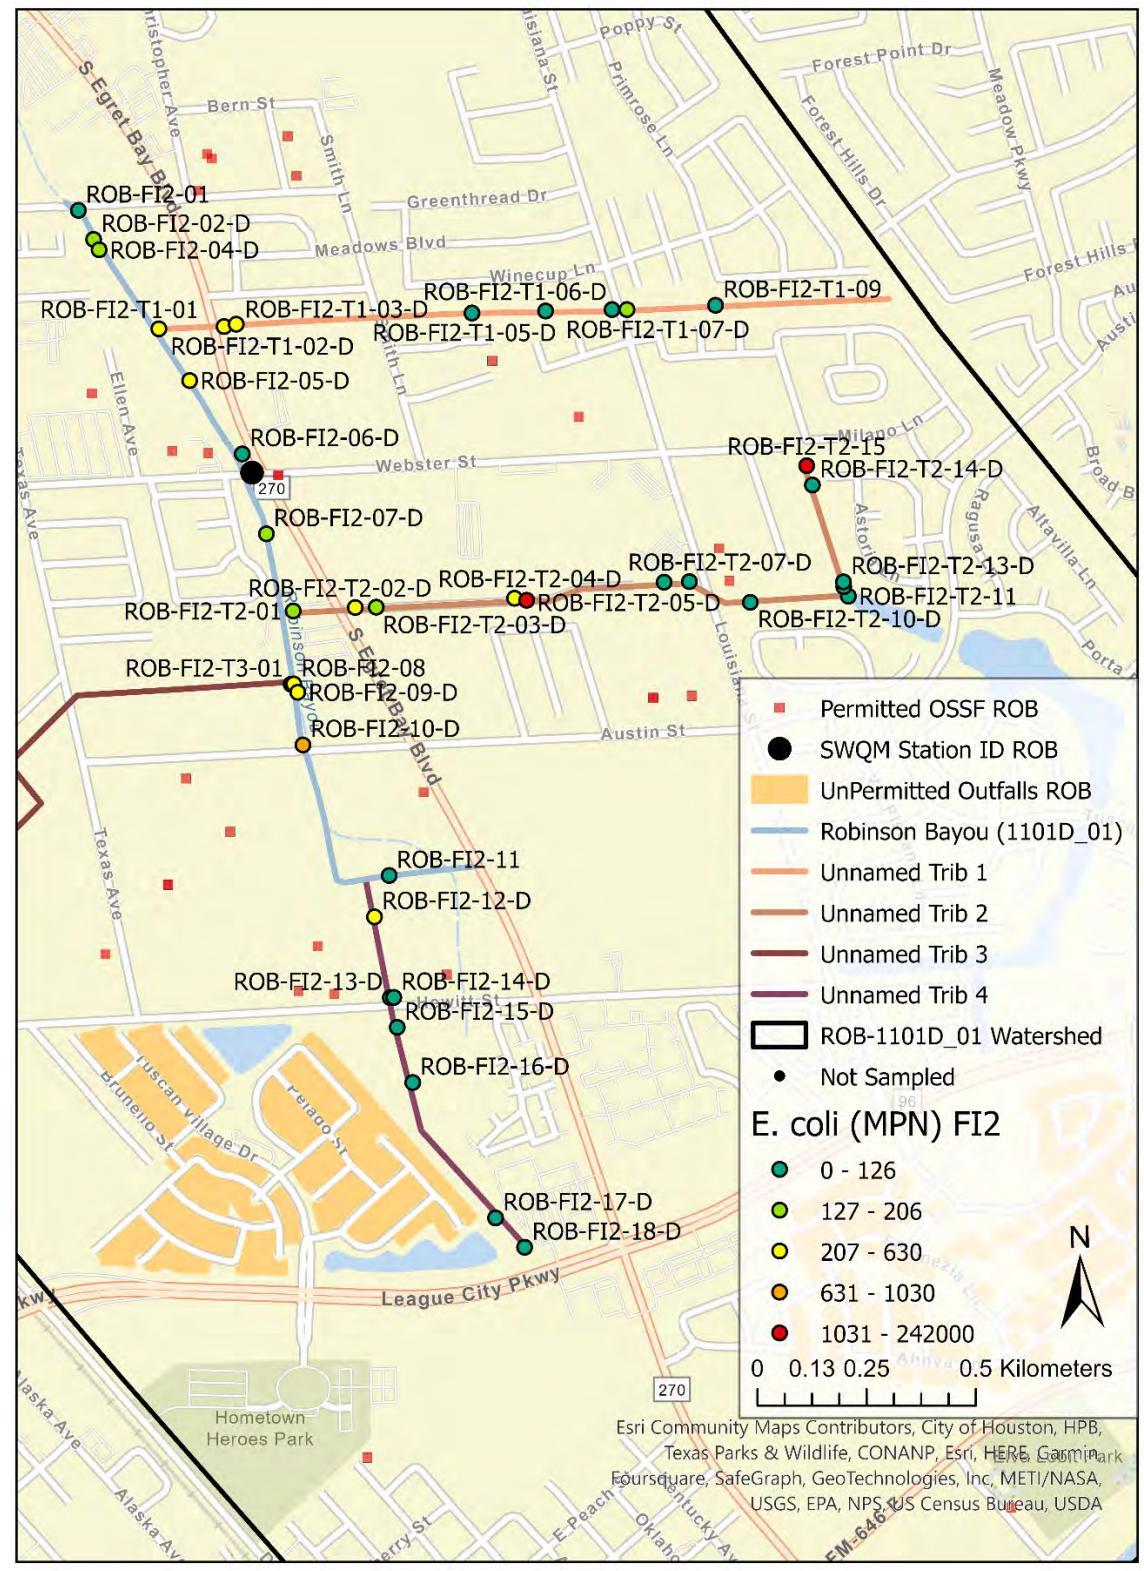
Figure 4: Field investigation bacteria sampling results from 5/2/2023 on Robinson Bayou (Assessment Unit 1101D_01).

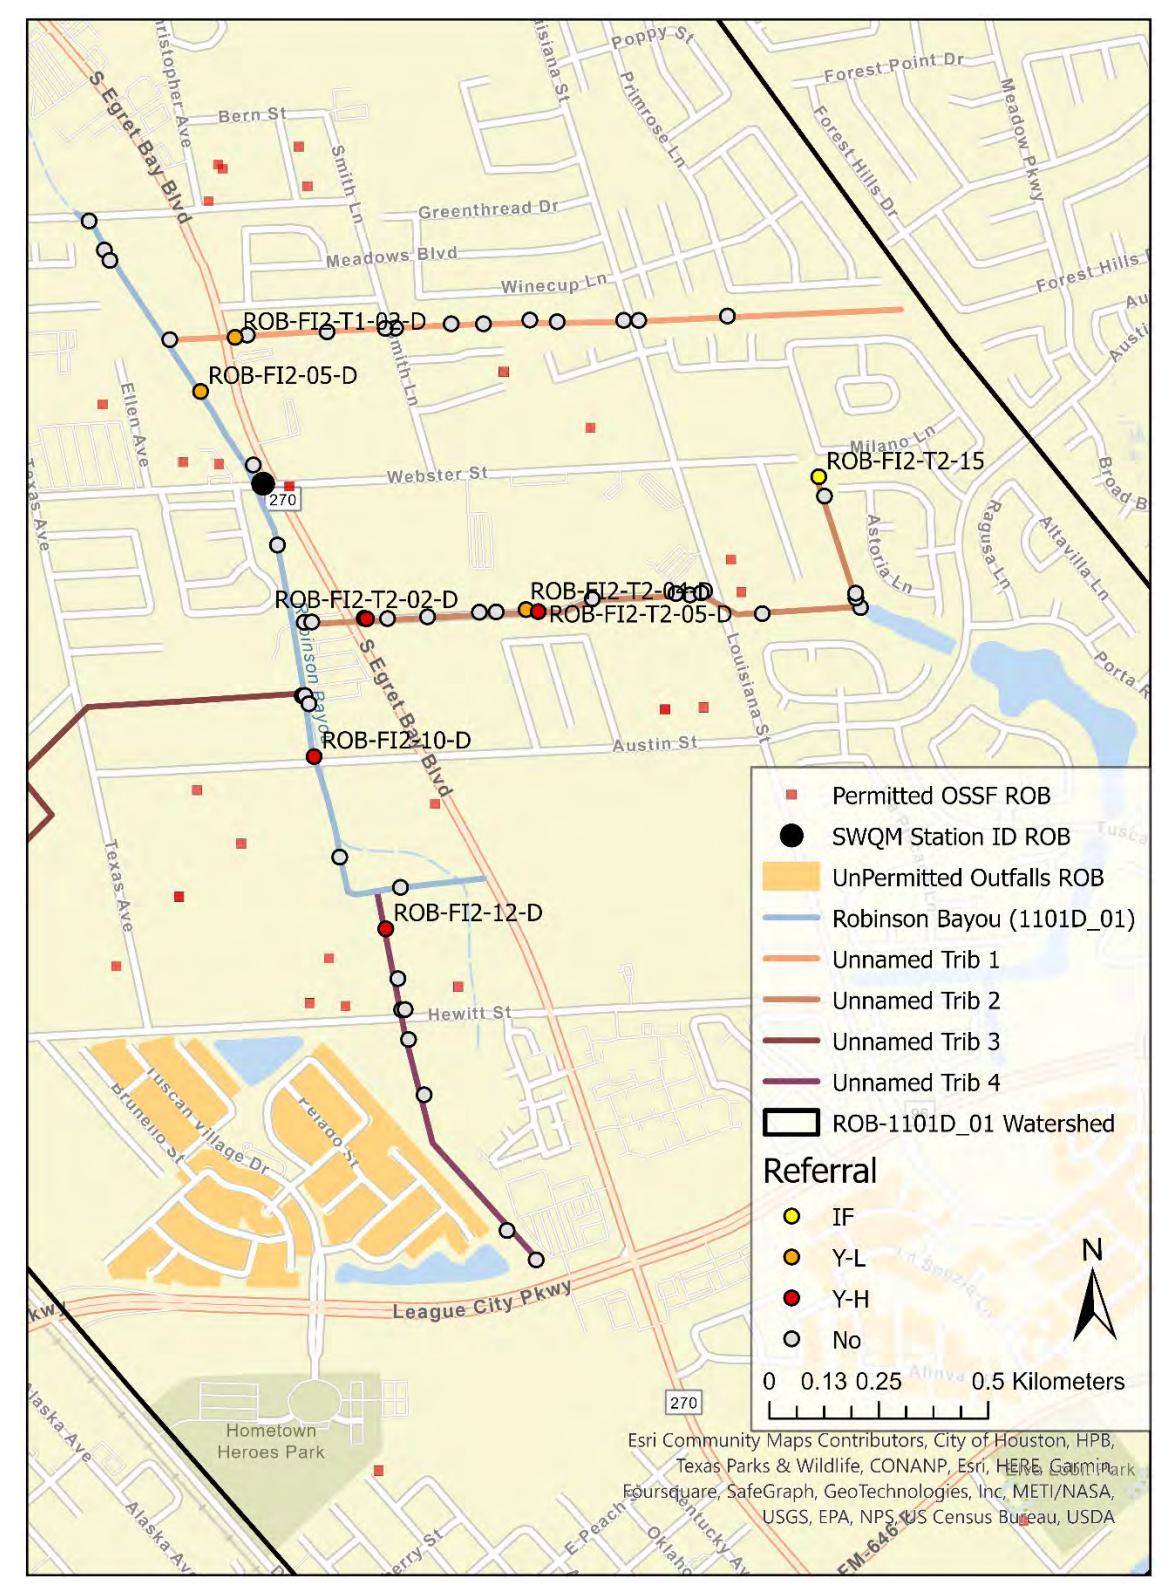
Figure 5: Field investigation sites sampled on 5/2/23 and identified for referral to the proper authorities on Robinson Bayou (Assessment Unit 1101D_01).

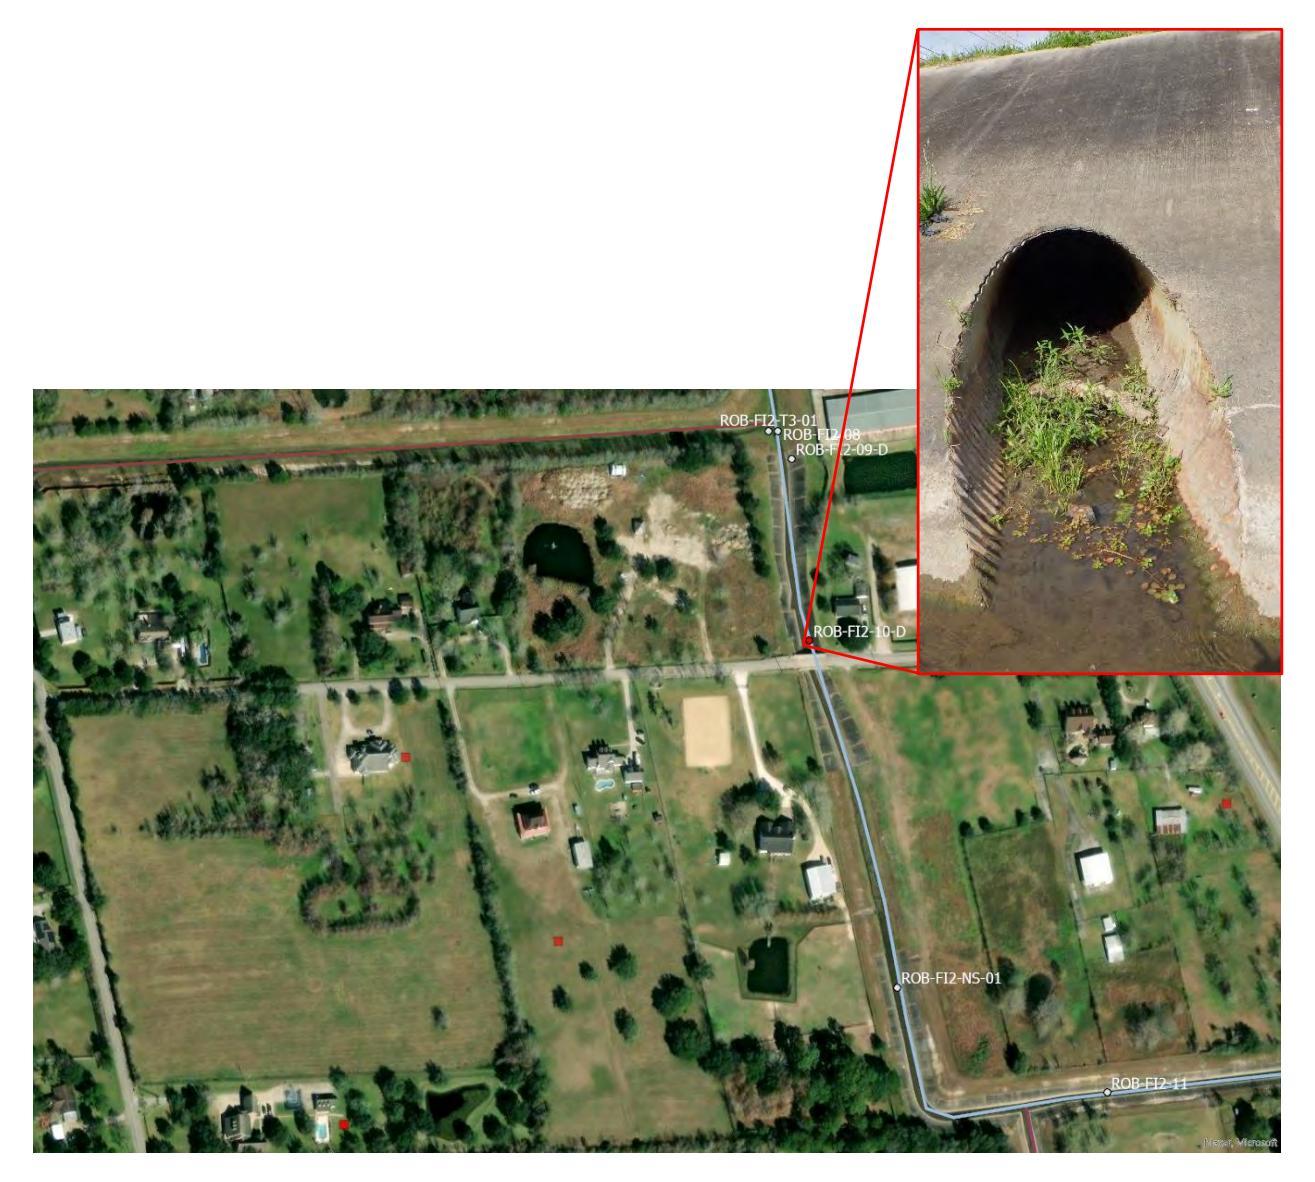
Referral site: ROB-FI2-10-D- High Priority

This is a 45 in. diameter metal pipe located on the left bank of Robinson Bayou. Water within the partially submerged pipe was 2 in. deep and trickling into the segment. There was a pipe on the right bank across from the sampled pipe that had a very small trickle but was not sampled. There are large lot single-family homes located in the area on the left bank, several of which have permitted OSSFs. Due to the pipe being submerged, the downstream sample was taken within the mixing zone in front of the mouth of the pipe and had a bacteria value of 850 MPN/100 mL. The ambient sample collected upstream of the pipe had a bacteria value of < 100 MPN/100 mL. This pipe is a high priority referral site for the proper local authority.

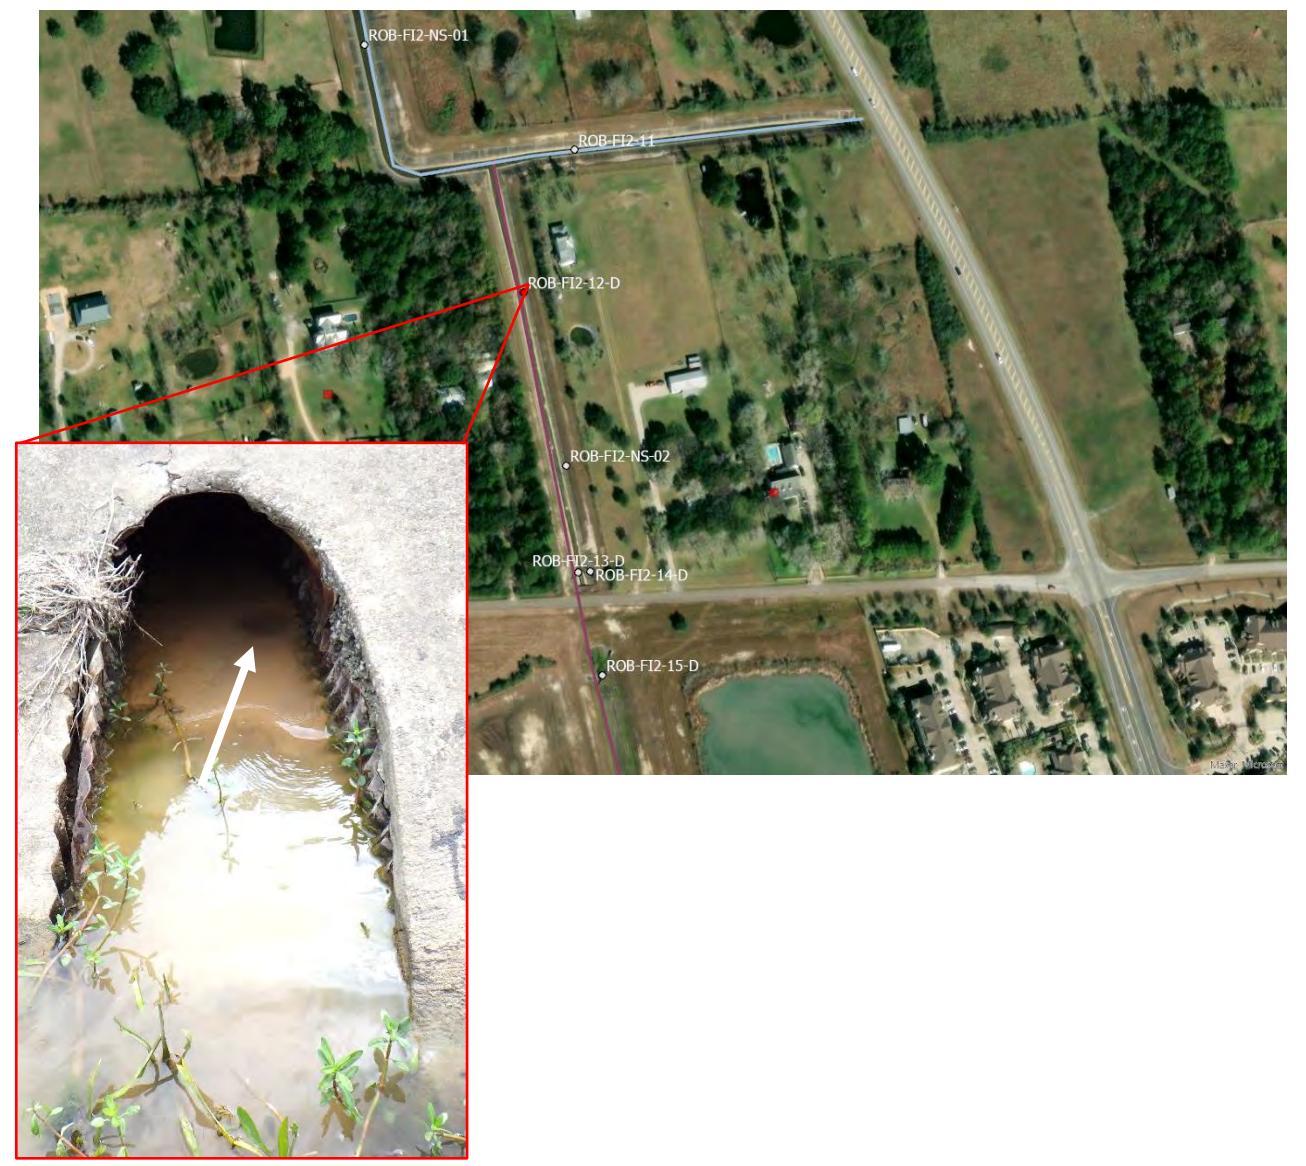
Referral site: ROB-FI2-12-D- High Priority

This is a 24 in. diameter metal pipe located on the right bank of Robinson Bayou. Water within the partially submerged pipe was 5 in. deep and flow was observed to be "bubbling" up from the substrate into the segment (white arrow). The substrate in the pipe was reddish in color. There was a pipe across the bayou (left bank) that was moist but not flowing which was not sampled. There are large lot single-family homes located in the area on the right bank. Due to the pipe being submerged, the downstream sample was taken within the mixing zone in front of the mouth of the pipe and had a bacteria value of 510 MPN/100 mL. The ambient sample collected upstream of the pipe had a bacteria value of 100 MPN/100 mL. This pipe is a high priority referral site for the proper local authority.

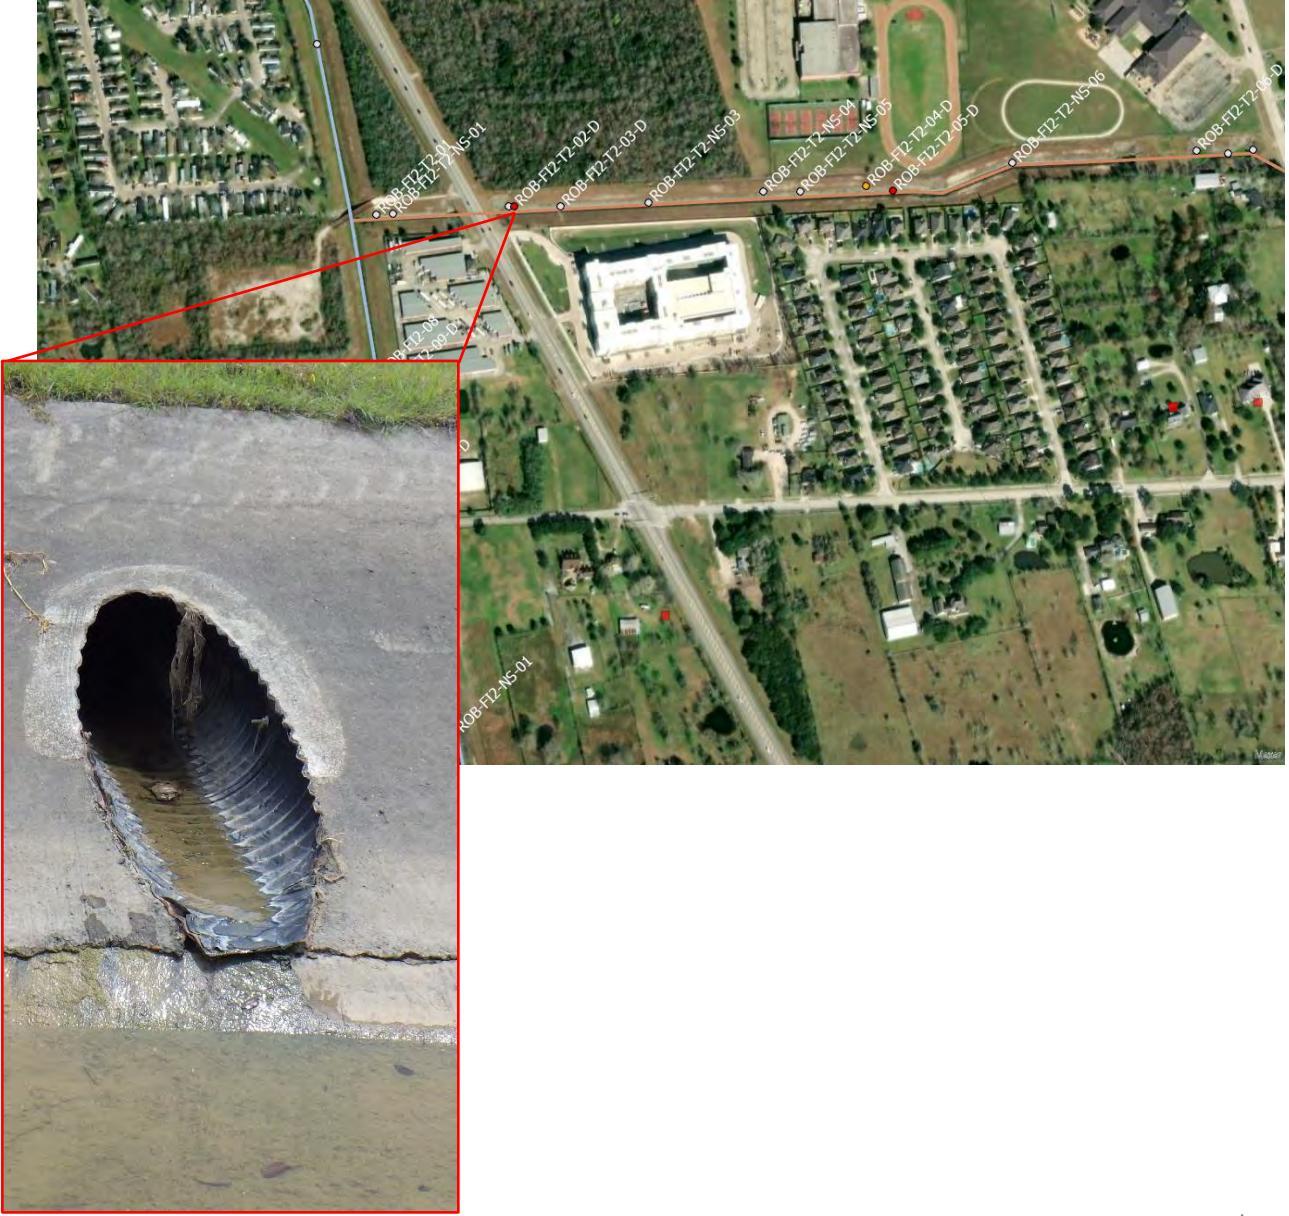
Referral site: ROB-FI2-T2-02-D- High Priority

This is a 24 in. diameter corrugated plastic coated pipe located on the left bank of Unnamed Tributary #2 to Robinson Bayou. Water within the pipe was 0.25 in. deep and dripping into the segment. There is a condominium complex located in the area on the left bank. A sample taken 0.1 m downstream of the pipe had a bacteria value of 410 MPN/100 mL. The ambient sample collected upstream of the pipe had a bacteria value of 100 MPN/100 mL. This pipe is a high priority referral site for the proper local authority.

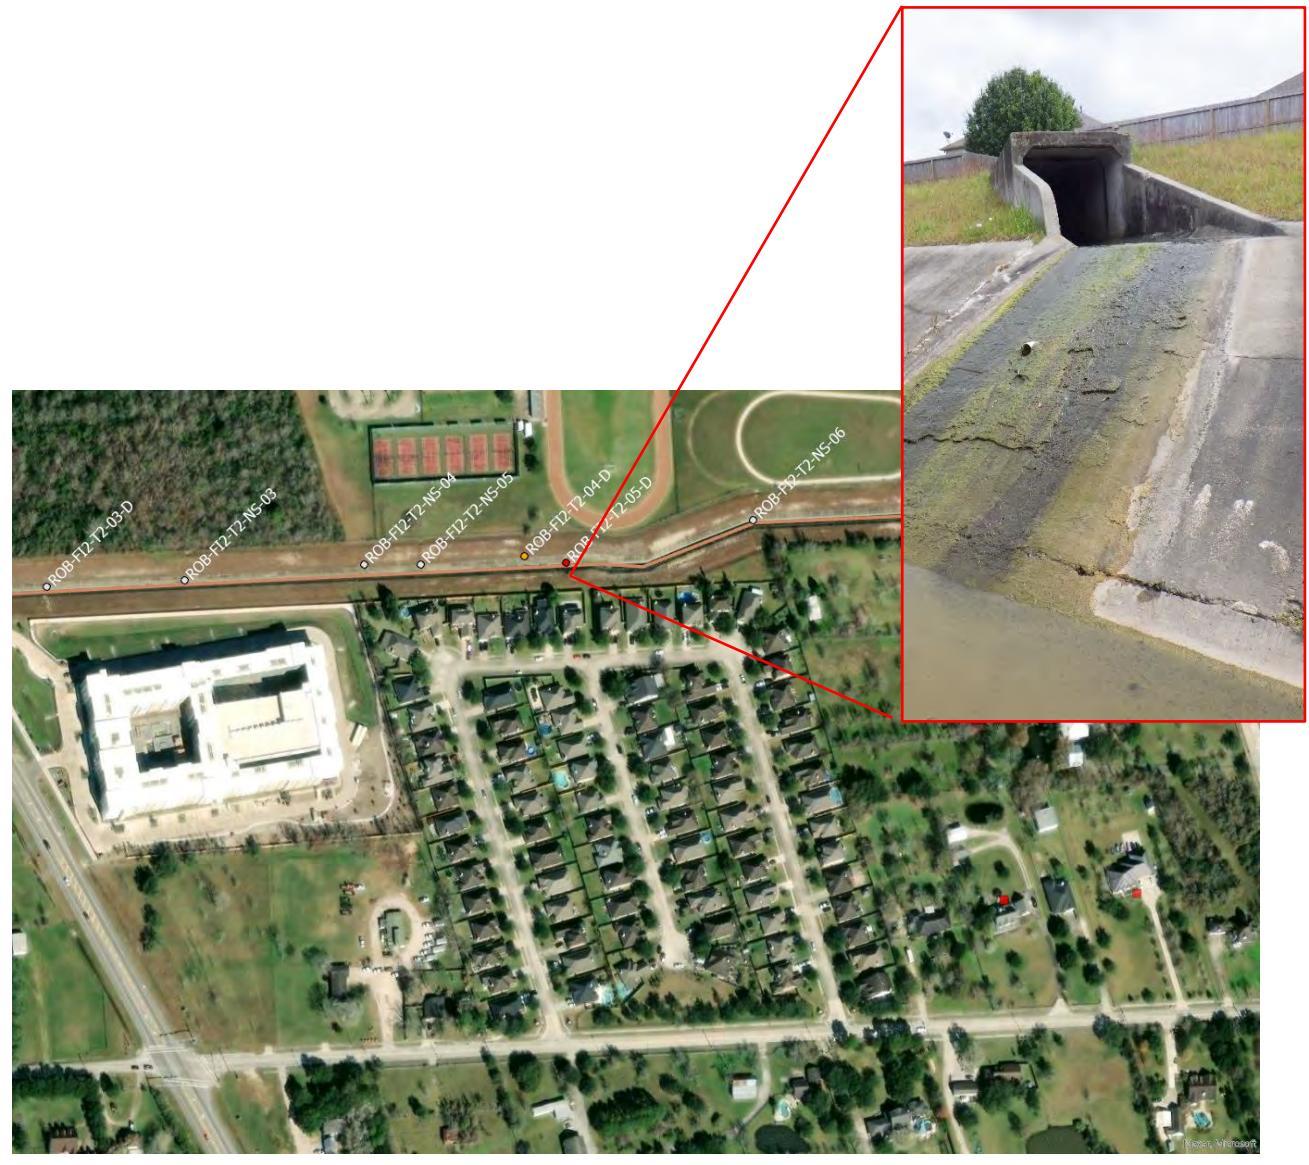
Referral site: ROB-FI2-T2-05-D- High Priority

This is an approximately 60 in. diameter square concrete culvert located on the left bank of Unnamed Tributary #2 to Robinson Bayou. Water within the culvert was 0.25 in. deep and steadily flowing into the segment. There are single-family homes located in the area on the left bank. A sample taken 3 m downstream of the culvert had a bacteria value of 6,700 MPN/100 mL. The ambient sample collected upstream of the culvert had a bacteria value of < 100 MPN/100 mL. This is a high priority referral site for the proper local authority.

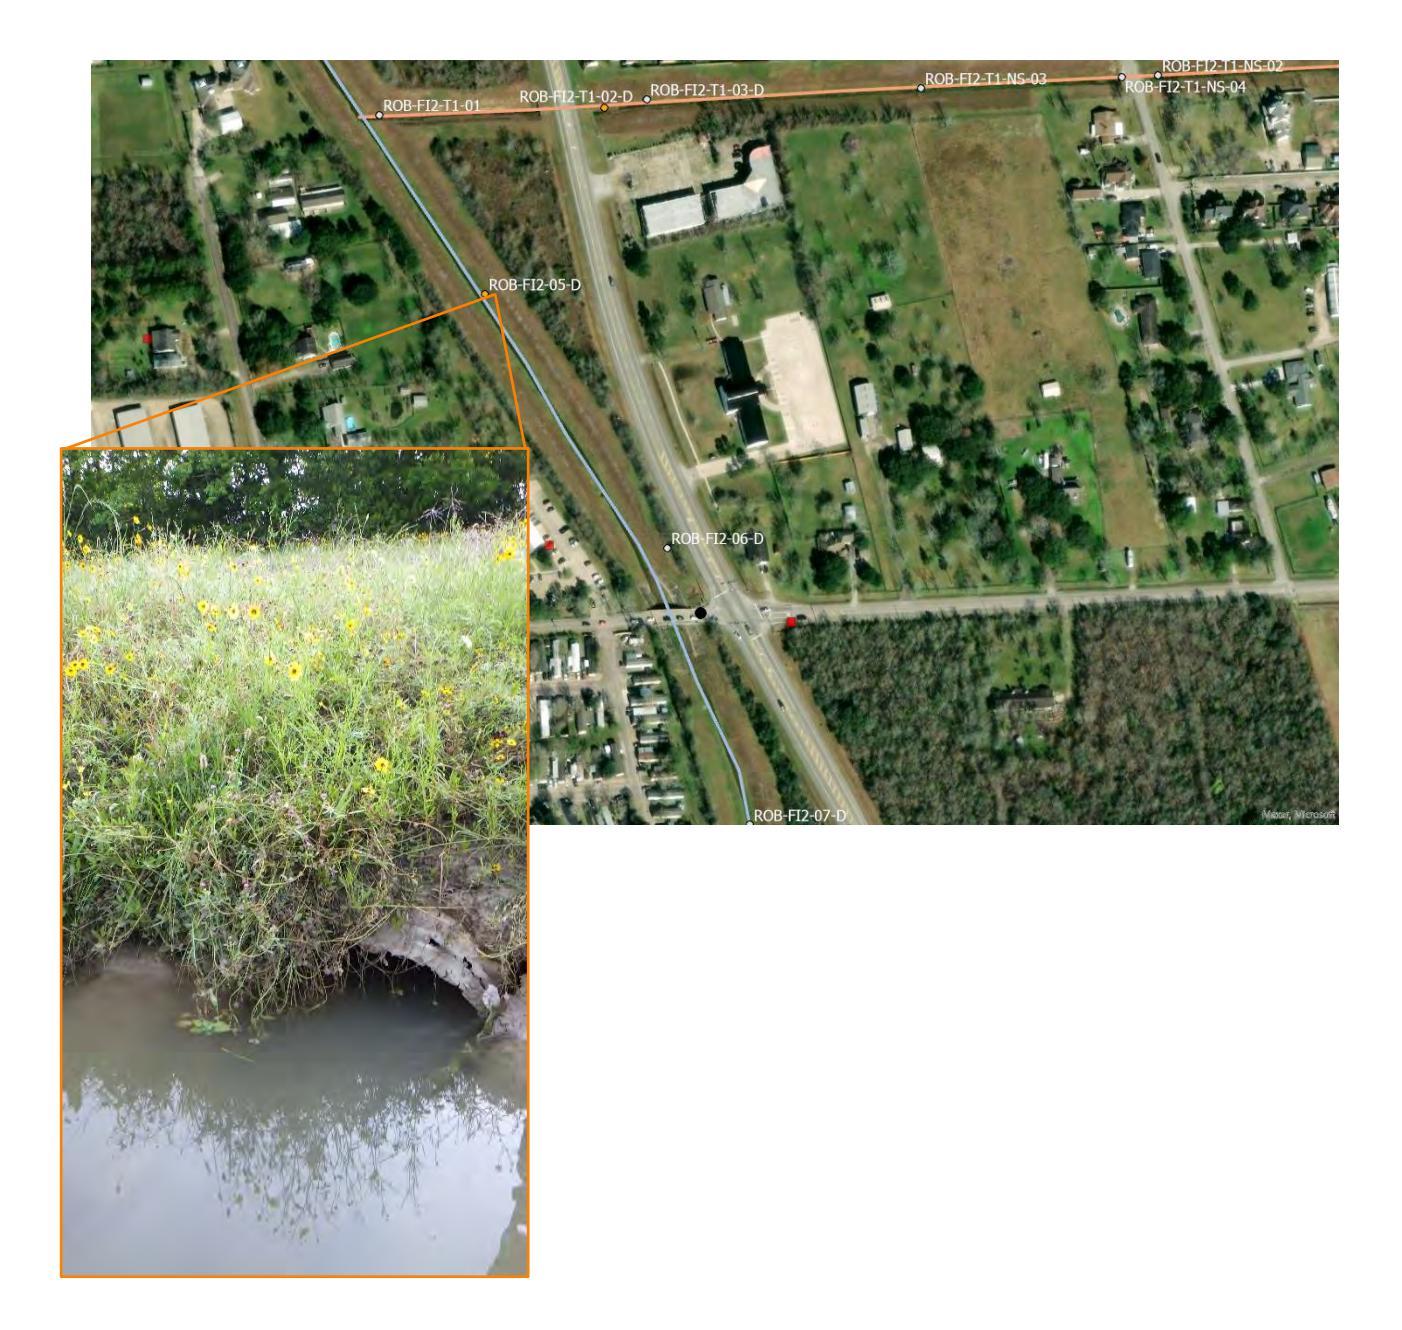
Referral site: ROB-FI2-05-D- Low Priority

This is a 12 in. diameter rusted metal pipe located on the right bank of Robinson Bayou. Water within the partially submerged pipe was 8.5 in. deep and the field crew was unable to tell if it was flowing into the segment. There is an undeveloped tract of land located in the immediate area on the right bank. A sample taken at the mouth of the submerged pipe had a bacteria value of 410 MPN/100 mL. The ambient sample collected upstream of the pipe had a bacteria value of 200 MPN/100 mL. This pipe is a low priority referral site for the proper local authority.

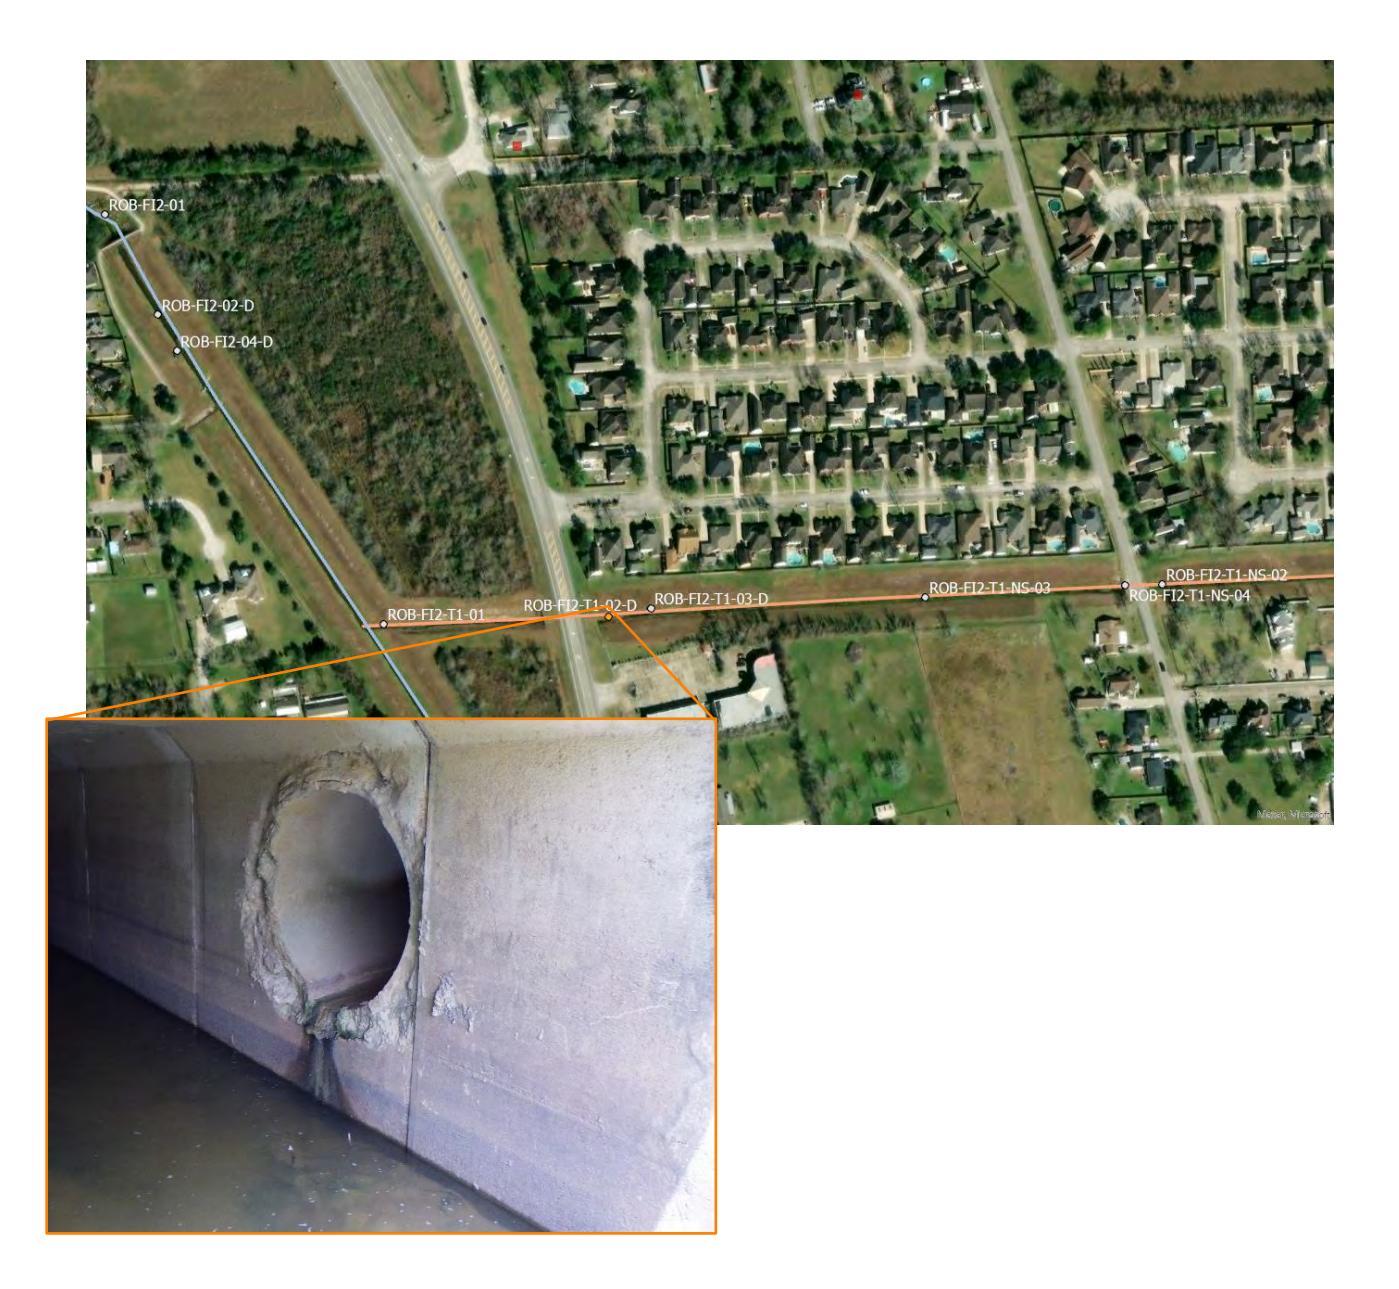
Referral site: ROB-FI2-T1-02-D- Low Priority

This is a 54 in. diameter cement pipe located under the 270 bridge, approximately 3 m from the upstream side of the bridge on the right bank of the Unnamed Tributary #1 to Robinson Bayou. Water within the pipe was 0.1 in. deep and trickling into the segment. There are single-family homes and a roadway located in the area on the right bank. A sample 0.5 m downstream of the pipe had a bacteria value of 310 MPN/100 mL. The ambient sample collected upstream of the pipe had a bacteria value of 200 MPN/100 mL. This pipe is a low priority referral site for the proper local authority.

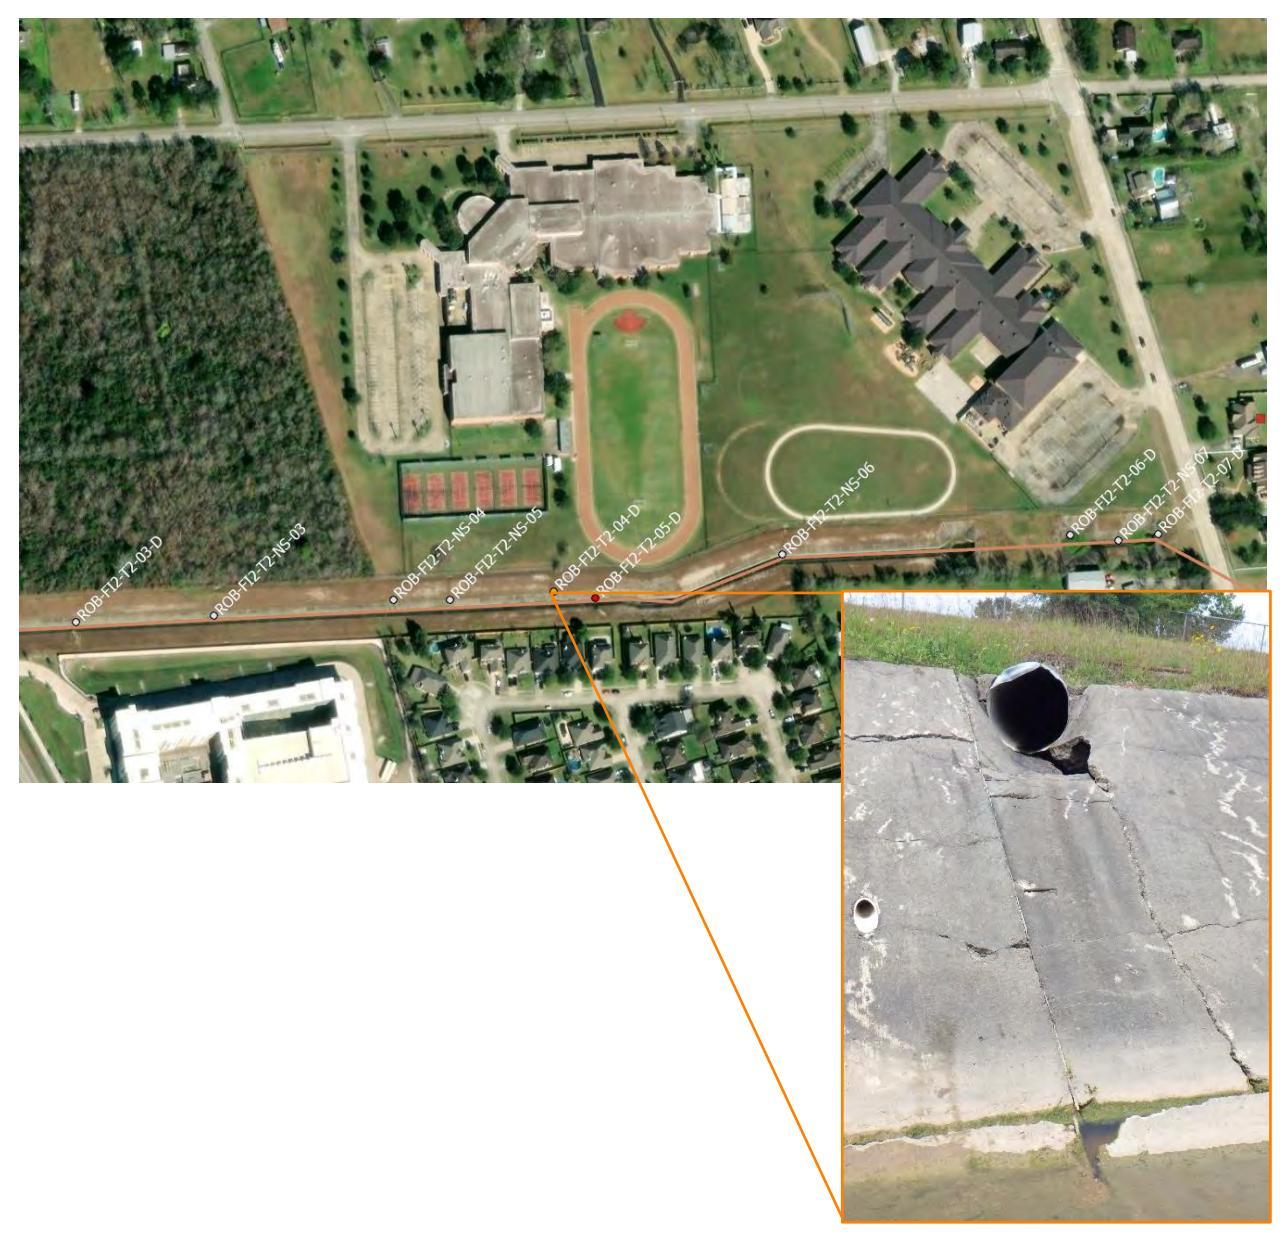
Referral site: ROB-FI2-T2-04-D- Low Priority

This is a 28 in. diameter metal pipe located on the right bank of the Unnamed Tributary #2 to Robinson Bayou. The cement apron around the pipe is broken and the sediment underneath is washed out creating a void where the water was flowing into. Water within the pipe was 0.5 in. deep and trickling behind the broken cement wall and then into the segment. League City Intermediate School is in the area on the right bank. A sample was taken where the water that is flowing behind the broken concrete meets the stream, approximately 3.5 m downstream of the pipe outfall and it had a bacteria value of 310 MPN/100 mL. The ambient sample collected upstream of the pipe had a bacteria value of 200 MPN/100 mL. This pipe is a low priority referral site for the proper local authority.

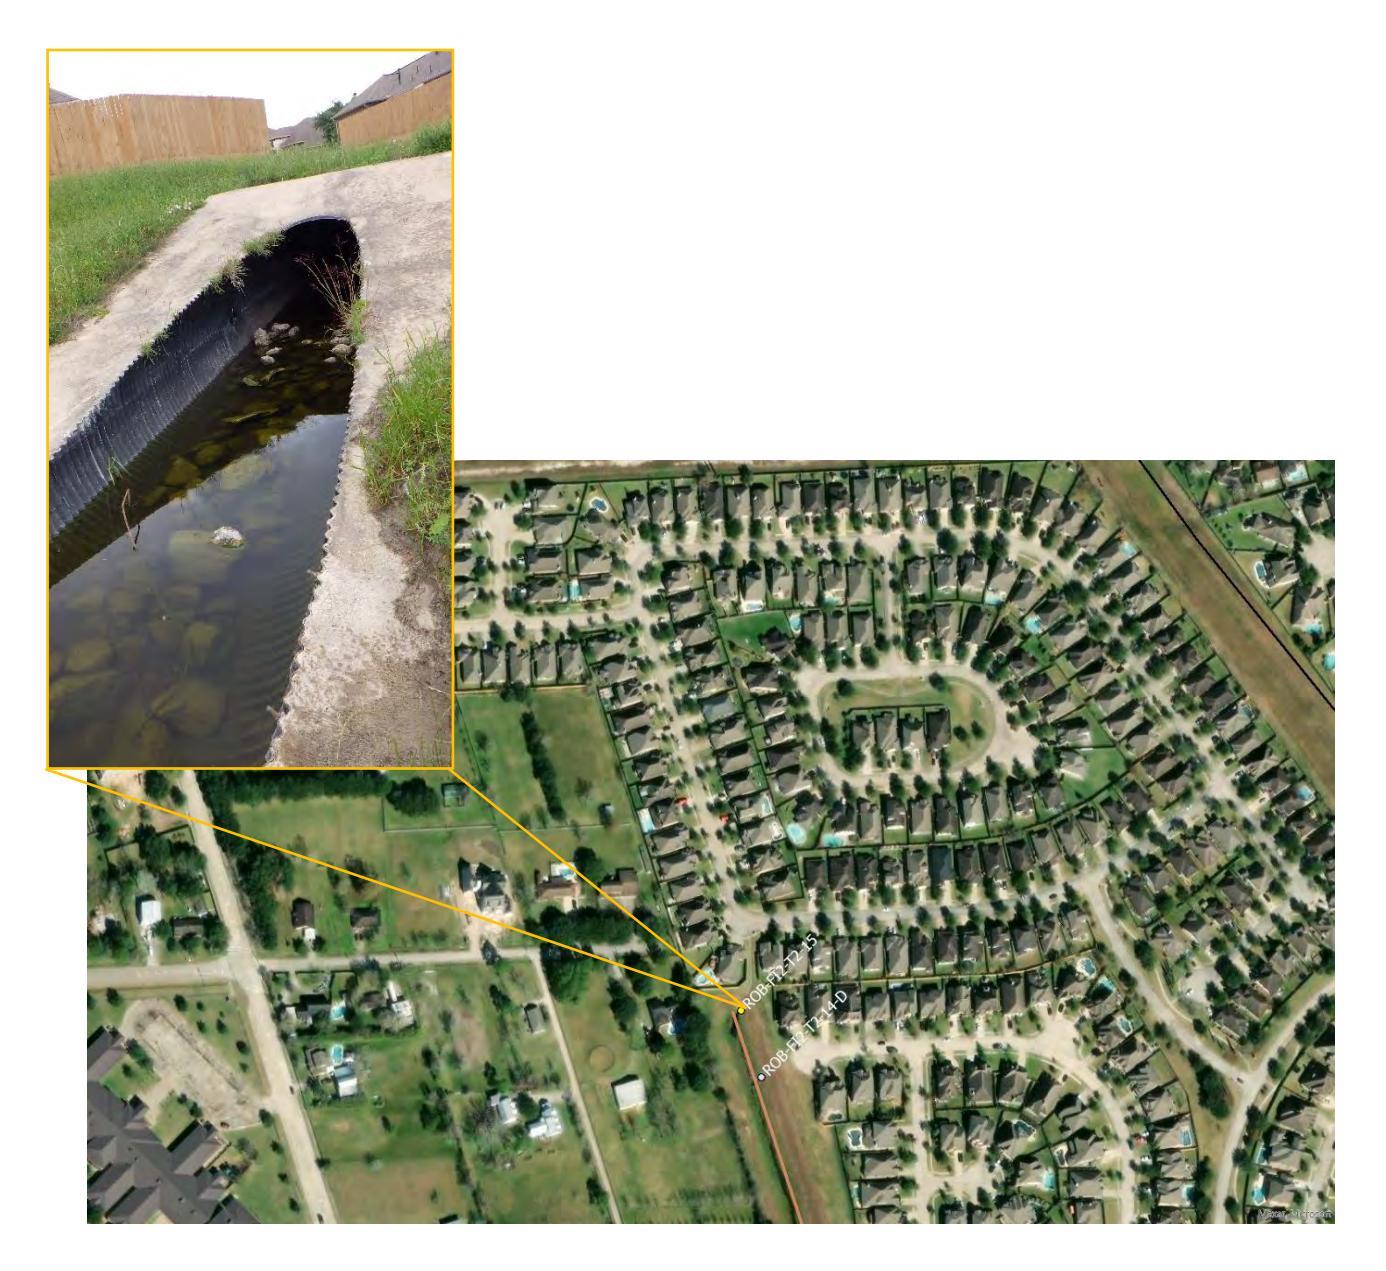
Referral site: ROB-FI2-T2-15 - Investigate Further

This was a single sample taken at the mouth of a partially submerged corrugated plastic-coated pipe at the most upstream portion of the Unnamed Tributary #2 to Robinson Bayou before the pipe goes underground. The ambient sample taken at the pipe had a bacteria value of 1,560 MPN/100 mL. Further investigation is recommended by the proper local authority to determine the source of elevated bacteria underground and upstream of the segment. There are single-family homes located upstream of the site.
