Targeted Bacteria Monitoring Project Executive Summary

Overview

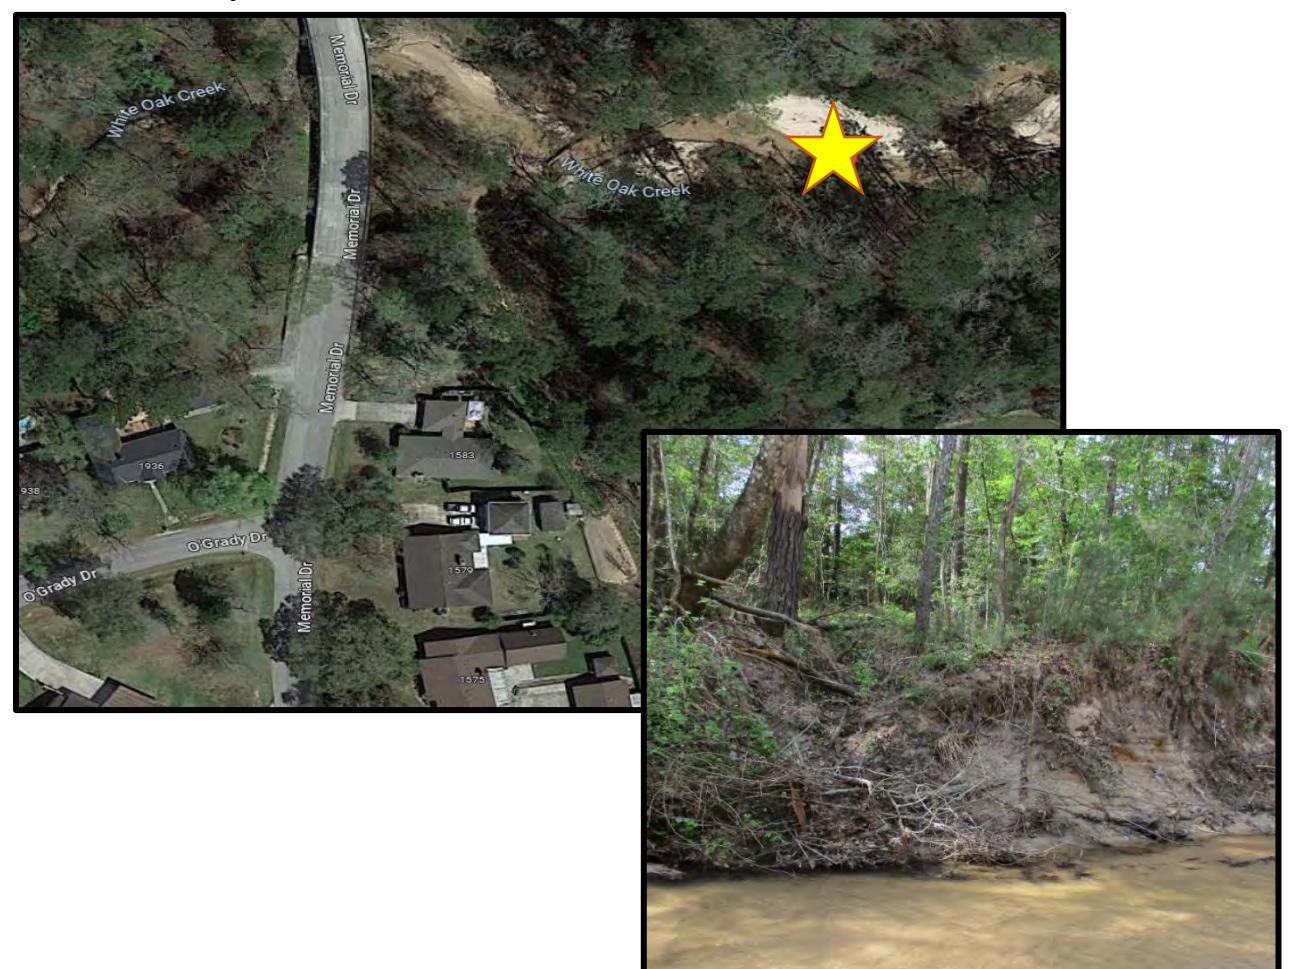
The first referral site is 23_WOC_FS_01 located in McDade Estates. It presented as a runoff along the left bank (Figure 3). It had noticeable bacteria input into the AU causing it to be listed as a referral site. The upstream sample was 310 MPN/100mL while the downstream sample was 740 MPN/100mL, showing a difference of 430 MPN/100mL.

Figure 3: Referral site 23_WOC_FS_01. Map with star showing referral site location. Subset image of Creekside view; yellow box outlines the runoff into AU.

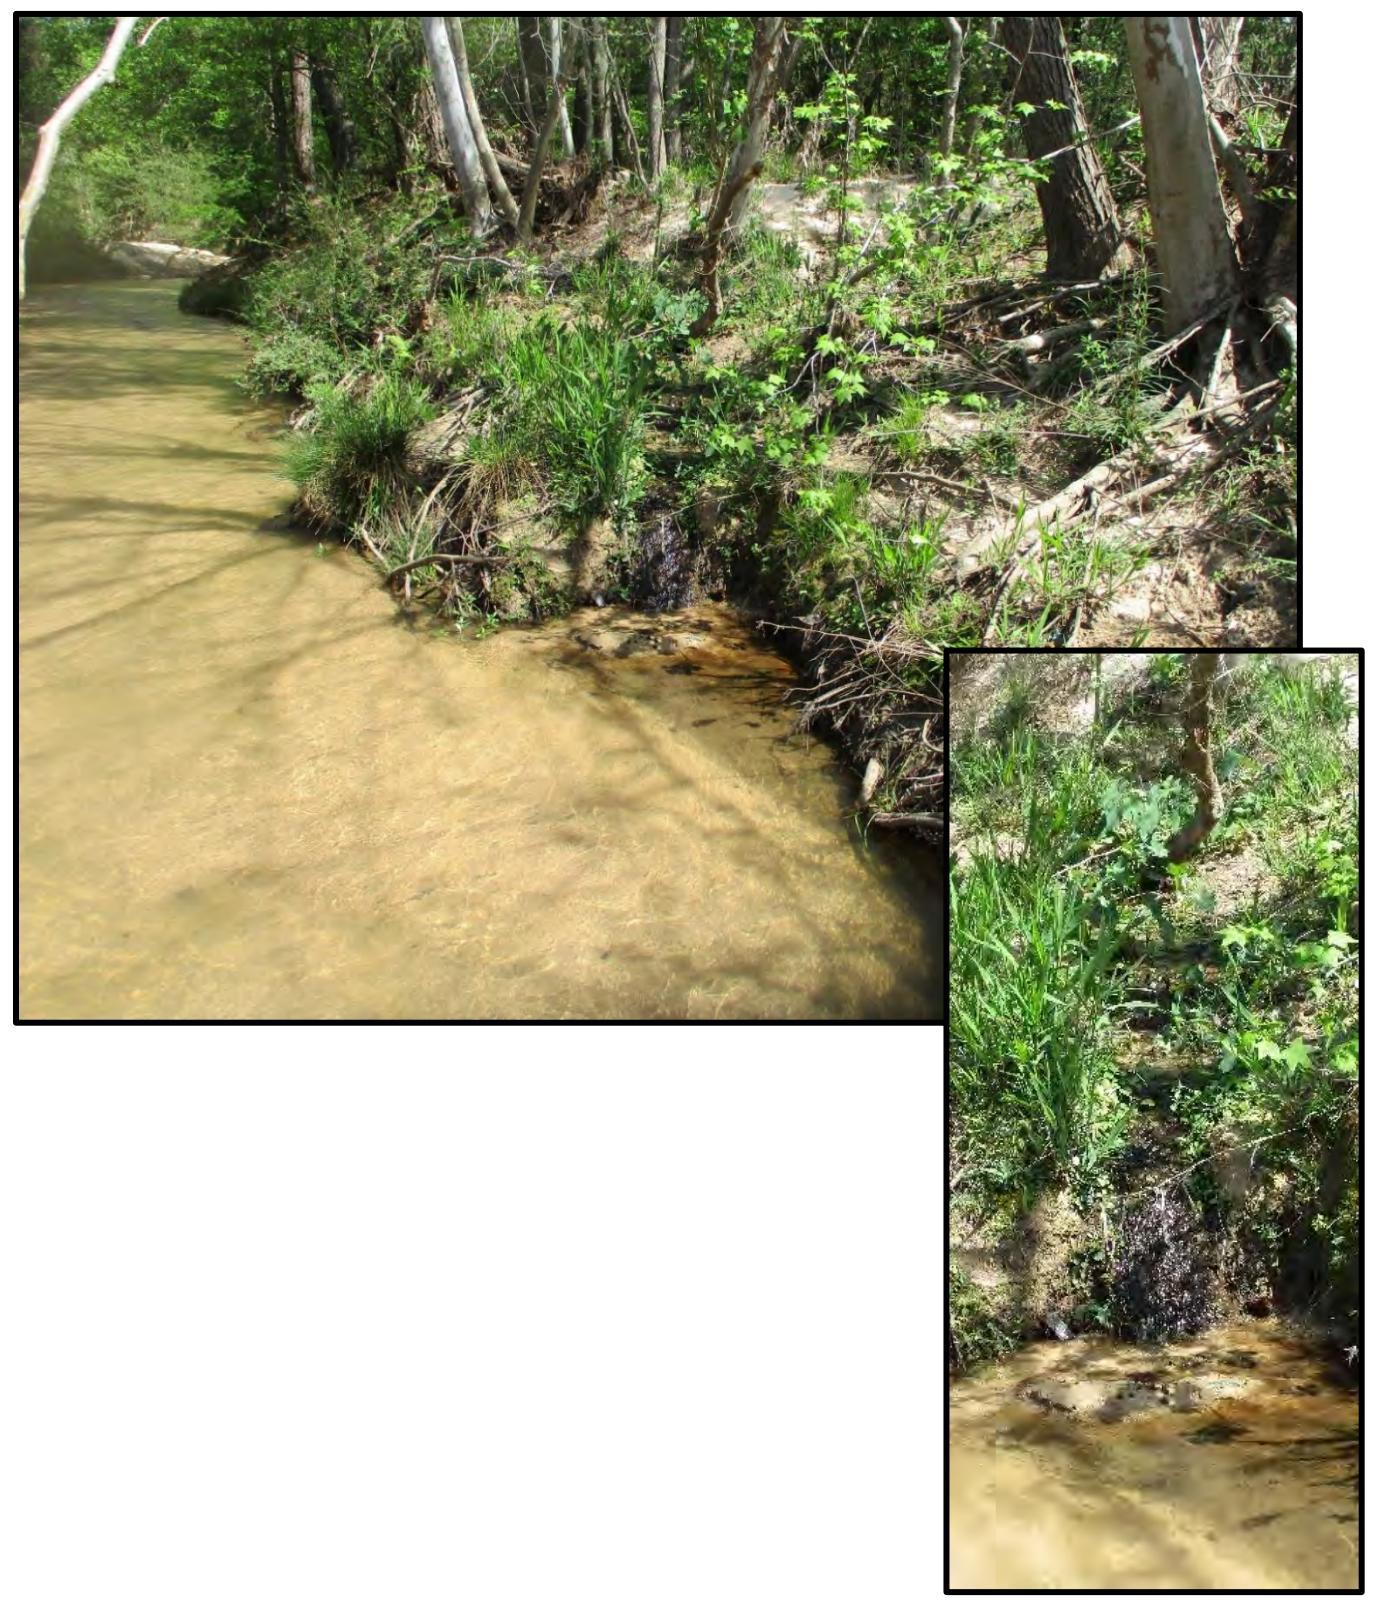
The second referral site is 23_WOC_FS_08 which was runoff associated with the Quick Quack car wash north of Highway 105 (Figure 4) on the left bank of WOC (Figure 5). It had a downstream reading of 1,920 MPN/100mL and upstream reading of 520 MPN/100mL showing a difference of 1,310 MPN/100mL.

Figure 5: Left-bank runoff and zoomed image.

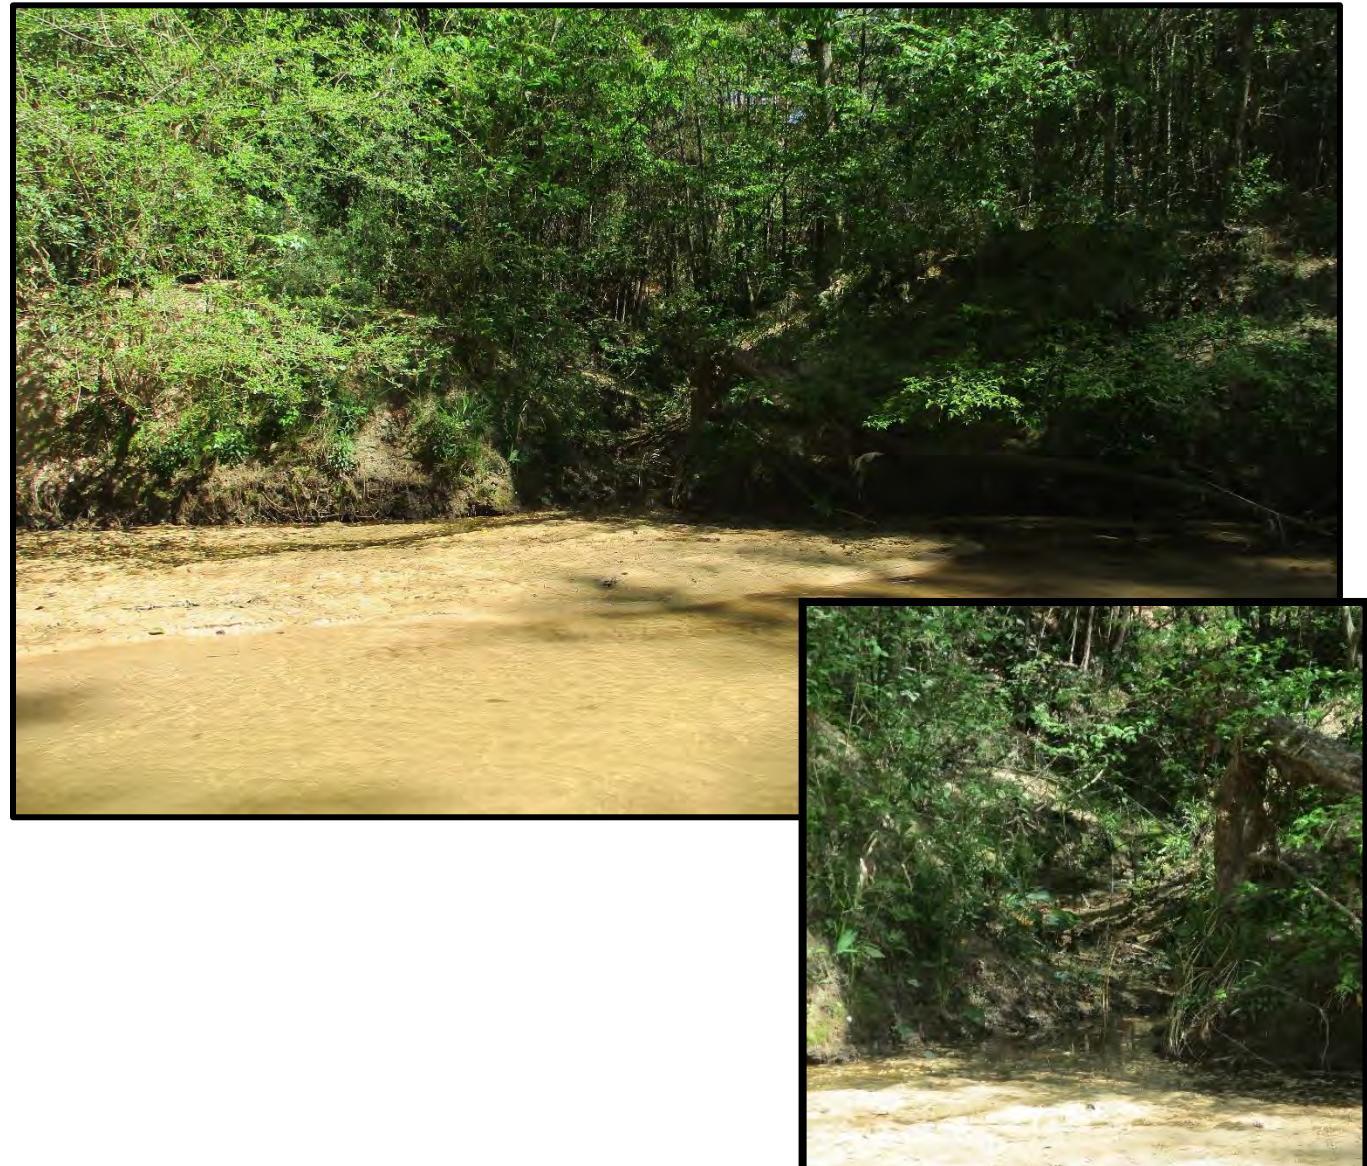
Referral site 23_WOC_FS_09 presented as runoff along the right bank of WOC (Figure 6) upstream of site 08 (Figure 4). The *E. coli* difference readings was 330 MPN/100mL between upstream (740 MPN/100mL) and downstream (1,090 MPN/100mL) samples. Given that both sites 08 and 09 presented as runoff and each were sampled both upstream and downstream of runoff input, it suggests both are contributing higher bacteria loads into the AU.

Figure 6: Referral site 23_WOC_FS_09. Right-bank runoff and zoomed image

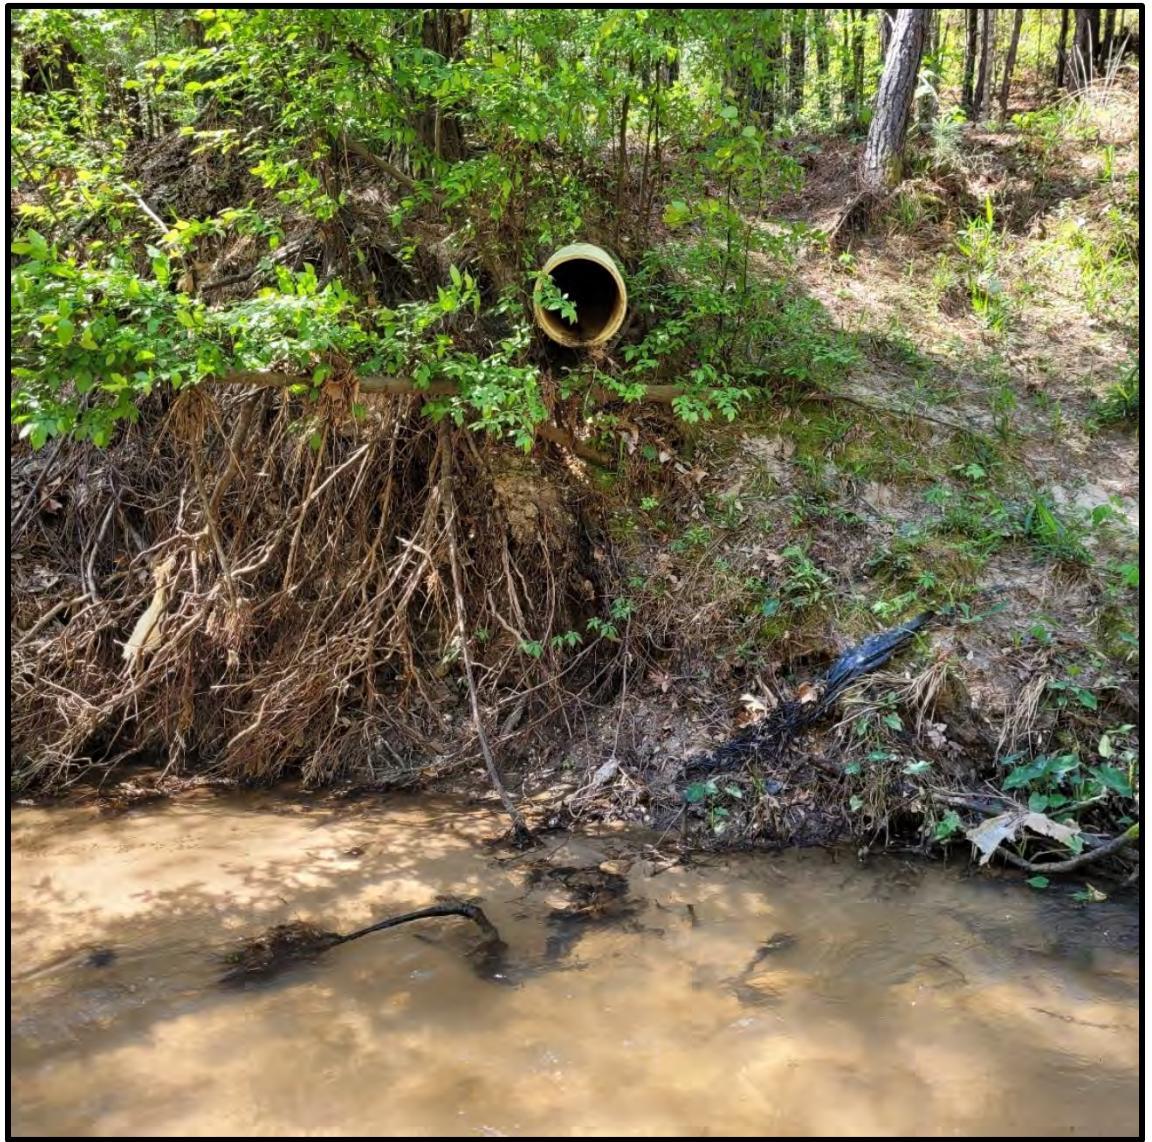
The referral site, 23_WOC_FS_11, occurred where a single pipe on the right bank had water dripping from it into the AU (Figure 7). The difference of upstream (200 MPN/100mL) and downstream (970 MPN/100mL) samples was 770 MPN/100mL. This sample location was close to other referral sites north of Highway 105 (Figure 4).

Figure 7: Referral site 23_WOC_FS_11. Pipe dripping into AU.

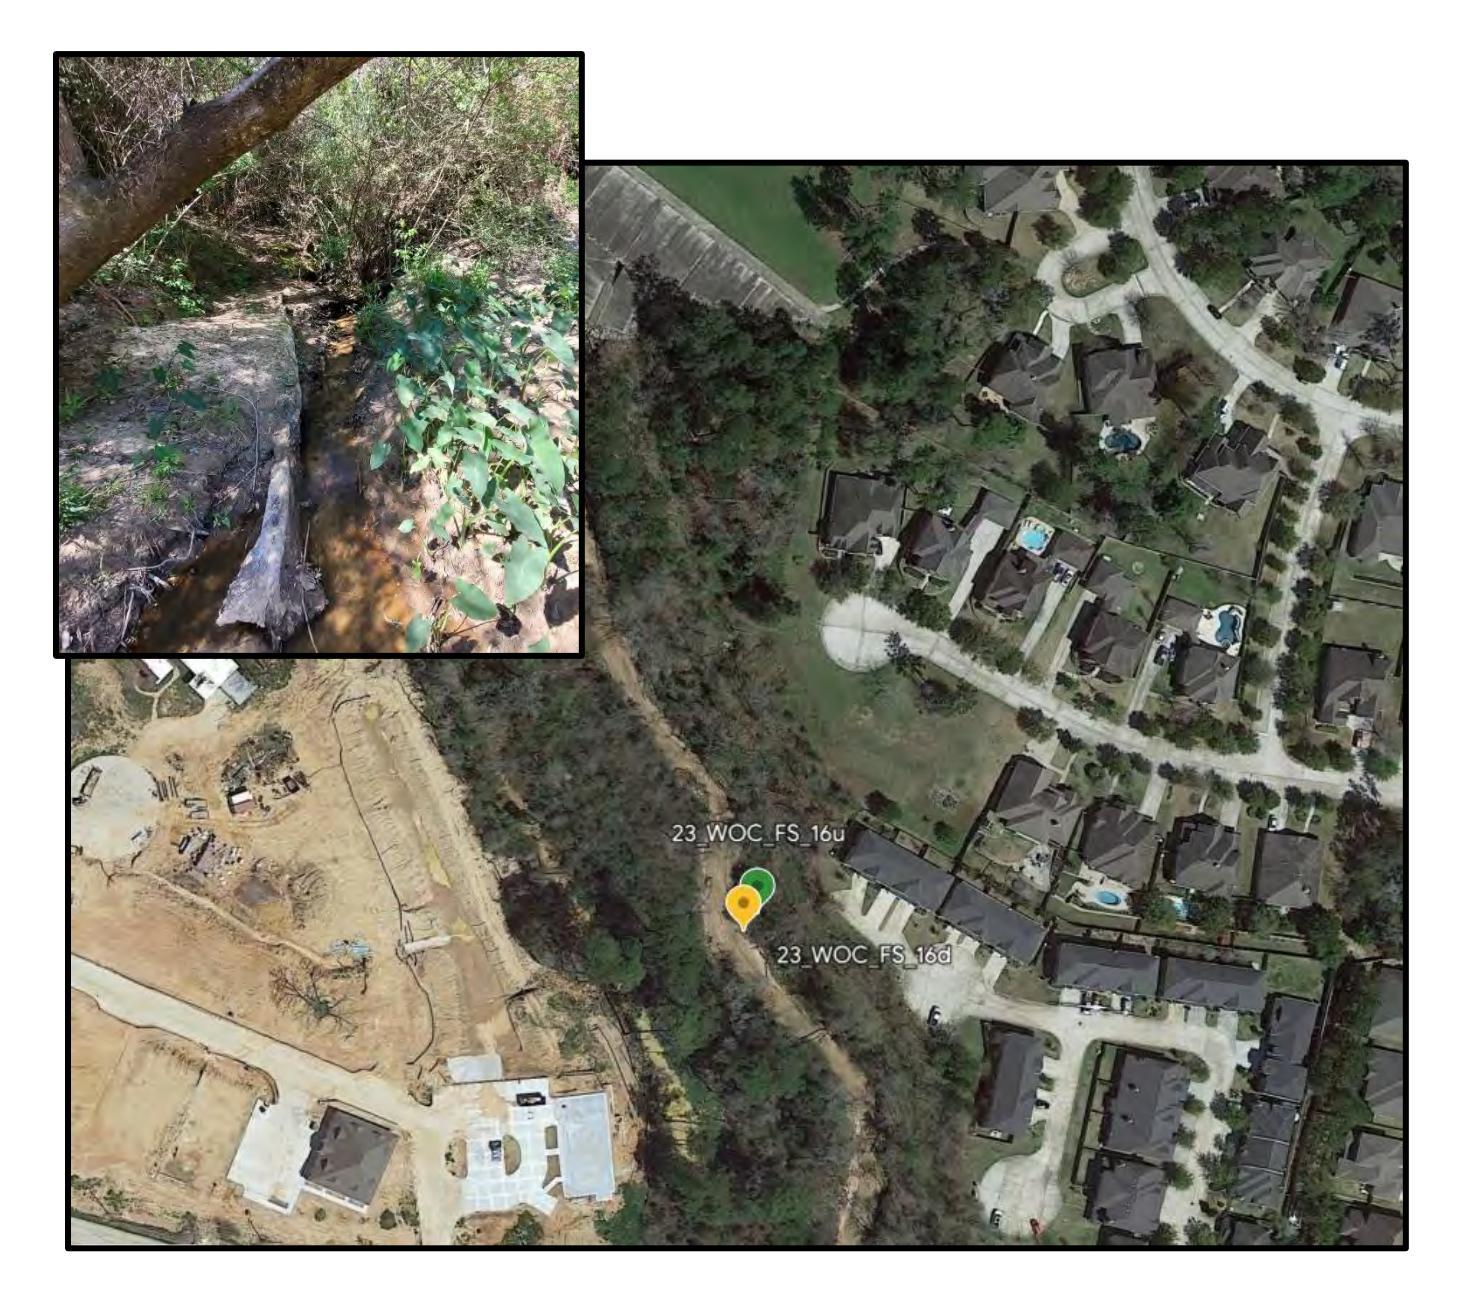
The referral site, 23_WOC_FS_016, was a small tributary of unknown origin that showed to influence the *E. coli* levels within the AU by having a difference of 530 MPN/100mL between upstream (100 MPN/100mL) and downstream (630 MPN/100mL) samples. Construction was not visible from the AU during the FI (Figure 8), but the tributary had a significantly cut path (Figure 9) through the sediment suggesting this tributary precedes any construction in the area.

Figures 8 and 9: Referral site 23_WOC_FS_16. Right-bank tributary.

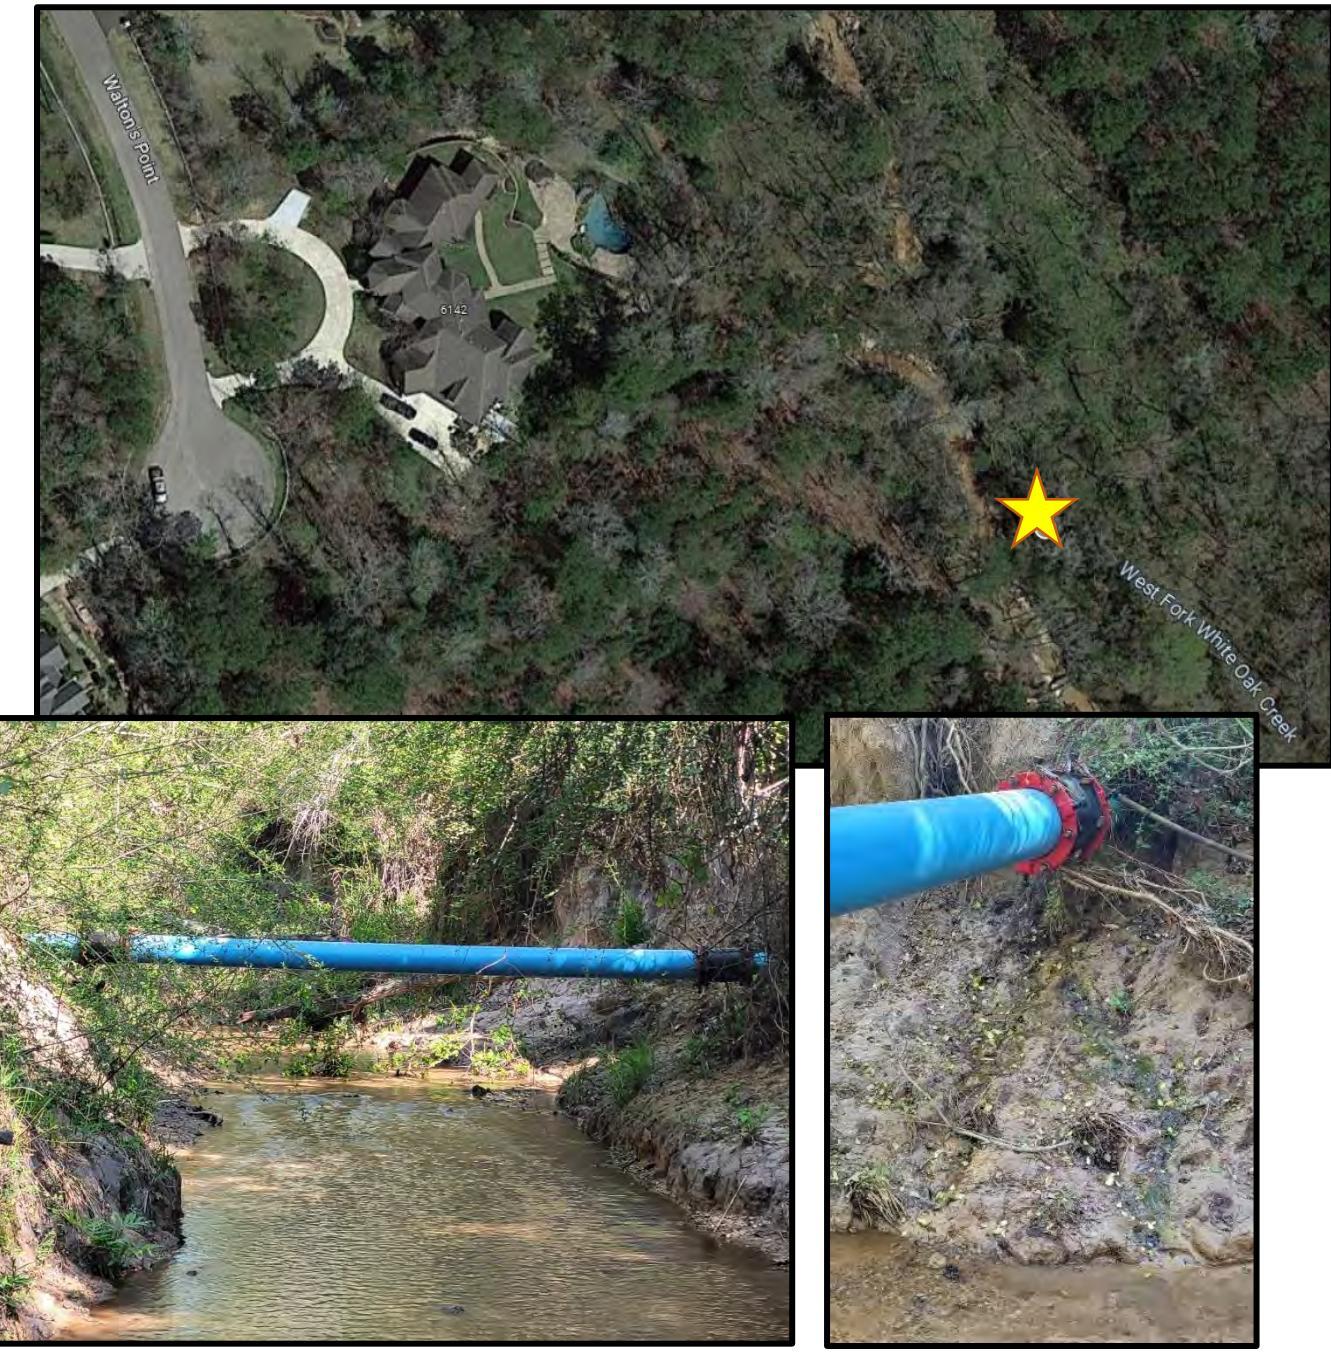
The referral site, Site 25, was a blue, 12-inch water pipe crossing the stream. Upon inspection, the field crew noticed it was dripping into the AU (Figures 11 & 12). This referral site was almost 350 meters upstream of the confluence of East and West Forks of White Oak Creek. The pipe crosses the stream south of the cul-de-sac street Walton's Point (Figure 10) in the neighborhood west of the AU. The difference of upstream (100 MPN/100mL) and downstream (520 MPN/100mL) samples at site 25 was 420 MPN/100mL suggesting the dripping water from the pipe is influencing the bacterial levels.

Figures 10, 11, 12: Referral site 23_WOC_FS_25. Map with star demonstrates sample and habitat location. Water transport pipe crossing AU; zoomed image of drippage.

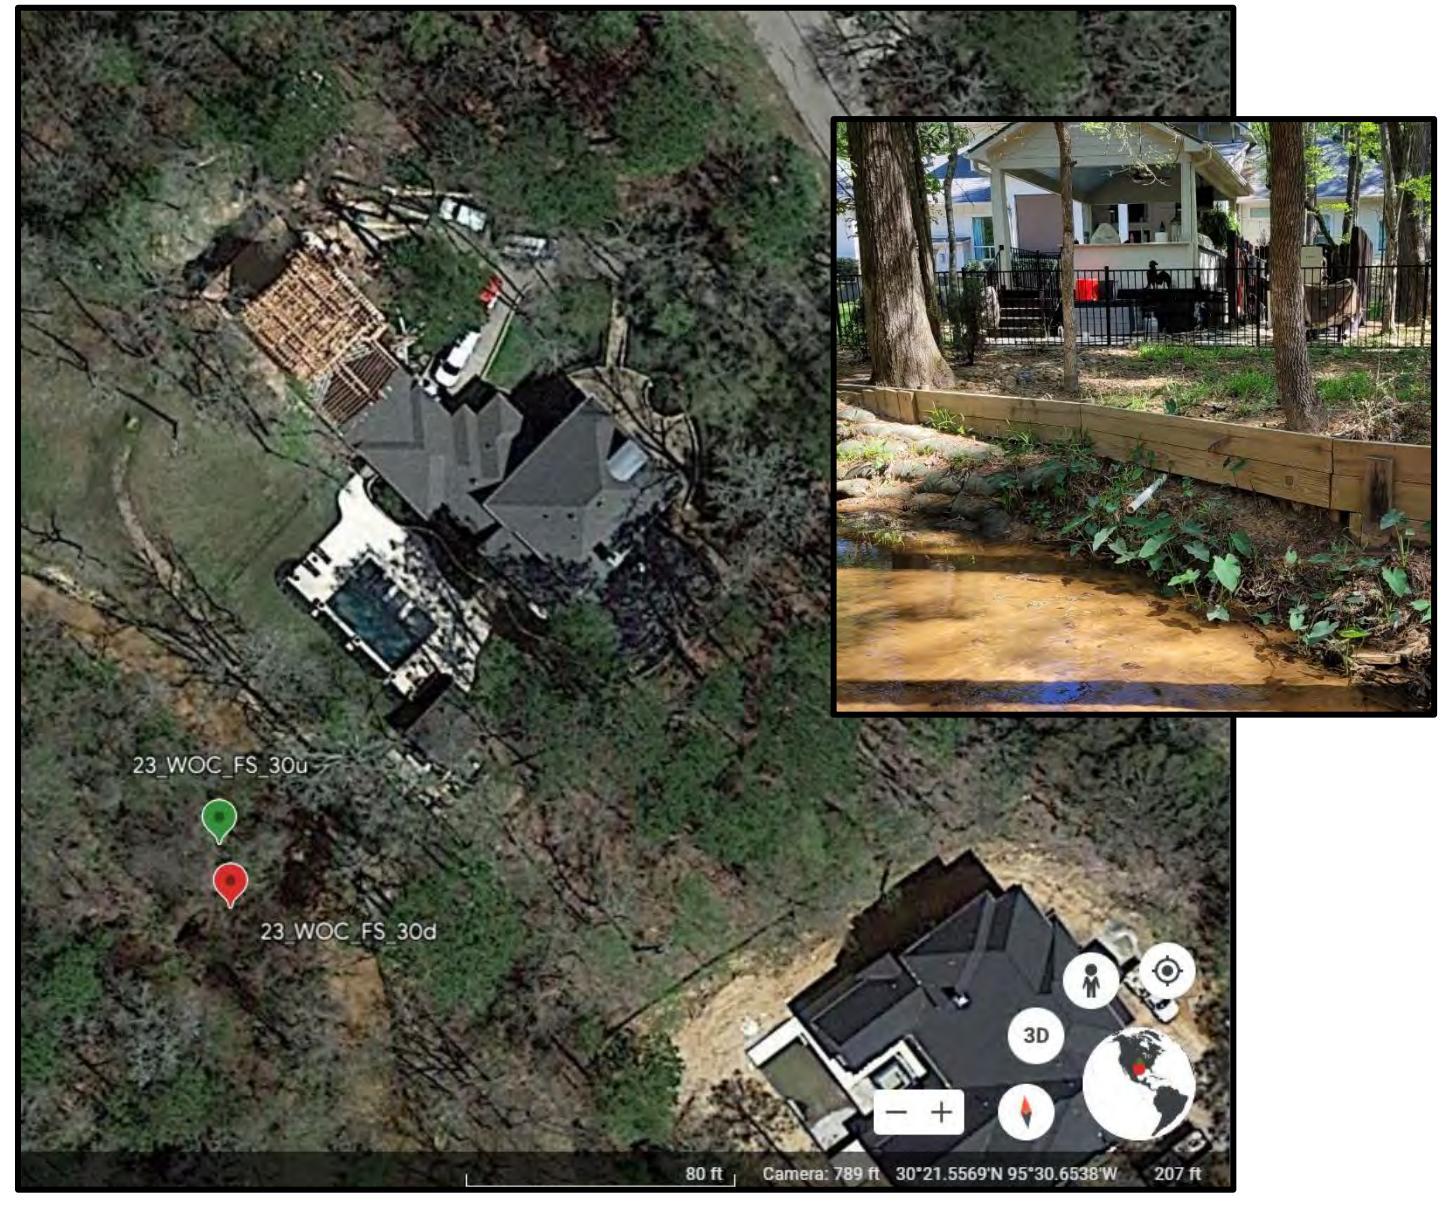
Site 23_WOC_FS_30 was sampled along the left bank of the West Fork of White Oak Creek in a fully residential area called Teaswood (Figure 13). A residence had a PVC outfall present, extending from under a bulkhead on the creek. Sampling occurred within 1 foot upstream and downstream of the pipe (Figure 14). The upstream sample was 410 MPN/100mL while the downstream sample was 2,110 MPN/100mL. This location was the highest bacteria reading of the whole FI. Retention ponds to the west of White Oak Creek (Figure 15) seemed to have little input on the West Fork of White Oak Creek during the Field Investigation.

Figure 13 and 14: Referral site 23_WOC_FS_30. Google Earth image of site and residence. Field-level picture of pipe from Teaswood residence dripping into AU.

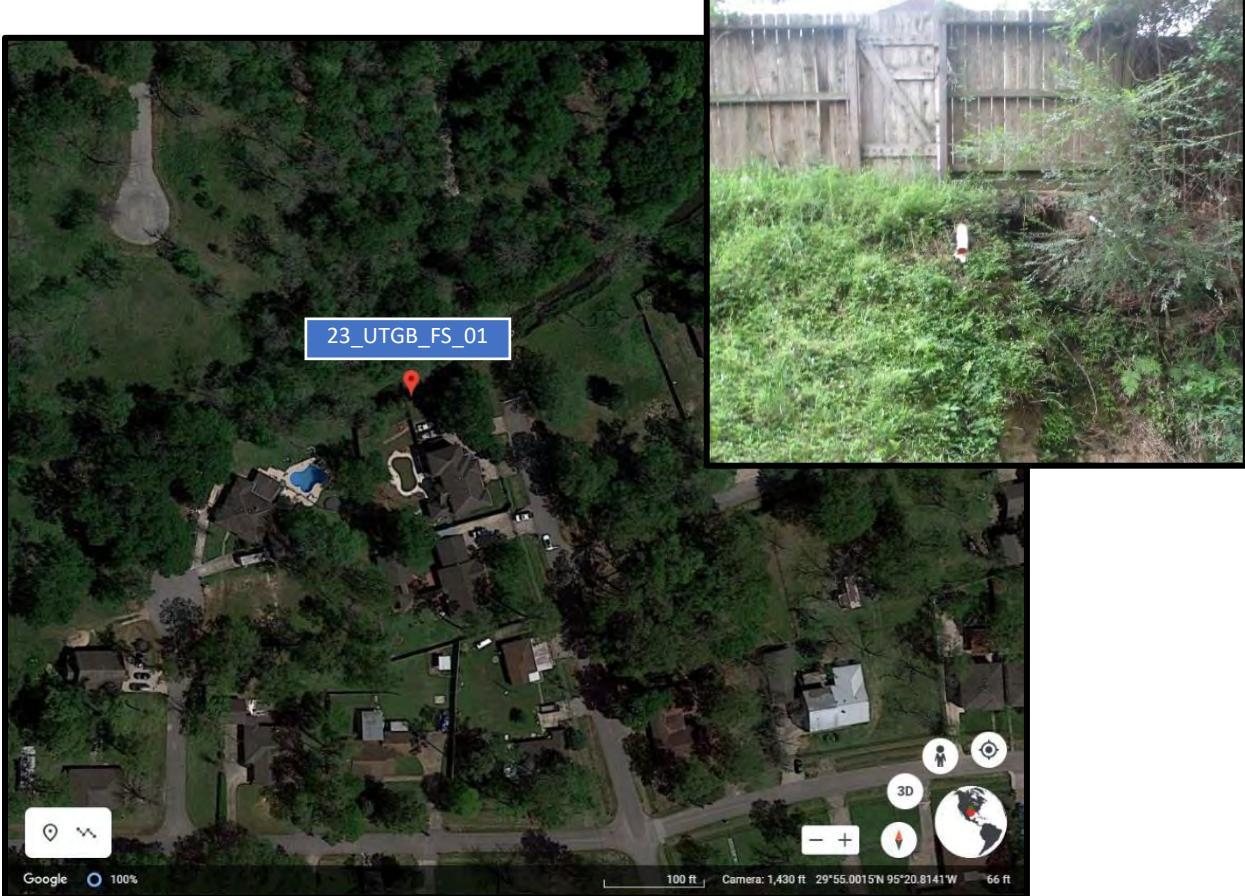
Referral site 23_UTGB_FS_01 was at a pipe that was discharging into the AU. The upstream sample was 2,960 MPN/100mL while the downstream sample was 7,980 MPN/100mL, showing a difference of 5,290 MPN/100mL. Based on aerial maps, it appears there are pools present at the property where the pipe was located.

Figure 3: Referral site 23_UTGB_FS_01. Map showing location of sampling and inset photo of Creekside view.

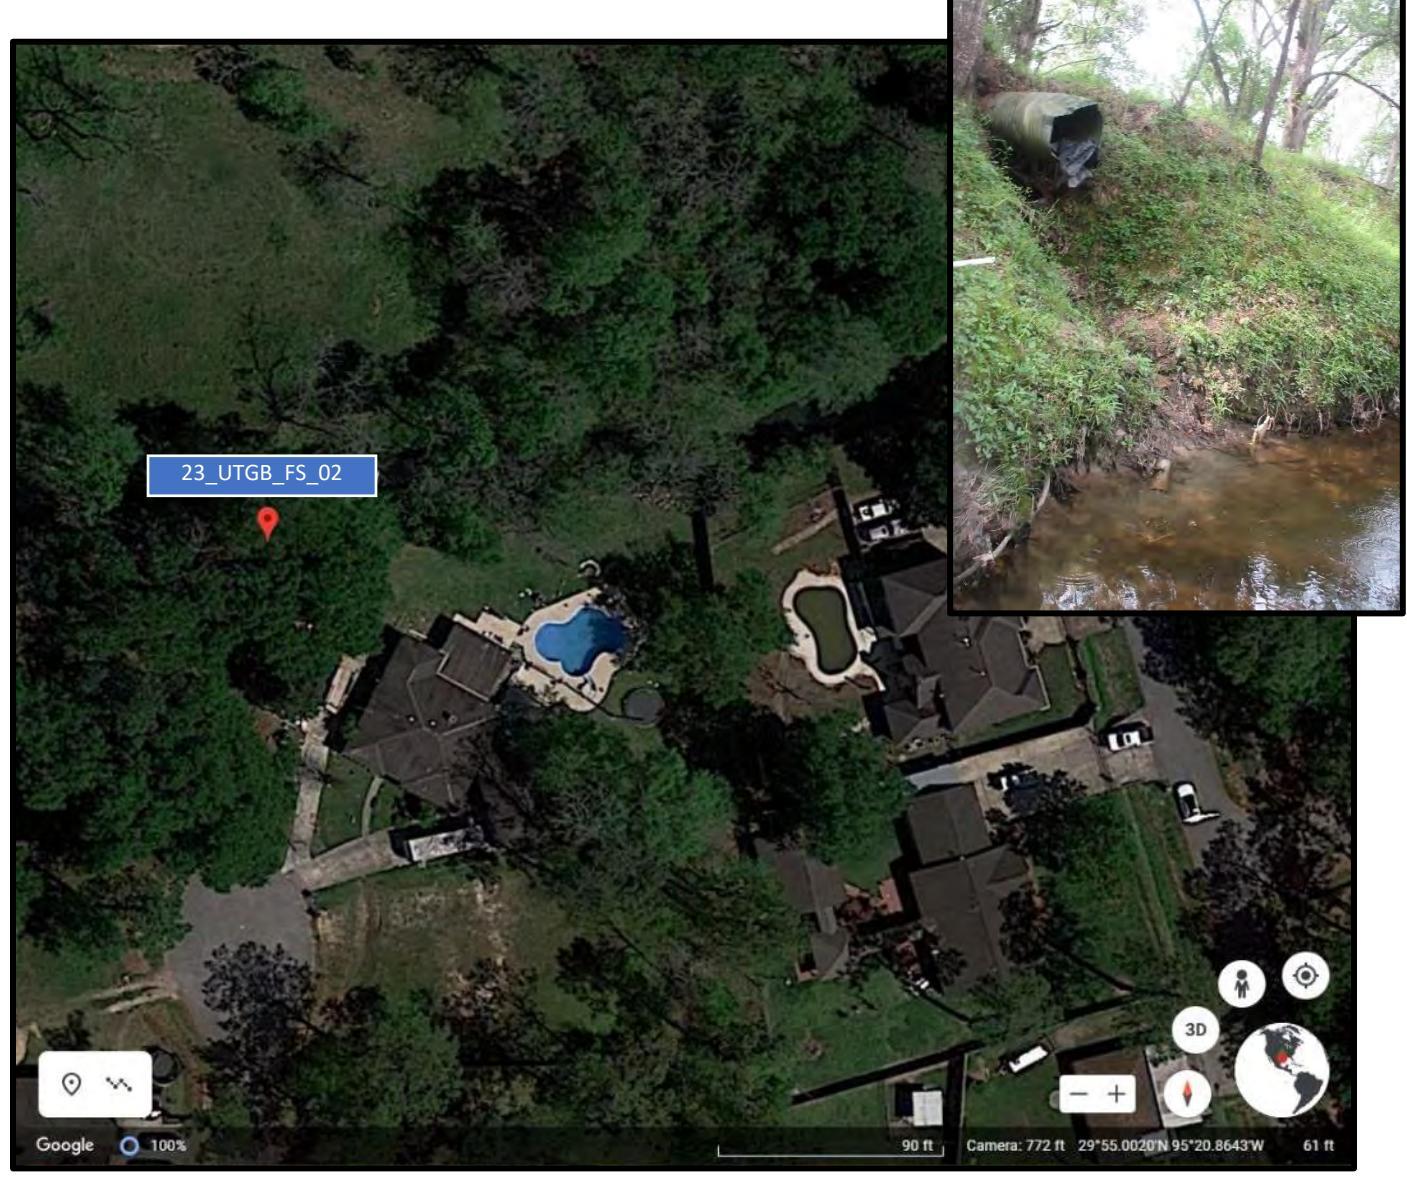
REFERRAL SITE: 23_UTGB_FS_02

Referral site 23_UTGB_FS_02 occurred at the neighboring property from site 01, where a pipe was discharging into the AU (Figure 4). The upstream sample was 1,730 MPN/100mL while the downstream sample was 5,560 MPN/100mL, showing a difference of 3,830 MPN/100mL. This property also has a pool present.

Figure 4: Referral site 23_UTGB_FS_02. Map showing location of sampling and inset photo of Creekside view.

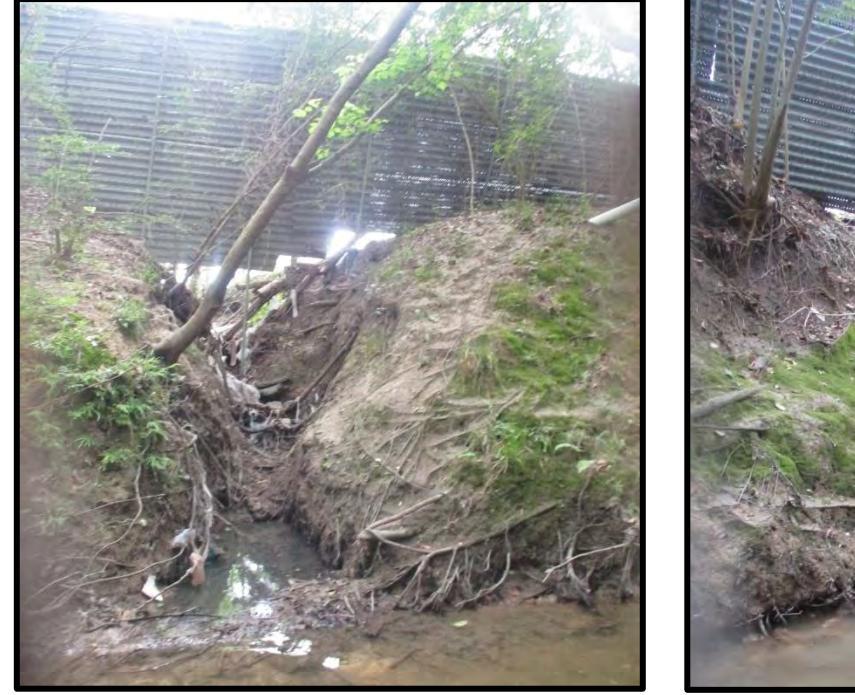
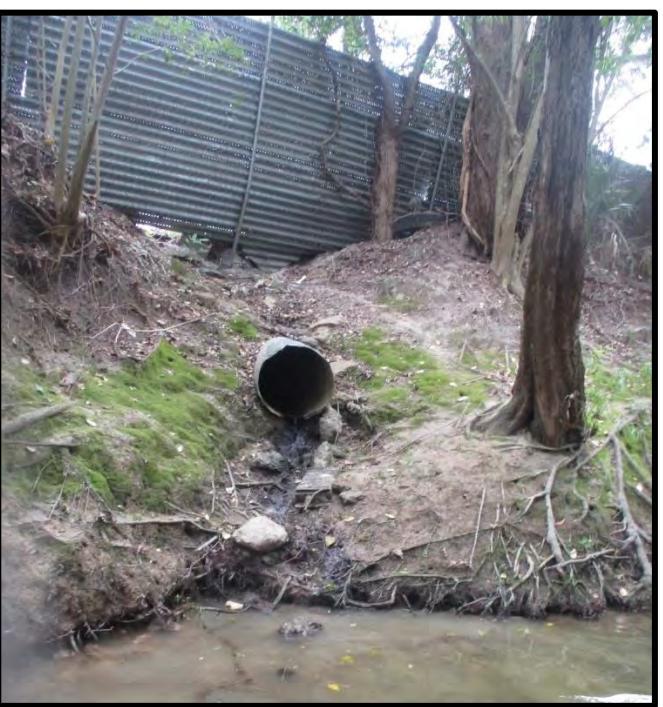
REFERRAL SITE: 23_UTGB_FS_03 and 23_UTGB_FS_04

Both sites were along the same property; therefore, are grouped together (Figure 7). Referral site 23_UTGB_FS_03 and 23_UTGB_FS_04 were sampled for observed discharge into the AU. Site 03 (Figure 5) had no piping while site 04 (Figure 6) did. For Site 03, the upstream sample was 530 MPN/100mL while the downstream sample was 5,540 MPN/100mL, showing a difference of 5,010 MPN/100mL. For site 04, the upstream sample was 5,560 MPN/100mL while the downstream sample was 6,310 MPN/100mL, showing a difference of 750 MPN/100mL.

Figures 5 & 6: Referral site 23_UTGB_FS_03, right-bank runoff. Site 23_UTGB_FS_04, pipe on right-bank.

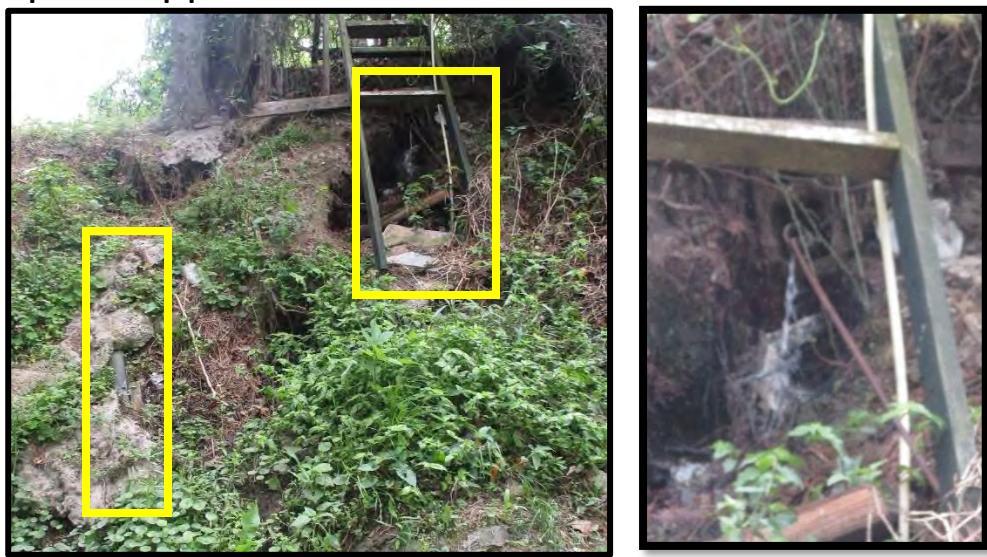
Referral site 23_UTGB_FS_13 was a flowing pipe emanating from a property (Figure 10). This site had two drainage pipes present that were both flowing into the AU (Figure 9). Samples were taken upstream of the nearest pipe and downstream of the farthest pipe. The upstream sample was 730 MPN/100mL and downstream was >242,000 MPN/100mL, showing a difference exceeding 242,000 MPN/100mL. Aerial maps show commercial use of properties (Figure 11).

Figures 9 and 10: Referral site 23_UTGB_FS_13, yellow boxes highlighting the output pipes. Zoomed in photos of pipe.

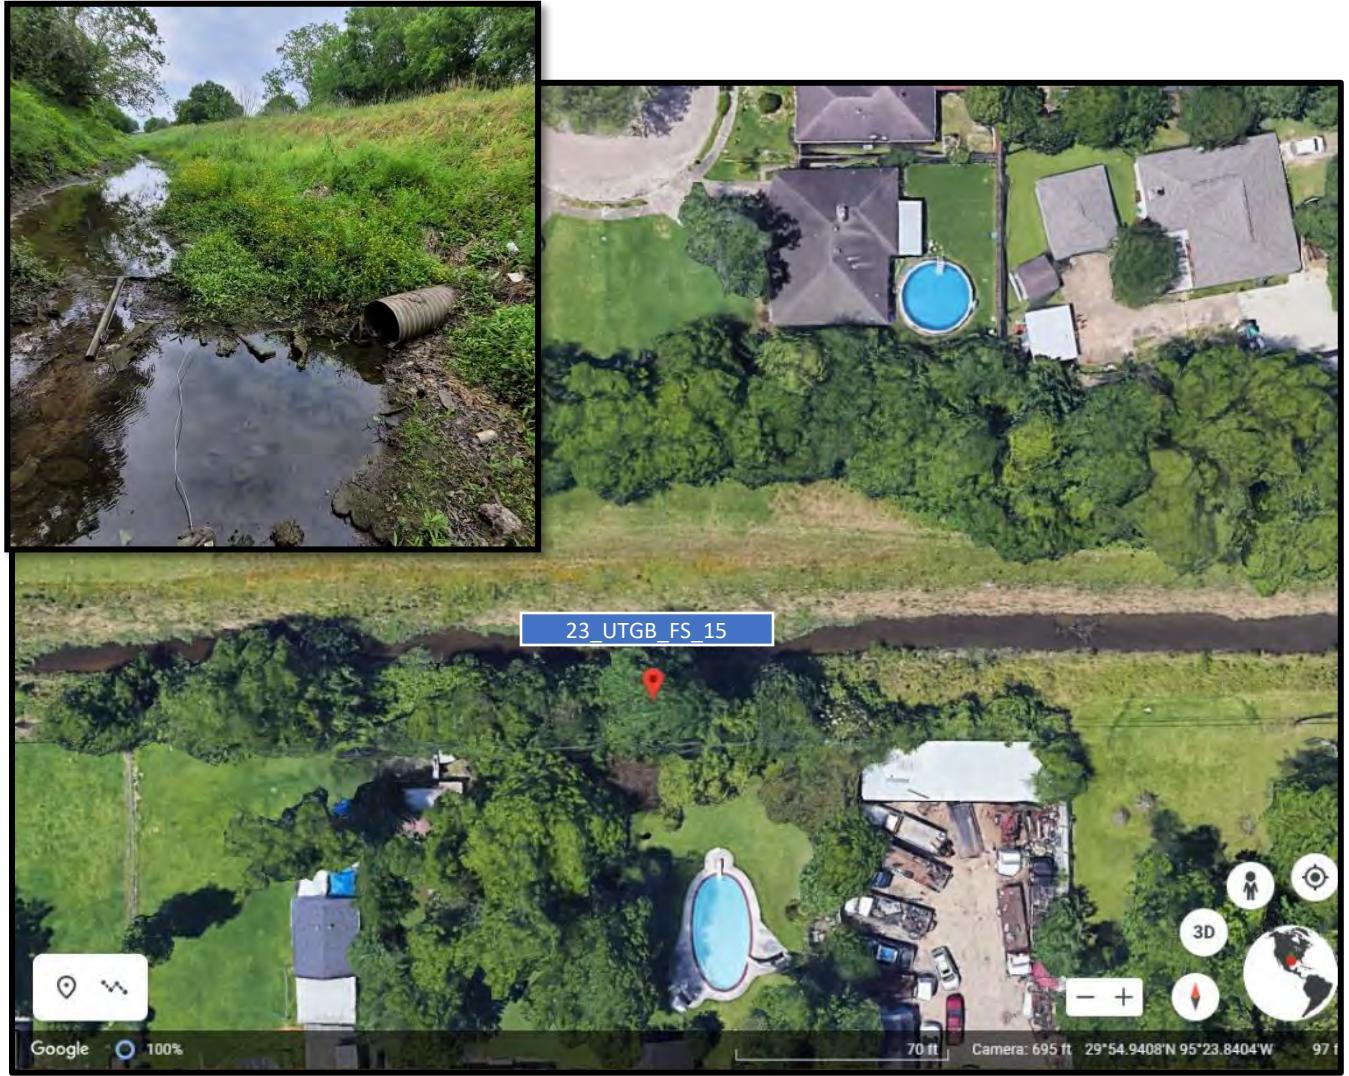
Referral site 23_UTGB_FS_15 is a pipe situated on the left bank of the AU (Figure 12). The upstream sample was 2,850 MPN/100mL and downstream was 5,290 MPN/100mL, showing a difference of 2,440 MPN/100mL. Given that aerial maps indicate there is a development north of the AU, this could be storm sewer systems (Figure 12).

Figure 12: Referral site 23_UTGB_FS_15. Aerial map of sampling site and inset photo of Creekside view.

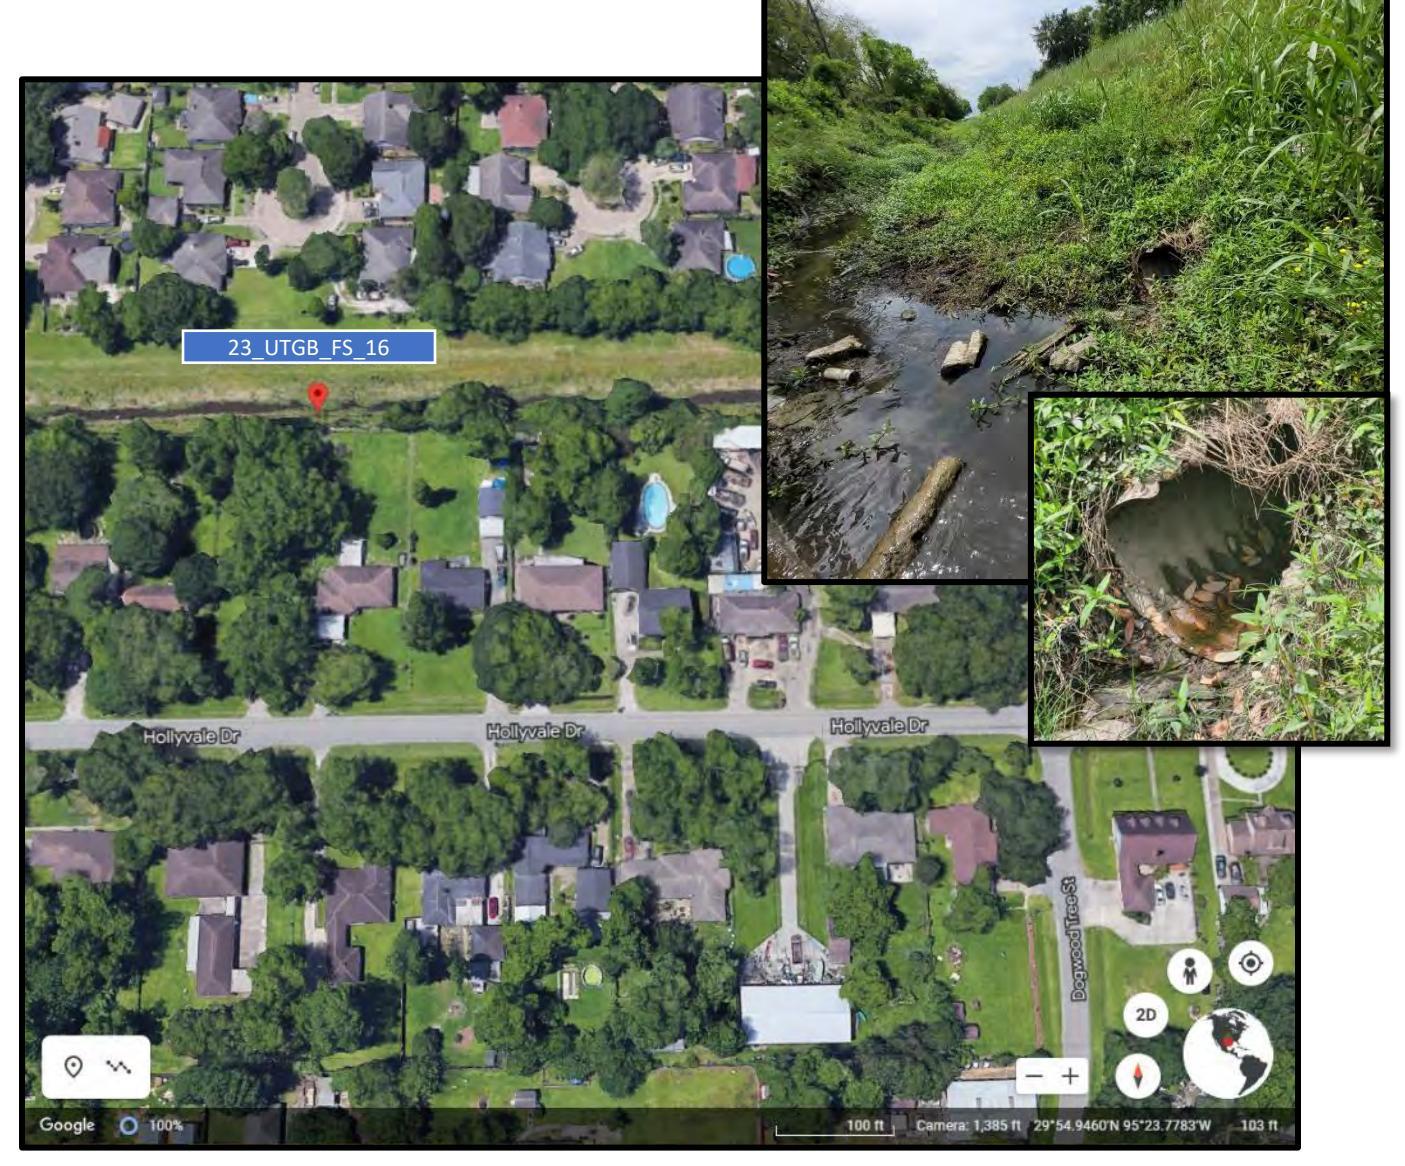
Referral site 23_UTGB_FS_16 is a pipe situated on the left bank of the AU (Figure 14). The upstream sample was 3,150 MPN/100mL and downstream was 5,810 MPN/100mL, showing a difference of 2,660 MPN/100mL. Given that aerial maps indicate there is a development north of the AU, this could be storm sewer systems (Figure 13).

Figures 13 and 14: Referral site 23_UTGB_FS_16 aerial map (Fig. 11). Pipe on left bank of AU with zoomed inset photo of water output (Fig. 12)

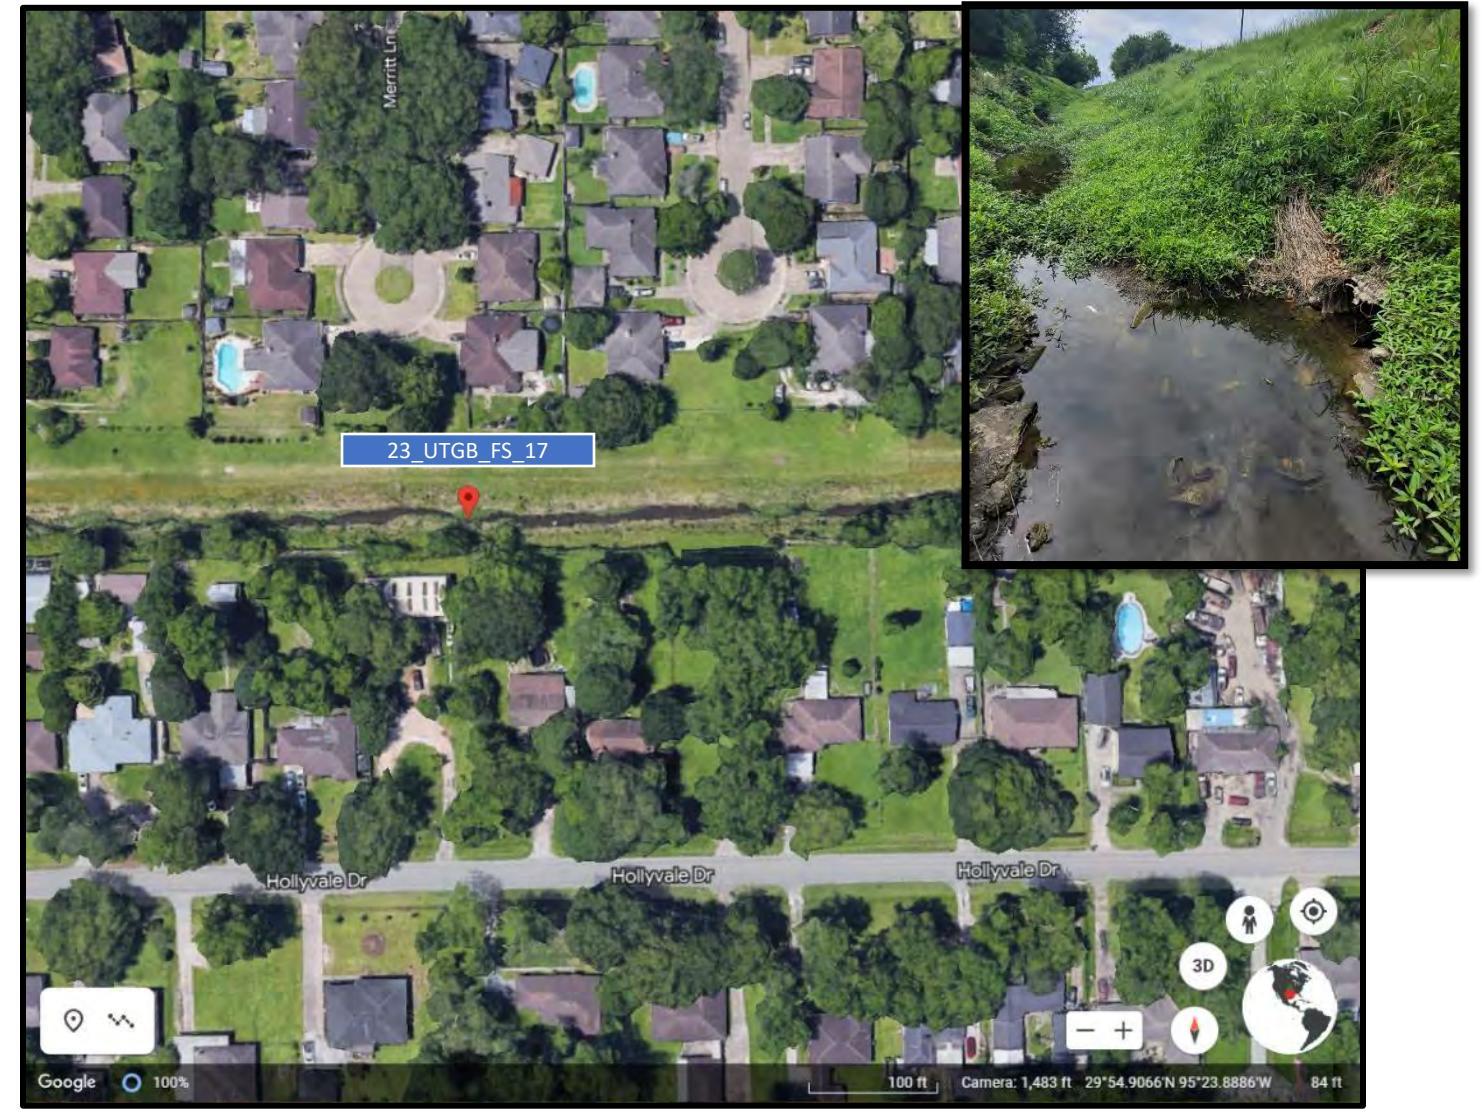
Referral site 23_UTGB_FS_17 is also a pipe on the left-bank in a residential area (Figure 15). The upstream sample was 16,640 MPN/100mL and downstream was 8,860 MPN/100mL, showing a difference of -7,780 MPN/100mL. This site is listed because there was significant input between sites 16 (5,810 MPN/100mL) and 17 (16,640 MPN/100mL) that was not viewed by the field crew. Given that aerial maps indicate there is a development north of the AU, this could be storm sewer systems (Figure 16).

Figures 15 and 16: Referral site 23_UTGB_FS_17. Aerial map (13) and Creekside sample site (14)
