Targeted Bacteria Monitoring Project Executive Summary

Overview

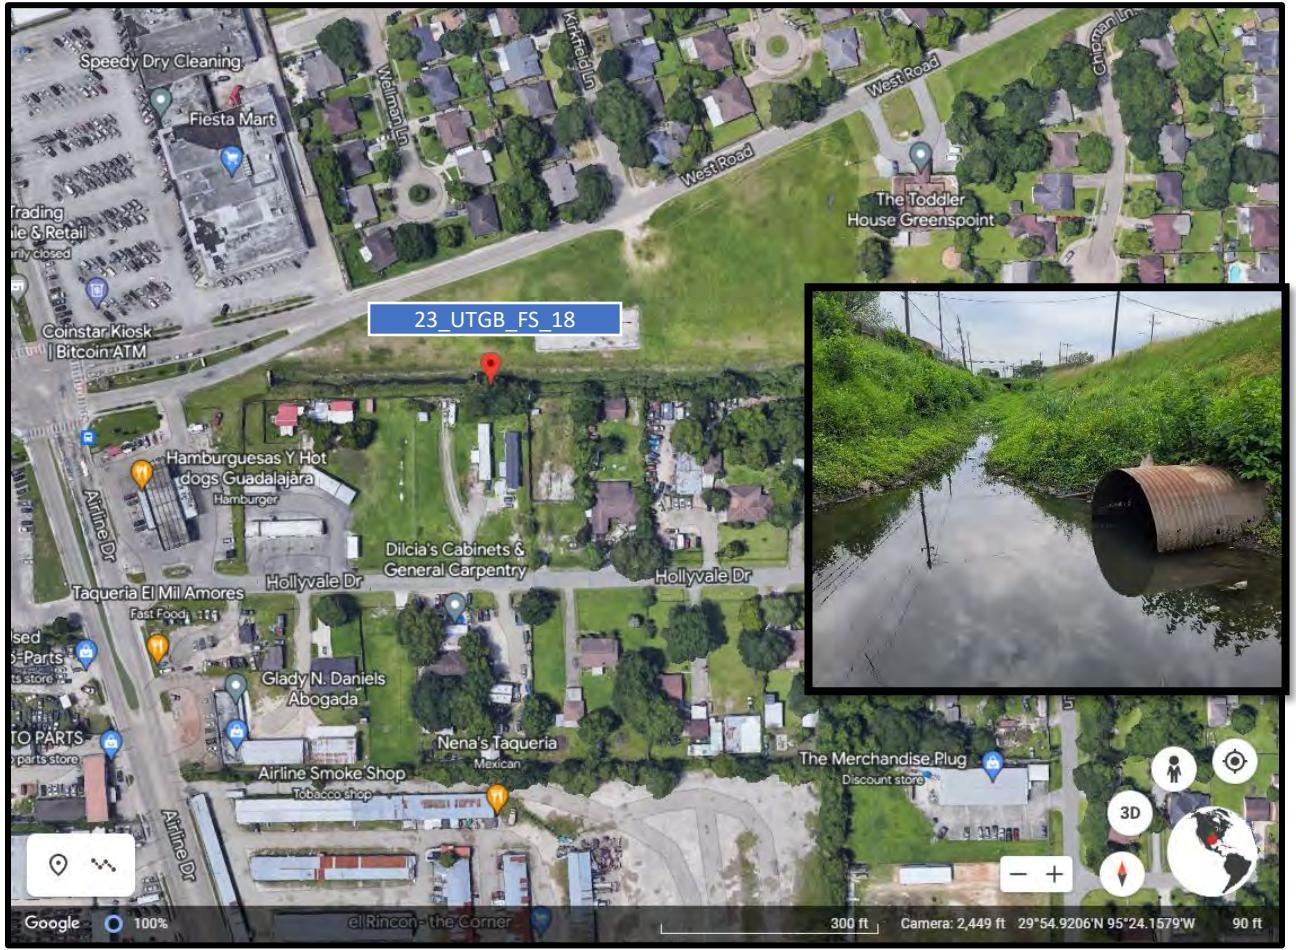
Referral site 23_UTGB_FS_18 is a pipe on the left-bank of the AU (Figure 18). This site is approaching the West Rd and Airline intersections so there is increasing industrial and commercial outputs in the area (Figure 17). The upstream sample was 198,630 MPN/100mL and downstream was 16,640 MPN/100mL, showing a difference of -181,900 MPN/100mL. The lowered *E. coli* is a welcomed reprieve; however, this site is mentioned for referral because of the extremely high *E. coli* measured for the upstream sample (198,630 MPN/100mL). Only one other pipe was noted between site 17 and site 18.

A corroded pipe of the same make and size as those listed in sites 16, 17 and 18 was observed upstream of site 18. Given that it appeared closed, the field crew did not sample there. However, the extremely high *E. coli* load for the upstream sample at site 18 warrants the disclosure of the coordinates for the corroded pipe: 29,915432, -95.402111.

Figures 17 and 18: Referral site 23_UTGB_FS_18. Aerial map of sample site (Figure 17) and Creekside view of sample site (Figure 18).

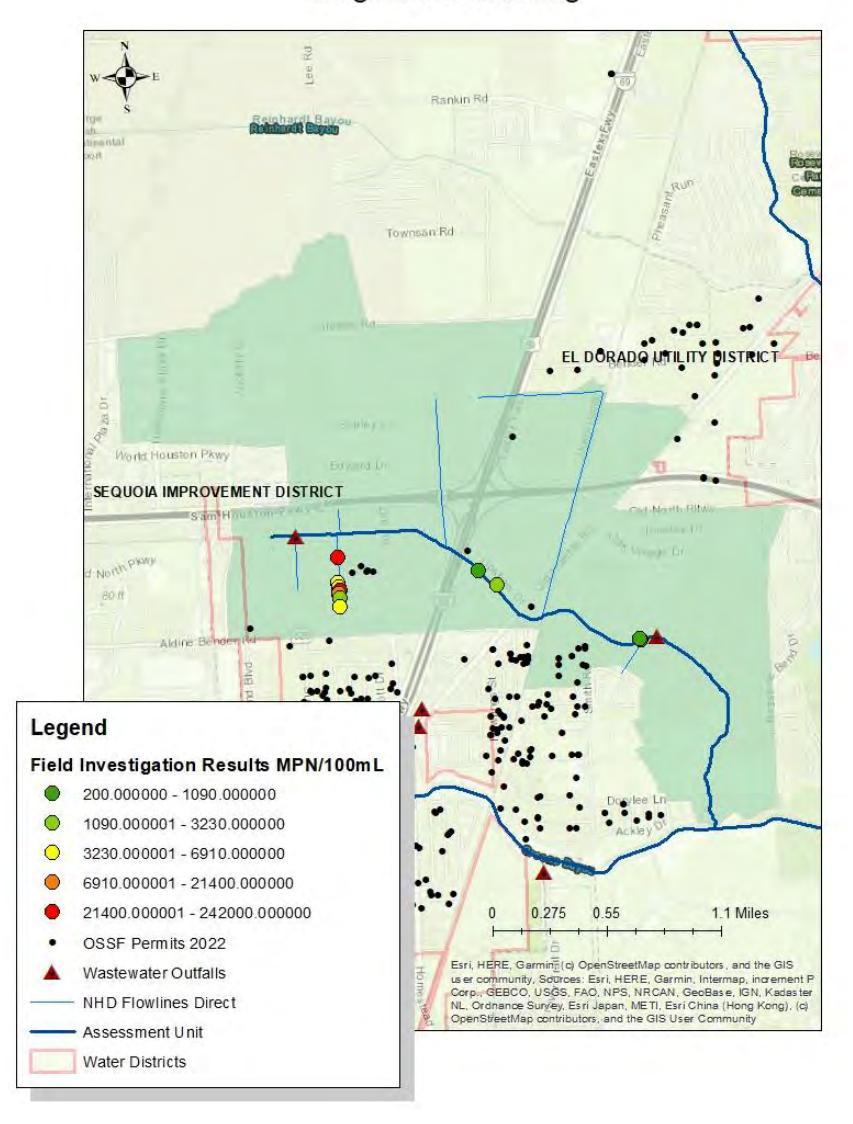
Figure 2. Field Investigation 2 Bacteria Results from 06/29/2023 on Unnamed Tributary of Greens Bayou (1016D_01)

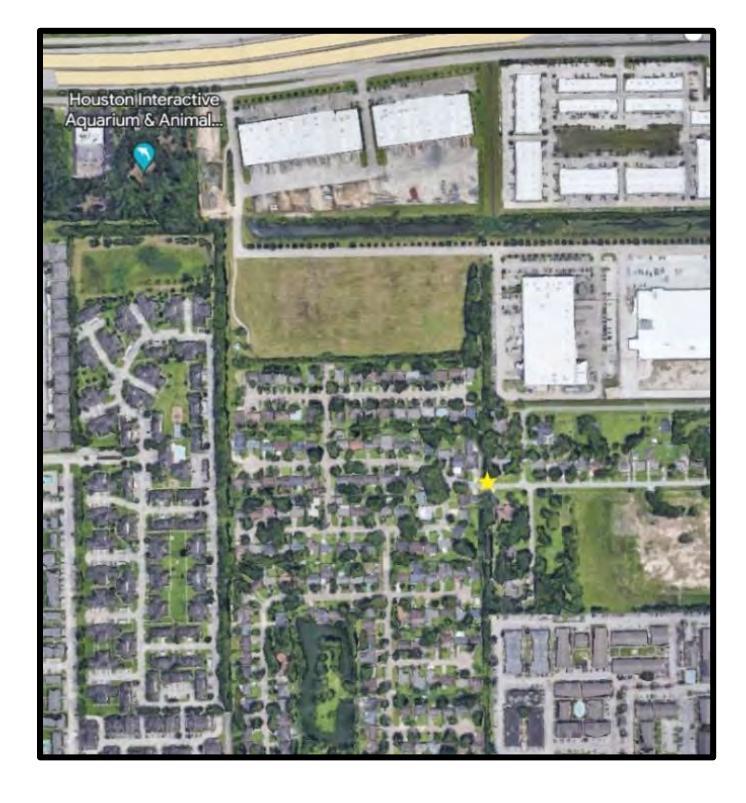
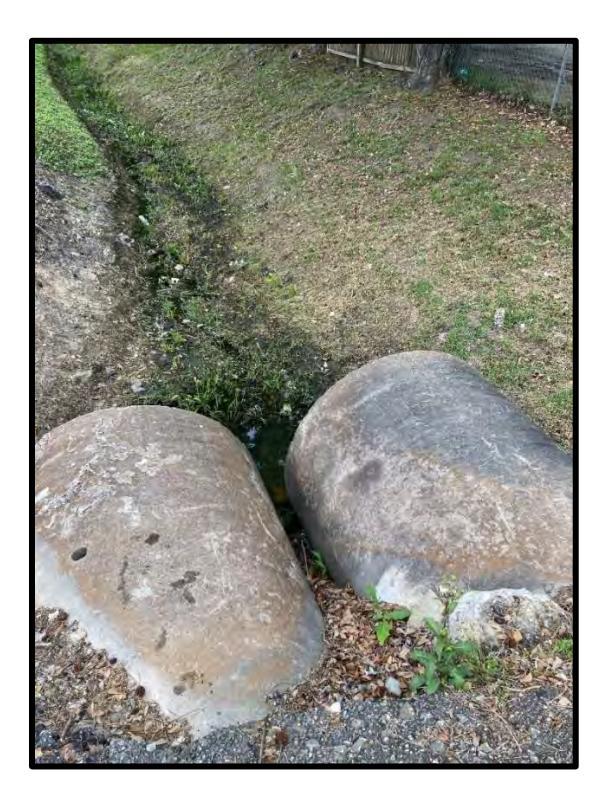
Several observations from FI 1 and FI 2 on the tributary are worth noting. The channel itself is choked with vegetation impeding water flow, so sources of bacteria that flow into the channel may linger for periods of time. A good amount of the vegetation in this reach consisted of elephant ears which could suggest the common presence of nutrients or bacteria sources like sewage. There was also a line of trash down the right bank coming from the northwest corner of the apartment complex. The debris trail looked like it came from a water flow from the complex parking lot, though no flow was present at the time of the FI. Similarly, several broken or questionable pipes were noted in that reach. These included a black pipe crossing the channel just upstream of McCracken Rd and attached to a cleanout pipe, a cleanout pipe with a garbage bag over it, and a broken pipe in the waterway with no identified source.

Figure 1: Referral site 1016DF1_06d. Map with star showing referral site location. Subset image of tributary view.

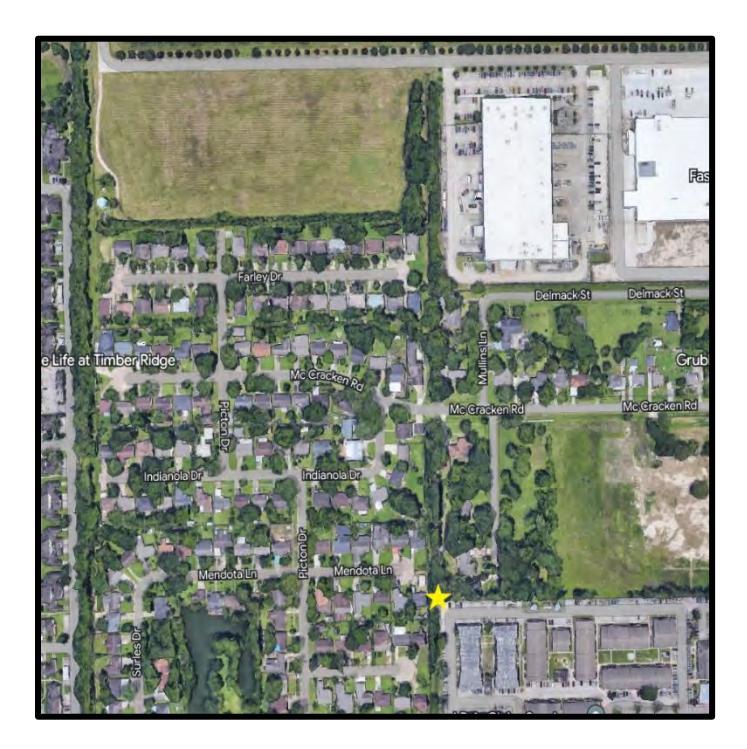
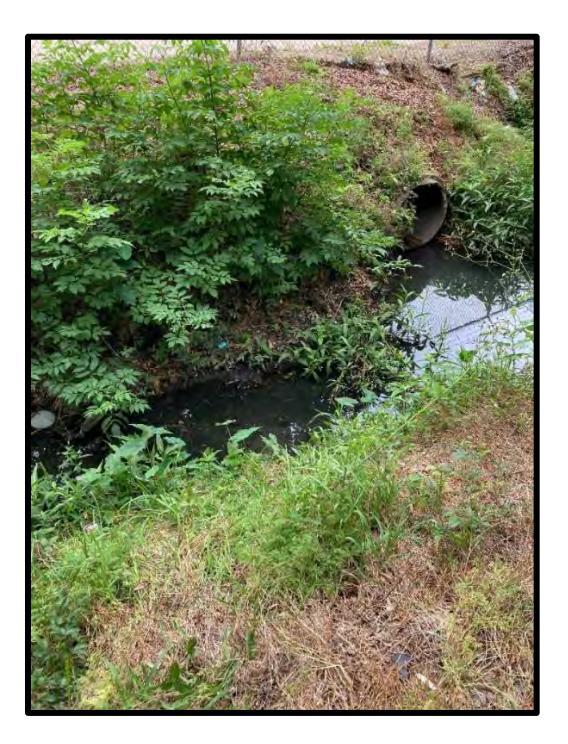
Figure 5: Referral site 1016DF1_07. Map with star showing referral site location. Subset image of tributary view.

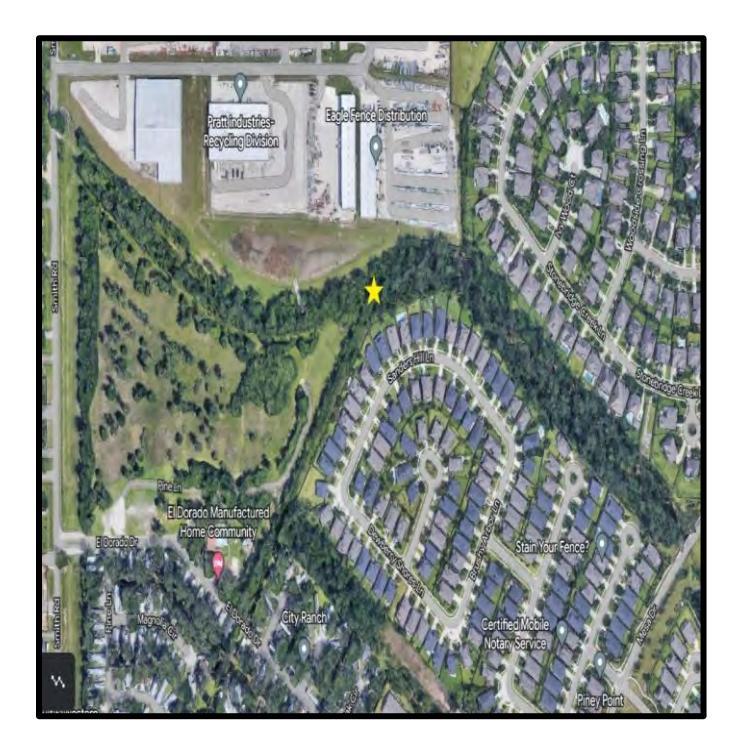
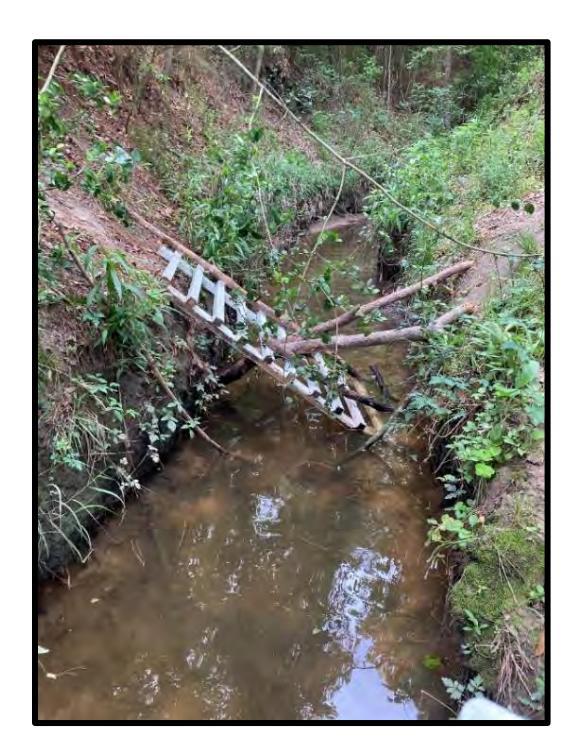
REFERRAL SITE: 1016DF1_03

Sample 10106DF1_03 was collected about 15 feet upstream on a tributary on the right bank of 1016D_01. The field crew did not walk this tributary during the FI, but desktop review has the tributary end at the El Dorado Manufactured Home Community next to what is potentially its water treatment system. Dewberry Shores Ln and Sanders Hill Ln in the Piney Point subdivision are also adjacent to the tributary. Further investigation of this tributary was attempted during FI 2, but the channel was experiencing intermittent flow conditions.

Figure 6: Referral site 1016DF1_03. Map showing proximity to two neighborhoods. Subset image of tributary view.

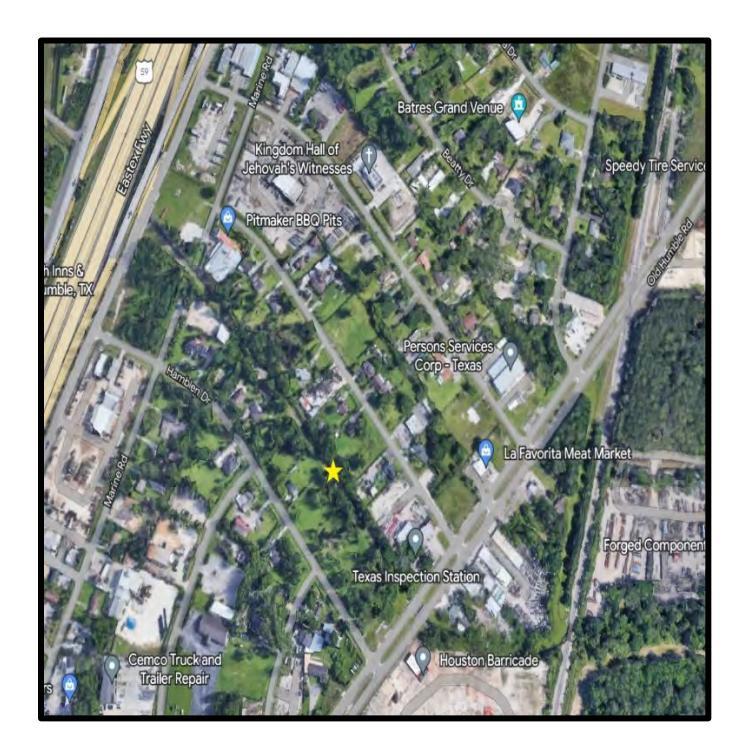
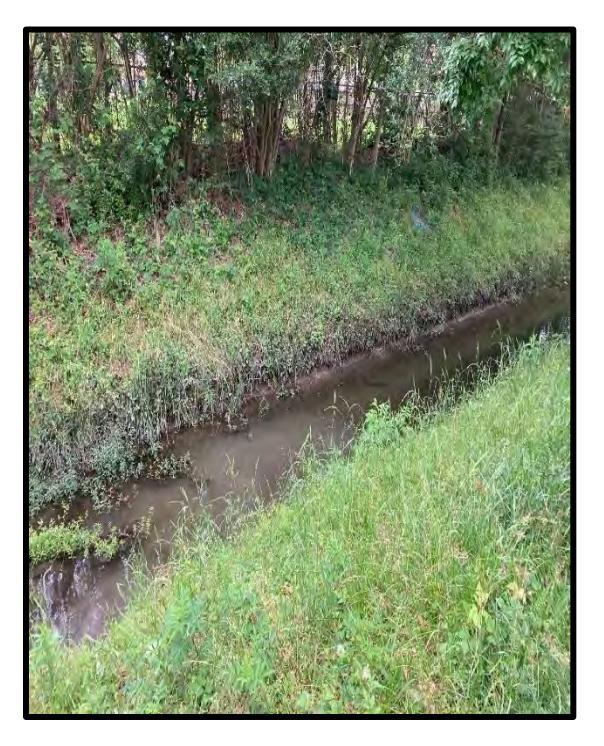
REFERRAL SITE: Residential Area between 1016DF1_10 and _11

As noted in the Results section, overall *E. coli* levels on channel 1016DF1_10 and 1016DF1_11 showed elevated levels of bacteria. Samples between Edmond Park and Marine Drive ranged between 2,850 MPN/100mL to 740 MPN/100mL at the time of the FI. While no dry weather flows were noted during the FI, bracketing samples were taken upstream at the end of Edmond Park and downstream of Marine Dr. Despite the lack of visible dry weather flows, the houses on the waterway had at least 10 dogs, a cow, and a horse in yards adjacent to waterway. Bacteria levels spiked from 740 MPN/100mL (1016DF1_11) upstream of the residential area to 2,850 MPN/100mL downstream of the residential area at the western edge of Edmonds Park.

Figure 7: Referral site 1016DF1_10. Map with star showing referral site location. Subset image of tributary view.

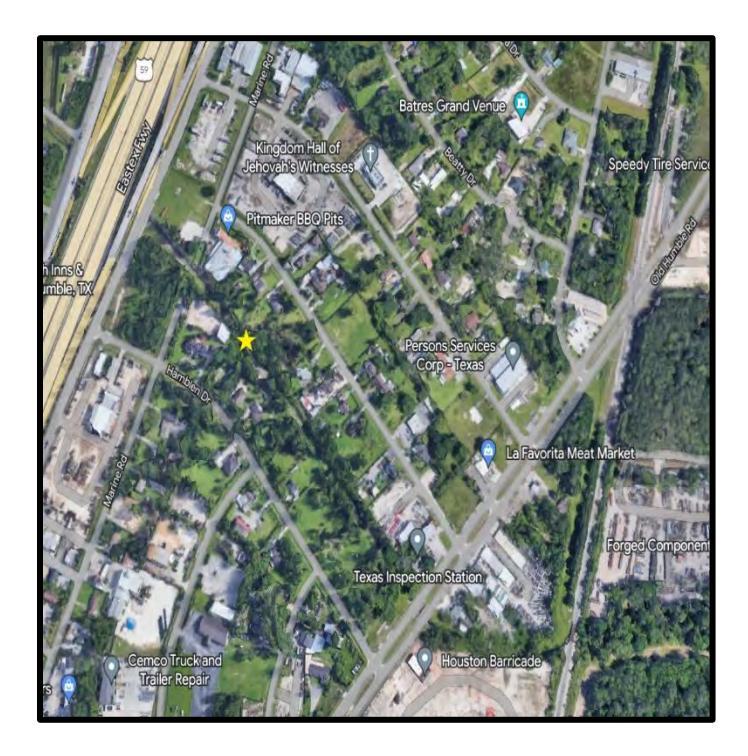
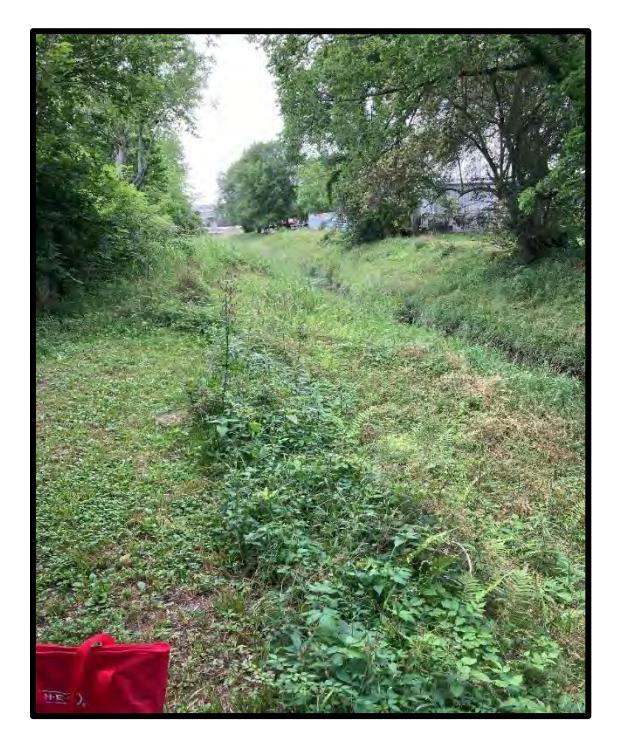
Figure 8: Referral site 1016DF1_11. Map with star showing referral site location. Subset image of tributary view.
