Targeted Bacteria Monitoring Project

FY24 Final Report

Assessment Units: 1007E_01 Willow Waterhole Bayou Above Tidal
and 1007I_01 Plum Creek Above Tidal

Houston-Galveston
Area Council

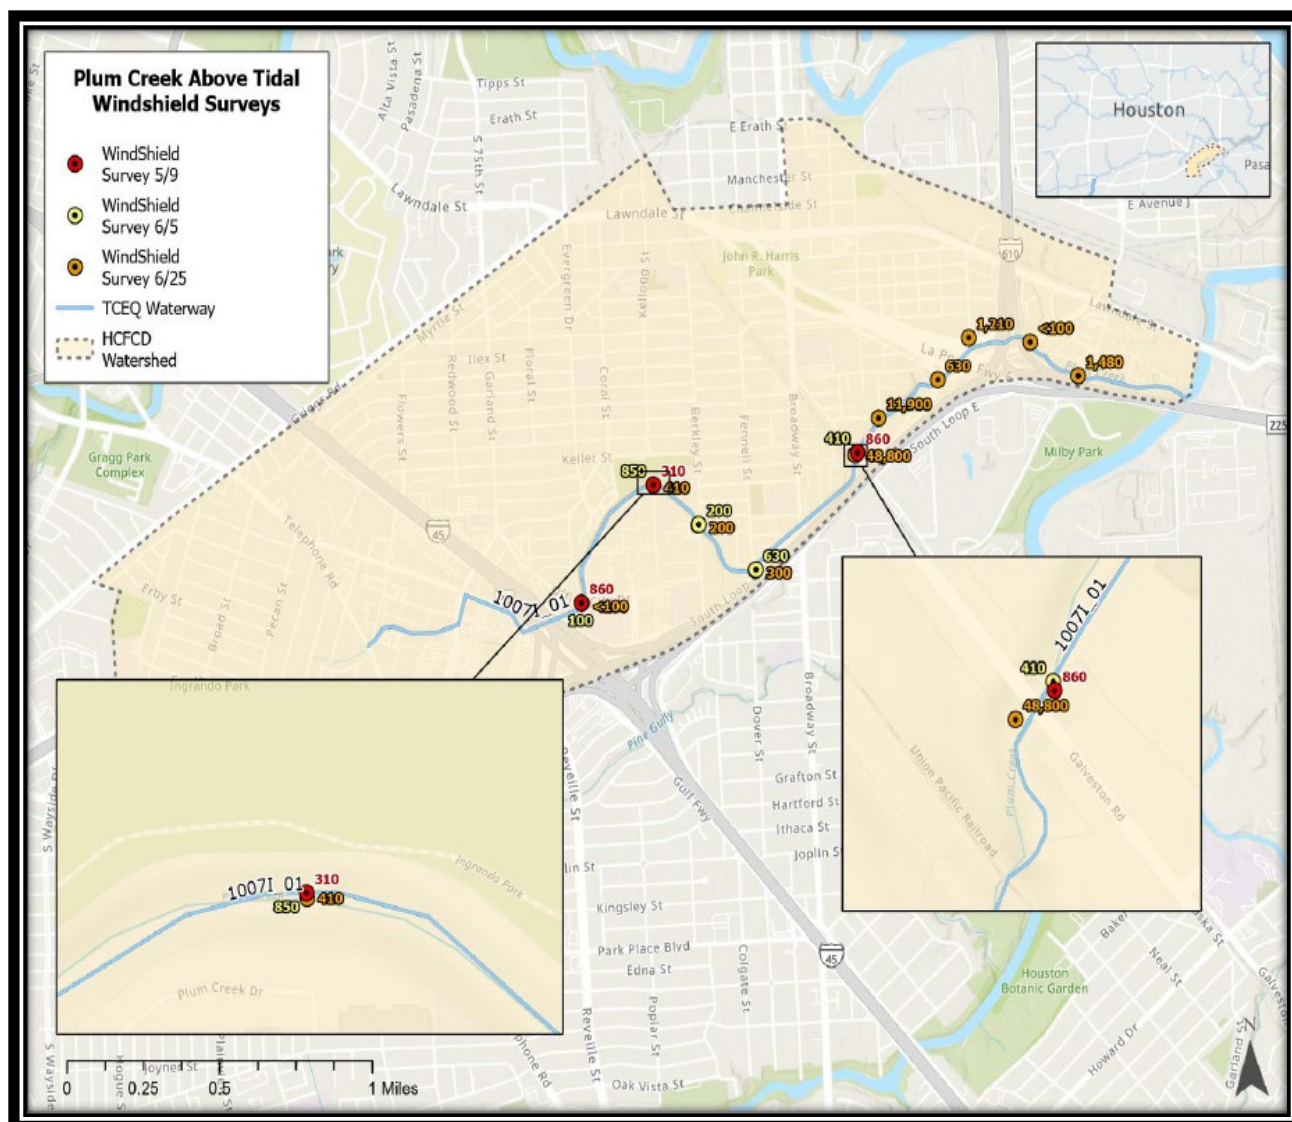
Figure 3. 1007I_01 Plum Creek Above Tidal Windshield Surveys

At the respective times of all WS conducted on 05/09, 06/05, and 06/25 for 1007I_01, it had been four days since the last significant rainfall in the watershed. A total of 18 samples were collected on the AU. Bacteria results from the ambient water samples collected during all WS ranged from less than 100 cfu/100 mL to 48,800 cfu/100 mL (Figure 3). At the time of the WS conducted on 06/26 for 1007E_01, it had been seven days since the last significant rainfall in the watershed. A total of 16 samples were collected on the AU. Bacteria results from the ambient water samples collected during the WS ranged from less than 100 cfu/100 mL to 2,950 cfu/100 mL (Figure 4).

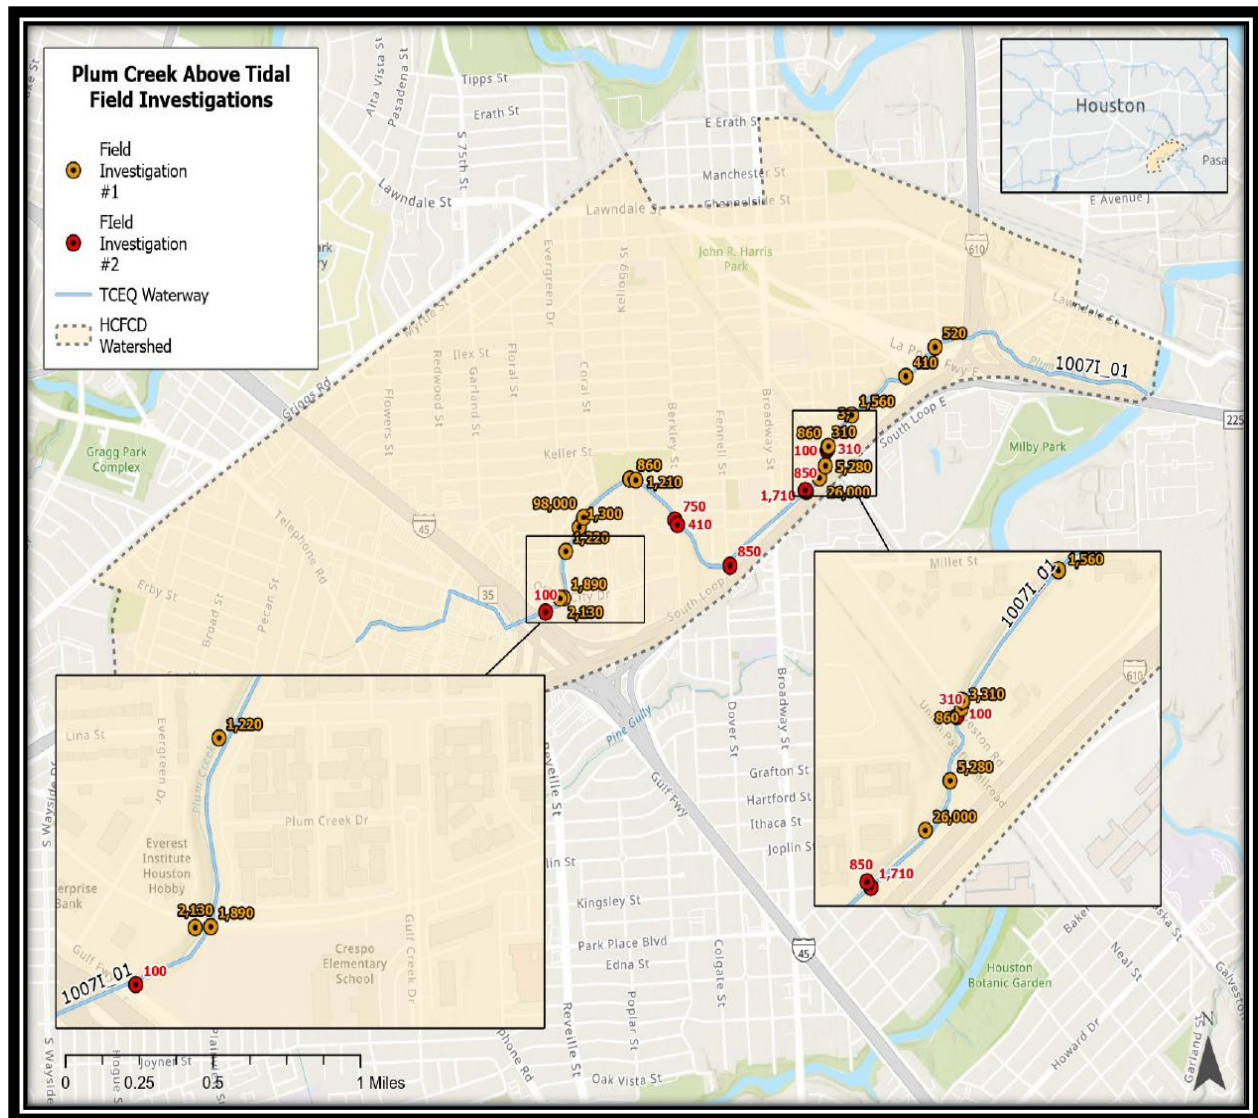
Figure 6. 1007I_01 Plum Creek Above Tidal Field Investigations 1 and 2

Of the samples collected, all 14 reflected a bacteria level greater than the primary contact recreation single sample criterion of 399 cfu/100 mL. Although these samples were all higher than the single sample criterion, there were only two locations that were deemed necessary for further investigation as they had particularly high bacteria levels that were direct sample collections from outfalls. It should be noted that samples 1 through 5 were analyzed within the 9th hour, past the required holding time (8 hours) for E coli. due to traffic. Areas suggested for further investigation are detailed in the Referrals to Responsible Parties section of the report.

Most of the locations sampled on the 1007I_01 channel showed higher bacteria results than during the WS. In particular, the sample taken from the stormdrain pipe at Office City Dr (1007I_01_FI_02) where the tributary comes aboveground was higher than all three results at the same location from previous WS (860 cfu/100mL, 100 cfu/100mL, and <100 cfu/100mL) and is recommended for further investigation. Additionally, the sample collected from the storm drainpipe at the location near Patricia Ln (1007I_01_FI_05) was exceptionally high compared to the nearest locations sampled during previous WS (310 cfu/100mL, 850 cfu/100 mL, 410 cfu/100 mL). Both areas had apartment complexes nearby which could be the source of the high bacteria levels.

The bacteria results also varied significantly between samples 1007I_01_FI_08 and 1007I_01_FI_09. Although no pipes, outfalls, or flows were identified, those samples enclose a sector of the channel where a lift station was observed. More information on the locations recommended for further investigation is included in the Referrals to Responsible Parties section.

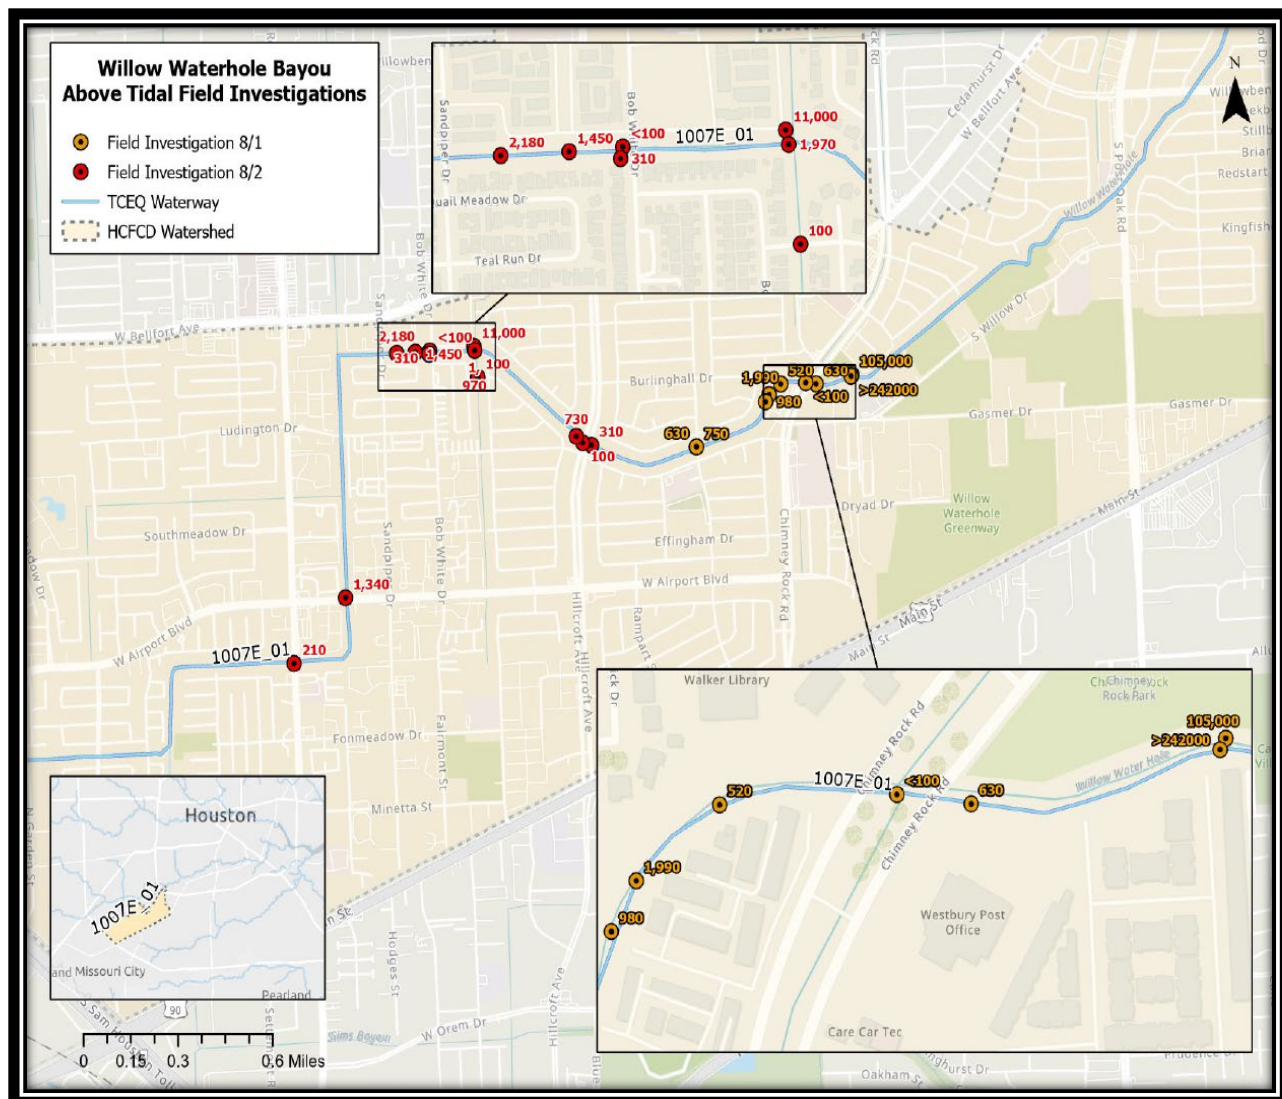
Figure 7. 1007E_01 Willow Waterhole Bayou Above Tidal Field Investigation

The FI for 1007E_01 featured 21 samples collected at 21 locations (Table 5). This tributary had extensive riparian overgrowth making extended walks for the field investigation difficult. An unnamed channel bracketing off north and south where two ambient samples were collected was also discovered. As with the previous FI, outfalls where direct samples were collected were noted as such in field staff notes. To enhance clarity of the sampling efforts, a field survey map (Figure 7) displays a singular icon for the collections. All locations are listed in Table 5 below.
