PRELIMINARY PAVEMENT ASSESSMENT

THE CITY OF WEST UNIVERSITY PLACE TEXAS

BUFFALO SPEEDWAY

May, 2010

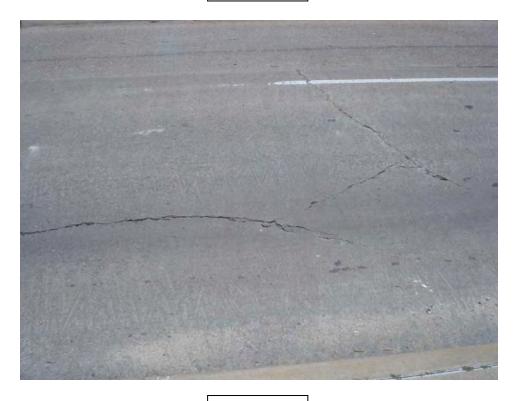
Location 1

Location No.	Description	Recommendation for repair		
1	Sunken joint, cracks	Replace ¼ panels – 150 LF		
2	Spawling	Clean & repair with high strength grout		
3	Large Cracks	Replace ¼ panels – 40 LF		
4	Spawling	Clean & repair with high strength grout		
5	Multiple cracks	Replace ¼ panel – 20 LF		
6	Multiple cracks	Replace ¼ panel – 30 LF		
7	Sunken joint, cracks	Replace ¼ panels – 70 LF		
8	Spawling	Clean & repair with high strength grout		
9	Spawling	Clean & repair with high strength grout		
10	Large cracks	Replace ¼ panel – 25 LF		
11	Spawling	Clean & repair with high strength grout		
12	Large crack (previously sealed)	Replace ¼ panels – 60 LF		
13	Storm inlet damage	Repair/Replace Inlet		
14	Multiple cracks	Replace ¼ panel – 20 LF		
15	Spawling at patch	Clean & repair with high strength grout		
16	Spawling at patch	Clean & repair with high strength grout		
17	Spawling & cracking	Replace ½ panel – 10 LF

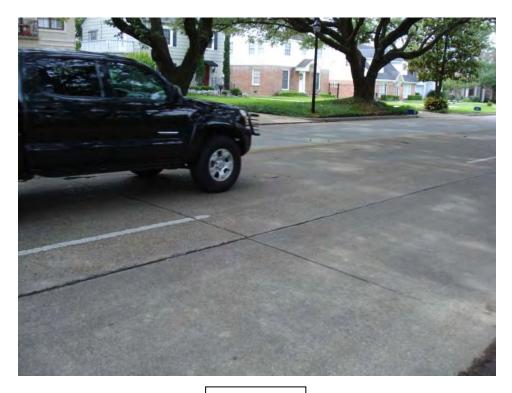
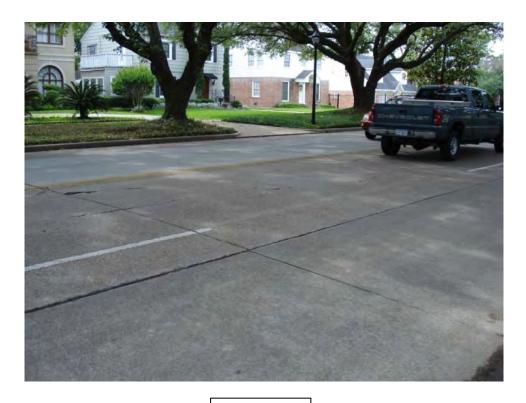
Location 21

18	Sunken pavers @ crosswalk	Re-bed pavers		
19	Large cracks	Replace ¼ panel – 20 LF		
20	Multiple cracks	Replace ¼ panel – 20 LF		
21	Multiple cracks	Replace ¼ panels – 60 LF		
22 .	Spawling on old & new pavement	Clean & repair with high strength grout		
23	Storm inlet sunk & spawling	Replace inlet & repair spawling		
24	Cracks	Replace ¼ panels – 40 LF		
25	Large cracks	Replace ¼ panels – 40 LF, ½ panel 20 LF		
26	Three cracked panels	Replace center ¼ panels – 70 LF		
27	Spawling	Clean & repair with high strength grout		
28	Multiple cracks	Replace ¼ panel – 25 LF		
29	Cracked panels	Replace center ¼ panels – 70 LF		
30	Cracks in panel adjacent to inlet	Replace ¼ panel – 25 LF		
31	Multiple cracks	Replace ¼ panels – 45 LF		
32	Multiple cracks	Replace ¼ panel – 25 LF

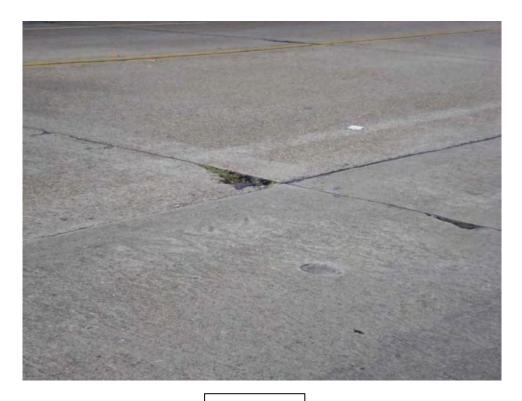
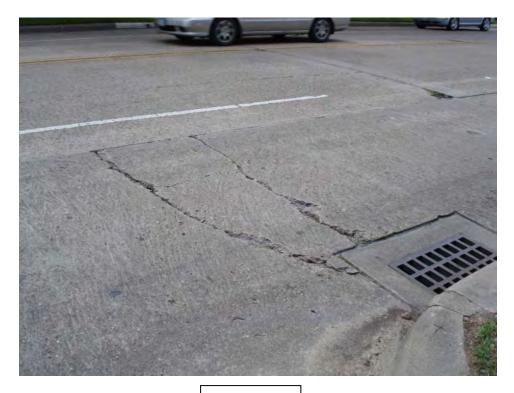
Location 33

Location No.	Description	Recommendation for repair			
33	Cracked panel @ inlet	Replace ¼ panel – 25 LF			
34	Multiple cracks				
35	Cracks	Replace center 1/4 panels - 60 LF			
36	Cracks	Replace ¼ panel – 10 LF			
37	Multiple cracks	Replace ¼ panel – 20 LF			
38	Two cracked panels	Replace ¼ panels – 60 LF			
39	Two cracked panels	Replace ¼ panels – 60 LF			
40	Large crack	Replace ¼ panel – 20 LF			
41	Multiple cracks	Replace ¼ panels – 70 LF			
42	Large crack in multiple panels	Replace ¼ panels – 150 LF

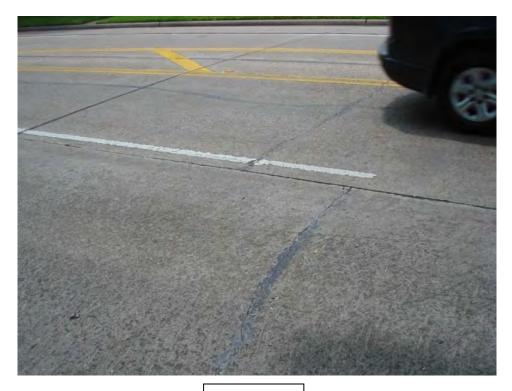
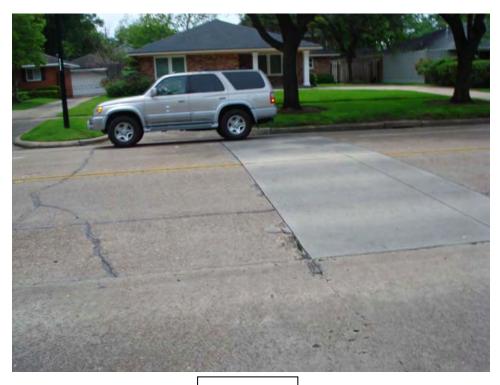
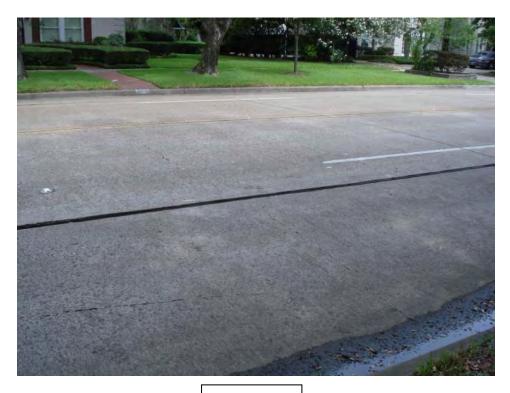
Sunken Joint

It was also noted that there is apparent evidence that the roadway may have sunken in some locations since at some of the joints the pavement panel is about one inch lower than its adjacent panel. The observed locations of these "sunken joints" are noted on the maps and a nominal linear footage for slab jacking is included in the cost estimate.
