FM 518 Corridor Study

Pearland, Texas

July 2025

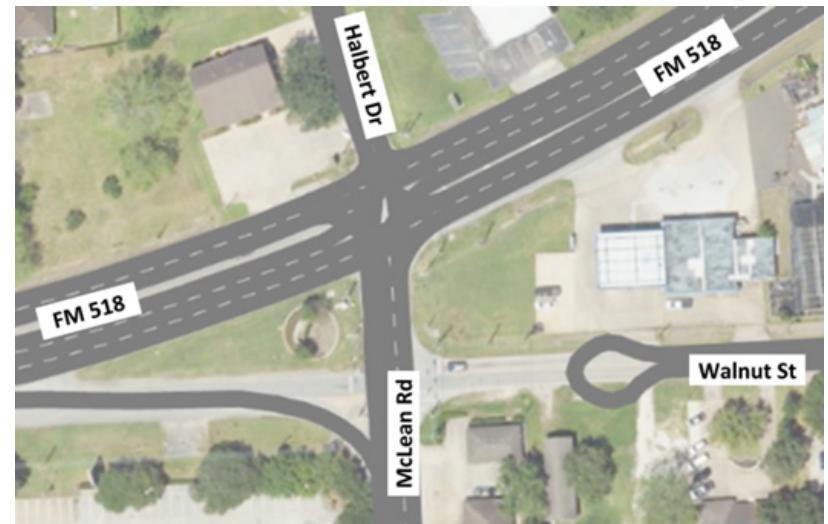
Figure 1: Walnut Closure Alternative

A medium-term alternative to remove the signal at Walnut Street and McLean Road was also studied, but ultimately determined by the Steering Committee to be unsatisfactory due to the potential restriction of emergency services. Figure 1 illustrates the Walnut Street Closure.

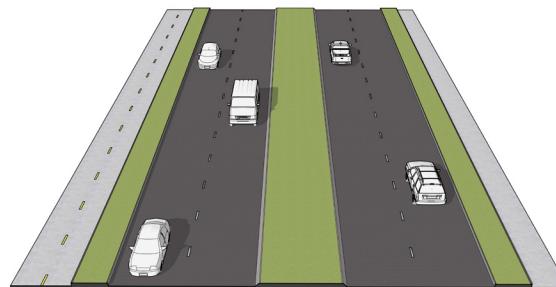
Figure 3: Alternative 2 Cross Section

The Access Management Alternative includes the addition of raised medians from McLean Road to the Friendswood City Limits, where raised medians currently exist (see). Walnut Street would remain a 2-lane facility. Figure 3 below illustrates a cross section of the corridor with a raised median, and Figure 6 is a map of the alternative.

FM 518 (Broadway Street) From McLean Road to Friendswood City Limits with four lanes and a raised median

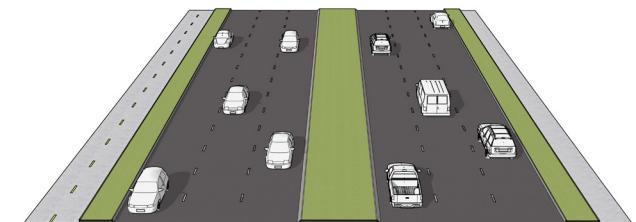
Figure 4: Alternative 3 Cross Section

Figure 4 below illustrates a cross section for alternative 3, and Figure 7 shows the location for the six-lane capacity improvement with raised medians.

FM 518 (Broadway Street) From Barry Rose Road to E. Edgewood Drive with six lanes and a raised median

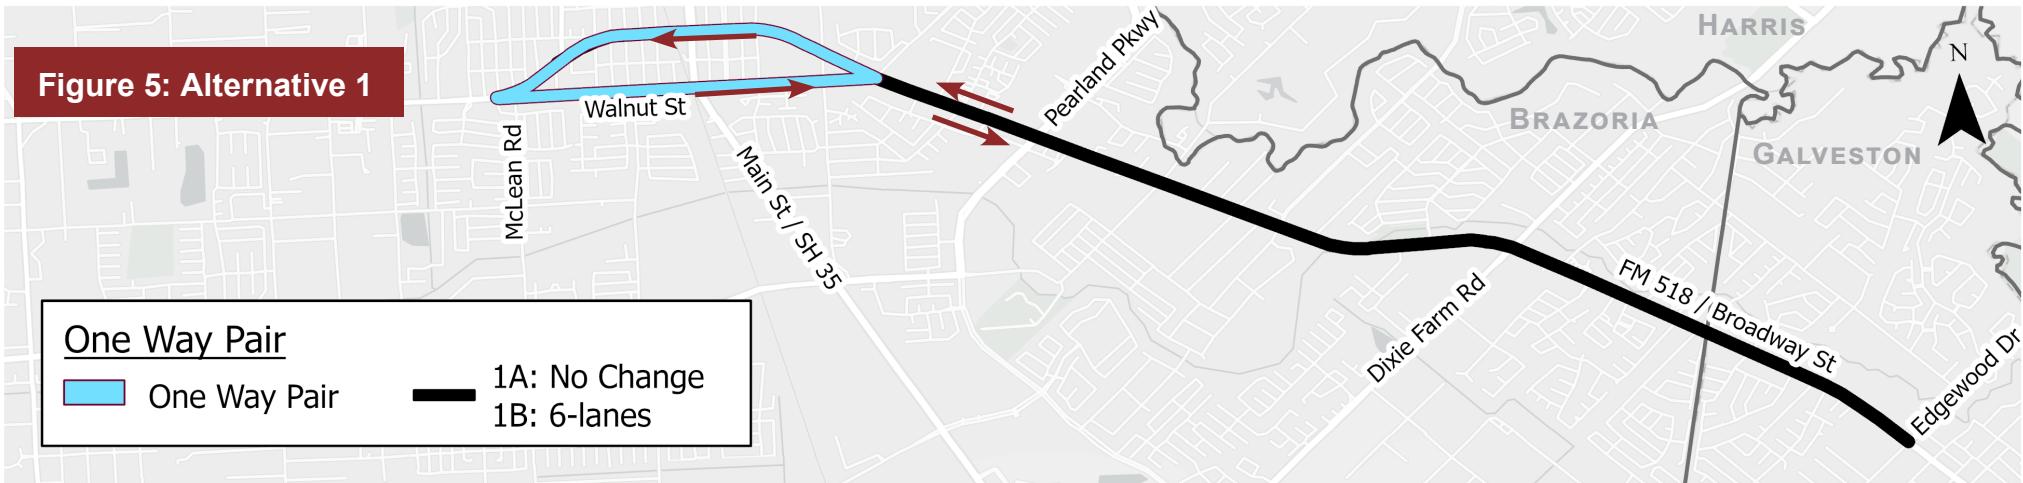
Figure 5: Alternative 1

The One-Way Pair Alternative would convert FM 518 to one-way west bound and Walnut Street to one-way east bound from McLean Road to Barry Rose Road (Figure 5). It includes three travel lanes in each direction on each of the aforementioned roadways.

One Way Pair

1A: No Change
1B: 6-lanes

Alternative 1B is recommended for long-term implementation out of the alternatives presented in this study. However, there are many other factors that influence the suitability of the alternative, and there are other potential improvements that can be analyzed for comparison to Alternative 1B.

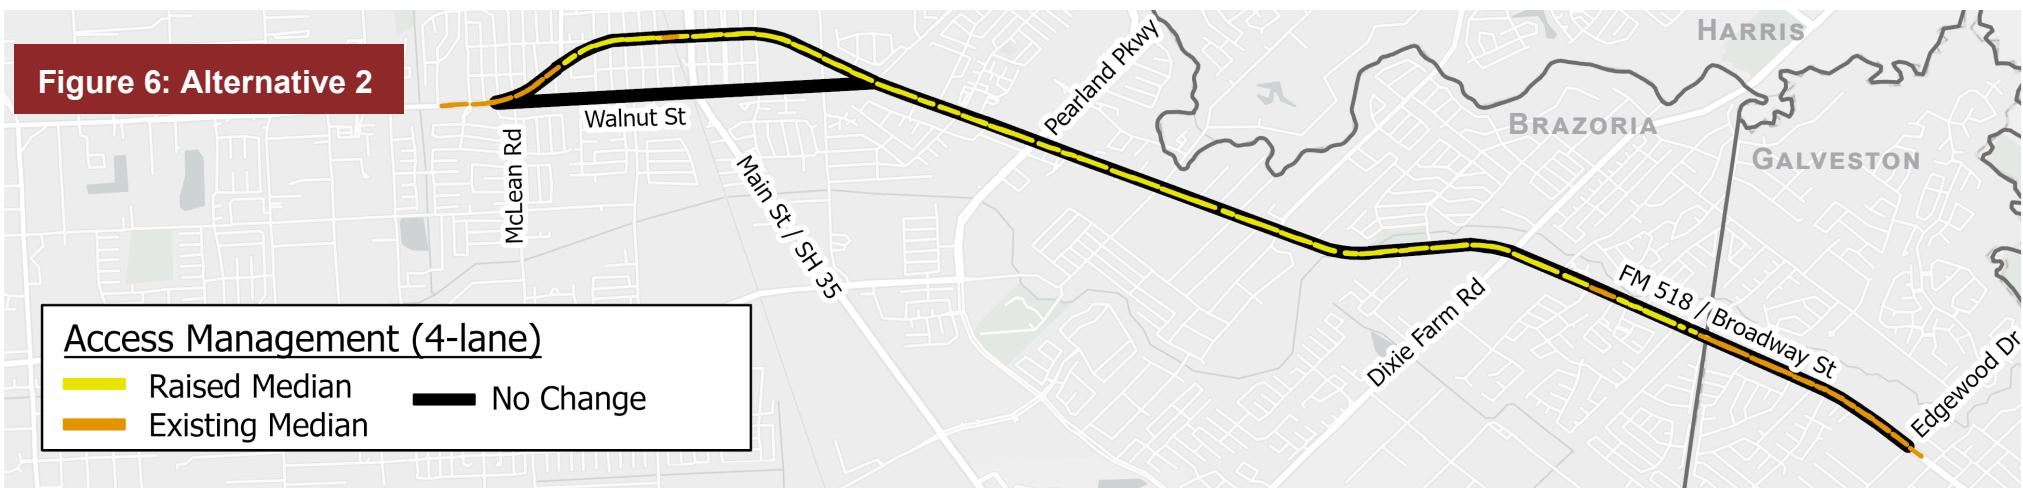
Figure 6: Alternative 2

Access Management (4-lane)

Raised Median
Existing Median

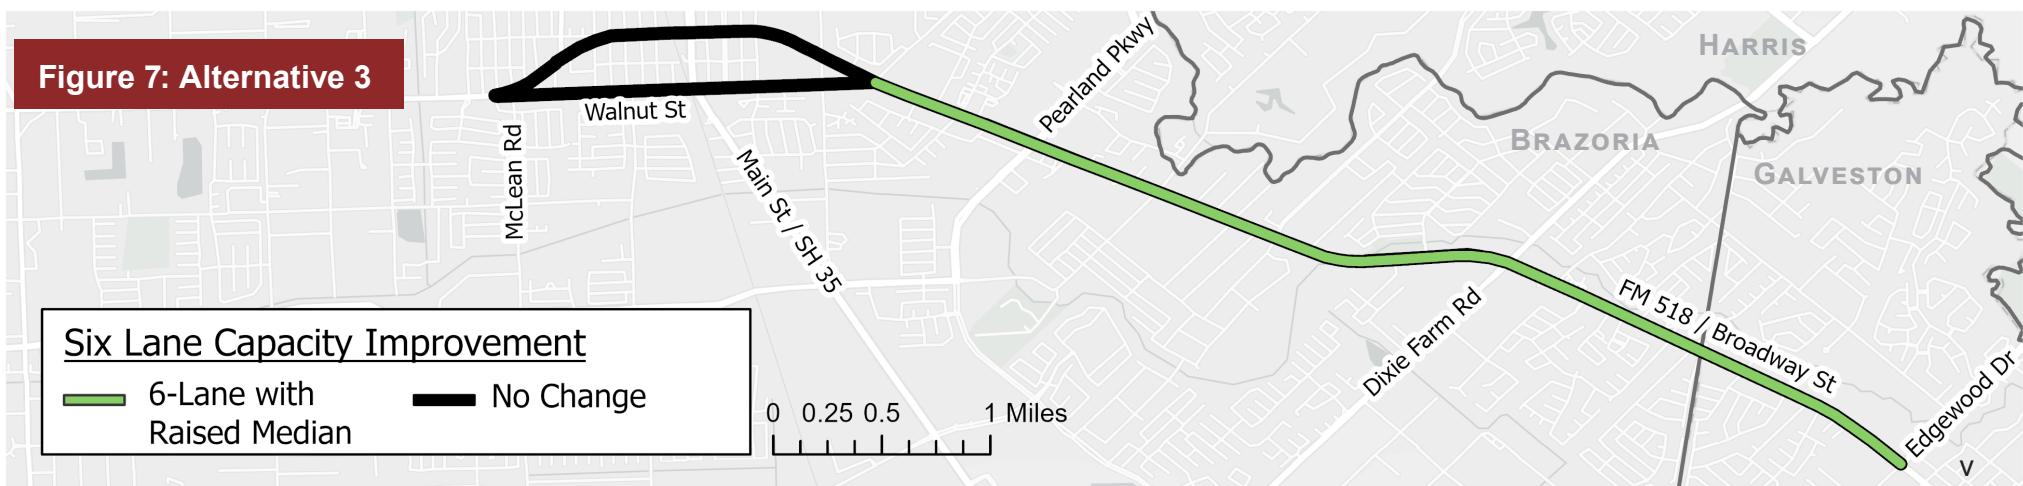
Figure 7: Alternative 3

Six Lane Capacity Improvement

6-Lane with
Raised Median

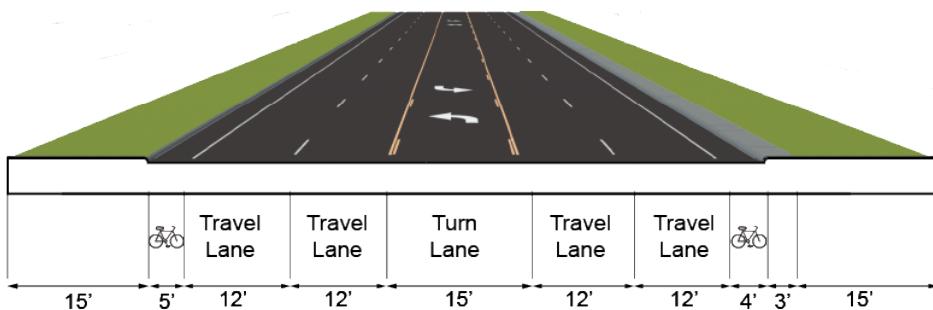
Four lanes with a striped median and a standard bike lane.

Length of 1.6 miles and approximate width of 105 feet.

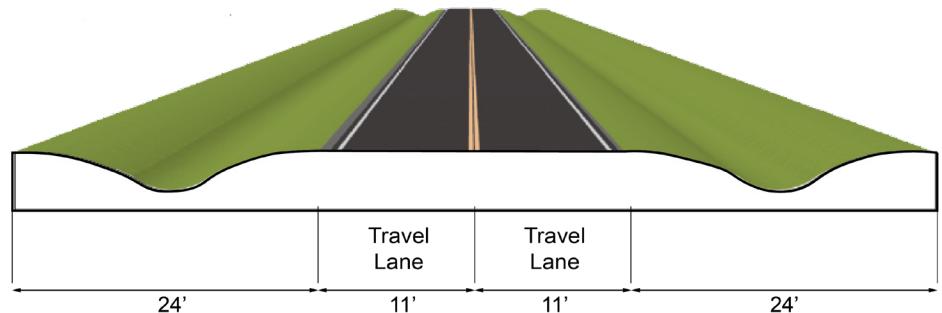
1B - W Walnut St (McLean Road to Barry Rose Road)

Most of this segment is only two lanes, but the road widens to four lanes with a median near the intersection with Main St. Length of 1.45 miles and approximate width of 24 feet to 70 feet.

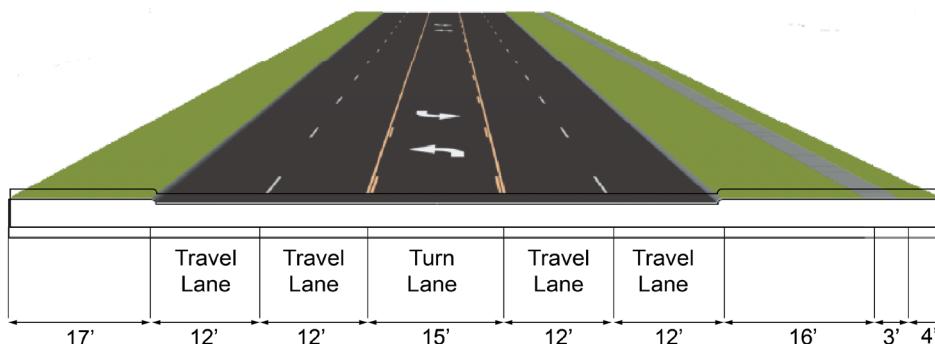
2 - FM 518 / Broadway Street (Barry Rose Road to Sunset Meadows Drive/Winding Road)

Four lanes with a striped median. Length of 3.56 miles in length and around 105 feet wide.

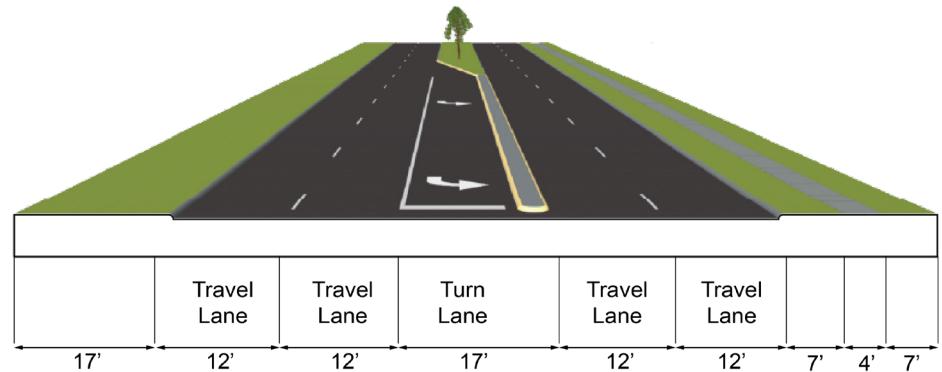
3 - FM 518 / Broadway Street / N Friendswood Drive (Sunset Meadows Drive/Winding Road to Edgewood Drive)

Four lanes with raised landscaped medians. Length of 1 mile and approximate width of 100 feet.

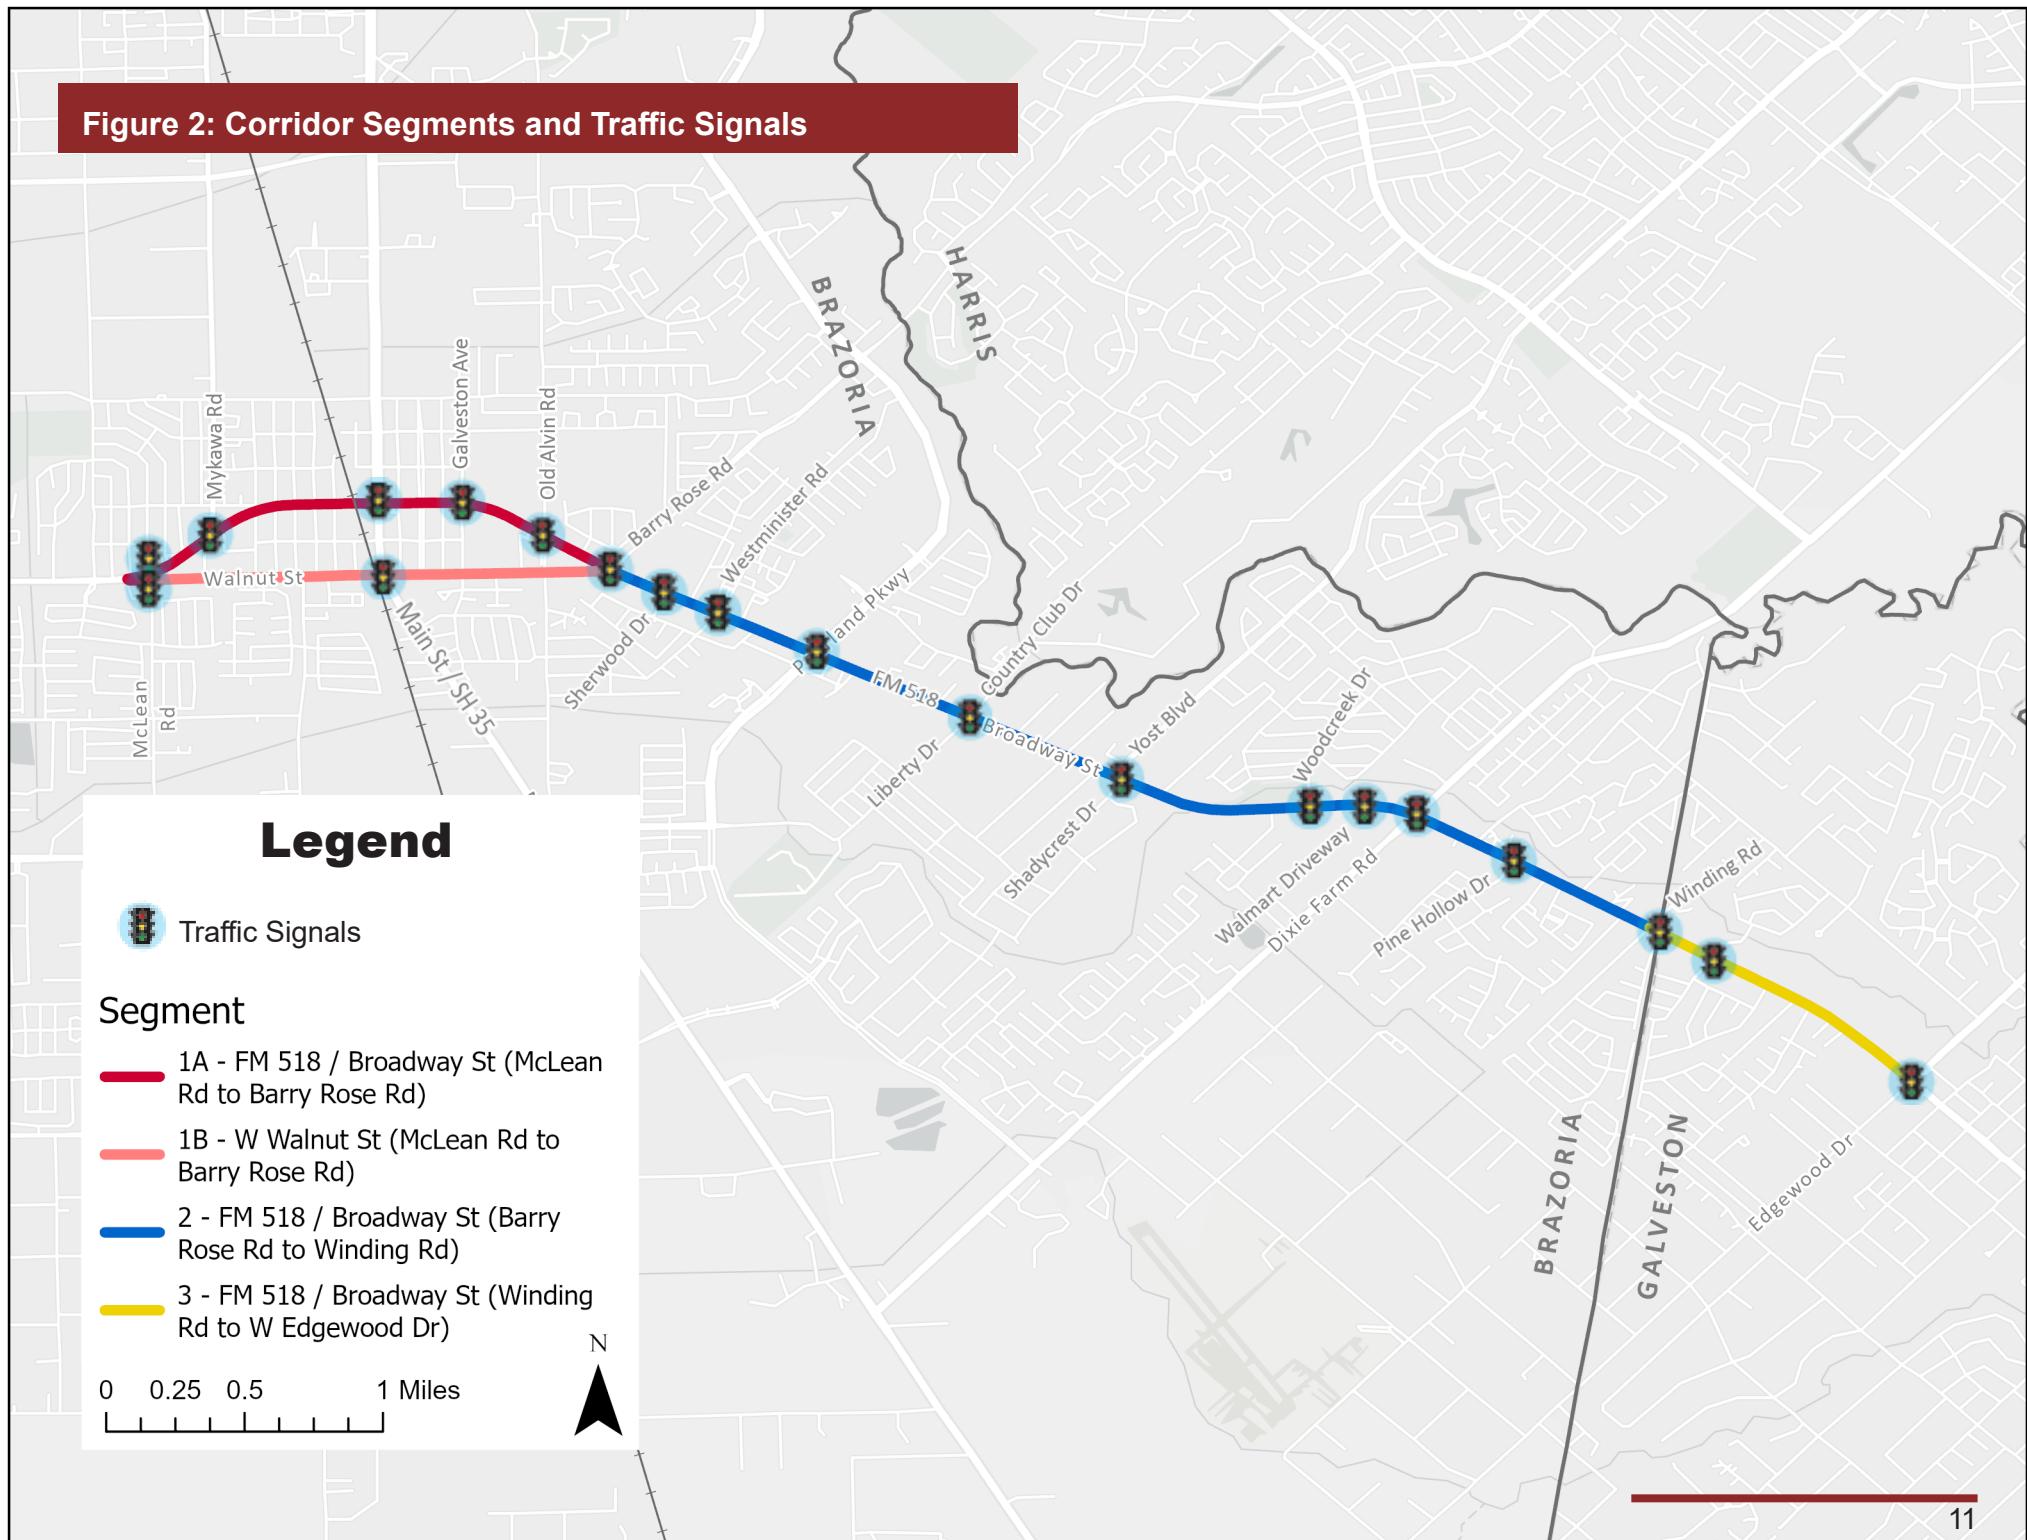
Figure 2: Corridor Segments and Traffic Signals

FM 518 (Broadway Street) is a state highway classified as a principal arterial. Within the 6.2 mile study area, there are 20 signalized intersections and four distinct segments. A map of signalized intersections and corridor segments can be seen in Figure 2.

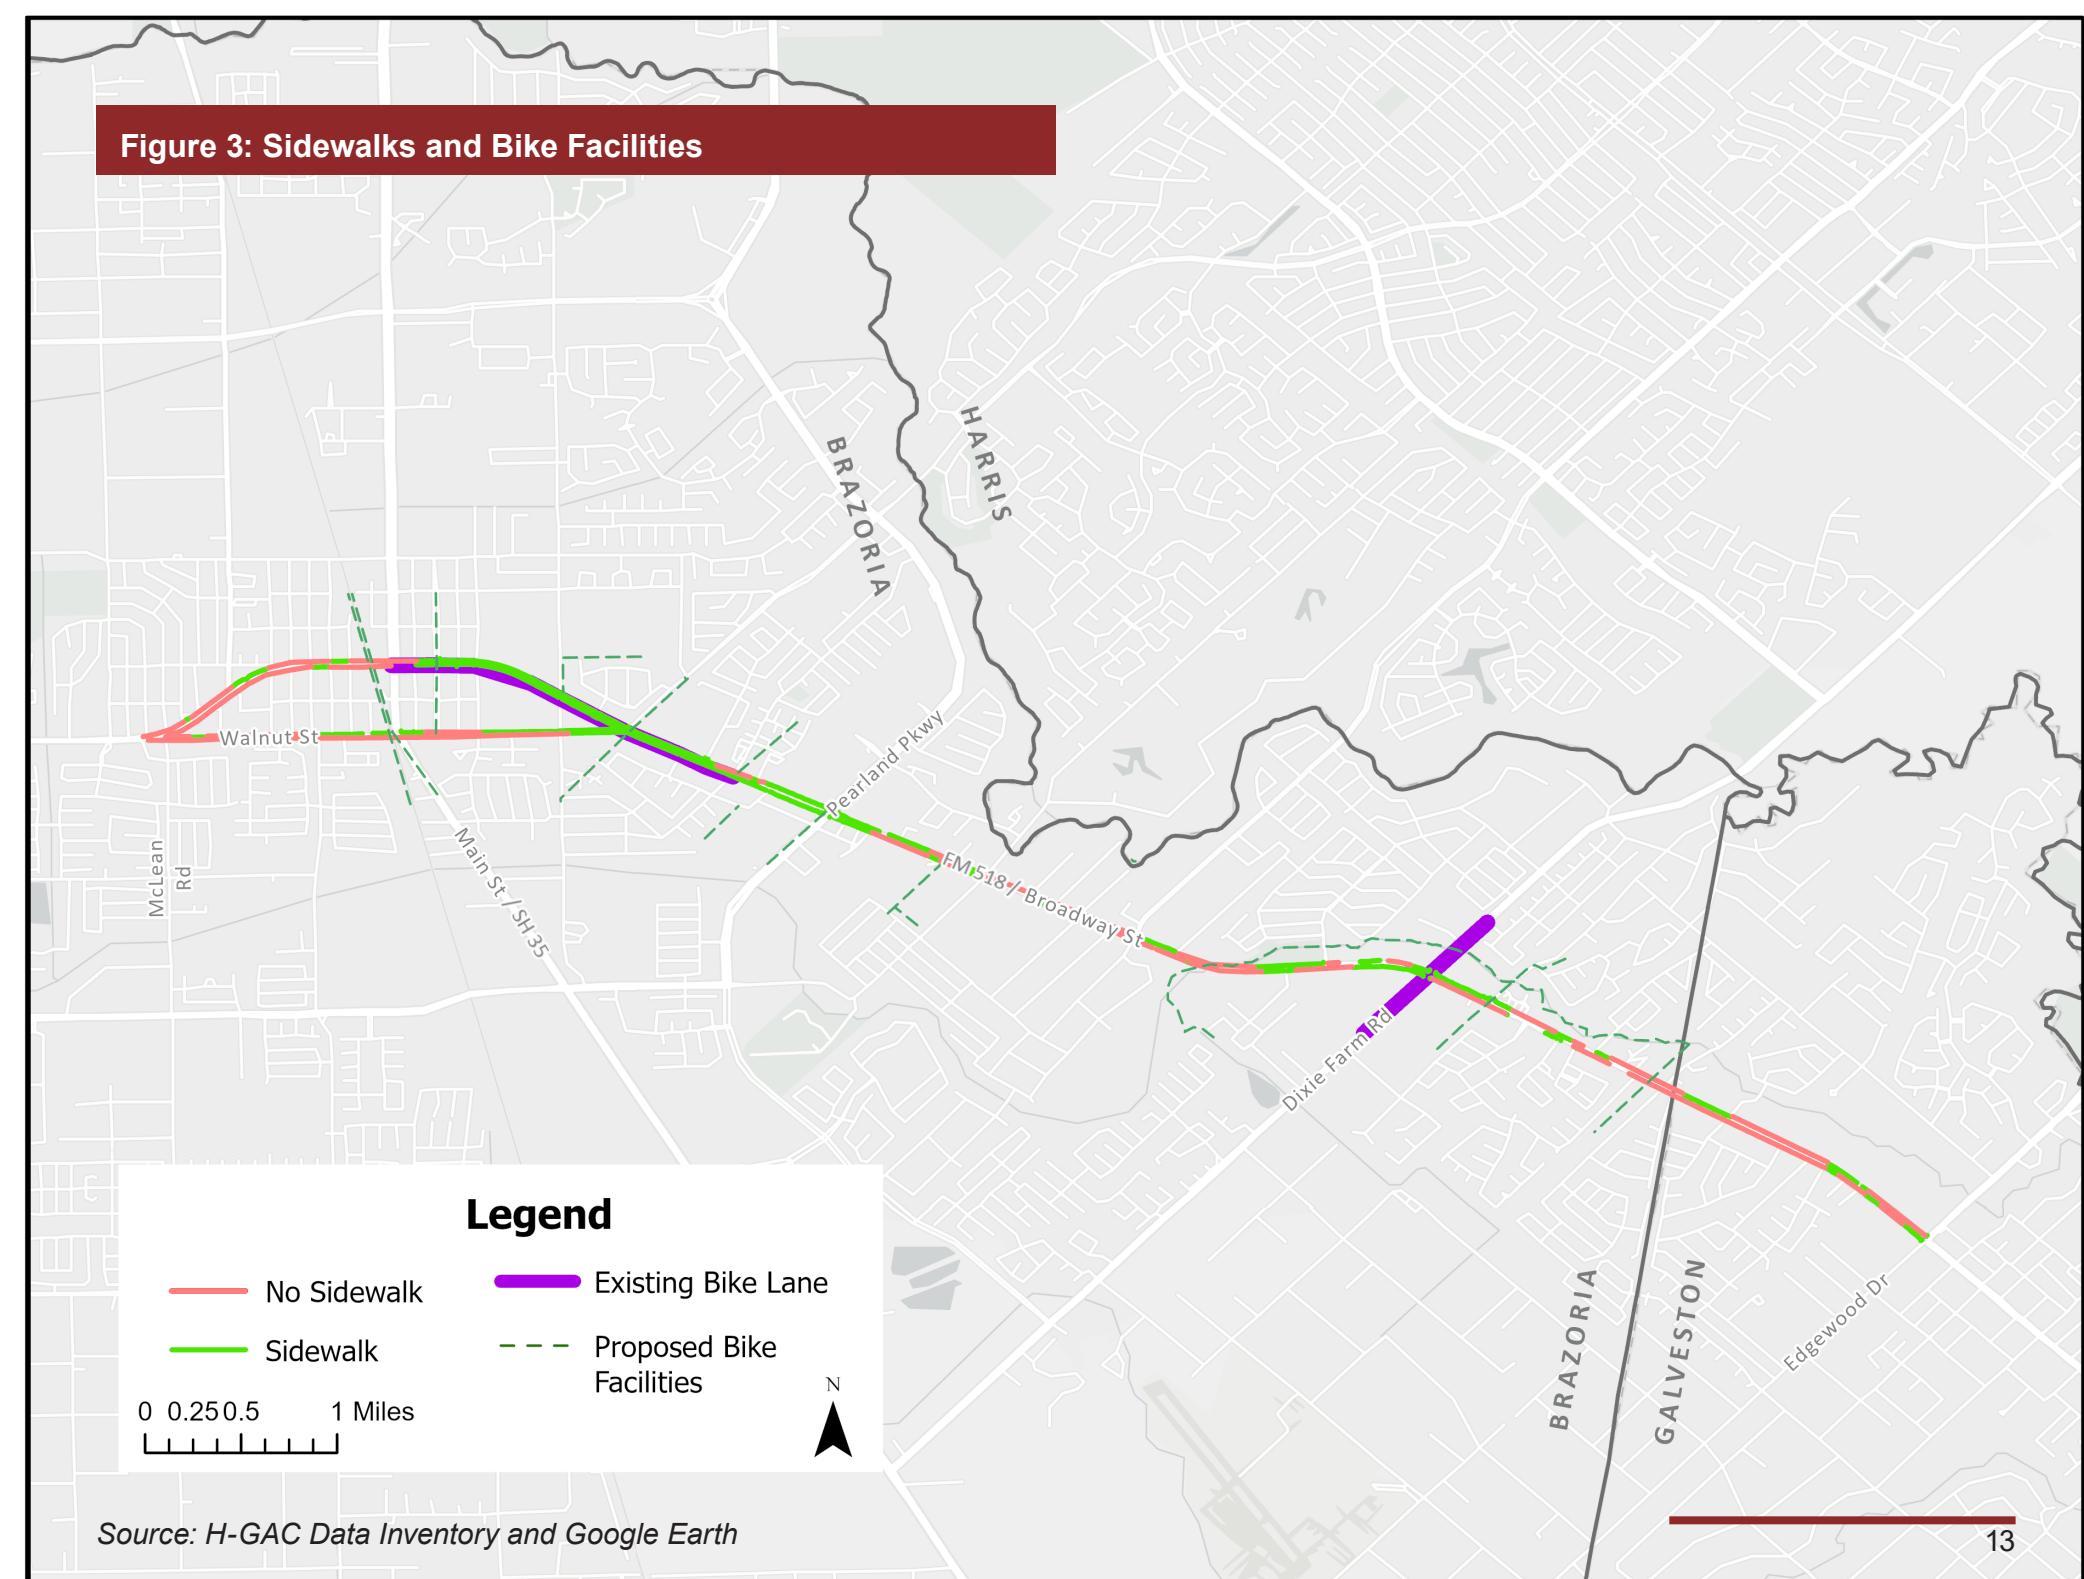
Figure 3: Sidewalks and Bike Facilities

For bicycle facilities, there is an existing on-street bike lane on the FM 518 (Broadway Street) corridor from Main Street to Westminster Road. In addition, the study area intersects with an existing bicycle facility (signed and striped bike lane) at FM 518 (Broadway Street) and Dixie Farm Road. Figure 3 shows sidewalks and bicycle facilities in the corridor study area.

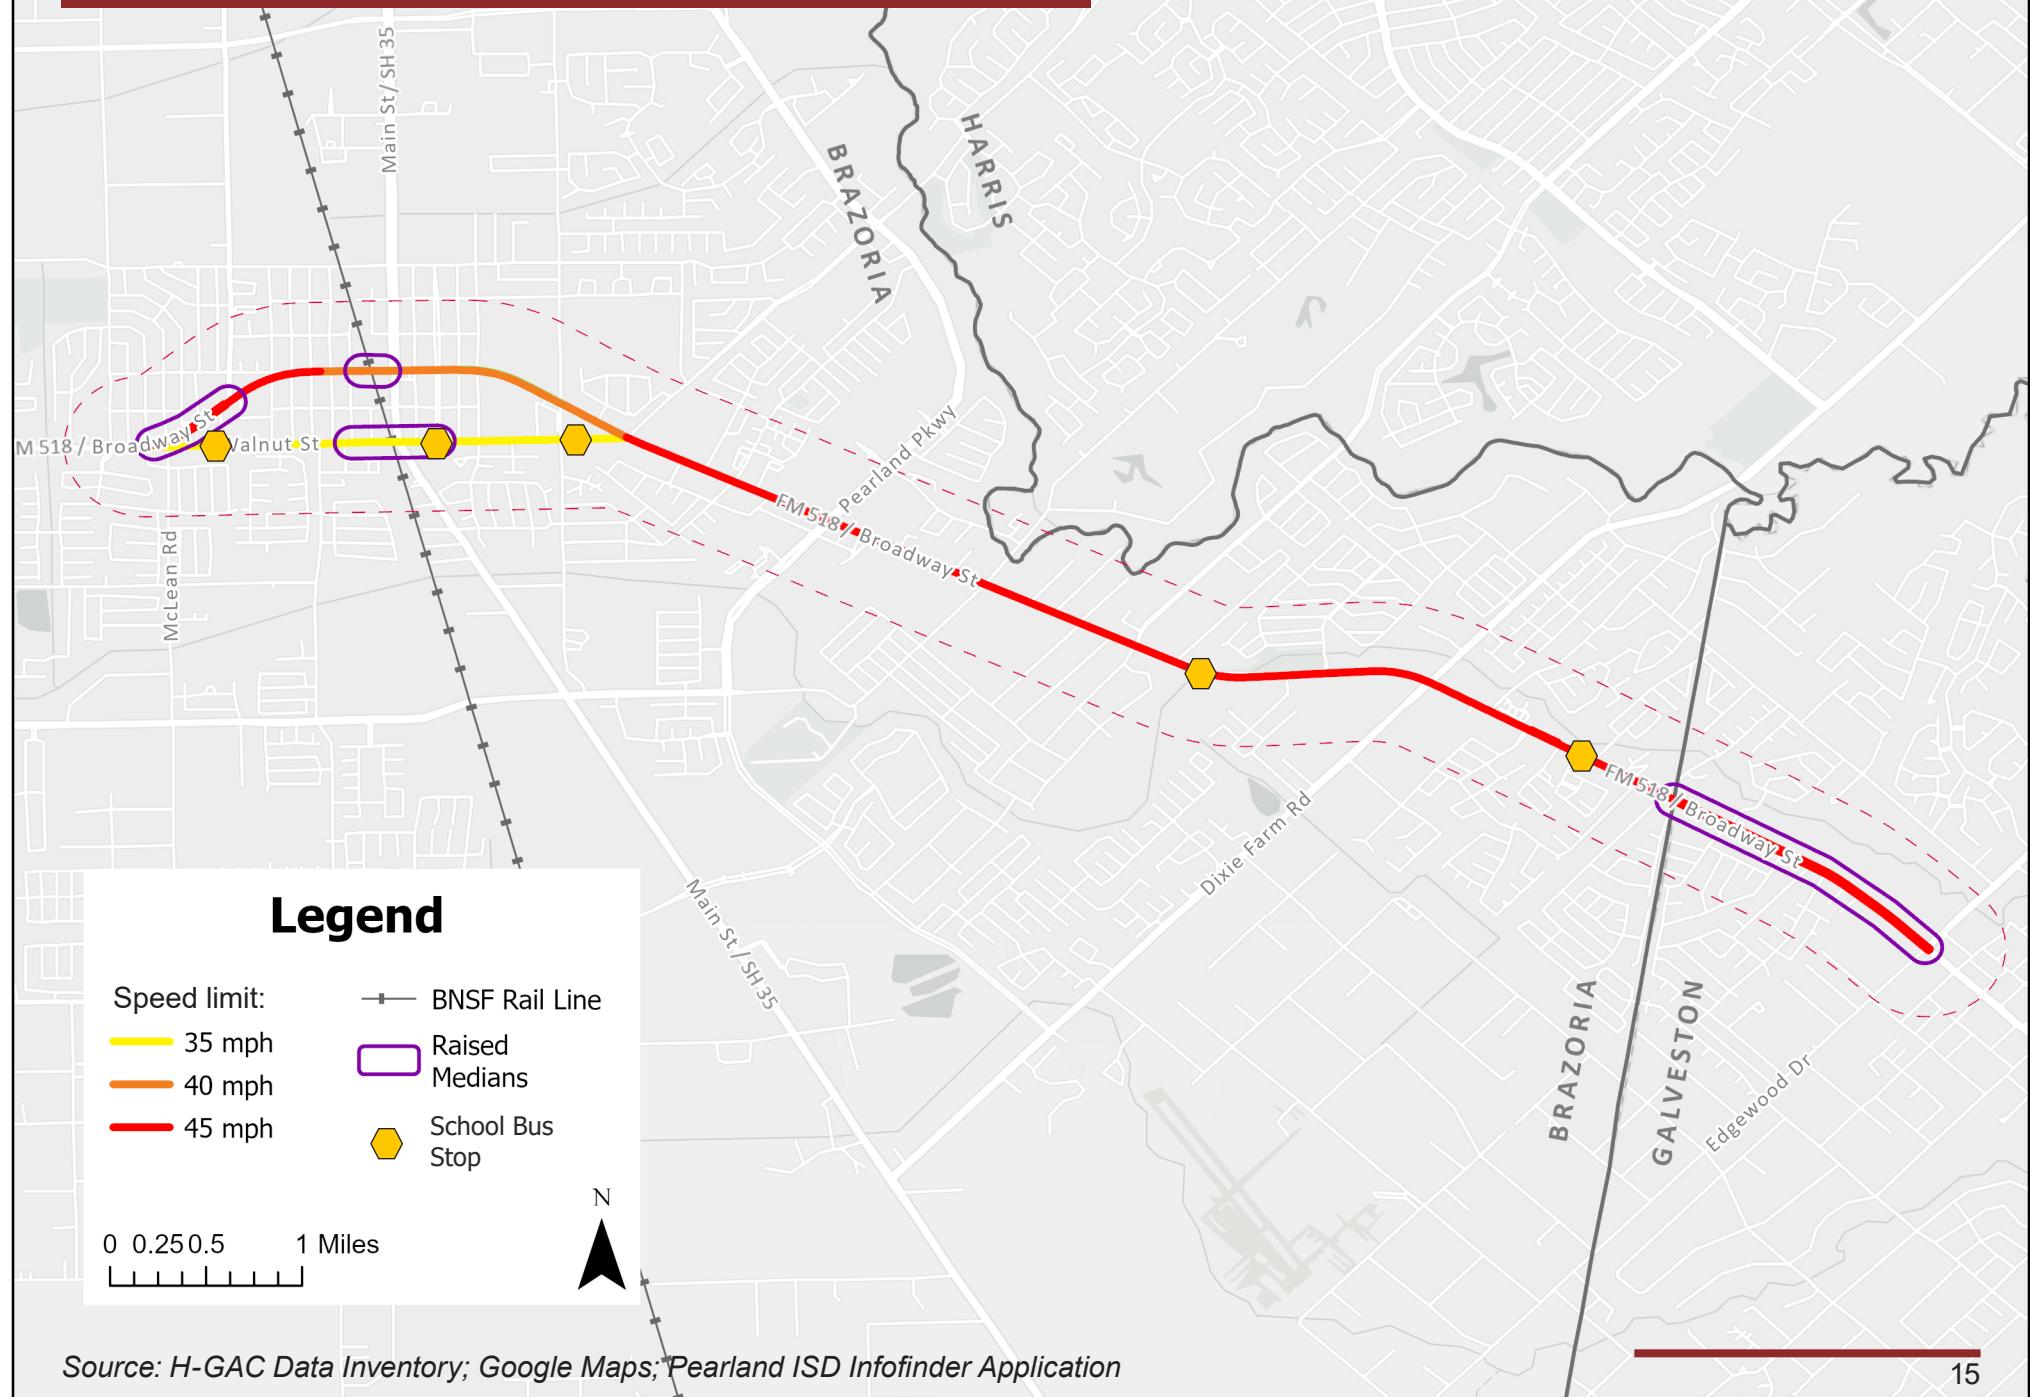
Figure 4: Raised Medians, Speed Limits, Bus Stops, and Railroad

School buses stop at five locations along the corridor. There are 11 bus routes that have scheduled pick up times between 6:25 and 8:00 in the morning and drop off times between 2:50 and 4:10 in the afternoon. Figure 4 illustrates the locations of bus stops along with other additional roadway characteristics.

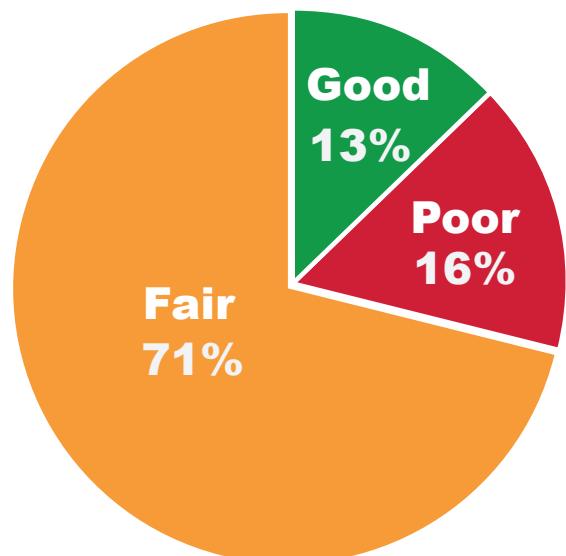
Figure 5: Pavement Conditions

The TxDOT Houston District provided 2024 pavement condition data for the FM 518 (Broadway Street) roadway. Walnut Street is a locally owned road and does not have pavement condition data available. Using the International Roughness Index (IRI), a measure that summarizes pavement qualities that impact vehicle suspension movement, roughly 13% of the corridor is in good condition, 71% is in fair condition and 16% is in poor condition.

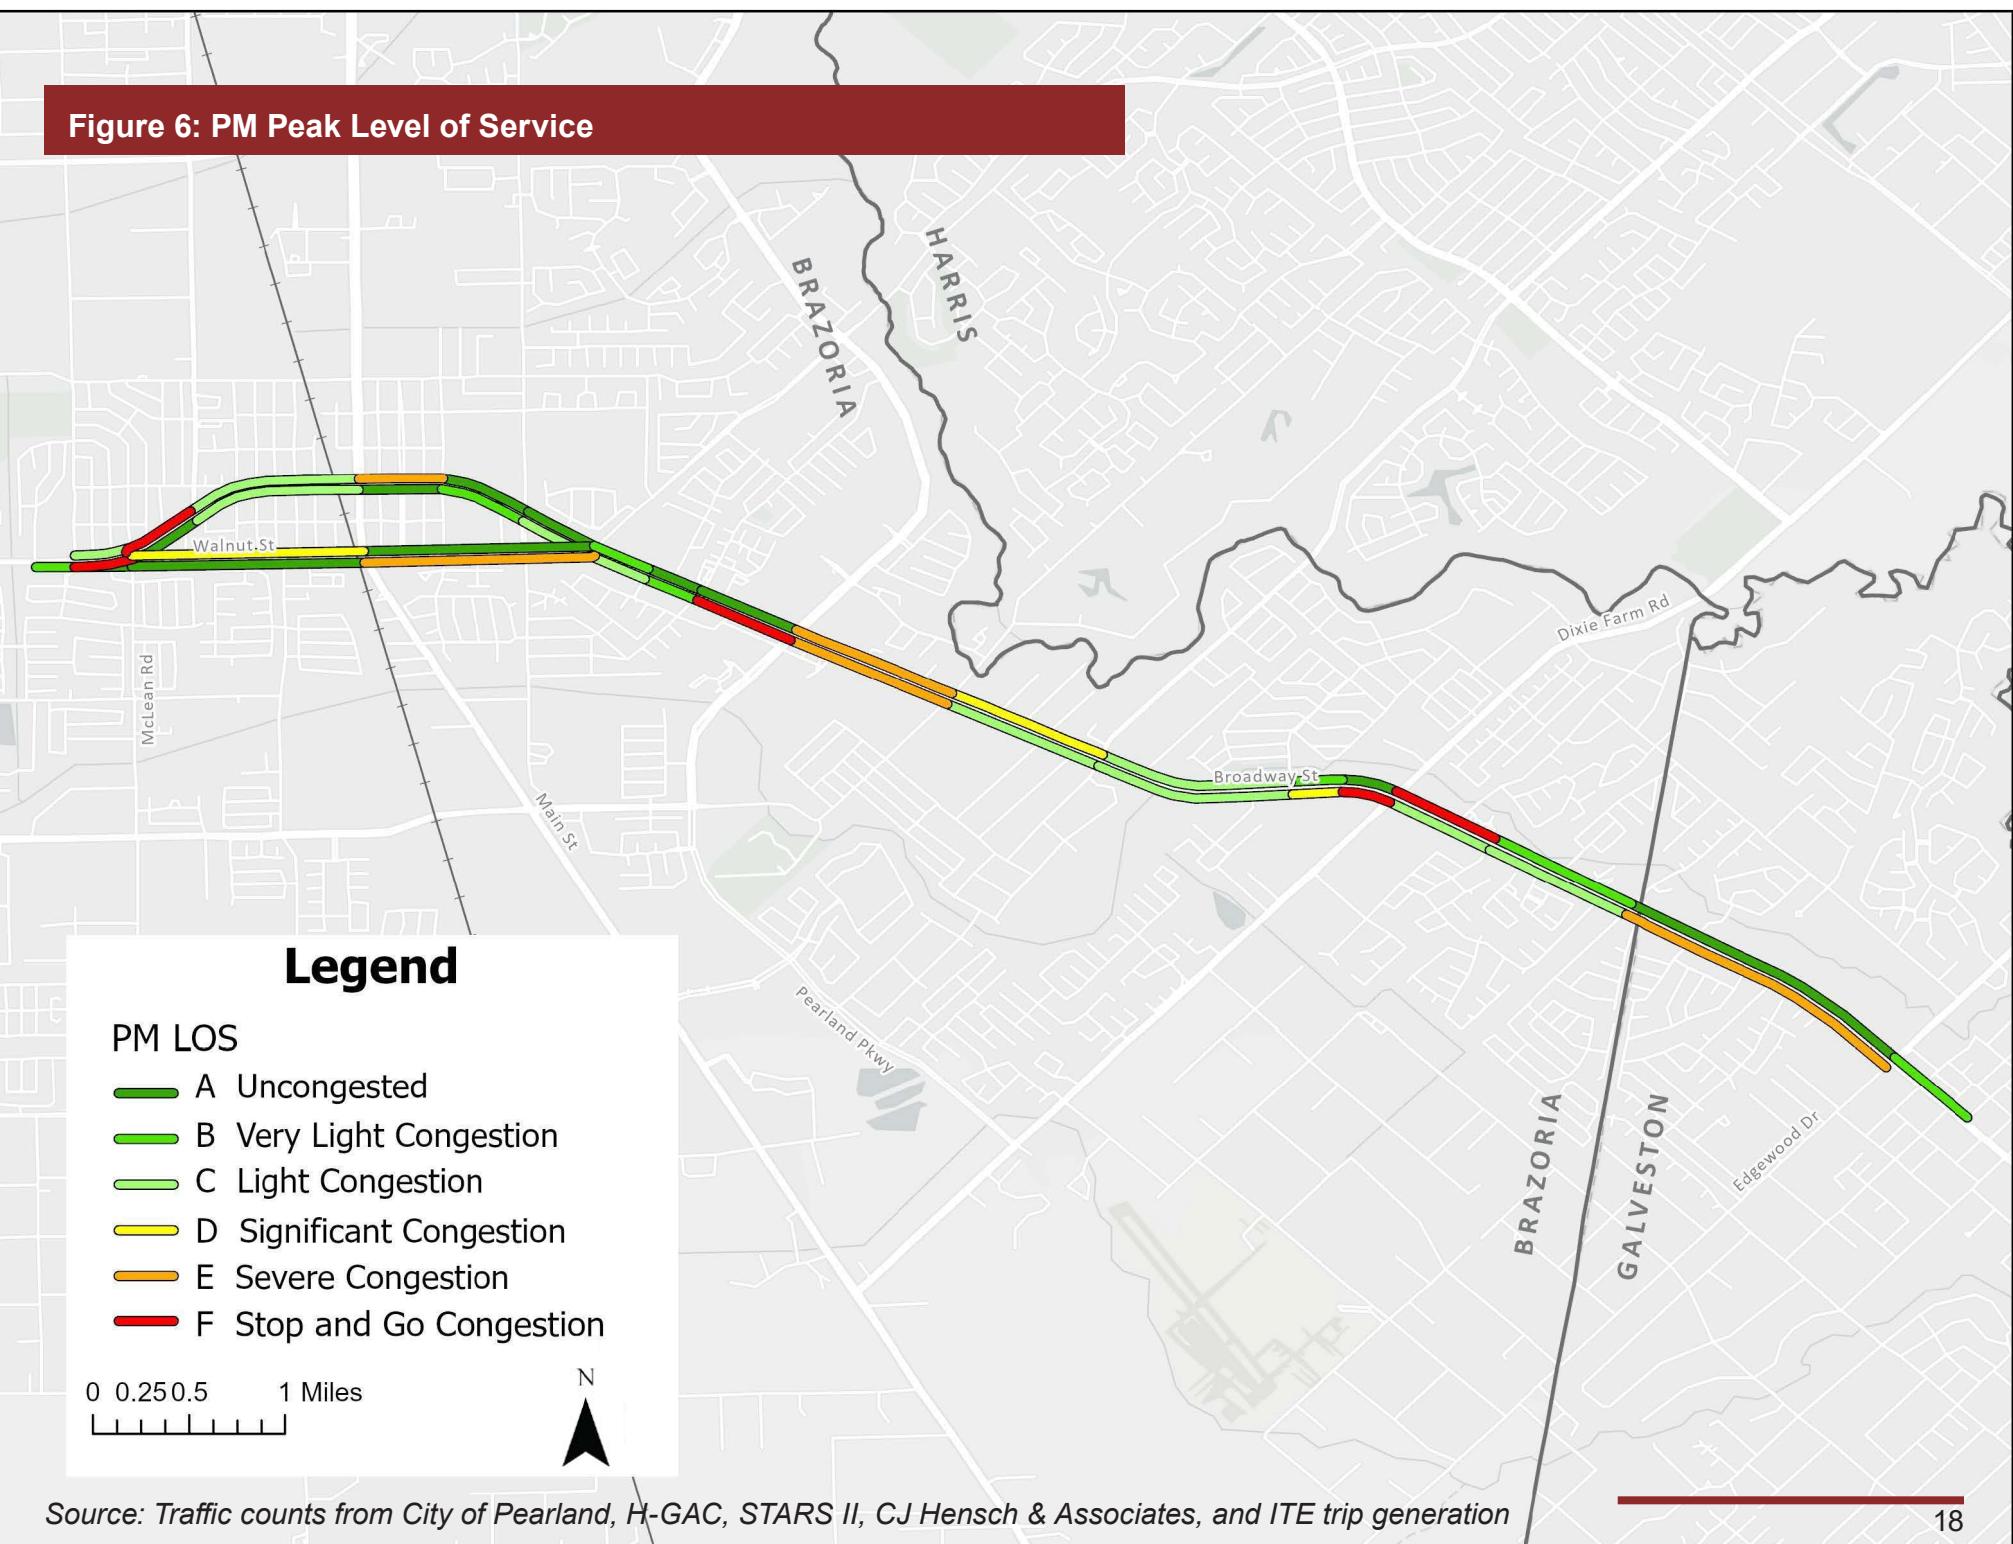
Figure 6: PM Peak Level of Service

Level of Service (LOS) is a method to convey the quality of traffic flow, categorized into six levels based upon speed and travel time, freedom to maneuver, traffic interruptions, comfort, and convenience. Generally, the minimum acceptable LOS is 'D' or better. Figure 6 on page 18 shows the LOS of segments along the corridor at the PM peak period.

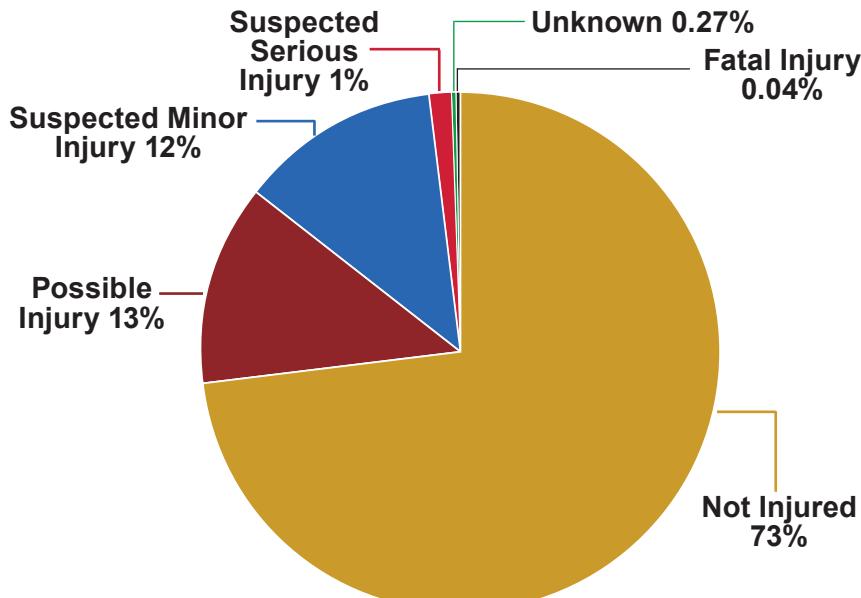
Figure 7: Total Crashes by Severity

A road safety analysis was conducted in accordance with Highway Safety Manual (HSM) procedures to diagnose safety issues. Crash data was obtained from TxDOT's Crash Record Information System (CRIS) for the recent seven-year period (2017-2023) which reported 2,231 crashes involving 6,620 persons resulting in a seven-year crash cost of over \$166 million. Assuming an average daily traffic volume of 26,500 vehicles per day, the corridor has a crash rate of 487 traffic crashes per 100 million vehicle miles. This is nearly twice the statewide average for urban FM roads.

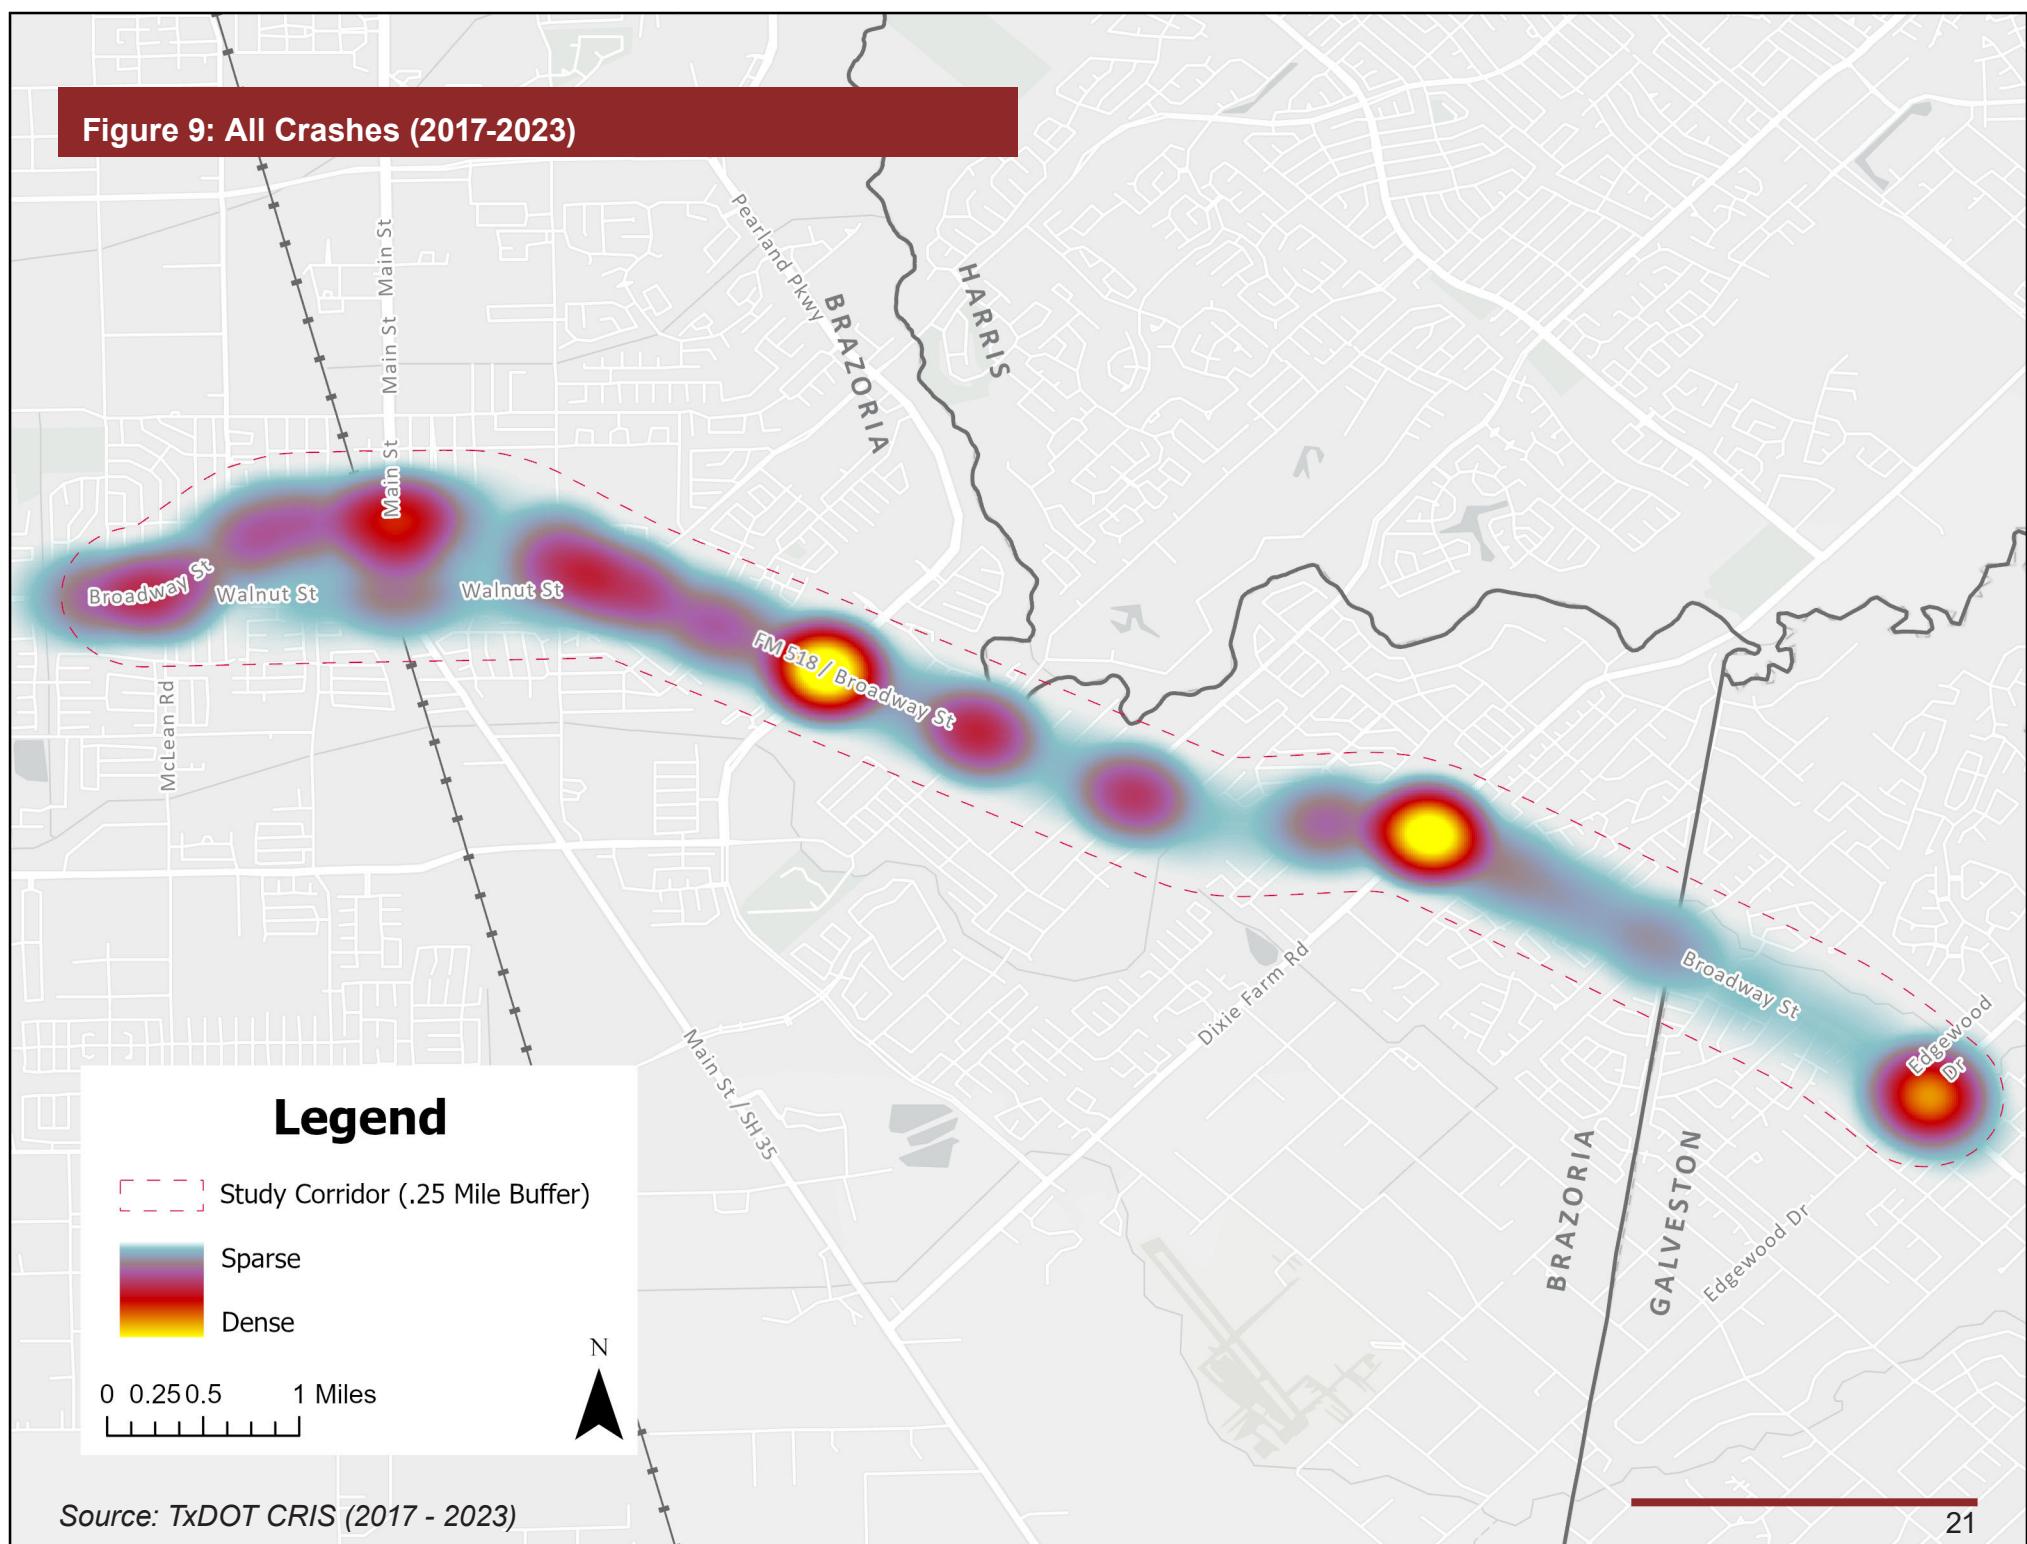
Figure 9: All Crashes (2017-2023)

The crash analysis found that over 55% of total crashes were reported at the 20 signalized intersections, and that around 35% of total crashes occurred within 250' of the top seven highest crash intersections (ranked by crash cost). Each of the seven signalized intersections have total crash costs of over \$4 million, and are listed in Table 3. Table 4 shows corridor crash history details for all types of crashes, and a crash hotspot map can be seen in Figure 9.

Note: Crash rates for short segments beyond (but within 0.25 miles of) the corridor limit are not displayed because the crash rate is inflated over small distances, and therefore does not provide an accurate representation of safety performance
