FM 518 Corridor Study

Pearland, Texas

July 2025

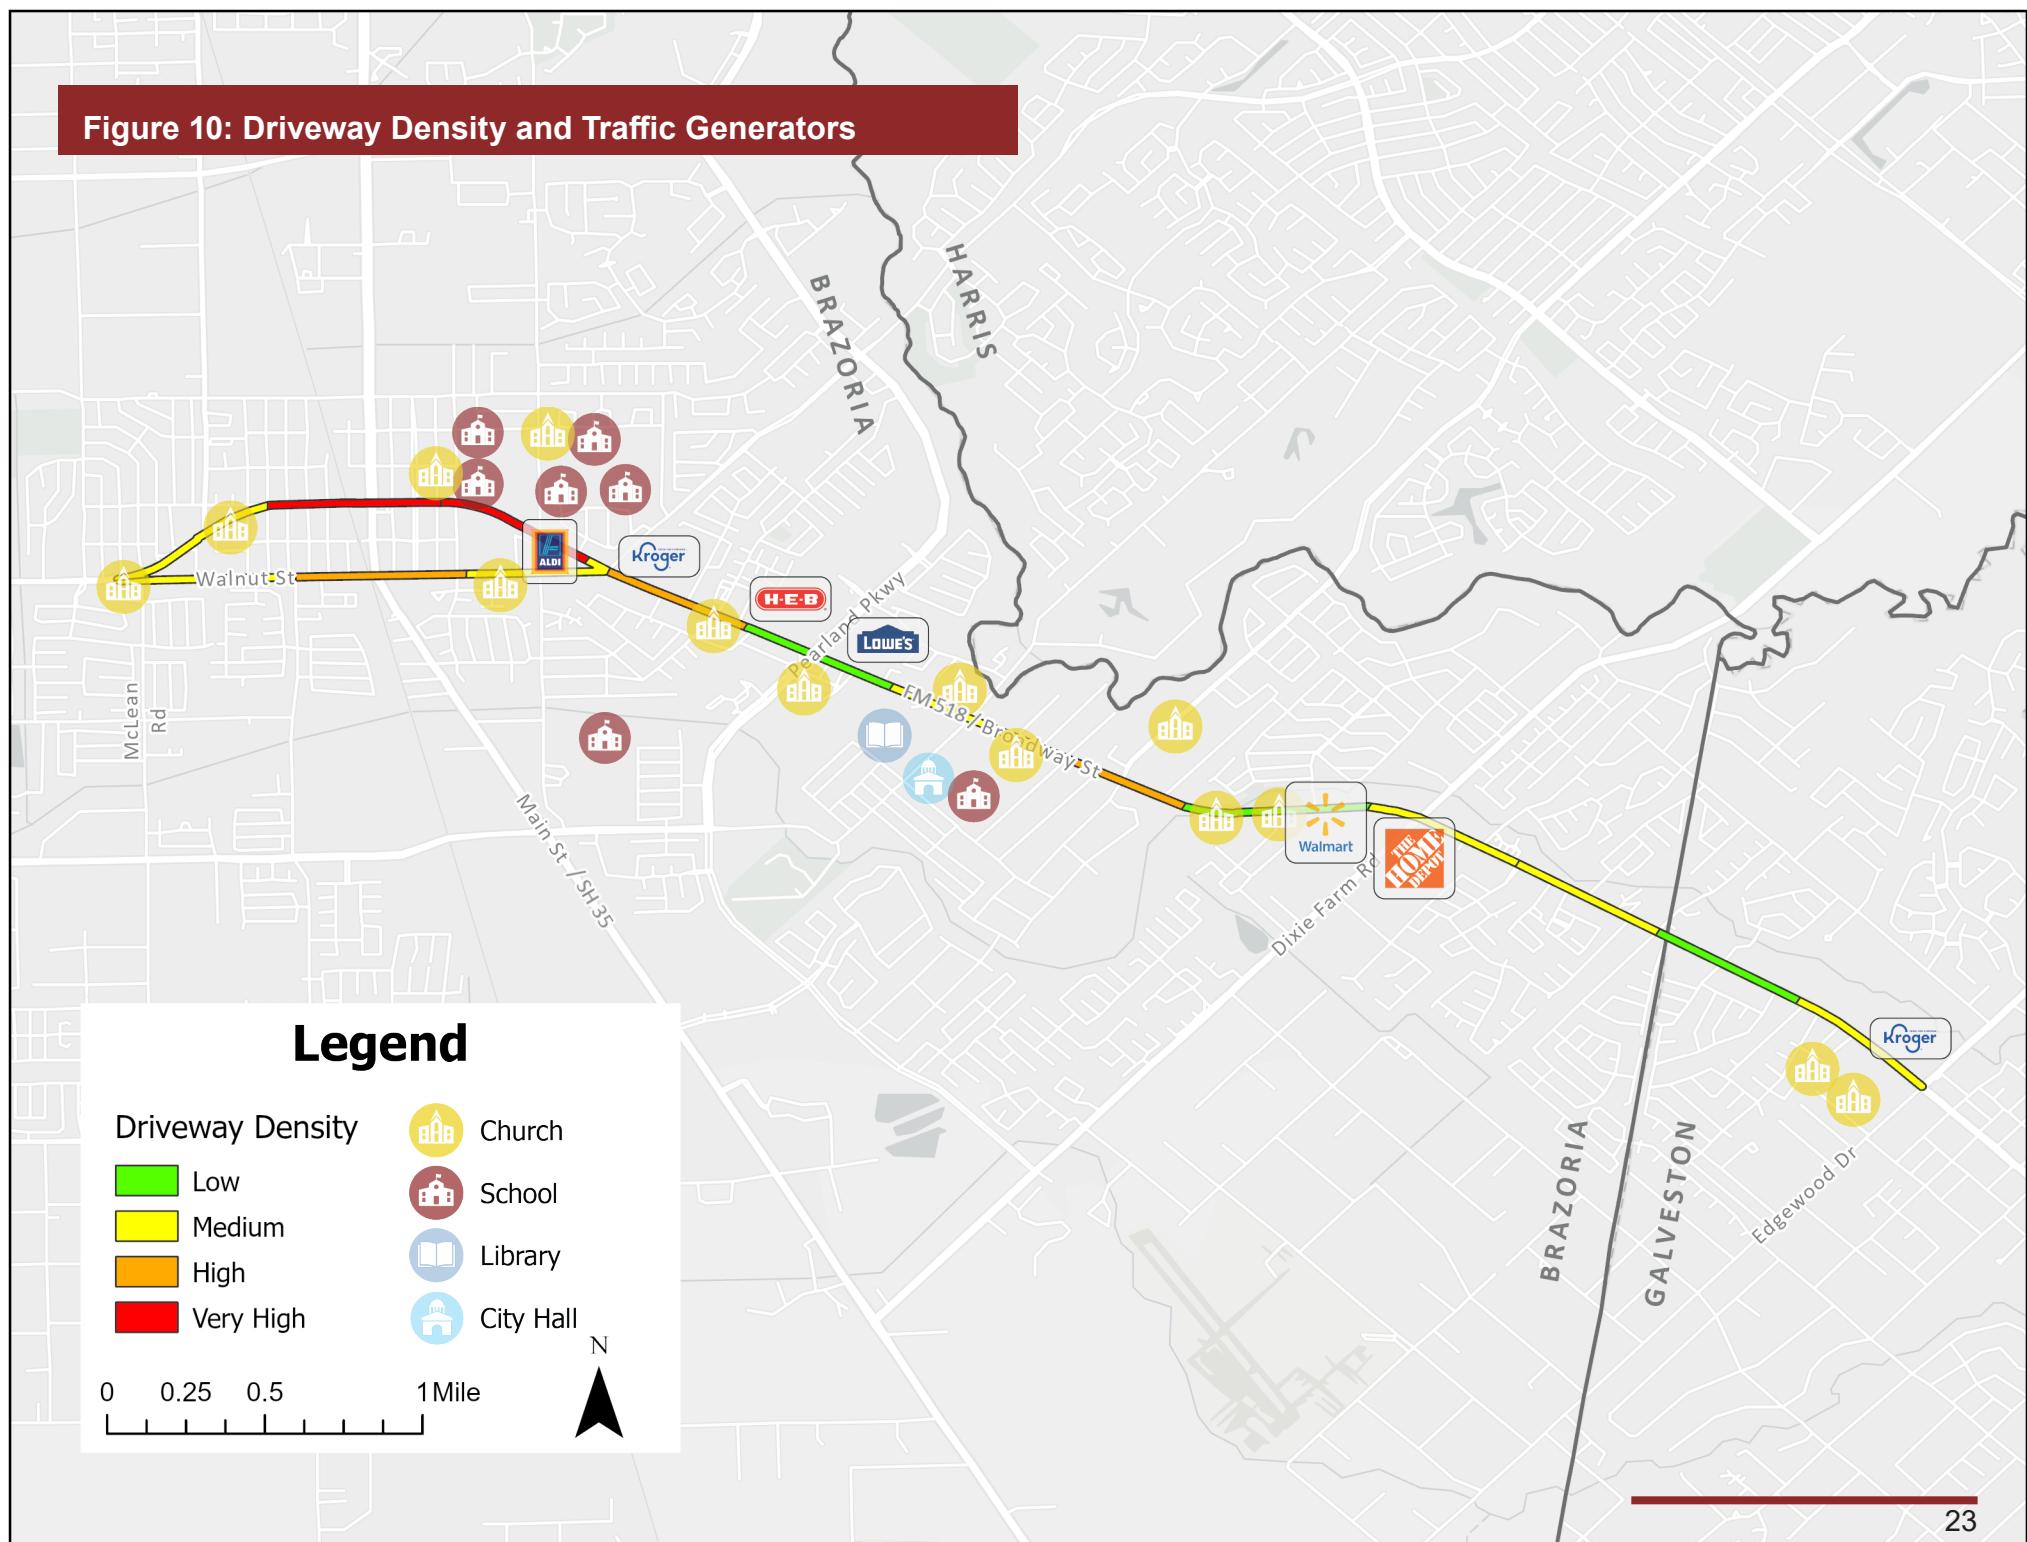
Figure 10: Driveway Density and Traffic Generators

Driveway locations along FM 518 (Broadway Street) were identified via Google Street View, and their density calculated per 0.5 mile segment to identify areas of concern, as shown Figure 10. There is approximately one mile of the corridor classified as a very high driveway density, which runs through Old Townsite on either side of Main Street/SH 35. Major retailers and traffic generators are also shown, which require a balance between adequate access and driveway corridor access management strategies.

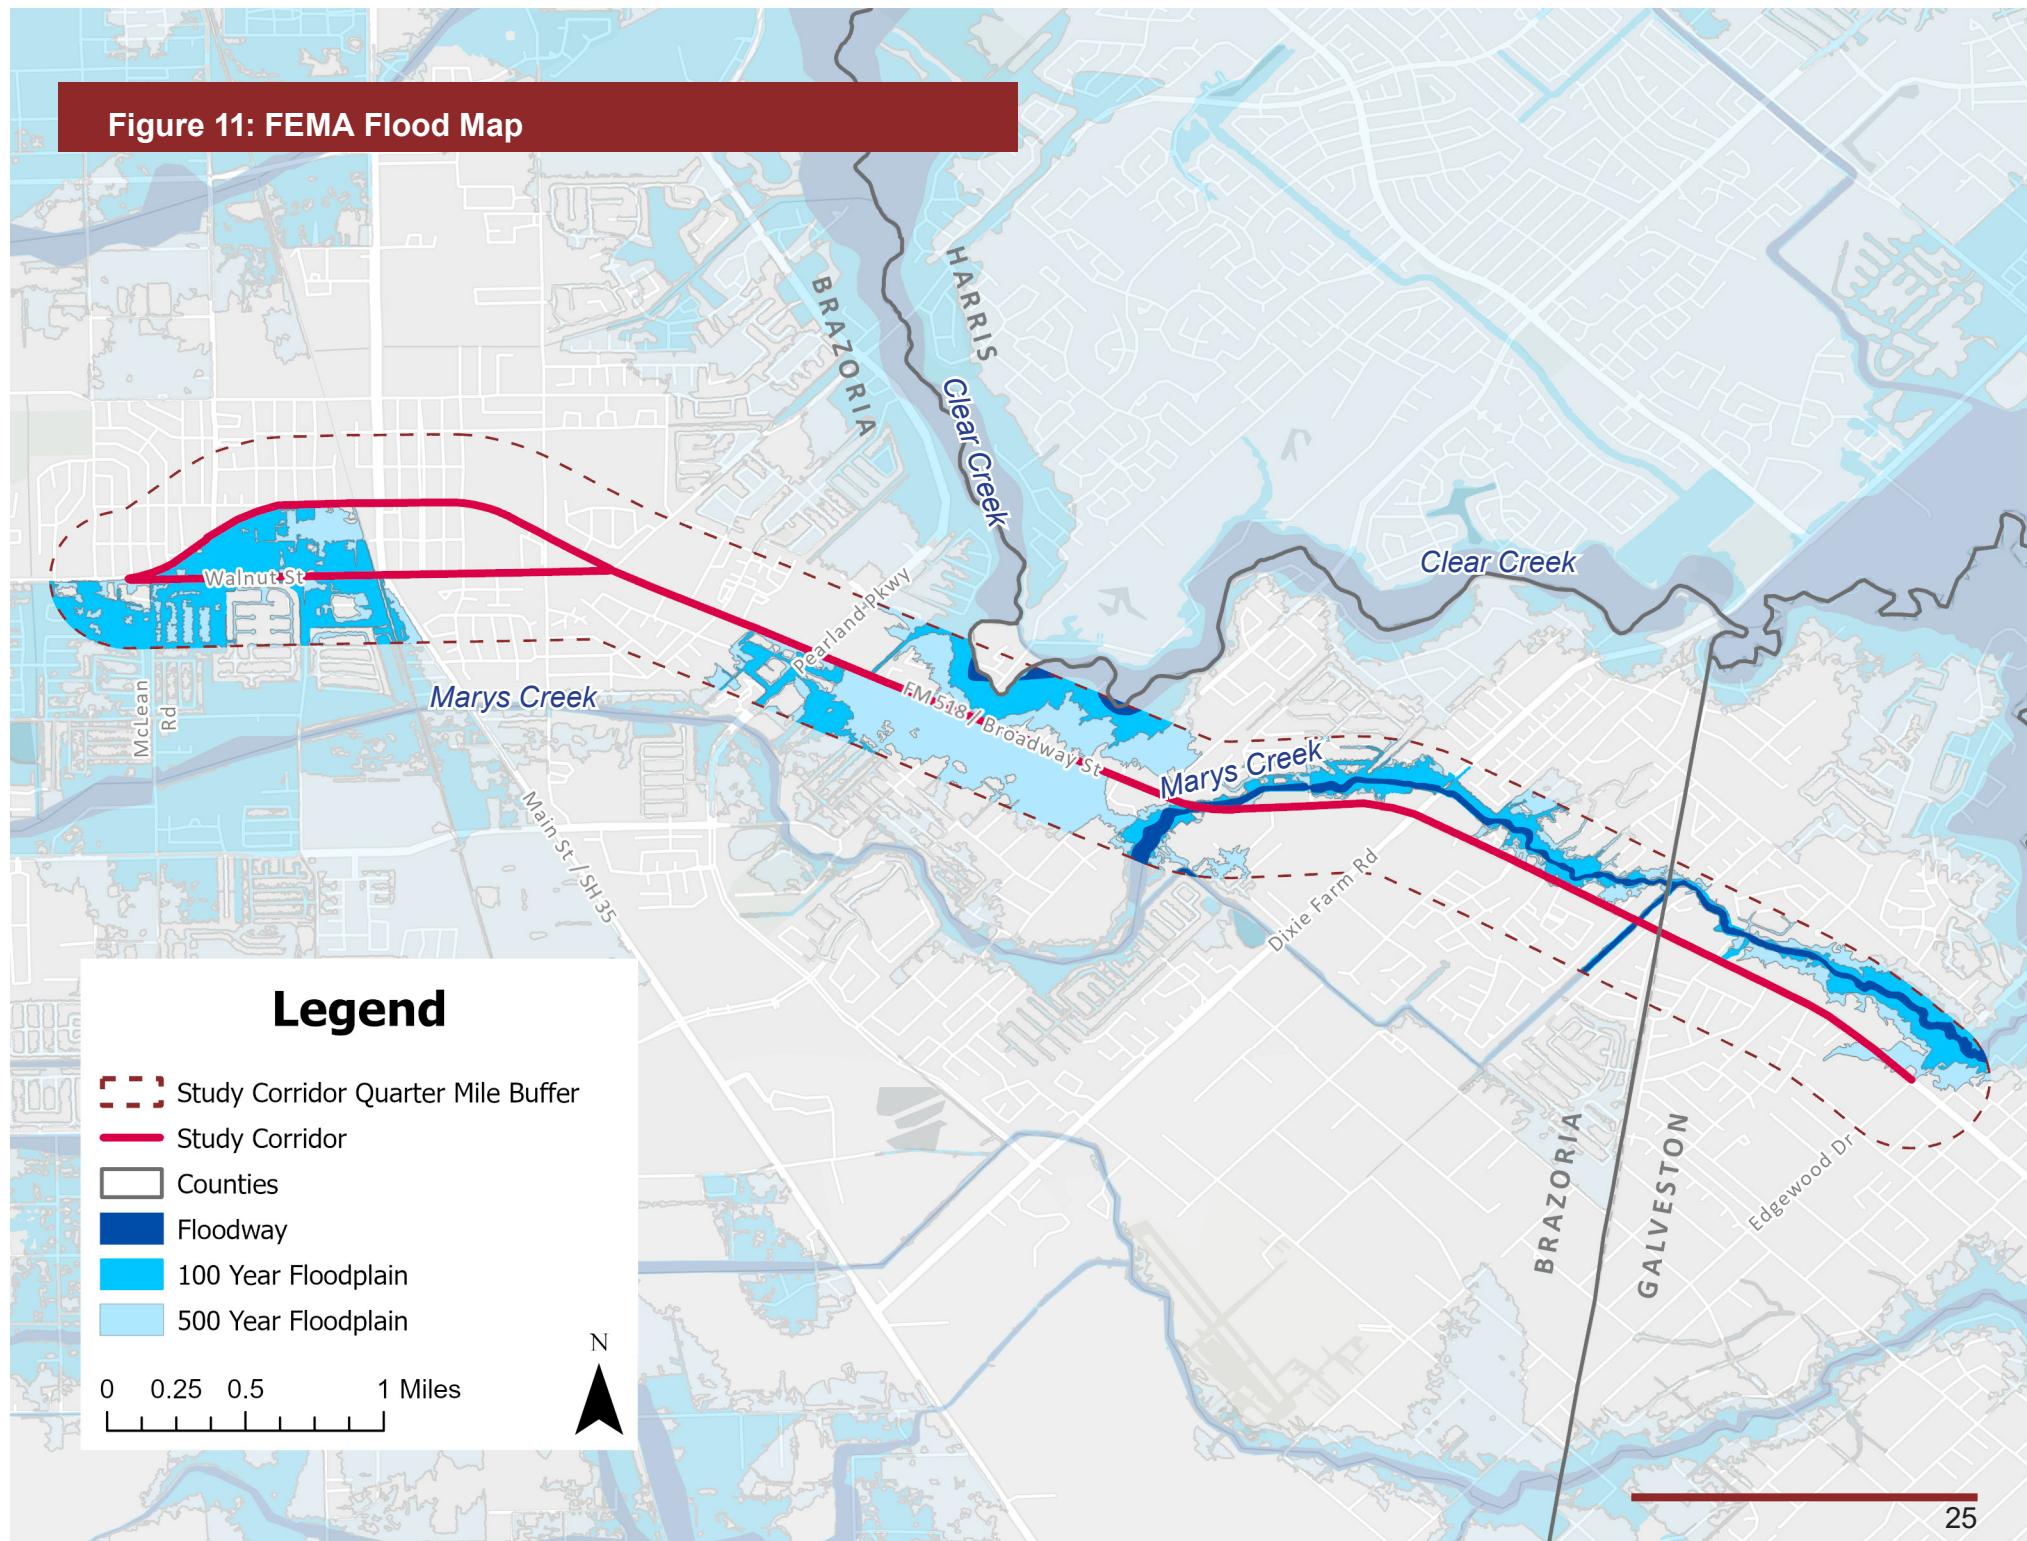
Figure 11: FEMA Flood Map

There are two creeks that intersect with the study area: a small portion of Clear Creek on the northern side, and Marys Creek on the eastern side. There are also several ditches and small ponds within the study area. These water features can support wetland habitats and are important for wildlife and stormwater management. For this reason, all future projects must consider potential impacts to environmental features. In addition, Figure 11 shows that much of the corridor is at risk of flood hazards.

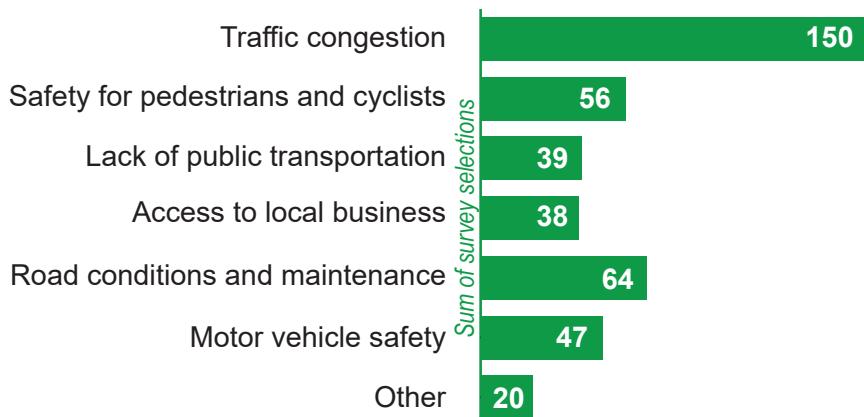
Figure 16: Top Concerns for the FM 518 Corridor

The majority of respondents also indicated that the following transportation issues are of concern to them: safety, road maintenance, traffic congestion, and a lack of connectivity, sidewalks, and public transportation options. By far, the main concern of survey respondents for the FM 518 Corridor was traffic congestion (Figure 16). The survey results also show that most respondents are in favor of improving signal timing along the corridor.

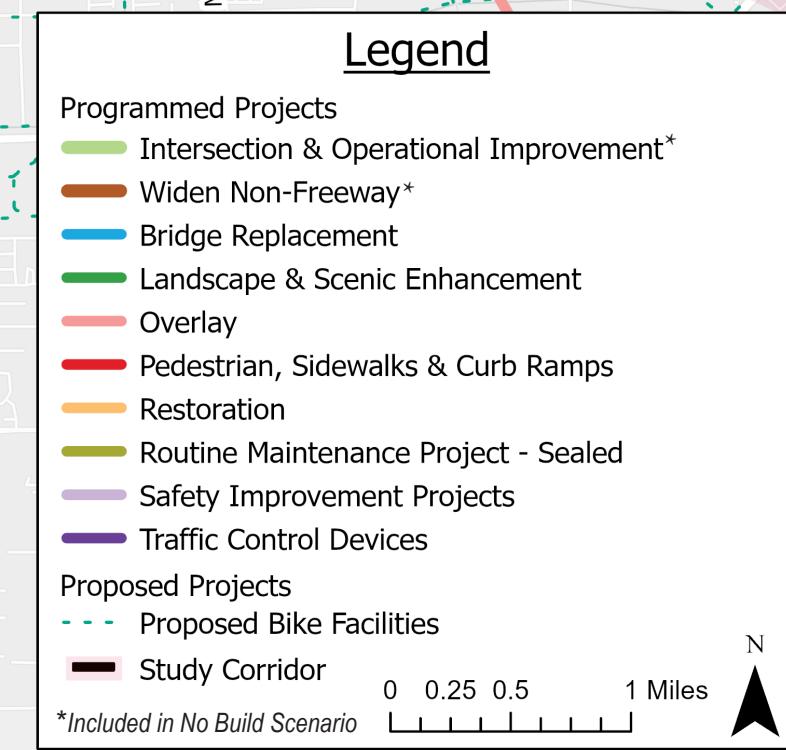
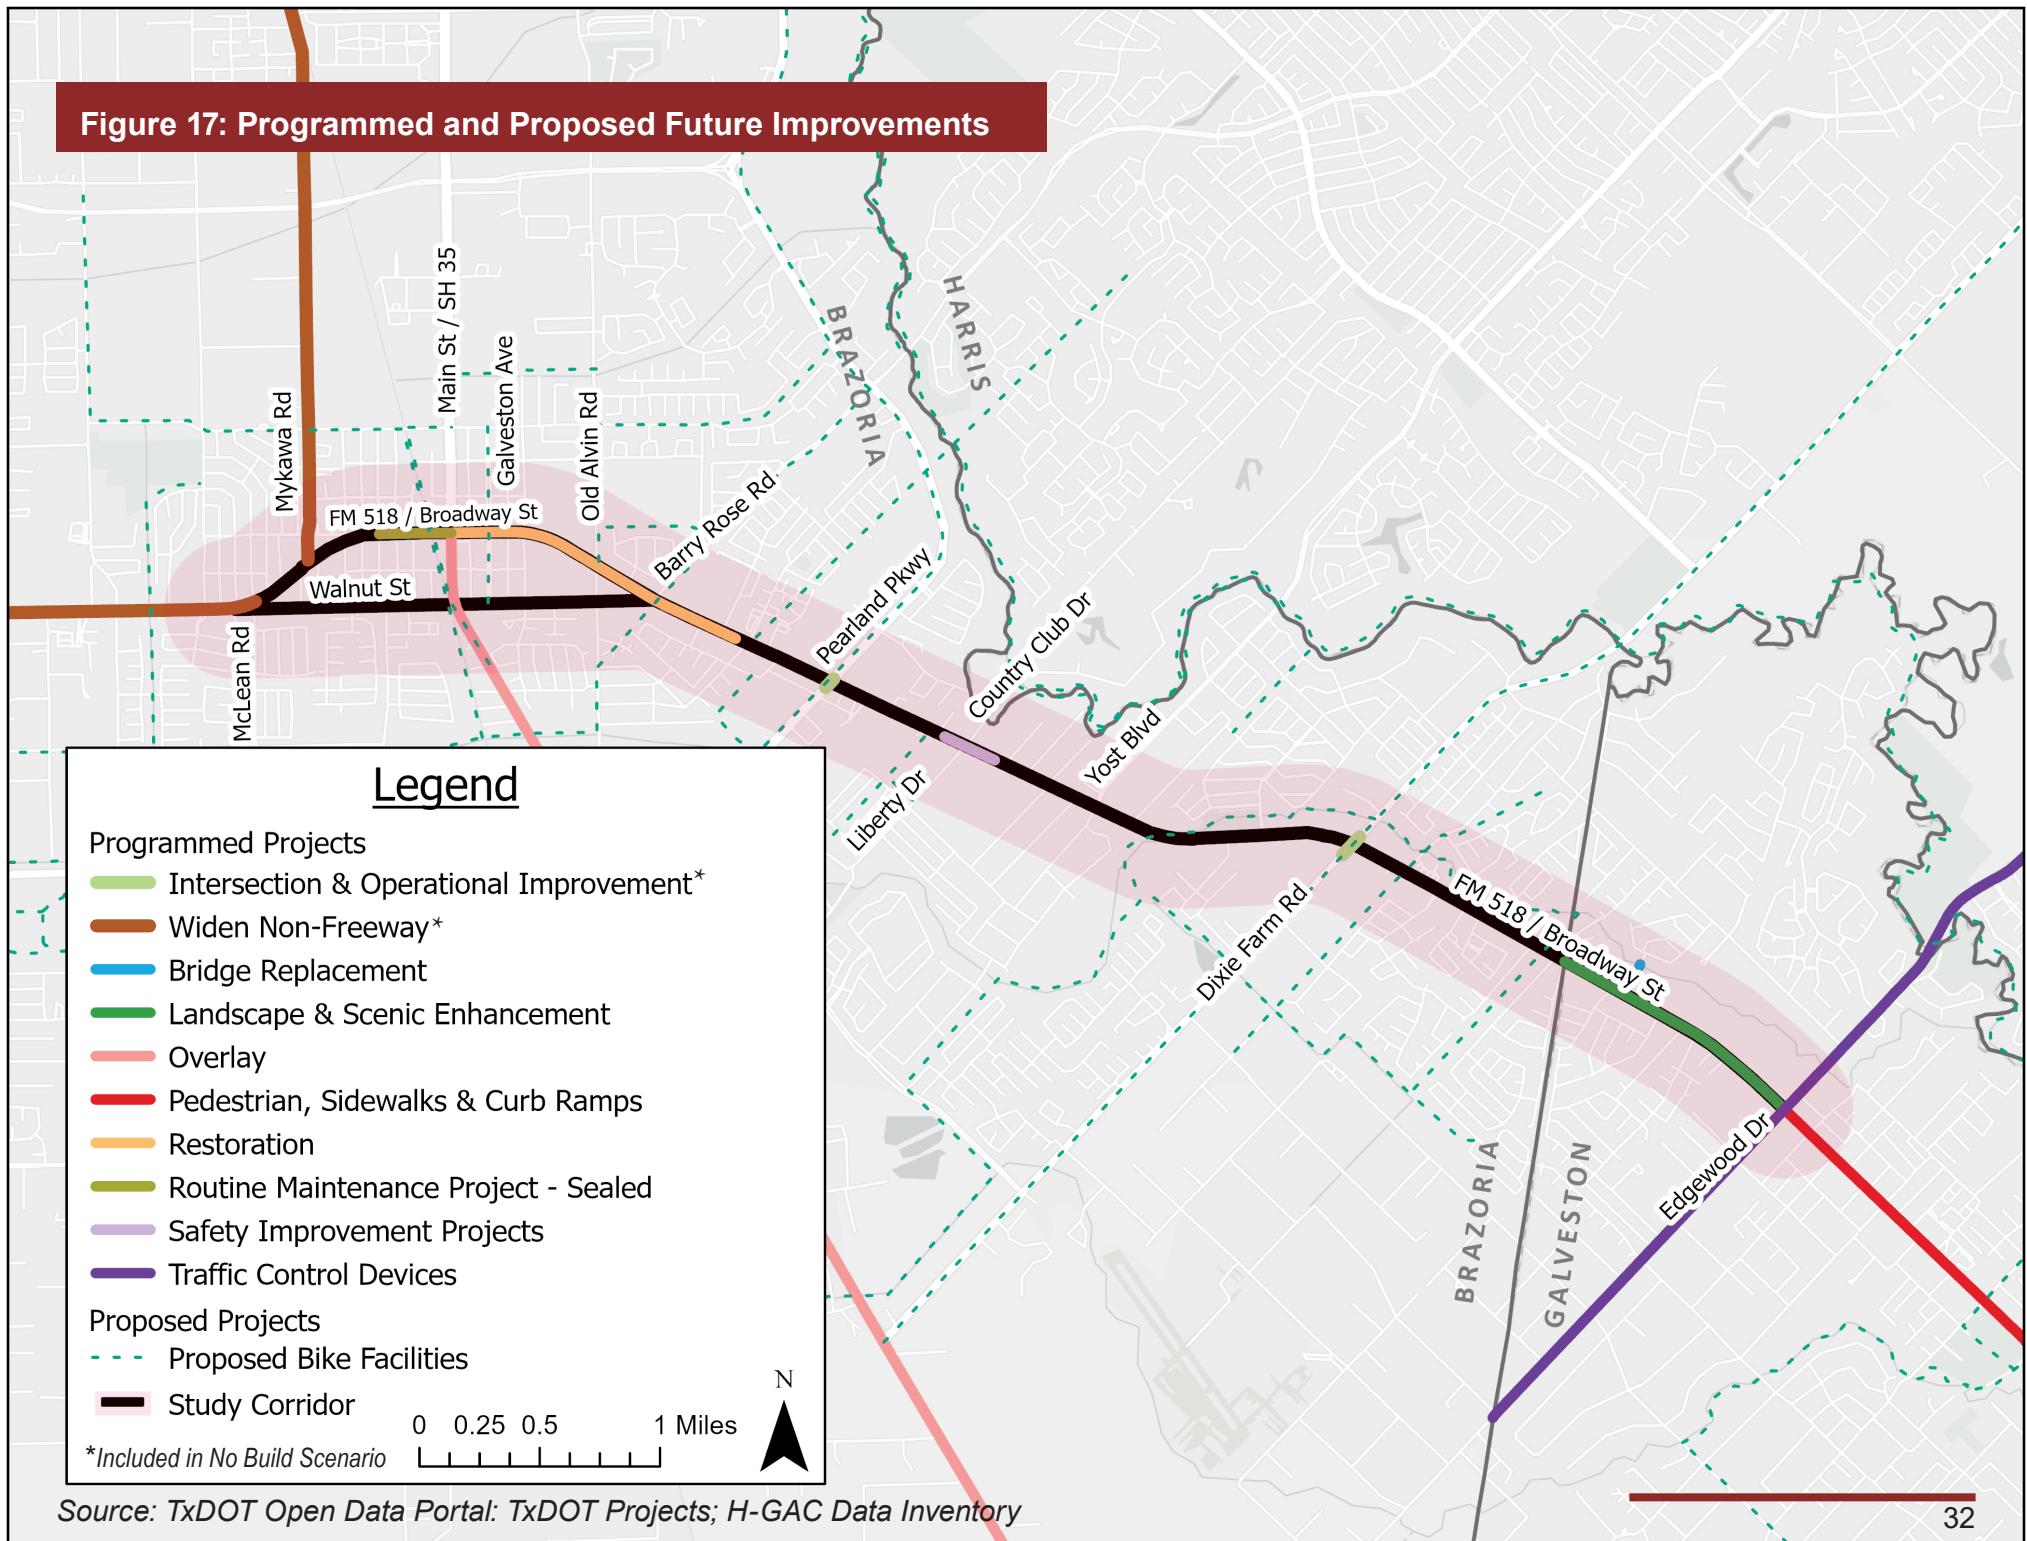
Figure 17: Programmed and Proposed Future Improvements

According to the TxDOT Project Tracker, there are several newly completed or planned projects within or in close proximity to the study area (see Figure 17). Examples include:

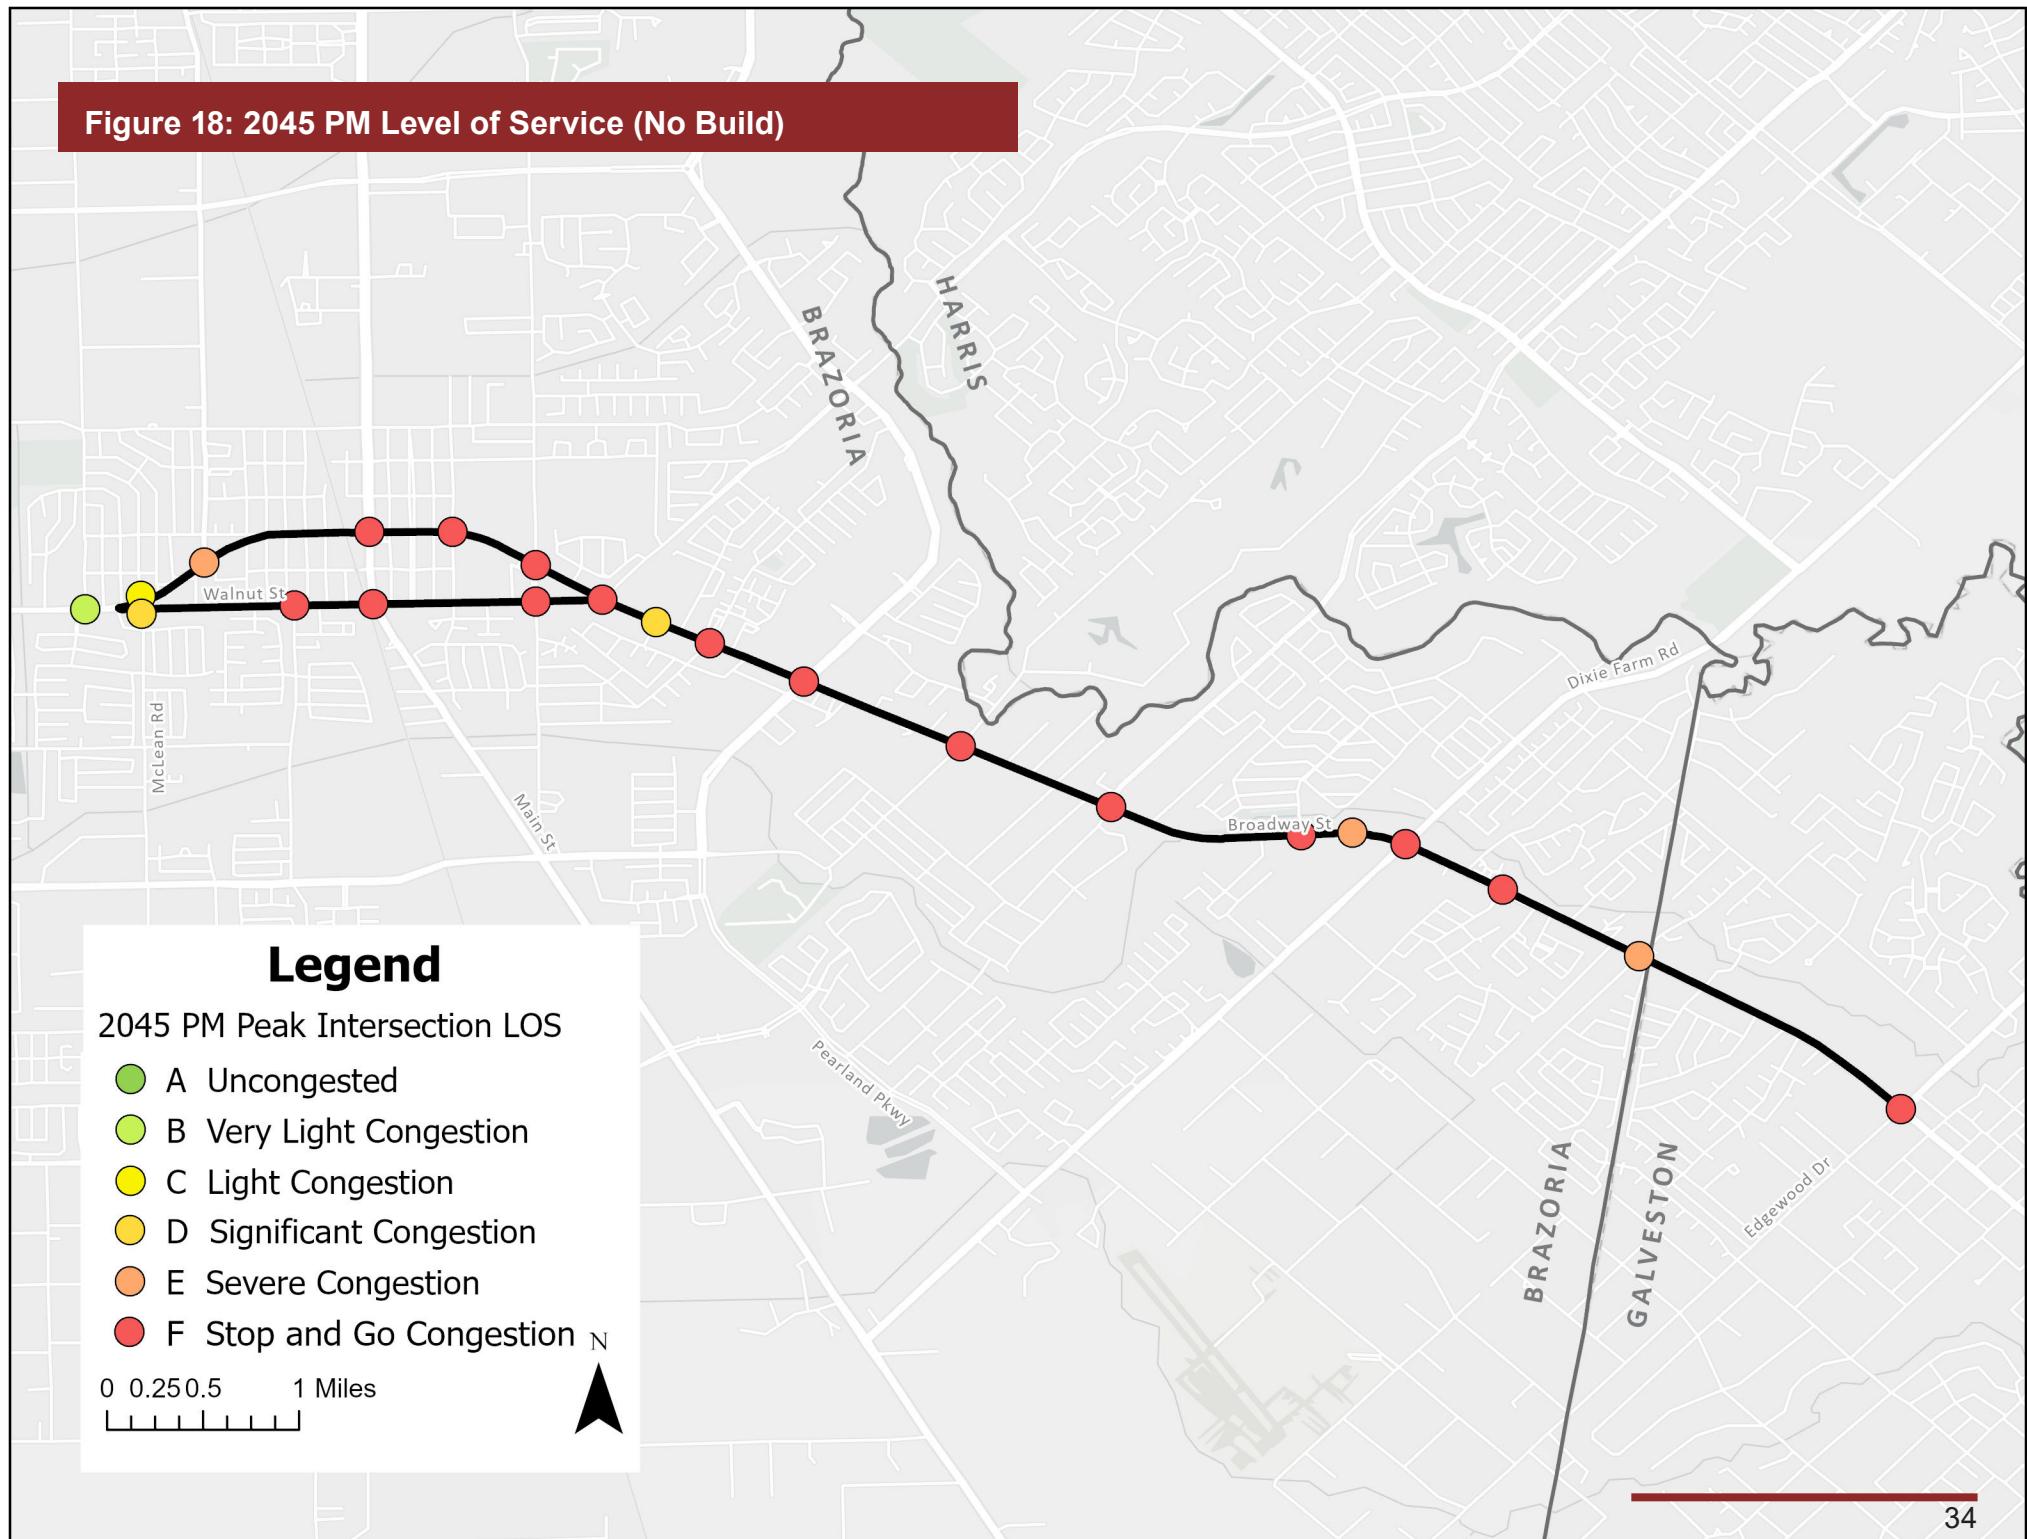
Figure 18: 2045 PM Level of Service (No Build)

With the projected volume increase and assumptions previously described, traffic conditions can be expected to significantly worsen over time (Table 5). In the 2045 No Build peak AM period, over half of the intersections are projected to operate at a LOS of E or F. For the 2045 No Build, peak PM period almost all of the signalized intersections are expected to operate at a LOS of D, E, or F. The considerable change in LOS from the existing conditions demonstrates that if no additional improvements are made to the corridor, severe congestion and stop-and-go traffic will be a major issue, especially in the afternoons and evenings. Figure 18 shows the PM peak period intersection level of service for the 2045 No Build scenario.

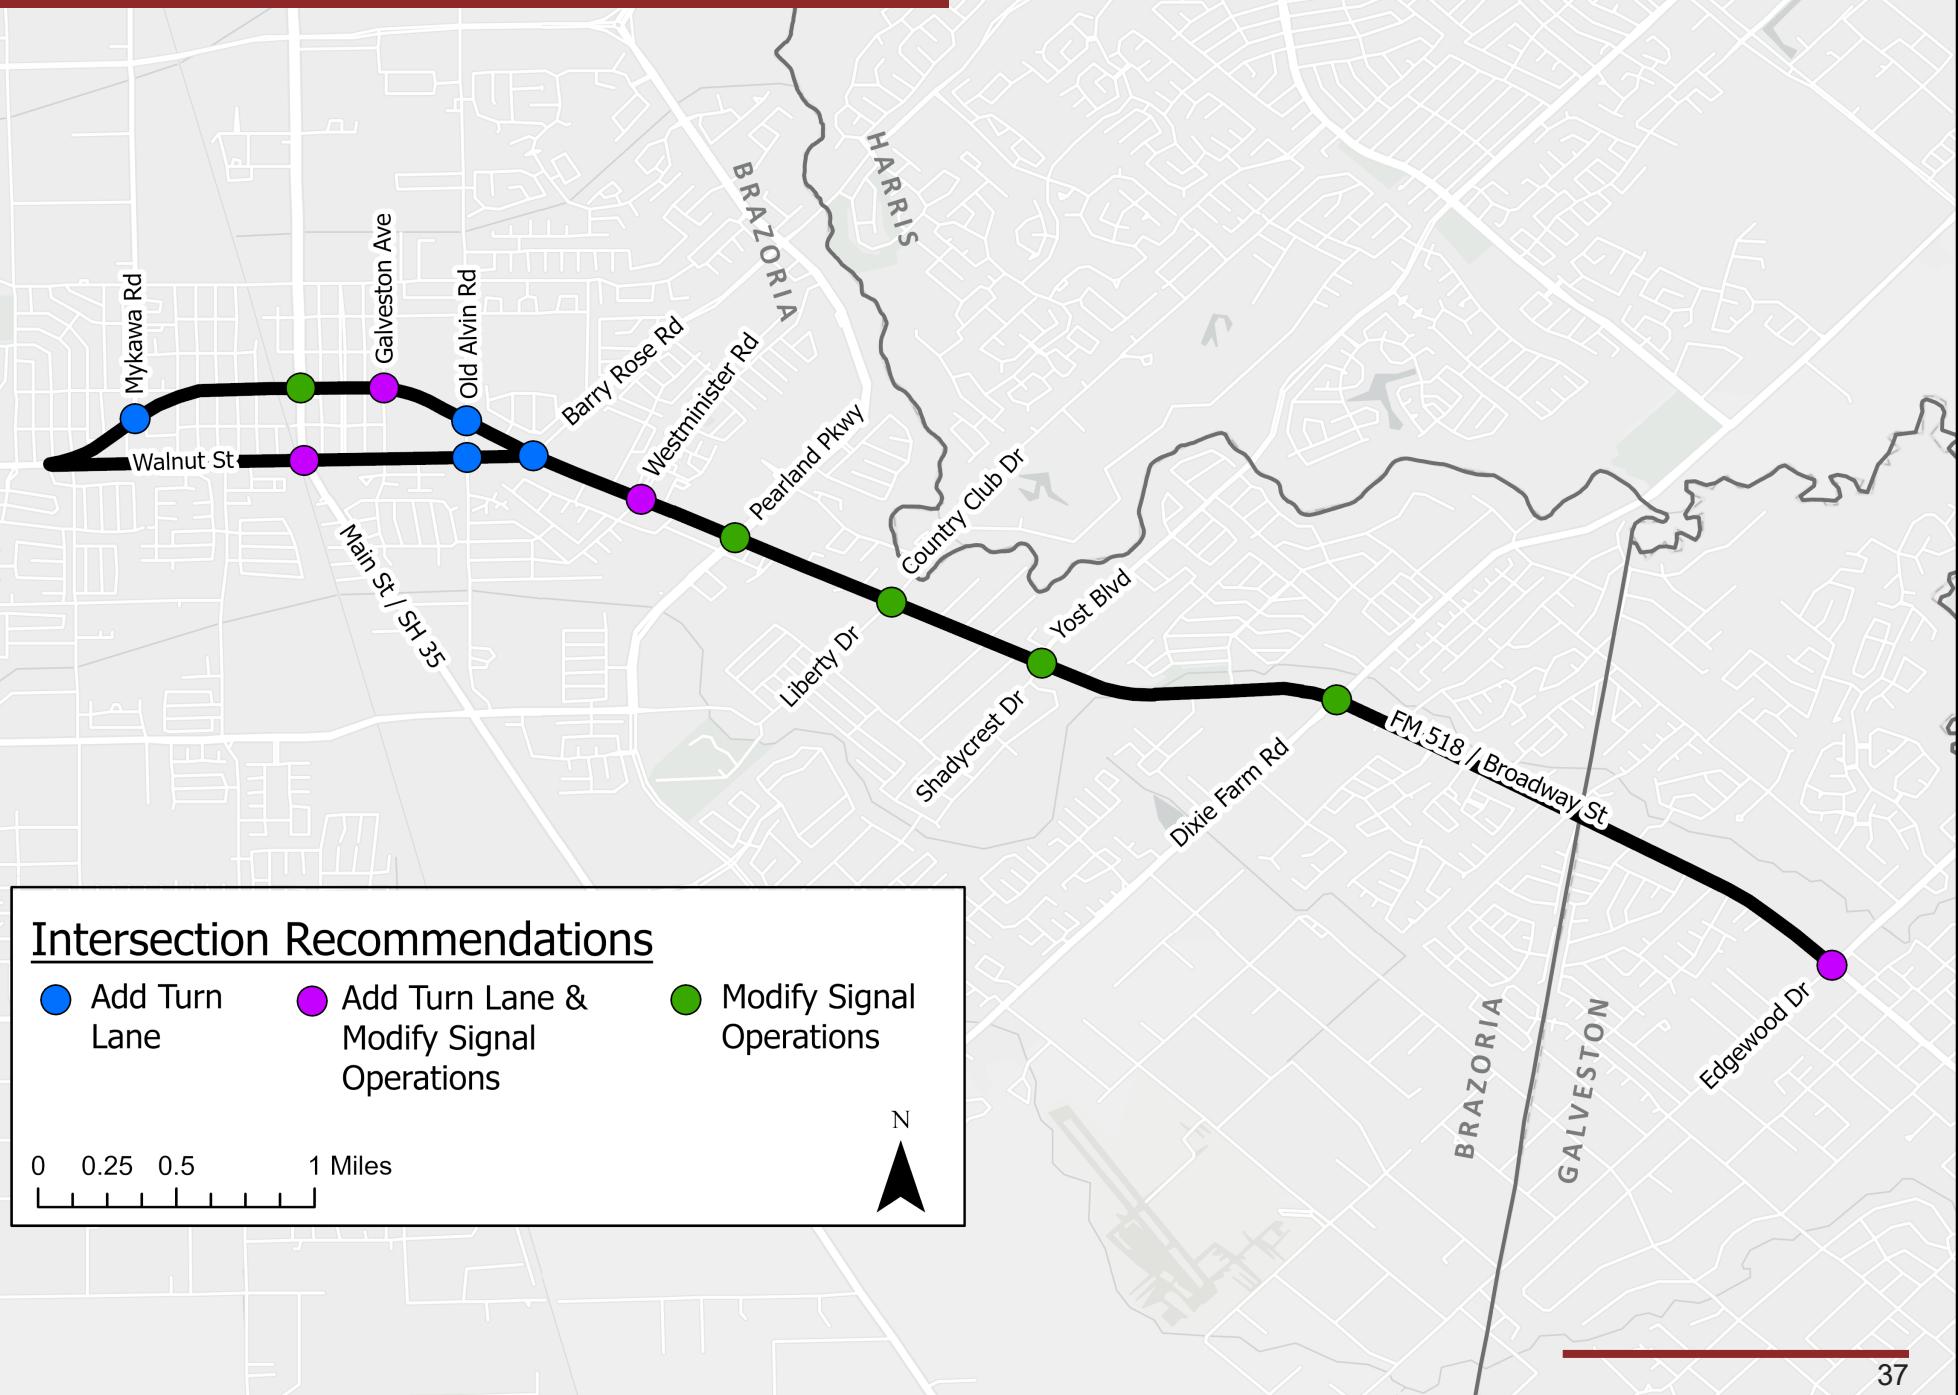
Figure 19: Intersection Improvements

Each intersection listed below contains an improvement recommendation description, impact to LOS,⁷ cost estimate, and specific safety countermeasures where appropriate.

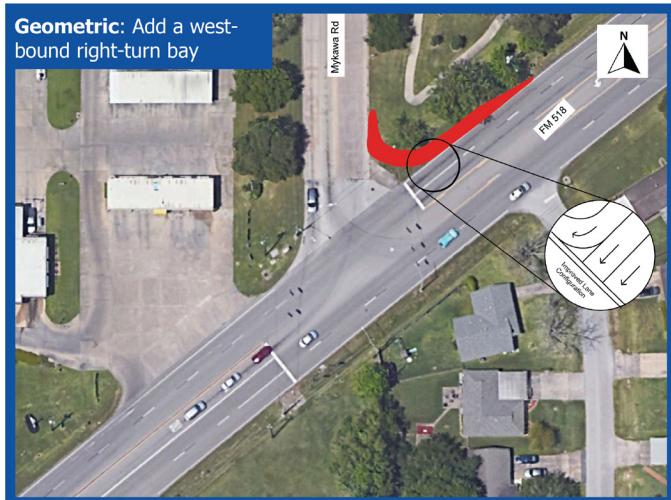
FM 518 (Broadway St) at Mykawa Road

This is a signalized three-legged intersection. The eastbound approach (FM 518) has two through lanes and a left-turn lane. The westbound approach (FM 518) has a shared through-right lane and one additional through lane. The southbound approach (Mykawa Road) has a right-turn lane and a left-turn lane. There is a proposed project that would widen Mykawa Road to 4-lanes from Beltway 8 to FM 518.

Recommendation: Add a right-turn bay on westbound FM 518. ROW is needed to make this improvement, as shown in red below. When Mykawa Road is widened, it should be aligned (squared up) with Ray Street or Johnson Street to safely accommodate the volume of turning vehicles, improve visibility, and provide more consistent and safer operations.

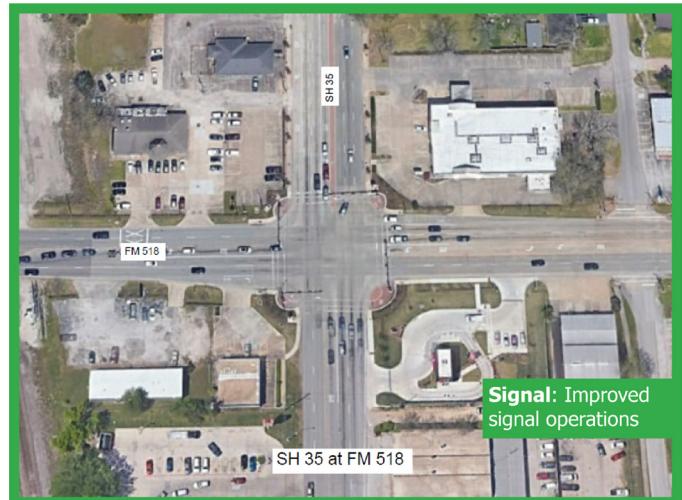
FM 518 (Broadway St) at SH 35 (Main St)

This intersection is a signalized four-legged intersection. The eastbound approach (FM 518) has one right-turn bay, two through lanes, and one left-turn bay. The westbound approach (FM 518) has one right-turn bay, two through lanes, and one two-way left-turn lane (TWLTL). The northbound approach (SH 35) has one right-turn bay, two through lanes, and one TWLTL. The southbound approach (SH 35) has one right-turn lane, two through lanes, and one left-turn bay.

Recommendation: Implement permitted/protected and lead/lag phasing for eastbound and westbound left-turns.

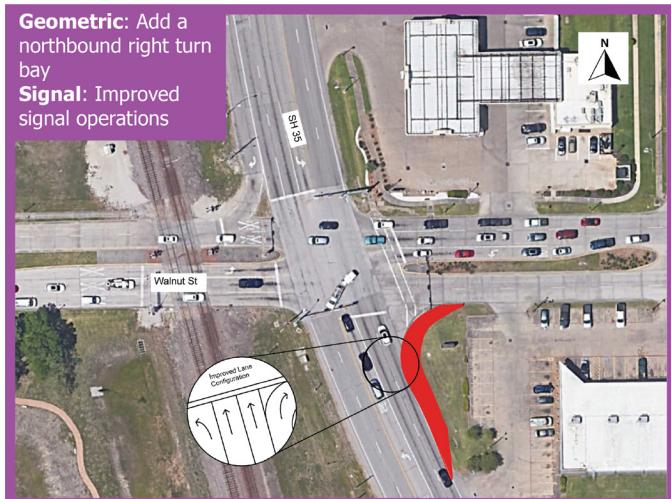
Walnut St at SH 35 (Main St)

This intersection is a signalized four-legged intersection. The eastbound and westbound approaches (Walnut St) have one shared through-right lane, one through lane, and one left-turn bay. The northbound approach (SH 35) has one shared through-right lane, one through lane, and one TWLTL. The southbound approach (SH 35) has one channelized right-turn bay, two through lanes, and a TWLTL.

Recommendation: Add a northbound right turn bay; Increase green time for southbound approach.

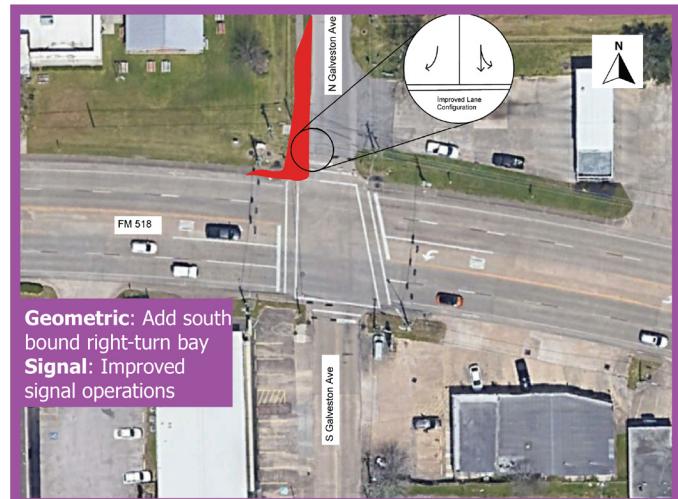
FM 518 (Broadway St) at Galveston Ave

This intersection is a signalized four-legged intersection. The eastbound and westbound approaches (FM 518) have one shared through-right lane, one through lane, and one TWLTL. The northbound and southbound approaches (Galveston Ave) have one shared lane for all turning movements.

Recommendation: Add southbound right-turn bay; Implement permitted/protected phasing for eastbound and westbound left-turn lanes. ROW is needed to make this improvement, as shown in red below.

Results: This is anticipated to provide a significant (67%) improvement during the AM peak period. Additional ROW is needed.

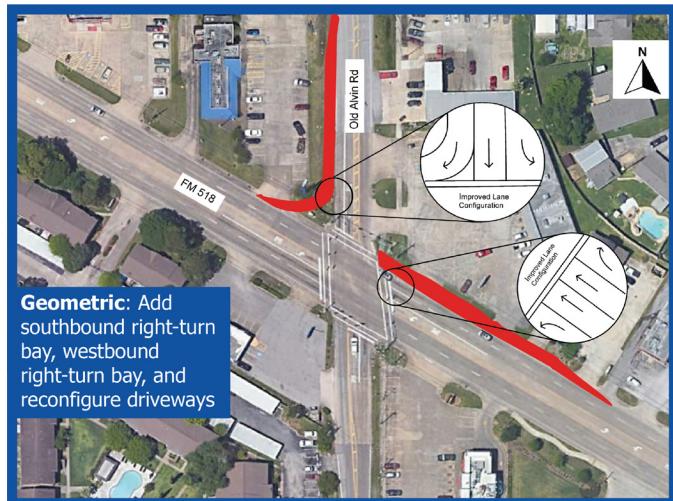
FM 518 (Broadway St) at Old Alvin Rd

This intersection is a signalized four-legged intersection. The eastbound and westbound approaches (FM 518) have one shared through-right lane, one through lane, and one TWLTL. The northbound and southbound approaches (Old Alvin Road) have one shared through-right lane and one left-turn bay.

Recommendation: Add southbound right-turn bay, westbound right-turn bay, and reconfigure driveways. ROW is needed to make this improvement, as shown in red below.

Results: This improvement is anticipated to result in moderate (34%) improvement in delay in the AM and a mild (8%) improvement in delay in the PM.

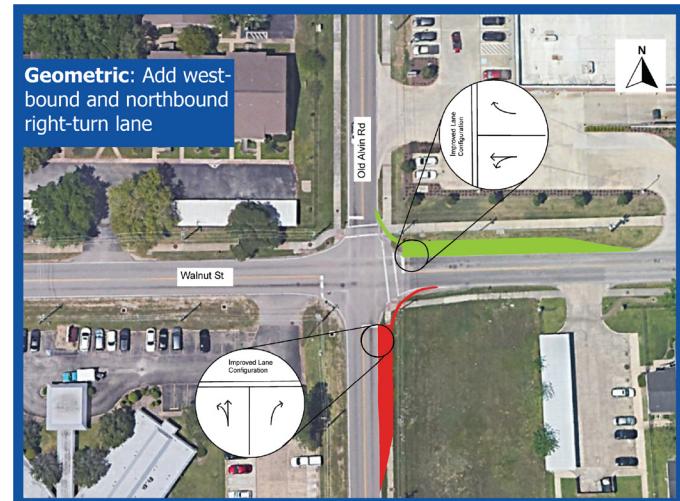
Walnut St at Old Alvin Rd

This intersection is an unsignalized all-way stop-controlled four-legged intersection. All four approaches have one shared lane for all turning movements.

Recommendation: Add westbound and northbound right-turn lane. No additional ROW is needed for northbound turn lane (shown in green below); additional ROW is needed for westbound turn lane (shown in red below).

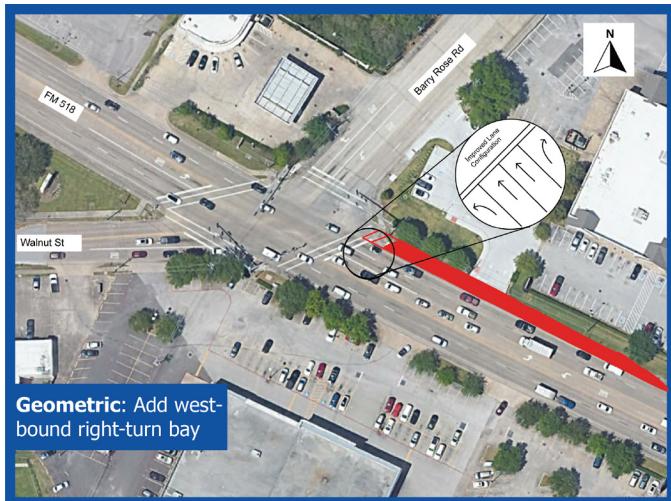
FM 518 (Broadway St) at Walnut St/Barry Rose Rd

This intersection is a signalized four-legged intersection. The approaches on FM 518 both have one shared through-right lane, one through lane, and one TWLTL. The approach on Walnut Street has one right-turn bay and one shared left-through lane. The approach on Barry Rose Road has one right-turn lane, one through lane, and one TWLTL.

Recommendation: Add westbound right-turn bay. ROW is needed to make this improvement, as shown in red below.

Results: No Improvement in delay at this specific location, however the lack of improvement in the PM peak hour can be attributed to the improvement seen at the intersections of Walnut Street at Old Alvin Road and FM 518 at Old Alvin Road. Some safety benefits may occur because of the improvement.

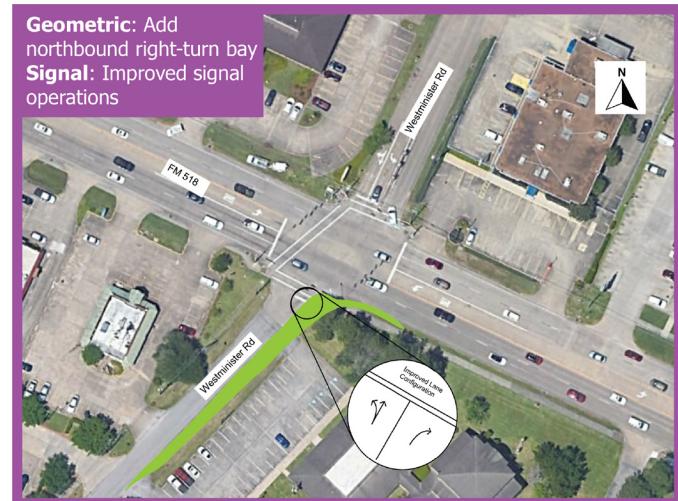
FM 518 (Broadway St) at Westminster Rd

This intersection is a signalized four-legged intersection. The eastbound and westbound approaches (FM 518) have one shared through-right lane, one through lane, and one TWLTL. The northbound approach (Westminster Road) has one shared lane for all turning movements. The southbound approach (Westminster Road) has one shared through-right lane and one left-turn lane.

Recommendation: Add northbound right-turn bay; Allow both approaches on Westminster Road to run simultaneously. No ROW is needed to make this improvement, as shown in green below.

Results: This improvement is anticipated to result in a mild (22%) decrease in delay in the AM and a mild (7%) decrease in delay during the PM period for 2029 when compared to the no build scenario.

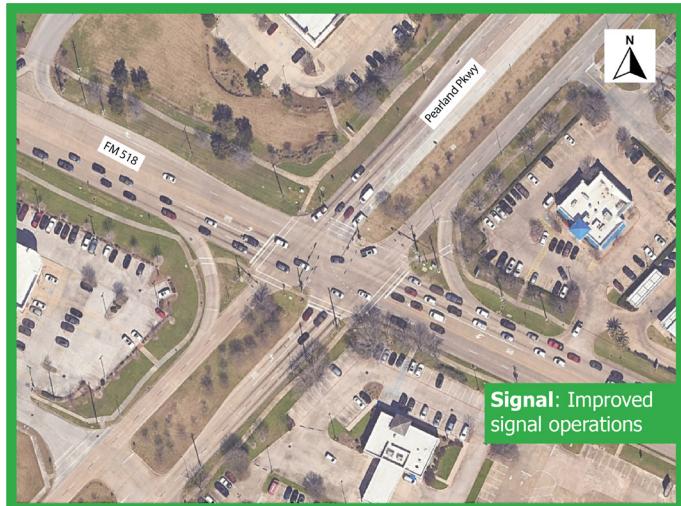
FM 518 (Broadway St) at Pearland Pkwy

This intersection is a signalized four-legged intersection. The eastbound and westbound approaches (FM 518) have one channelized right-turn bay, two through lanes, and one TWLTL. The northbound approach (Pearland Parkway) has one shared through-right lane, one through lane, and one left-turn bay. The southbound approach (Pearland Parkway) has one shared through-right lane, one through lane, and two left-turn bays. The City of Pearland currently has plans to upgrade the signal and construct dual left turns on the northbound approach, along with right-turn bays on northbound and southbound approaches.

Recommendation: Traffic signal timing optimization.

Specific counter measures identified to address the high frequency of crashes include installing raised medians and conducting an Intersection Control Evaluation (ICE) to consider intersection configuration with reduced conflict points.

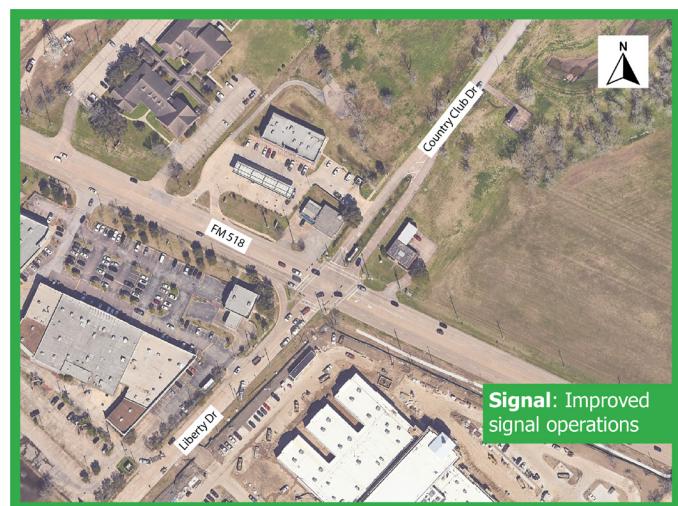
FM 518 (Broadway St) at Country Club Dr/Liberty Dr

This intersection is a signalized four-legged intersection. The eastbound and westbound approaches (FM 518) have one shared through-right lane, one through lane, and one TWLTL. When data was collected in April 2024, the northbound approach (Liberty Drive) had one shared through-right lane and one left-turn lane. The southbound approach (Country Club Drive) has one shared through-right lane and one left-turn lane. As of January 2025, the northbound approach has one right-turn bay, one shared left-through lane, and one left-turn lane.

Recommendation: Traffic signal timing optimization

- Install raised median
- Operate protected only phasing for east bound and west bound left

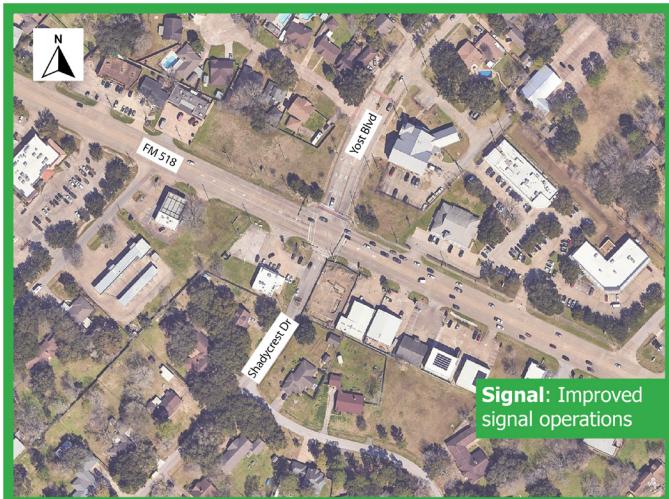
FM 518 (Broadway St) at Yost Blvd/Shadycrest Dr

This intersection is a signalized four-legged intersection. The eastbound and westbound approaches (FM 518) have one shared through-right lane, one through lane, and one TWLTL. The northbound approach (Shadycrest Drive) has one shared through-right lane and one left-turn bay. The southbound approach (Yost Boulevard) has one right-turn lane, one through lane, and one left-turn bay.

Recommendation: Traffic signal timing optimization

- Install raised median
- Operate protected only phasing for east bound and west bound left
- Pavement friction management
