FM 518 Corridor Study

Pearland, Texas

July 2025

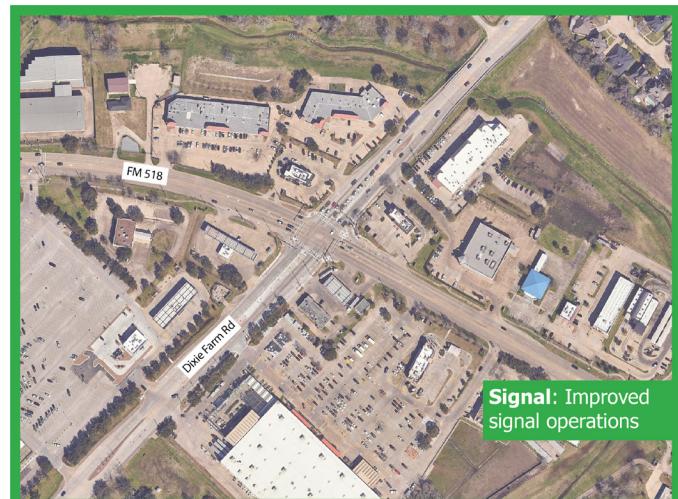
FM 518 (Broadway St) at Dixie Farm Rd

This intersection is a signalized four-legged intersection. The eastbound and westbound approaches (FM 518) have one channelized right-turn bay, two through lanes, and one TWLTL. The northbound and southbound approaches (Dixie Farm Road) have one right-turn bay, two through lanes, and two left-turn bays.

Recommendation: Traffic signal timing optimization

- Install raised median
- Bicycle green markings

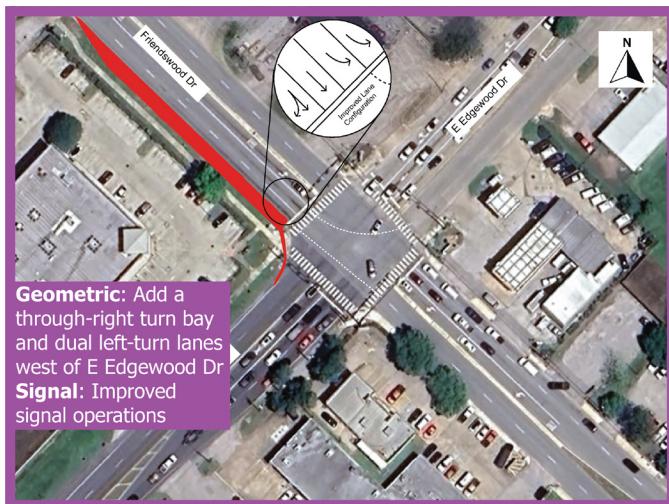
FM 518 (Friendswood Dr) at E. Edgewood Dr

This intersection is a signalized four-legged intersection. The approaches on Friendswood Drive have one shared through-right lane, one through lane, and one TWLTL. The approaches on E. Edgewood Drive have one shared through-right lane, one through lane, and one left-turn bay.

Recommendation: Add a through-right turn bay and dual left-turn lanes west of E. Edgewood Drive; Optimize signal timings. ROW is needed to make this improvement, as shown in red below.

Results: This is anticipated to have a significant improvement to delay during the AM period (64%) and a moderate improvement to delay (25%) during the PM period.

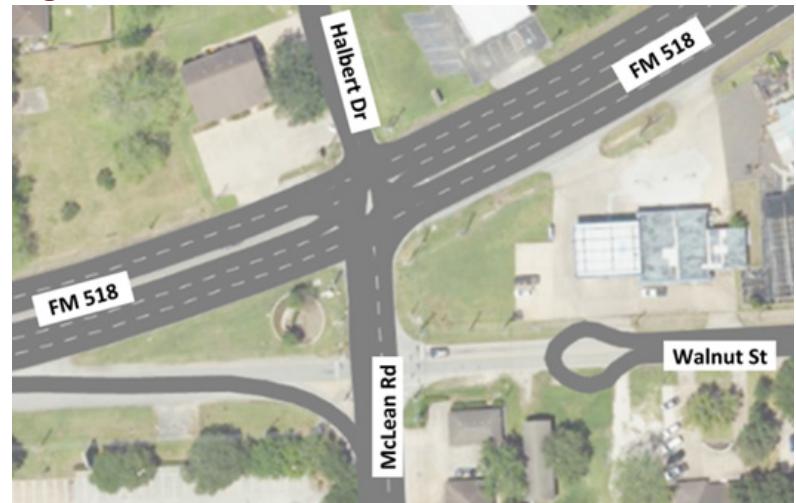
Figure 20:Walnut Closure Alternative

The Walnut Street Closure alternative includes the removal of the signal at Walnut Street and the removal of the connection of Walnut Street to McLean Road on the east side of McLean Road. The western terminus of Walnut Street (east of McLean Road) becomes a cul-de-sac. Traffic headed eastbound on FM 518 must either continue on FM 518 or is diverted to travel southbound on McLean Road. Traffic headed westbound on Walnut Street to proceed west on FM 518 must turn into Veterans Drive, turn right on Fite Road, then turn right on McLean Road. From McLean Road, traffic would turn left to proceed on FM 518 west. This alternative could be implemented relatively quickly, but may require some ROW acquisition.

The Walnut Street Closure alternative was not pursued further due to concerns about access for emergency services, as identified by the Steering Committee. Although this alternative could have positive impacts on certain goals, the restriction of emergency services precludes it from further consideration.

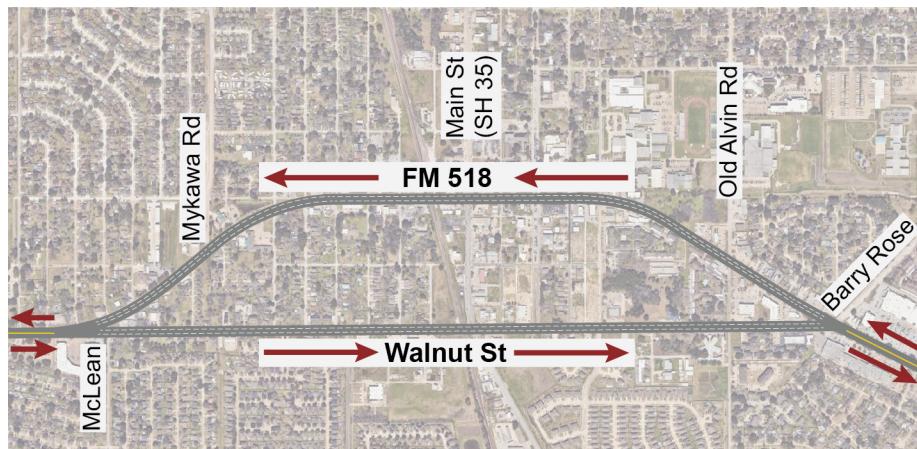
Figure 21: Alternative 1 - One Way Pair Traffic Direction

The One-Way Pair Alternative would convert FM 518 to one-way west bound and Walnut Street to one-way east bound from McLean Road to Barry Rose Road (Figure 21). It includes three travel lanes in each direction on each of the aforementioned roadways. See Figure 22 for One-Way Pair location.

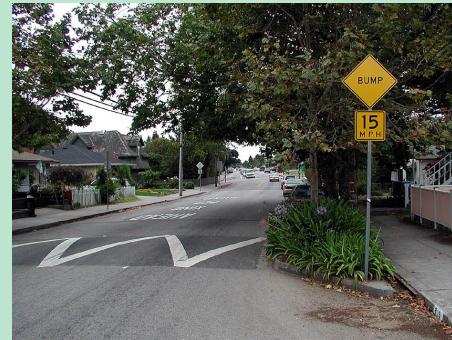
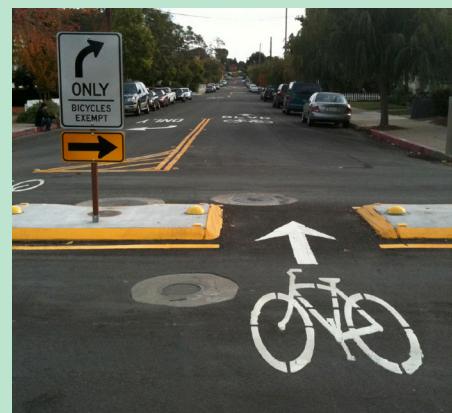
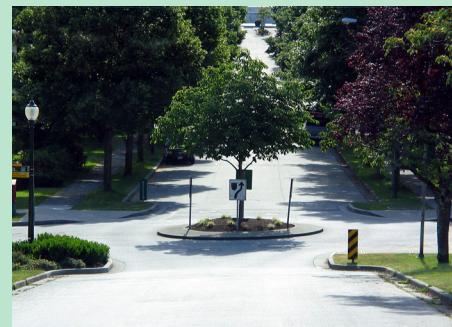
One-Way Pair Conversion Strategies to Reduce Cut Through Traffic

The One-Way Pair Alternative redirects the flow of traffic on FM 518 (Broadway Street) and Walnut Street, primarily using the existing roadway cross sections. With the change in east and west movement, there is a concern that vehicles will use local neighborhood streets to facilitate north and south movement across the pair of one way streets.

Middle: Diverted street, Credit PBIC-Adam Fukushima

Bottom: Neighborhood traffic circle, Credit PBIC-Dan Burden

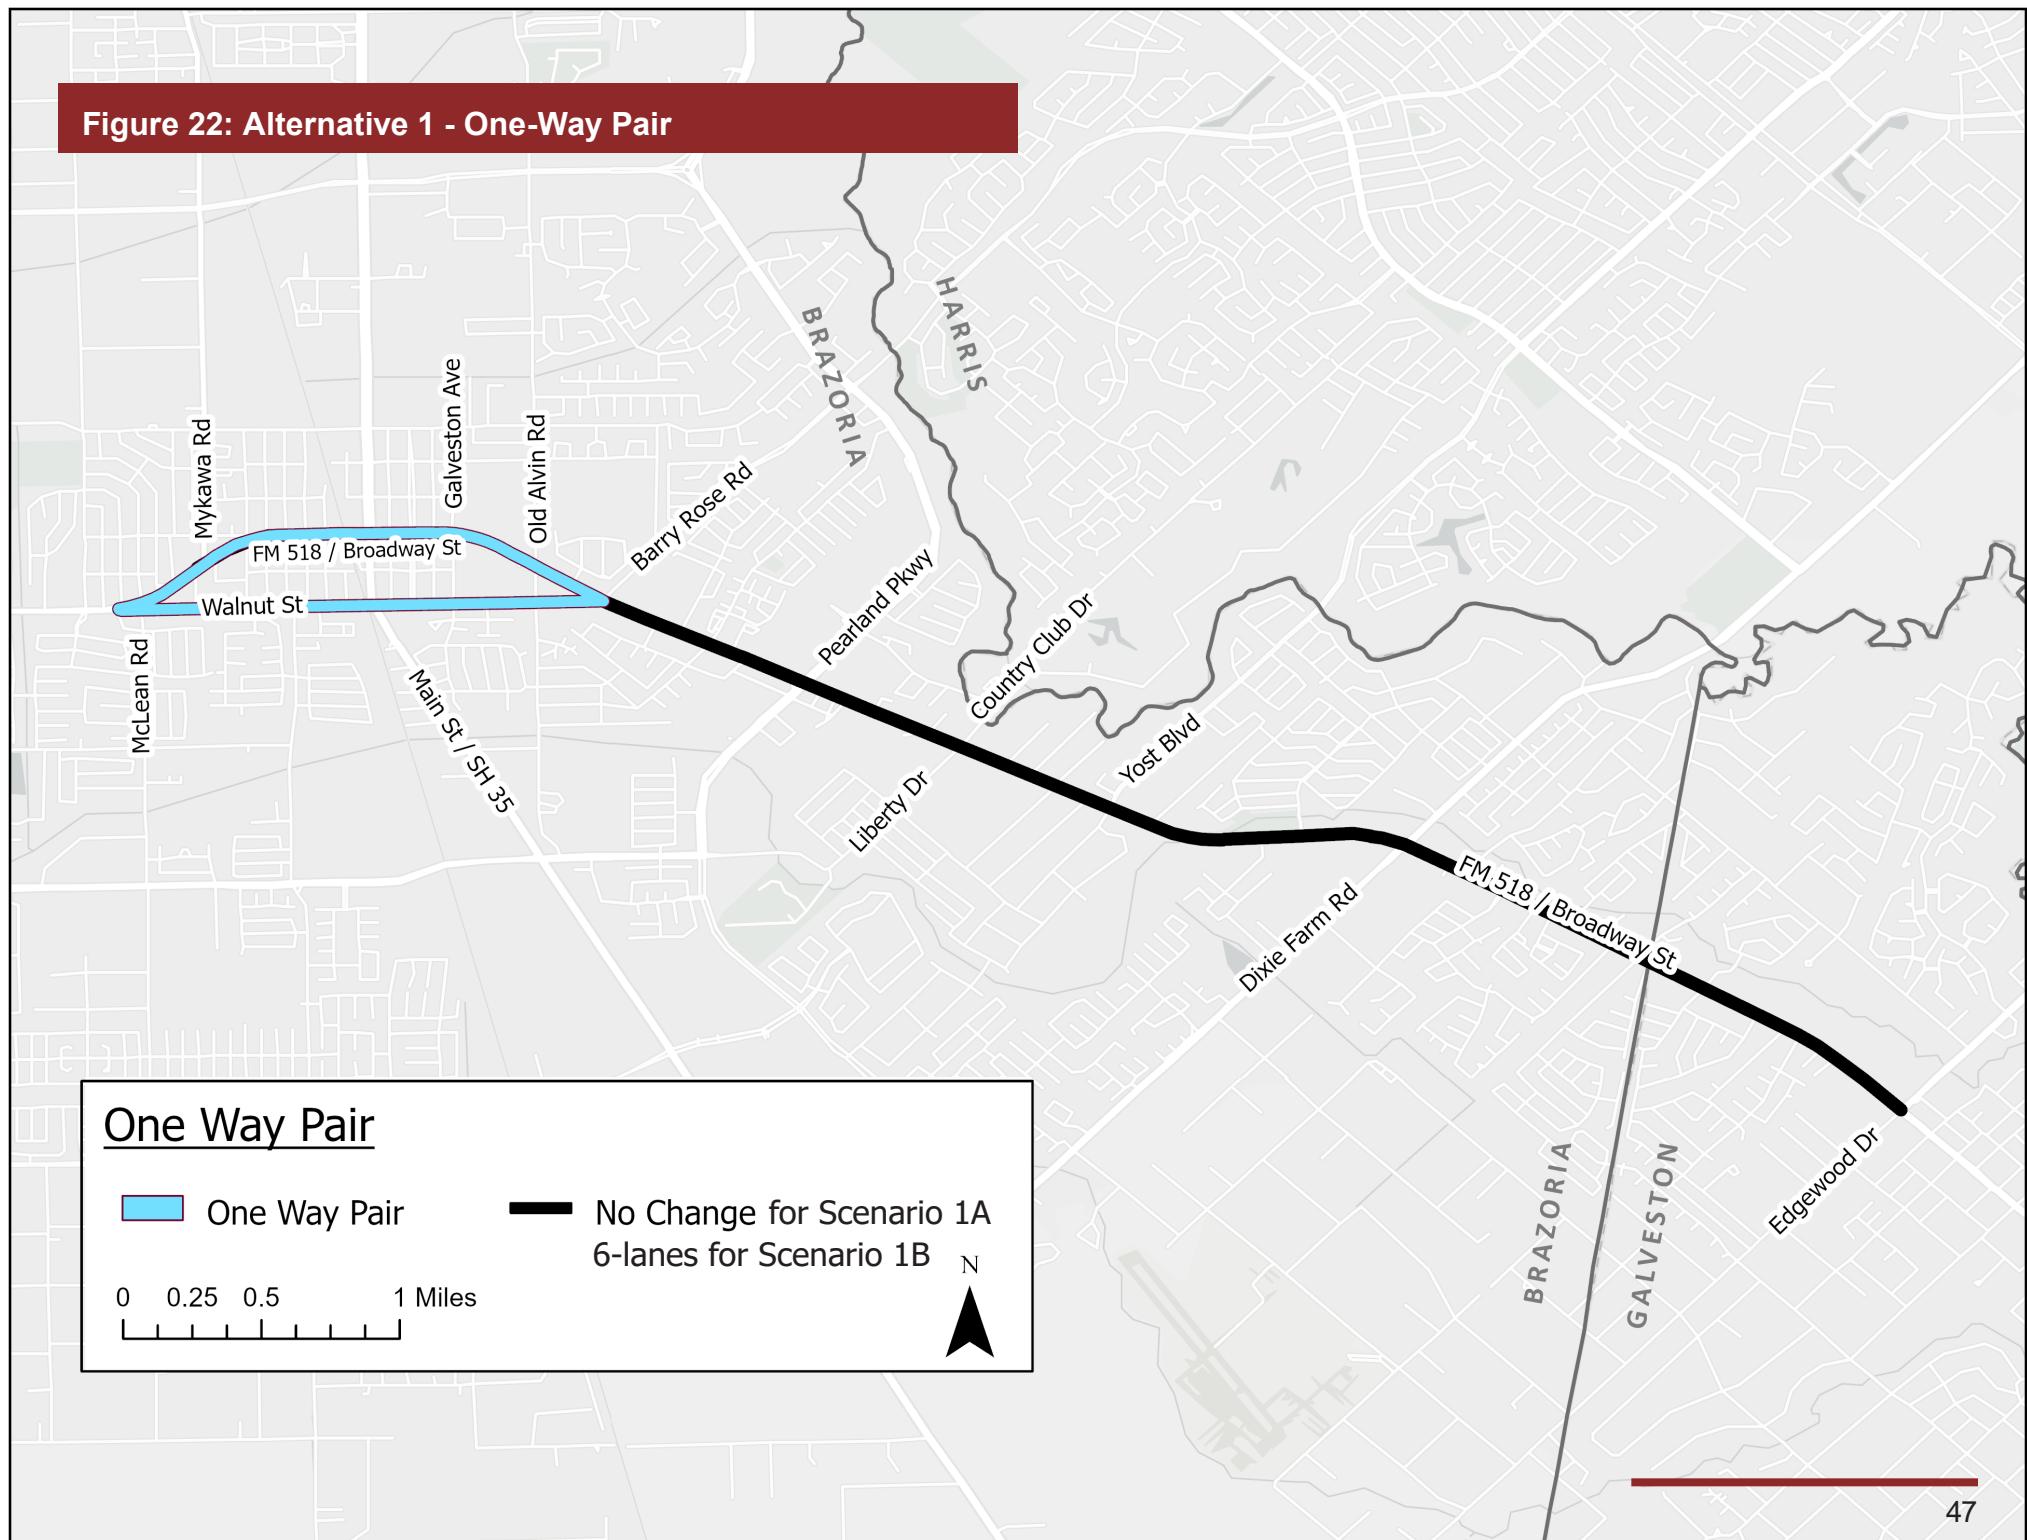
Figure 22: Alternative 1 - One-Way Pair

- **Scenario A** with FM 518/Walnut Street one-way pair from McLean Road to Barry Rose Road, and 4-lane with a two-way left-turn lane from Barry Rose Road to E. Edgewood Drive.
- **Scenario B** with FM 518/Walnut Street one-way pair from McLean Road to Barry Rose Road, and 6-lane from Barry Rose Road to E. Edgewood Drive with a raised median.

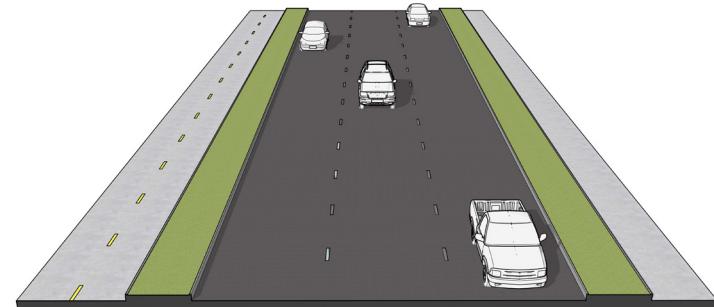
FM 518 (Broadway Street) from McLean Road to Barry Rose Road with three lanes in one direction, sidewalk, and side path

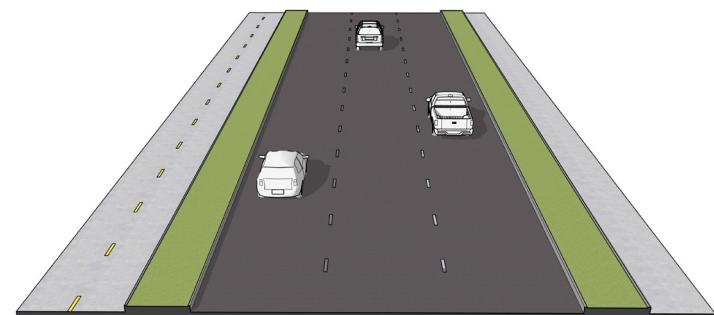
Walnut Street from McLean Road to Barry Rose Road with three lanes in one direction, sidewalk, and side path

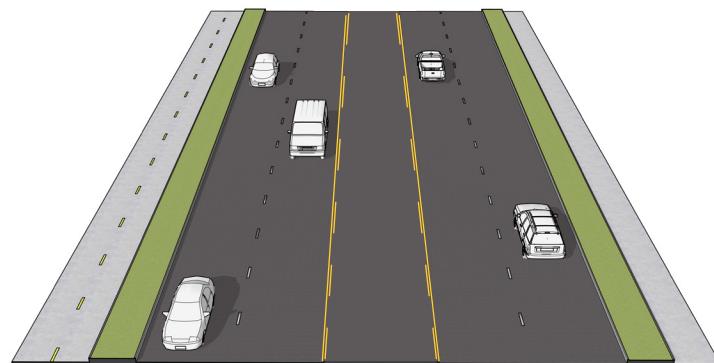
FM 518 (Broadway Street) From Barry Rose Road to E. Edgewood Drive with four lanes and a TWLTL

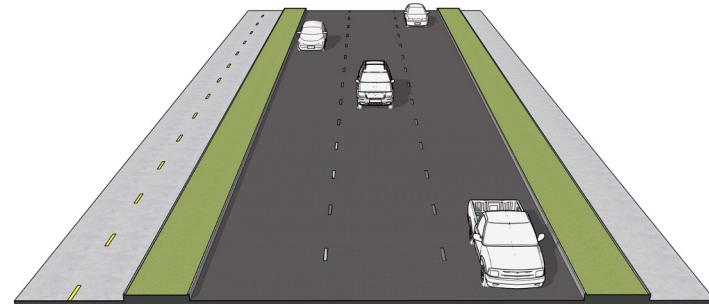
FM 518 (Broadway Street) from McLean Road to Barry Rose Road with three lanes in one direction, sidewalk, and side path

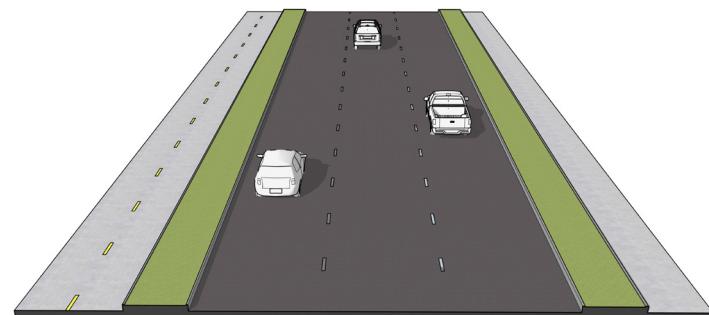
Walnut Street from McLean Road to Barry Rose Road with three lanes in one direction, sidewalk, and side path

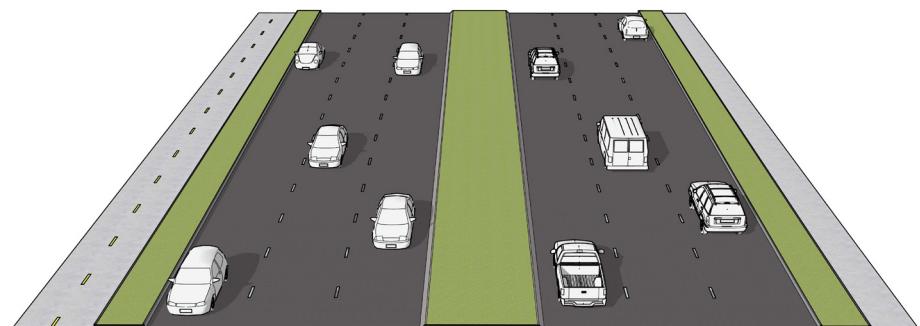
FM 518 (Broadway Street) From Barry Rose Road to E. Edgewood Drive with six lanes and a raised median

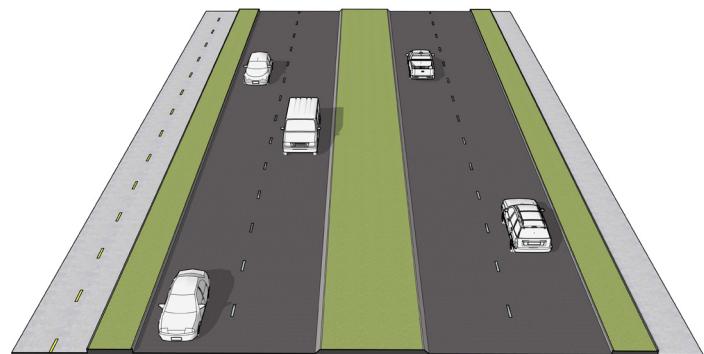
FM 518 (Broadway Street) From McLean Road to Friendswood City Limits with four lanes and a raised median

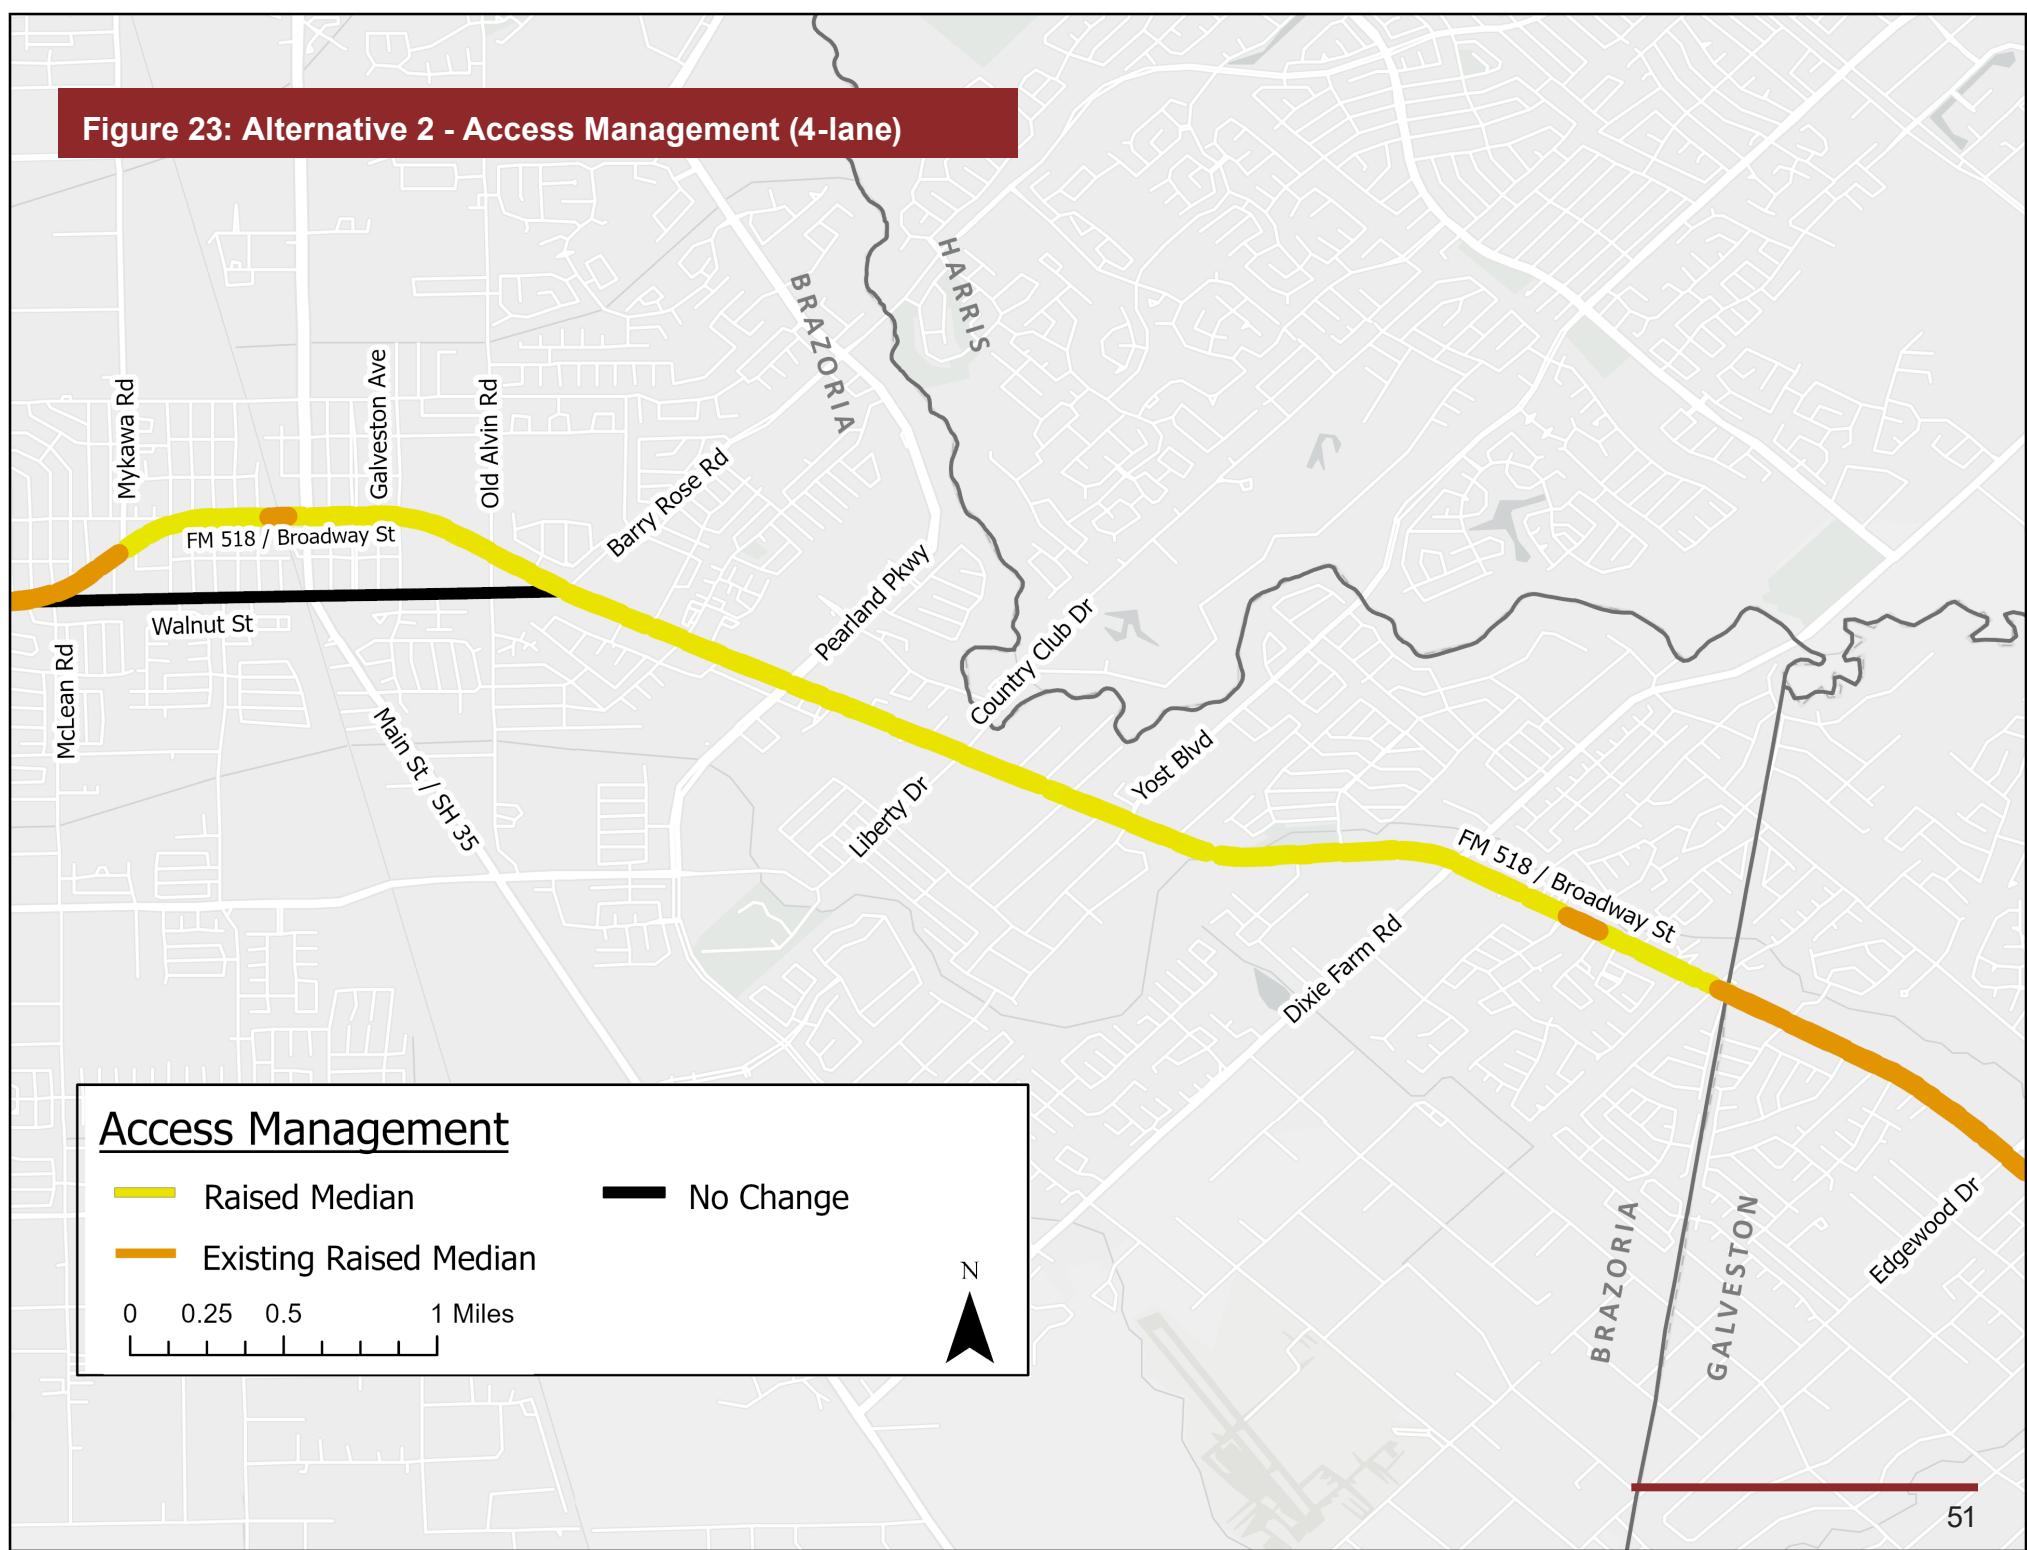
Figure 23: Alternative 2 - Access Management (4-lane)

The Access Management Alternative includes the addition of raised medians from McLean Road to the Friendswood City Limits, where raised medians currently exist (see Figure 23). Walnut Street would remain a 2-lane facility.

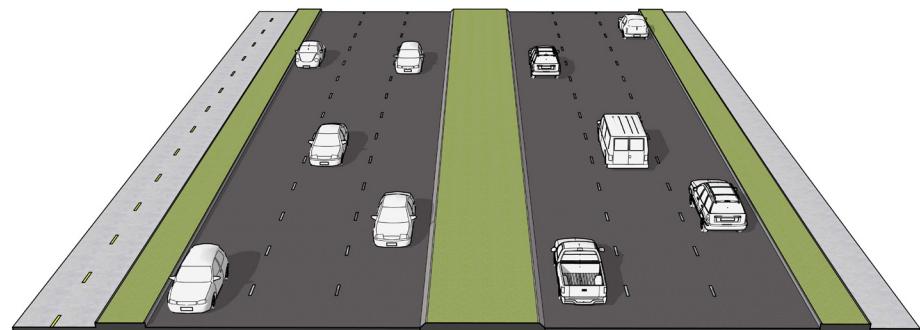
FM 518 (Broadway Street) From Barry Rose Road to E. Edgewood Drive with six lanes and a raised median

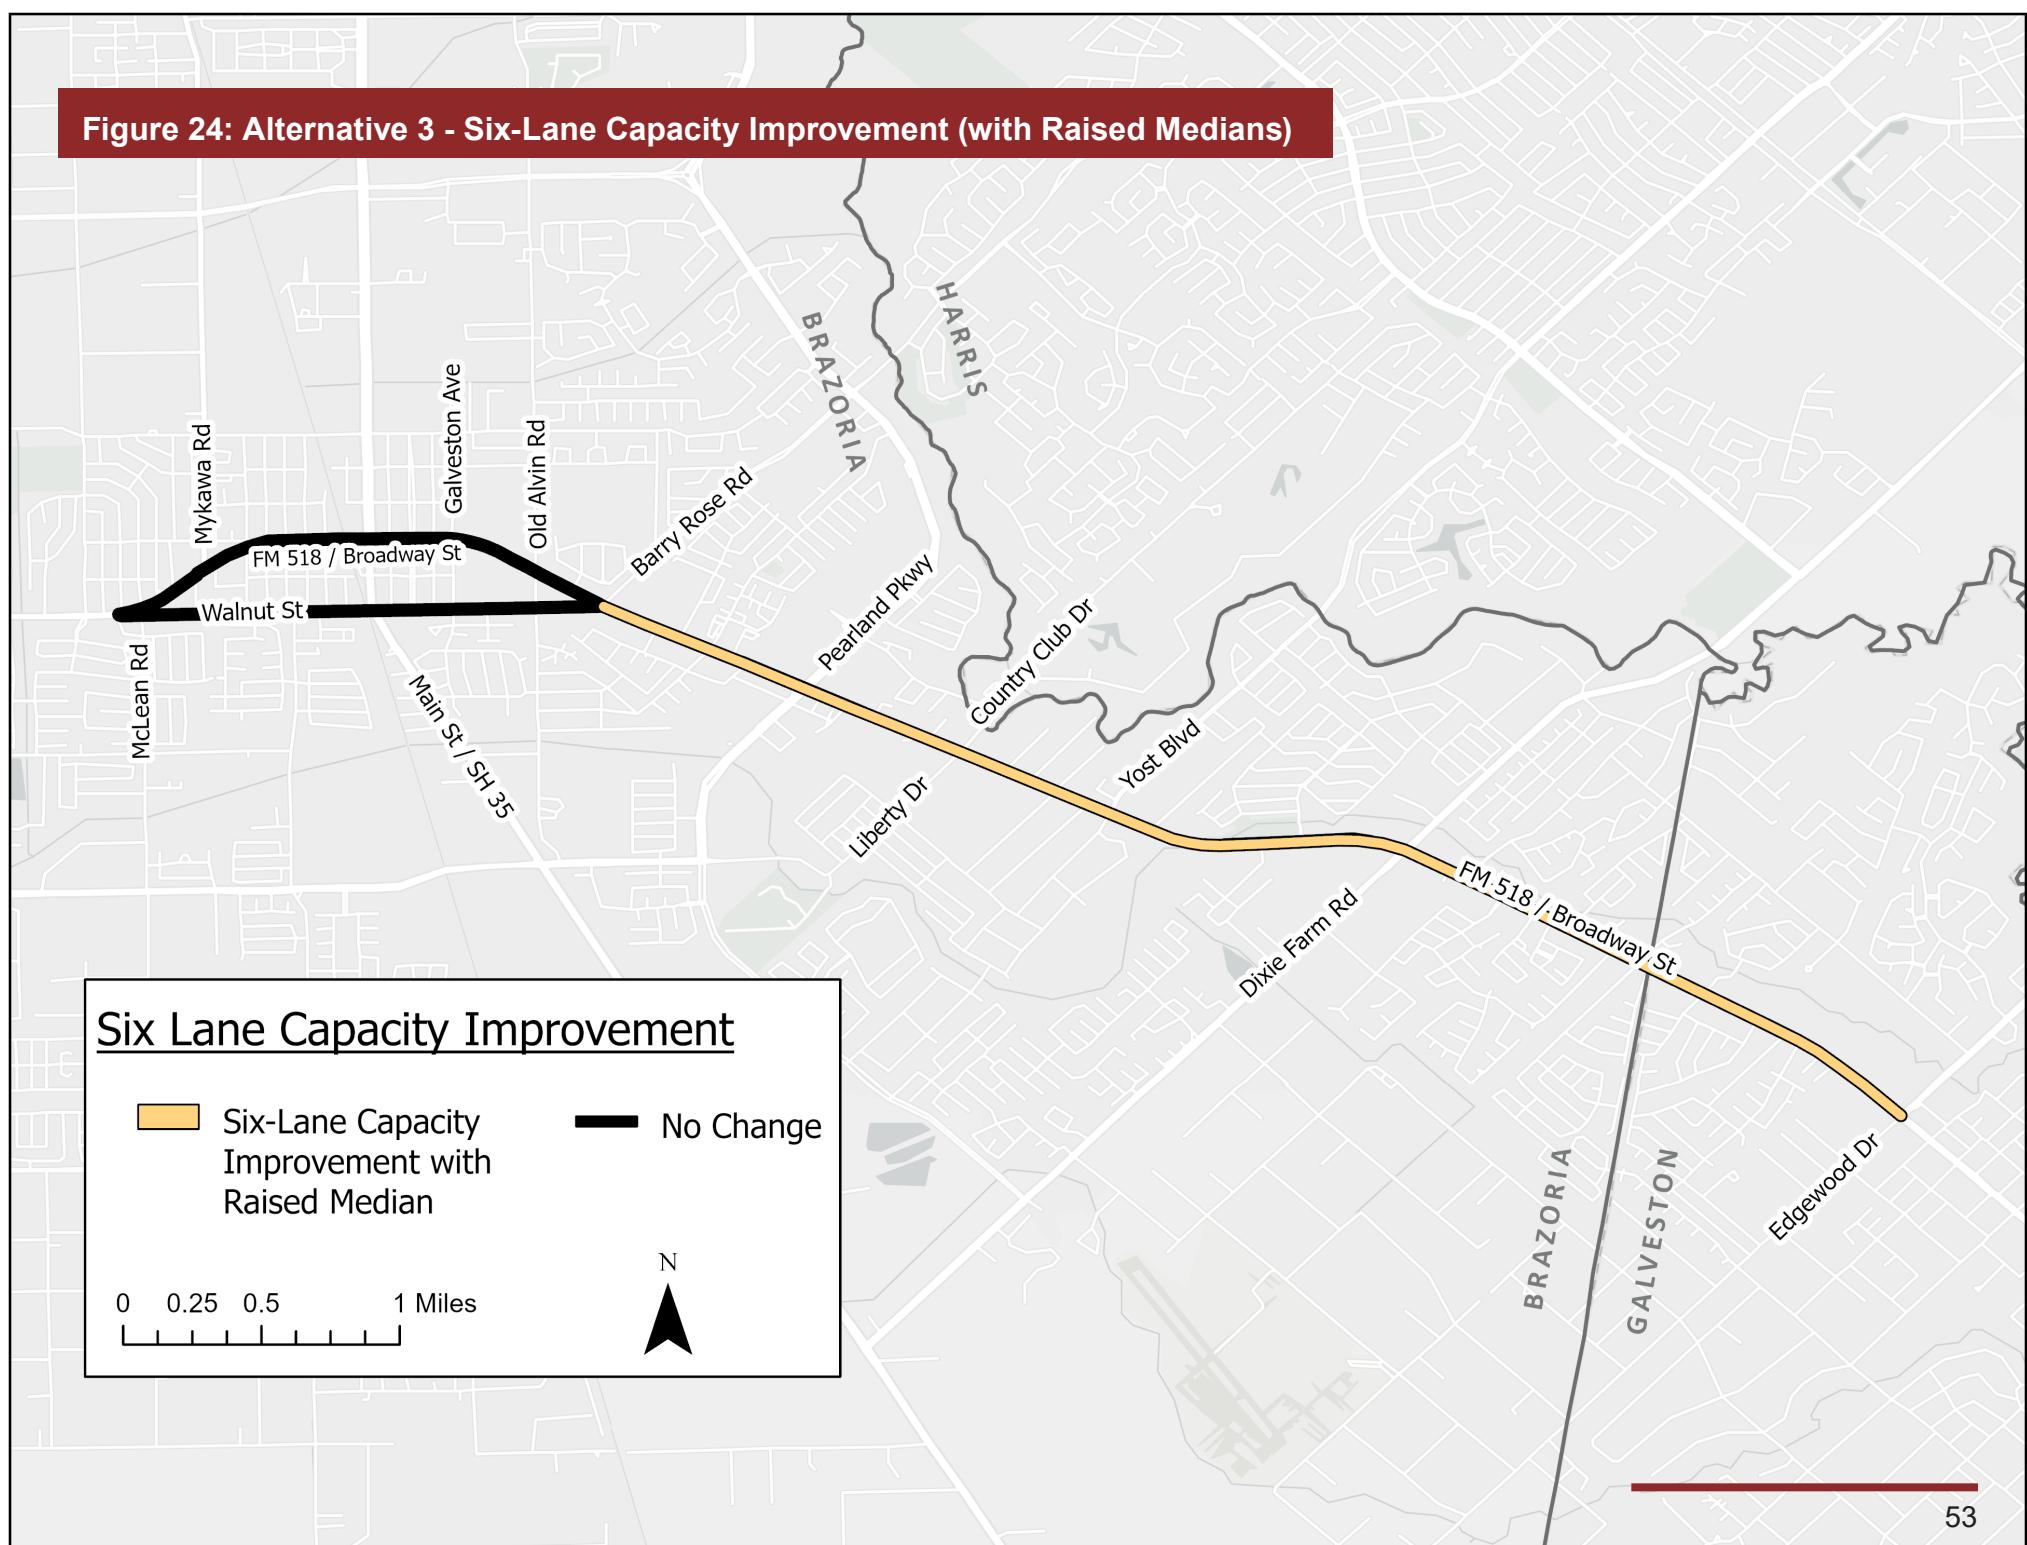
Figure 24: Alternative 3 - Six-Lane Capacity Improvement (with Raised Medians)

The six-lane capacity improvement includes adding an additional lane in each direction and installing a raised median from Barry Rose Road to E. Edgewood Drive. Walnut Street would remain a 2-lane facility, as it is today. According to TxDOT, adding a lane to FM 518 (Broadway Street) in each direction from McLean Road to Barry Rose Road would not be feasible due to the presence of historical properties.

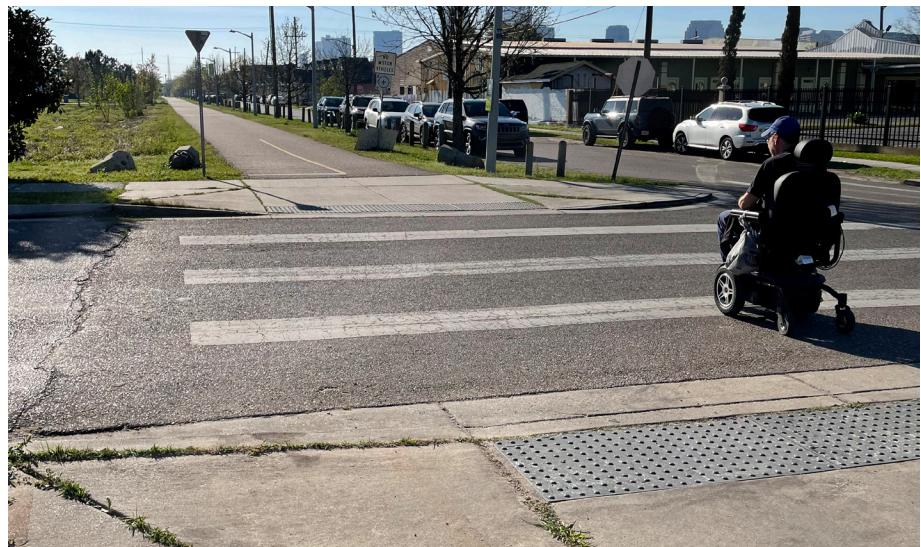
- Sidewalks: Six-foot in width, with a six-foot buffer, on the south side of the roadway.
- Side paths: Ten-foot in width, six-foot buffer, on the north side of the roadway

Source: ATG|DCCM - Example Sidepath in New Orleans

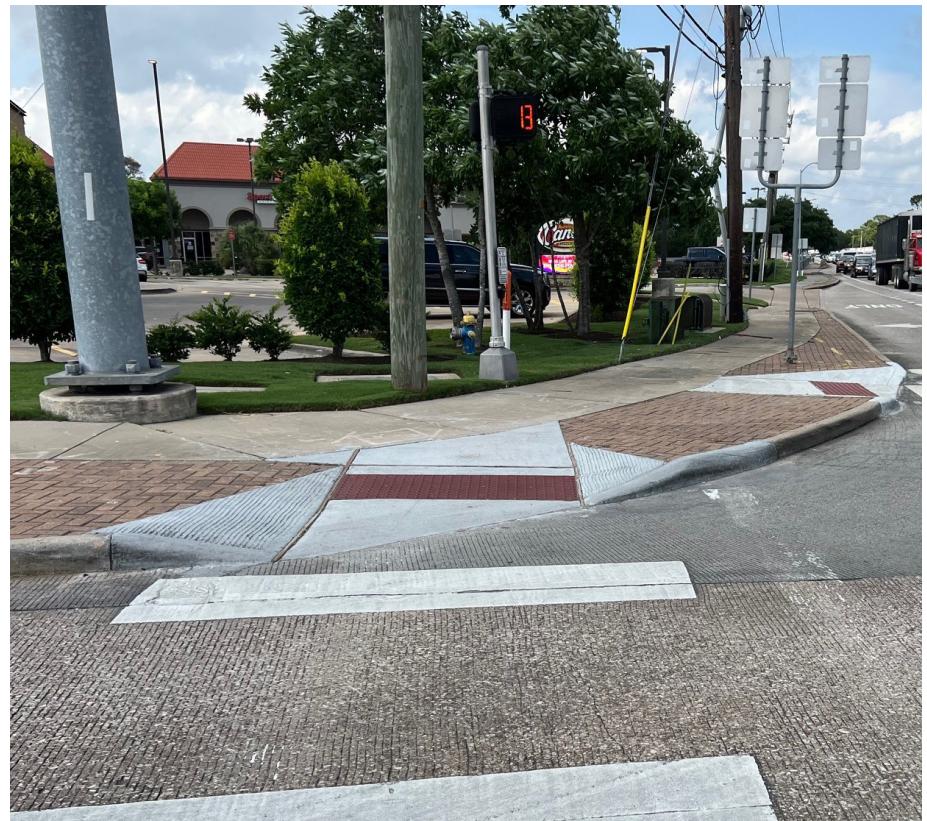
Update for ADA Accessibility: Existing sidewalks and crosswalks should also be updated to ADA standards with curb ramps and other accessibility features so that pedestrian facilities are usable for all.

Sidewalks and ADA features at Dixie Farm Road at FM 518
